Jobsgreen Farm, Oldbury-upon-Severn South Gloucestershire Historic Buildings Investigation and Recording

February 2018

Client: Horizon Nuclear Power

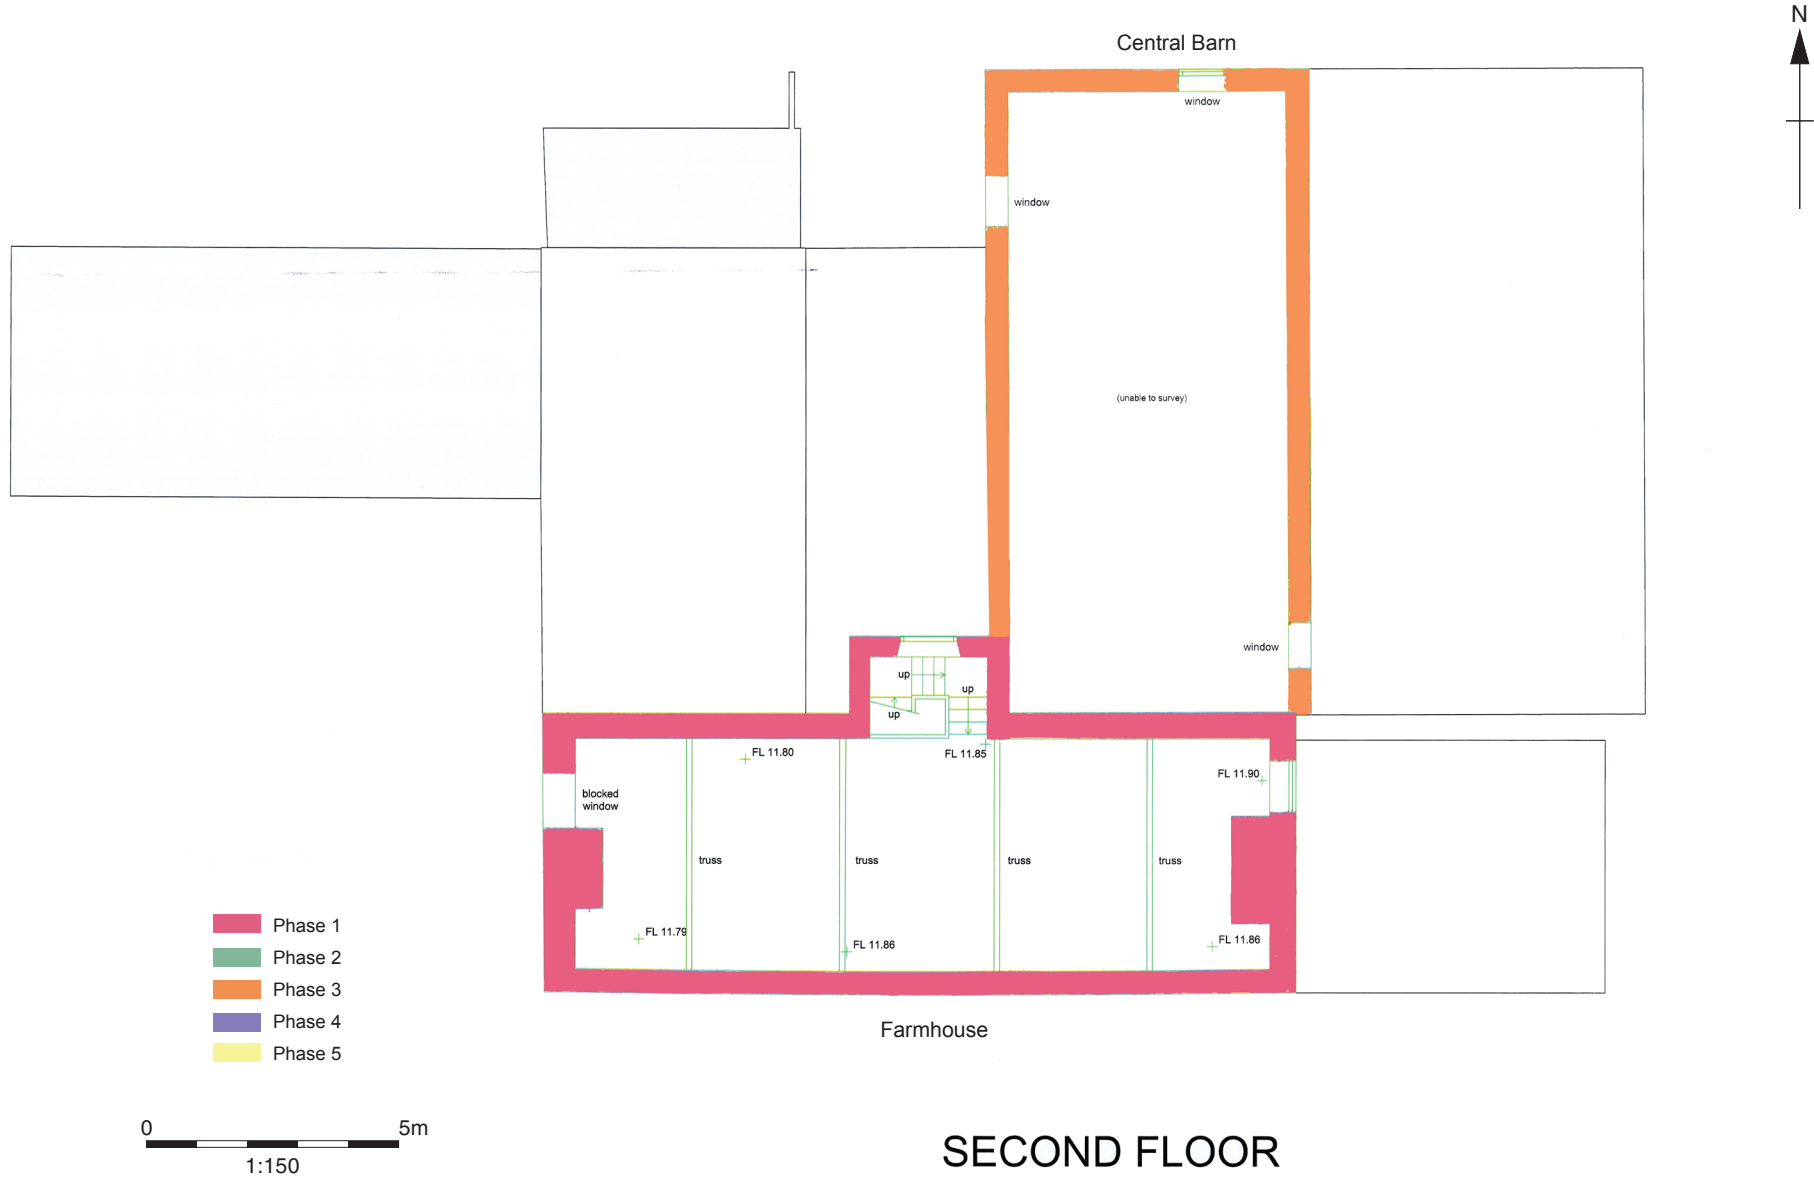
Figure 9: Second floor plan

- 3.2.25 *The Attic Space* The attic comprises three large bays, with two smaller bays at the east and west gable ends, divided by four trusses (Fig. 9). During the previous survey, the whole space was accessible but the two western bays have now been sectioned off as a bat roost, which is inaccessible. It was observed in 2009 that both gables feature a chimney breast and the window to the right of that in the west gable was at the time blocked with breeze blocks. There is a small 4-pane wooden framed window in the left side of the east gable, which has been blocked on the exterior since the previous survey (Plate 22). The windows and the boarded floor are all indicative that this roof space was used as storage or possibly accommodation.

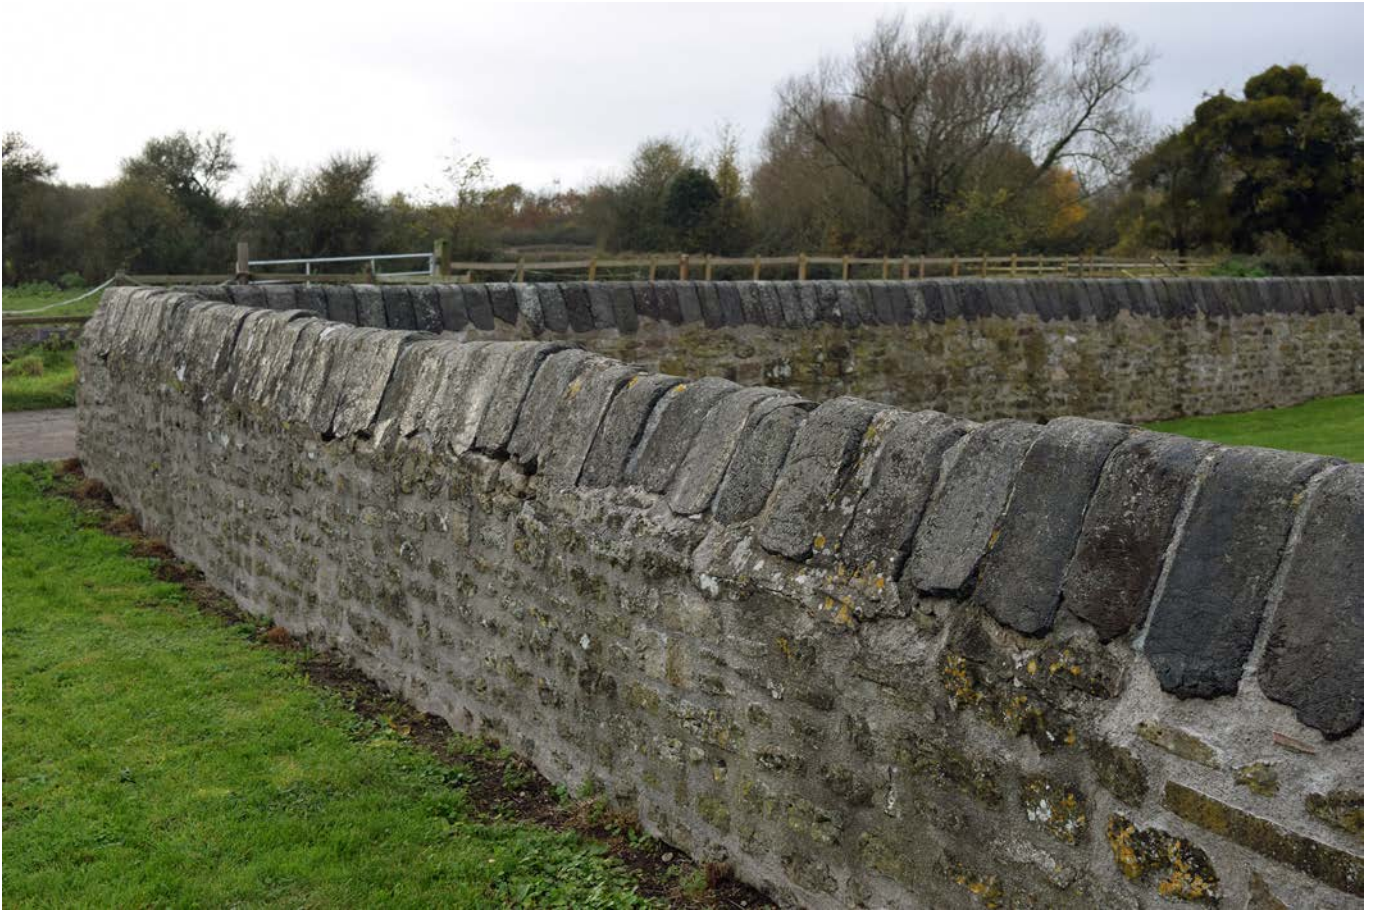
Plate 5: The garden wall of Jobsgreen, looking north-west

- 3.2.6 The garden wall is of interest with coping stones made of triangular blocks of copper slag with rounded angles topping the robust stone-constructed wall (Plate 5). The moulded copper slag blocks are a by-product of the copper industry of the late 18th and 19th centuries and are most likely to have derived from the industry in Bristol given its proximity, although another nearby source is Swansea. The slag was commonly cast into different shapes as building blocks and can be seen in historic buildings in Bristol and Swansea. The run of coping blocks is complete and the loose blocks recorded in 2009 have been reinstated.

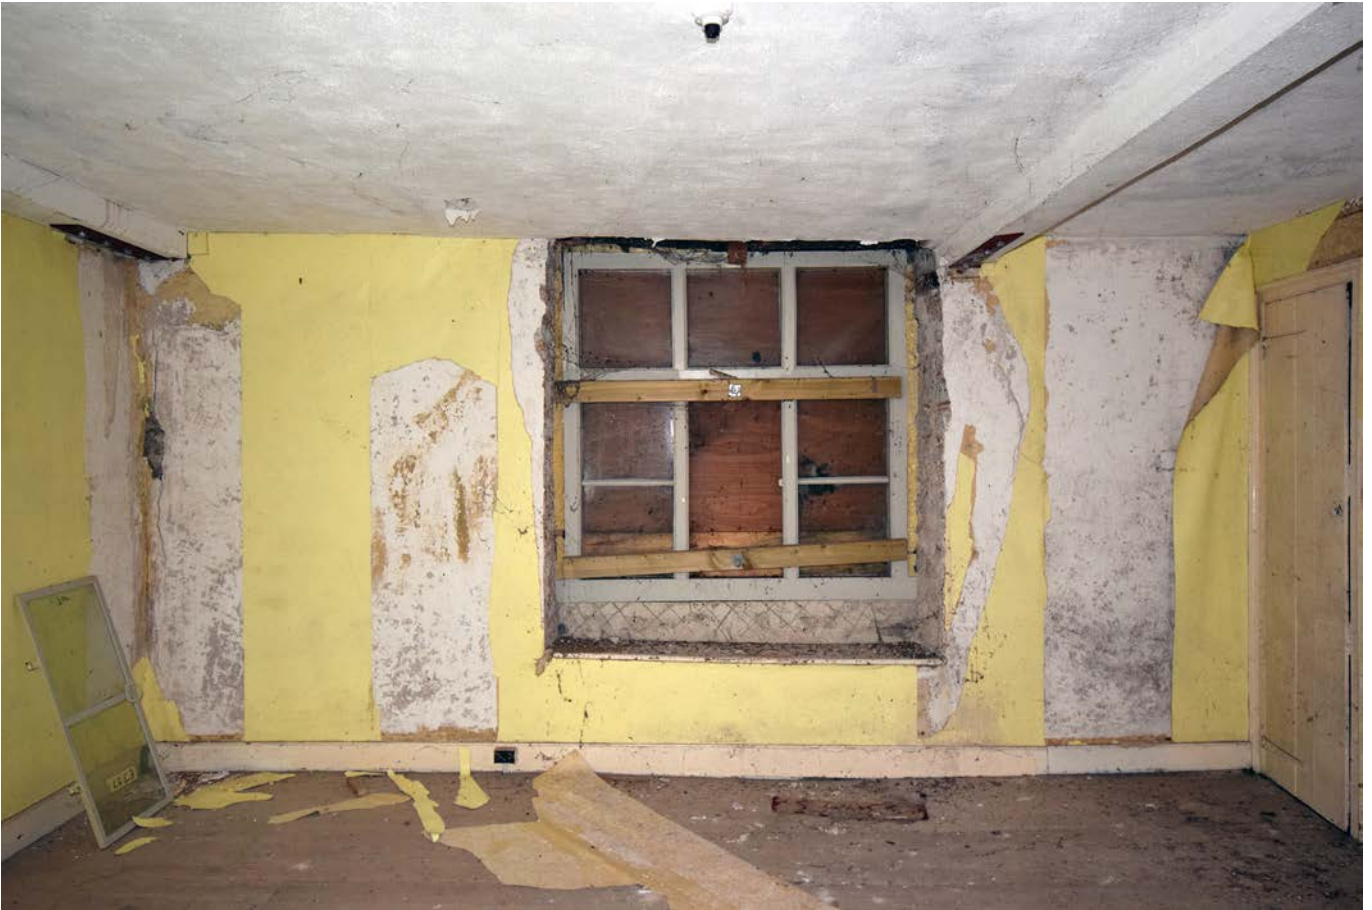
Plate 14: The west bedroom of Jobsgreen farmhouse, looking south

3.2.17 *The West Bedroom* The west bedroom is entered through a doorway in the west wall of the first floor landing. The doorway has a beaded architrave and a simple boarded door hung on strap hinges. There is a large 9-paned window with a moulded wooden frame in the south wall which is a replacement as recorded downstairs. A narrow sill between the frame and back rest of the window seat is now absent, although the

wooden window seat remains (Plate 14). The window reveal area has been stripped of plaster, presumably as part of the window replacement, and expanding foam is visible around the edges of the frame securing this into the wall.

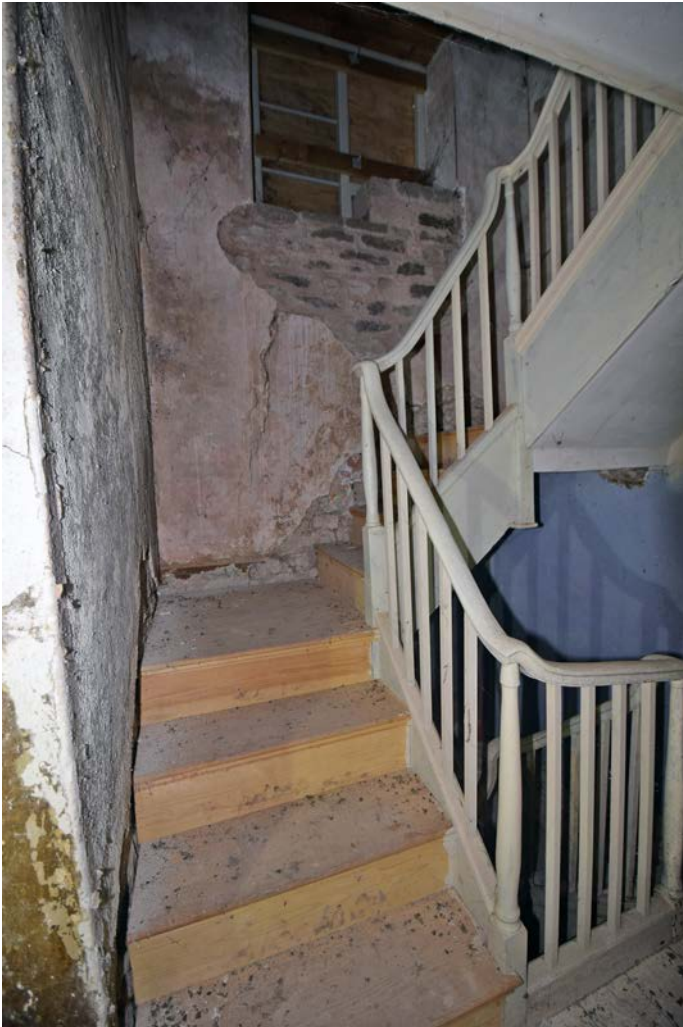
Plate 21: The staircase of the first floor of Jobsgreen farmhouse, looking north-east

- 3.2.24 The Georgian staircase continues from the landing, rising south to north, and then turns to rise north to south to attic level. An 8-paned casement window sheds light on it from the north wall (Plate 21). Since the previous survey in 2009, the masonry below the sill has been subject to repair where dampness had been an issue, and the lower right-hand pane has been built over and blocked.

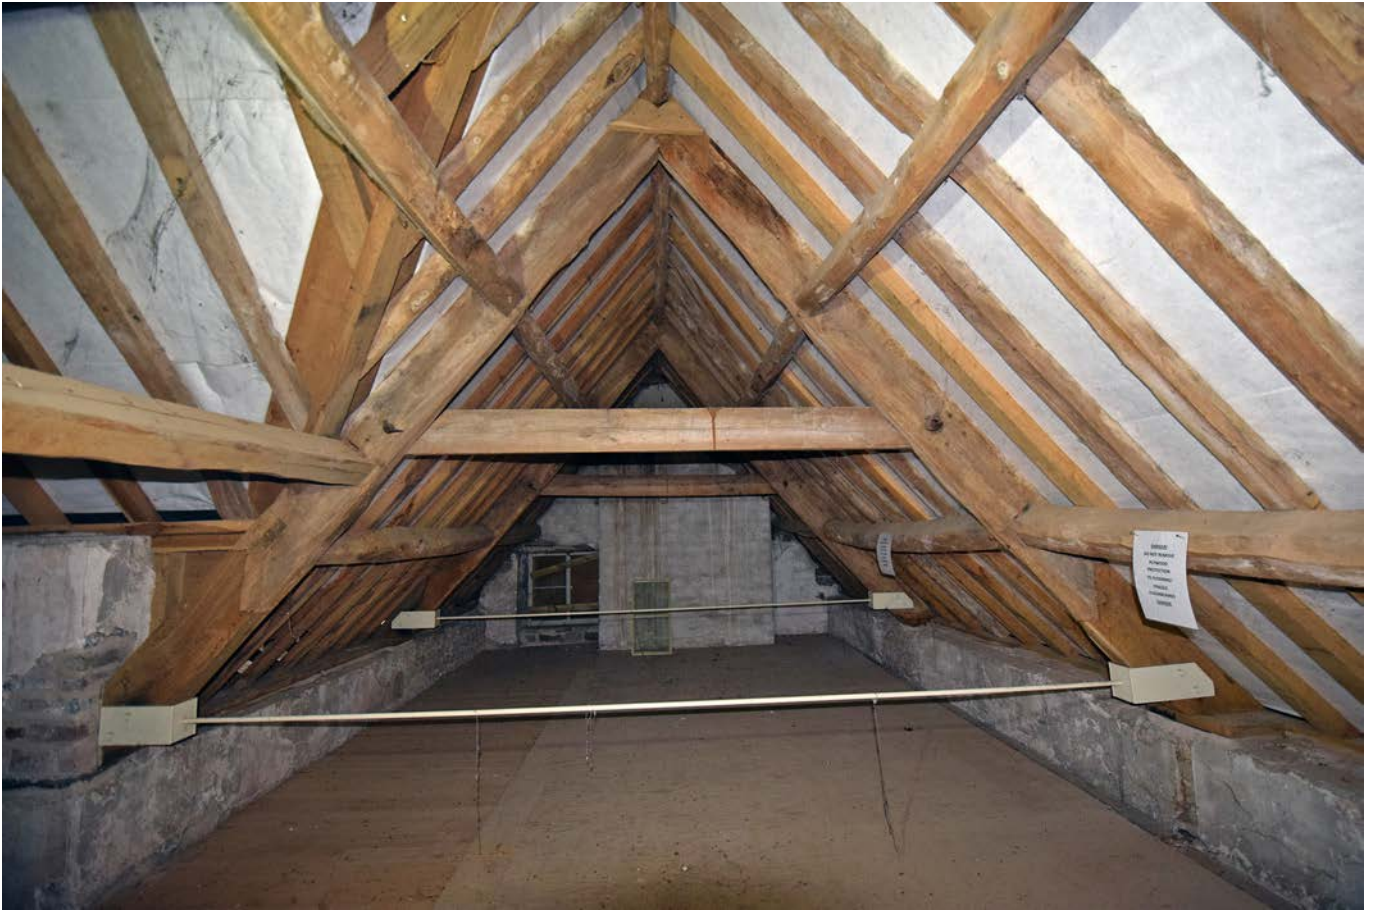
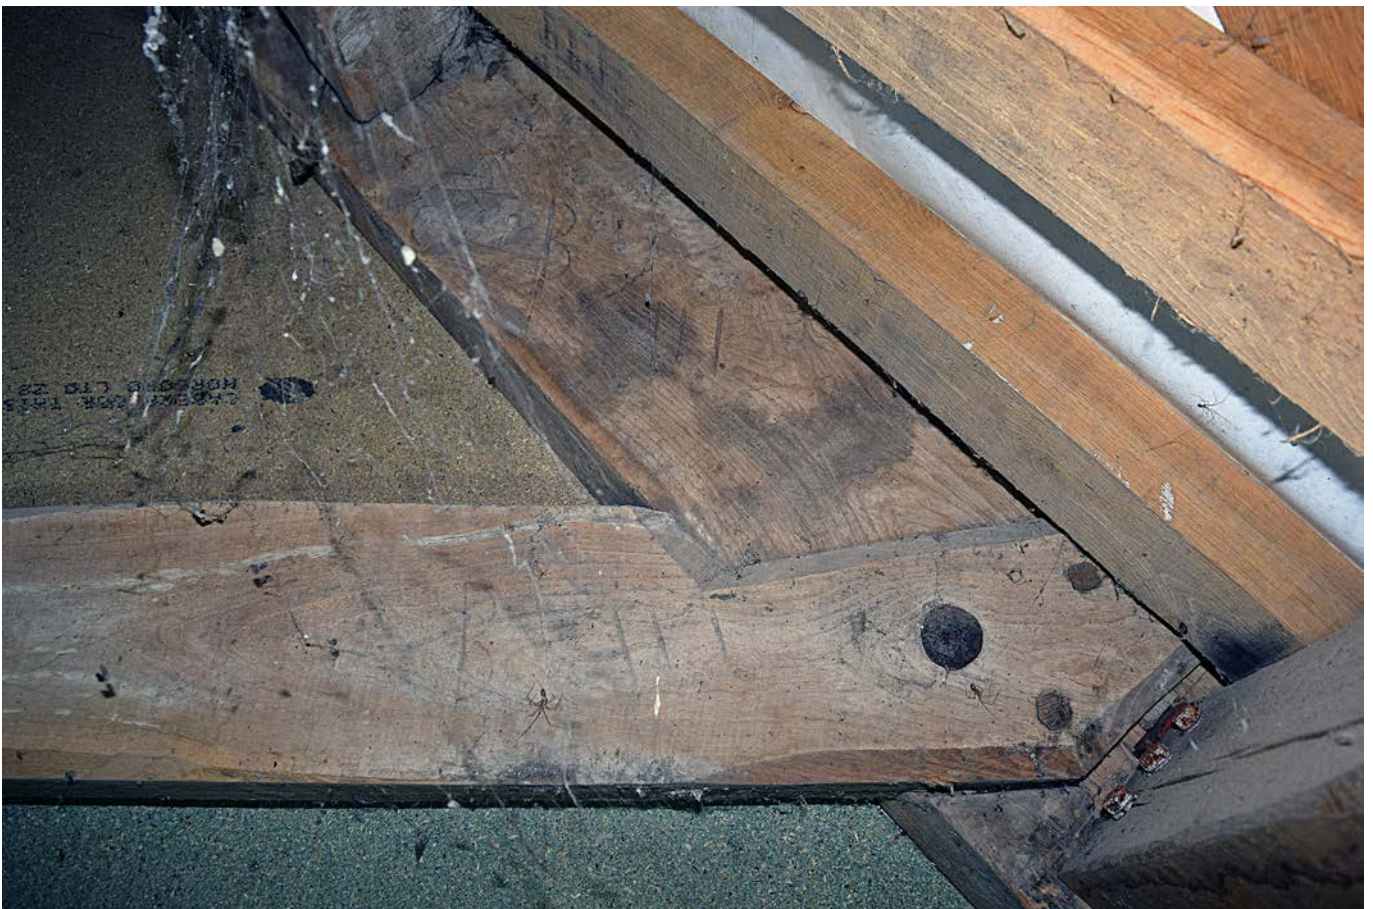
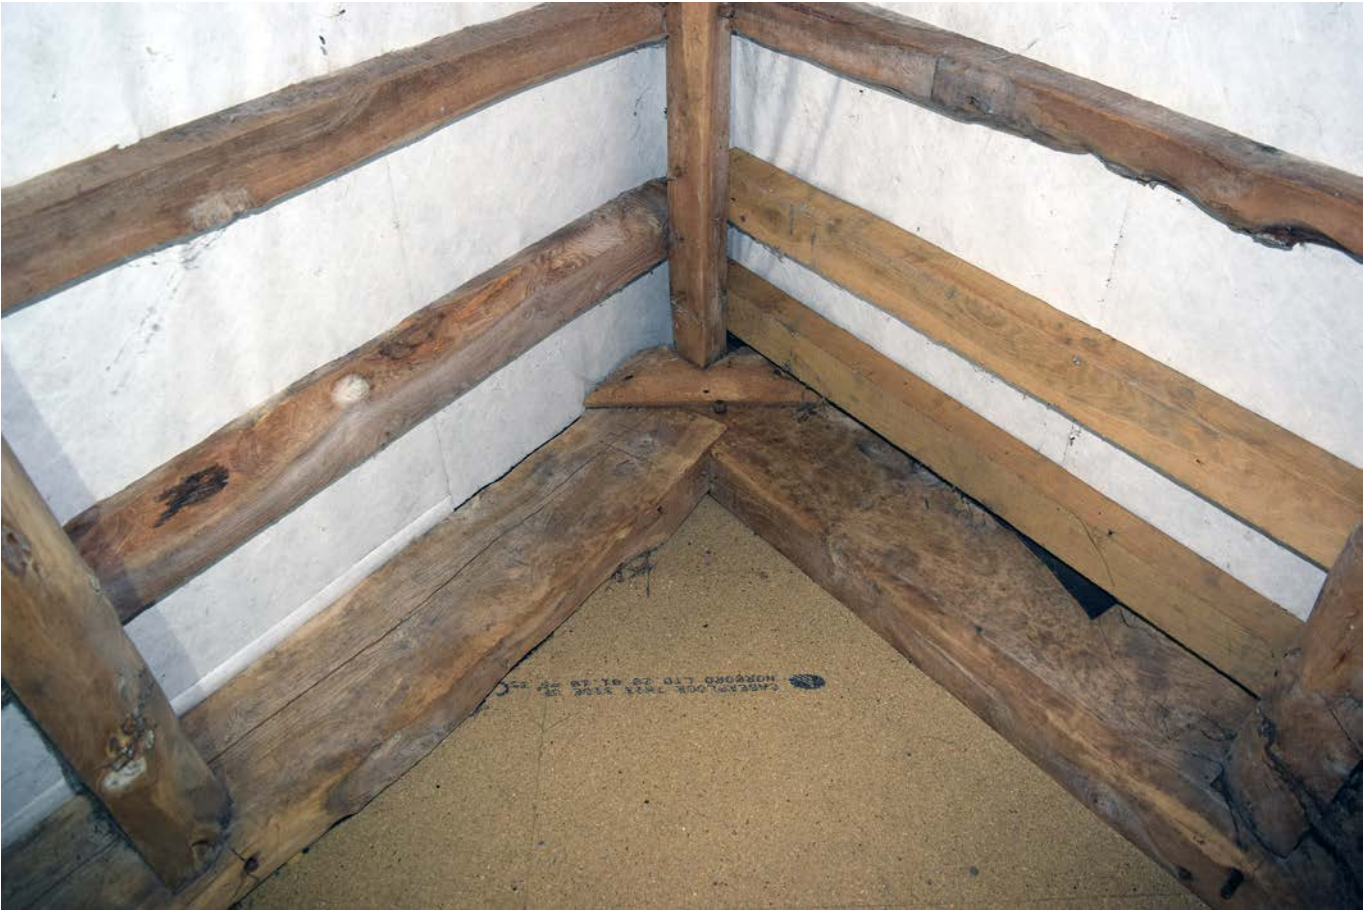
- 3.2.29 Repair work has been carried out to the roof since the previous survey and the foot of the second principal rafter from the east, on the north side (that on the east side of the stair turret), has been replaced with a modern timber, joined with a scarf joint (Plate 27). Large iron straps have also been bolted between matching pairs of principal rafters to prevent lateral spreading of the trusses (Plate 22). Some of the common rafters have also been replaced with new timber (Plates 22, 23 and 26).

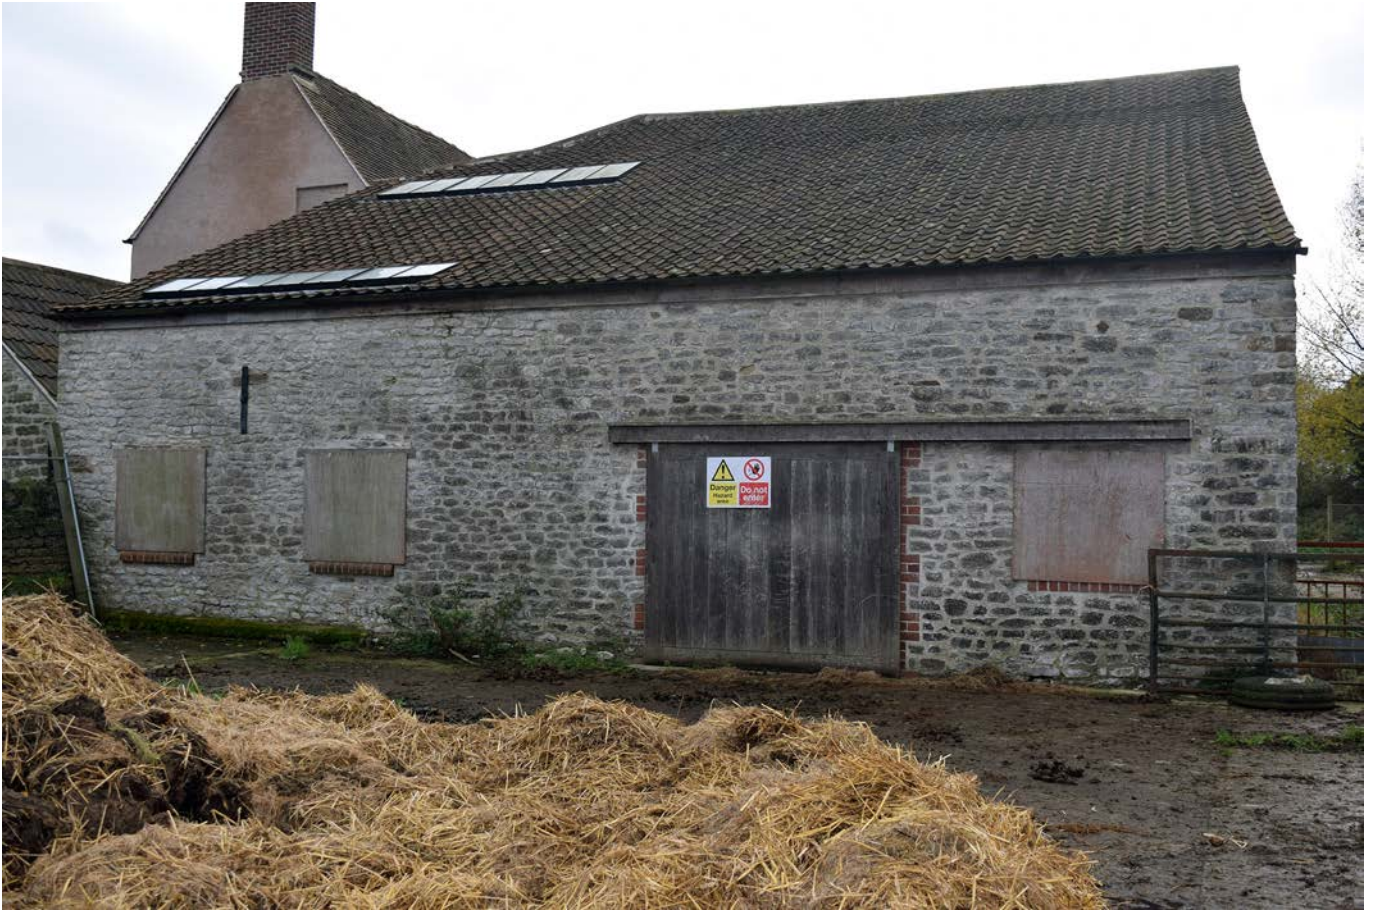
Plate 43: The east elevation of the east lean-to, looking west

- 3.3.19 In the east elevation, there are three original timber-frame windows with red brick sills, that may be later insertions (Plate 43). These are now boarded over with plywood. Between the central and north window is a large opening which is likely to be later as it features an RSJ (Rolled Steel Joist) as a lintel. This has red brick quoining to its jambs and has a boarded door. Since the survey in 2009, mature vegetation growth has been removed from this elevation and the door to the wide opening has been inserted. It was also observed from this side that where the roof had fallen away towards the south end, it has been reinstated and two rows of skylights added.
