AXWELL HALL, BLAYDON, GATESHEAD,

Archaeological Roof Survey and Watching Brief

Oxford Archaeology North

February 2010

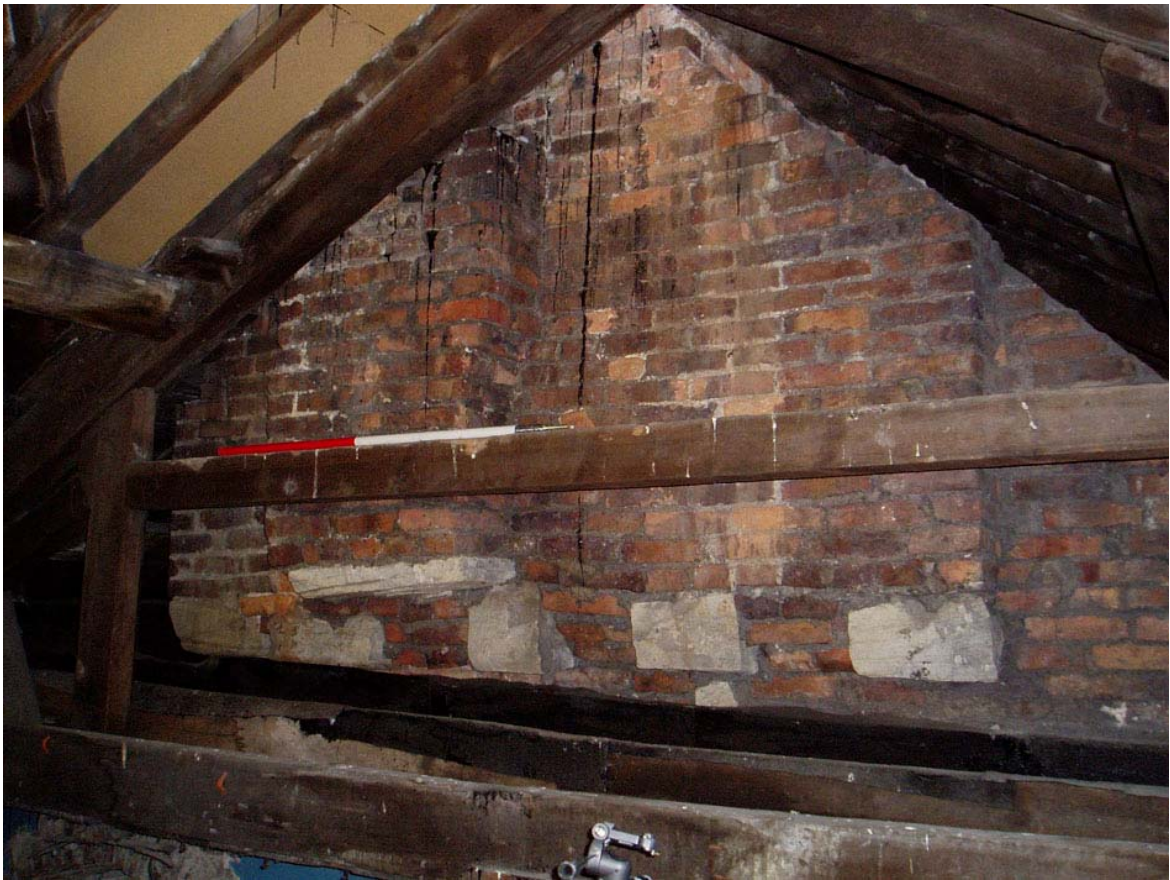
Plate 1: Dividing wall within roof space, with angled drainage channel

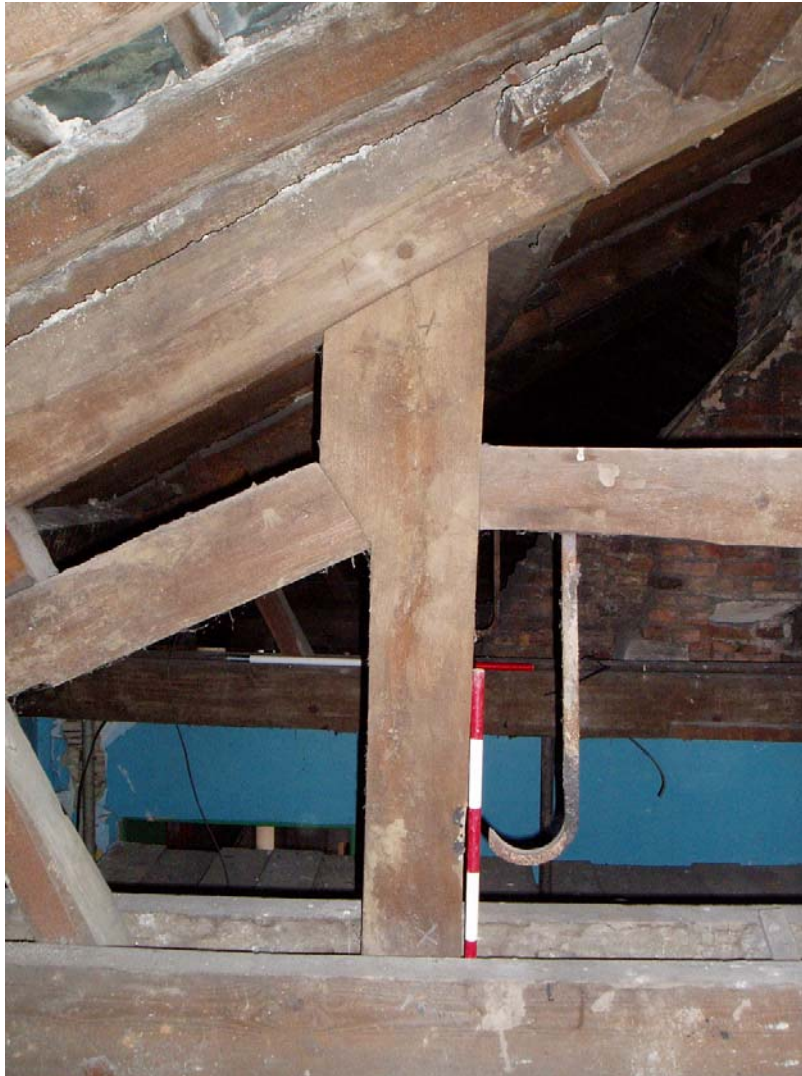
Plate 3: Iron strap, presumably for sprinkler system supply pipe

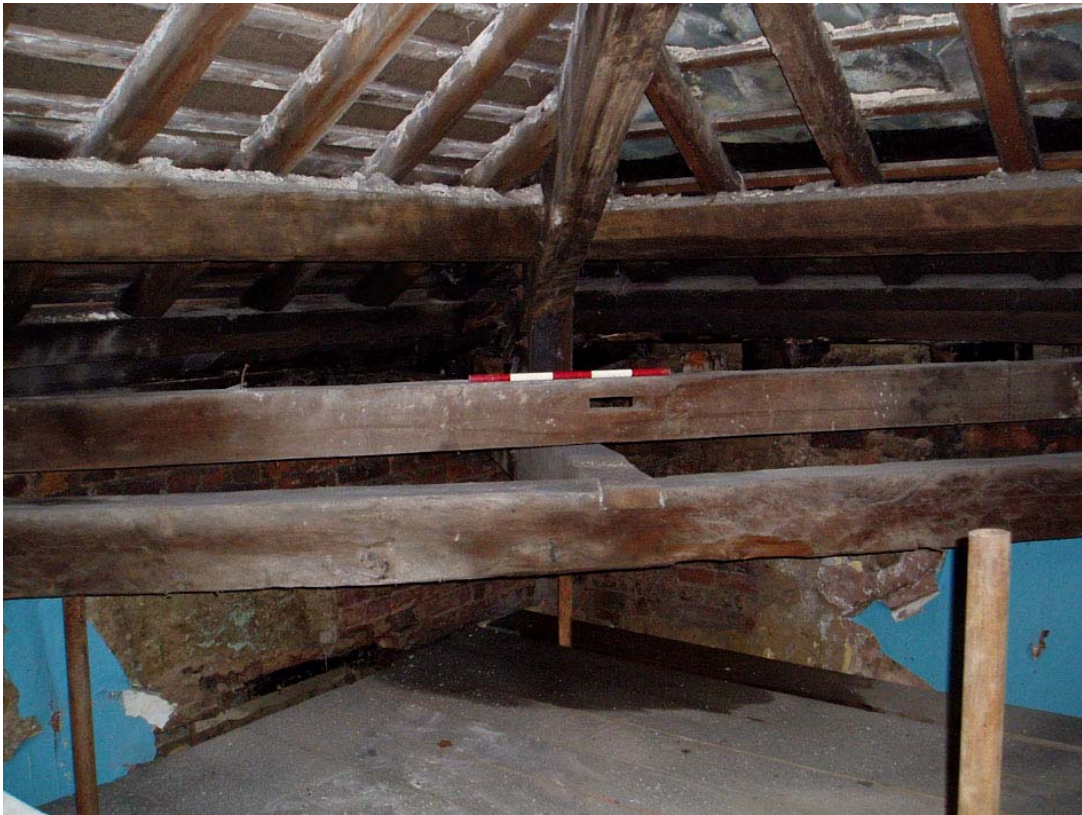
Plate 5: Dragon beam with additional redundant wall tie above, Area A

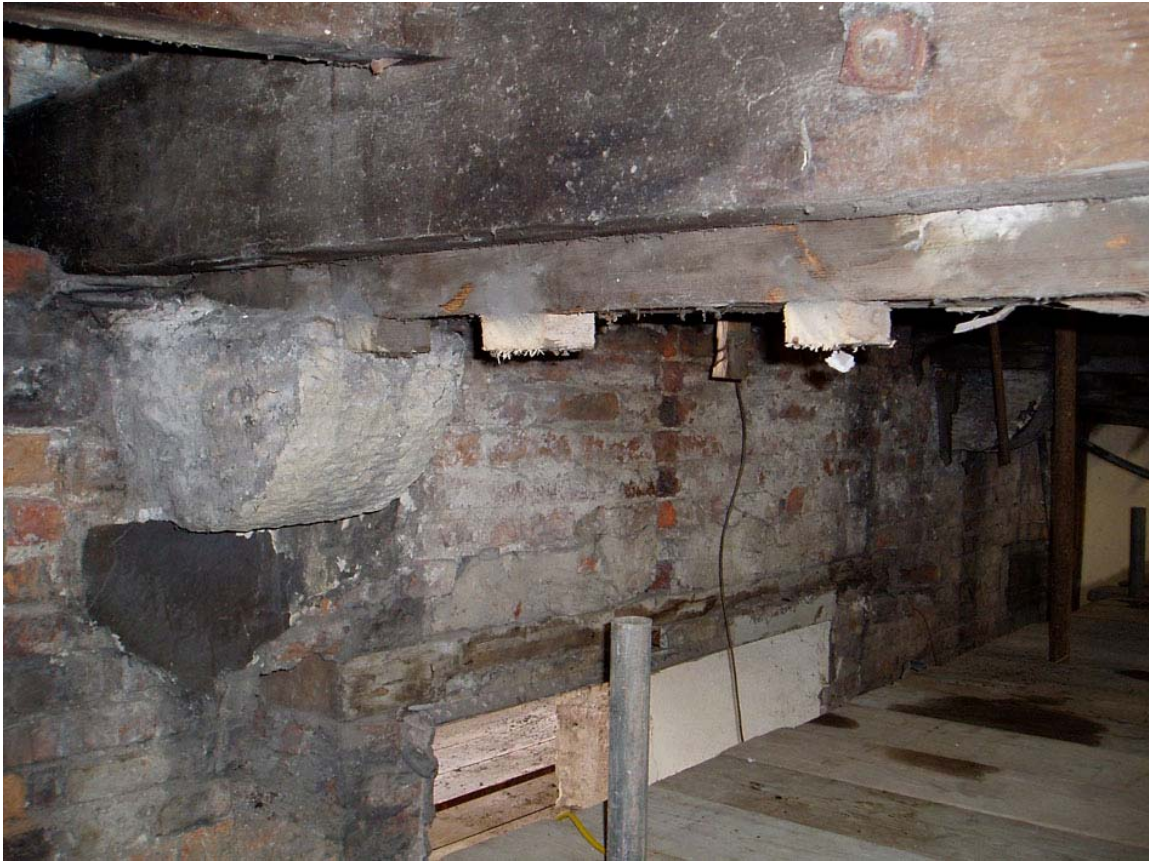
Plate 7: Corbel supporting tie beam, with additional supporting member bolted to face

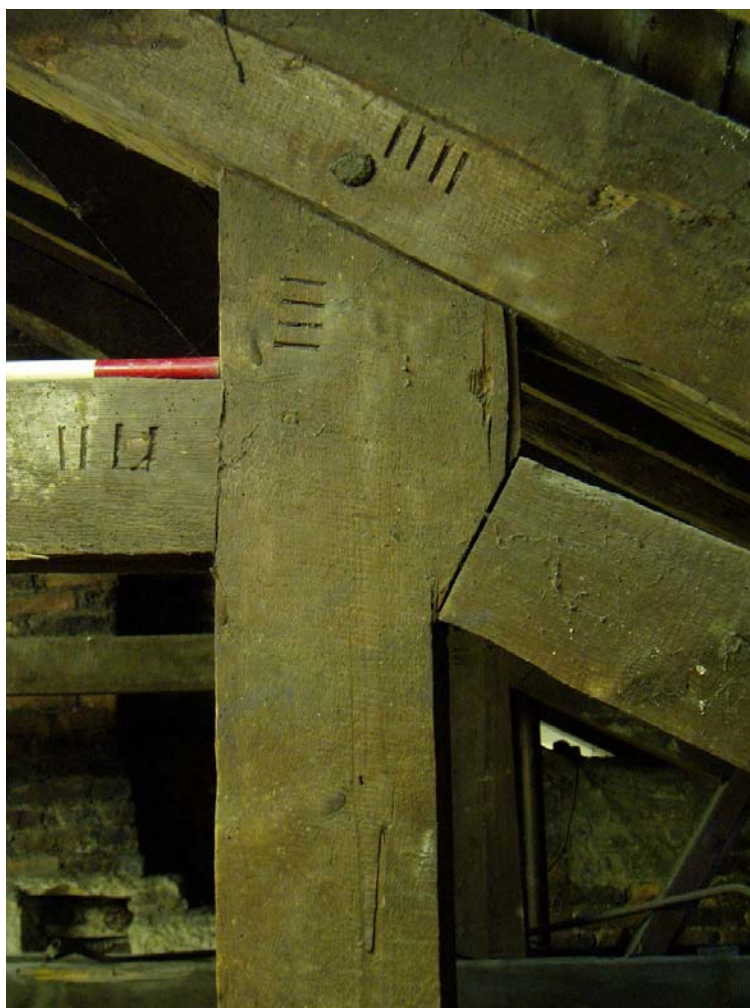
- 4.3.3 **Truss 11:** this is the same as Truss 10, with assembly marks 'IIII' on the upper face (Plate 10). It also has Baltic Timber marks on one of the blocking wedges between brace and principal rafter, and also on the eastern strengthening member to the tie-beam. At its joints with the purlins, the south principal rafter is marked 'XII', whilst the northern principal rafter is marked 'IIII', as the upper face of the truss. The lower north purlin is again marked 'XI'. A Baltic Timber mark was also observed on the southern purlin of the lower pitch between Trusses 11 and 12.

Plate 10: Assembly marks 'III' and queen strut assembly, Truss 11

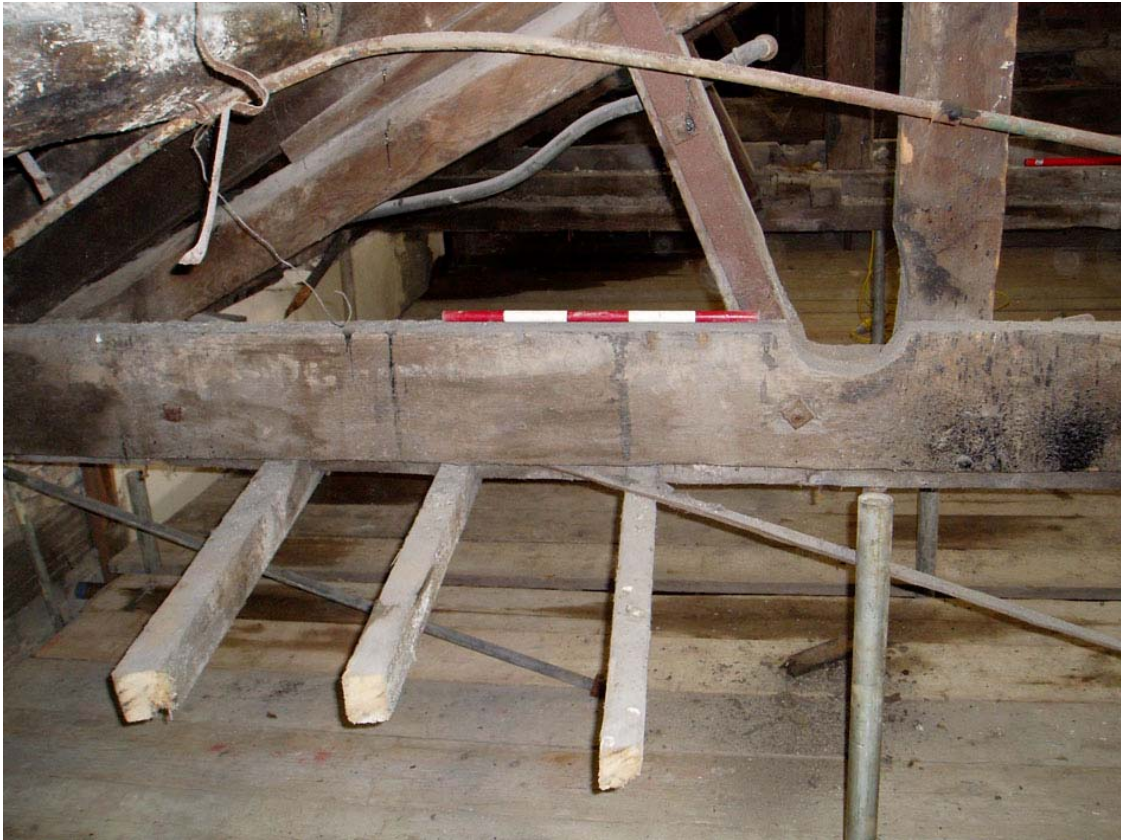
0.05m), positioned between, and also slightly cutting the northern queen strut and the angled brace to the northern principal rafter (Plate 11). This feature appears to almost certainly relate to the large wrought-iron U-shaped hooks observed on trusses elsewhere, presumably for housing a water pipe. At its joints with the purlins, the south principal rafter is marked 'XIII', whilst the northern principal rafter is marked 'IV', except for the upper purlin on the north pitch to Truss 14, which is marked 'VI', as the upper face of the truss.

Plate 11: Cut-out in Truss 13, presumably for sprinkler system supply pipe

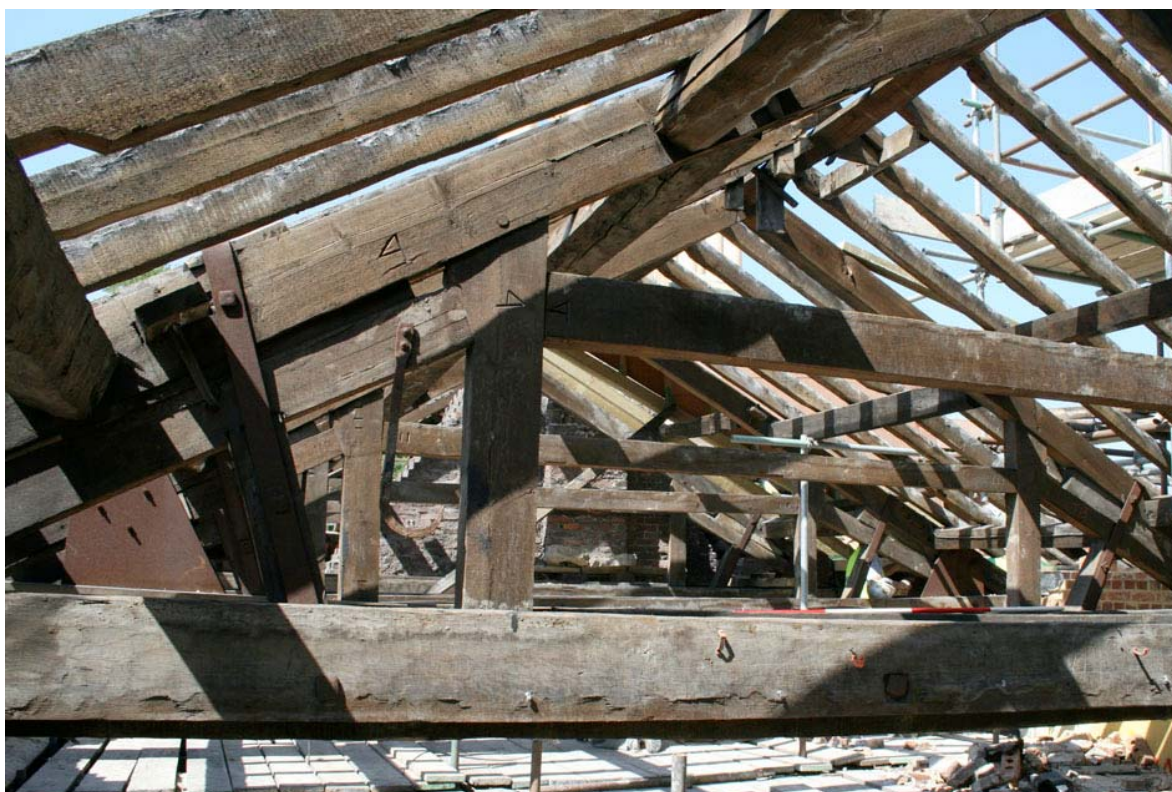
4.5.3 **Truss 2:** this is of similar style to Truss 1 with assembly marks '4' (Plate 16), as opposed to the conventional Roman numerals 'IV' or 'IIII' more typically observed in roof construction. The numbering of trusses within Area D demonstrates that, during the original design and construction of the roof, the truss numbering commenced at the northern end of Area D, within the west range of the building. Baltic Timber marks were observed on the outer face of the southern additional tie brace, on the lower face of the collar, and on the northern two rafters of the west pitch, between the purlins.

Plate 16: Assembly marks '4', Truss 2

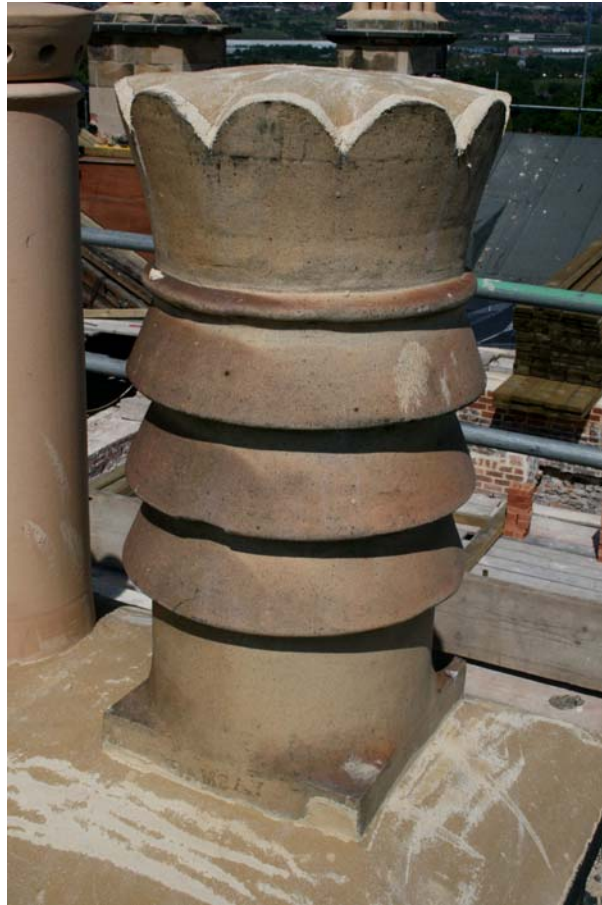
4.5.4 In the western wall, immediately north of the truss, is an intramural flue, 1' x 10.5" (0.30m x 0.27m) wide, which presumably serves a fireplace below. The flue dog-legs to the south, 5' (1.52m) below tie-beam level, and is blocked with debris below this point. On the eastern wall, a chimney stack, 5'7" x 2'3½" (1.7m x 0.7m), butts the southern side of Truss 3, and extends above the roof as an ashlar block stack. The three chimney pots are repaired / replaced, comprising a simple plain roll example, with modern ceramic flue ventilator capping, and two more ornamental 'Ramsay' three-lift crown pots (Plate 17).

Plate 17: Chimney pot, probably of nineteenth century date

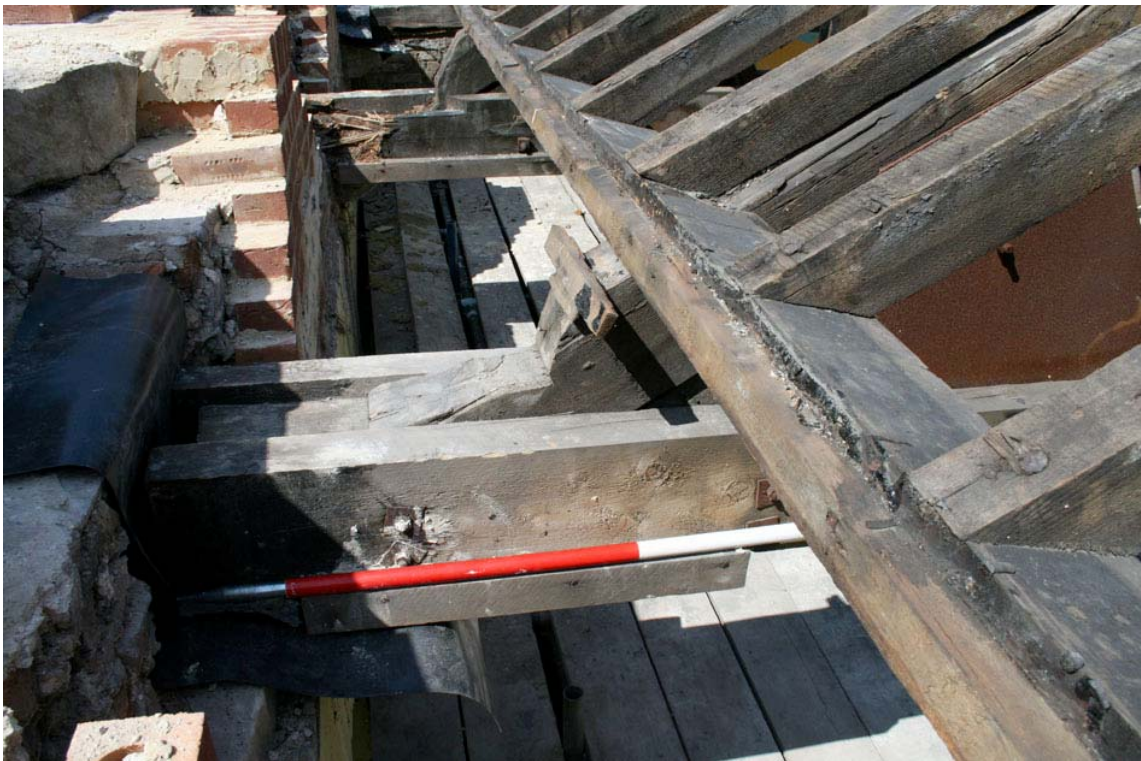
Plate 18: Cut principal rafter, presumably for remodelled parapet drain, Area D

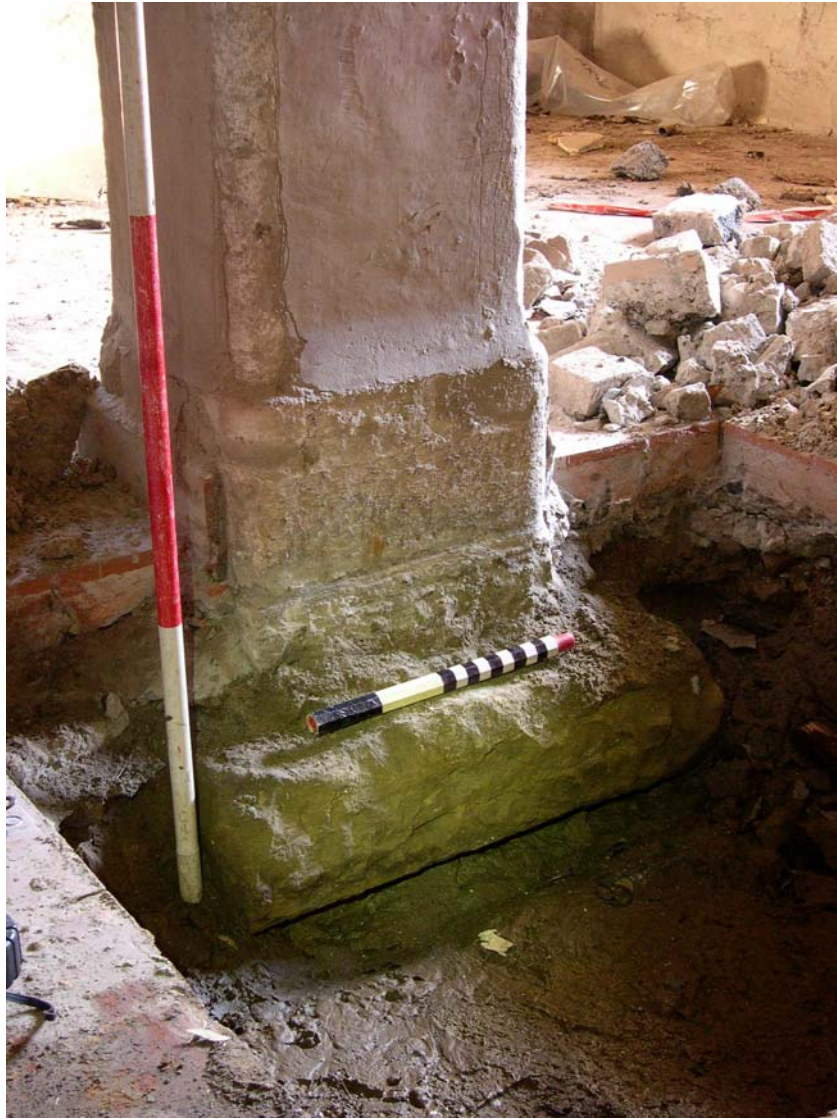
- 4.6.3 In addition, the base of a pilaster on the north wall of room **1** was revealed, and was found to be resting upon a plinth (13" by 23"; 0.33m by 0.58m) atop a sandstone flag (29" wide by 9" thick; 0.74m by 0.23m) and a layer of clay. This appears to be the common arrangement for all of the columns within the basement. Certainly, the central column within room **8** was also observed to rest upon a substantial sandstone flagstone measuring 32" (0.81m) long and 10" (0.25m) wide, with a plinth, 30" (0.76m) long and 19" (0.48m) wide, and a clay deposit below this (Plate 20).

Plate 20: Detail of the foundations of a column within the cellar

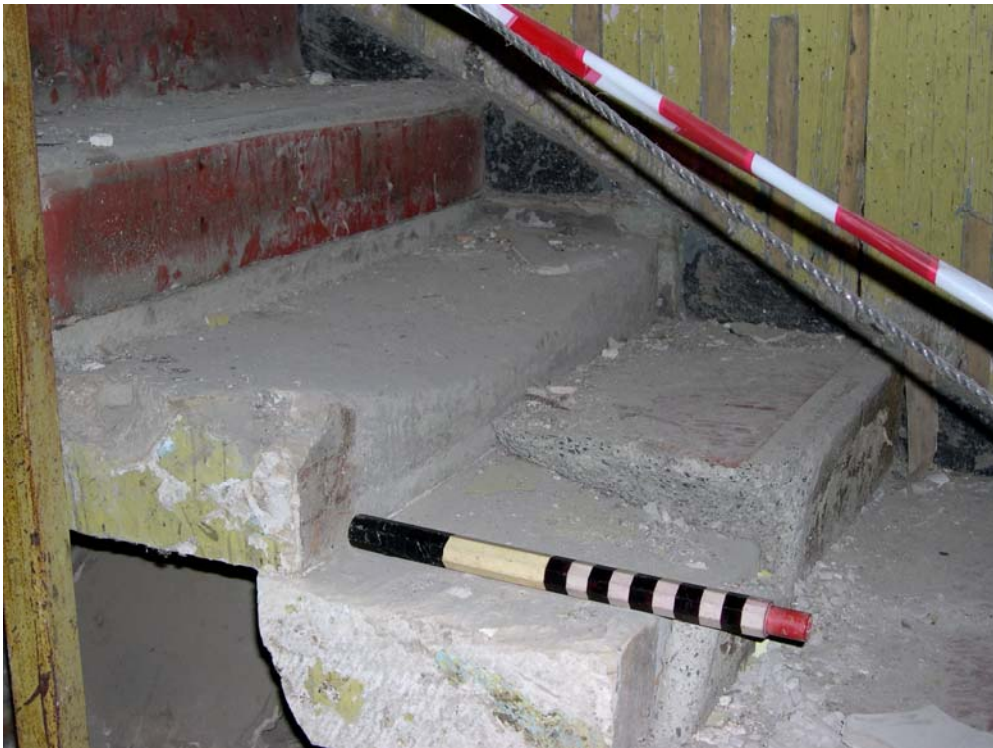
- 4.6.8 **Rooms 24 and 26:** these rooms flank the original imperial staircase (room 25) and contain the servants' staircases (Fig 5). The staircases comprised well-worn steps measuring 37" (0.93m) wide by 13½" (0.34m) long by 6" (0.15m) high, which were formed from single blocks of sandstone that had been skimmed with concrete to even out the treads during later renovations (Plate 24). Traces of the original cast-iron balustrade were also visible in the form of a pair of lead-filled sockets on each tread.

Plate 24: Detail of the servants' sandstone staircases in rooms 24 and 26, which have been repaired with concrete during renovations

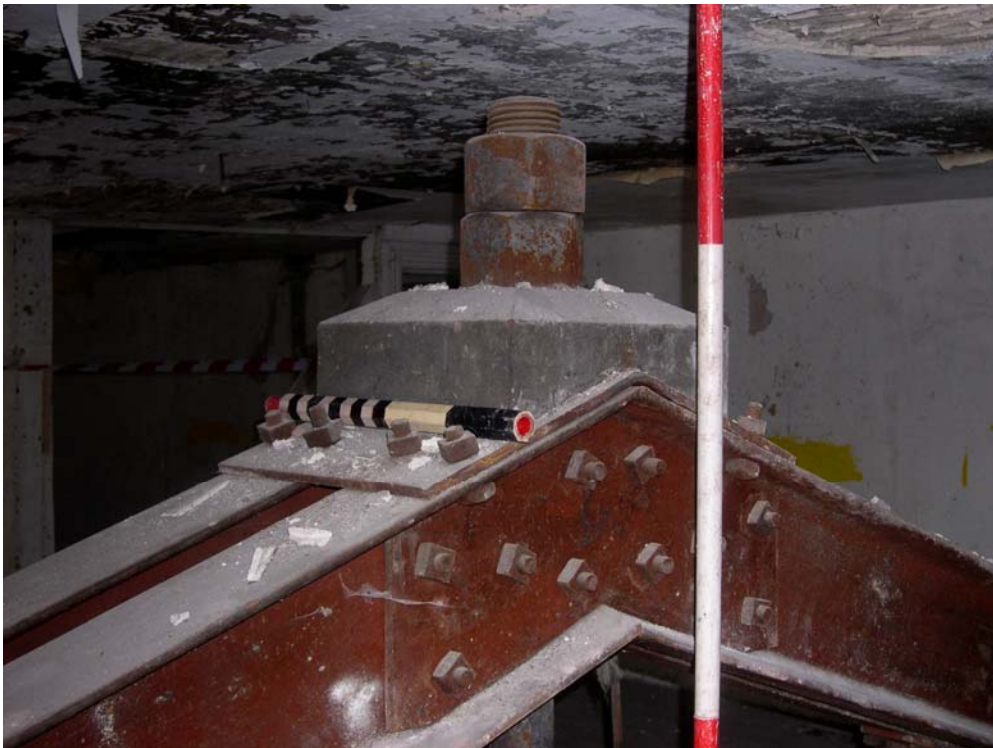
- 4.6.14 The principal rafters measured 10" (0.25m) by 6" (0.15m), whilst the tie-beams measured 12" (0.3m) by 6" (0.15m) and the braces were 6" (0.15m) by 4½" (0.11m). These individual members were joined with gusset plates and square-headed bolts, and from the additional bolt-holes and ground bolt-heads, the trusses appeared to be reused. A series of alpha-numerical construction marks (3-3, G-G, E-G and 5-5) on the north face showed that the truss was assembled on site. Patching on the ceiling above demonstrated that some damage was caused when the rod was inserted.

Plate 29: Detail of the iron rod supporting the ceiling of the floor below

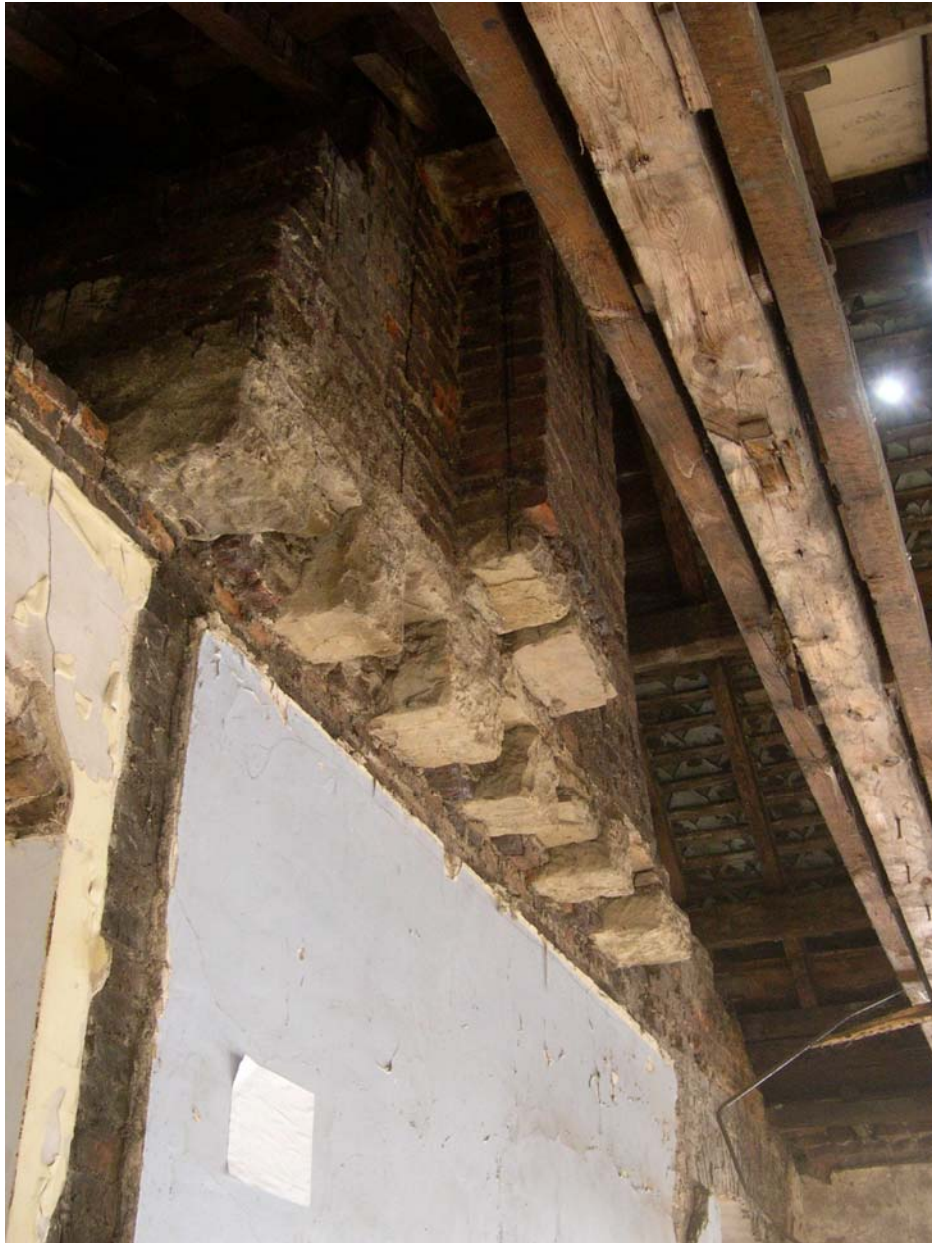
- 4.6.19 **Room 60:** as with the rest of the rooms to the rear of the building, the floor was in bad condition during the original survey (OA North 2004) (Fig 8). At the time of the watching brief, little remained, although a small section was visible within the north wall. It appeared to consist of one main north/south aligned beam, with lesser beams assisting in the support of the east/west joists. As such, it was comparable with the construction of other floors observed during the watching brief. In addition, a brick chimney-breast supported by five sandstone corbels, in a similar manner to the one observed in room **58**, was also exposed on the west wall (Plate 35).

Plate 35: Detail of one of the corbelled chimney breasts, as observed in rooms 58 and 60
