# LOWER HOUSE FARM, MIDDLEBROOK,

# HORWICH, BOLTON

## Archaeological Building Investigation

December 2004

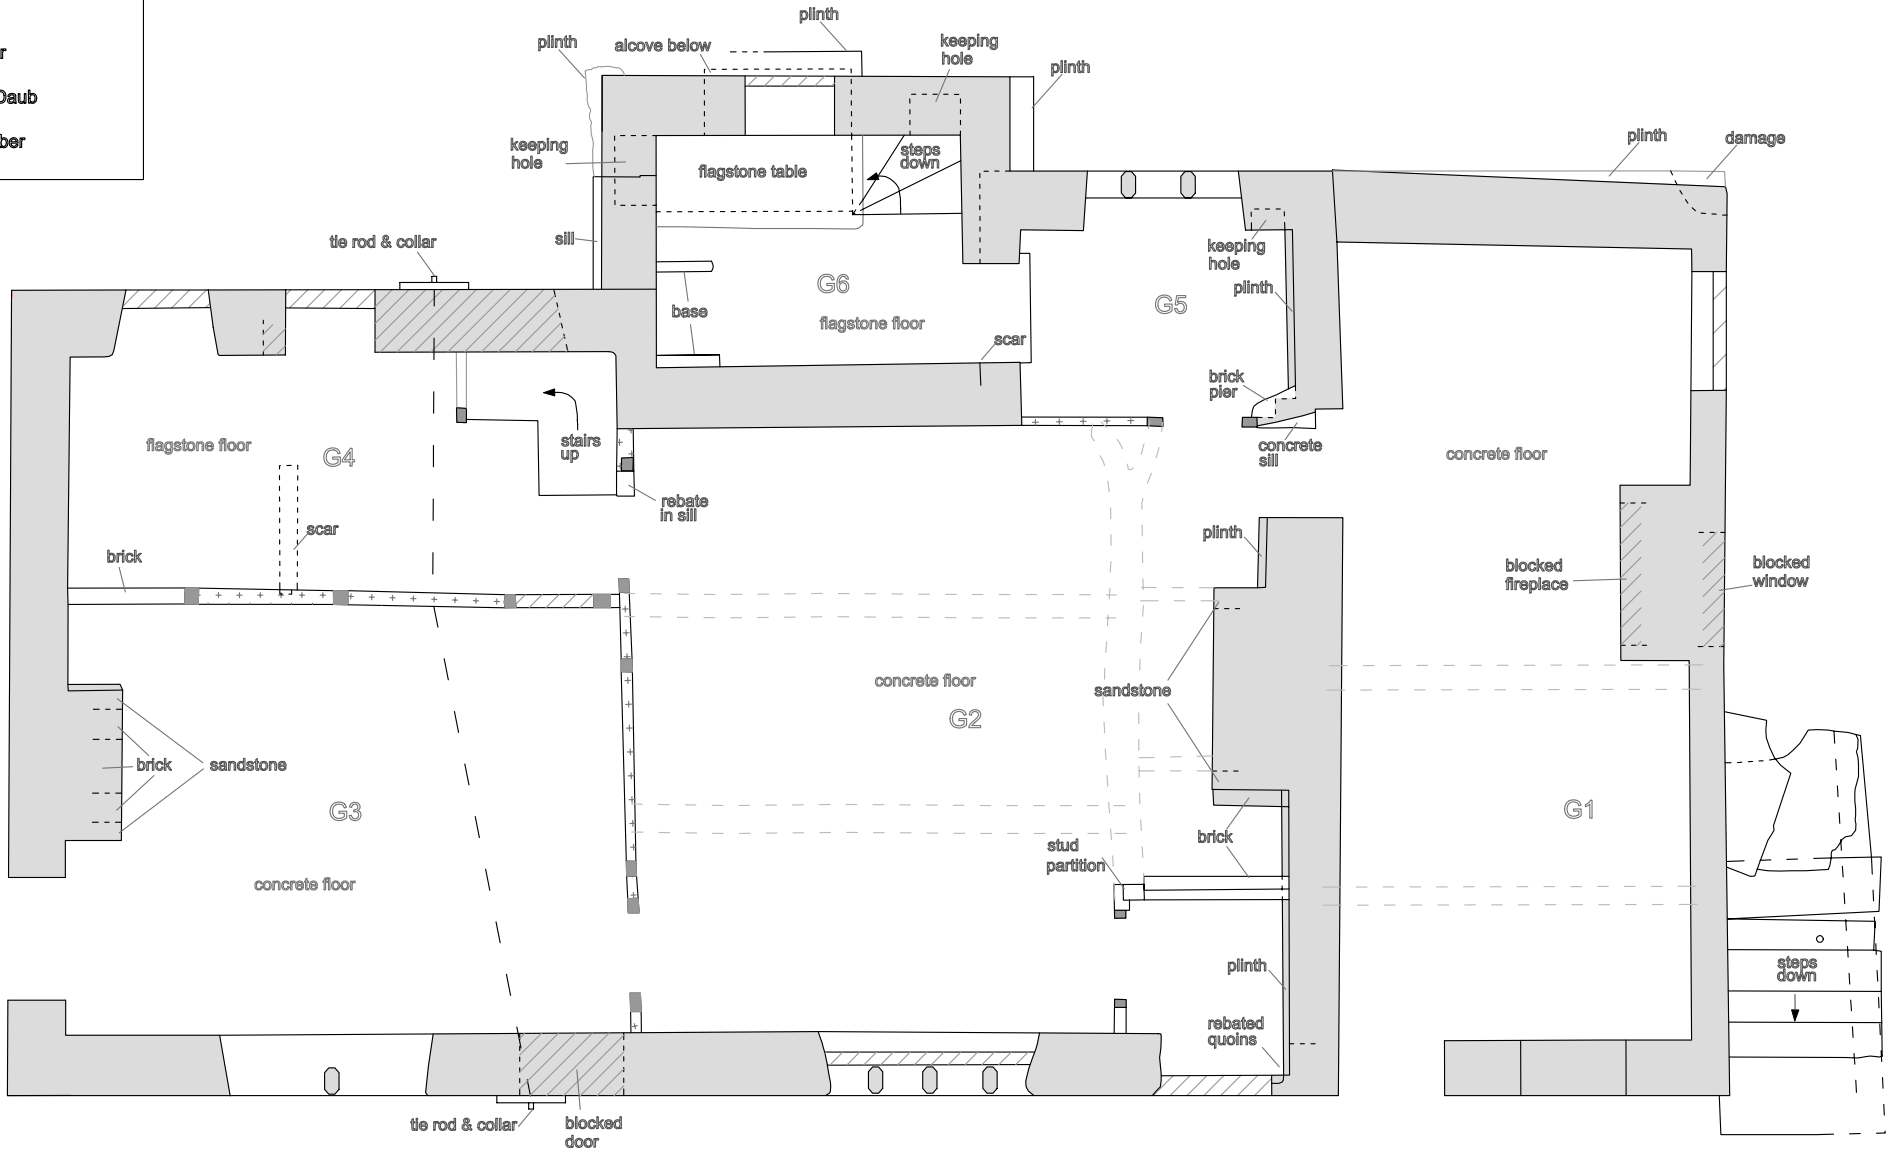
Figure 6: Ground floor plan

- 4.5.2 **Ground floor, Room 1 (Fig 6):** this forms the interior of the eastern extension and is currently two storeys high as the floor is missing, leaving it open to the ceiling. The west elevation is the original east external elevation of the main house and has a slight plinth making up the lower c0.6m. There is an inserted doorway north of centre, with a re-used timber lintel with peg holes and a possible carpenter's mark. The wall thickness is apparently greater at the base of the wall than it is above the doorway, and there is an inserted window above the doorway that has been blocked with stone. At the top of the gable the ends of three purlins from the main house project through the wall, and the wall top has been raised to match the increased height of the extension. A further small blocked aperture is evident in the west elevation, apparently entering the back of the firehood on the first floor. The east elevation has an inserted fireplace and chimney breast near the centre constructed of moulded bricks with a single piece dressed stone surround. This has had later cement rendered blocking inserted. There is an inserted square window to the north of the fireplace.

- 4.5.4 **Ground Floor, Room 2 (Fig 6):** this is the main room of the original house. The main access is via a doorway in the south-east corner, which forms a baffle entry at a heck wall (which has subsequently been turned into a lobby). A bressumer beam runs from the heck wall, supported by the heck post, which has a joweled and stepped head, to a post forming part of a timber partition along the north elevation, where it is forked (Plate 14). The bressumer beam is lap-jointed into the posts at either end. The short section of stud partition wall at the north end of the bressumer is finished with wattle and daub and has an arched doorway allowing access into the partial outshut in the north-east corner. The framing is chamfered and appears to have a dove lap-tail joint assembly. There is a mullion window in the centre of the south elevation, as per the external elevation. The west side of the room is made up of a stud partition wattle and daub wall, with what appear to be original doorways at the north and south ends. The bressumer beam and western partition wall support the ends of large east/west orientated beams with deep chamfered scantling. The north/south orientated joists are jointed into these and many are original and finished with stop chamfer decoration. In the north-west corner there is a square section trimming the edge of a joist, which appears to be the position of an earlier access hatch into the first floor c0.6m by c1.2m.

- 4.5.7 **Ground Floor, Room 3 (Fig 6):** there is a single large window in the south elevation, with a deeply chamfered timber lintel. A c1.75m wide chimney breast projects from the west elevation (Plate 16), which is probably contemporary with the main build of the house. It has a 0.9m wide hearth with chamfered dressed sandstone jambs and a c0.34m deep lintel. The hearth has subsequently been narrowed with brick in a soft grey cement mortar to form a smaller opening with a cast iron lintel (Plate 16). Later blocking with salt-glazed brick has also been carried out, probably to accommodate later heating. The east elevation is a timber-frame partition, with a doorway at the south end. The north elevation is also a timber-frame partition dividing Rooms 3 and 6 (Plate 15). This butts east frame but would appear to be contemporary. There is doorway blocked with brick in the north-east corner (Plate 15) that has later framing on the south face and simple iron pintels in the south face of the east jamb.

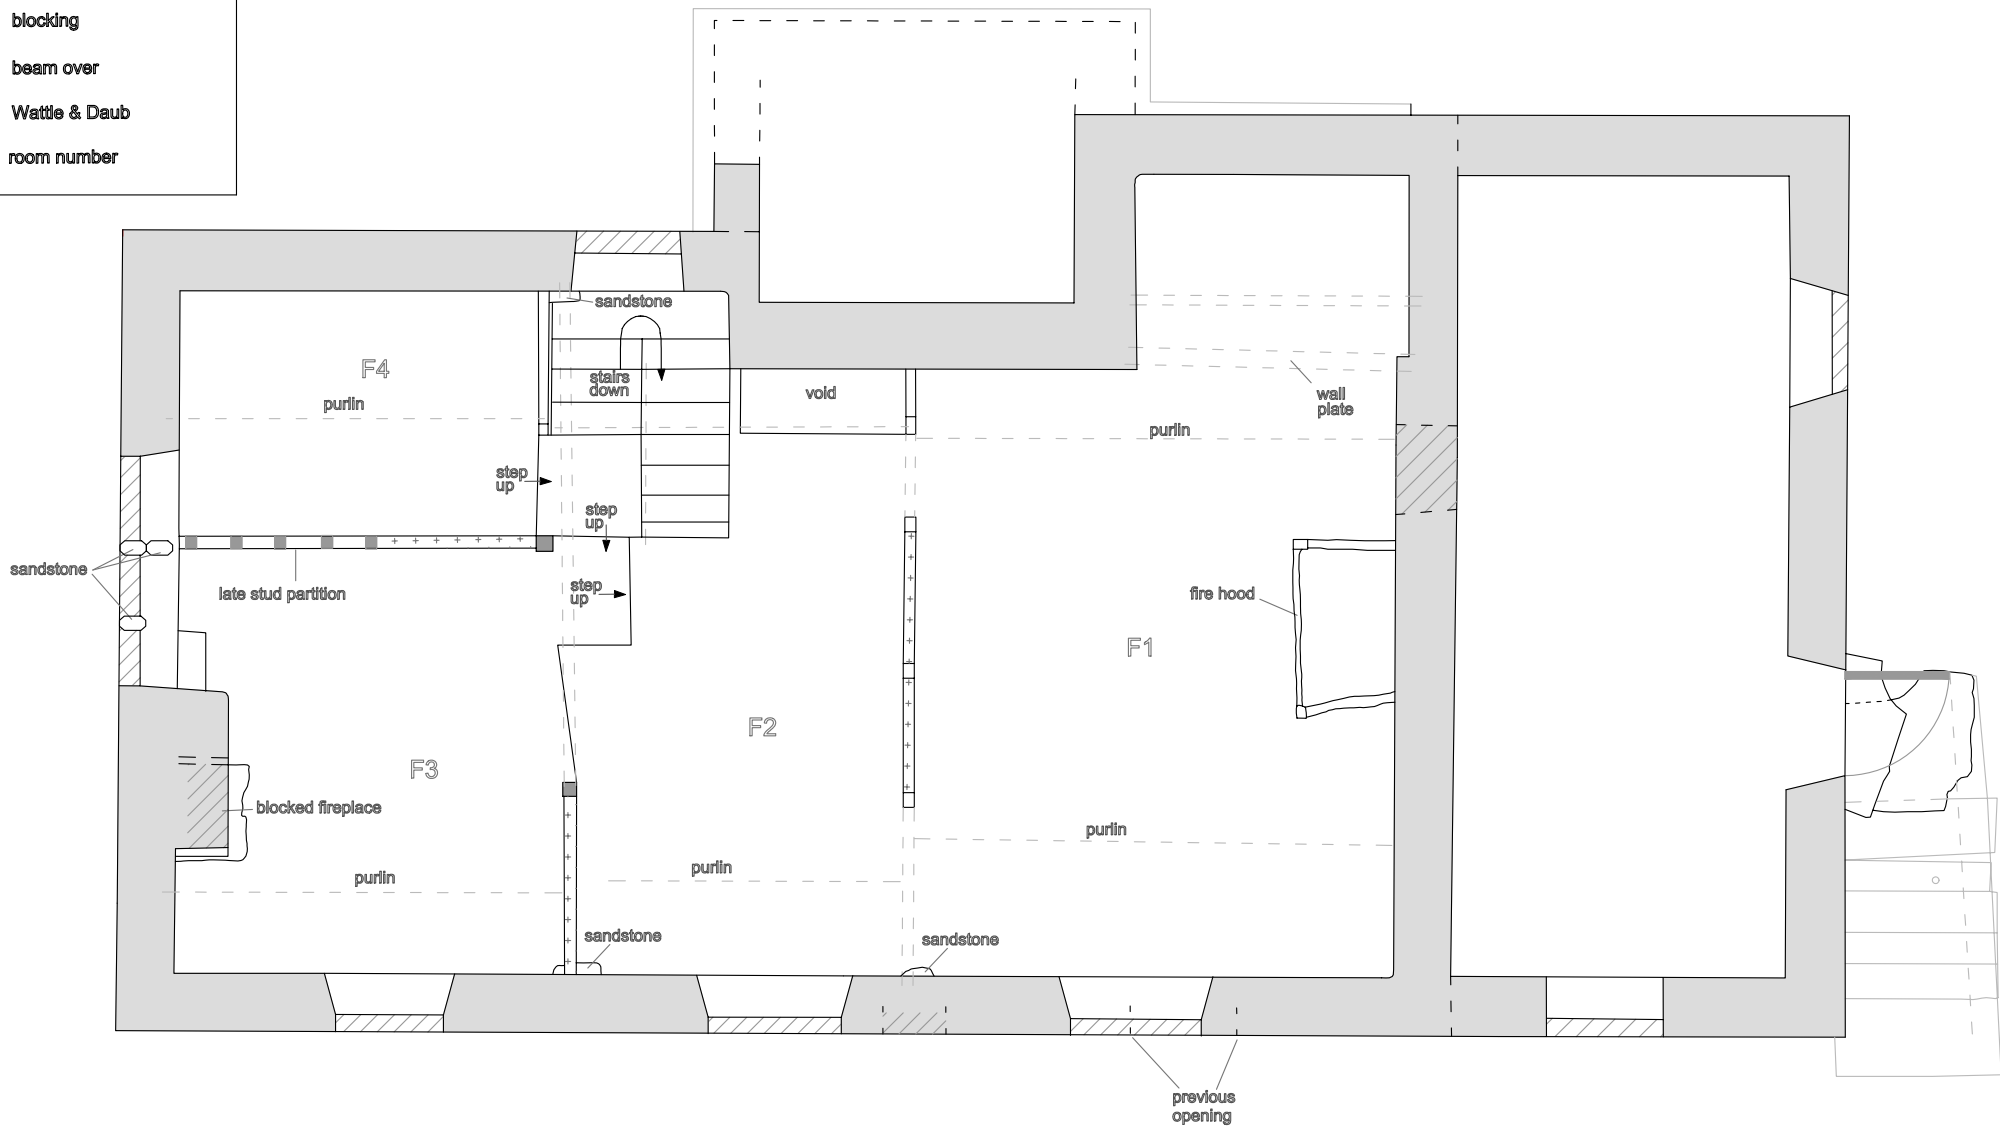
Figure 7: First floor plan

- 4.5.12 **First Floor, Room 1 (Fig 7):** the south elevation has a large window with splayed reveals that are obscured by render. The decayed remains of an original purlin are present in the east elevation and the lower part of the elevation is covered with daub beneath limewash and horsehair plaster. In the centre of the east elevation the remains of the firehood are present, offset to the south of the ridge (Fig 9-11). This comprises two re-used timbers angled from *c*1.25m at the base to *c*0.65m apart at the top and positioned *c*0.75m from the wall. There are horizontal rails at *c*0.75m and *c*1.8m from the floor, which are tenoned and pegged into the north post and lap jointed to the south (Plates 24-26). Both have grooves for stakes in the upper surface and stake holes in the soffit. The upper one is broken and the lower re-used. Parts of the panelling remain *in situ* at the base and comprise two layers of daub behind lime plaster. There are additional rails between the firehood and the gable at *c*1.2m and *c*2.4m above the floor. The lower rails are lap-jointed on the upper surface, and the uppers lap-jointed on the lower surface. The interior of the hood is coated in soot and scorched in some areas. At the top the brick stack is supported by a pair of cast iron bars and a sandstone pad (Plate 27). The south side has been rebuilt above the upper rail and the north side has been rebuilt above the cast iron base plate, both in brick and with some frogged. There is a small aperture to the north of the firehood leading into the upper floor of the eastern extension, which has been blocked with brick.

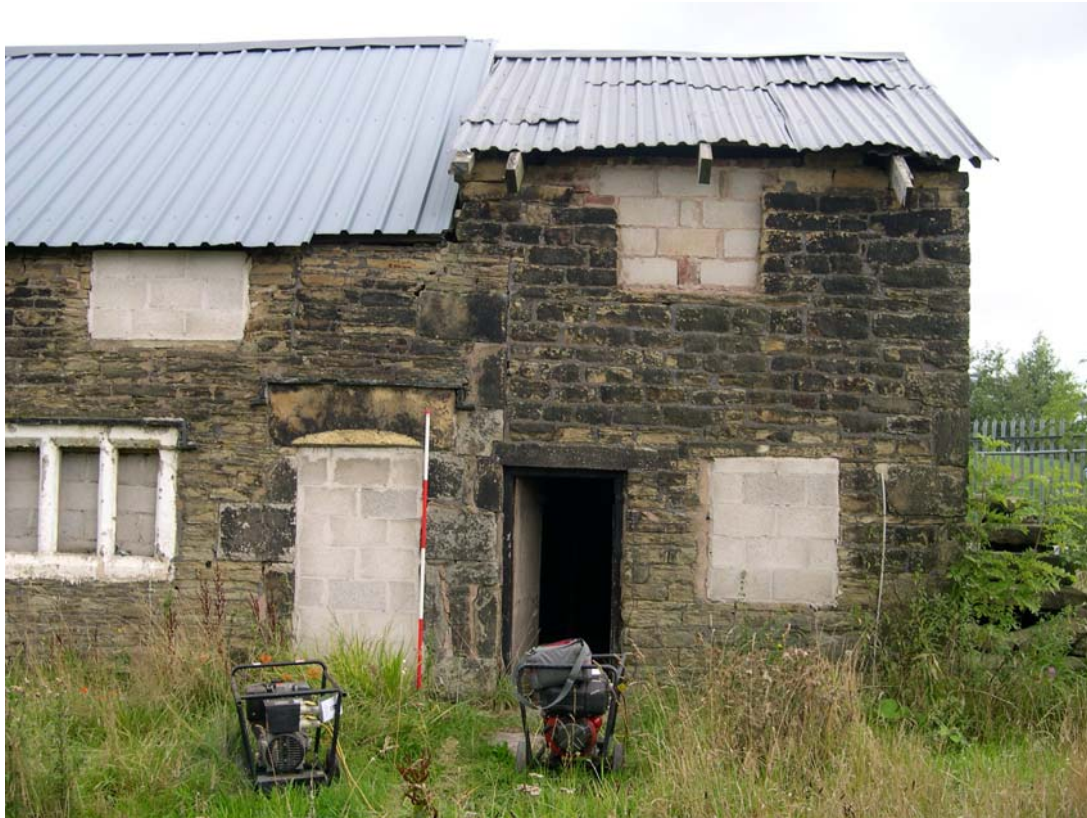
- 4.4.1 **Front (south) elevation of house (Fig 3):** there is a doorway at the east end with a roughly finished heavy stone lintel decorated with a stop chamfer and hood mould (Plate 6) To the west is a four-light horizontal window with a plain chamfered sill and splayed sandstone mullions and a flagstone label mould. There is a similar, albeit smaller, window to the west (Plate 7). Excavations carried out at the base of the wall, perhaps as part of the current or a previous development, reveal the foundations to consist of a plinth of four courses, which projects c0.13m. There are three inserted windows immediately below the wall head (Plates 6 and 7), all of which are filled with clinker blocks. The easternmost inserted window is situated to the west of an earlier aperture, which has been blocked with stone (Plate 6). A doorway has been inserted between the two ground floor windows, towards the centre of the elevation. This has evidently been narrowed on the east side before being blocked with stone (Plate 7). A tie-rod with a cruciform plate c0.6m across has been inserted above the top left corner of the blocking. The entire elevation has been repointed and the remains of a whitish lime plaster with gravel inclusions are visible in places. The east end has been extended with a later extension (see *Section 4.4.5*).

Plate 6: East end of the front (south) elevation

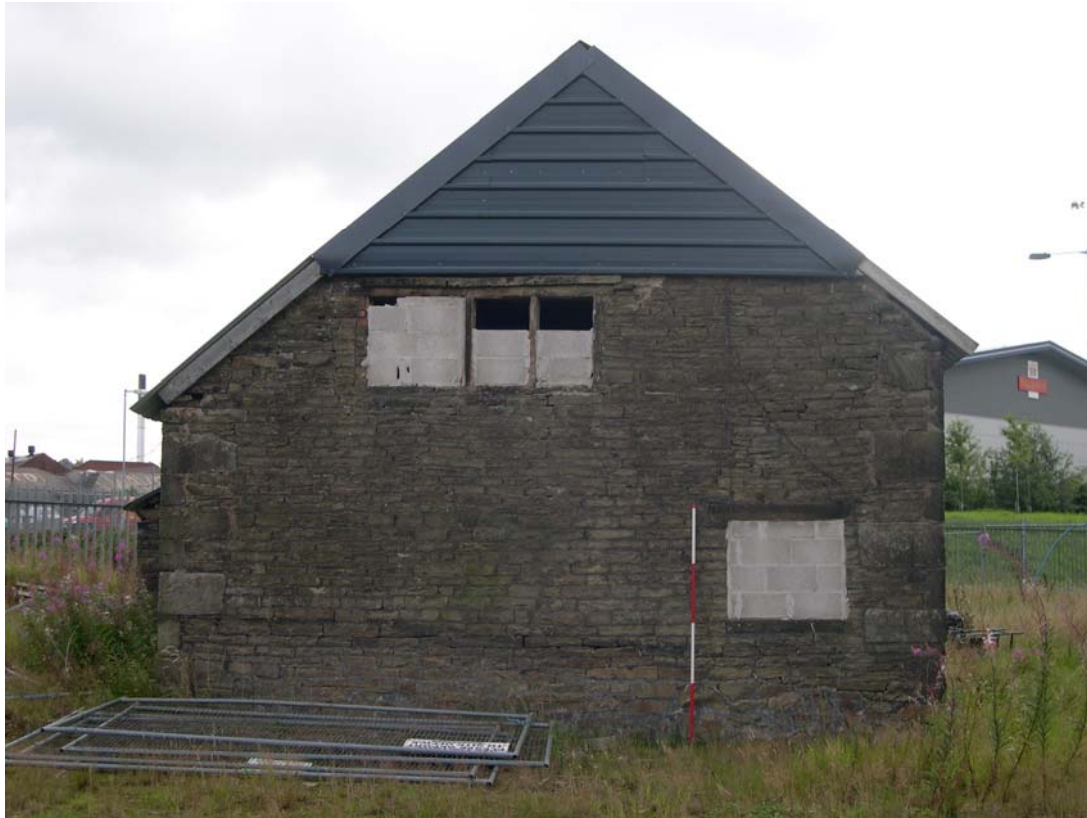
- 4.4.2 **West gable (Fig 5):** this forms the gable end of the main part of the building (Plate 8). The ground level has been reduced for the entire length of the wall, exposing a projecting rough rubble plinth. There is a square window on the south side of the ground floor with a flush sandstone square dressed lintel and sill, probably a later insertion (Plate 8). There is a horizontal three, possibly originally four, light window in the first floor with narrow splayed mullions (Plate 8). It also has a flat slab sill and lintel and a crude projecting label mould above. This has been damaged at the north end where the jamb has been replaced in stone and brick.

Plate 8: West gable

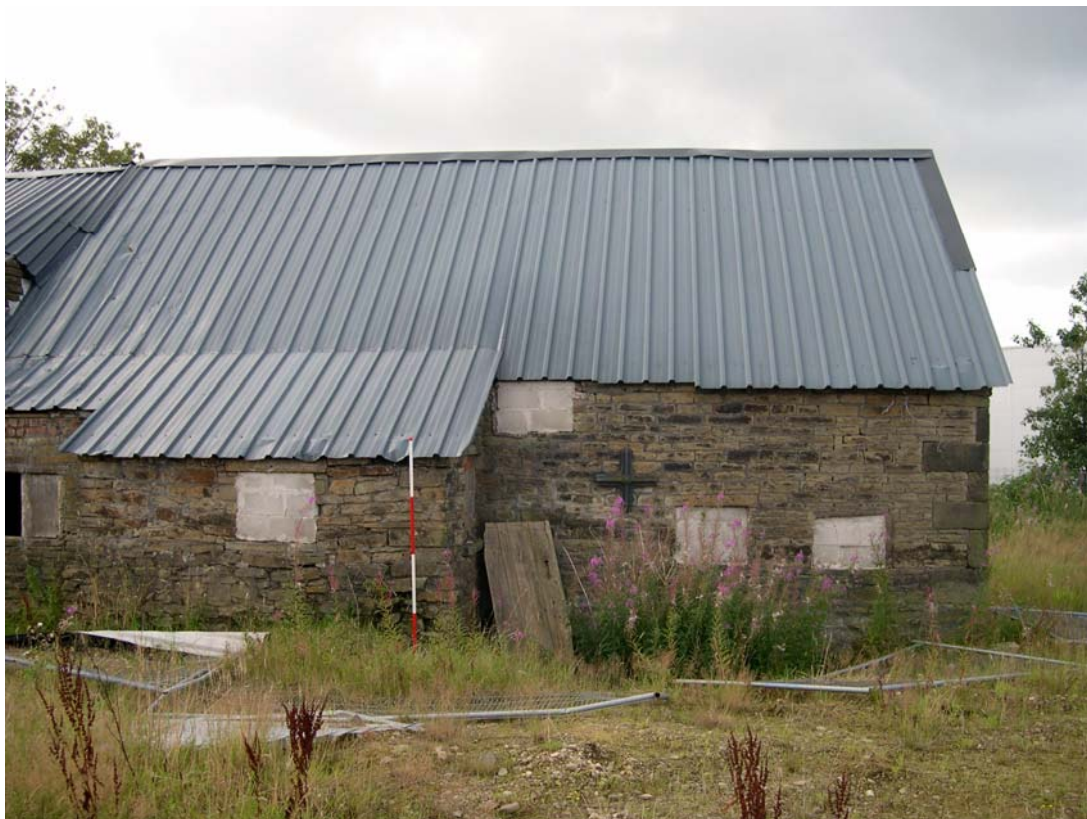
- 4.4.4 **Outshuts to north elevation:** the east side of the north elevation has been extended with the addition of two outshuts (Plates 9 and 10; Fig 4). The earliest of these appears to be contemporary with the main part of the house and comprises a short section of wall at the far east end of the north elevation (Plate 10). Both ends of this are finished with quoins and there is a single, central three-light rectangular window with flush stone surrounds and splayed mullions (Plate 10). The wall height above has been increased slightly with the addition of two rows of bricks in header courses apparently bringing it to the same height as the outshut to the west (Plate 10). The outshut to the west of this fills the re-entrant angle of the north elevation. It is of stone rubble construction, similar to the rest of the building, but slightly more randomly coursed. There is a central square window in the north elevation with a flush sandstone lintel and sill, which has been filled with clinker blocks (Plate 9). The wall construction is more irregular below the level of the windows and slightly thicker; suggesting an earlier phase of building or perhaps an earlier structure, and this appears to continue across the west end of the main elevation (Fig 4). The wall is higher than the original outshut to the west at the junction of the two, which changes the angle of the roof (Plate 10). Two wrought iron S-section brackets have been added to the extension to the wall height to the east to support the rainwater goods. These comprise an ogee moulded timber gutter (which has come away and is lying on the floor) with lead end capping, which may be contemporary with the outshut.

Plate 9: West end of north (rear) elevation

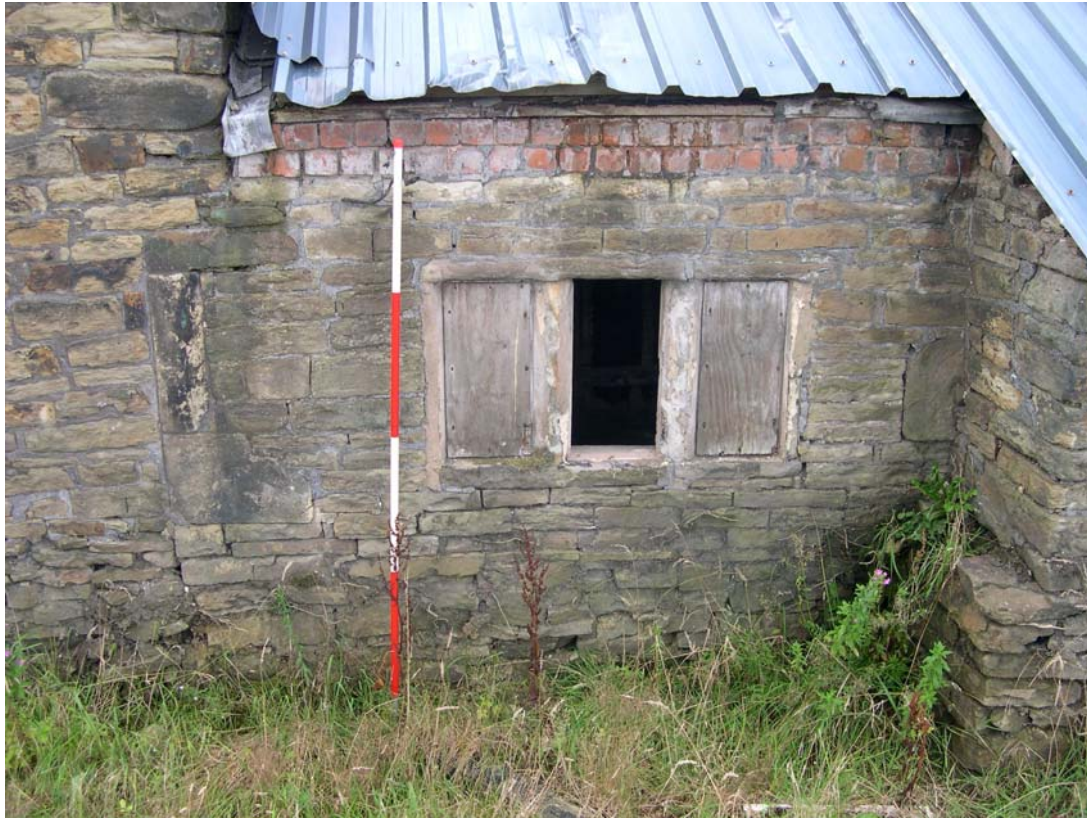
Plate 10: Detail of partial outshut in rear elevation

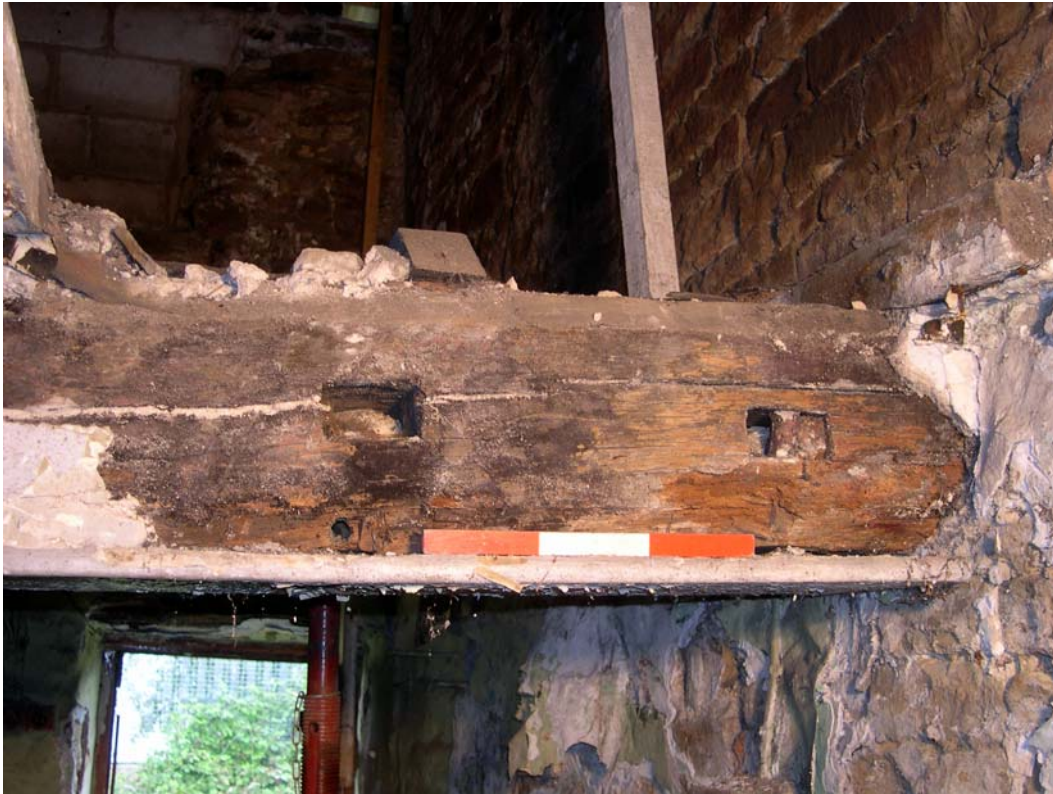
Plate 12: Empty socket holes in ceiling of ground floor Room 1

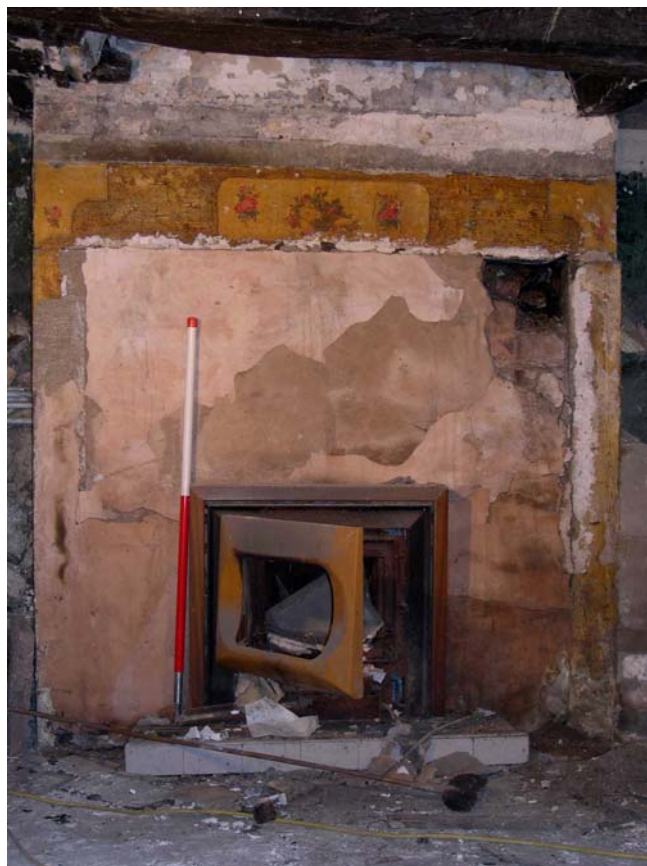
- 4.5.6 The inglenook fireplace forms the majority of the east elevation. The bressumer beam has deep chamfering. The south end meets the timber-frame wall of the baffle entry, which is built onto the heck post. The wall-plate extends beyond the heck post to form a chamfered boss. The fireplace is a later insertion with a dressed flat sandstone surround (Plate 13), probably contemporary with that in Room 1. A modern burner and tiled hearth has also been added (Plate 13). There are re-used bridging joists above the fire surround, which support the blocking of the front part of the firehood above. These re-used timbers may have originally formed the top plate of a partition along the north side of the fireplace.

Plate 13: Fireplace in east elevation of ground floor Room 2

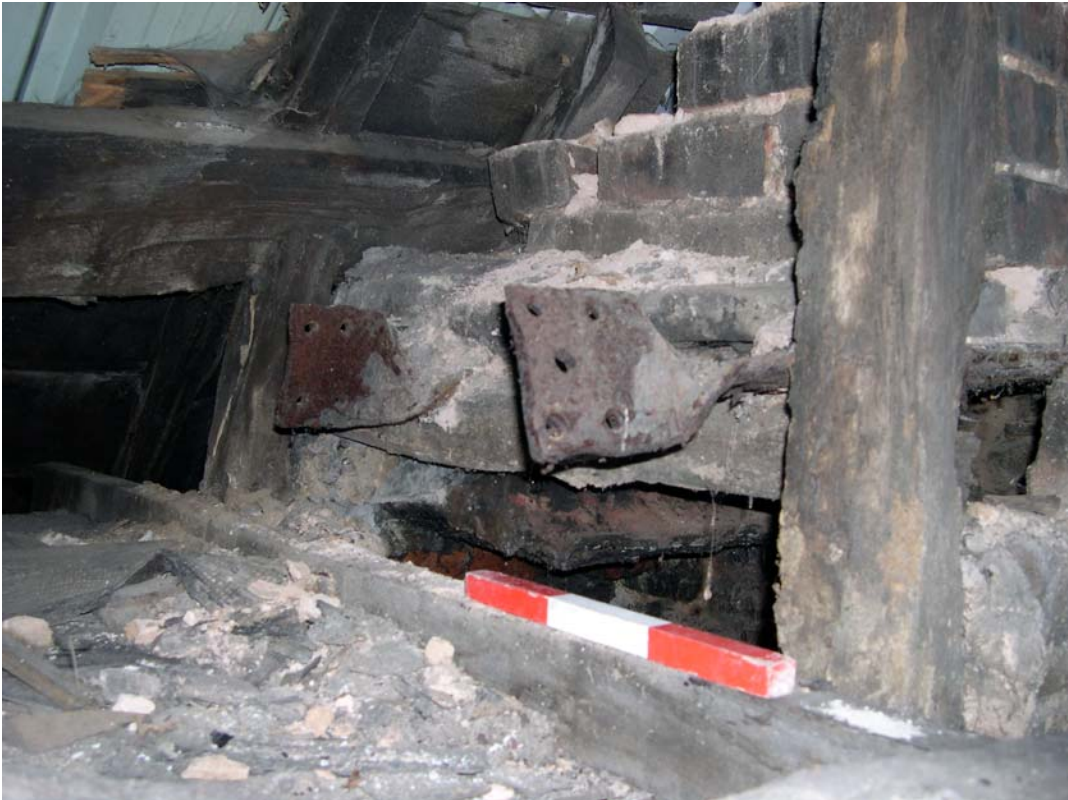
Plate 27: Chimney stack above firehood in roof space, supported by iron plates and sandstone pad

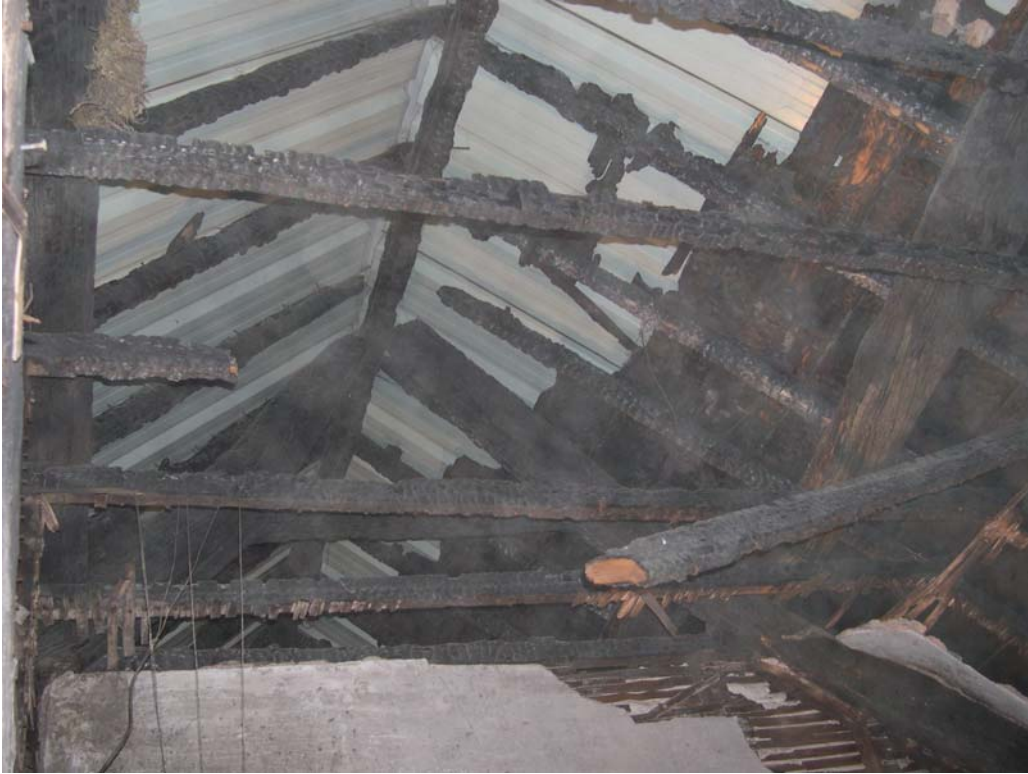
4.5.16 The north elevation is a timber-frame partition, which comprises five panels at the east end, with the east post rebated on the north side for a doorway into Room 4. There is a mortice hole for a rail to the south but the panel has been replaced with a later rectangular section studs for lathe and plaster panelling. The post also has a groove for mortices suggesting that it may have formed the bottom rail for a timber mullion window. The top rail also has numerous empty peg holes and mortices. The roof structure exposed above survives but has been severely damaged by fire (Plate 32).

Plate 32: Remains of fire damaged roof over first floor Room 3
