HAMPTON POYLE - CHURCH OF MARY THE VIRGIN

HPMV92

The Oxford Archaeological Unit was commissioned to undertake a watching brief at the Church of Mary the Virgin, Hampton Poyle, Oxon (SP 4985 1555), during the construction of drains around the W, E and S sides of the building.

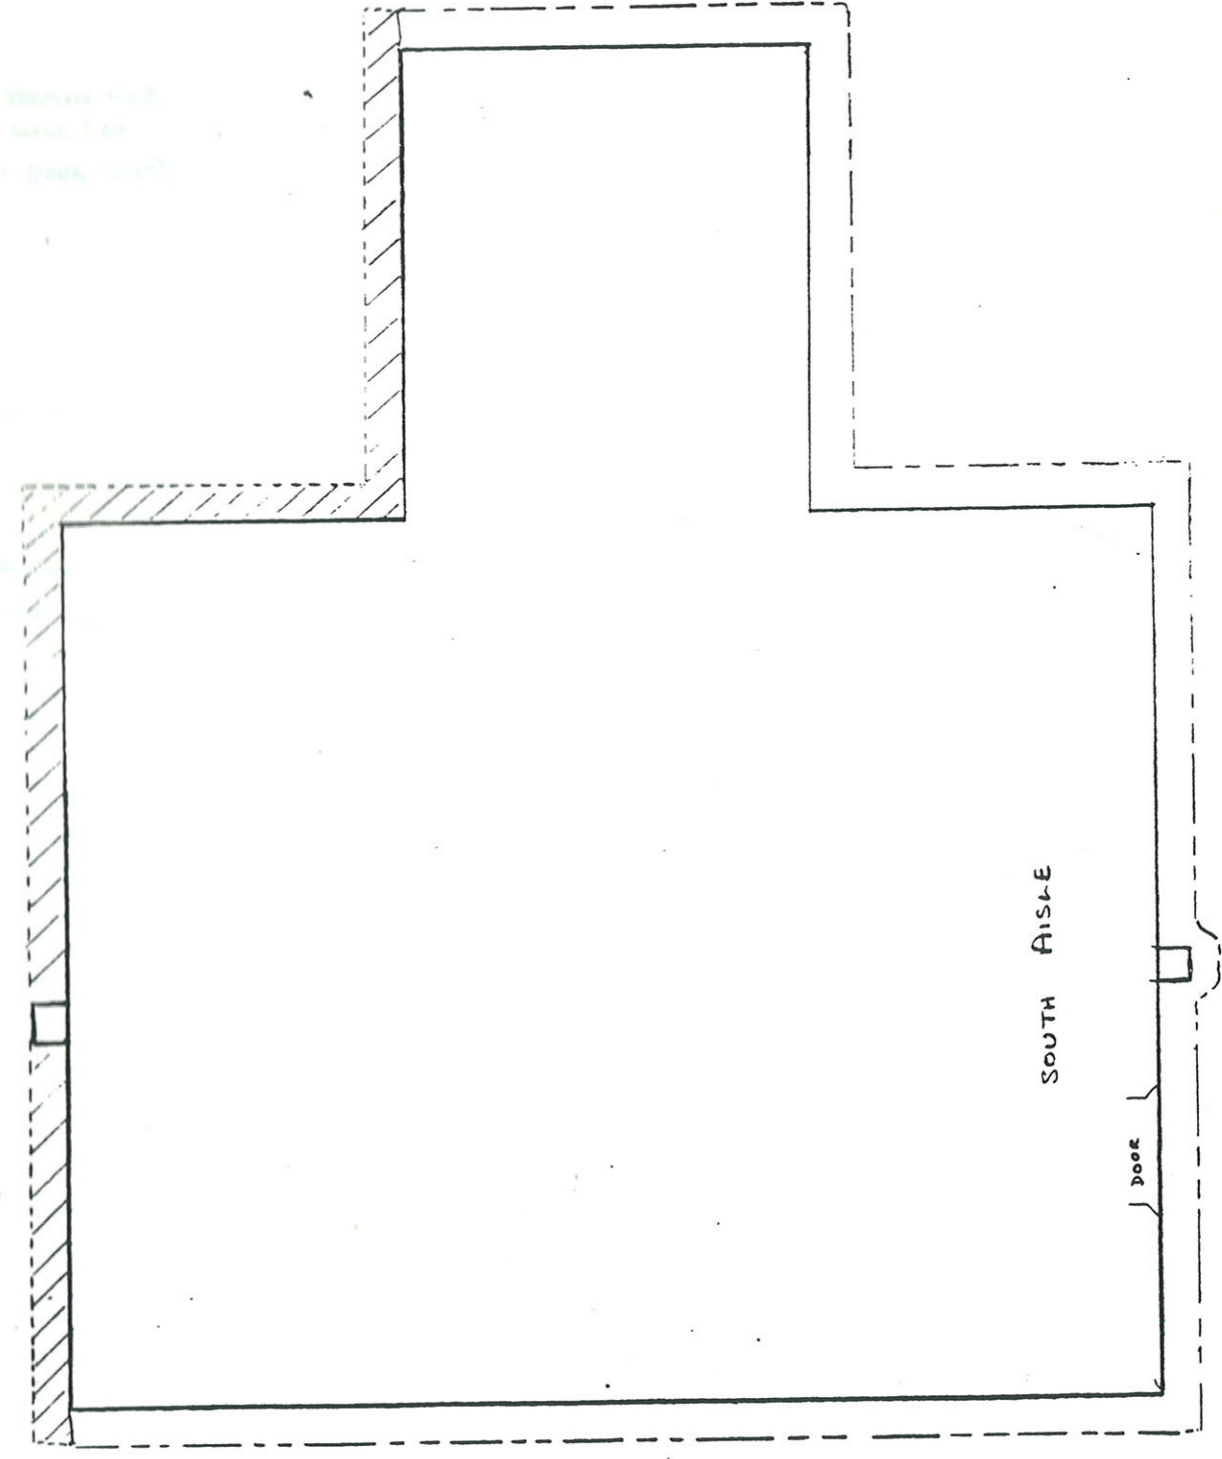
Plan No. ②
SECTION PLAN.

This overlaid, to the W and E of the present South Door, two light wall foundations, [3] and [4], oriented N-S, abutting the Aisle wall, [17], and continuing S beyond the trench. The foundations were of small to medium rough limestone blocks, unmortared.

The existing buttress, [10], rested on a pad of large, roughly worked limestone slabs, [9], which in turn was set onto a wall foundation, [7], 0.75 m wide, of medium to large roughly worked limestone slabs. The wall foundation [7] was oriented N-S, and bonded to the Aisle wall, [17]. A construction trench, [11], was visible in plan, on either side of [7], backfilled with dark brown sandy silt and decayed mortar.

At the E end of the Aisle a wall foundation, [8], was revealed in the bottom of the trench, oriented N-S, and overlaid by [18]. The foundation was of medium to large rough limestone blocks, and between 0.75 m and 1.0 m wide.

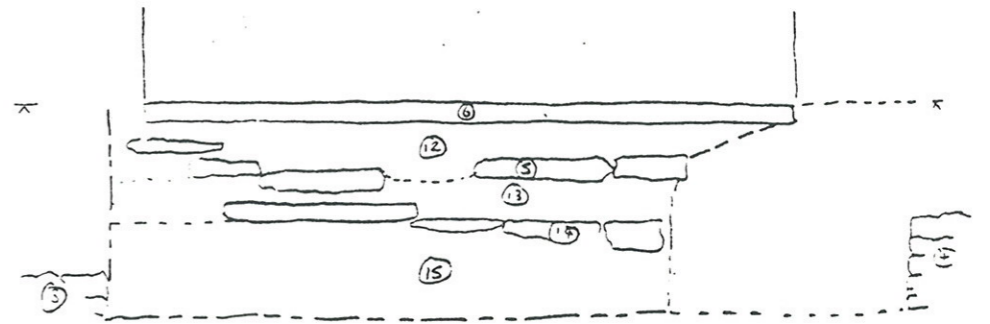
SECTION No 2.

Underneath the present South door step [6] and its bedding layer of gravel and soil [12] were two uneven layers of rough limestone slabs, [5] and [14], separated by a make-up layer of orange-brown sandy silt, [13]. Layer [14] appeared to continue in the S section of the trench.

Underneath [14] was a layer of orange-brown sandy silt, which continued below the bottom of the trench, and extended W to [3], and E to [4].
