# **HOLLIES FARM, SCHOOL LANE, HARTFORD,**

**CESHIRE WEST AND  
CHESTER**

## **Archaeological Building Investigation**

**Oxford Archaeology North**

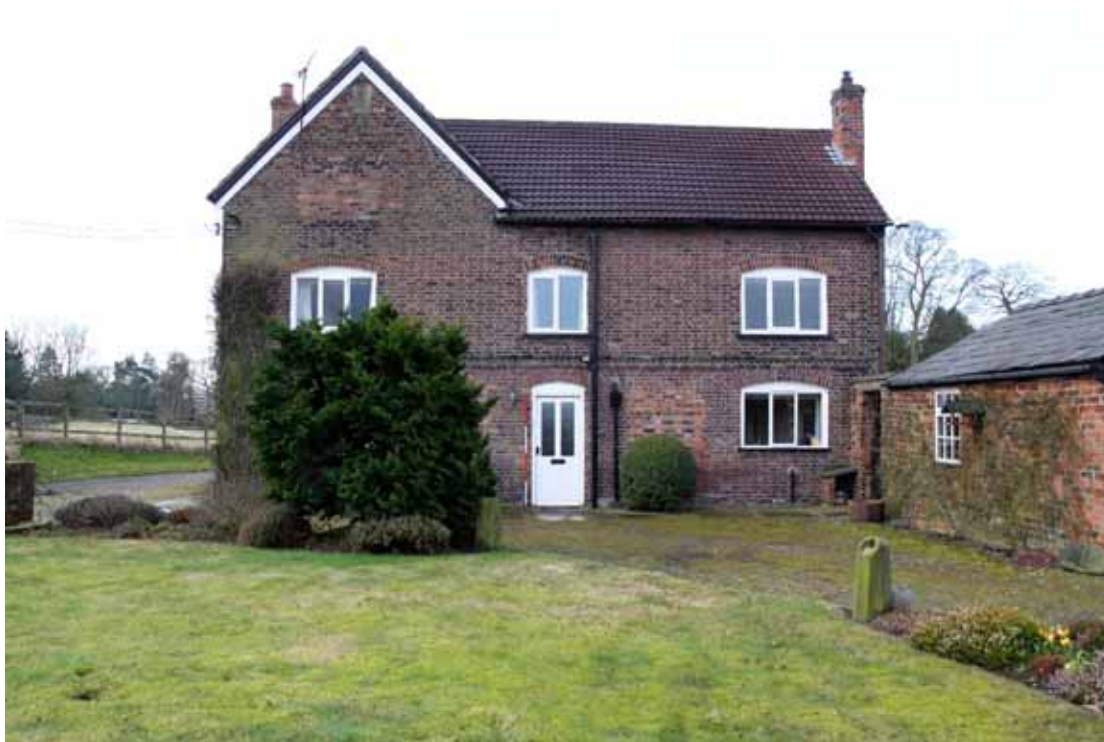
Plate 2: Front elevation of the farmhouse, one of the blocked doorways is evident, as is the blocked window at attic floor level, and the datestone

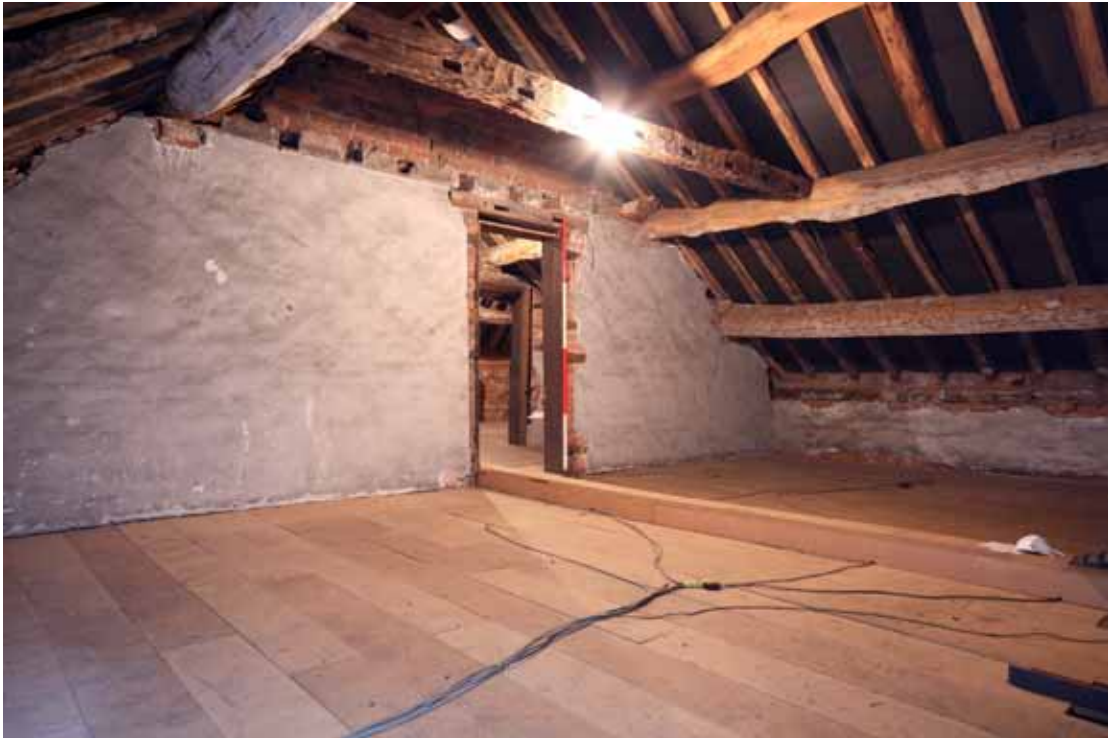
4.3.16 It is obvious that there have been a number of modern alterations to the second floor space; the entire attic space has been re-boarded with modern floorboards, and a number of raised ducts have been placed on the floor for pipes or wiring running into Rooms 1 and 2. A new felt and concrete tile roof has been added recently, and a number of the roof timbers have been replaced or strengthened with modern timbers. The majority of the walls have some evidence of being rendered and painted, although this is absent in places due to changes that have occurred. Where the render is present, it is only up to a height of 2m, and this, along with voids in much of the brickwork suggests that this floor originally had a ceiling, in some, if not all of the rooms.

Plate 11: Attic space showing sockets for ceiling joists within the tie-beam and brickwork

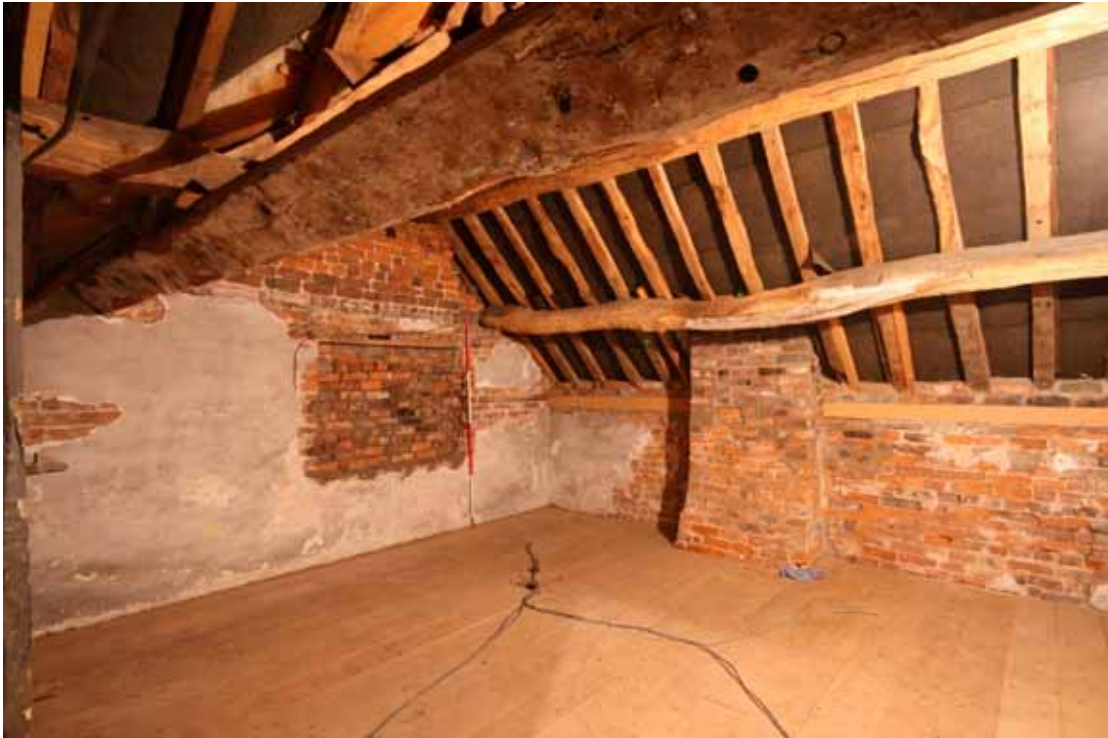
- 4.3.19 **Room 3:** this is the front room within the wing of the house. The blocked window is clearly evident from this perspective, and has a large timber lintel (Plate 13). The chimney breast seen on the previous two floors is also present here, although narrows in a stepped-formation, and the change in brickwork, where the new stack has been added can be clearly observed.

Plate 13: Blocked window within the attic, and partially re-built flue

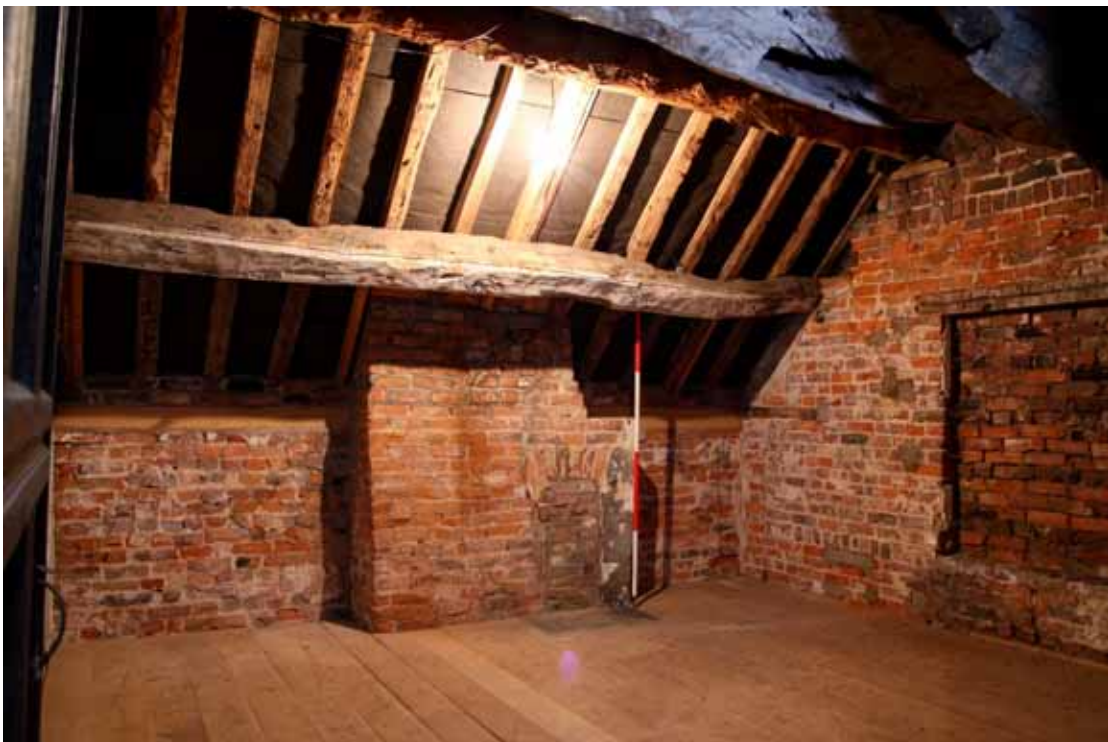
Plate 14: Blocked fireplace and blocked window in the attic

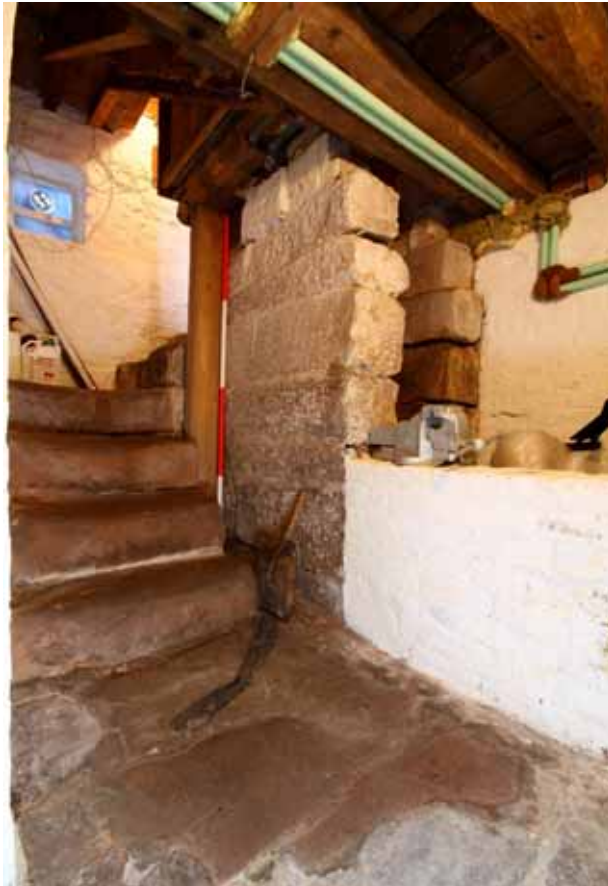
4.3.23 **Cellar:** the cellar is entered via a well worn half-turn sandstone staircase. The upper flight of which is supported by an open sandstone ashlar block construction (Plate 16). This leads into a single cell brick-vaulted cellar with a brick and cobblestone floor (Plate 17). A partially blocked cellar light or coal chute is evident on the front cellar wall. The timber joists from the floor above can be seen within the stairwell, and it appears the stairs above have also undergone some modern renovation or strengthening with plywood.

Plate 16: Detail of staircase in the cellar

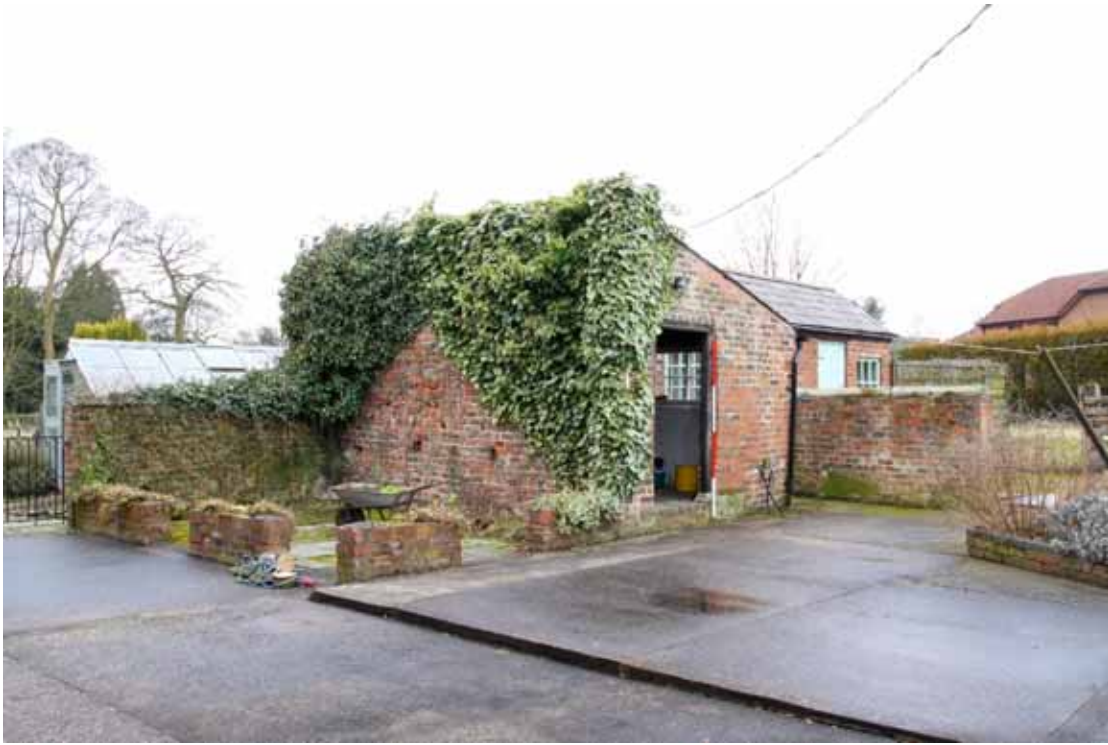
4.4.4 **Storage Shed:** a small building with a single pitch roof of open slate, which appears to have been adapted from the structure of the original house (Fig 2; Plate 18). Although most of the exterior is overgrown with vegetation, it is clear that the side elevation of the building extends above the roofline and a single casement window is present to the other side elevation with the entrance being on the gable end. Internally, the building has a partial chequer board pattern red and black tiled floor, although this has been repaired or replaced in part with a brick floor.

Plate 18: The brick outbuilding formerly attached to the farmhouse

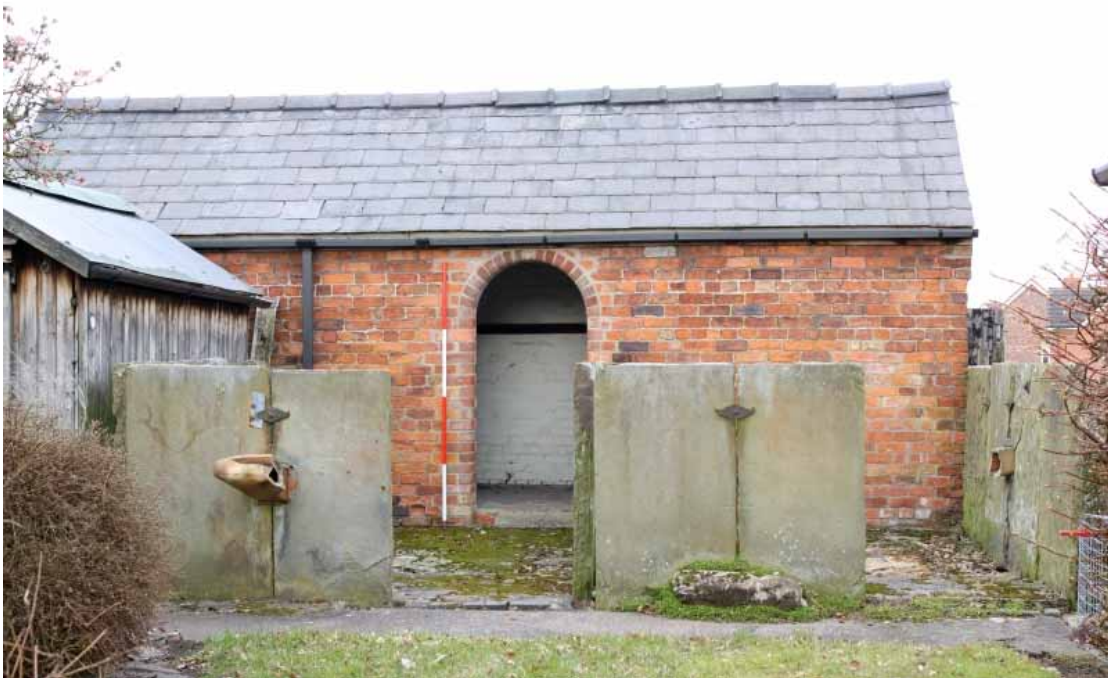
4.4.2 **Pigsty:** the pigsty, although single storey, had a poultry loft (Fig 2; Plate 19). It was constructed from handmade bricks in an English Garden Wall bond with an open timber and slate roof. It would originally have had three external pens, only two of which remain. These were constructed from large flagstones set on end. A glazed ceramic feeding chute for the two remaining pens is present. The entrance into the covered portion of the sty was through small arches with double bull-nosed brick surrounds. The two end arches remain, although these are now blocked, and have been replaced with a central tall doorway. The half-height floor which separated the pigs from the poultry has been removed, presumably to allow easier access. Poultry holes can be seen in both end elevations.

Plate 19: Pigsty with original ceramic feed hoppers in external pen walls

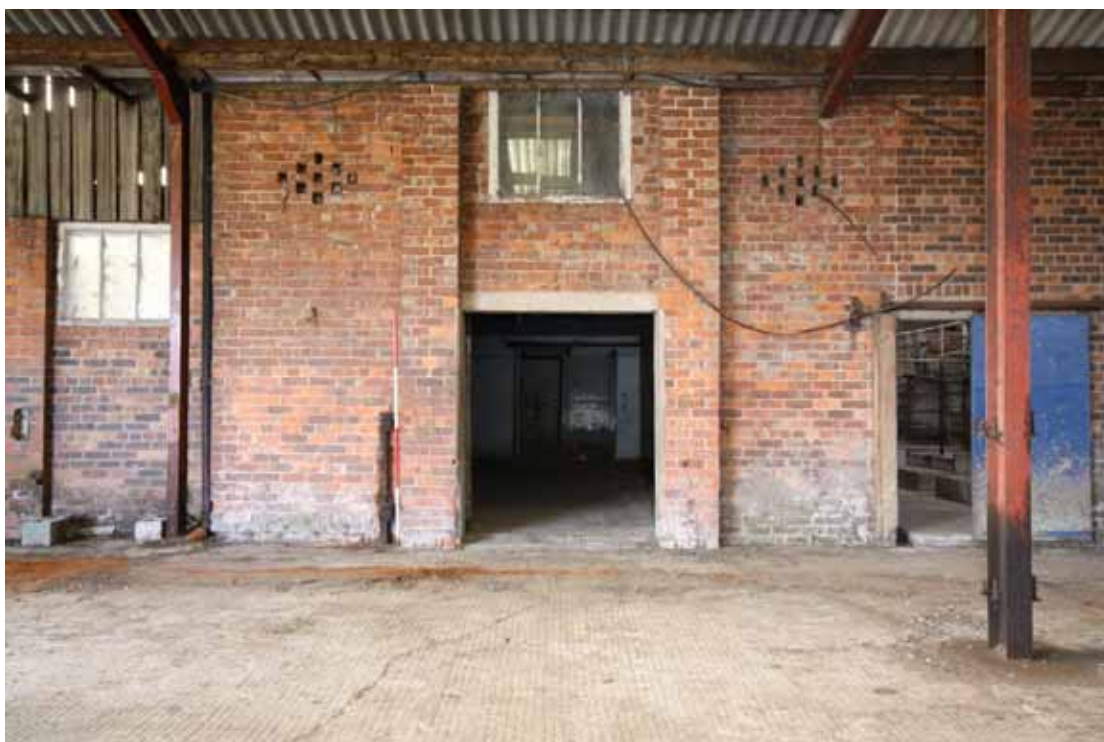
Plate 23: Gable end of the barn (Building 1), now internal, showing re-built face with Building 3 keyed in on the right

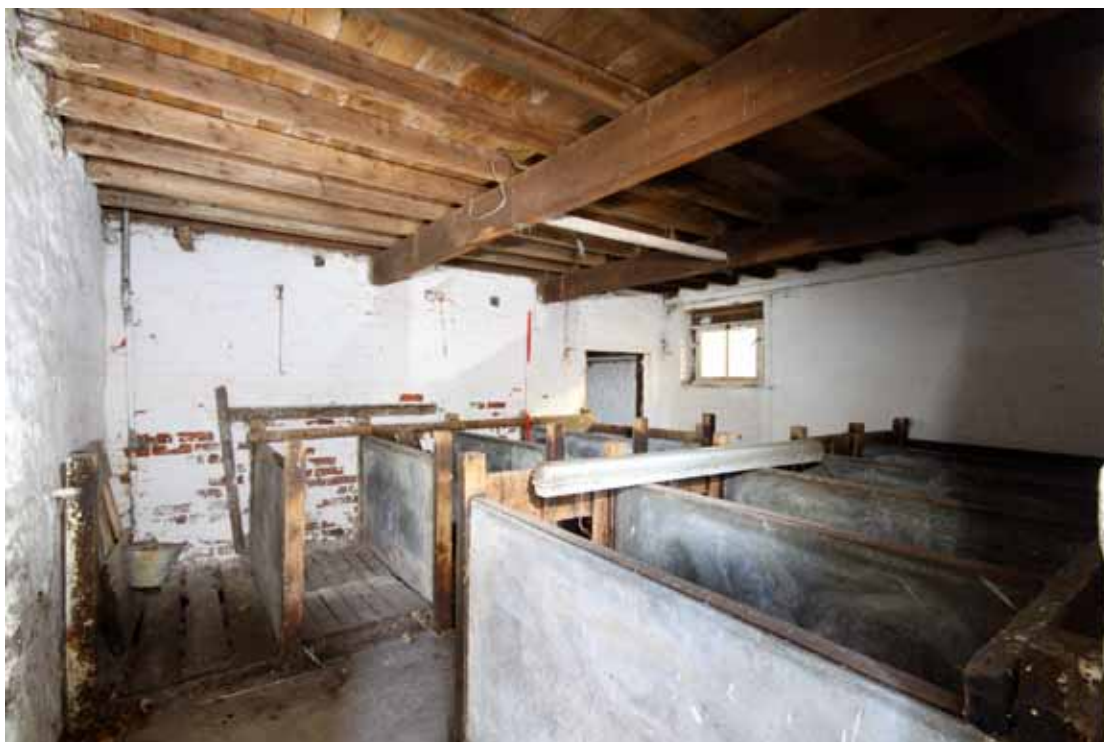
- 4.5.8 The doorway into the next room does not appear to be the original access as it has been cut quite crudely through the wall. The subsequent bay contains 10 stalls for calves, five on each wall (Plate 27). This room has a concrete floor and the new timbers to the ceiling suggest that the floor above has been replaced recently. The door through to the central bay is diagonally opposite. The only remarkable feature in this bay being a blocked air vent to the wall that divides this building and Building 3. The floor above is constructed of modern timber joists and timber panelling floor. An impressed concrete floor continues into the room beyond. The far wall of the bay is a modern addition, being roughly keyed in to the side walls. It has a centrally-placed sliding wooden door, with a large concrete lintel. It does not extend to the full height of the barn, continuing to the base of the new truss as brick buttresses. The fourth and fifth bays at the northern end of the barn comprise a room of two stories in height being open to the roof. Two buttresses also supporting a truss (Plate 28) sub-divide the bays. The walls in these bays have an additional skin of bricks up to first floor height and have been rendered up to a height of 1.9m.

Plate 27: Calf shed with modern beams over

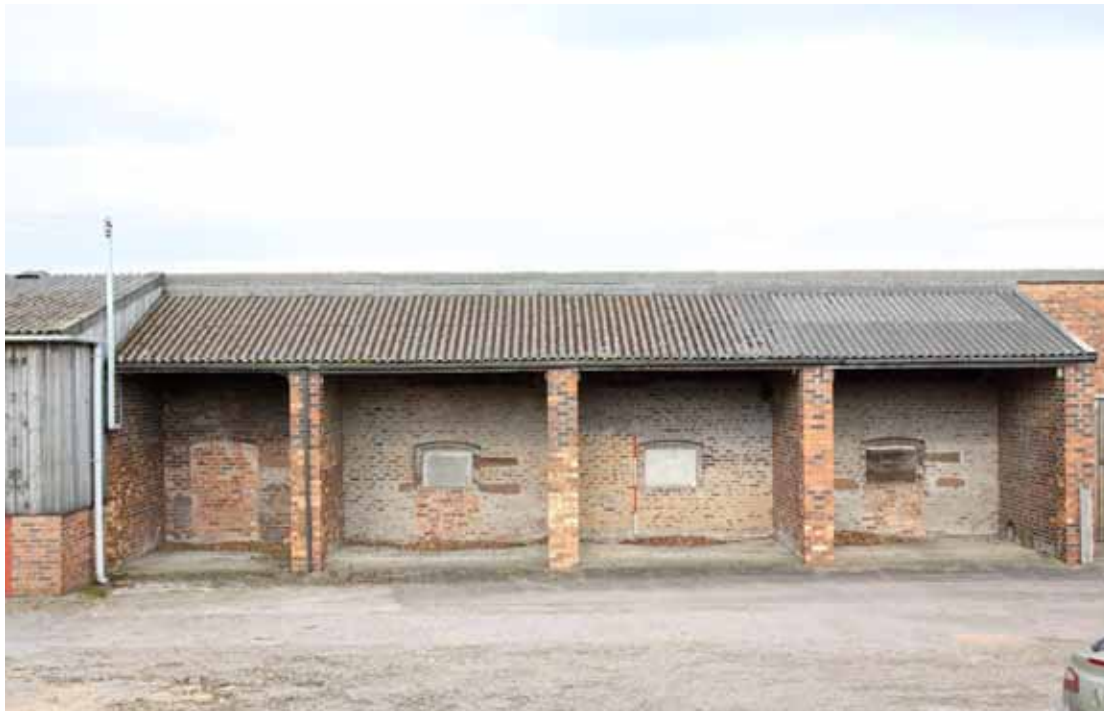
- 4.5.16 **Building 5:** is an open-fronted four-bay storage area. It was originally constructed to support the failing wall of Building 2 (Plate 30). Five one-brick wide walls were constructed to act as buttresses to prevent the collapse of the cow shed (*pers comm* John Eaton), and followed with a single pitch asbestos and timber roof. Within each bay a blocked up doorway is evident; these appear to originally have had bull-nosed reveals and sandstone pads in the jambs, prior to being bricked up to form windows, which have also since been covered. Every other bay also contains a circular brick pitching eye of the same style as noted in Building 1. Several brick air vents are present and these have mostly been blocked or are now behind the projecting walls.

Plate 30: Building 2 incorporated into Building 5, showing a series of blocked doorways
