The Town Hall Deddington Oxfordshire

Historic Building Investigation

March 2013

Document Type: Historic Building Recording and Investigation

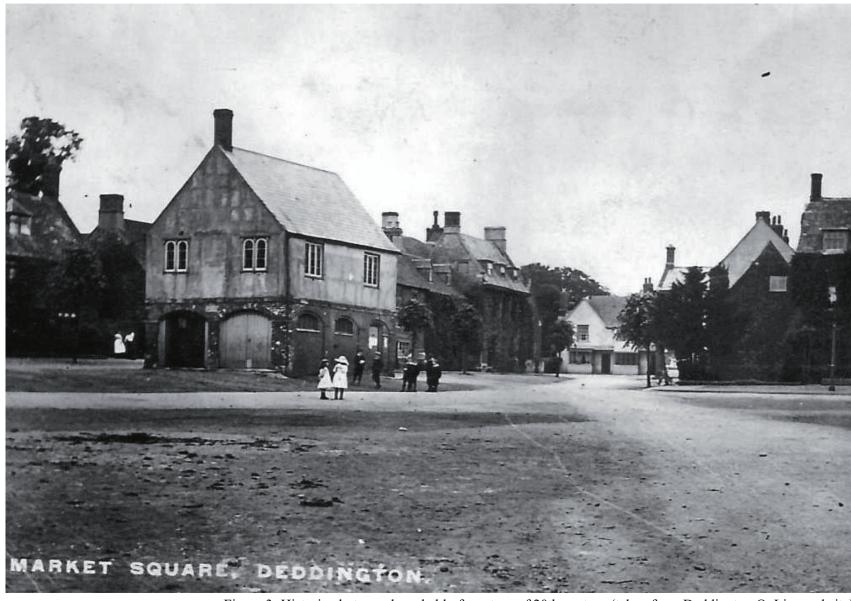
Figure 3: Historic photograph probably from turn of 20th century (taken from Deddington OnLine website)

- 2.1.6 The ground floor, which was originally open sided, had three stalls used by butchers on market days but in the mid 19th century it was blocked up and enclosed to form a shelter for the parish fire engine which had previously been kept in the church. An historic photograph probably taken from around the turn of the 20th century survives and this shows the building with the enclosed ground floor (see Fig 3). The photograph is taken from the Deddington OnLine website.

- The east elevation has two timber windows at first floor, each of which has three 3.2.1 columns of four small lights. An historic photograph (see Fig 3) possibly from around the turn of the 20th-century shows the elevation and the windows are shown with a similar arrangement to those today. The windows appear to be of later 19th-century date and they are likely to be the same as those in the photograph. At ground floor there are three segmental brick arches, the two southernmost of which are open and allow access to the covered area. The northernmost arch is partially infilled with brick and incorporates a doorway into the building as well as two large noticeboards. The photograph from the turn of the 20th century appears to show this doorway and northernmost infilled arch but it also shows the other two arches as being enclosed. These arches each appear to have had brick infill and high windows following the line of the arch. These windows appear similar to those surviving in the north elevation. A string course divides the ground floor from the upper storey. At each end of the elevation there are plates from tie-bars that run through the building and help to strengthen the north and south walls. At the southern end of the elevation is a lamp fixed to the wall which is not shown in the historic photograph.

- 3.2.2 The *south elevation* has two first floor windows and between these is a large crest with a coat of arms. Each window has eight lights (two columns of four lights) and although the openings appear the same as those shown on the historic photograph the windows themselves are different. Those shown on the photograph have semicircular heads to the two lights in each window and they appear to have had simple hood mouldings. The two ground floor arches are today open faced but the historic photograph shows that around the turn of the 20th century each of these had double doors for the fire engine that was

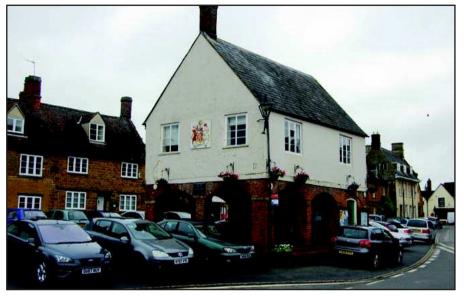
Plate 1: General view from south-east

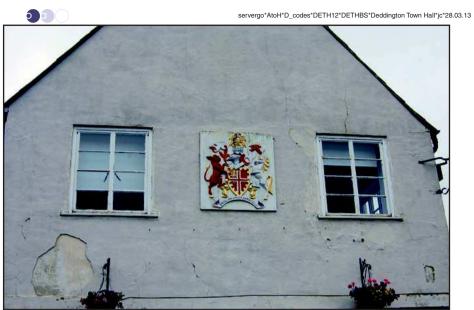
Plate 2: Coat of arms on south elevation

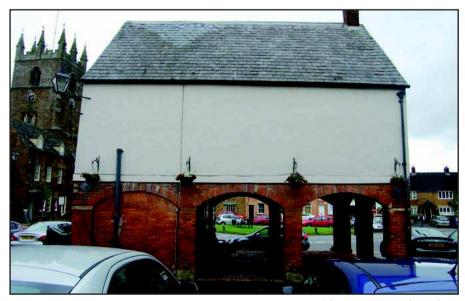
- 3.2.5 The *west elevation* is relatively featureless with no windows at all and the northern of the three ground floor arches infilled with brick. This brick infill incorporates a smaller segmental arch immediately below the main arch and although there are no straight joints beneath this there does appear to be a section very carefully rebuilt, which is suggestive of a former window. This would have been a conventional window as opposed to one of the high windows surviving in the north wall.

Plate 3: West elevation

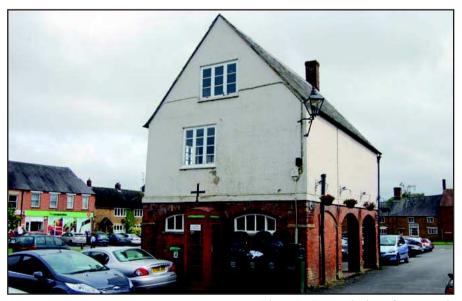
- 3.2.4 The *north elevation* has a window at first floor and a further window above towards the apex. The lower of these windows has 12 lights (three groups of four windows divided by two timber mullions while the window above is similar but with 9 lights (three groups of three divided by two mullions). At ground floor the two arches have been infilled with brickwork and they each retain high windows which appear to be the same as those shown in the historic photograph in the east elevation. At the centre of the elevation is a phone box and as mentioned above this is a Grade II listed building.

Plate 4: General view from north

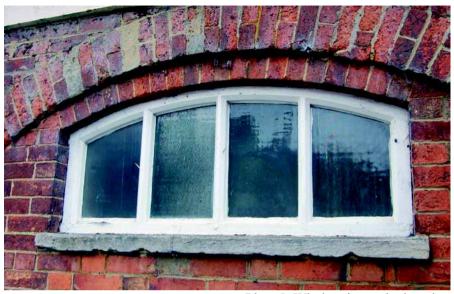
- 3.3.13 The lower window in the north wall is likely to be of mid 20th-century date (or later) with 12 lights and simple curves to the glazing bar intersections. The upper window at this end is too high for a close examination but it also appears to be relatively modern with 9 lights and two simple timber mullions.

Plate 5: Window in north elevation

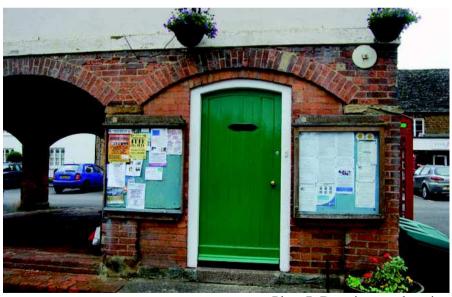
Plate 7: Door in east elevation

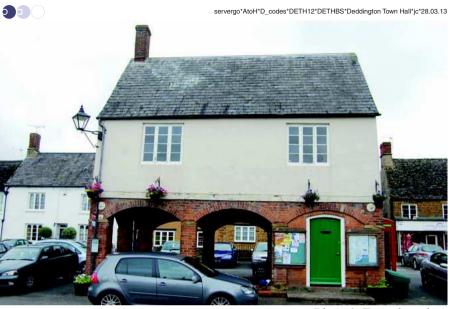
Plate 6: East elevation

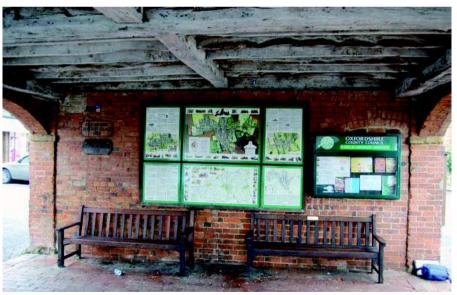
Plate 8: North side of undercroft

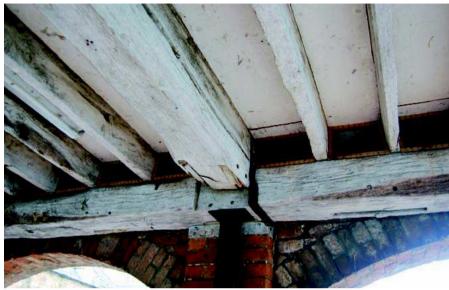
- 3.3.2 One of the most interesting aspects of the building is the underside of the first floor, visible from within the covered area, and the clear evidence of the former arrangement when the building (or a previous building from which this was reused) was fully timber framed. This floor structure has the form of a 16th or earlier 17th century building and it seems likely that it was from the previous town hall which had been built by 1611. It is uncertain whether the floor was fully dismantled and reconstructed or whether this floor could be a surviving in-situ fragment from a heavily altered building.

- 3.3.3 The current floor comprises intersecting chamfered beams (E-W principal joist [30 cm²] N-S binder and E-W common joists). At the eastern and western ends are wall plates which support the common joists. Mortices in the undersides of the wall plates and the ends of the principal joist confirm that there would have been timber posts instead of the current brick piers and the posts would have had arched braces to the sides and curved brackets inside.

Plate 9: Details in underside of first floor

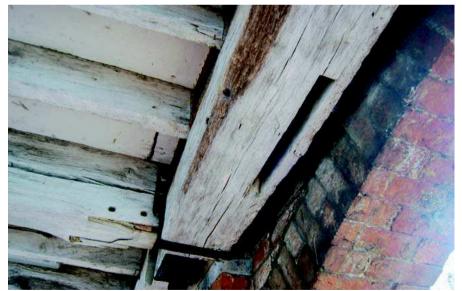
Plate 11: Empty mortice in underside of first floor

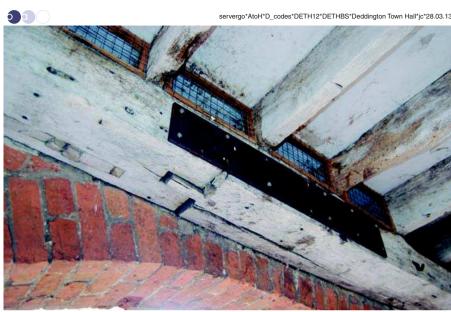
- 3.3.5 Several iron and/or steel strengthening bars and plates have been added to the timber floor, particularly to brace joints. Some of this is likely to be from the early 19th century reconstruction but some is recent. The underside of the stone hearth on the south side of the building is visible

Plate 10: Scarf joint and metal strengthening in first floor

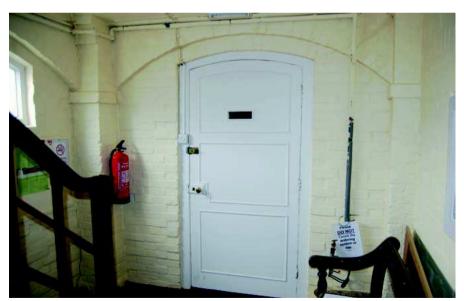
Plate 15: Rear of front door

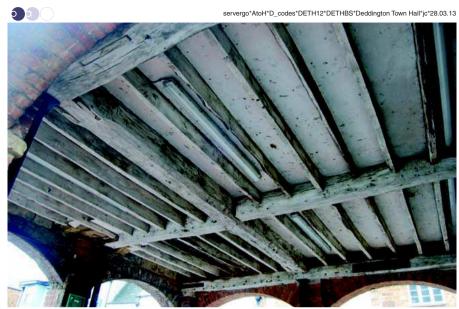
Plate 14: General view of underside of first floor

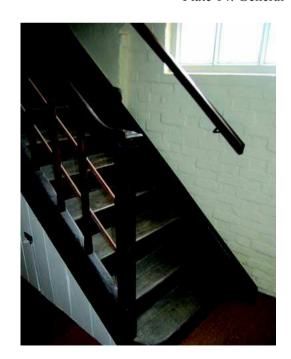
3.3.8 The northern bay of the ground floor is an enclosed internal space and it comprises a staircase against the north wall, rising from the north-east corner, and two small rooms against the west wall (a WC and store). The timber staircase has a plain square-section newel post, square-section balusters and tongue-and-groove board cladding beneath it. They appear to be be of earlier 20th-century date. The walls in this area are of painted (unplastered) brick and there is a simple ceiling. The windows in the WC is a hopper light, hinged along the base.

Plate 16: Staircase

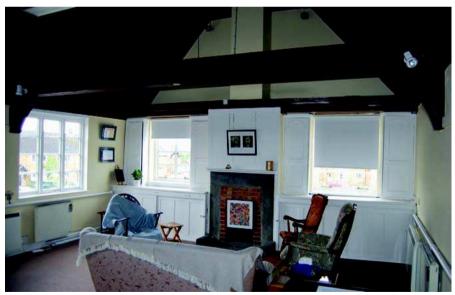
- 3.3.10 The first floor is largely a single open space with a panelled enclosure at the north-west corner housing the head of the staircase. The room is open to the slope of the roof but the rafters are hidden by dark stained tongue-and-groove boarding which is secondary (possibly earlier 20th century). There are two trusses with tie-beam supported by corbels at each end, principal rafters and a high collar but the nature of these members is largely obscured by boxing/cladding which is probably contemporary with the tongue-and-groove ceiling boards. There is a moulded cornice around the edge of the room which is also dark and appears to be secondary.

Plate 19: General view of first floor room

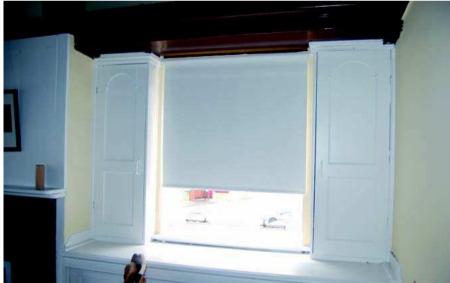
- 3.3.11 At the southern end of the room there is a simple stone fireplace with plain timber mantelpiece which is likely to be primary (with some alterations) and built-in cupboards to either side with sliding doors. Above and within this panelling there are two windows which are of metal framed, crittal type and likely to be from the inter-war period. Each one has two 4-light casements and a timber sill. It is interesting to note that to either side of the window the panelling incorporates tall narrow arches which are similar to the arches in the window formerly at this location and shown in the Edwardian (?) photograph (Fig 3). Presumably the panelling was contemporary with the former window and formed part of the same design.

Plate 20: Panelling and window in south wall

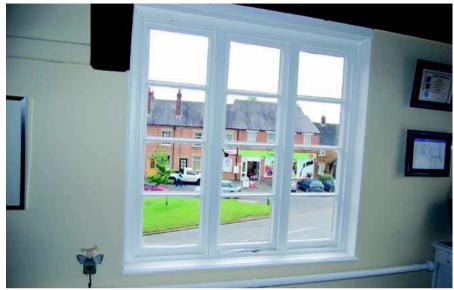
- 3.3.12 The 12-light timber windows in the east wall (3 'piers' of four lights divided by two simple ovolo moulded mullions) are of probable later 19th-century date and are very likely to be the same windows as those shown in the historic photograph from the turn of the century. The central four lights are a casement.

Plate 21: Window in east wall

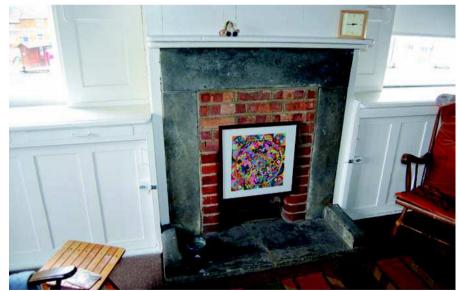
Plate 23: Fireplace in south wall

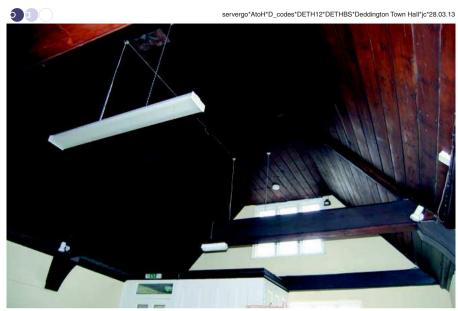
Plate 22: General view of roof

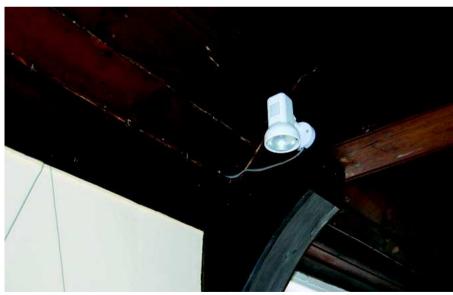
Plate 24: Detail on corbel in roof structure
