# Montague Farmhouse Hethe

**Building Recording  
and Investigation**

March 2009

**Document Type:** Building Recording and Investigation

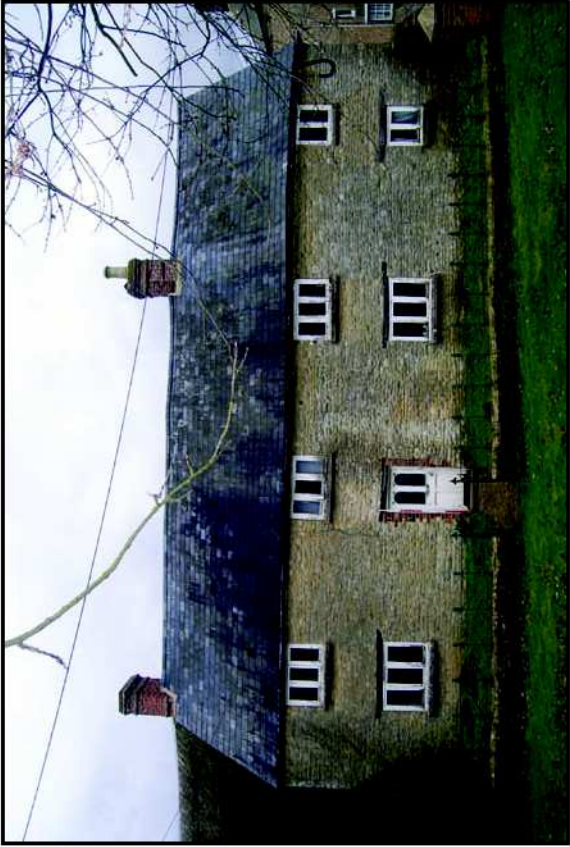
- 3.2.1 *West Range:* The western elevation has a façade of roughly worked but evenly coursed small stones (Plate 1). This appears to have been re-pointed with cement fairly recently. There is an iron S-shaped tie in the upper right hand corner. The slate roof has a steep pitch with two later red brick chimneys. The right chimney, unusually, appears to have two phases, indicated by a break in the brickwork and irregular detailing.

Plate 1: West Elevation

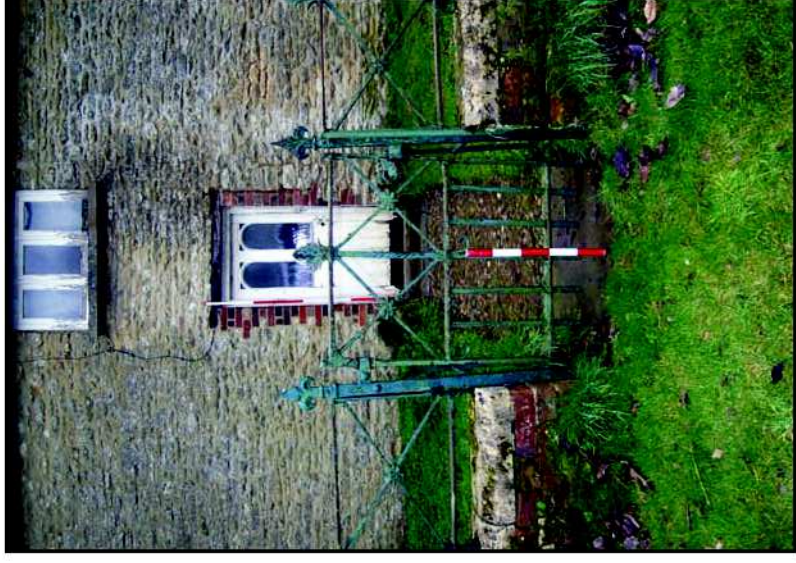
- 3.2.3 There is a late 19th/ early 20th century red, brick garden wall and a low iron fence surrounding a small patch of ground in front of the west range. What appears to be an original cobbled path leads to the door (Plate 2).

Plate 2: Doorway on west elevation

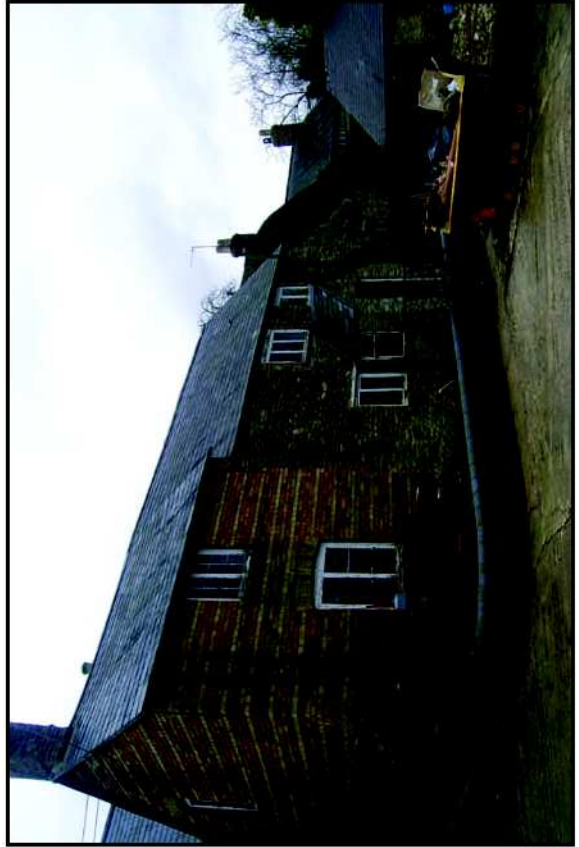
- 3.2.4 *East Range:* The eastern range is made up of the original, two-storey stone built farmhouse, a stone lean-to at the northern end, which may or may not be contemporary with the farmhouse, and a 19th century, two-storey red brick extension at the southern end (Plate 3).

Plate 3: East elevation, looking north west

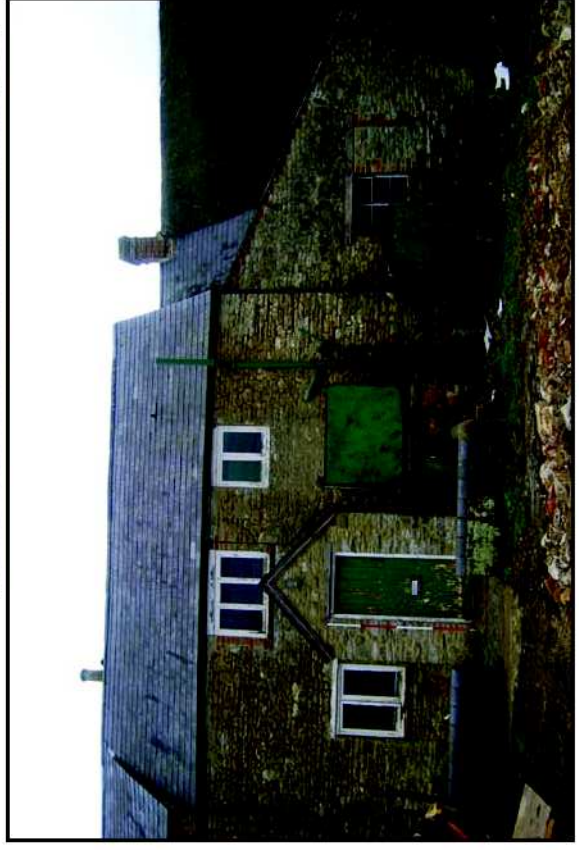
- 3.2.5 The central original elevation has a façade of small, roughly worked but evenly coursed stone with a smooth, yellowish lime mortar and is divided into three bays (Plate 4). The ground floor has two windows, one in the first bay and one in the third (left-right), which

is blocked and a door in the central bay. A modern breeze block porch with a facing similar to the original stonework is built around the original doorway. The upper storey has a three-pane wooden casement with red brick quoining in the central bay and a smaller two-paned casement in the third bay. All of the windows on this elevation appear to be contemporary with the windows in the west range. There is an area of red brick patching under the ground floor window in the first bay.

Plate 4: East elevation, Original farmhouse and lean-to, looking west

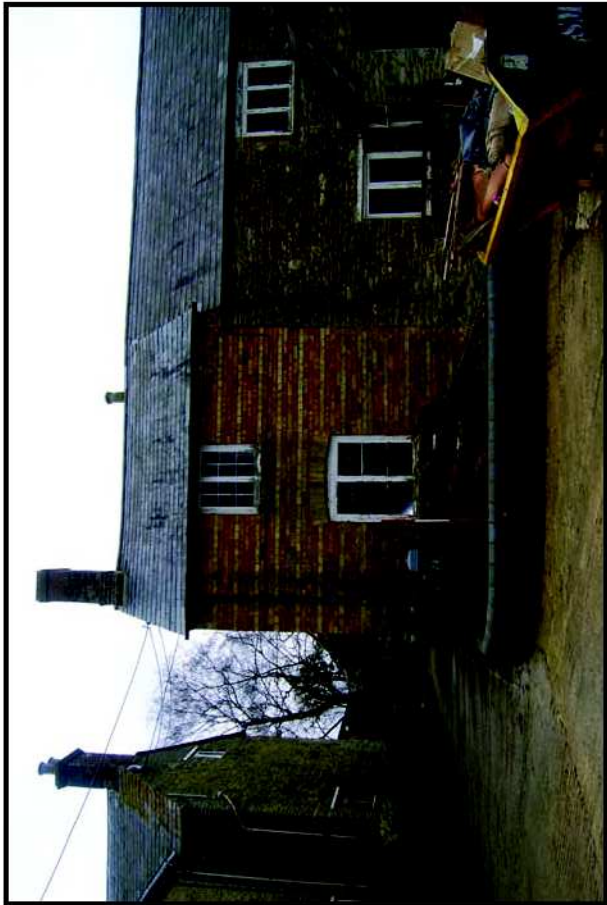
- 3.2.7 The 19<sup>th</sup> century extension on the south end of the range is a two-storey brick built structure (Plate 5). It has English bonded red brick with a row of yellow headers every fourth course. On the ground floor is a large, six-pane wooden casement window with a segmental arch of yellow brick over it. On the first floor is a smaller twelve-pane casement that sits under the eaves. Although the ridge beam on the roof of the extension and the original house join, the east face of the extension is sighter taller than that of the original making the angles of the two roofs different and the pitch of the extension slightly shallower. The roof of the extension slightly overlaps the roof of the original house.

Plate 5: East elevation, 19th century extension

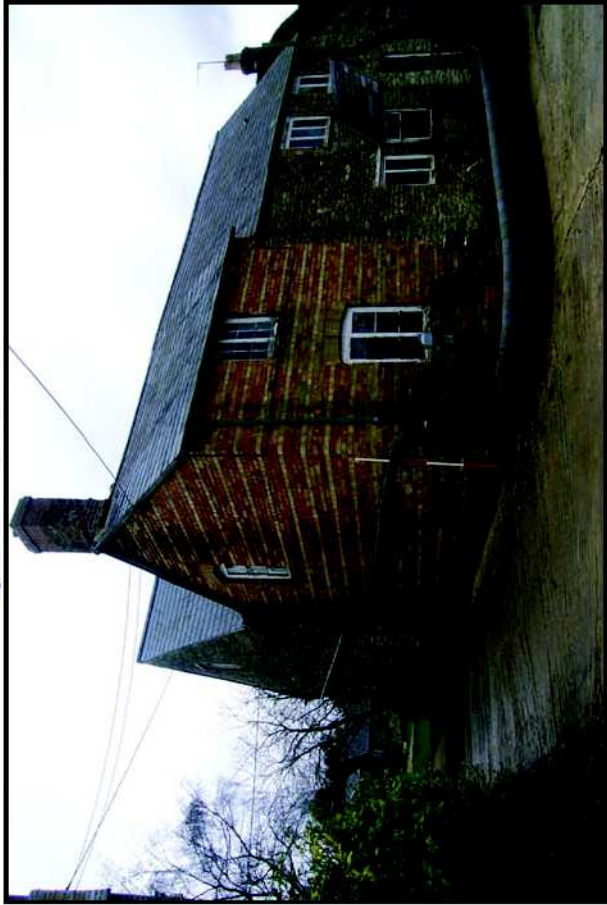
- 3.2.8 *South elevation:* The south elevation is made up of the two gable ends of the adjoining east and west ranges (Plate 6). The gable of the 17<sup>th</sup> century west range is taller than the gable of the 19<sup>th</sup> century extension on the east range and stands proud from it by approximately 0.5m. It has small roughly worked but evenly coursed stones and has recently been re-pointed with cement. There is a small loft window with a wooden frame and a stone lintel in the centre of the gable.

Plate 6: South elevation, gable end looking north west

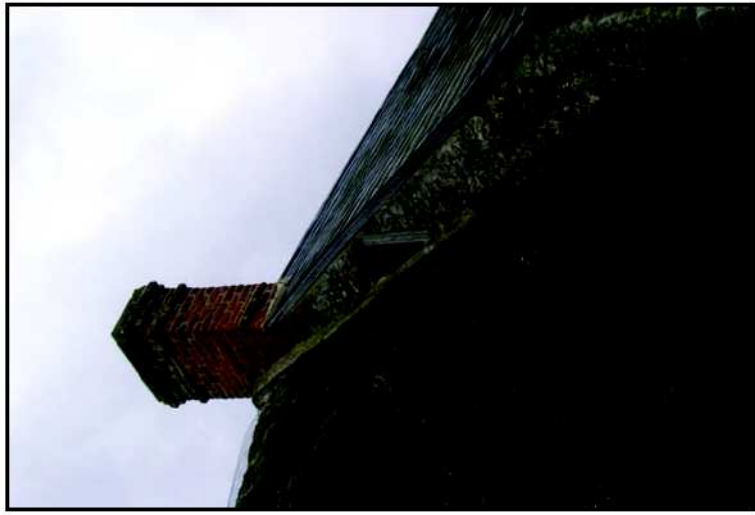
- 3.2.11 The gable end of the west range stands proud of the eastern gable by approximately 3m at the northern end. There is a thatched cottage built onto it which obscures most of the wall and half of a small loft window on the right hand side (Plate 7).

Plate 7: North elevation, Window obscured by Thatch cottage

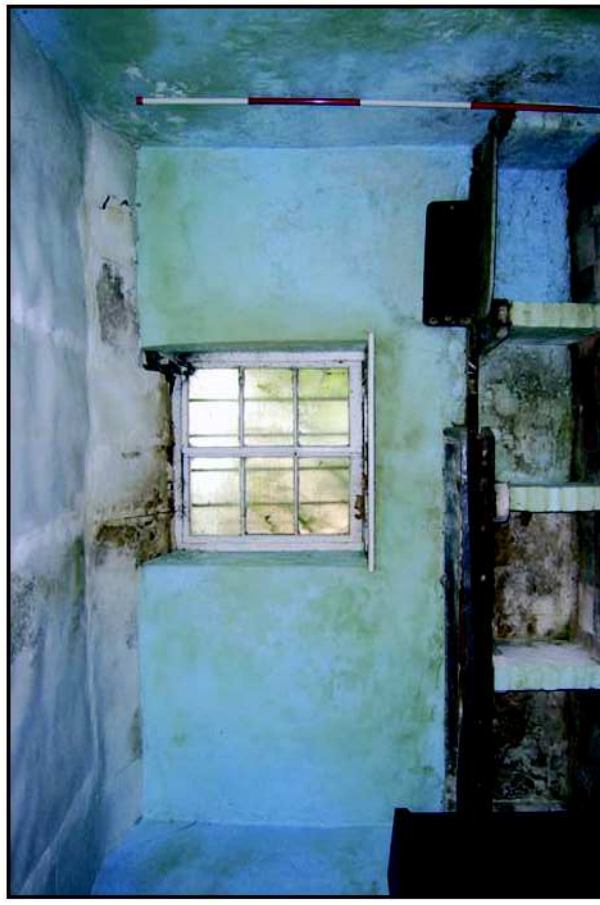
- 3.3.1 *Room 1* - The dairy is located in a single storey extension located in the north eastern corner of the rear (eastern) range (Plate 8). The flooring is laid with red clay tiles which have been painted alternately black and white. The ceiling is 20<sup>th</sup> century plaster board with roughly applied plaster over the joins and it is angled downwards towards the northern edge, presumably due to the angle of the single pitch roof above. The northern

wall has a 20<sup>th</sup> century wooden casement window with metal bars on the outside. The eastern wall has a larger opening for a window, this has been partly blocked and a modern casement window with metal frame inserted. The west wall has a section of deeper walling with a curved return. This wall is shared with the adjoining thatched cottage which may explain the structure of the wall at this point.

Plate 8: Room 1, east wall

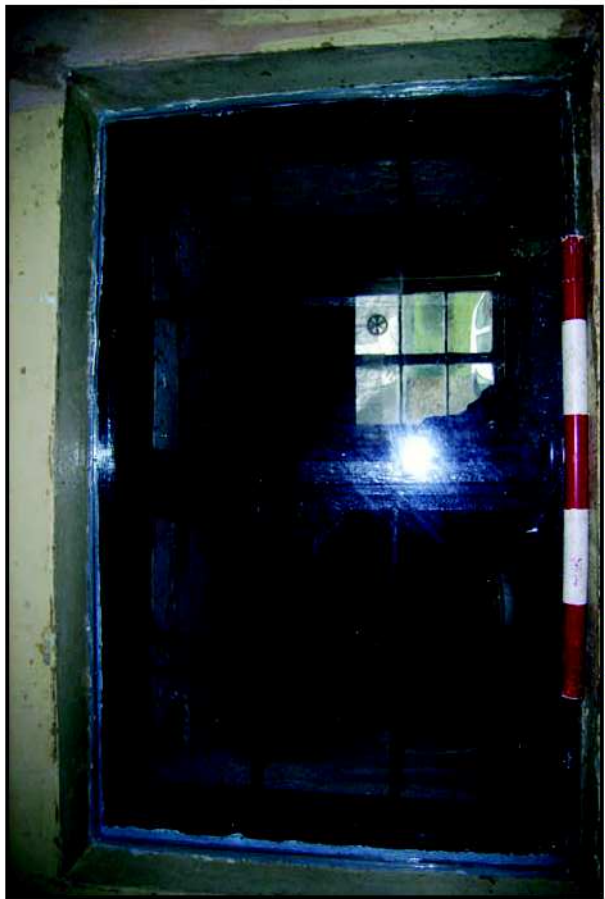
- 3.3.7 *Room 5* - This room is the ground floor of the 19<sup>th</sup> century brick extension to the main house and contains a large fireplace on the south elevation which currently has an Aga style cooker (Plate 14). There are large cupboards to each side and the north elevation has a large wooden dresser. Above some late 20<sup>th</sup> century kitchen cupboards on the west

elevation is a small casement window enclosed from this room by a glass panel (Plate 15).

Plate 15: Room 5, Internal casement window, looking west

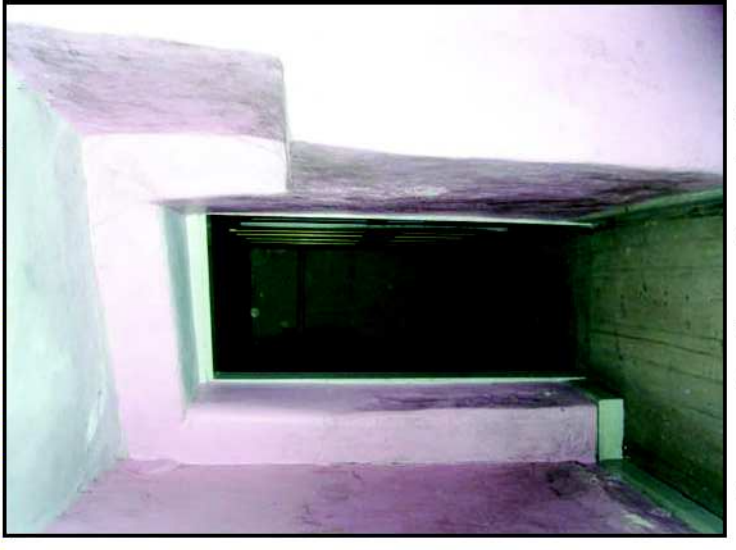
- 3.3.18 *Hallway* - The hallway is mostly covered with a thick rough plaster (Plate 28). There is a small shelf cut into the wall beside the entrance to room 13. The 19<sup>th</sup> century wooden staircase leading up to the attic is accessed via a plank and batten door. The staircase has been enclosed with a wall of timber planks.

Plate 28: First floor Hallway, looking south

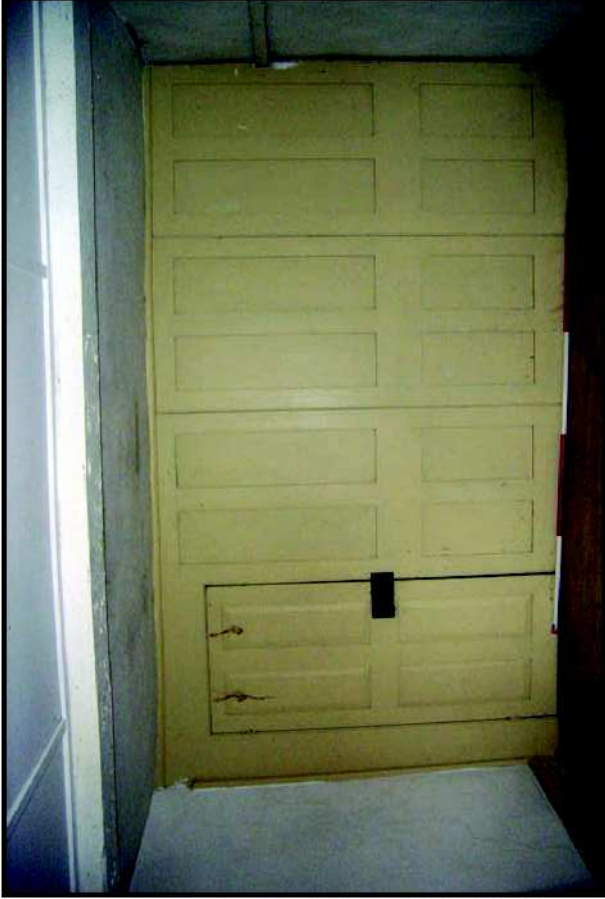
- 3.3.15 *Room 12* - This room is separated from the hallway by a thin divide formed of wooden panels (Plate 25). The ceiling is partially plastered and partially board and batten as seen previously. A timber beam is visible and spans from north to south. The north wall is angled from top to bottom.

Plate 25: Room 12, East wall

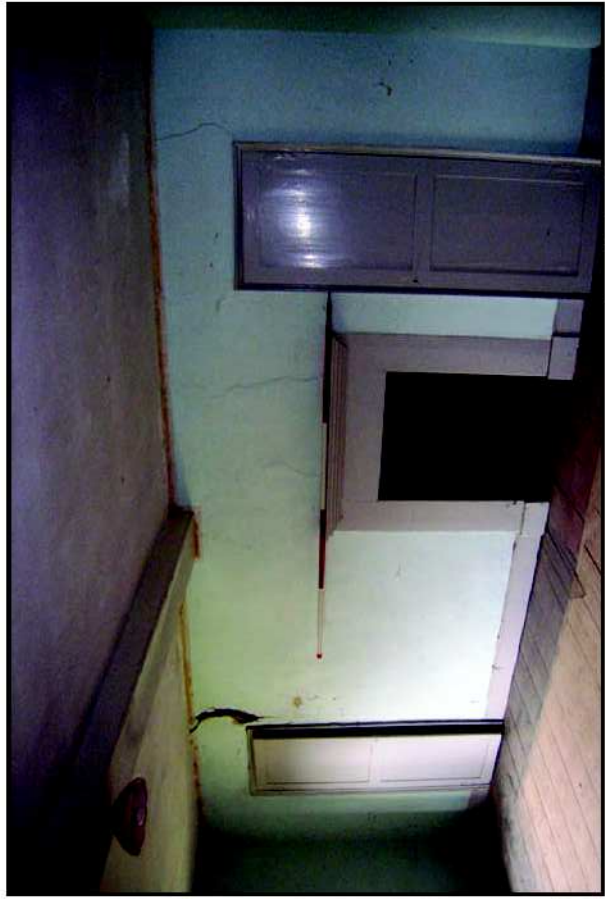
- 3.3.17 *Room 14* - This room has another 19<sup>th</sup> century fireplace set off centre between two cupboards (Plate 27). The north western cupboard has 19<sup>th</sup> century blue and beige wall paper within. The window for this room is a late 19<sup>th</sup> century/ 20<sup>th</sup> century replacement. The beam spanning the room from north to south has been encased with timber planks, presumably to hide modern electricity fixings.

Plate 27: Room 14, North wall, looking north west

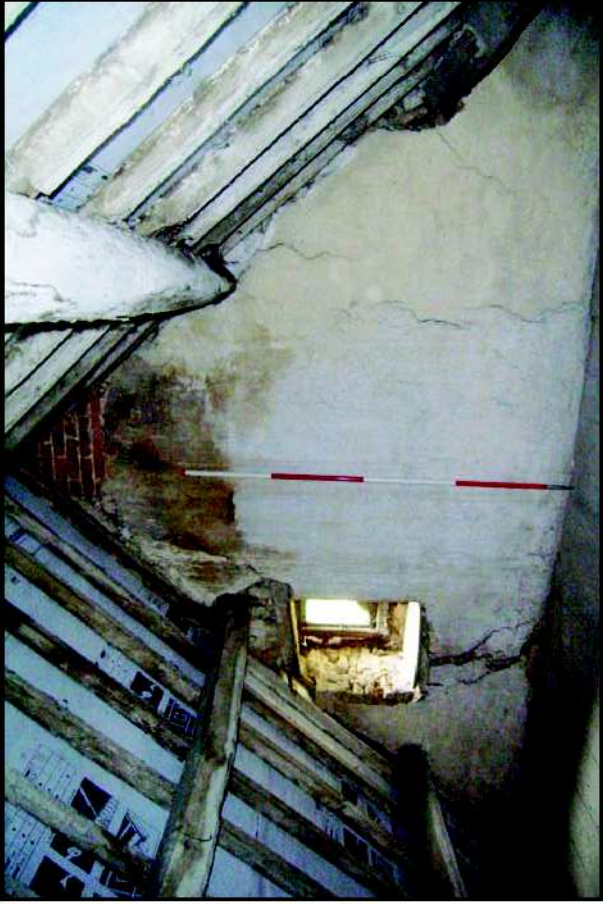
chimney stacks rising from the ground floor. The northern room has a small window which is partially obscured by the neighbouring Rose Cottage's thatched roof (Plate 29). The window is currently loosely blocked on one side with old clay roof tiles. There is a patch of red bricks in the gable wall beneath the apex but otherwise this wall is of stone construction and plastered. The southern room is smaller in size as it has lath and plaster partitions sectioning off the base of the pitched roof on the east and west sides. There is also a lath and plaster ceiling with angled edges to allow for extra room height however the butt purlins of the roof structure can still be seen (Plate 30). The central roof space allows the construction of the butt purlin roof to be seen in full (Plate 31). It is known that the roof of Montague house were extensively repaired in the late 20<sup>th</sup>/early 21<sup>st</sup> century by the previous owner, however it can be seen that many older timbers survive so the repairs were mainly to the tiles boarding forming the covering. The flooring of the attic is wooden planks, however at the location of the cupboard in room 13 the planks are laid differently suggesting that this was used as stair access to the floors below.

Plate 29: Attic, North gable end, looking north

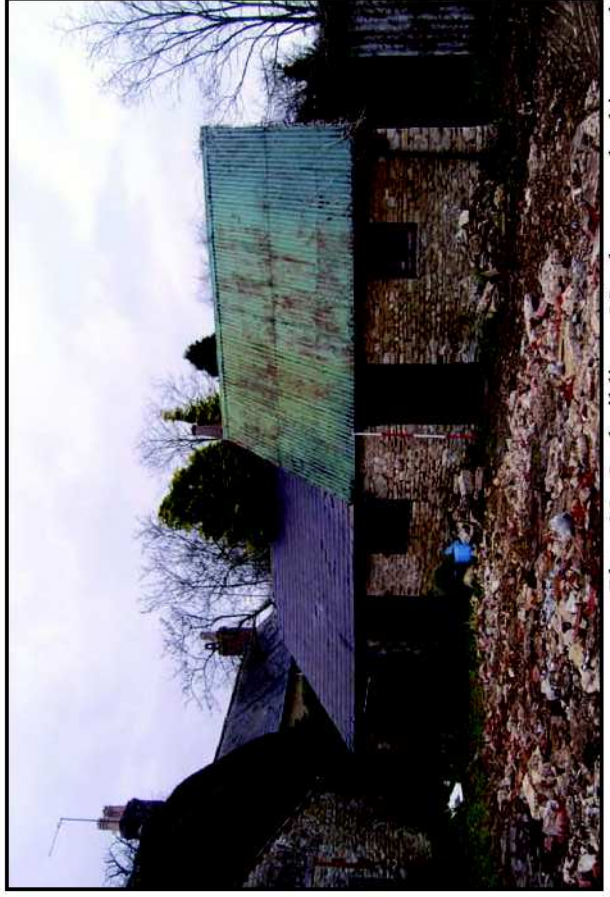
3.4.2 *The North Range-* The North range is made up of two adjoining sheds and, although altered over time, both appear to date to the 17th century (Plate 32). It is likely that the left hand shed is contemporary with the original structure in the east range of the farmhouse, the right hand shed being built soon after.

Plate 32: Outbuildings, North range, looking north

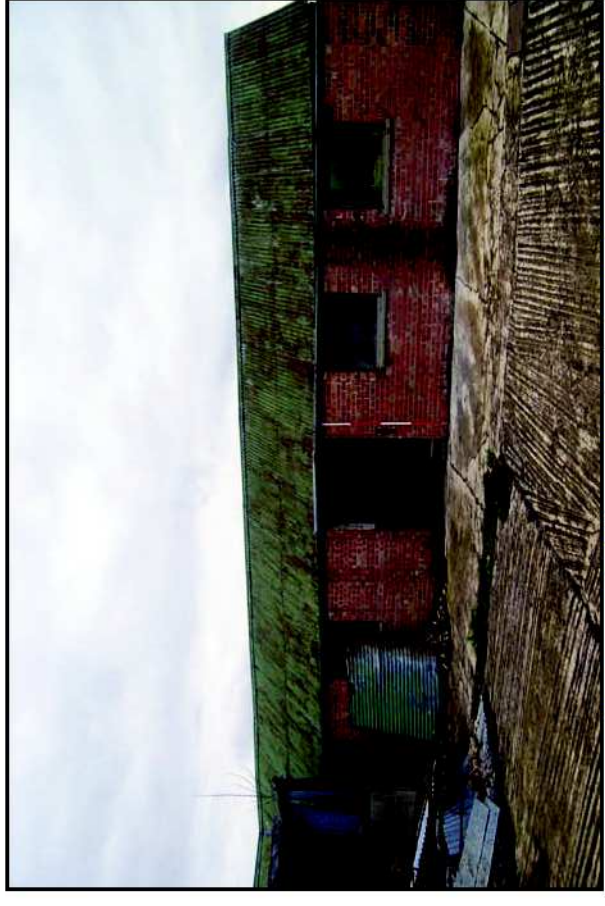
Built on to the east side of the gable is the end of a 20th century red brick building with a corrugated iron roof running north to south (Plate 36). The four windows are unglazed and the entrances, one on the west face and two on the east face, have no doors.

Plate 36: Outbuildings, East shed of central range, looking east
