St Martin's Hospital
(Former Union Workhouse)
Bath
Somerset

**Historic Building Investigation
and Recording**

March 2006

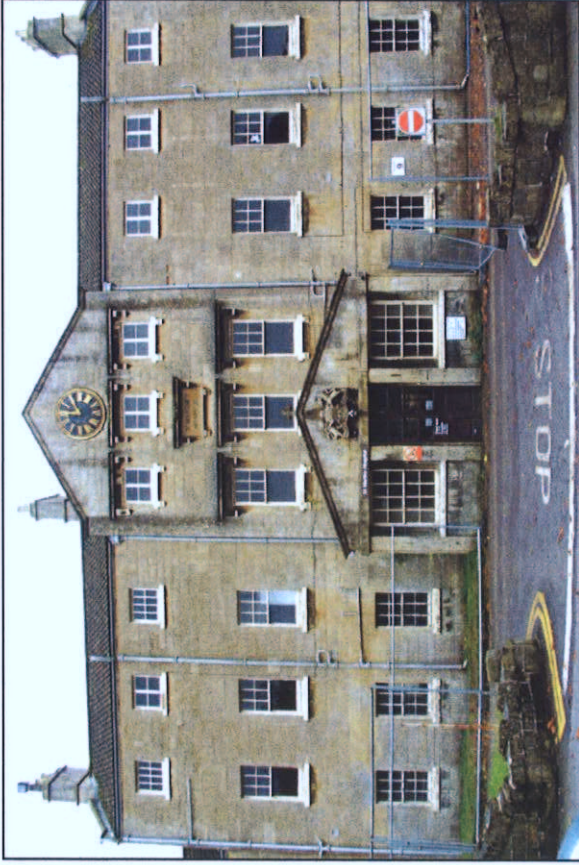
3.2.1 **Introduction:** Block 1 comprises the north block of the hexagon fronting onto Frome Road (Plate 1). This is the main entrance and face of the institution and contained the receiving wards and administrative offices. New inmates would come into this block to be processed. Husband and wife, parents and children, brother and sister were separated from each other and sent through high passages to their allotted areas. Here their fate was to live and work according to the prevailing regime that regarded poverty almost as a crime or at least the result of laziness and immorality and therefore deserving of punishment and correction not pity. Dickens after a visit to a workhouse in 1850 wrote; 'We have come to this absurd, this dangerous, this monstrous pass, that the dishonest felon is, in respect of cleanliness, order, diet, and accommodation, better provided for, and taken care of, than the honest pauper.'

Plate 1: Block 1, central north elevation.

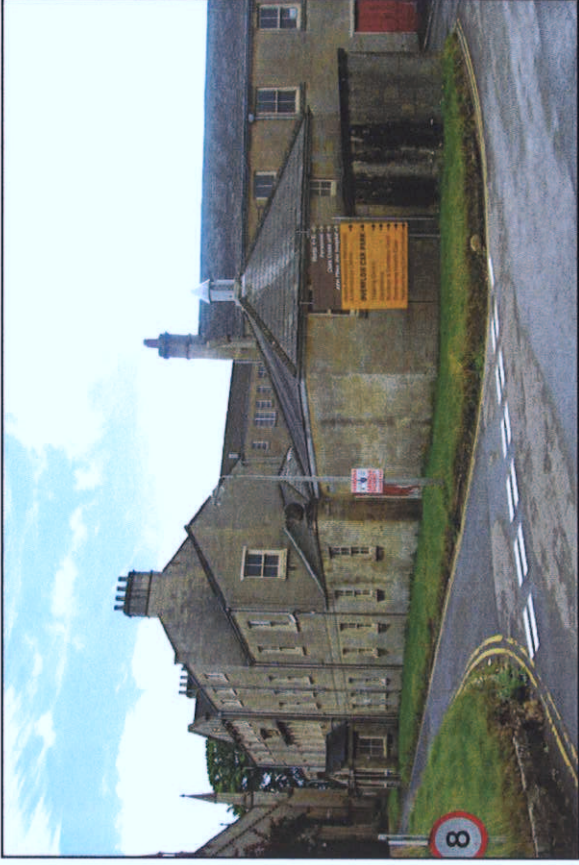
3.2.4 At the west end of the block is a later single storey extension of asymmetrical shape set back slightly from the line of the main block (see Plate 2). This room is five sided as it is built across the angle between Blocks 1 & 2 but this is not clear from the exterior. It has a low slate hung roof of five irregular sections rising to a central conical topped lantern vent. There is a door in the east end of the north wall and a doorway blocked in stone at the east end of the south wall. A later small lean-to of probable early 20th century date has been built against the south end of the west wall.

Plate 2: Block 1, looking south east with extension on right.

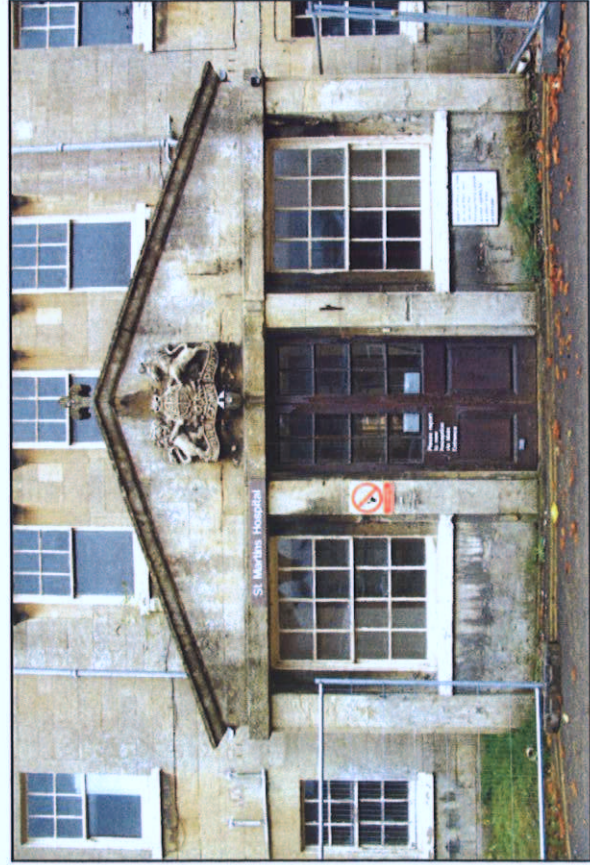
3.2.3 There is an added projecting single storey entrance (Plate 3) with two large square glazing bar sashes and a central door between pilaster strips. Above them is a pedimental gable with a carved Royal Coat of Arms and a fleur-de-lis finial.

Plate 3: Block 1, later entrance porch.

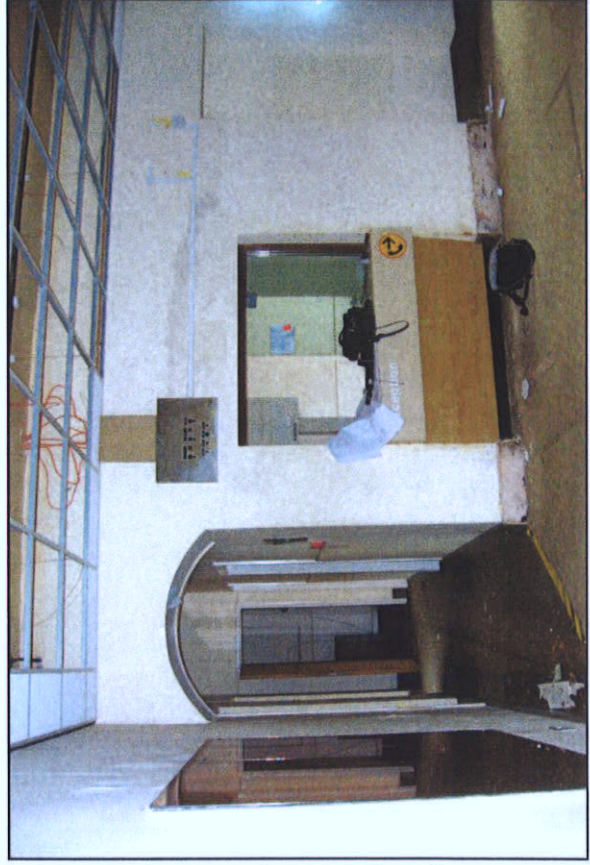
- 3.2.5 **Internal Description:** Ground Floor (Fig. 5). The entrance bay contains the entrance passage and a small room to either side. The entrance passage opens through glazed doors into a large square room, originally called the Waiting Hall, which extends the width of the central break of the block and the full depth of the block. Two glazed doors on either side of the central door in the north wall of this room give access to the two small rooms either side of the entrance passage. The main room contains a modern reception desk built into the west wall with an opening above it into the next room (Plate 4). The east wall has a modern c1970s York or imitation stone low fireplace built against it. At the south ends of both walls are segmental arch headed openings to access the rest of the block (see Plate 4).

Plate 4: Block 1, central ground floor room looking west.

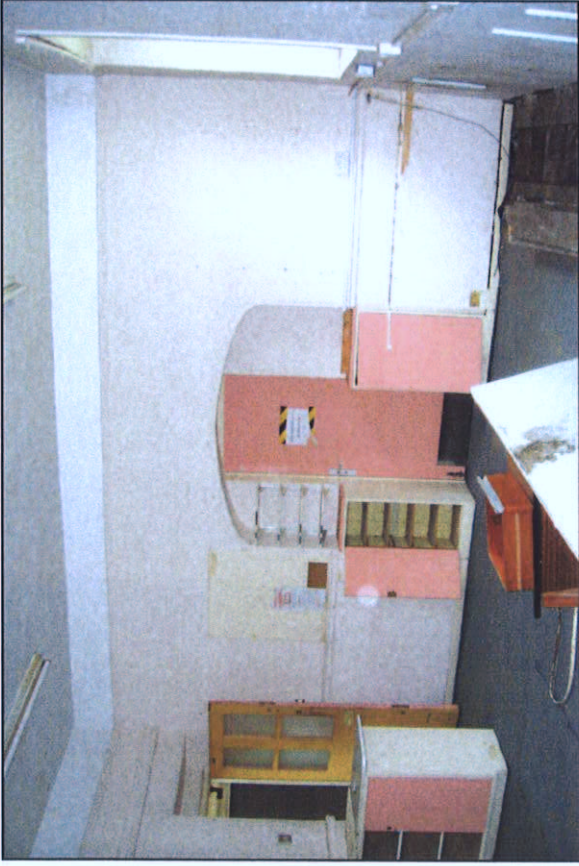
- 3.2.8 In the centre of the west wall is a wide alcove under a low three centred arch (Plate 5). In the back of this is a door into the next room. Built into the alcove either side of the door are small modern shelved cupboards. The western room of the original block has plain painted walls and two windows like those already described and a door through to the rear extension.

Plate 5: Block 1, alcove in ground floor room, looking west.

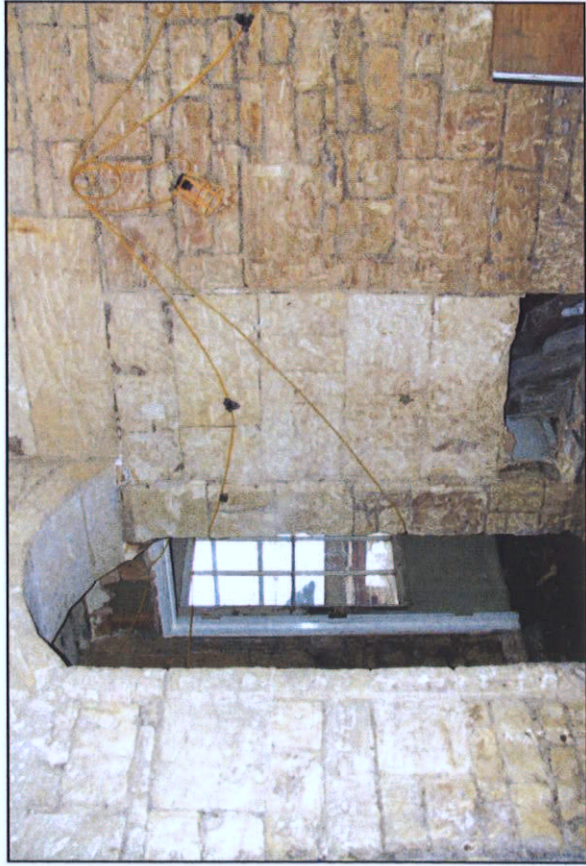
- 3.2.14 **Watching Brief:** During stripping out of Block 1, wall plaster, later partitions and the stairs and safe were removed. Several blocked openings, fireplaces and other features were revealed. In the central room on the ground floor there were blocked doorways in the north ends of the east and west walls and at the east end of the south wall. Those in the east and south walls were blocked with stone masonry and while this blocking probably dates to the 19th century, that on the west was blocked more recently with concrete blocks. The blocked doorway in the south wall led originally into the north end of Block 3 containing the stairwell serving both Blocks 1 and 3 (Plate 7).

Plate 7: Block 1, arch and blocked doorway in central room after stripping out.

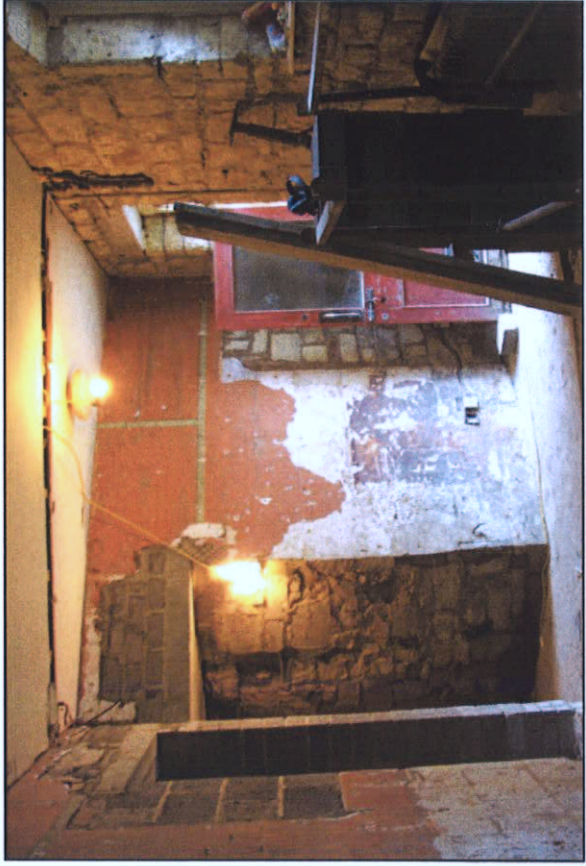
- 3.2.15 In the south wall of the third room east of the central bay where the later extension was built on, a new door into the extension was cut through an earlier window, which had also been blocked more recently. The ground floor room of the extension also contained a blocked door into the end of Block 4, this was an old blocking in coursed rubble. The room contained some interesting primary decoration. This consisted of painted plaster over the stone

masonry; the upper walls were painted in a red ochre colour with thick green lines dividing the field into an upper row of rectangular panels like large masonry blocks and there was a dark brown line at dado level with a slightly lighter brown coat below (Plate 8).

Plate 8: Block 1, ground floor room of south east extension.

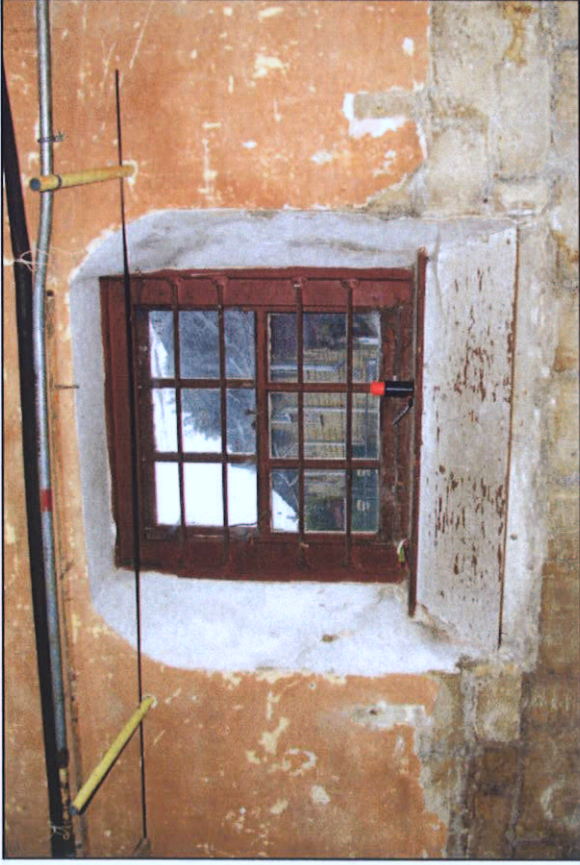
- 3.3.7 The second bay is a separate room with access in the south east wall and no access to other rooms. This room has been made from the two former storerooms to the shoemakers and tailors workshops. The next four bays north of the cross passage are divided longitudinally. The south eastern half contains a staircase to the first floor in the south west bay and the rest is divided into two unequal rooms by a later partition and there are no early features of interest. The north western half however contains two rooms with primary or early paintwork and other features. These rooms correspond to the shoemakers shop on the 1838 plan, the stud and lath and plaster partition wall between is a later addition (Plate 12). They had sliding sash windows painted dark brown, some with horizontal iron bars fitted. The windows had deep splayed reveals curving in towards the flat heads and steeply sloping sills (Plate 13). The southern room had remains of cream yellow paint over plaster on the upper walls and the northern one had light buff brown paint on the upper walls and dark brown paint on some of the lower walls. The floors were boarded (see Plate 13).

Plate 13: Block 2, window in former shoemakers shop looking west.

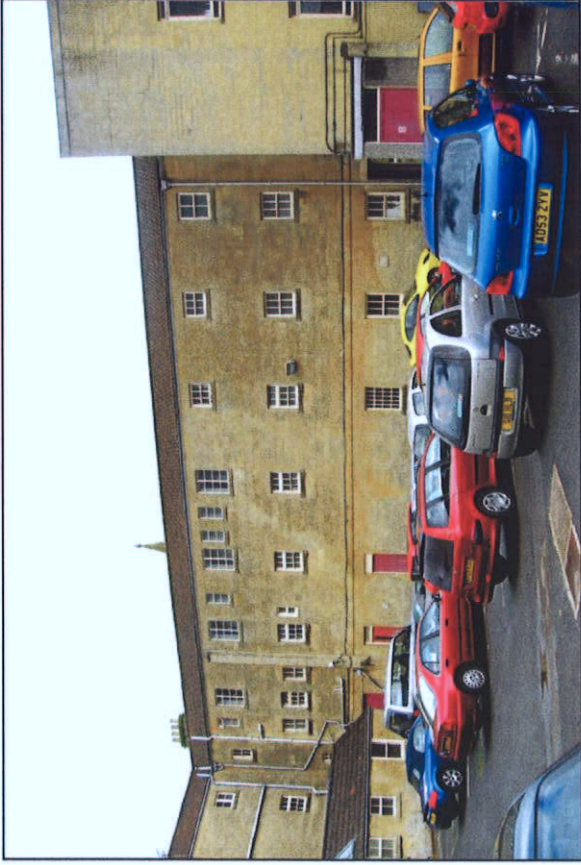
- 3.4.2 **External Description:** This block is of three storeys constructed of Bath stone comprising coursed ashlar facings over snecked rubble backing (Plate 17). The roof is pitched and clad with pantiles and there are no extant projecting chimneys. On the west side of the block at the south end is a later flat roofed lift shaft and stair block which dates from after 1948 when the building became a hospital (Plate 18). The ground floor windows on this side have glazing bar sliding sashes, the first floor contains seven equally spaced original window openings with sliding sashes or sash and pivot casement combinations and three smaller possibly inserted windows at the north end. The second floor contains three small windows with sliding sashes to the south and four larger crittal windows to the north which are in the positions of original openings which may have been enlarged slightly. In addition there are four smaller windows with crittal frames which have probably been inserted. On the east side there are many sliding sashes surviving in original openings on all floors with less inserted openings and crittal frames than on the west. There is also one large inserted double door opening on this side and smaller original door openings with later doors.

Plate 17: Block 3, looking east.

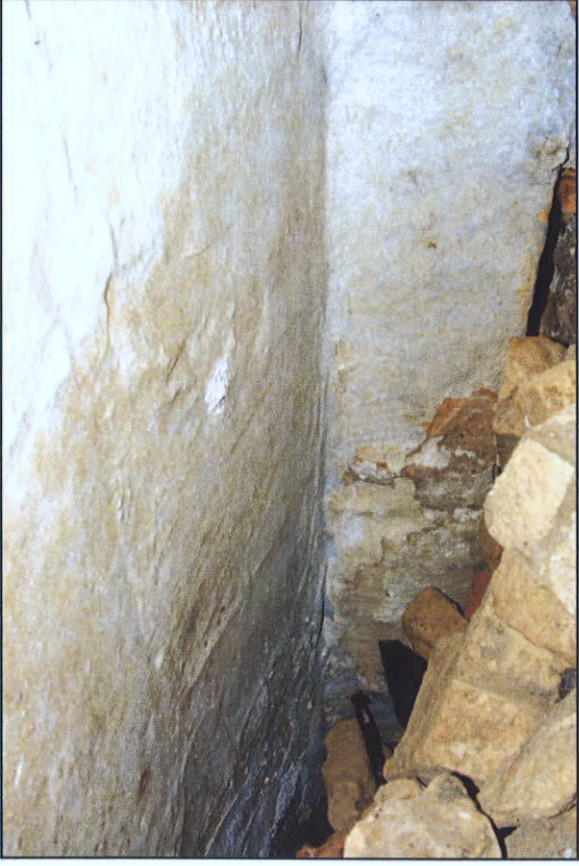
- 3.5.6 **Watching Brief: Barrel Vaults.** During the present works the floors of the building were required to be lowered by 400mm. Contractors made a start on this work by excavating a small trial hole in the north west corner of the larger ground floor hub room and this revealed solid stone at just above 400mm depth which was broken out. The stone proved to be part of a barrel vault which was infilled with rubble with a low void remaining at the top. A wall and the top of a doorway were visible on the south west side of the vault (Plate 22). The concrete floor and the loose fill below it were subsequently removed from this room to reveal the tops of two parallel stone vaults aligned north west to south east (Plate 23). Once the vaults were identified as such it was decided that no more material should be removed from the structure of the vaults and the methodology of the building work should be revised so as to preserve the vault fabric in situ.

Plate 22: Central hub, interior of barrel vault looking south east.

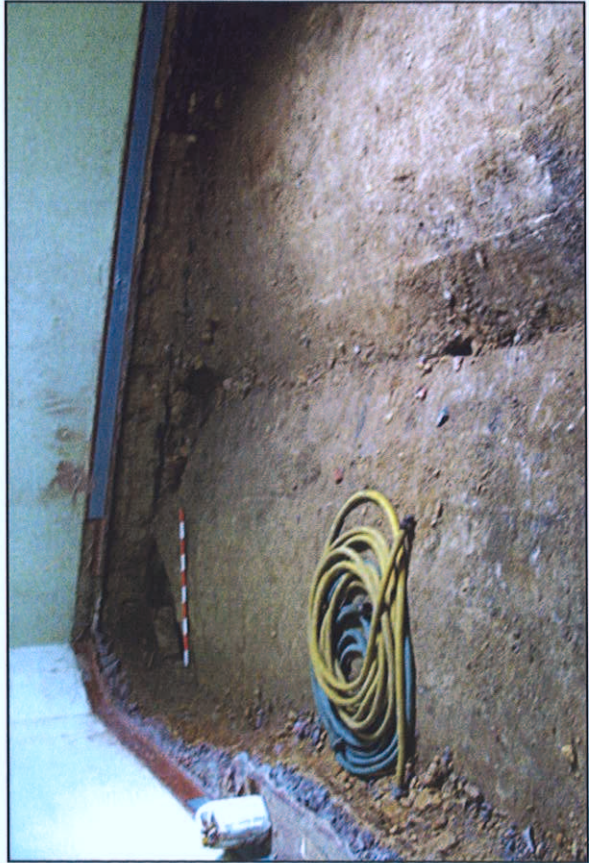
the hub. The most likely use for the vaults directly below the kitchen is probably coal storage for the kitchen ranges and other fires, and/or for provisions in addition to the provisions store in Block 3. The trench also exposed the primary offset coursed rubble foundations of the workhouse and the abutting brick foundations off the modern stairwell and lift shaft extension of Block 3.

Plate 23: Central hub, exposed barrel vaults looking north west.

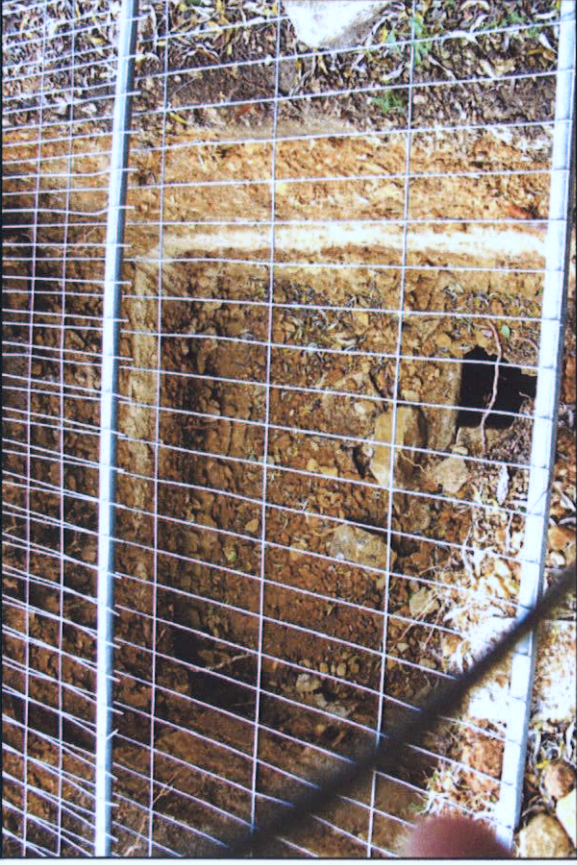
- 3.7.20 An external test trench was excavated by contractors south of the west end of the block. This trench was 2m square and was located between 6 and 8m south of the south wall and between 2.5 and 4.5m east of a line extended from the west end of the block. For safety reasons the trench could not be accessed but was approximately 1.5m deep. At the base of the trench a stone vault was encountered and a small hole was broken into this which revealed a void and then water some distance below (Plate 38). The hole in the vault was located at 6.5m south of the block and 3.6m east of a line extending from the west end. There was some stone masonry exposed in the upper part of the south side of the trench but this could not be examined closely. At the base of the masonry at about 1m depth was a layer of crushed stone which extended around all sides of the trench. The vault must belong to one of the large rectangular underground water reservoirs shown on the 1838 plan west of block 7 (see fig. 3). The masonry possibly belongs to some earlier access to the reservoirs. A small stone lined shaft to the reservoirs is located 7m west of block 7 and 5m north of a line extending from the south end of that block. The shaft is too small for human access but could have been for checking the water level and/or for topping the level up or drawing water off.

Plate 38: Test trench with stone vault of reservoir in base, looking west.
