Carrington Wire Works, Warrington

Archaeological Buildings Investigation

Oxford Archaeology North

September 2005

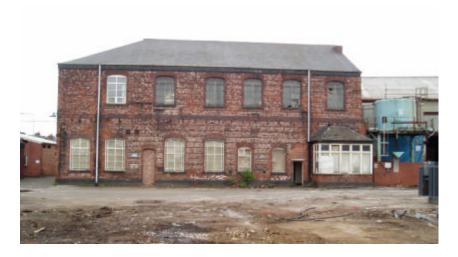
(Plate 1), with shallow basement, constructed largely of machine-made brick, bonded with a grey speckled sandy mortar that at some stage was re-pointed with cement. It had a Welsh slate roof, hipped at the western side, with a chimney located just below the ridge on the eastern gable. The building comprised seven bays each of which, with the exception of the first floor in the western bay, had a window in the south elevation. This formed the front of the building which had two doorways (one of which was blocked, Plate 2), with a windowed porch attached to the east corner (Plate 17). The west-facing elevation comprised a blocked doorway at the south end, replaced with a wood framed entrance (Plate 9). The north-facing elevation comprised five windows along the first storey, with a loading platform and a projecting steel beamed hoist (Plate 4). The ground floor had a further four windows, two of which were blocked, and one of which was subsequently turned into a doorway. Directly below the loading platform in the upper storey was a large loading entrance, which was remodelled for a railed hung door (Plate 5). The east elevation was partially obscured by Building 7, however, three blocked windows along the first floor were observed. Two of these had flat glazed brick lintels (Plate 14), the other having an arched sandstone lintel. A blocked doorway with an iron runner above, was observed at ground floor level (Plate 16). At the northern end of the eastern elevation was a projecting brick tower, which appeared to be part of the original construction, and may originally have been a toilet tower (Plate 18).

Plate 1: General view of Building 5, looking north

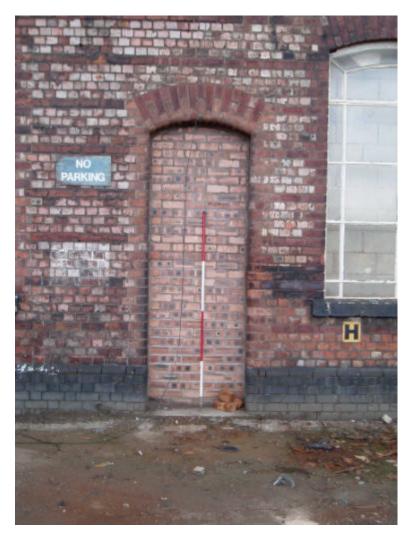
Plate 2: Blocked doorway at west end of south external elevation of Building 5

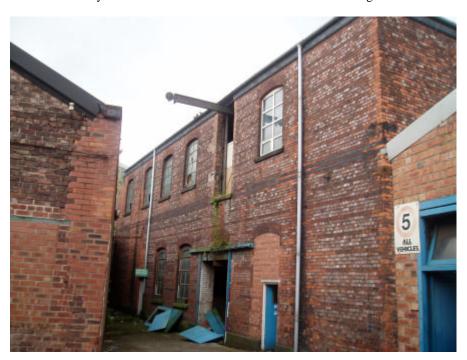
Plate 4: North external elevation of Building 5, looking south/east

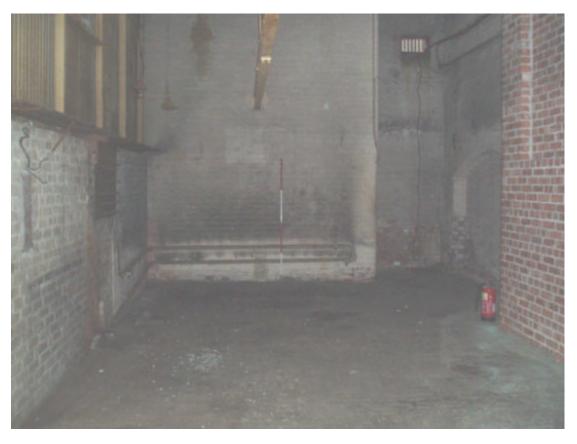
- 4.2.6 Within the interior, the ground floor was split by an east/west aligned brick partition wall, with a blocked arched bay entrance at its east end (Plate 6). Within the northern part of the ground floor, the building contained several I-section steel rails associated with the loading gear that transected the entire room and terminated in the loading bay area (Plates 7 and 8). The floor comprised patterned stone and brick sets. The loading bay room also contained a MDF style constructed office annexe that was positioned next to a spiral staircase connecting the first floor. A large office with plaster rendering occupied the south area of the building (Plate 10). A similar constructed office was built at the west end of the building on the first floor (Plate 15).

Plate 6: View of north room interior in Building 5

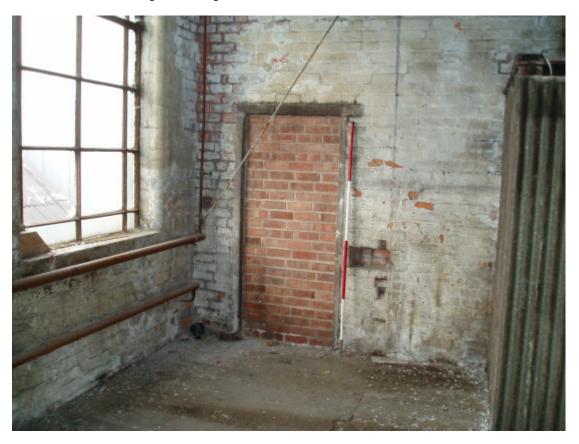
Plate 12: Blocked doorway within the east wall of Building 5

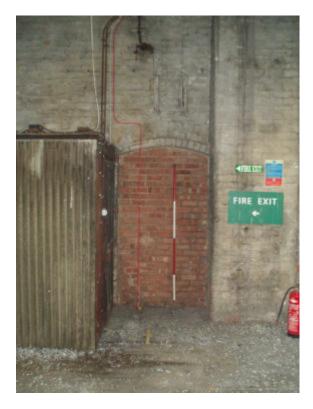
Plate 14: Blocked window within the east wall of Building 5

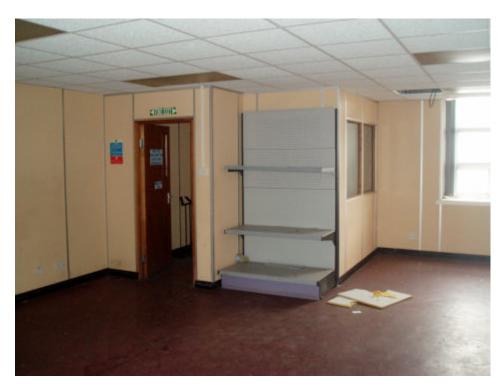
Plate 15: Office within the west end of Building 5

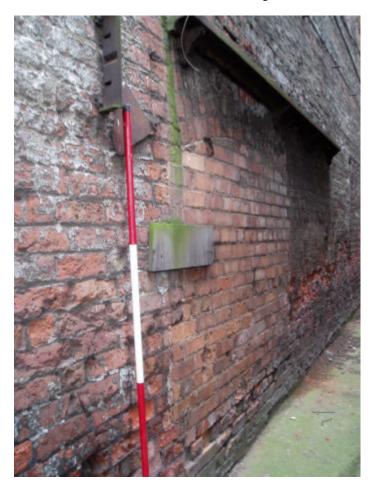
Plate 16: Blocked doorway along east external elevation of Building 5

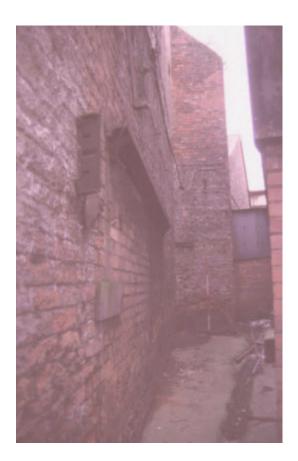
Plate 18: Remains of a possible toilet tower attached to the east wall of Building 5

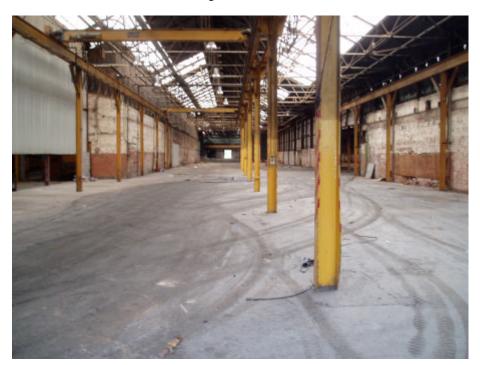
- 4.2.9 **Building 7.** a large processing shed (Plate 28) of similar construction to Building 6, but with multi-pitched roof. Internally (Plate 20) the roof structure comprised metal L-section lattice trusses with gussett plate and similar section metal purlins typical of the late 19th and early 20th centuries. A series of steel I-section stanchions supported a network of hydraulic gantries. Set within the concrete floor were several pits, tanks and machine platforms (Plates 32 and 33) associated with the wire making process.

Plate 20: Interior of Building 7, looking east

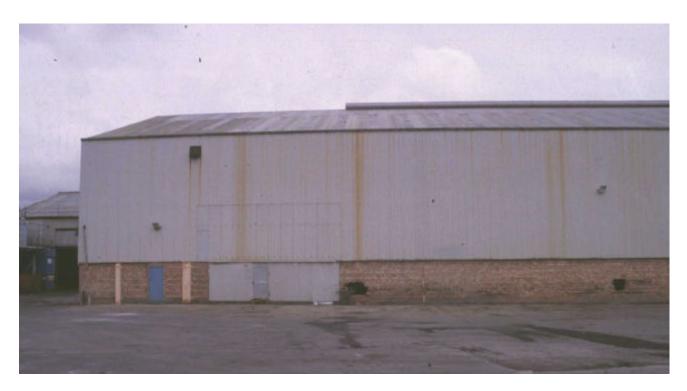
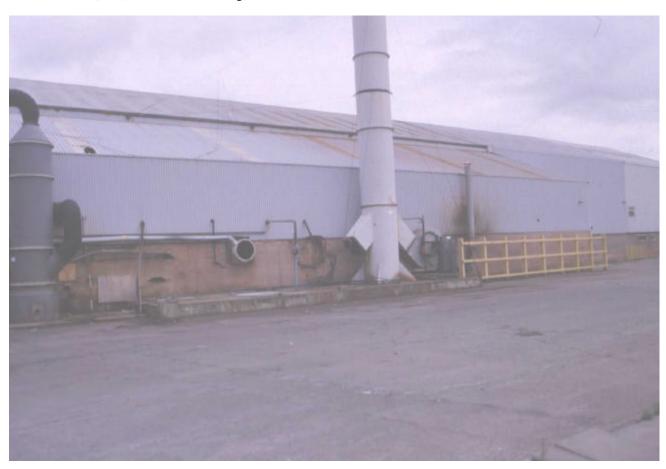
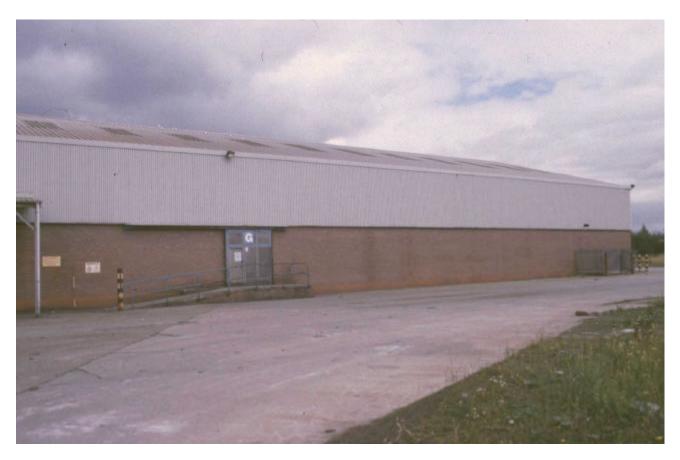
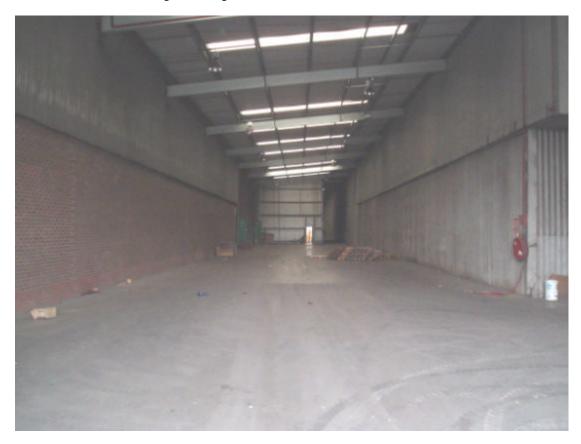
- 4.2.8 **Building** 6: the building (Plates 21, 22, 23 and 30) comprised a late 20th century addition to the southern side of Building 7. It was brick construction to c2.5m below corrugated iron sheeting, which also covered the pitched roof. Two large projections along the southern face comprised a chemical plant and an addition to the main processing area.

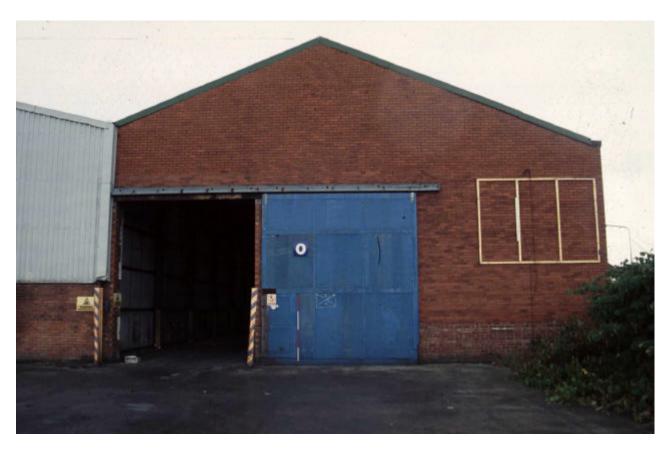
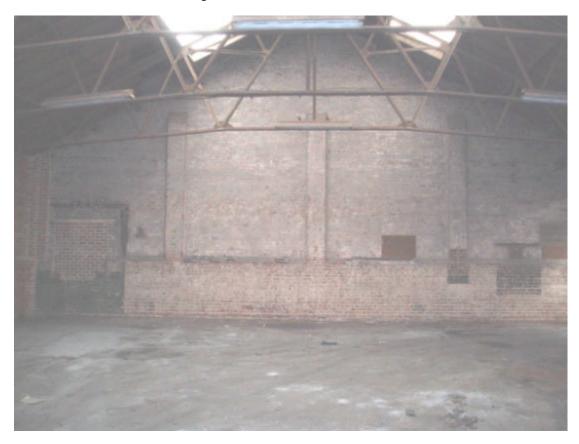
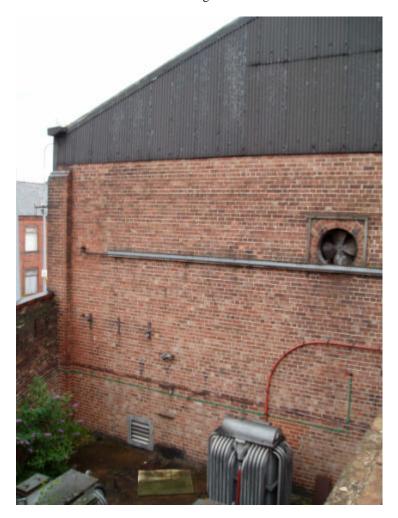
- 4.2.10 *Building &* this structure appeared to represent the earliest survival of the processing sheds (Buildings 6-8). It had extruded brick walls (Plates 25, 34 and 44), in English Garden Wall bond, with internally buttressed gables, and had a similar roof structure to Building 7, covered with corrugated sheeting and incorporating several skylights (Plate 24). As with Building 7, it also incorporated several later gantries (Plate 29), supported on I-section steel stanchions, and associated pits and tanks.

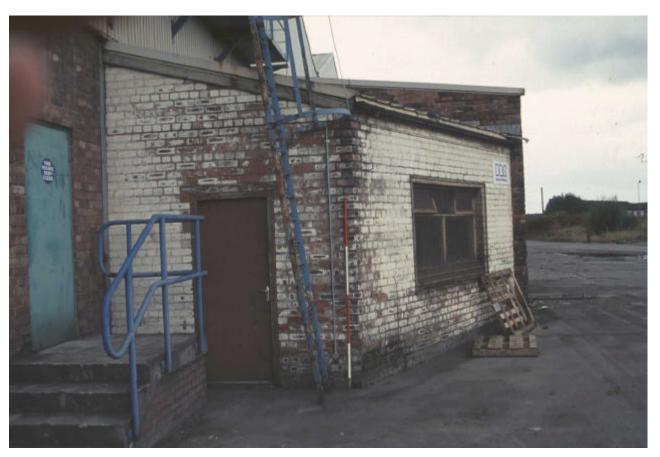
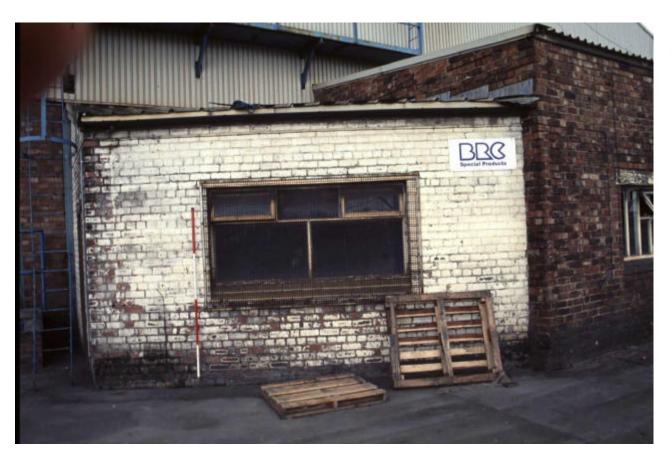
- 4.2.15 *Building 13*: this comprised two brick extensions butting the eastern elevation of Building 7 (Plates 26 and 27). Both were single storey, with single pitched corrugated metal roofs, with the northern two bays, constructed in English Garden Wall bond, appearing to represent the earlier addition. This part was slightly taller, and had a window in each bay in the eastern elevation, with a further window in the northern elevation. Any external access was removed by the addition of a single bay to the south, also in English Garden Wall bond, with a window in the eastern elevation and a doorway in the southern elevation.

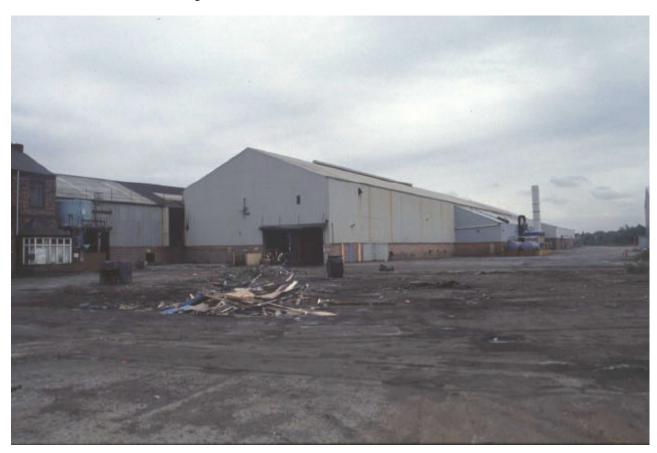
Plate 28: General view of Buildings 6 and 7, looking north/east

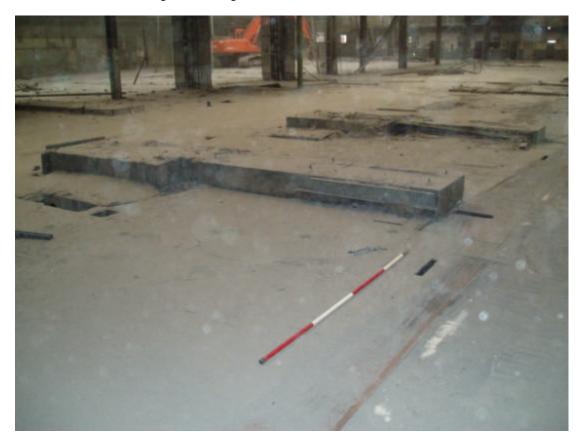
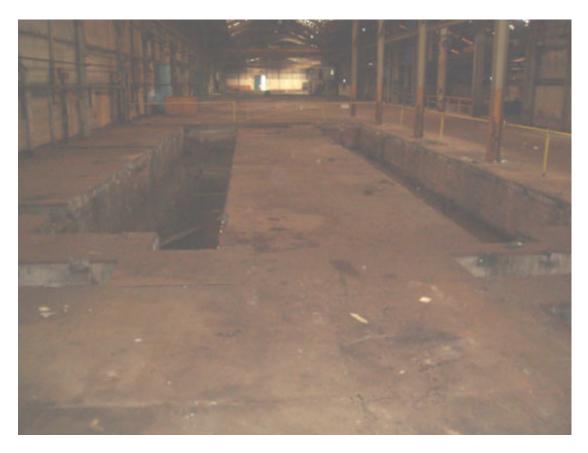
Plate 32: Machine platforms in Building 7

Plate 33: Concrete tanks in Building 7

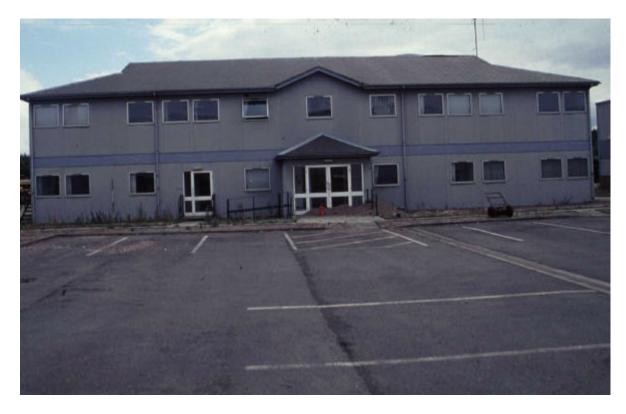
- 4.2.3 **Building 3:** a late 20th century east/west aligned two storey offices. The building was probably of block or concrete construction concealed with blue render (Plate 37). Its had a gambrel roof with central gablet on the front, southern elevation, above a projecting hipped porch.

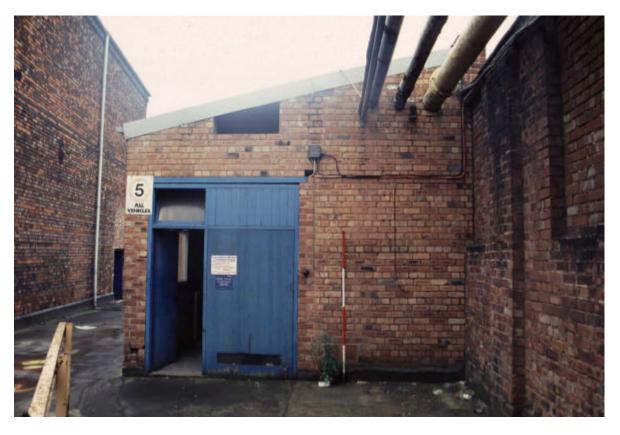
- 4.2.4 **Building 4:** a north/south aligned late 20th century single storey brick structure constructed in English Garden Wall bond (Plate 38). The building had a single pitch roof rising to the west, and was butted at its south-west corner by a single storey toilet block in stretcher bond with a flat roof, which also butts Building 1.

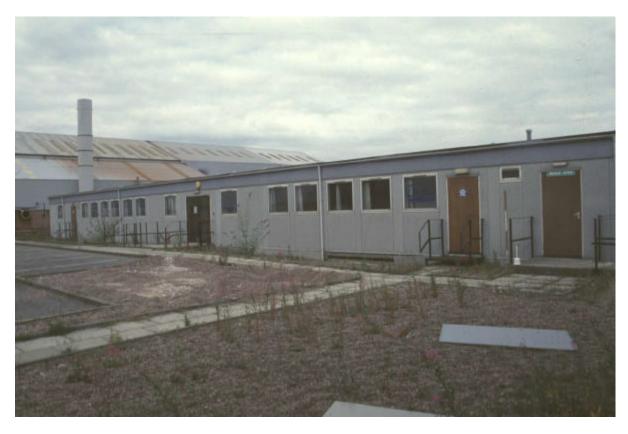
- 4.2.11 **Building 9**: this comprised a low of single storey, flat-roofed, prefabricated offices, set onto a concrete base. Several entrances were observed on the western side (Plate 39), accessed via metal stairs.

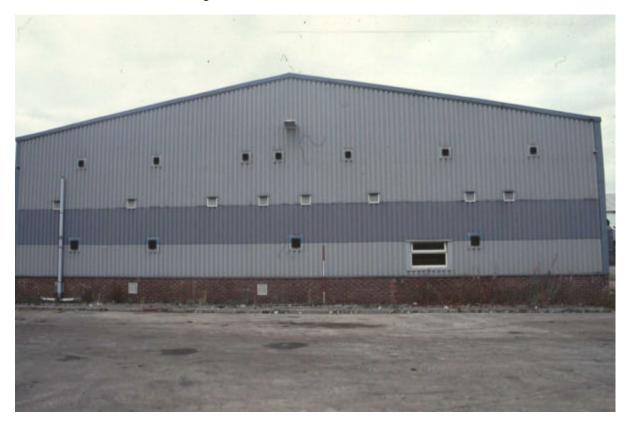
- 4.2.12 **Building 10**: north/south aligned rectangular shed (Plate 40), similar in construction style to Building 7. It was last used as a machine shop and engineering department.

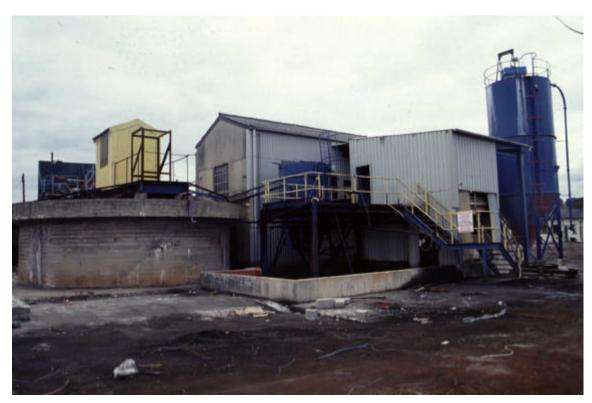
- 4.2.14 *Building 12*: effluent plant treatment, comprising a circular concrete effluent tank and two rectangular, steel-framed corrugated metal sheds (Plate 42). A further small corrugated shed was located on a metal gantry above the effluent tank, with a further inspection gantry located in the angle between the two associated sheds.

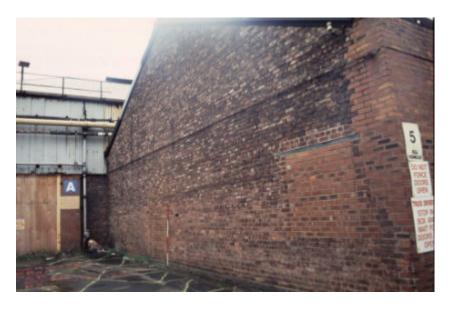
- 4.2.16 *Building 14*: a single storey brick extension to Building 7, infilling the reentrant angle to the north of Building 5. It was of brick construction, in English Garden Wall bond, and had a pitched, corrugated metal, roof. It had

several blocked apertures in the western gable (Plate 43), and appeared to have been used latterly as a storage area.
