CCC AFU Report Number 873

An Historic Building Recording Survey at No. 28 Eastbury Avenue, Northwood, Hertfordshire

Building Survey

June 2006

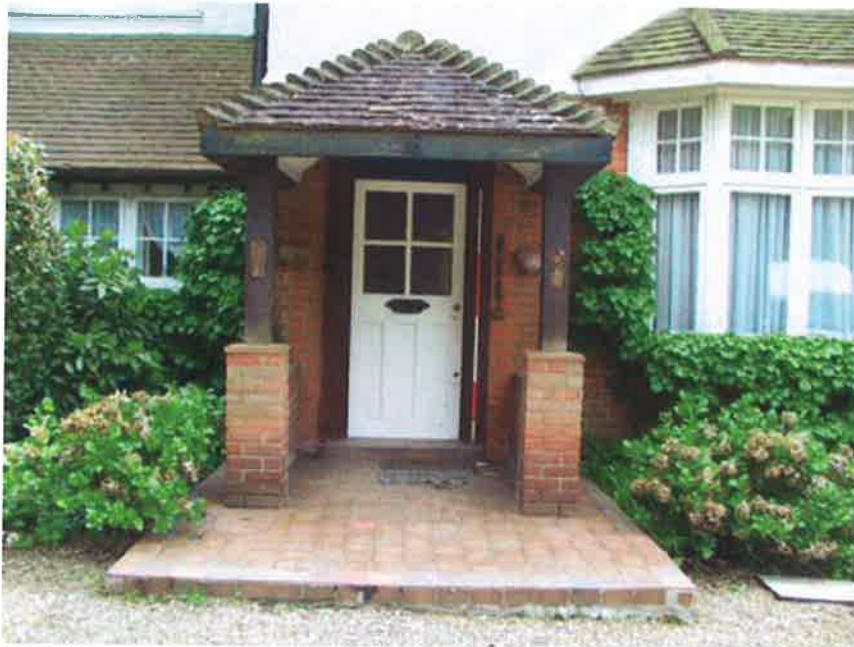
Plate 3: The main entrance and porch, facing south

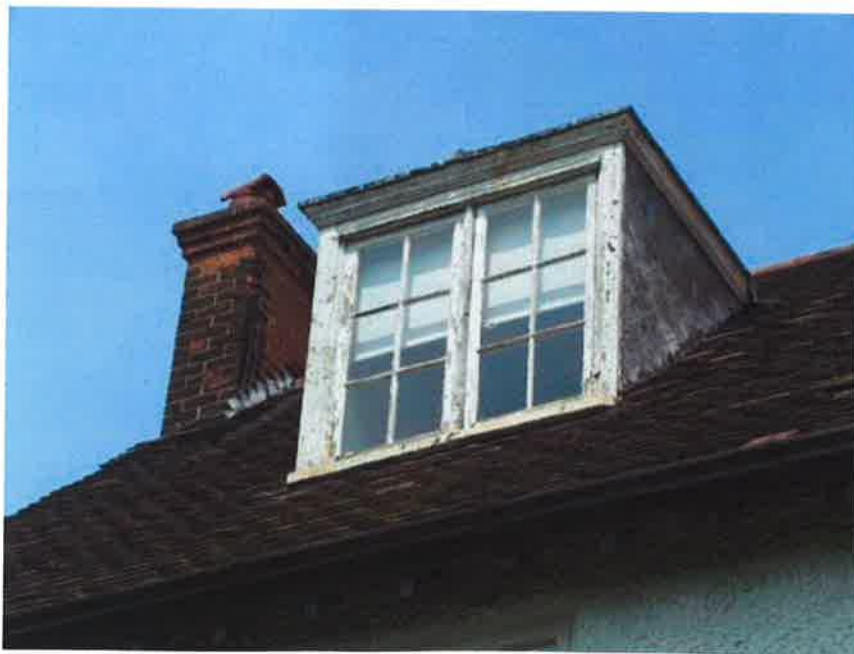
There are two brick built chimneystacks (both in Stretcher bond with traces of orange paint remaining) situated at the western end of the roof and at the east end where the roof height drops, as stated above. Both are wide with neatly stepped flared platforms, and red clay pots are cowed with a horizontal half pipe (Plate 4).

Plate 4: View of the western chimney and dormer, facing northwest

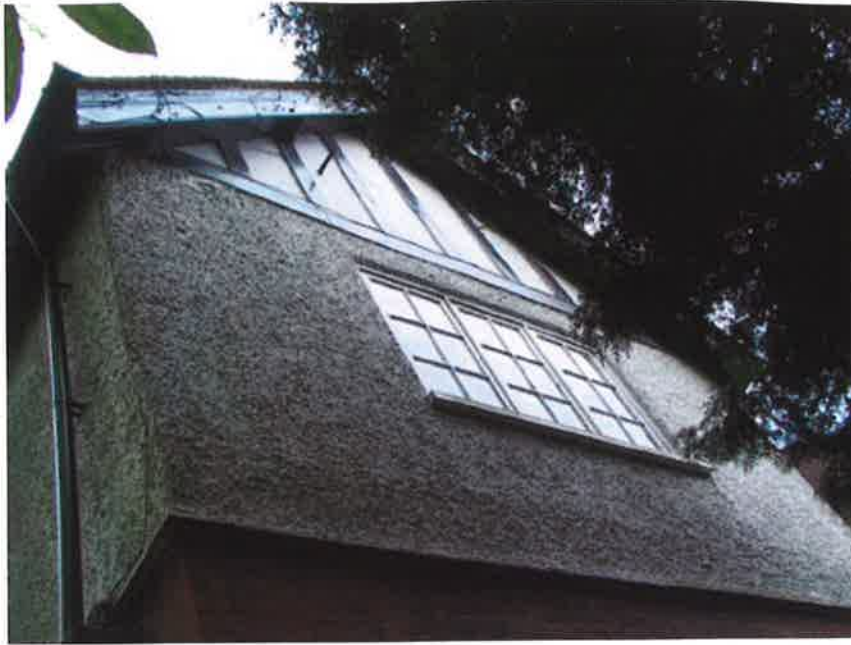
The western gabled projection is adorned with mock Tudor style close-studded magpie-work in the Edwardian/Arts and Crafts style, and suggests a date range of 1905 to 1915 (Plate 5).

Plate 5: View of the magpie-work on the north elevation

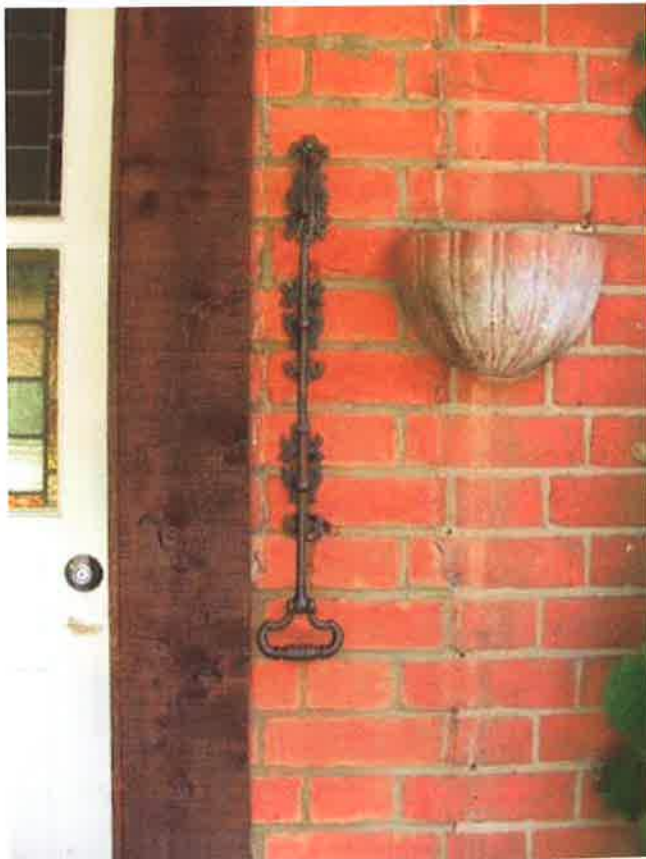
It is clear that there have been alterations to the porch, possibly at the same time the extension to the southern elevation was added. Newer brick has been added at the edges of the doorway, and although the door itself appears to be original, it is possible that the porch has been enlarged to make a grander entrance (Plate 6).

Plate 6: View inside the porch, showing alteration to brickwork and original iron bell pull

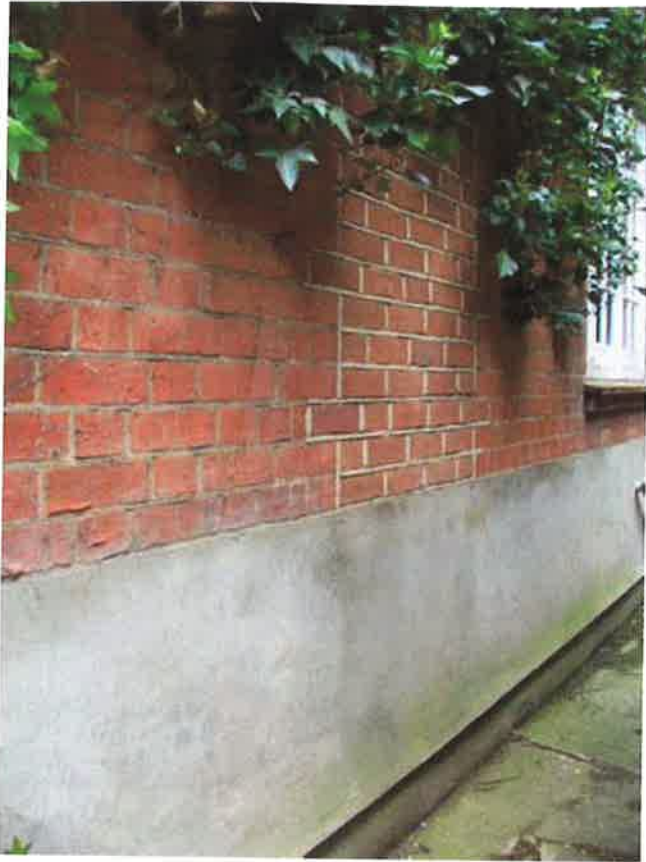
The second doorway, on the left hand side of this elevation is now blocked, with only the relieving arch retained (Plate 7). The area is now in-filled with modern bricks laid in Stretcher bond. The lower third of this blocking is partially covered with concrete render. Originally this doorway formed the only external access to room G5 (see below).

Plate 7: View of the east elevation facing northwest, showing the blocked up doorway

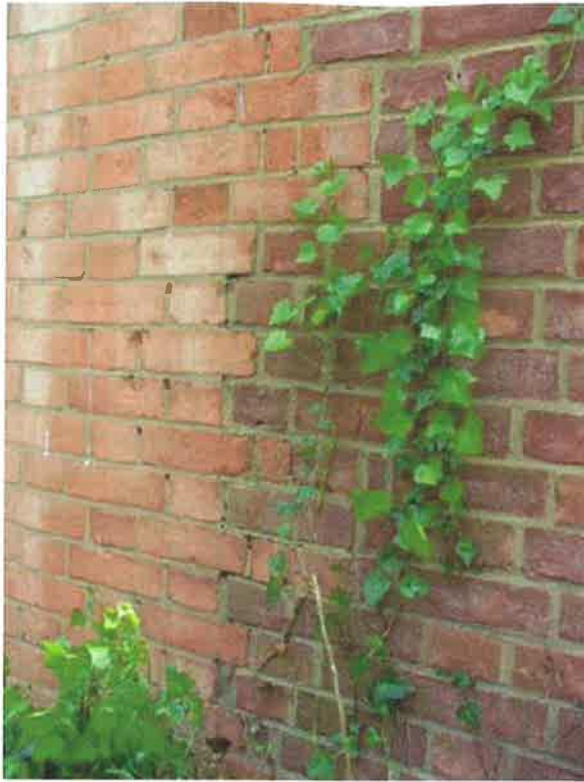
The extension added to G3, is clearly later than the house, as the newer brick does not match the original fabric and has been roughly keyed into the main structure (Plate 9).

Plate 9: View of the join of the extension brickwork (right) keyed with original brickwork, looking northeast

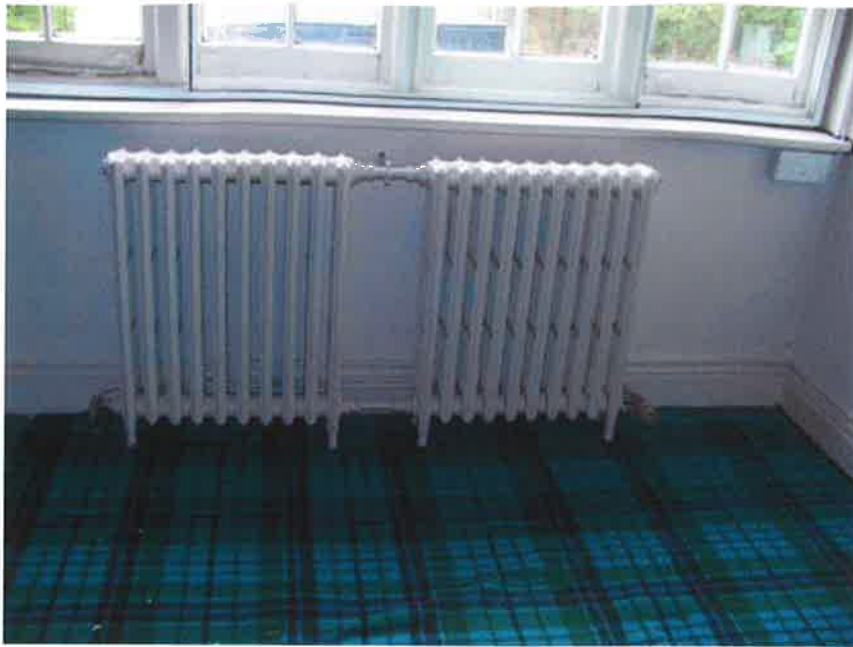
Plate 19: View of the original cast iron radiators in F9, facing north
