# **THE THREE TOWERS, DALLAM TOWER ESTATE, CUMBRIA**

## **Management Plan**

**Oxford Archaeology North**

November 2005

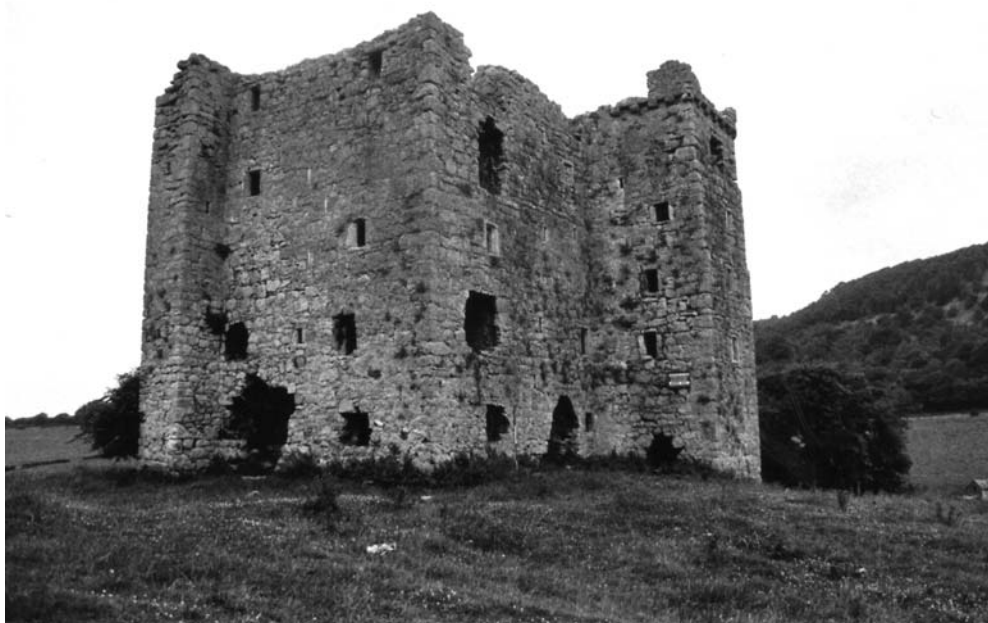
Plate 2: South-east and north-east external elevations, Arnside Tower

- 5.4.6 **South-East Wall – External:** the top courses of the masonry should be taken down, rebbed and tied across at the top of two areas of cracking which extend through two storeys from the wall top. The cracking pattern requires some tying across the joints. An area of loose masonry to the south garderobe turret requires a small amount of rebuilding at the south-east corner and all the open joints of the quoins to the turret should be repacked out, consolidated, and repointed. The rest of the wall face is in good condition, the pinnings between the stones are largely intact and only localised areas of the top courses and in the vicinity of cracks should be reinstated.

- 5.4.7 The windows on this wall are mainly in good condition, apart from those on the second floor, where the sills and jambs have been robbed, and attention is required to throw water from these sills as they are causing water to gather below. The north-east wall of the garderobe tower is in perilous condition and the upper courses, where the raking stonework has fallen away, require rebuilding to a height of approximately 3m. The lower courses contain numerous open joints, and the masonry is unstable in a number of areas, including to the north-west where the masonry fall took place. The lower courses are also badly eroded and require deep packing and repointing. The south-east face of the Tower requires repointing of the quoin stones and possible tying across. The upper courses of the garderobe tower will benefit from tying across. The lower courses of the south-east wall have suffered from a modern opening at the lower level, which provided access to the lower ground floor prior to the fall of 1884. Masonry in this area is remarkably stable, considering, and there does not appear to be any associated cracking or deterioration of the surrounding areas and masonry.

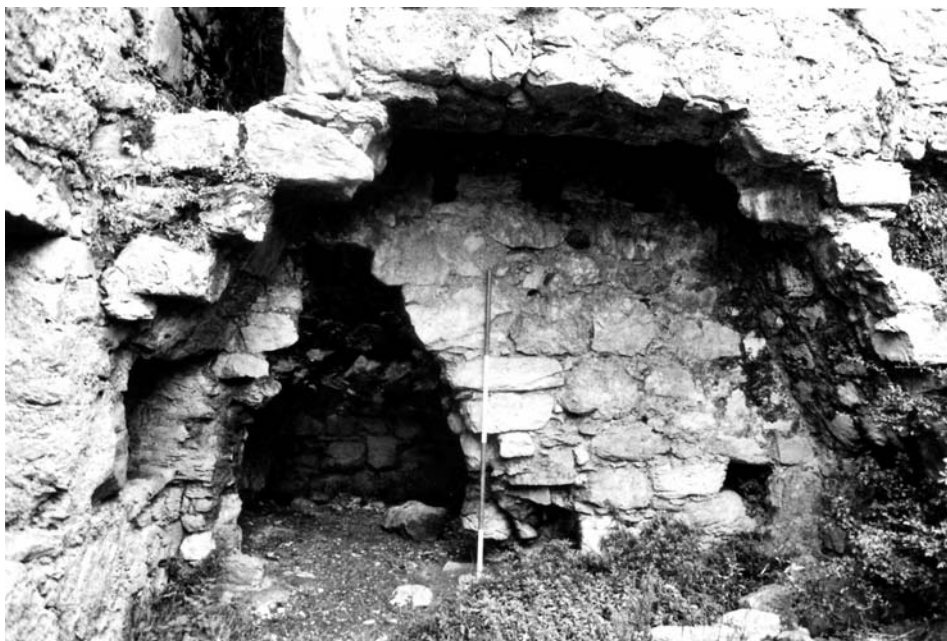
Plate 3: Large fireplace within north-east internal elevation, Arnside Tower

- 5.4.14 At ground floor level the fireplace masonry has been robbed and a natural arch formed above the fireplace opening. A further hole has been knocked through to the oven beyond. Here, again, the soffit and surrounding stonework requires consolidation, particularly as this arch is very close to the entrance to the staircase into the mural chamber, where strengthening across the base of the staircase opening and the fireplace will be required as there is considerable damage to a principal stone at this point. The opening adjacent to the fireplace appears to be in good condition. Between the fireplace and the window to the south-east another large opening has been formed in the stonework to the flue, which is unstable at the junction with the fireplace arch.

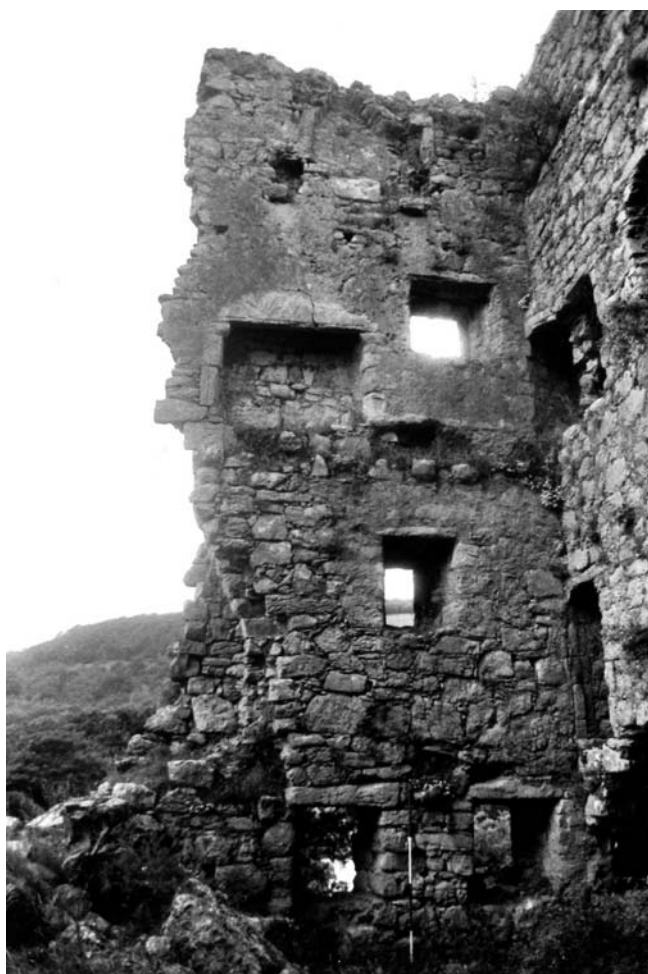
Plate 4: North-west internal elevation, Arnside Tower

tops. The upper fireplace has lost its outer lintel and facing masonry, exposing the flue and the fireback. The north-east jamb is also missing, and the remaining masonry is unstable. The hearth has been lost and is uneven and requires a sill. An area of masonry to the north-east, including a beam socket, is in a state of collapse. This is the most vulnerable area of masonry and could lead to a collapse of the upper floor at this point. The window to the north-east of this fireplace is filled with a rubblework infill panel, and this is falling inwards. Again, it could collapse as the lintel is broken, and above the window numerous loose stones are unstable. This lintel requires a steel plate to reinforce it from below, and the area of masonry above should be rebbed.

5.4.18 At first floor level the main fireplace is intact, the lintel is cracked and there is evidence of stress along the vertical line parallel to the break line. This fault is reflected on the outer wall face. The sill is missing, and there is a considerable loss of masonry along the line of the floor, indicating that a number of joists have been removed from this position. The hearth should be consolidated and drained correctly. The window to the north-east is open, the internal sill is missing, and loose masonry below that level requires consolidation and repointing. Generally, the wall faces at first floor level are in good condition, apart from a number of cracks above the window and at ceiling level. Extant plaster on this wall is probably the best surviving example on the Tower.

5.4.19 Below the second floor fireplace the internal leaf rubblework facing is in a poor condition with numerous open joints, it has lost its pinning stones, which should be replaced during any consolidation works, and the area repointed. A ledge at first floor level has been colonised by vegetation, and this should be removed prior to consolidation works to form a level shelf. There is an area of masonry missing immediately north of the hearth, which will require tying back. The back of the fireplace and the flue is in good condition and requires only repointing in accessible areas. The junction with the north-east wall requires deep packing and pointing, together with areas of adjacent repointing to the wall faces. The north-east jamb is missing and the rubble core exposed. However, the sides of the flue provide good support to this wall, and this area will require consolidation and repointing along exposed edges. The interior is covered with fallen rubble stonework beneath this wall, and the overburden conceals the base of the wall to some considerable depth. This wall is in remarkably good condition considering the earlier collapse. There are few areas of cracking, which would indicate an imminent major collapse; the lintels are intact, together with the jambs of existing windows, which also have stone relieving arches above them. However, two areas of concern, below the second floor fireplace and the window immediately to the north-east, and below the first floor fireplace and adjacent window, require immediate action as further loss of masonry could lead to a loss of the magnificent fireplaces on this wall.

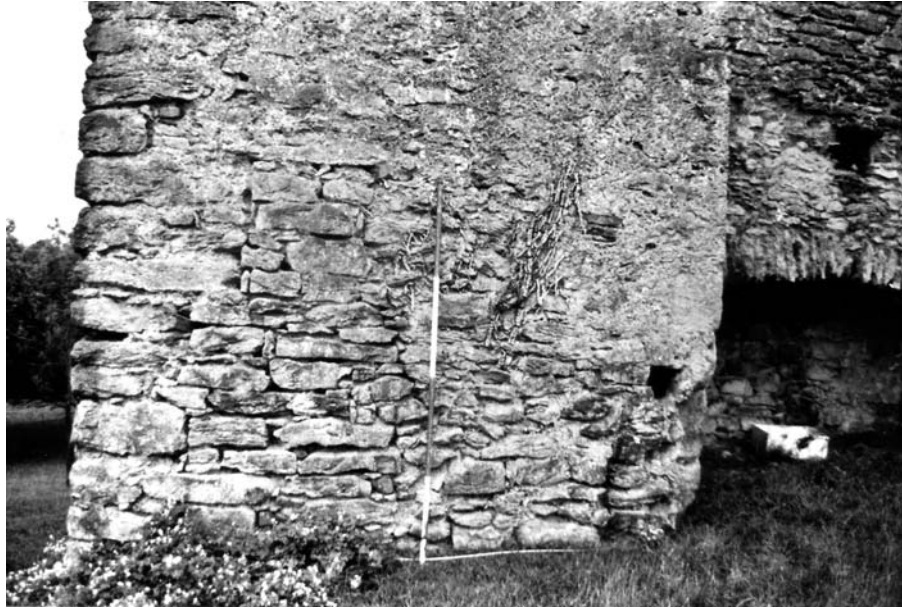
Plate 17: Detail of east external elevation showing stub wall and area of rebuilding, Hazelslack Tower
