AGRICULTURAL BUILDING, CHURCH LANE, TUNSTALL

LANCASHIRE

Documentary and Building Survey Report

August 2016

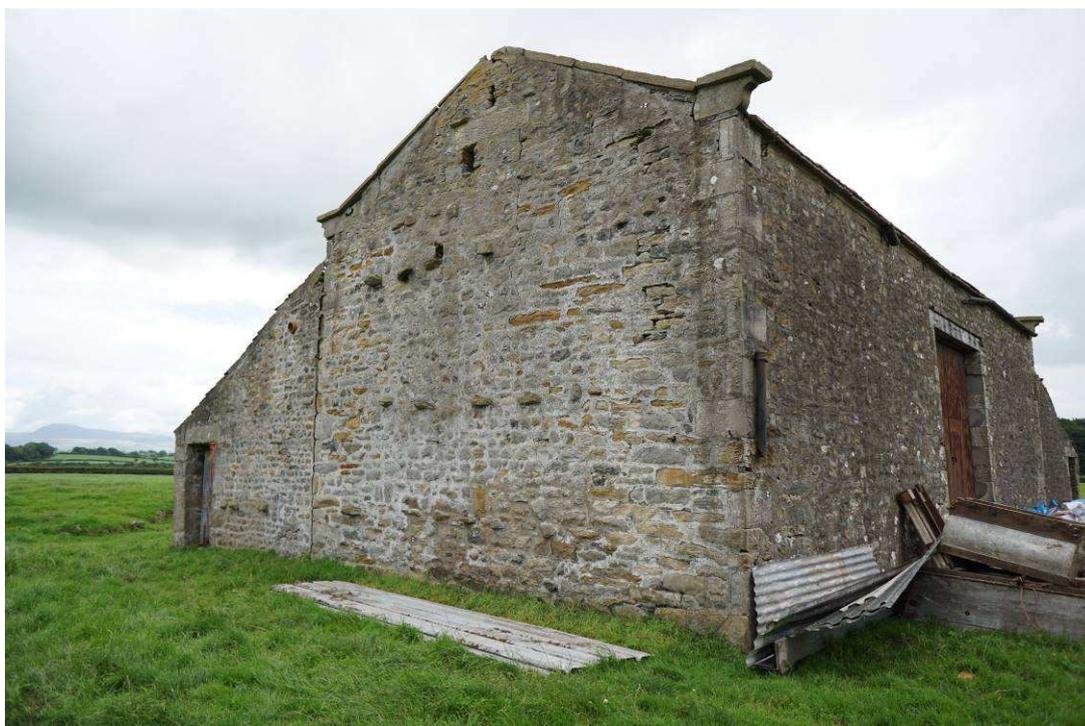
- 4.1.6 Evidently, there had been a series of small openings at ground-floor level but their blocking, and the application of a rough cement mortar, made it difficult to measure their dimensions. Several projecting through-stones were identified across the elevation but appeared to be arranged in three distinct courses across the height of the wall.

Plate 9: Northern elevation of the Main Barn

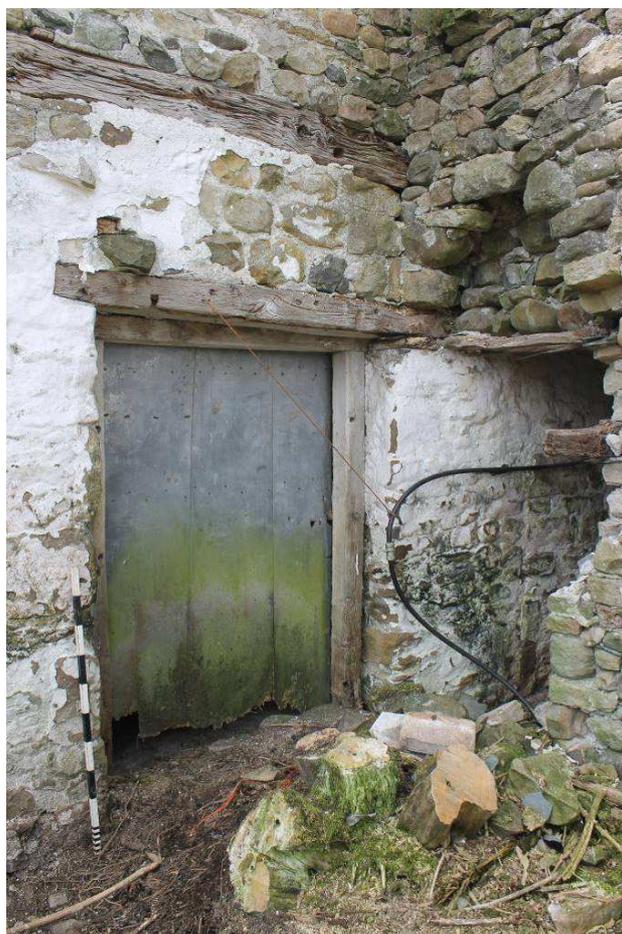
Plate 11: Central eastern doorway. Note the infilled portion to the right of frame

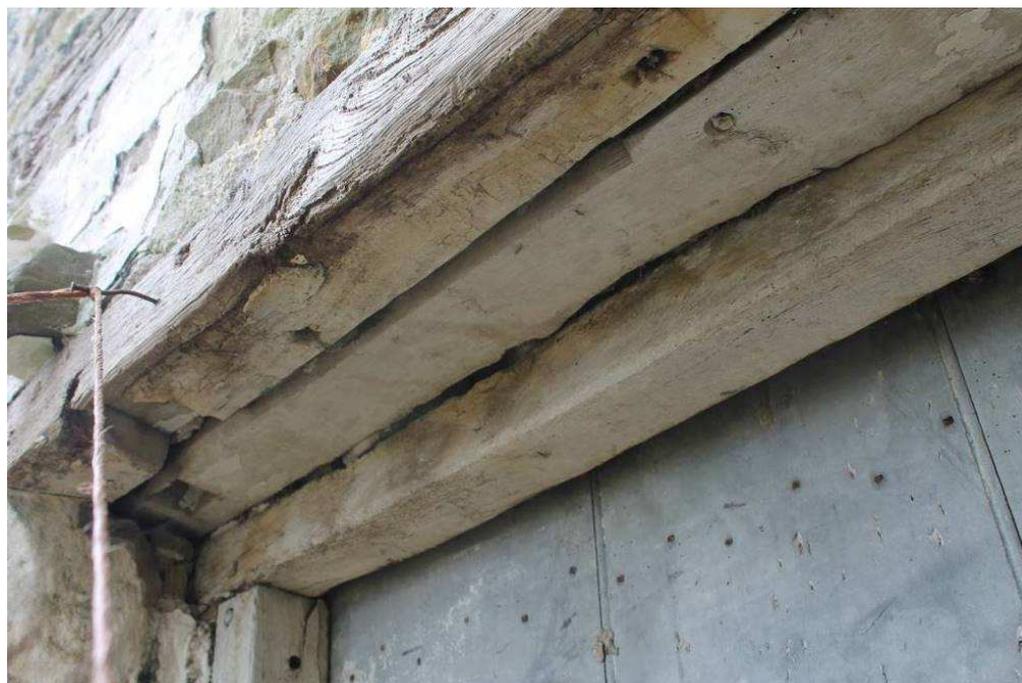
Plate 12: Underside of the lintel of the central eastern door showing re-used timbers

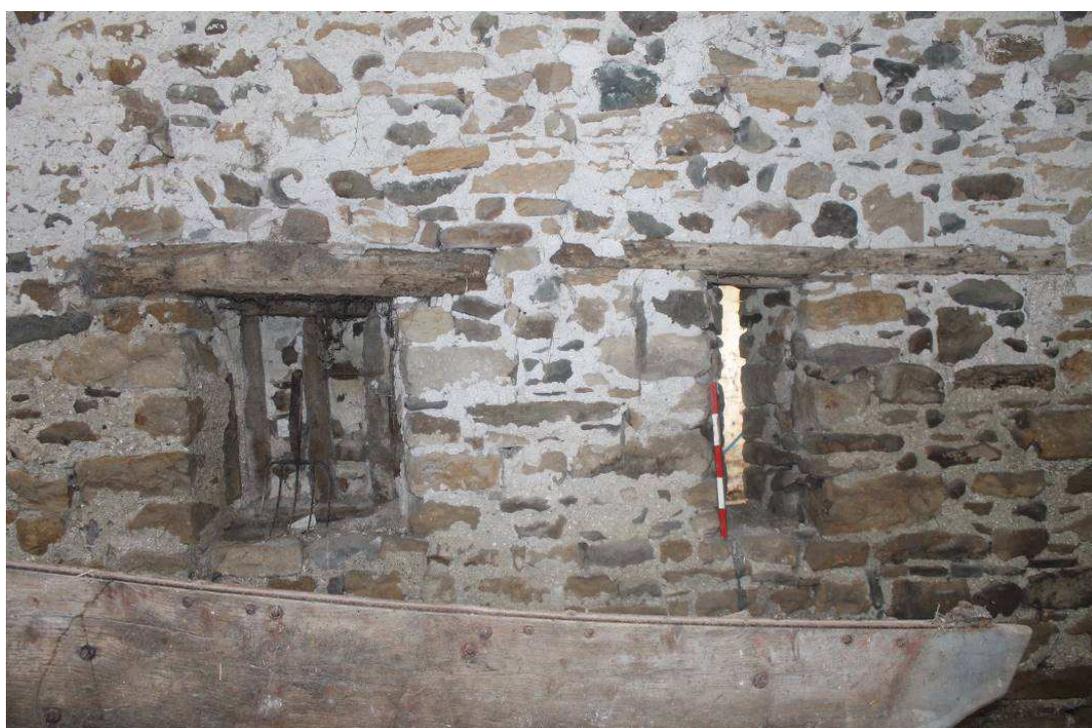
Plate 17: Blocked window and vent at the northern end of the eastern elevation

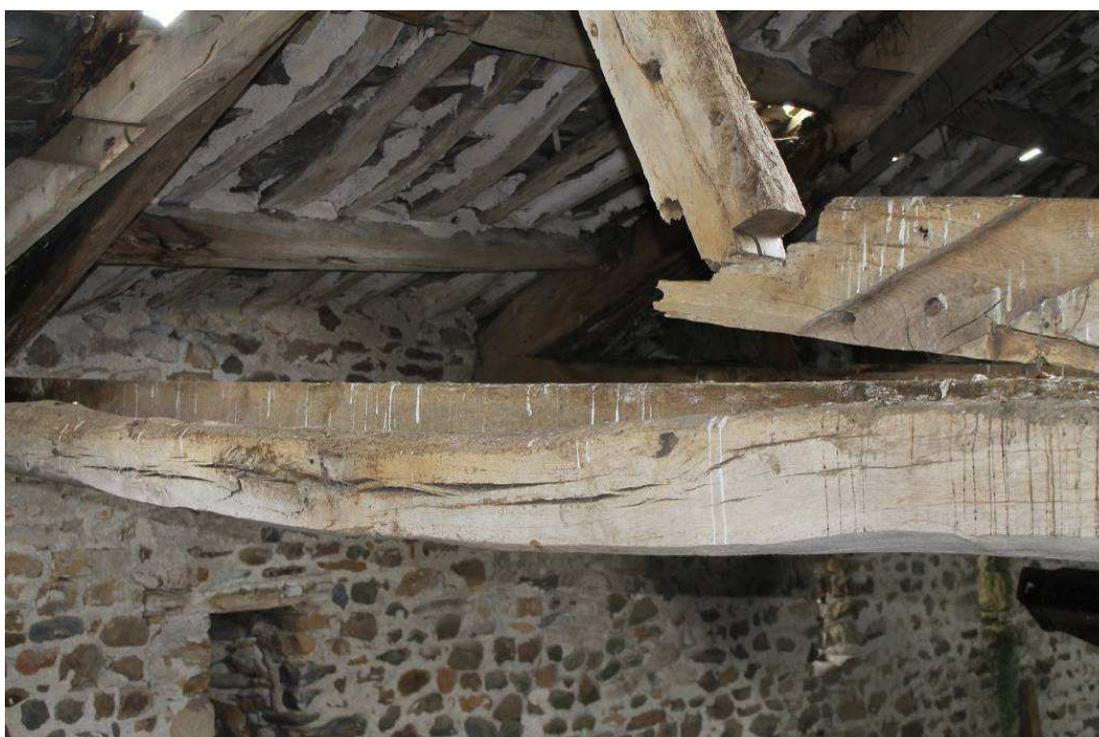
- 4.2.4 Two of the trusses were in a very poor condition and had been shored up with the addition of a matching truss immediately to the south. The original trusses were numbered on the northern face of their western joints with roman numerals from I at the southern end increasing to V at the northern end (Plate 20). Notably truss IV was not present, and again perhaps highlights the reuse of the timbers from another building. Trusses I –III were further numbered with a series of punched dots on the northern faces of their eastern joints (Plate 21).
- 4.2.5 Several pieces of wheeled farming equipment had been preserved in the barn, probably dating to the first half of the twentieth century, and a small free standing piece of equipment bearing the name ‘unchokeable’ and the manufactures name ‘J.R. Warwick’ of ‘Lancaster’ stood in one corner (Plate 22).

Plate 19: A failed principal rafter on the northern truss. The empty halfting joints can be seen on both rafters indicative of their reuse

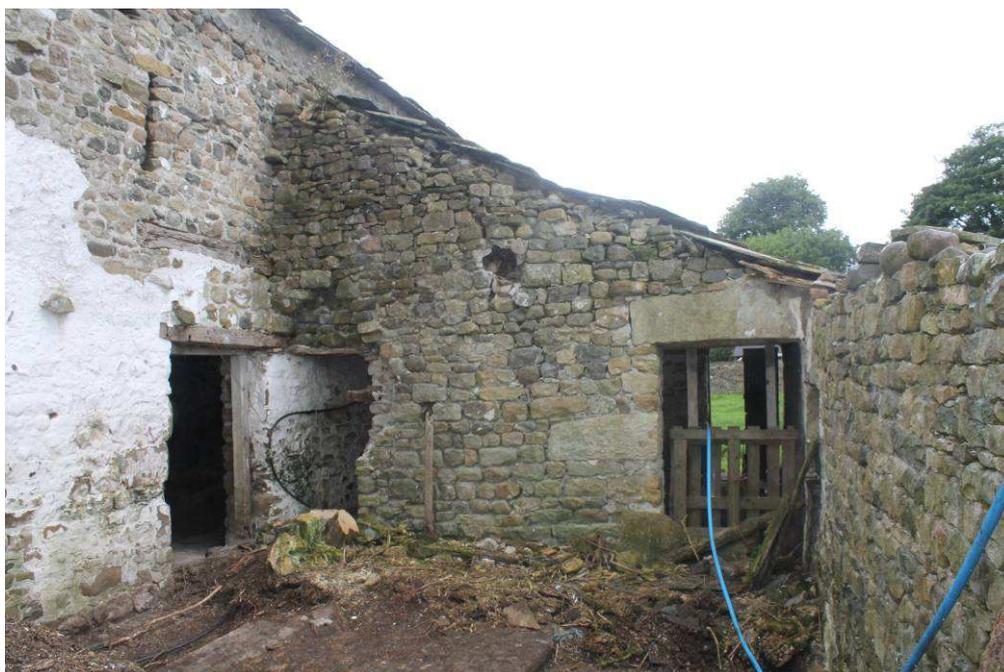
- 4.3.4 ***Southern Elevation:*** the southern wall had been incorporated into this adjoining building and was in a fragile state (Plate 25). Although construction appeared much the same as the remainder of the structure, the lime core had been washed out leading to structural damage. There were doors at the eastern and western ends of the elevation, the former being partly constructed with large sandstone block work was the larger of the two, while the latter had

Plate 25 : Southern wall of the north-eastern lean-to

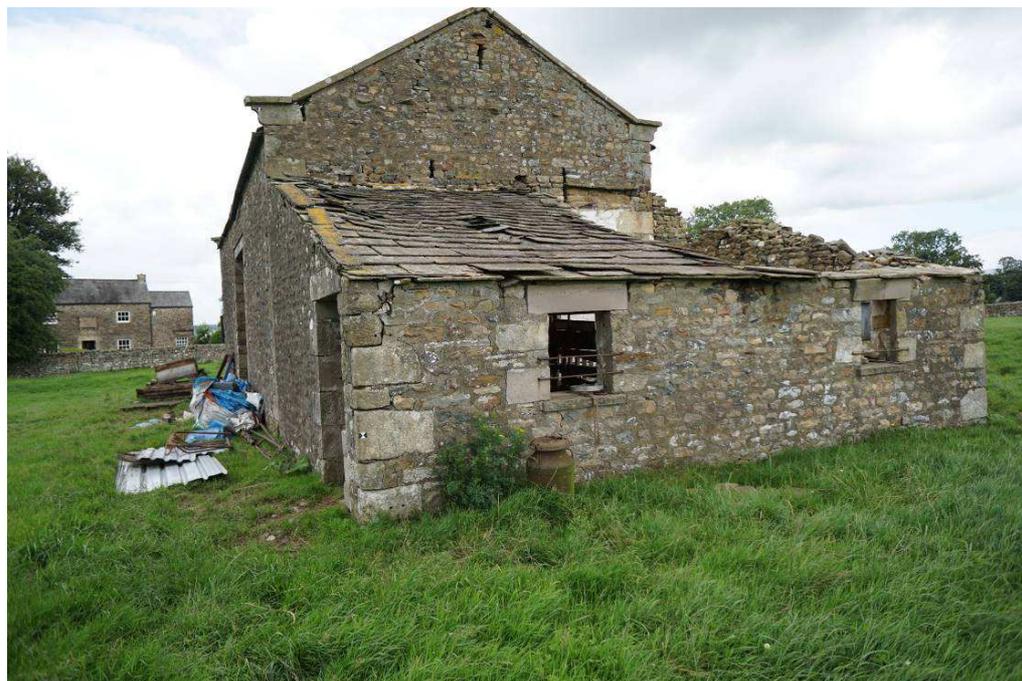
end of the structure had also led to the washing out of the lime mortar joints at the head of the wall, making the structure more fragile to the east.

Plate 33: Southern elevation of the southern lean-to

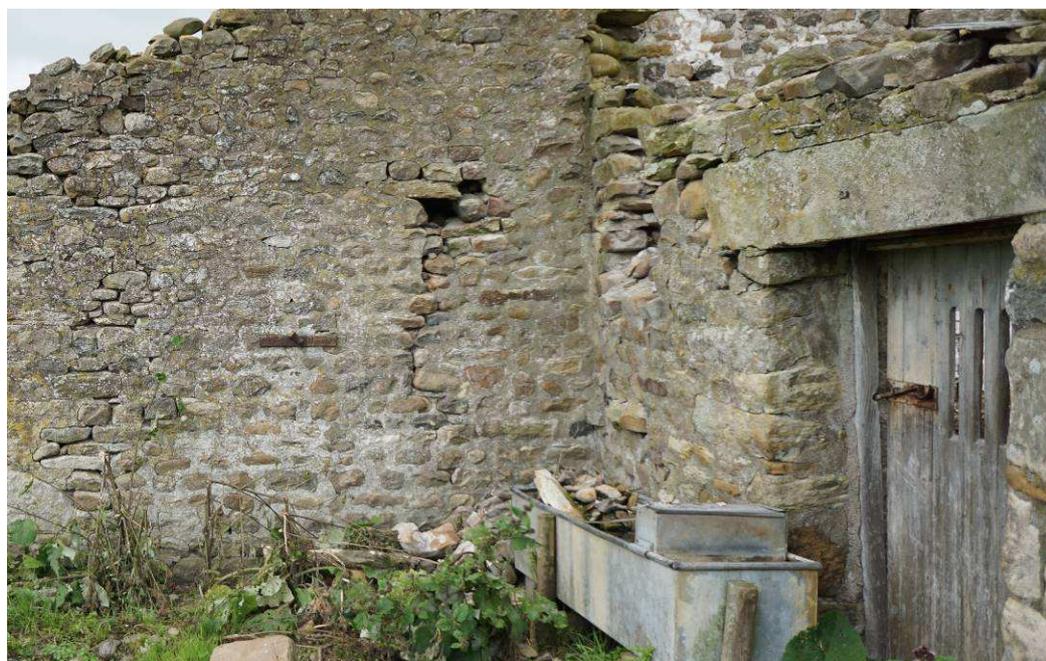
- 4.6.5 At the northern end of the eastern wall was a rectangular niche, with splayed jambs and a timber lintel, which matched the position of the disturbed masonry noted on the exterior. The two features can probably be identified as a window, blocked on its external face to leave a recess on the internal elevation.

Plate 35: Area of disturbed masonry at the northern end of the eastern wall
