The Temple Bar Hertfordshire

Report on the Archaeological Investigation of Temple Bar During its Dismantling

Oxford Archaeology

February 2005

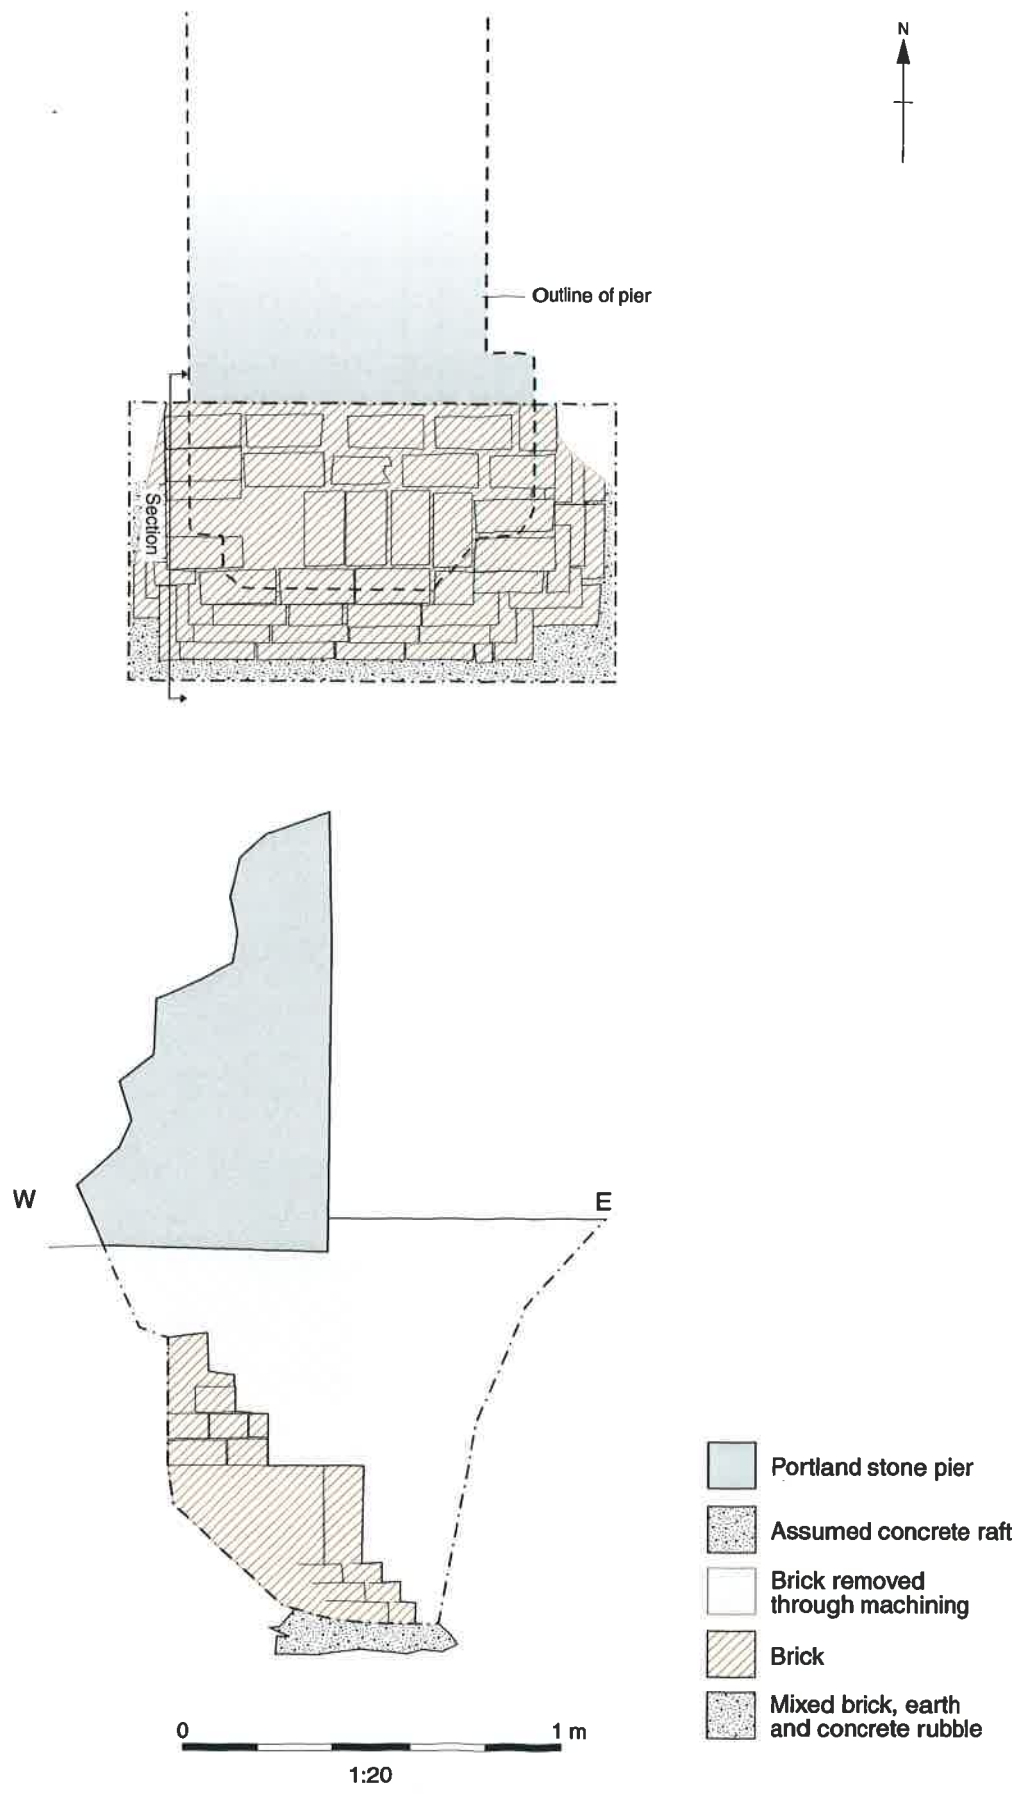
Figure 14: Temple Bar, test pit 1, plan and section

8.2.1 Test Pit 1 (Figure 14) (Plates 51 and 52) was not excavated to the full depth of the foundations due to time constraints and poor weather conditions. The upper 0.70 m of the foundation was truncated by the machine excavation, and had been loosened prior to examination by the removal of the stones of the Bar. The foundation here was for the western pier between the main central arch and the western pedestrian arch.

8.2.2 The vertical foundation continued 0.97 m below ground level before stepping out in a series of three steps, each just under a brick's width - 60-80 mm. The vertical portion of the foundation measured 1.14 m in width and was revealed to a depth of 0.60 m. The brickwork was not consistent, particularly away from the edge of the foundation, with edge, end and side laid bricks; half bricks were also included in the construction. The bricks measured 215 × 115 × 75 mm with a shallow frog, they were bonded with a pale cement mortar.

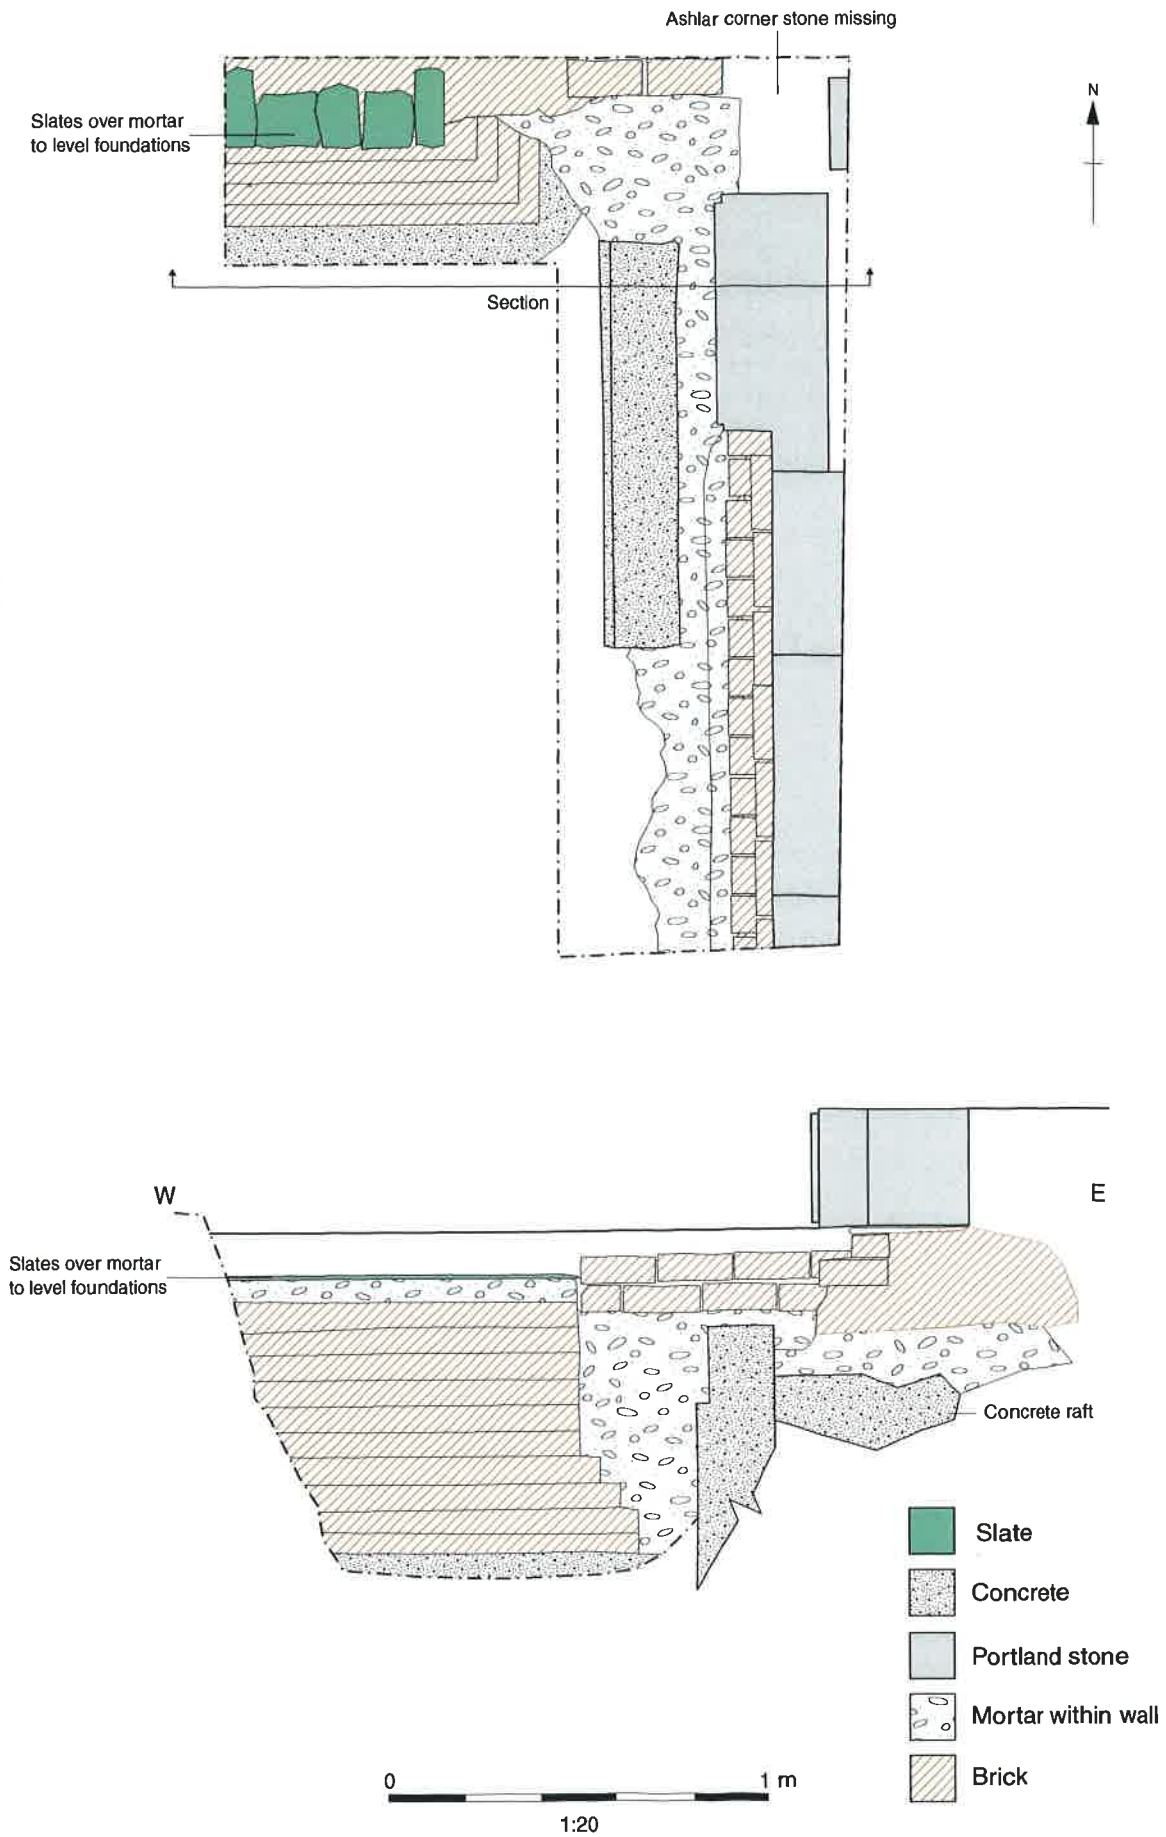
Figure 16: Temple Bar, test pit 3, plan and section

- 8.4.1 Test Pit 3 (Figure 16) (Plates 55 and 56) was opened in the corner formed by the southern wall of the stair up to the Bar's upper room and the front, west wall of the Lodge, in order to investigate the relationship between the Bar and the Lodge at foundation level.

- 8.4.2 The foundations underneath the western side of the stair-well to the east of the Bar and apparently continuing towards and under the Bar itself was constructed in a similar manner to those found in test pits 1 and 4. Six courses of bricks formed a vertical wall resting on a series of three stepped brick ledges projecting 50-70 mm. The brick elements rest on a concrete raft poured into a construction trench, the sides of which were not seen. On the top of the brick pier a thick layer of mortar was topped with grey slates, which may have been inserted as a form of damp coursing, or to level the foundations before erecting the stones of the Bar. These slates were approximately 120 mm below ground level, and the first course of ashlar would most likely have been set directly on them.

- 8.4.3 The Lodge's foundations are later than, and abut, this brick construction. The stair-well is also supported along its eastern wall by the foundations for the Lodge rather than the foundations for the Bar. This suggests a very small gap between the reconstruction of the Bar and stair-well and the building of the Lodge. Or, the

- 8.4.4 The Lodge's ashlar rests on two brick courses stepped out by 50 mm on the top course and 100 mm below that. Between the bricks and ashlar are several slates, perhaps used to level up before laying the ashlar. Underneath these brick courses is 250 mm of brick, it is not clearly coursed and the bricks appear to have been cut back. The lower part of this layer appears not to be full bricks at all but rather a mix of broken and crushed bricks bonded with a pale mortar. This sits, 420 mm below ground level, on top of a concrete raft of uncertain thickness.

- 8.4.5 Within the test pit in the corner a large piece of pre-cast concrete beam was identified: it measured 1.16 m long by 220 mm wide, and was at least 0.70 m deep. It was set on its long edge forming the west side to the foundation of the Lodge. It was not clear what purpose this piece served. It was clearly cast and set before being deposited within the trench. Although initially it was thought to be some form of buttress, added after the Lodge was built, as it only covers a small part of the length of the Lodge and is not in direct contact with the substantial parts of either foundation this seems unlikely. It may be that it was inserted into the foundation cut dug for the Lodge as part of the hard-core fill below the brick coursing, this mixed material certainly continues around the north and south ends of the beam. At the northern end of Test Pit 3 between the wall of the Lodge and the brick built foundations the full depth of the foundation is filled with a loose hardcore bonded with white mortar.

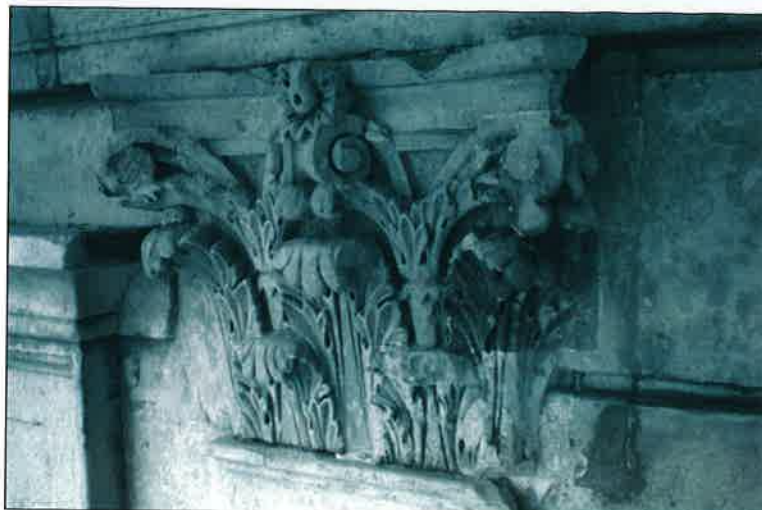
- 4.1.4 The capitals of the pilasters on the north and south fronts of the Bar are later replacements, probably dating from the reconstruction of the Bar in 1888. They show numerous repairs (Plates 9 and 10) of both whole sections of moulding, and individual elements like leaf tips. Where blocks of moulding was cut out and replaced, the new stone was fixed with a fine white gypsum plaster. All the repairs seem to be of one period using this method. John Schofield of the Museum of

Plate 9: Detail of middle capital on the north facade, note rectangular block replacements (OA 2004, F6/28)

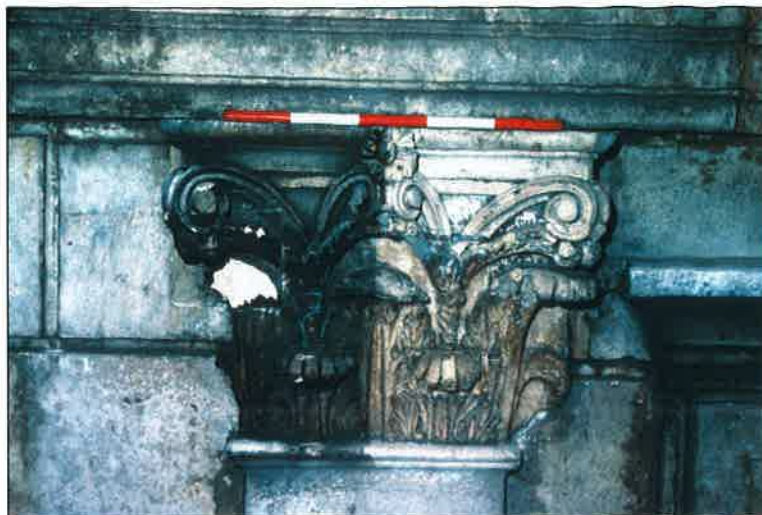
Plate 10: Capital showing repaired sections, half cleaned (OA 2004, F3/3)

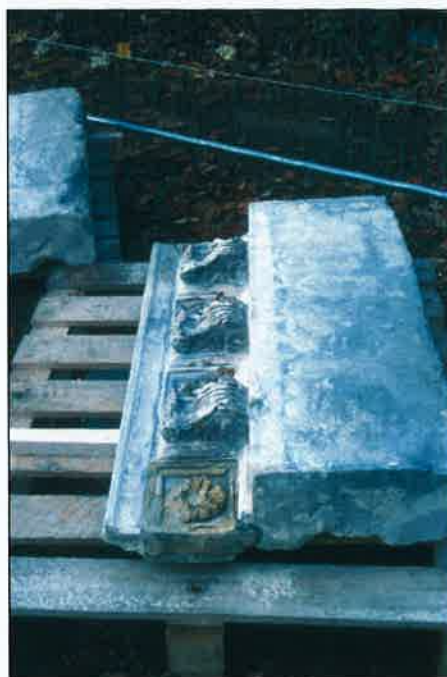
Plate 11: Cornice modillion section with replaced floral soffit, note the mason's mark to the right of the replaced section (OA 2004, F7/23)

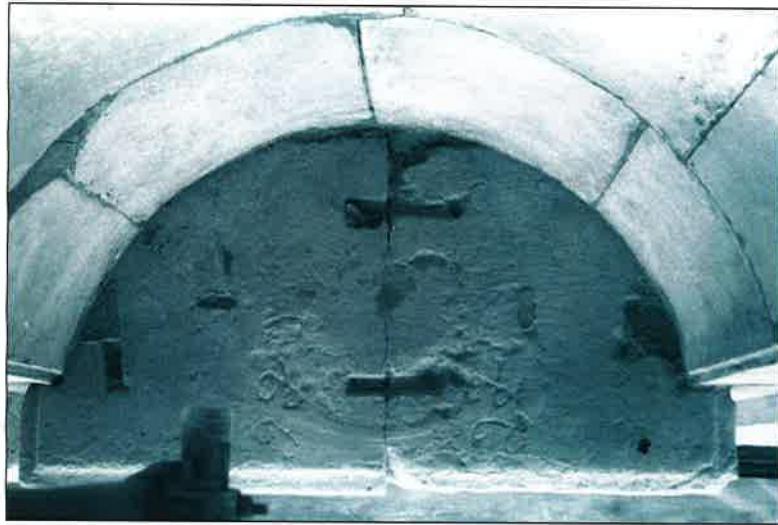
Plate 23: Base stones of niches showing sockets for missing cramps and pintel holes for lifting the stone in place (OA 2004, F6/17)

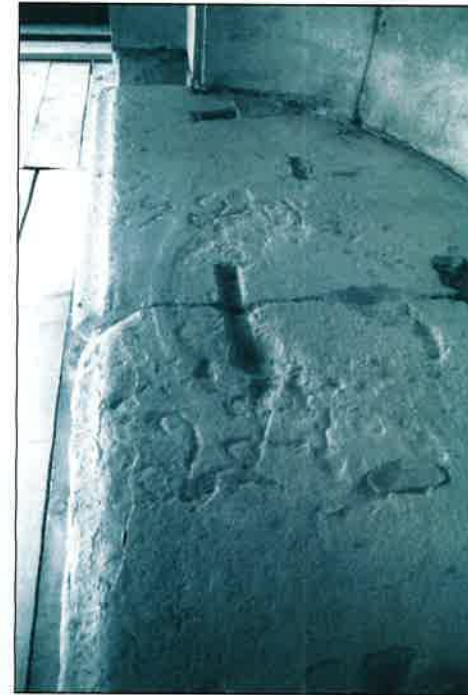
Plate 24: Niche base with curvy numbers, possibly from the first dismantling (OA 2004, F6/20)

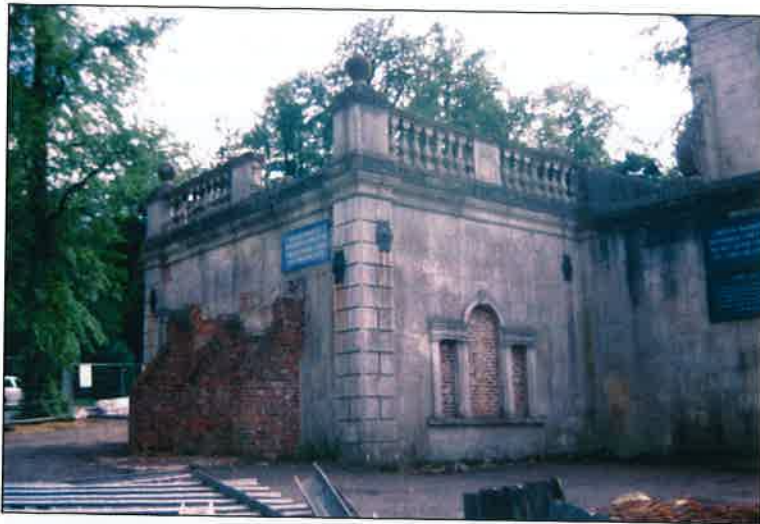
- 7.2.1 The Lodge has the same Portland stone exterior as the Bar and only has a single storey or possibly a storey and a half (Plate 42). The main walls are smooth ashlar, leading straight down to the ground with no plinth, and the corners are accentuated with large rusticated pilasters, the projection of which continues up through the cornice and into blind corner panels within the balustrade. The west face has the front and main entrance into the Lodge and is divided into three bays the middle one, containing the door and date plaque, breaks slightly forward of the bays on either side. The rear of the lodge, its eastern side is plain ashlar with brick at the centre where the annexe once was. This annexe had been previously removed, and now three brick buttresses abut this area (Plate 43).

Plate 43: The rear of the lodge with brick buttresses replacing the original annexe (OA 2004, F5/17)

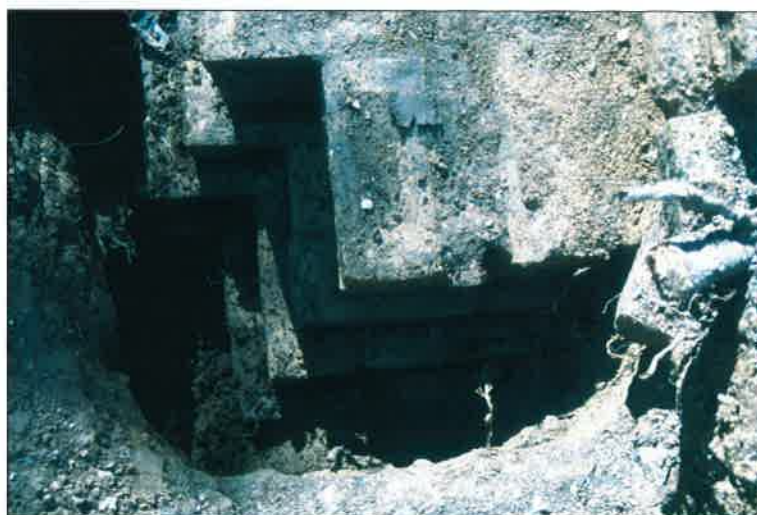
Plate 52: Test pit 1, stepped bricks at the base of the foundation (OA 2004, F13/13)

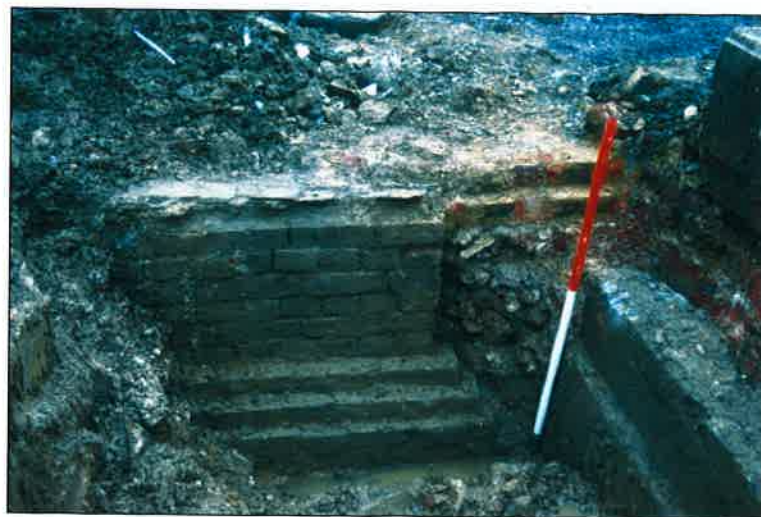
Plate 56: Test pit 3, corner shot showing rubble fill of the lodge's foundations abutting the stepped brick foundation of the bar (OA 2004, F13/22)

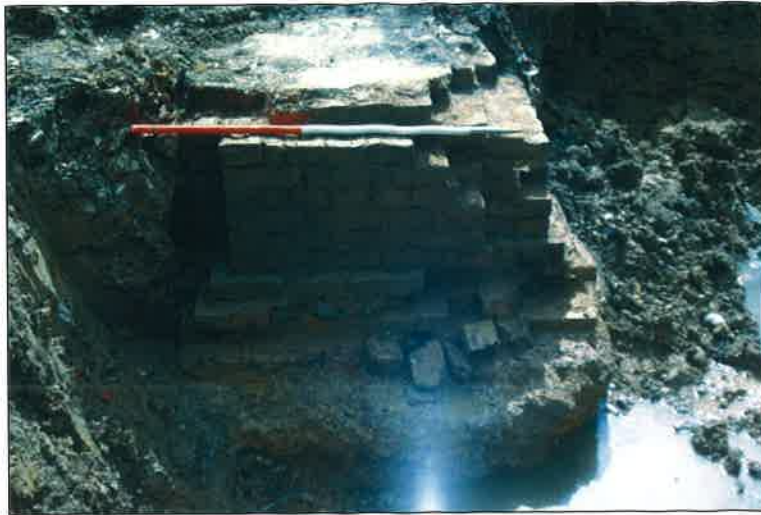
- 8.5.1 Test Pit 4 (Figure 17) (Plate 57) was excavated at the northern end of the eastern pier wall to the central arch under the Bar. The foundation was excavated to its full depth of just less than 1 m below ground level and in general character was the same as those foundations found in Test Pit 1 and 3. The north western corner of the foundation was damaged during the machine excavation.

Plate 57: Test pit 4, general shot looking south (OA 2004, F14/2)
