The Church of St Mary the Virgin, Hurley, Berkshire.

Watching Brief during Construction Work Interim Report

Oxford Archaeological Unit
March 1996

NMR DATA	
Site Name	Church of St Mary the Virgin
Address	Hurley High Street
Town	Hurley
Parish	Hurley
County	Berkshire
NGR	SU 8258 8410
Status	SAM No. 19020
Visit/Survey Date	11th - 15th January 1996
OAU Site Code	HUMA 95

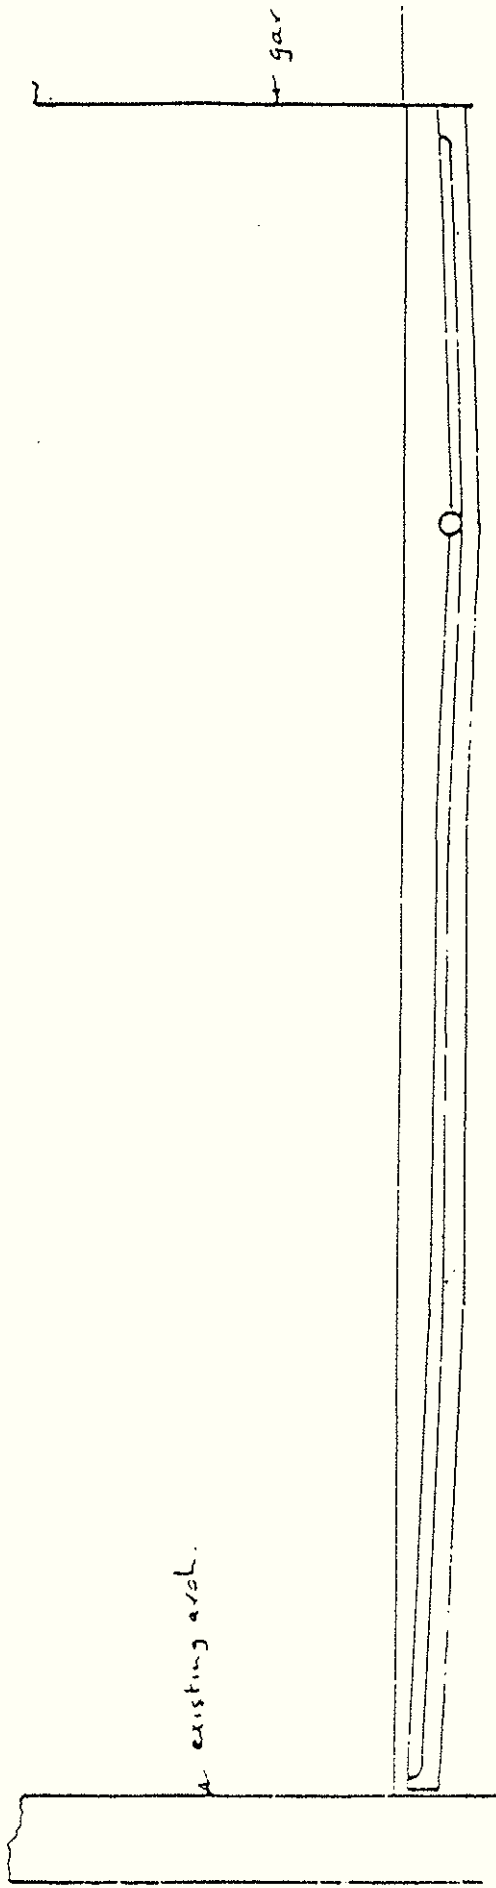
Typical Cross-Section
(1/2" = 1ft.)

3.4.1. During the winter of 1972-3, the western half of the north wall was tanked on the outside in an effort to reduce damp. This work consisted of excavating a trench c.50-75 cm deep, the bottom of which was filled with concrete. Upon this was laid a DPC. A concrete block wall was erected from this, c.10cm from the flint rubble of the church wall. The void was filled with concrete and the whole tanked with bitumen and capped with tiles and lead flashing (see appendix C). Between the 15th and 29th November 1995 the trench was partially re-opened to enable the concrete blocks and concrete infill to be removed. The decision had been taken to leave the concrete pad in situ together with the lowest course of blocks and indeed in the area of the blocked north door the work was removed only to ground level. Where the flint rubblework of the wall was exposed it was repointed prior to backfilling. Due to the fact that no archaeological deposits were expected to be disturbed and that no significant features were discernable to the architect, the work was not monitored by OAU.

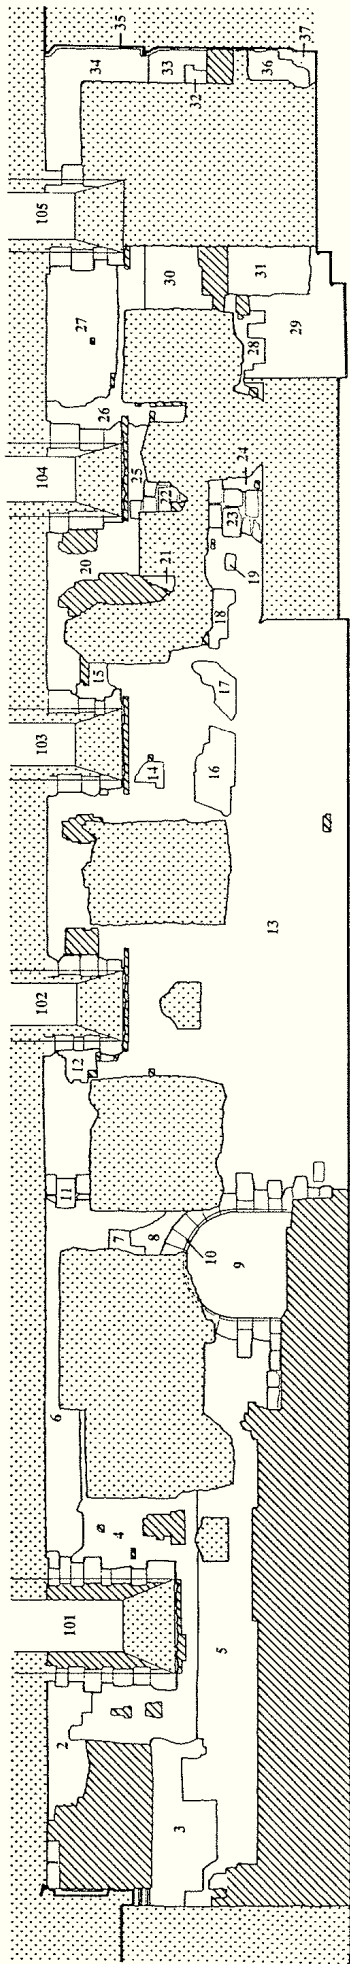
Internal Elevation: North Wall

- 3.1.1 The north wall would appear to reflect two main phases of construction, the first being from the east end up to, and including, the line of quoins **11**. The second phase continues from this point westward. Both phases one primarily constructed of flint rubblework with very few clunch inclusions. The blocked Romanesque door would appear to be contemporary with this second phase. Contexts **11, 13, 20, 21, 24, 25, 27, 32** and **34** and quite probably **26** belong to the first phase. Contexts **1, 2, 5, 6, 8** and **10** belong to the second phase. Unfortunately monuments and later rebuilding have obscured the exact sequence of events, but it would appear possible that the new west end was completed before the old was removed.

- 3.1.2 Areas of squared, coursed blocks of clunch with prominent tool marks were noted , principally **22, 23, 29**. The purpose of these could not be identified due to the in-situ monuments and choir stalls, but they would appear to be early in origin. There were similar, though less well coursed patches, principally of tooled clunch notably **26, 28, 30** and **33**. Apart from **30**, which appeared contemporary with the later restorations, the rest also appeared to be reasonably early.

- 3.1.3 Underlying the Lovelace monument at the extreme east end of the north wall were two patches of handmade clay roof tiles, **31** and **36** mortared, edge to edge. Each had two peg holes and would appear to be contemporary with the monument.

- 3.1.4 The final phase is represented by the areas of red, handmade bricks shown hatched in fig.1 and the areas of hard mortared, small uncoursed clunch which appear to be associated with them (**3, 4, 7, 12** and **14-19**, with the brick reveals of **101** and the cills of **102 -105**). These are no doubt associated with the 19th-century restoration.

3.3 Few of the window splays were cleared of render. The western reveals of **104** and **105** in the north wall were exposed and appear to be early, being of clunch and flint rubble. Both reveal the larger window in the north wall (**101**) were exclusively brick. All the windows had brick sills. **107**, the decorated window on the south wall had pieces of brick in its exposed northern reveal. Though much restored on the outside there is no reason to doubt the authenticity of their positions and proportions or their inner quoins and voussoirs.

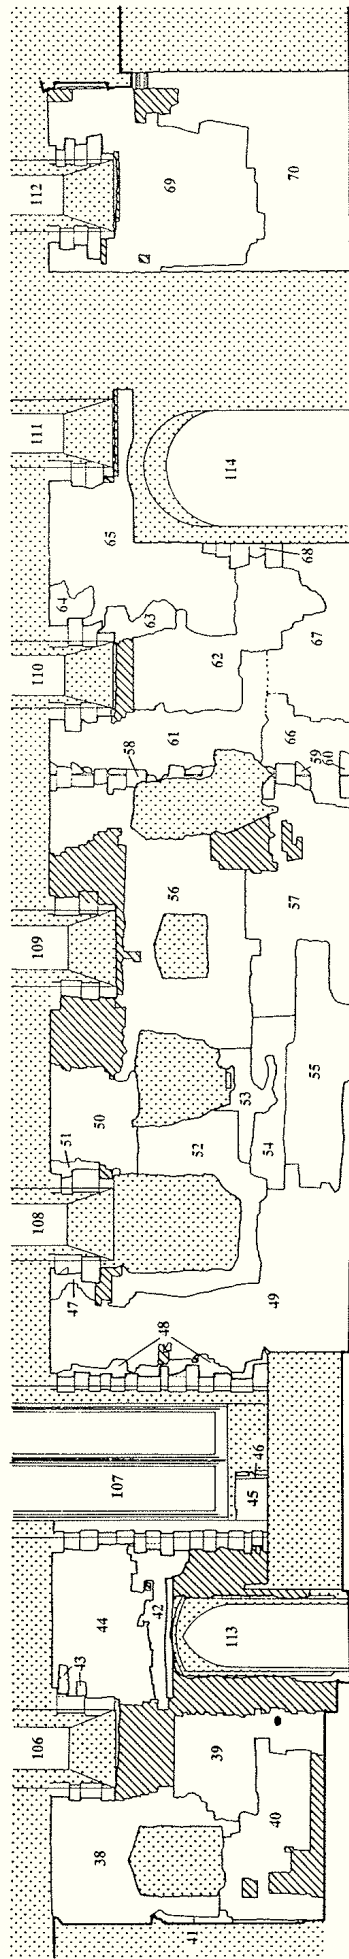
Internal Elevation: South Wall

- 3.2.1 The South Wall reflects the phasing of the north, **58** representing the break between the phases. Of the flint rubble walls of the eastern half, those portions represented by **38, 44, 49, 50** and perhaps **53** and **57** remain intact. Contexts **61, 65, 67** and **70** again of flint rubble though with more clunch fragments would appear to date from the 12th century eastward extension of the church. Context **57** may also date from this time. **65**, on area of rubble walling containing a very high proportion of clunch and a low proportion of flint, may also be contemporary.

- 3.2.2 At the west end an area of squared tooled coursed clunch blocks (**40**) was noted corresponding to **22, 23, 29** on the north wall. Other older repairs of uncoursed clunch rubble were also noted, principally **54, 55**, and **66**.

- 3.2.3 Beneath the decorated window **107**, the rear of a small niche (**46**) in the exterior of the wall could be seen. Though only a small part was visible it was clear that it was originally pierced, if not glazed, and had only been blocked at a later date.

3.2.4 As with the north wall, there were many areas of hard mortared, small, uncoursed clunch, principally **39, 42, 43, 47, 48, 51, 56, 62-64** and **69**. These were again intimately associated with the red brick and would appear to date to the 19th century restoration.
