Historic Buildings Recording

OA East Report No: 1057

**Mill Hall, Dunnings Lane, Pulham Market, Norfolk**

*Historic Building Survey*

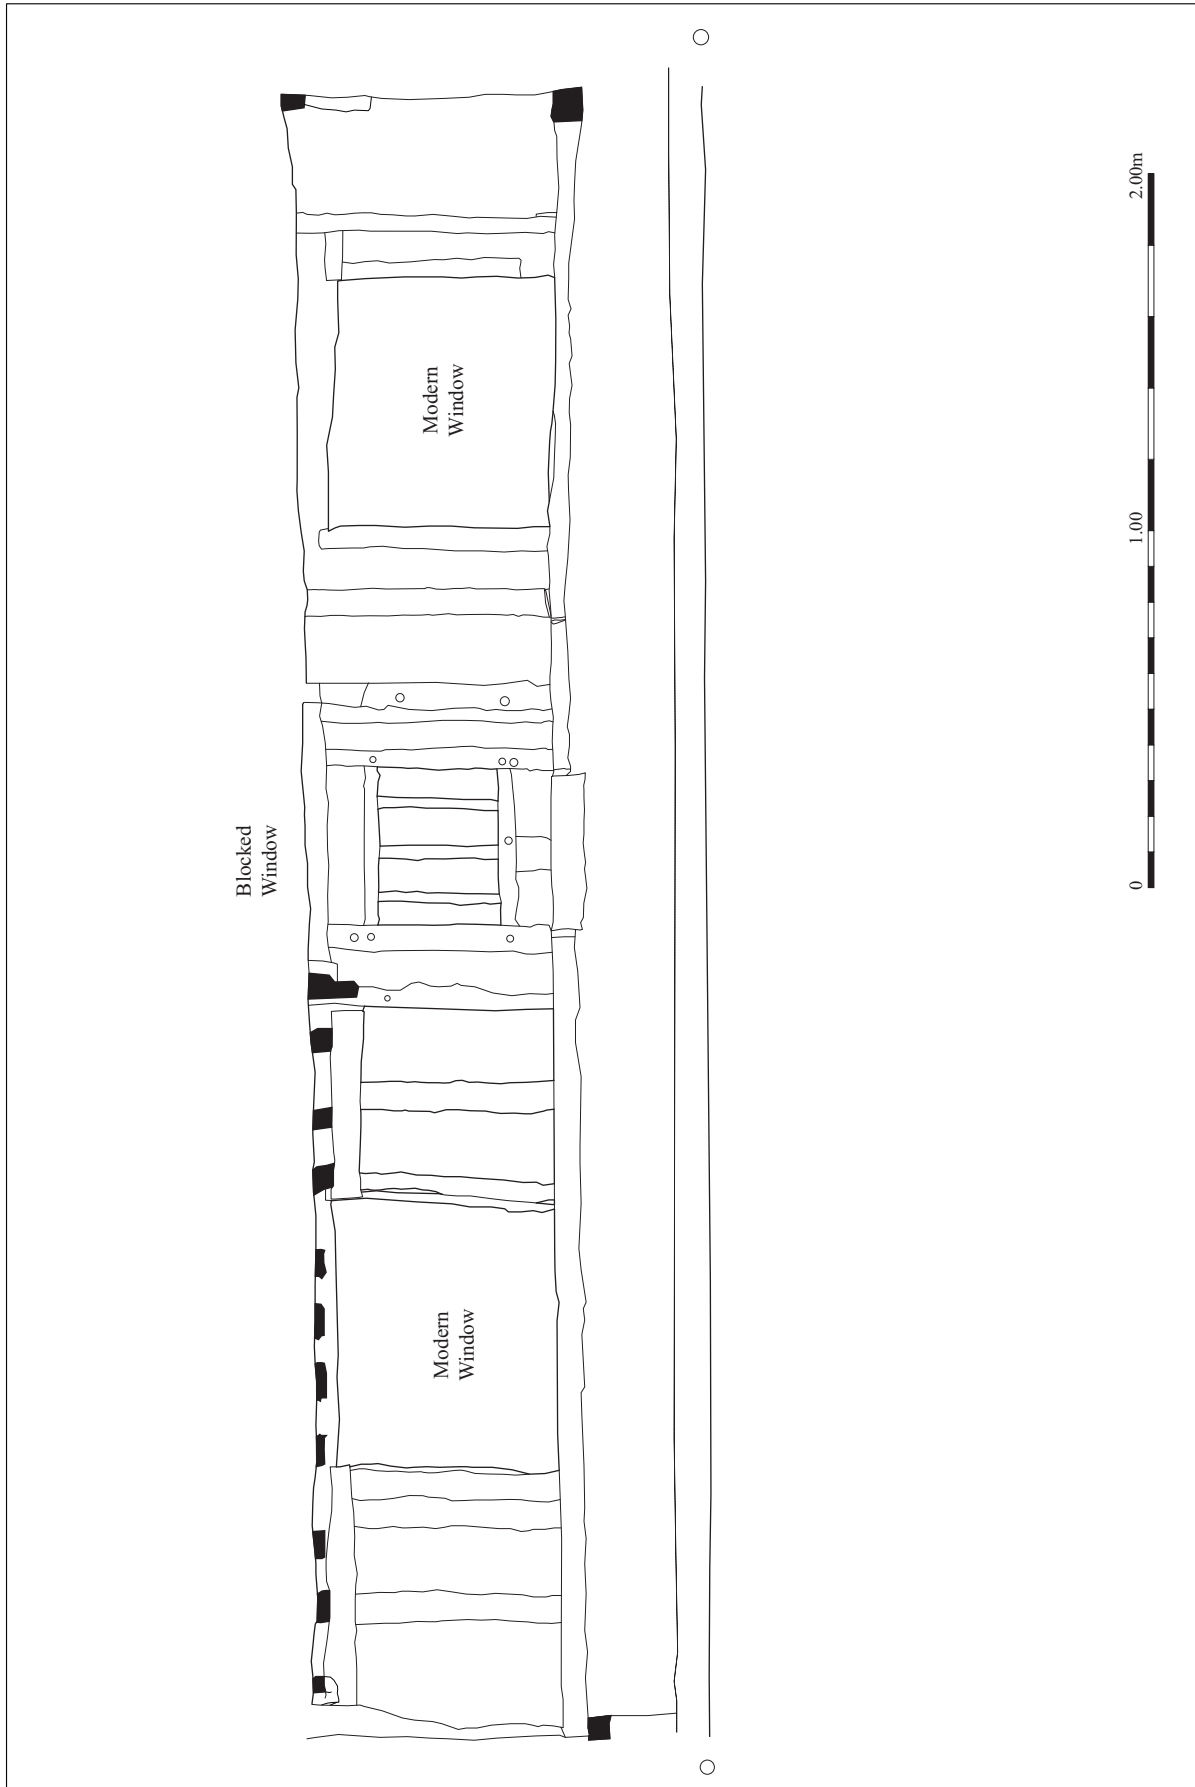
Figure 9: Elevation 2

- 4.2.10 To the left of fireplace 2 a blocked window was also recorded (plate 7) (Figure 9, elevation 2) This elevation also provides evidence of repair with several stud posts having been replaced using other sills and beams. Beneath the blocked window, a break was recorded in the horizontal sill beam. This gap was 50cm wide and had been in-filled with another piece of timber at some stage, perhaps when the window was added. This gap may represent the location of a doorway. If there was a doorway here, the brick plinth below would have been in-filled and plastered and painted over.
