Winchester City Mill Hampshire Historic Building Investigation and Recording

September 2018

Client: National Trust

Historic Building Investigation and Recording

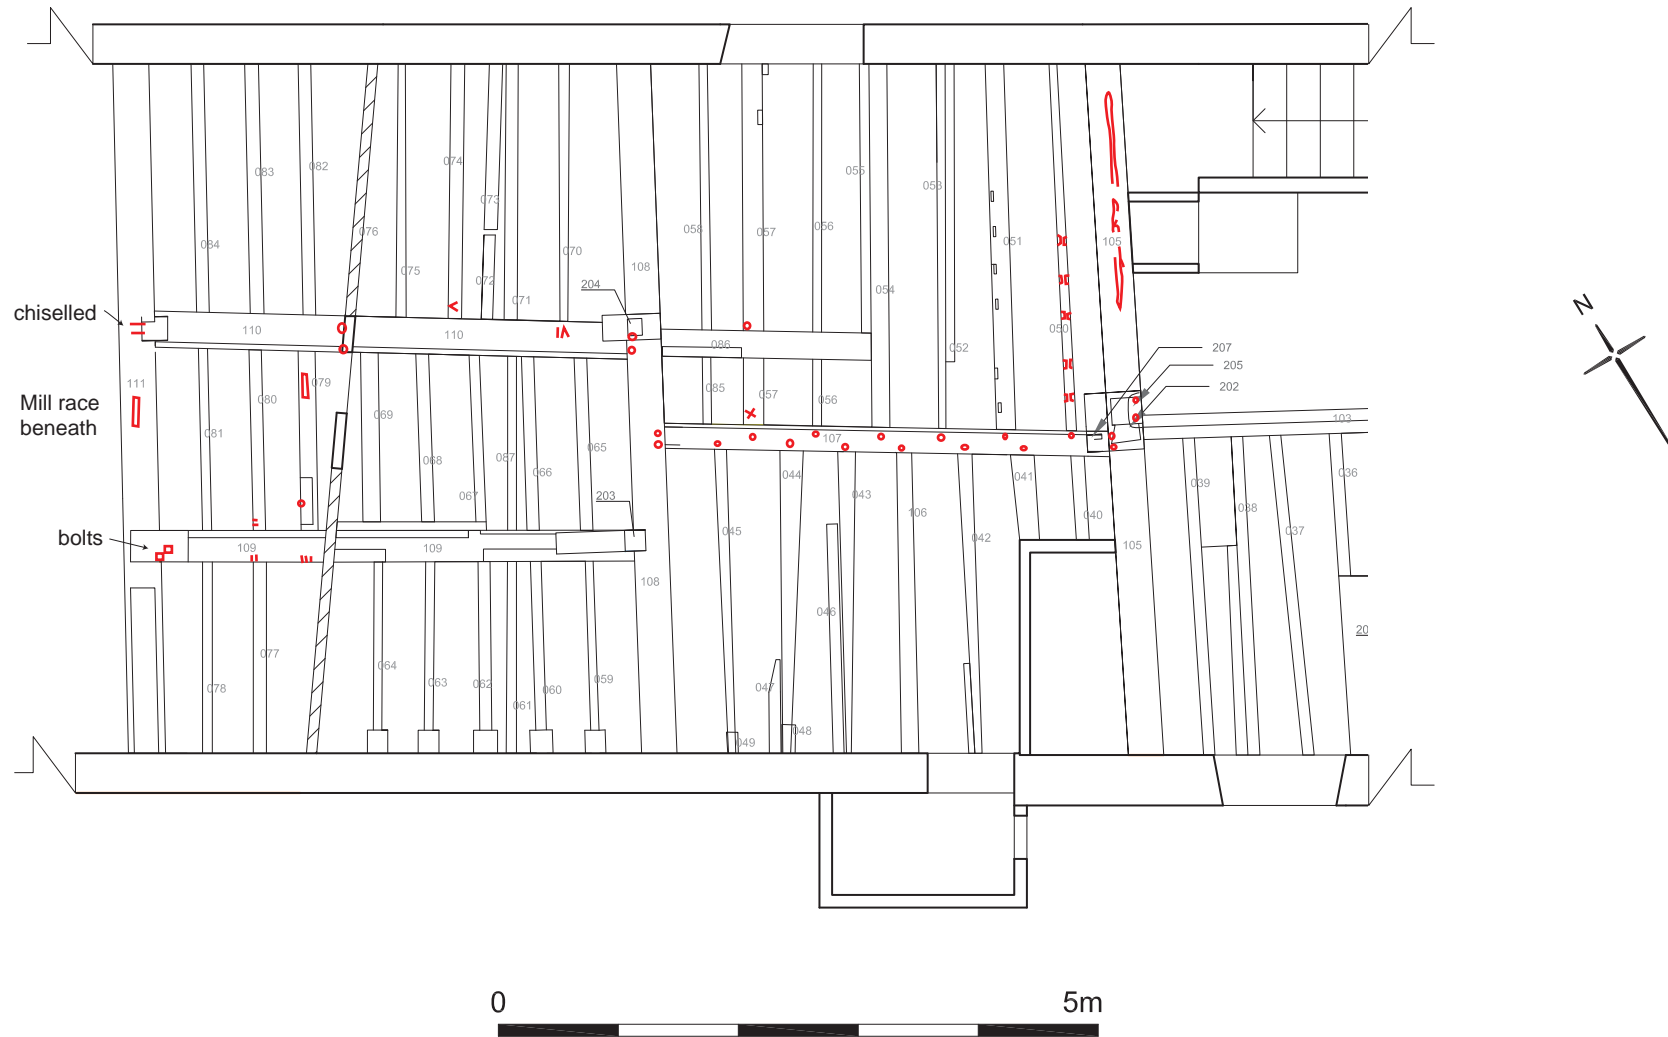
Figure 5: Plan of joists in western half of ground floor (from MOLA study) showing carpenters' marks, pegs and other features on top of joists recently exposed by removal of floorboards

- 3.2.20 The main areas of the floor which were monitored and recorded when the joists were exposed were Areas K and Q and parts of M, N and P (as defined in MOLA's 2016 report). The upper faces of the old joists were generally heavily worn and although there were many marks which could have been from carpenter's marks they were too indistinct to interpret or clearly identify. As previously noted in the MOLA report many of the joists were reused (See Fig 5 and Plates. 4-6, 17-30).

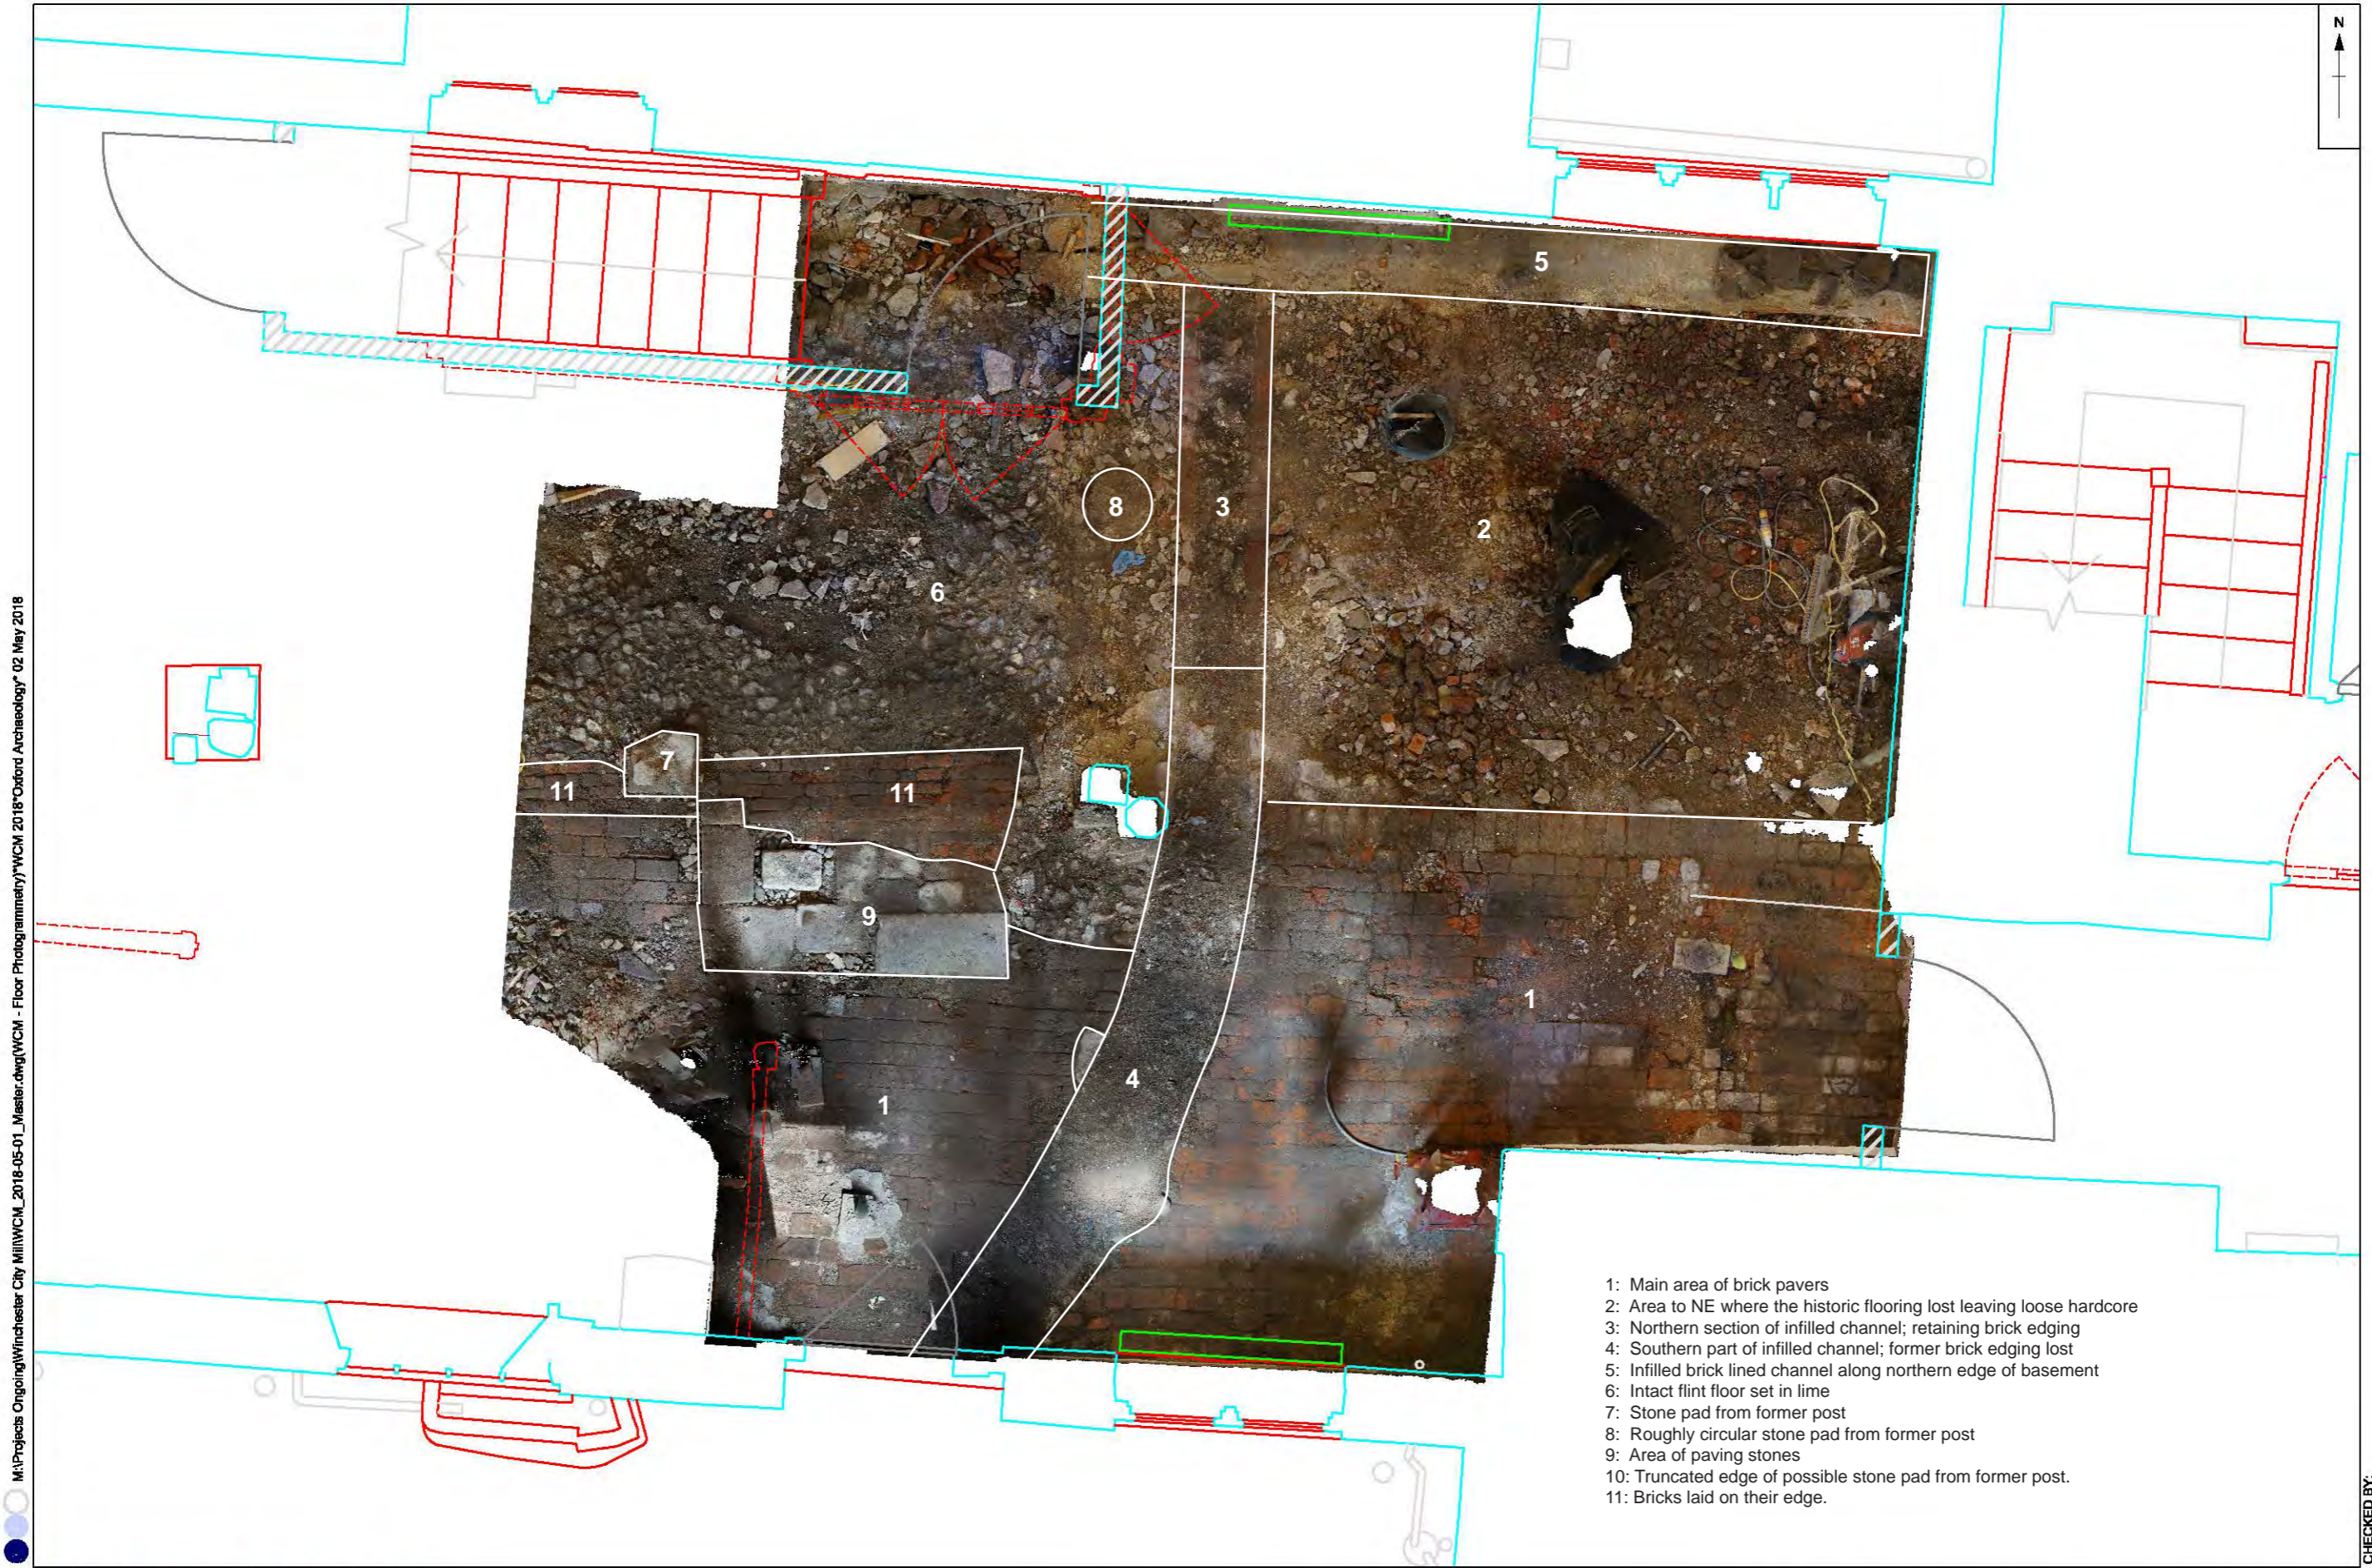
- 1: Main area of brick pavers
- 2: Area to NE where the historic flooring lost leaving loose hardcore
- 3: Northern section of infilled channel; retaining brick edging
- 4: Southern part of infilled channel; former brick edging lost
- 5: Infilled brick lined channel along northern edge of basement
- 6: Intact flint floor set in lime
- 7: Stone pad from former post
- 8: Roughly circular stone pad from former post
- 9: Area of paving stones
- 10: Truncated edge of possible stone pad from former post.
- 11: Bricks laid on their edge.

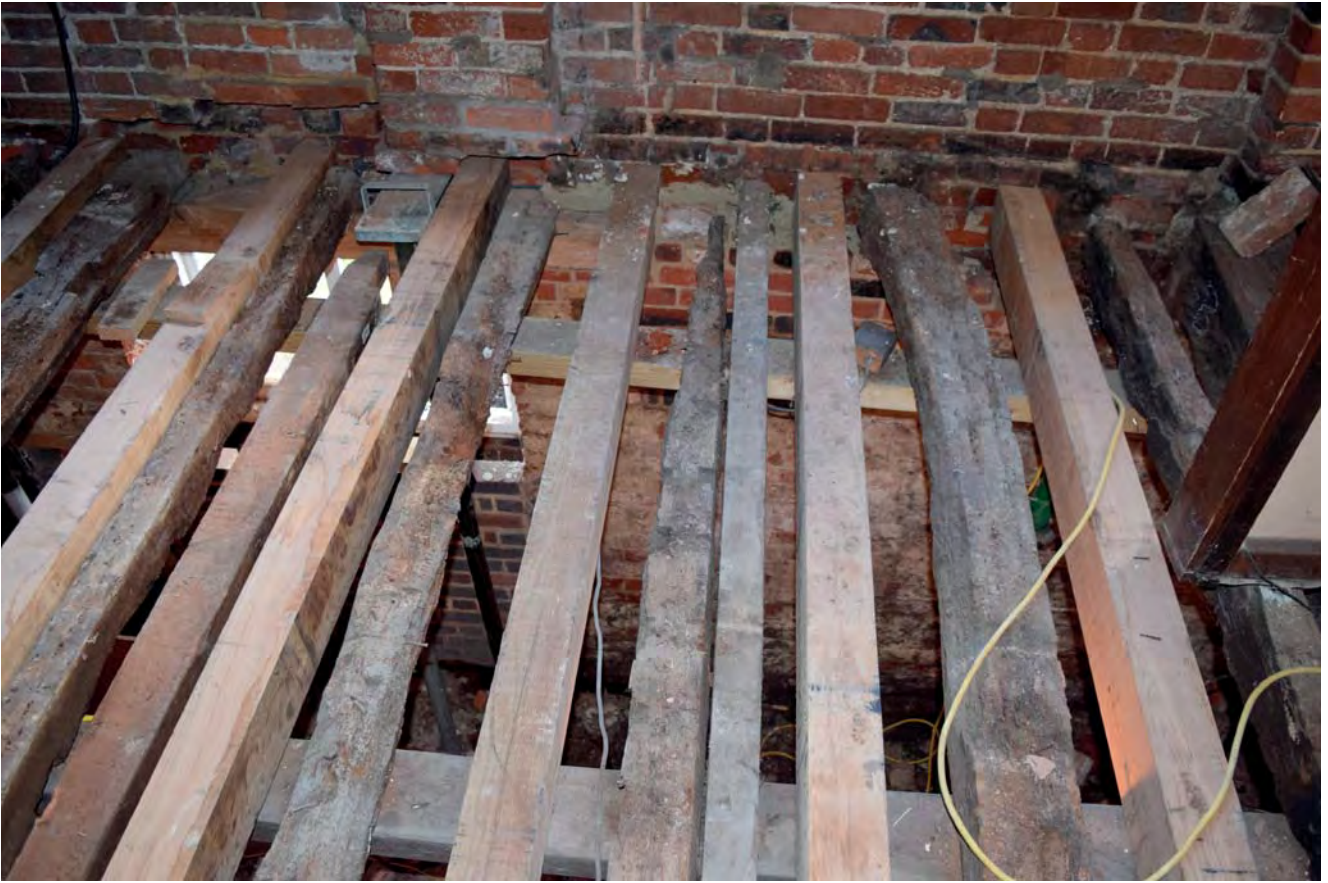
- 3.2.21 Using the joist numbering from the MOLA report the main marks noted were:
- 3.2.22 **No 50** (Area K): This joist had at least five notches in either side, relating to a previous use. The notches may have been from ceiling battens.

Plate 17: Joists during repair works in Area K looking north

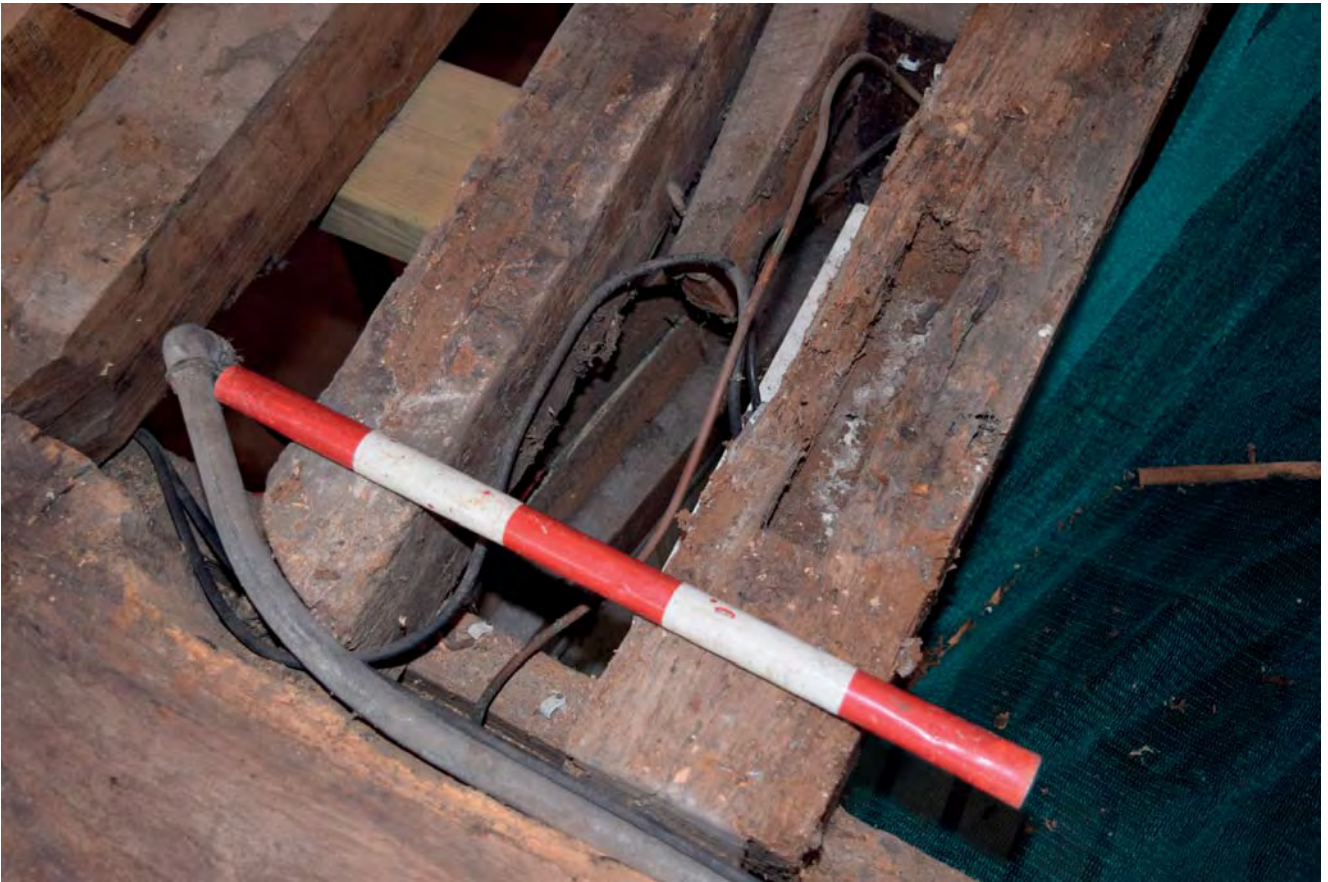
- 3.2.25 **No. 79** (Area Q): slot mortice in upper face
- 3.2.26 **No. 103** (between Areas H and G): it is clear that this bridging beam is a later insertion to replace a previous joist. The empty mortice from the previous joist is visible adjacent to No.103 but at a slightly higher level.

Plate 22: Trench mortise in Joist 79 (Area Q) looking south

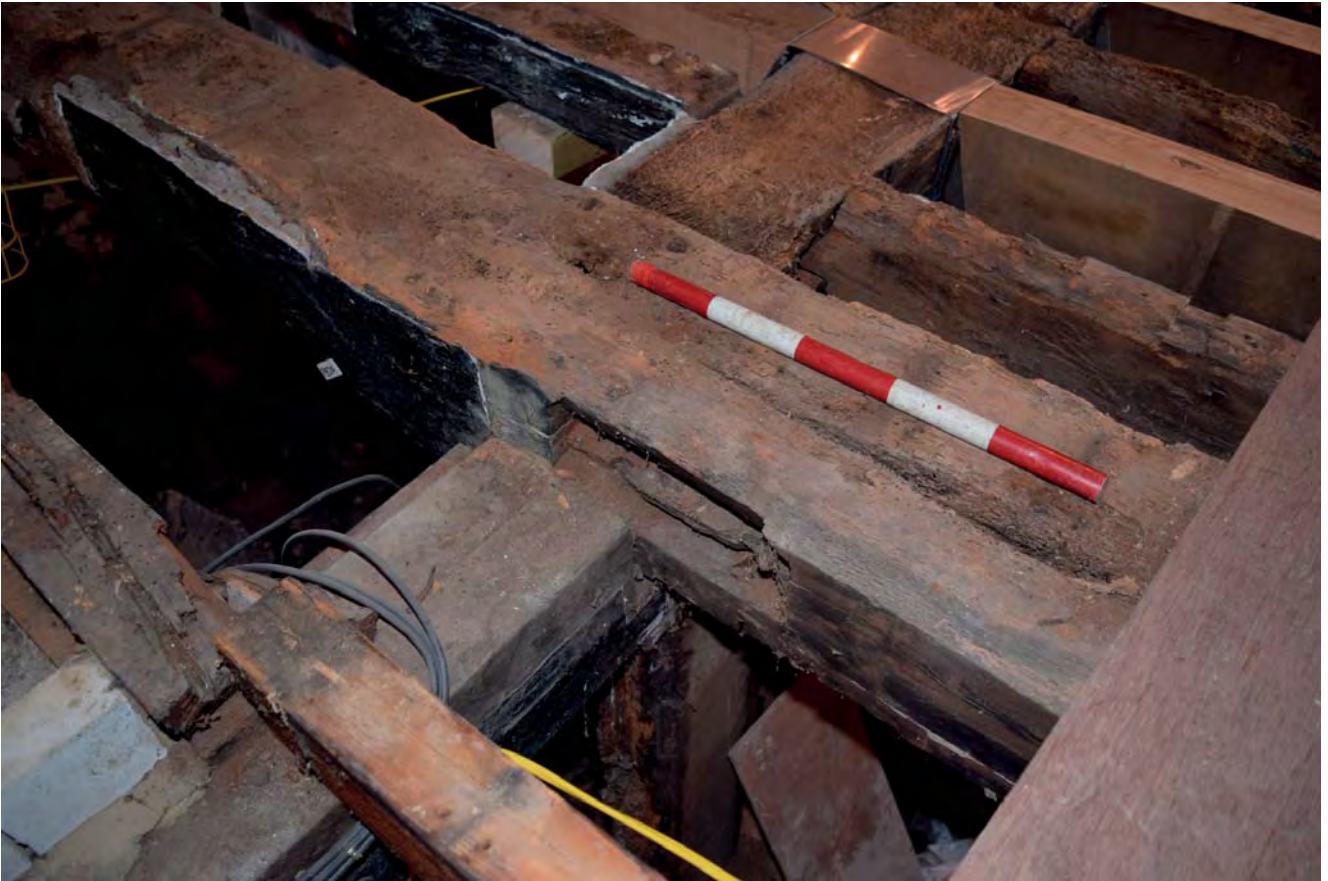
- 3.2.27 **No. 105** (between Areas K and H): this N-S principal joist had what appeared to be a long shallow groove in the top, in the northern half, but the fact that it was not straight suggests that it was probably just a surface crack in the timber.

Plate 25: Mortise in beam 105 (Area G) looking south-west

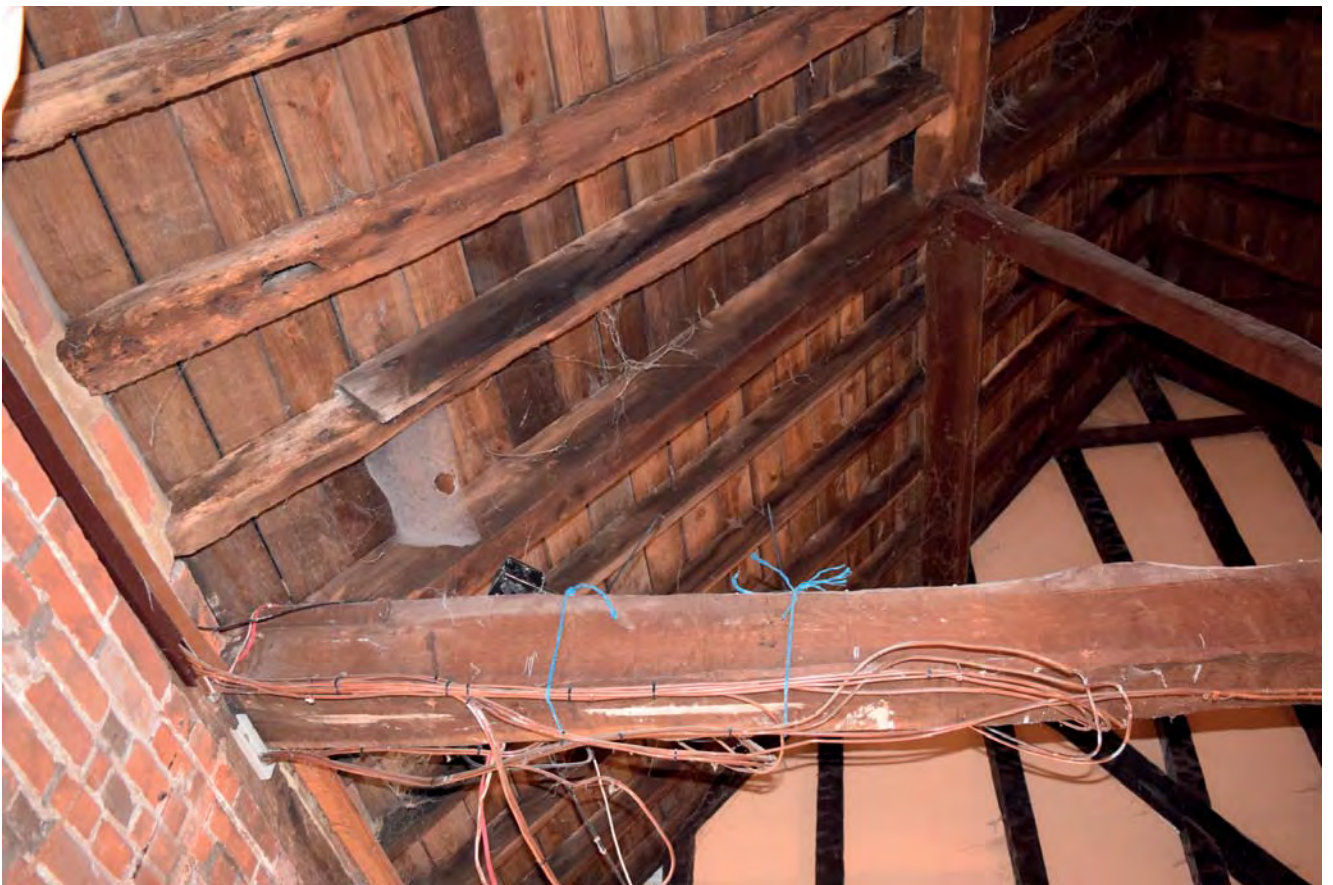
- 3.4.11 Truss 3 has simple metal straps at the ends, just securing the ends of the tie rather than the principal rafter, which could be original.
- 3.4.12 The easternmost truss in the open room (Truss 5) has a secondary tie-beam with metal straps at the end which may be early 20th-century in date (Pl. 56). The principal rafters in this truss are old however so it appears that the tie was merely replaced rather than the full truss.

Plate 50: north end of Truss 3

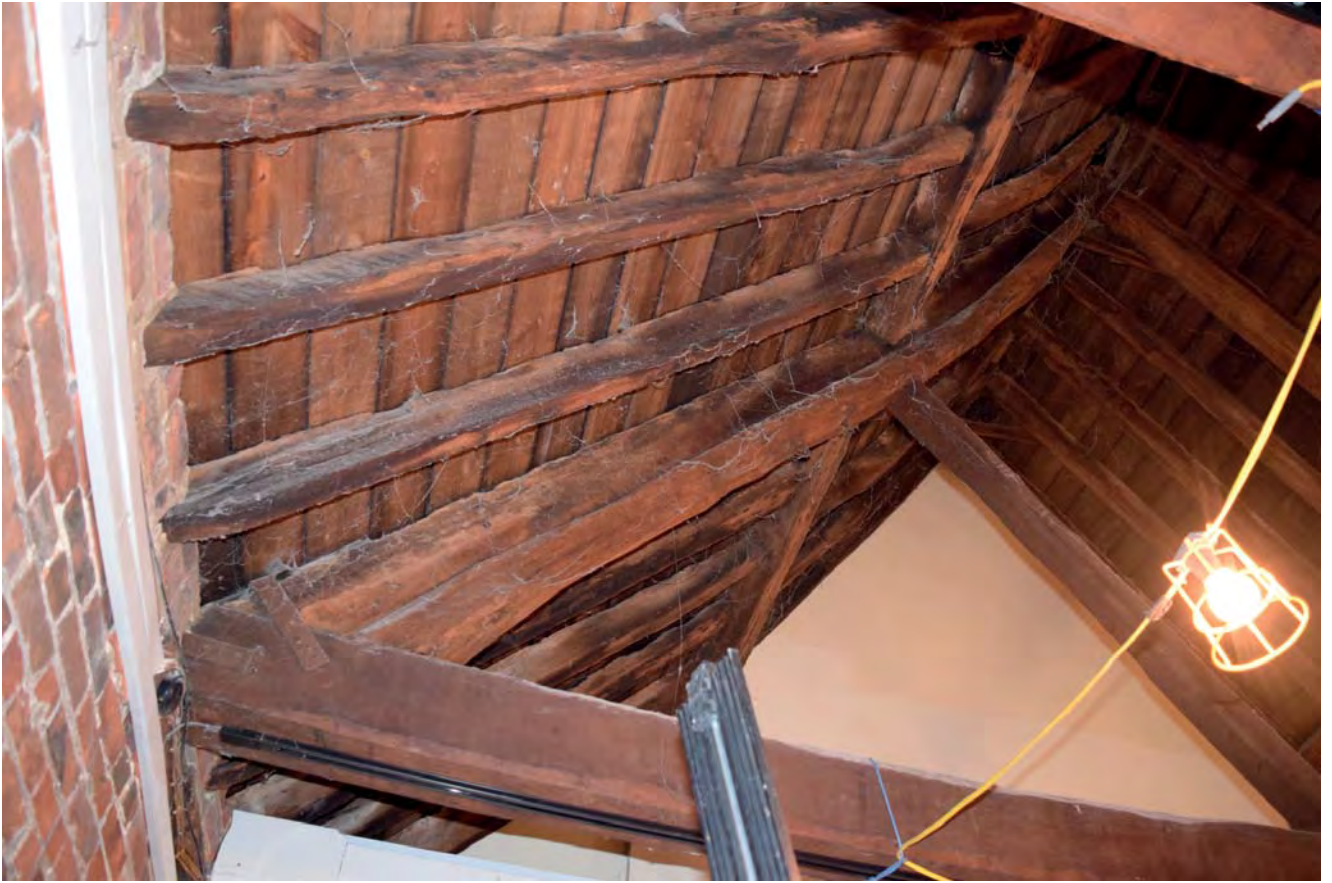
Plate 55: Truss 5 looking east
