## Canons Park Harrow

**Archaeological Investigation Report**

Client: London Borough of Harrow

Date: 18th December 2003

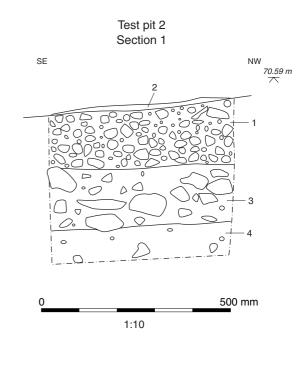
Figure 13: Test pits 1 and 2, plans and sections

- 9.7.3 Test pit 2 was situated directly on the north east corner of the northern facade of the Temple structure (Figs 9 and 13) The test pit was excavated to a depth of 0.42 m and natural geology was not reached. The earliest deposit recorded was a clay silt layer (4) that contained frequent inclusions of charcoal and coke indicating that it is likely to have been re-deposited, possibly as part of landscaping works in this area. The full depth of this deposit remains unknown. This deposit was overlain by a further 0.15 m layer of made ground (3) that contained fragments of broken bricks, plaster and mortar, that in turn was overlain by a compacted flint pebble deposit (1) sealed beneath topsoil (2). Deposit 1 is thought to either represent the remains of a former metalled surface/path way associated with the Temple, or to form part of a compacted foundation deposit/raft upon which the northern front facade of the Temple has been constructed, possibly similar in function to deposit 6 recorded in Test pit 1.

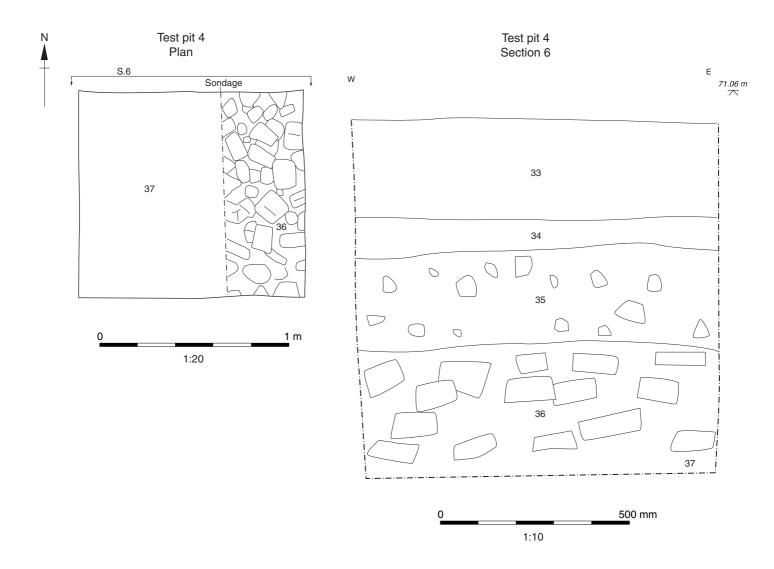
Figure 14: Test pits 3 and 4, plans and sections

- 9.7.5 Test pit 4, measuring 1 m by 1m, was located within the raised platform area fronting the southern side of the Temple structure (Figs 9 and 14). The test pit was excavated to a depth of 0.92 m and natural geology was not reached. The earliest deposit recorded was a mixed re-deposited silt clay deposit (37) containing charcoal. This deposit was overlain by a layer of demolition rubble (36) containing frequent broken bricks, thought to be have been deposited prior to the construction of the Temple. Demolition deposit 36 was sealed by a 0.35 m thick layer of made ground (35) composed of re-deposited natural mixed with rubble and debris. Overlying this made ground was a 0.30 m thick deposit of ash and cinders (34) believed to be indicative of soil improvement processes in this area associated with the southern facade of the Temples use as a glass house. This deposit was sealed by topsoil (33).

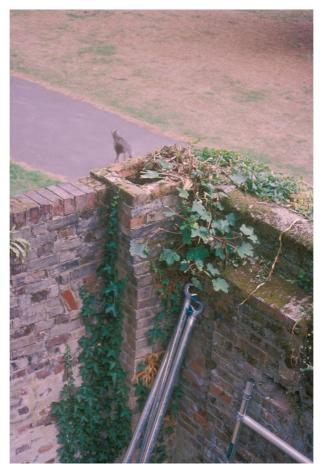
Plate 1: Flue in south east corner of former side range of Temple, looking south east

10.2.13 One feature of some significance is a small flue at the south-east corner of the former side range to the east (Plate 1). The brickwork surrounding the flue is largely a twentieth-century rebuild but at the bottom of the flue is a small iron lined opening (25 cm x 19 cm) in the west face of the stack. The opening has now been infilled with brick but the wrought iron lining survives together with two hinges presumably from a small former door. It may be that a small firebox could be inserted into the hole to provide some warmth and possibly guard against frosts within the glasshouse.

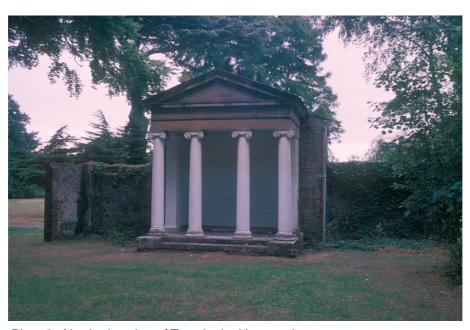
Plate 2: North elevation of Temple, looking south

- 11.2.20 Additional low level earthworks were also identified around the base of the northern facade of the Temple. Test pitting in this location did not reveal any buried evidence for the remains of a stepped access into the Temple, although potential surfacing deposits around the north facade were indicated immediately adjacent to the north east corner of the facade. A precise interpretation of the earthworks recorded at the base of the northern facade remains somewhat ambiguous, although, it is possible that they relate to the construction of the Temples foundation, deposits of which were recorded by test pitting.

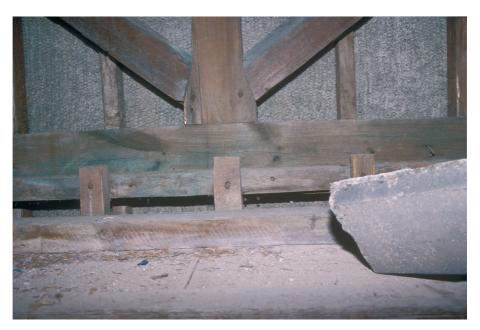
Plate 4: Roof space of Temple

- 10.2.17 The rafters are largely twentieth-century replacements but there appears to be several older, possibly primary, reused rafters. A second (and secondary) purlin has been added to the backs of each the two primary purlin when the roof was re-covered and

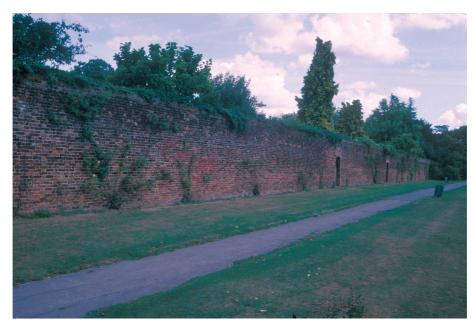
Plate 7: Memorial Garden Walls, south side, looking east

10.3.9 The George V Memorial Gardens were constructed as the main walled kitchen garden to serve the house. Although some areas have been repaired the main brickwork strongly appears to be of no later than mid eighteenth century date, as if contemporary with the existing house constructed in the 1750s by William Hallet. This is in contrast with the evidence of the 1800 Phipps plan which shows a larger kitchen garden (Fig. 5), with walls further to the west and south, but all four walls strongly appear to be essentially of the same date, and so may be from a nineteenth-century phase. There are areas of repair and rebuild and the largest of these is to the east wall associated with the construction of the pavilion in 1937 as part of the works to create the existing memorial gardens.
