# B U X T E D P A R K

## D M V Survey

**BUXTED PARK, EAST SUSSEX  
DESERTED MEDIEVAL VILLAGE EARTHWORK SURVEY  
OXFORD ARCHAEOLOGICAL UNIT [BXBP 90]**

Buxted Park, Sussex BXPB 90  
DMV Earthwork Survey

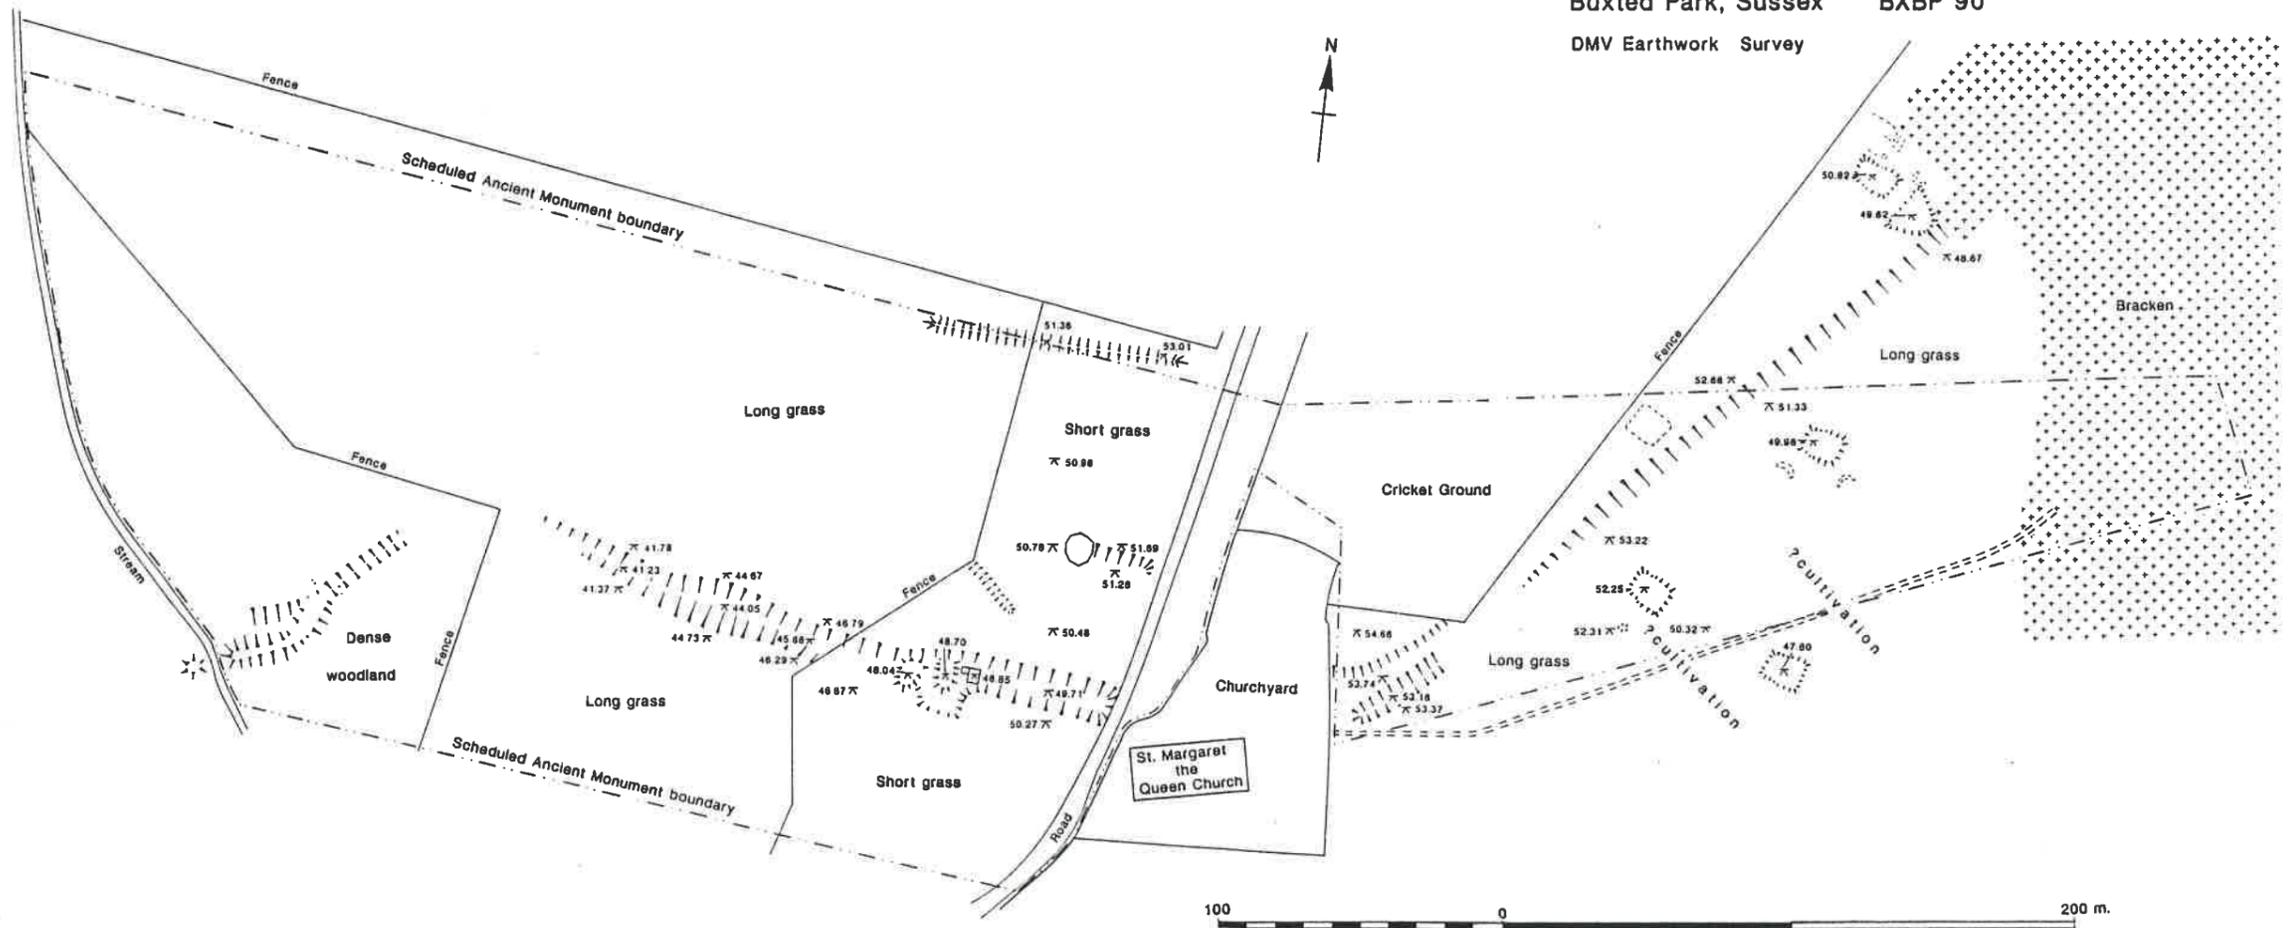
The earthworks to the west of the church consist of a hollow way running down the slope away from the church. It is approximately 14 m. wide, 200 m. long and varies in depth between 1 m. and 50 cm. There are two humps c.20 cm. high located in the hollow way approximately 60 m. west of the road. There are also traces of a brick-built structure 50 m. along the hollow way. Traces of the hollow way appear further west, then as it descends a steep slope it turns to the south-west, becomes a bank (c.1 m. high), and terminates at the stream. There is an oval mound on the far bank of the stream, outside the scheduled area, which may be the remnants of a dam for a fishpond. Due to the vegetation (thick woodland) it was not possible to take exact levels in this area.

To the north-west of the church there is a low bank c.50 cm. high running east-west and a probable ditch c.30 cm. deep running north-west.

The earthworks east of the church consist of a possible hollow way running north-east; this is approximately 36 m. long, 8 m. wide, and 56 cm. deep. Some 40 m. further north-east is a bank c.1 m. high; this runs in a north-easterly direction and disappears into thick bracken after 190 m. It appears to be a plough lynchet, coinciding with the line of (and possibly enhanced by levelling for) the broad double avenue running from Buxted Place (see map). There are three platforms to the east of the bank and two to the west; these are all approximately the same size as each other (10 x 14 m.). They are flat, sharply defined and clearly terraced into the slope; one is roughly trapezoidal, the others rectangular with sharp corners. In four cases crescent-shaped mounds with slight hollows occur close to them. At the east end of the survey area close to the bracken two distinct platforms and a third less well defined one occur in a close cluster. These platforms do not obviously have the appearance of house platforms, being too regular, flat and sharply defined. Their apparent association with the crescent-shaped features (which are noticeably more regular and sharply defined than tree holes which are also visible) suggests that these platforms are in fact the remains of tees and for greens with bunkers for a small private golf course. We have been informed that

Although it is possible that slight traces of earthworks associated with the DMV were obscured by the length of the grass at the time of the survey, there is little indication of any substantial village remains on the surface. East of the church relatively regular undulations along the closely mown path beside the edge of the scheduled area may be the remains of ridge-and-furrow suggesting that this part of the monument may have been cultivated prior to the laying out of the park.

The golf course could be planned to avoid any serious impact on any subsoil features in the scheduled area by raising the ground level where needed without disturbing any of the ground surface. It is desirable to leave intact the lengths of hollow way as a visible feature. If disturbance of the ground surface were unavoidable, this would have to be preceded by geophysical survey and/or trial trenches or soil pits, requiring Scheduled Monument Consent, to establish whether there were subsoil remains of structures not visible on the surface.
