# Chastleton House Stables Archaeological Survey

# Chastleton House Stables: Archaeological Survey

## Archaeological Evaluation of Stable/Brewhouse Courtyard

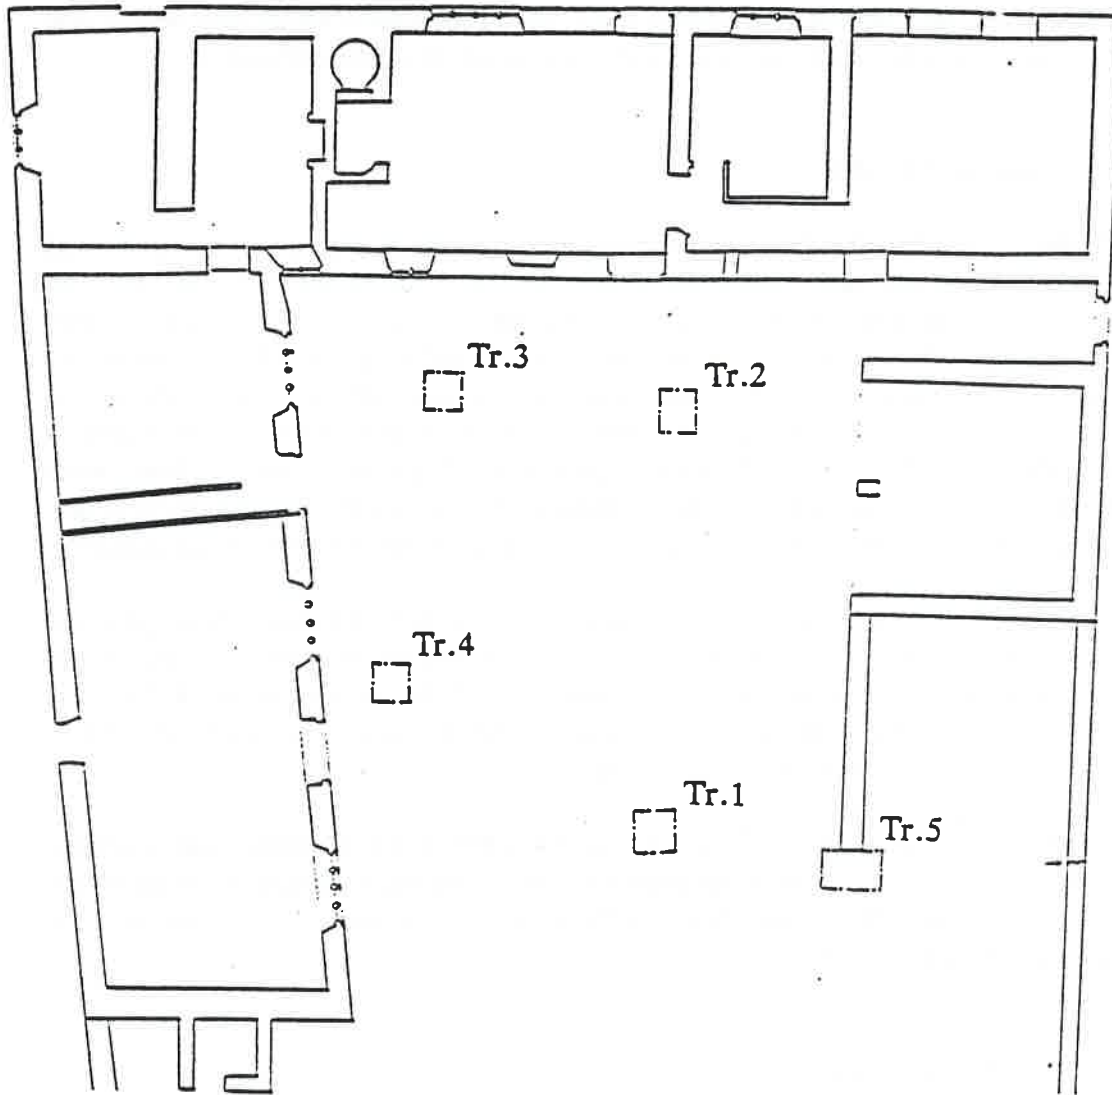
Fig. 1 Location of evaluation trenches (scale 1:200)

Trench located within central area of courtyard. The trench was excavated by hand to reveal a well compacted surface comprising smooth rounded cobbles up to 0.10m in diameter with occasional flat semi-angular limestone pieces of similar size within a matrix of pale grey mortar and gravel. The cobbled surface was overlaid by a fairly well compacted pale grey chalky layer containing pea grit and small gravel, this in turn being overlaid by modern turf and topsoil. The cobbled surface was located at a height of 174.10m OD.

Trench located within central area of courtyard. Turf and topsoil directly overlie a well compacted cobbled surface similar in nature to that encountered in Trench 1. In the southern half of the trench the cobbled surface has been disturbed by the laying of a brick paved area which appears to extend most of the way across the courtyard terminating just short of the garage/coach house on the eastern edge of the yard (fig. 2). The cobbled surface was located at a height of 173.98m OD.

Trench located within central area of courtyard. Turf and topsoil directly overlie a well compacted cobbled surface similar in nature to that located in Trench 2. The northern half of the exposed surface appeared to be stained by cinders or coal ash. The cobbled surface was located at a height of 173.91m OD.

Trench located within central area of courtyard. The topsoil was mixed with substantial amounts of building debris (predominantly stone tile fragments). This layer overlaid a further deposit of building debris which appears to disturb the cobbled surface in this trench which only appears in the north-east corner of the excavated area. The precise nature of the disturbance was not apparent within the limited area of excavation, though the proximity of modern services (electricity and water) was noted. The cobbled surface was located at a height of 173.85m OD.

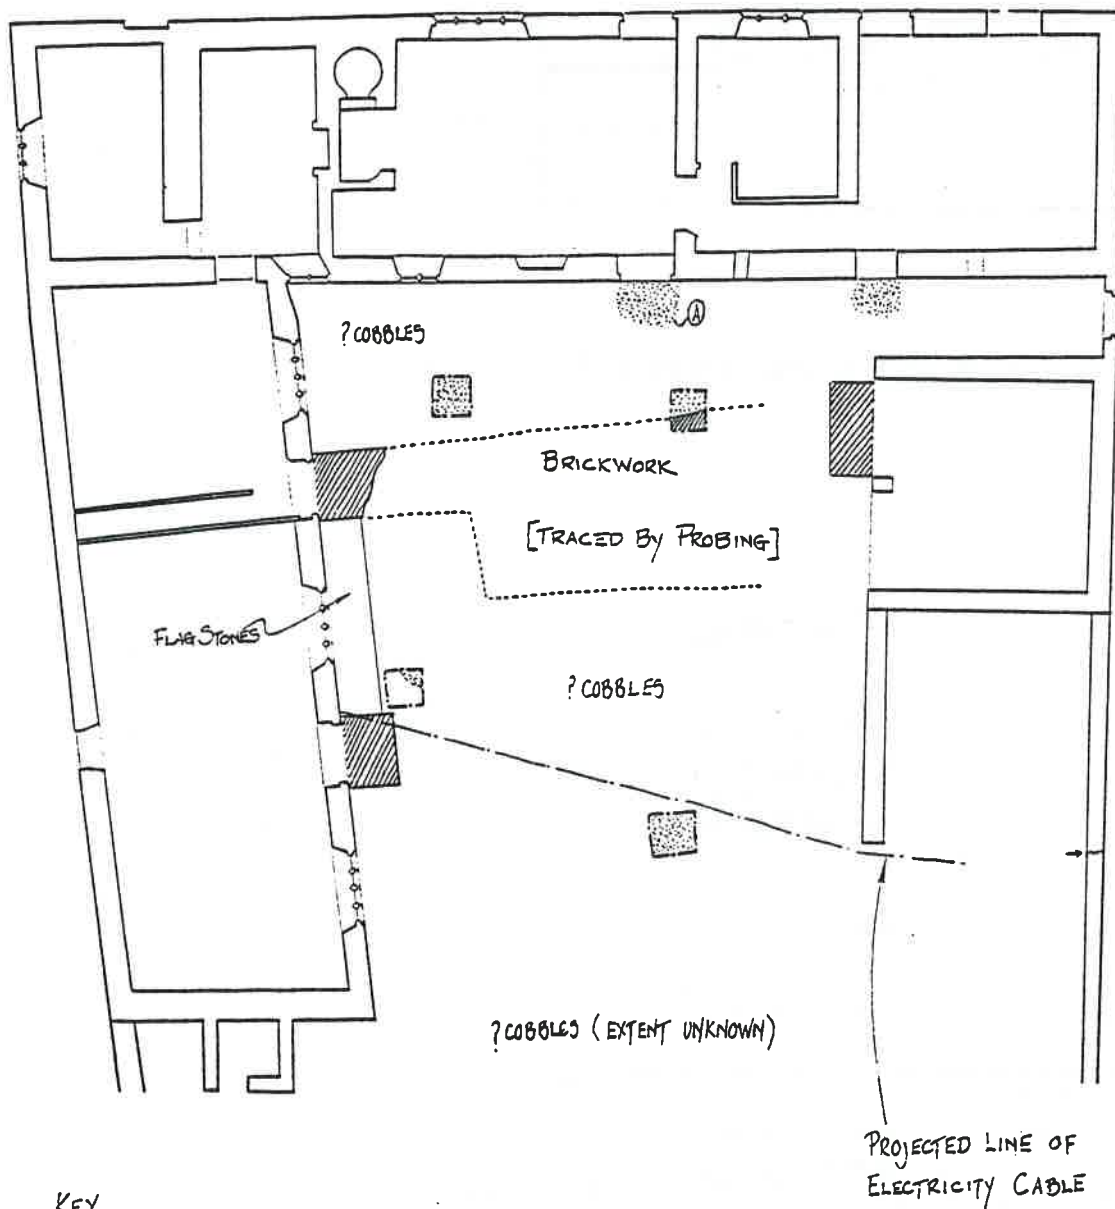
Fig. 2 Location of visible courtyard surfaces (scale 1:200)

In addition to the five hand-excavated trenches described above, a visual survey was undertaken to record any visible surfaces. These surfaces were plotted onto an existing 1:50 plan and the results are summarised in Fig.2. As has already been stated, a small amount of probing was involved in defining the limits of identified surfaces. The north-west corner was obscured by scaffolding at the time of the survey, apart from a concrete patch outside the Brewhouse window that is related to water services. This end of the yard is probably all cobbled, since cobbles were found in Trench 3, and in distinct areas outside the two doors into the north range. These last consisted of patches of larger cobbles than those observed in the trenches.

The brickwork uncovered in Trench 2 is also visible outside the stable door, and was traced by probing in a broad path across the yard leading towards the cartshed, where it may reach the brick paving that is also visible round the north entrance of the shed. The south door to the stable also has a patch of brick outside the door, and this is linked to the north door by a flagstone path.

The cobbled surface found in Trenches 1 and 4 were of small stones, and a similar surface probably extends across the southern end of the yard, though its exact extent was not discovered. It is understood that the extent of this surface is visible on early aerial photographs.

The cobbled courtyard surfaces, where located, were overlaid by an average of c.0.10m of turf and topsoil and it is felt that unless heavy machinery is to be manoeuvred within the courtyard area during building work, this depth of overburden will be sufficient to protect the surfaces from damage from normal traffic. However, in the immediate vicinity of the brewhouse, where scaffolding, ladders and building activities are likely to be more intensive, some protection with planking may be necessary to preserve the cobbling from damage. Similarly, the brick surfaces next the stable doors should be protected from damage from traffic and heavy gear.

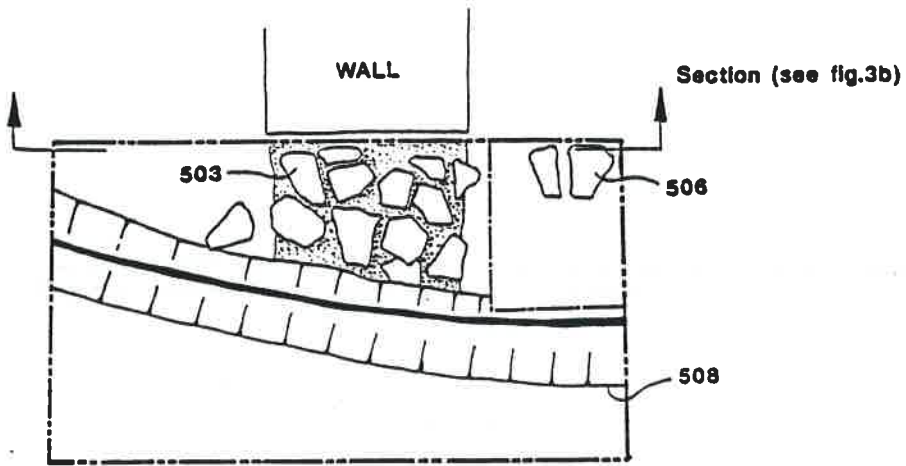
Fig. 3a Trench 5 Plan (scale 1:20)

Trench 5 was positioned to investigate the relationship of the courtyard surface to any surviving floor layers within the supposed barn on the east side of the courtyard. A rubble foundation (503) for the extant wall was located at a depth of 0.15m below the present ground surface, and the construction trench for this wall (502) would have destroyed any surviving floor layers within the limits of the trench. A metal pipe 0.02m diam. containing an electricity cable (508) was exposed running east-west across the trench, cutting the rubble foundation and further disturbing any deposits

relating to the supposed barn. A possible flat stone surface (506) was located in the extreme north-east of the trench at a height of 174.07m OD, but the limited area exposed within the trench makes positive identification of this feature as a floor layer very tentative. No cobbled courtyard surface was encountered within this trench, and so no relationship between courtyard and floor layer could be defined.

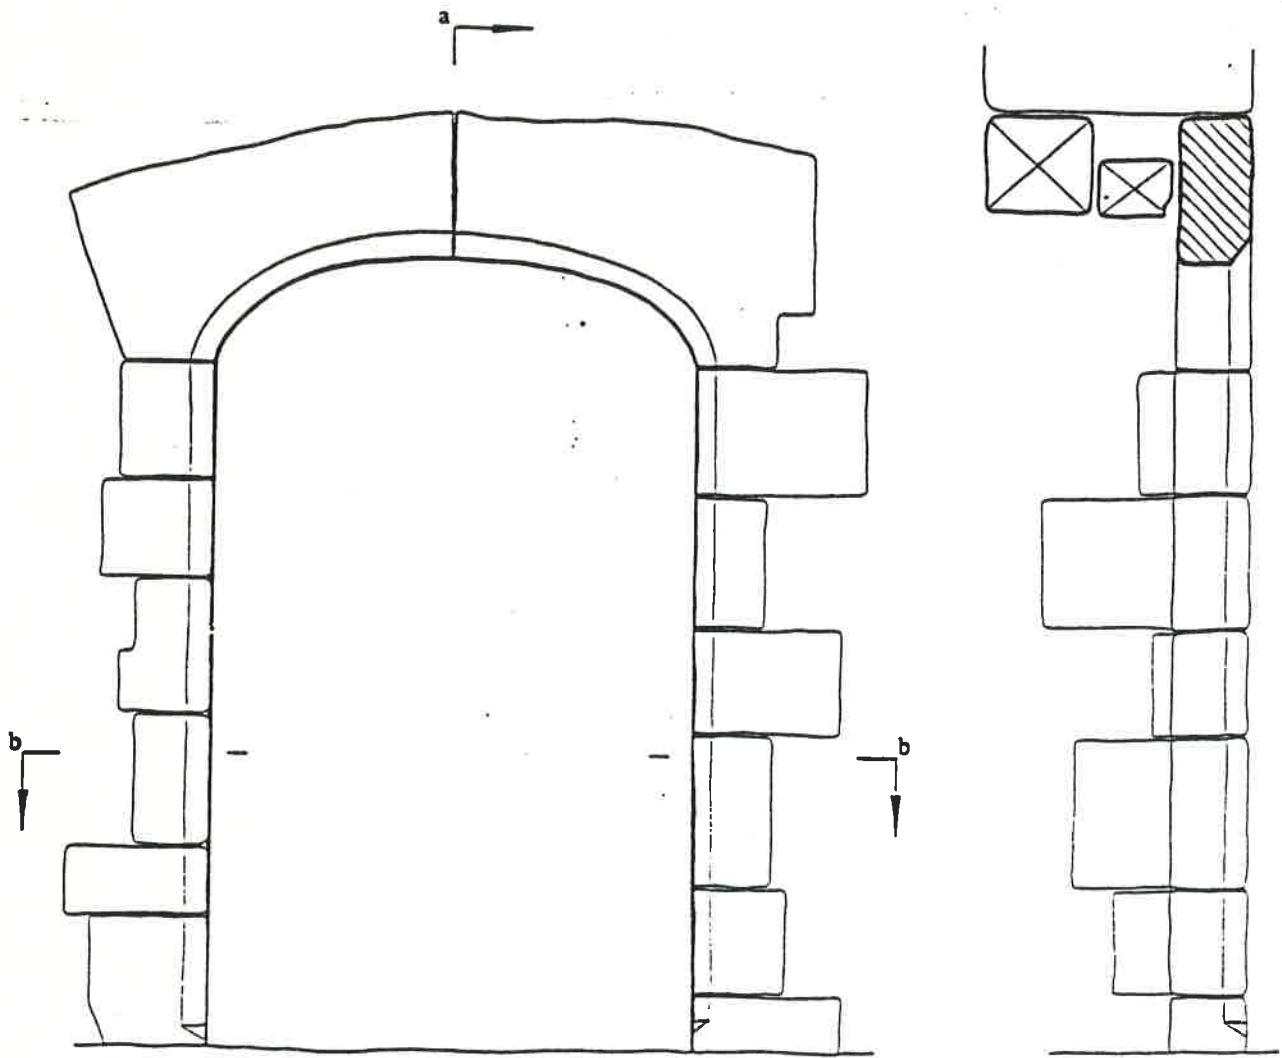
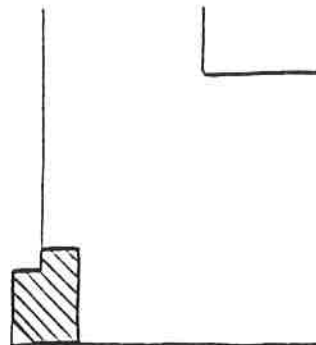
Fig. 3 Details of standard door.

*Doors:* (Fig. 3) Four-centered arch consisting of two or three large pieces of ashlar of irregular outline; jambs with plain chamfer, stopped at joint with lowest stone, which has a plain triangular (?curved) stop; Internally, most have a rebate for the door, and two beams supporting the soffit of the opening (the door lintels are flat slabs on the face of the wall, and only the jambs below have a return into the reveal).

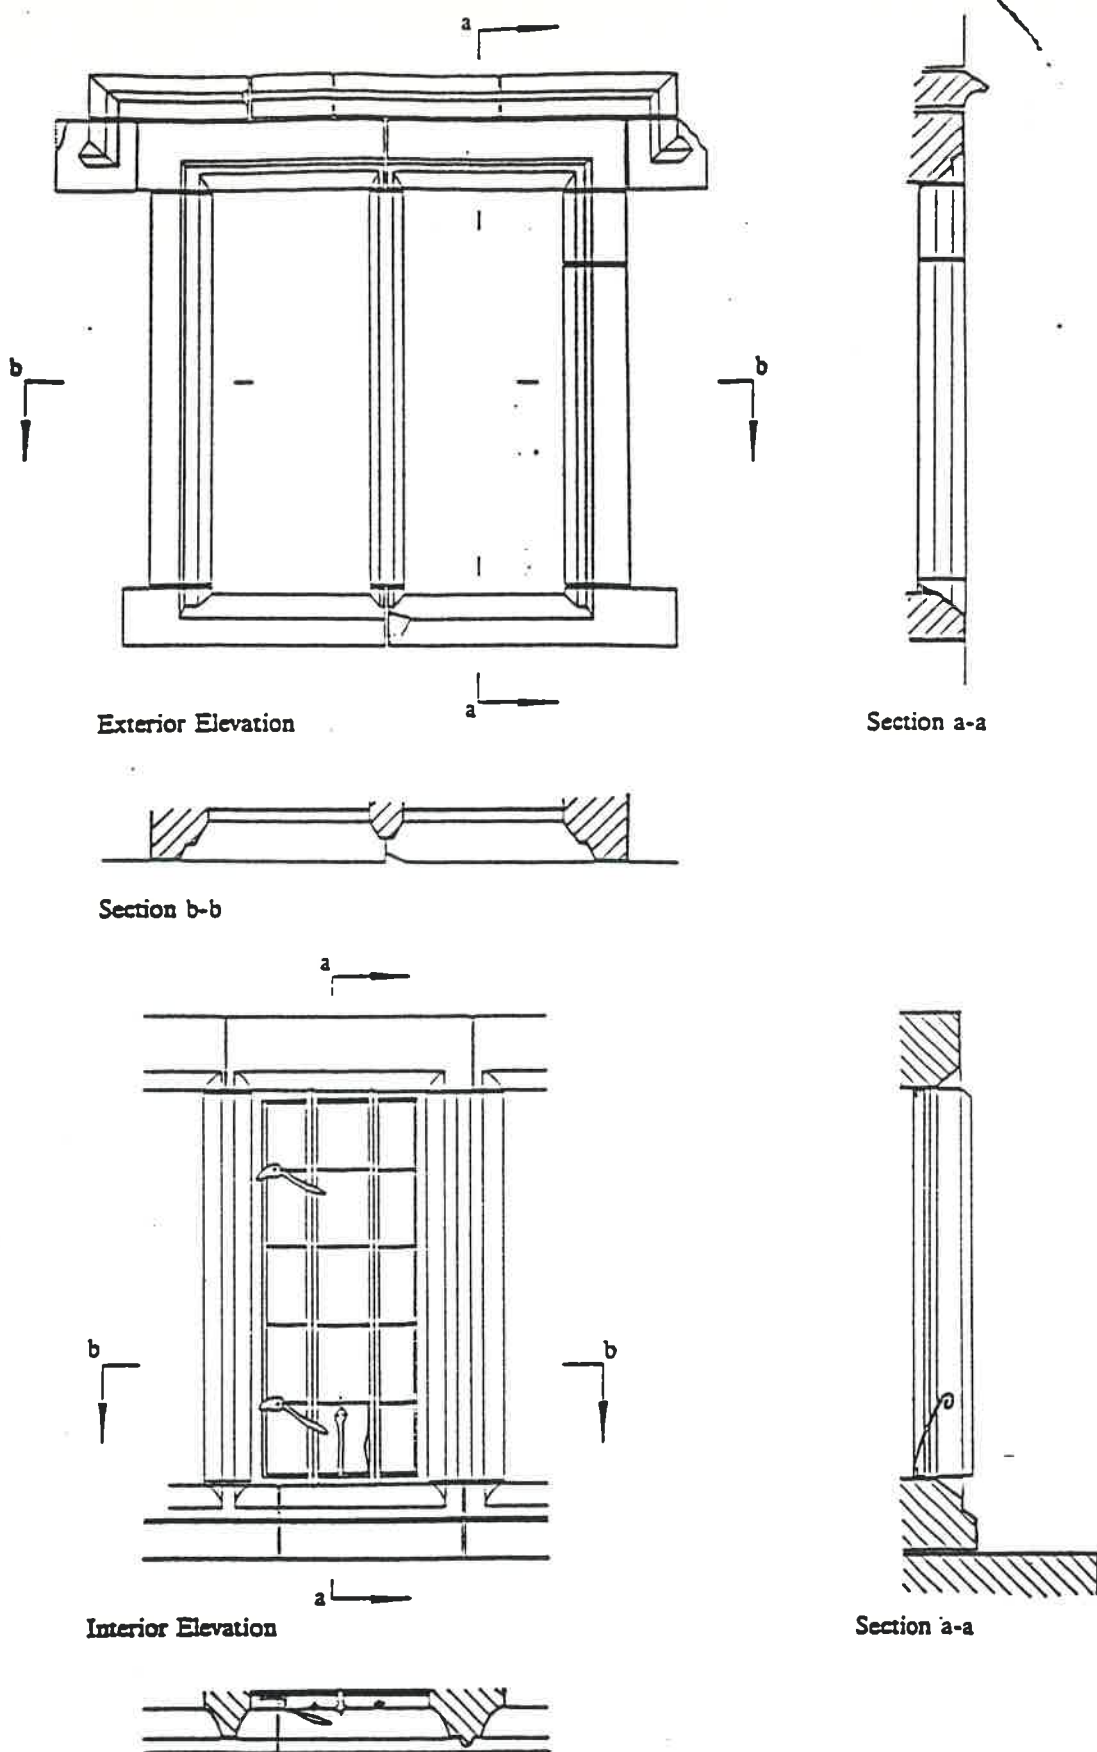
Fig. 4a  
Fig. 4b

*Windows:* (Fig. 4a) Hood moulds over a separate lintel, with plain-chamfered mullions and a sloping sill. Between two and four lights (mostly three), with a variety of heights and widths; this, together with the poor fit of many mullions to the sills and lintels, may suggest that sills and lintels were made in pairs, and the other stones produced in non-standard lengths that were then cut to size. A few windows have hollow chamfers (Fig. 4b)

*Window fittings:* (Fig. 4b) Many window jambs and mullions are externally drilled as if for fitting bars or shutters. The variety of window leading suggests replacement at different times. Older windows are perhaps those with external iron bars to which the leaded lights are fitted with wire twists; the opening casements have iron frames and some of these have single or double catches to close the windows, and an attached handle at the bottom of the frame to open or shut the window; externally some of these have curved runners with sprung bands to support the open windows.

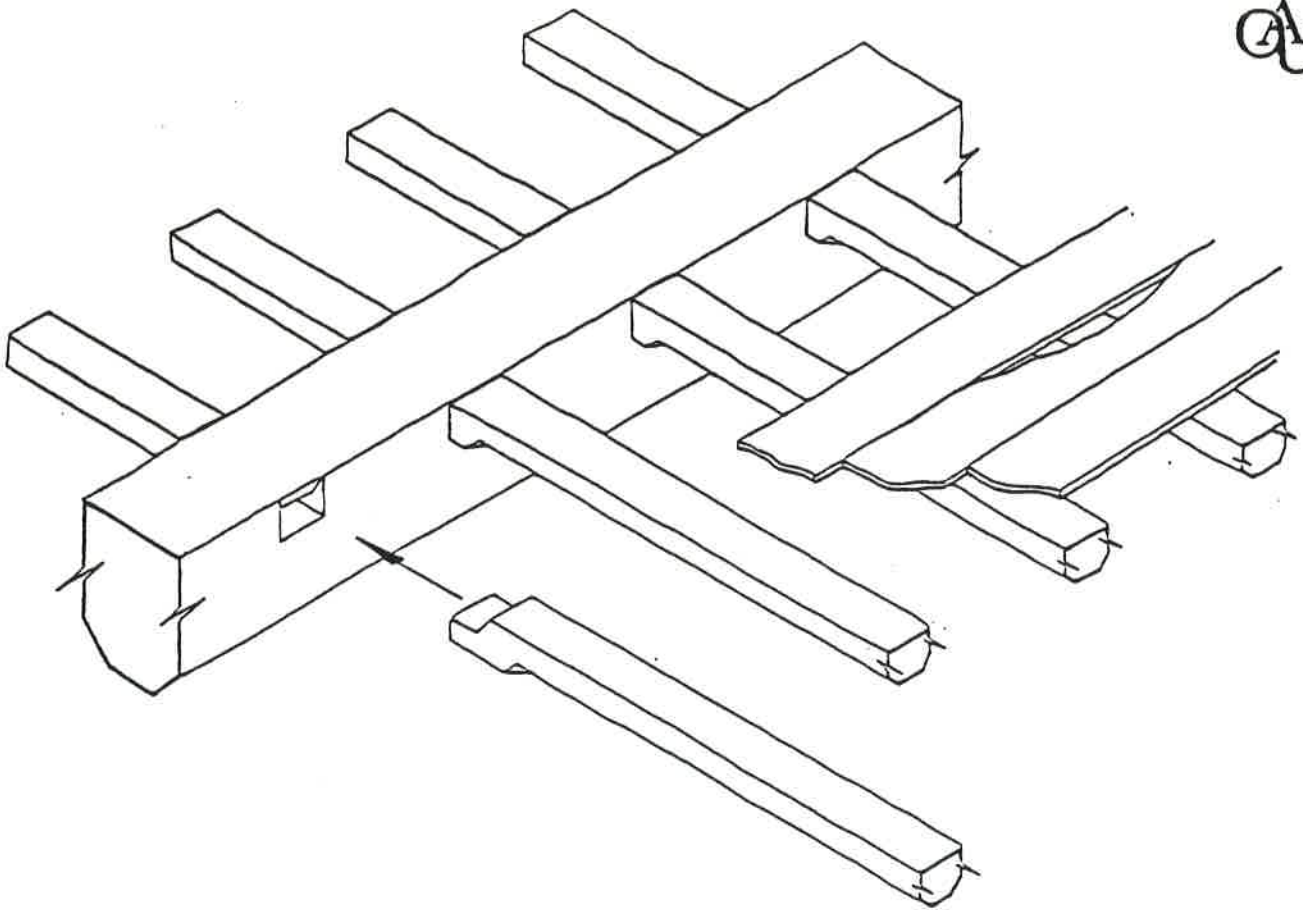
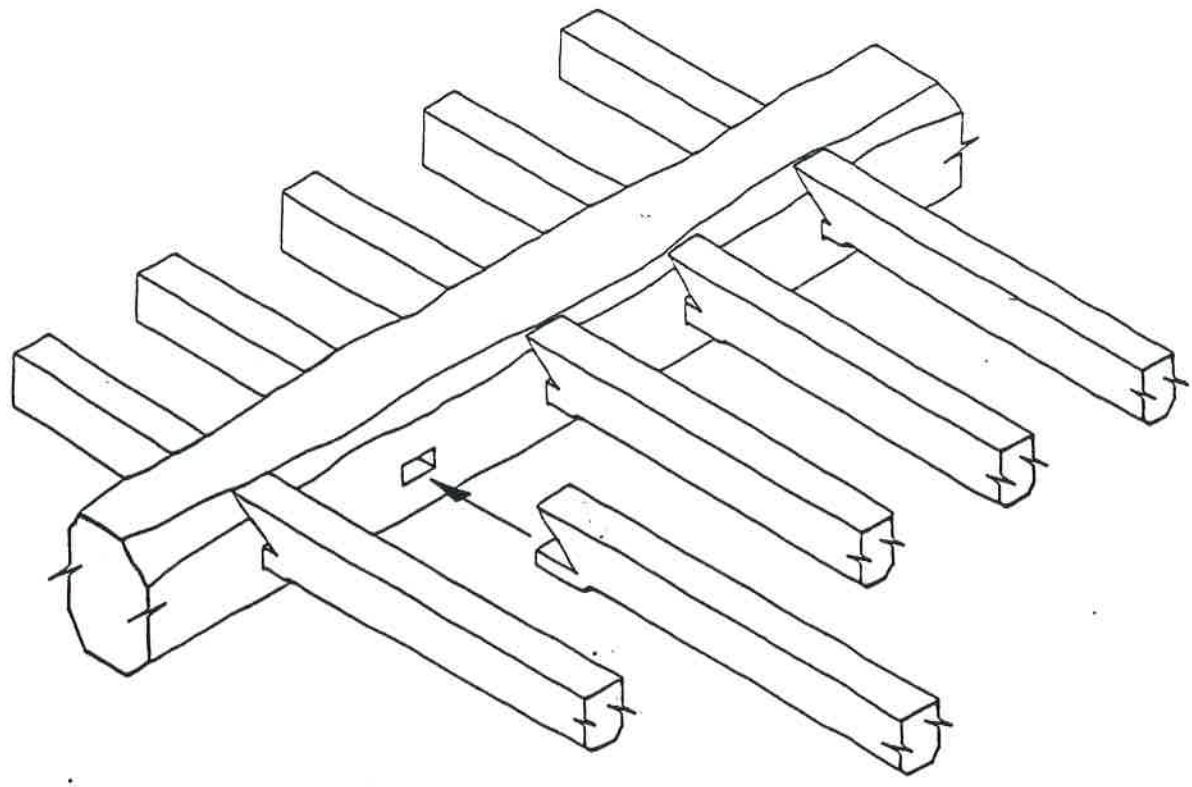
Fig.5a  
Fig.5b

*Floor joists:* (Fig. 5) Most original floor joists are square or upright rectangular, and have soffit tenons with diminished haunches. These only operate when meeting a square arris on the principal joist (Fig. 5a), and where this is waney the shoulder may slope forward rather than back, forming a 'spurred' tenon (Fig. 5b).

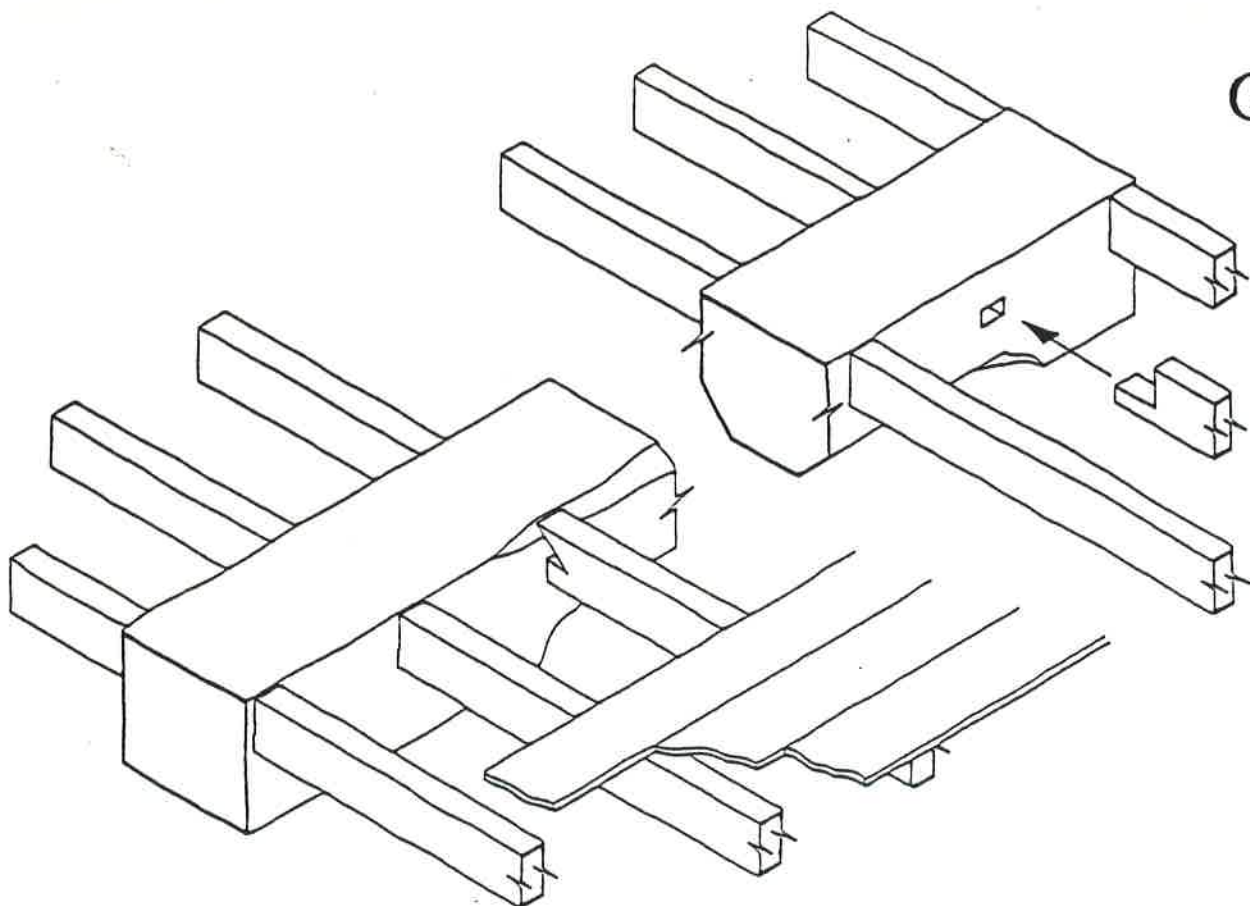
Fig.6a  
Fig.6b

The stable is unevenly divided into two parts, with a stair between them. At the *north end* are two stalls, of no great antiquity. The ceiling is original, with fourteen common joists on a large chamfered principal (Fig. 6a). As shown on the figure, the chamfer stop at the east end is nearer the wall than the one at the other end; this does not imply re-use, but was probably intentional to allow for a hay manger at the west side, so that hay could be let down directly from the hayloft into the stalls. Although the flooring of the attic has been renewed, there are some indications on the principal floor joists of former attachments for this.

The *south stable* has five stalls, two windows to the yard and a small window to the road. The stalls, perhaps 19th century, have planked partitions and iron grills at the top; they were made all together and have paired doors that allow the stalls to be joined or separated. The paving of blue engineering brick is probably contemporary. The ceiling has been renewed (Fig. 6b) with a higher series of softwood joists and a plaster ceiling, but the principal joists are as described in the other stable. The window mullions have at one time been cut for horizontal bars, but now have vertical iron bars to which the glass is attached.

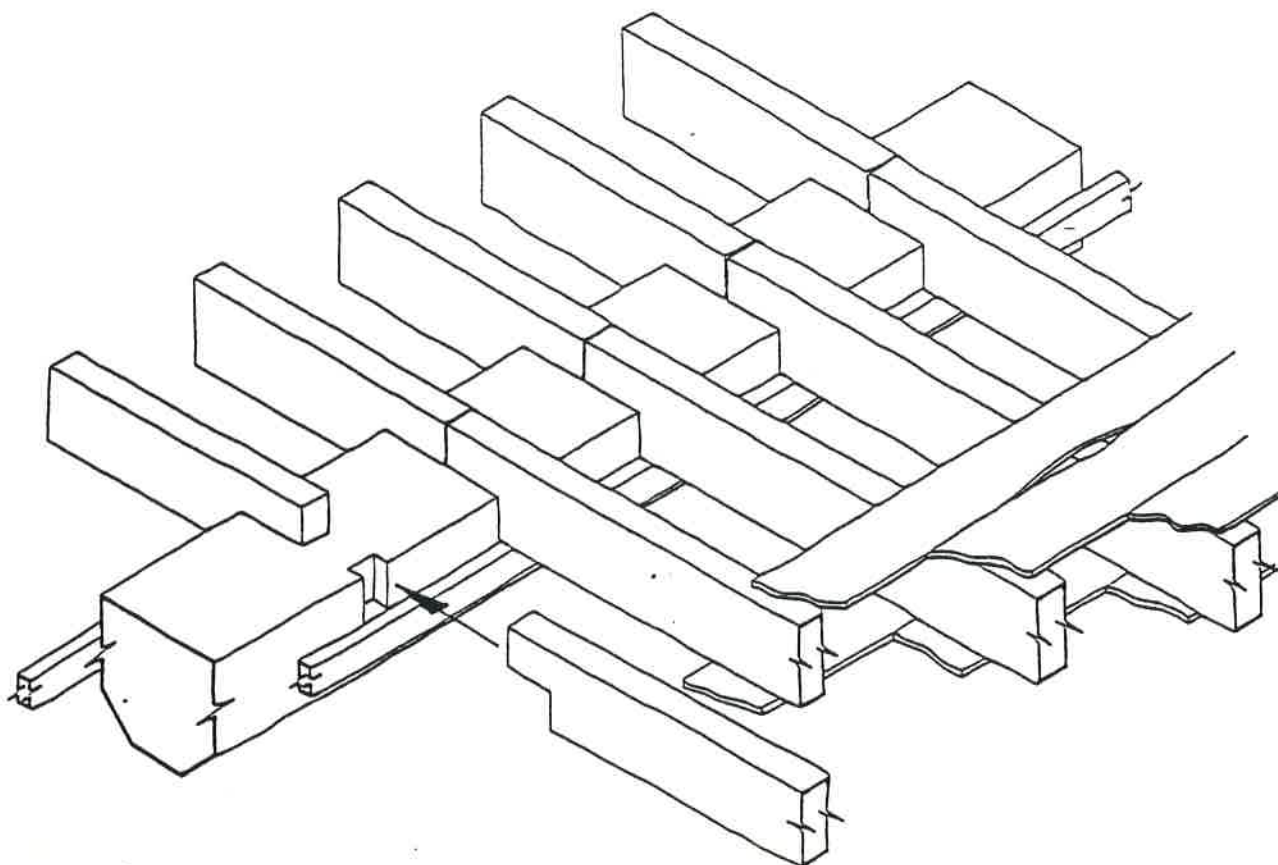
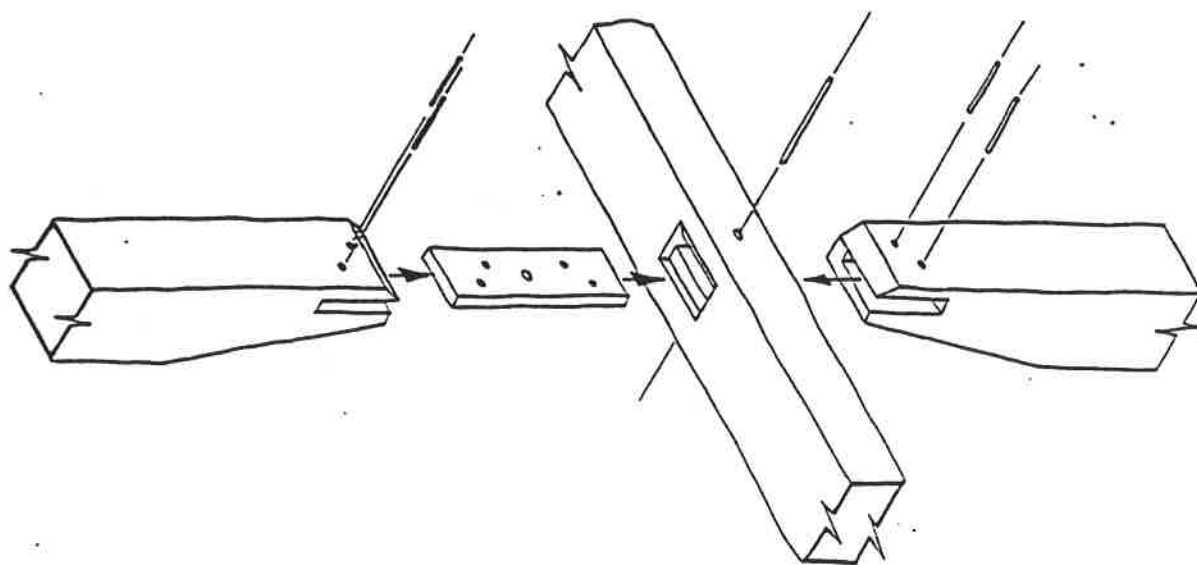
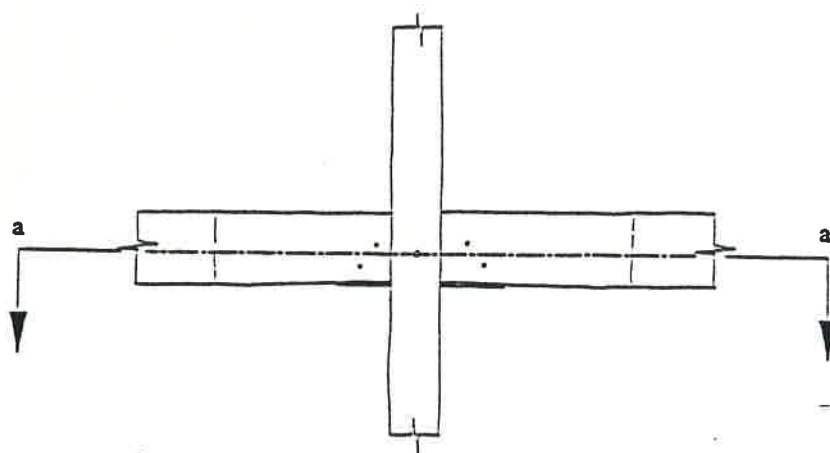
Fig.7 Roof detail: purlin joints to principal rafter.

*Purlin scarfs:* (Fig. 7) The principal rafter has a mortice containing a free tenon that protrudes on each side of the rafter. The purlins have tapered ends (only on the inner face) and a mortice on their soffits; they are slotted over the free tenons, introduced a short way into the mortice in the rafter, and double-pegged to the tenon. This is a not uncommon regional type of scarf.

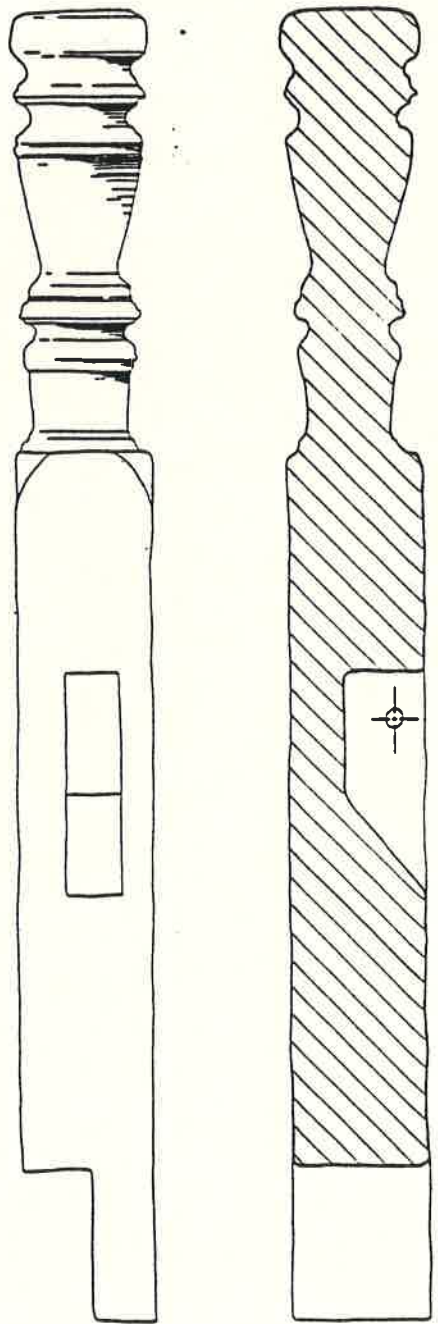
Fig.8      Brewhouse: detail of turned stair newel.

At the south end of the stone wall is a timber door frame supporting the string for the framing of the *stair*, now mostly removed, giving access to the first floor. This has a turned wooden post at the top (Fig. 8), evidently re-used, since it has a large chase mortice for a downward rail that is not used in its present position. It is framed to a handrail and sillbeam over the stairwell, resting on the floor joists and connected to the other corner post which is octagonal with a roughly turned head. The stairwell has caused the floor in the adjacent two bays to be framed differently, with common joists running north-south over the present kitchen.
