St Laurence Church West Challow

**Historic Building Assessment
and Recording**

September 2006

Client: Parochial Church Council

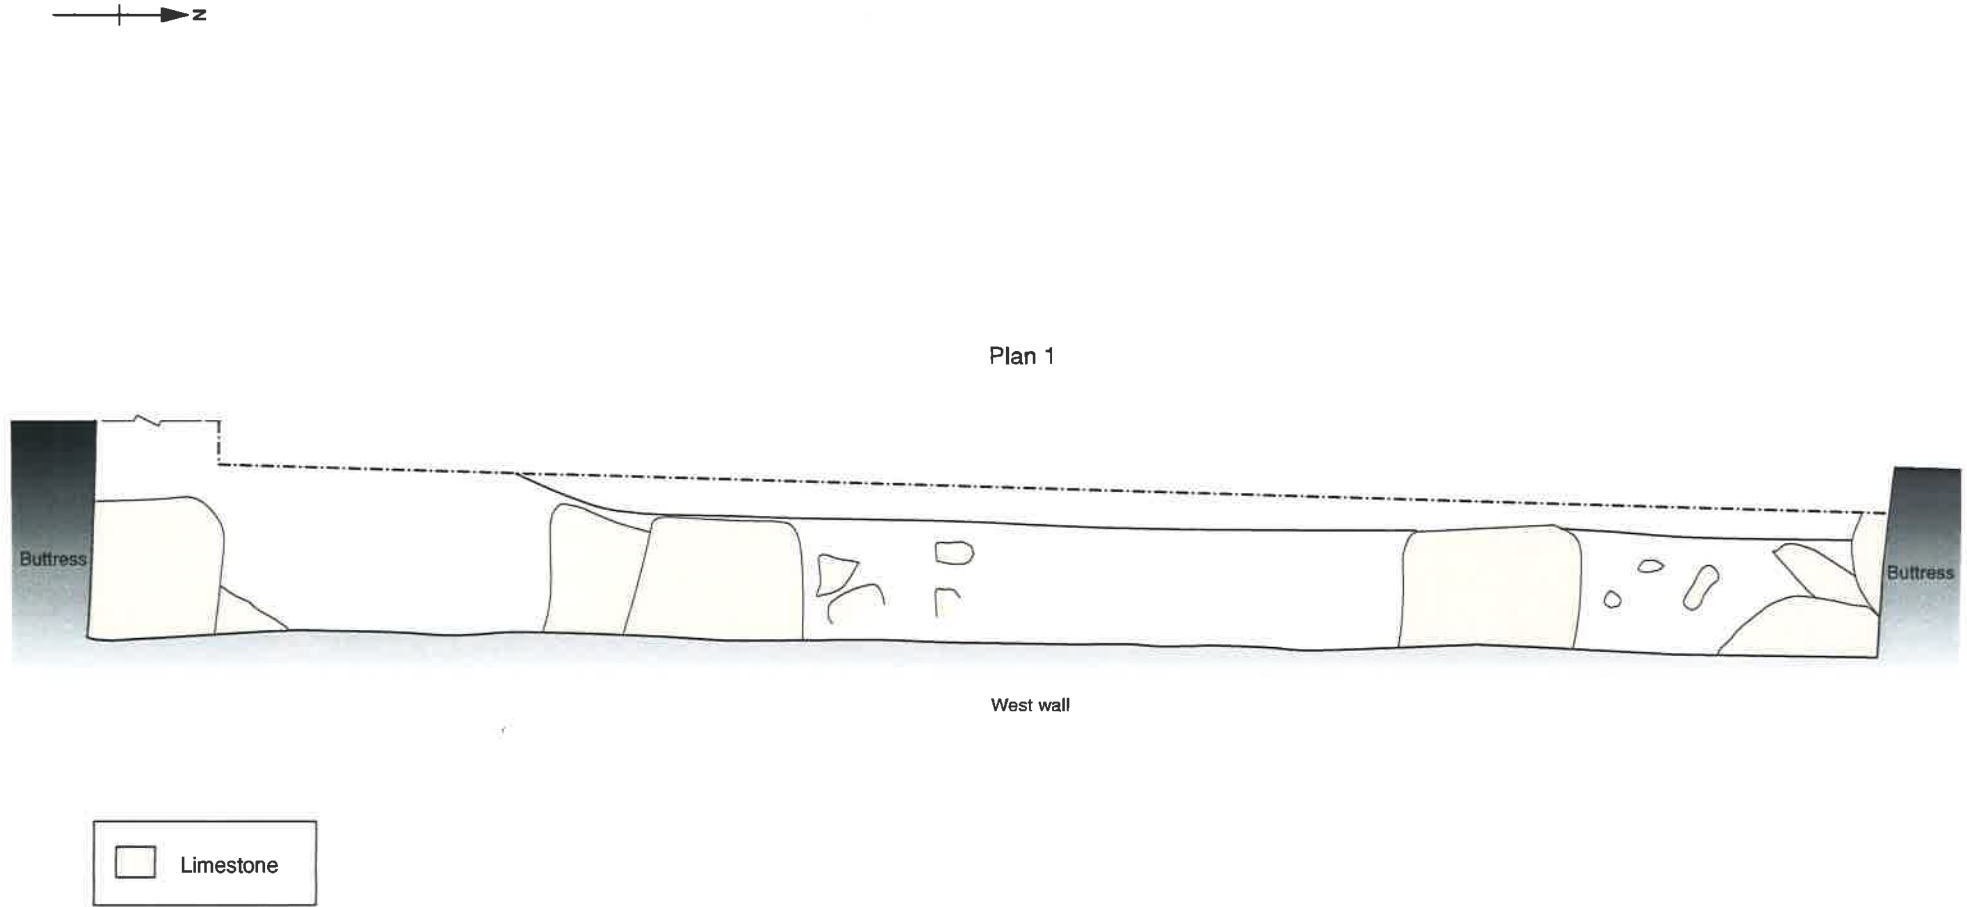
Figure 4: Saint Laurence's Church West Challow, Plan of West End

- 3.1.2 In the trench along the west wall two limestone blocks were discovered. Each block measured 0.50m in width and more than 0.30m deep (more detail cannot be given as the structures disappear under the main structure of the church). A further two blocks are spaced 1.60m apart at the west end of the church. The blocks are positioned 0.16m below the base of the church (fig 4).

- 4.1.1 No firm conclusions can be made regarding the date of the stones, however assumptions can be made regarding their purpose.
- 4.1.2 The distance the blocks are set apart would indicate that they are foundations for an archway or tower structure. Another possible scenario could see the limestone block foundations supporting a redundant door.
- 4.1.3 The stones are unlikely to be an extension of the nave as they stand out from the west side of the church. The possibility of the stones being part of an earlier structure is best suited to the evidence provided by the spacing and positioning of the stones.
- 4.1.4 There is no evidence beneath the south wall of any clear phasing or building breaks.

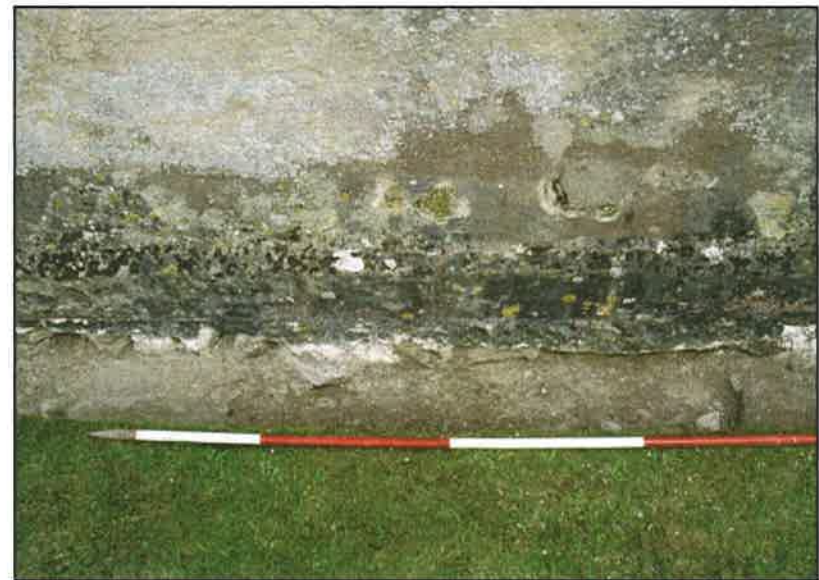
- 3.1.1 The trenches along the south and west walls were dug in order to lay the drainage pipes for the building. The drainage ditches were positioned 0.30m out from the edge of the church. The west wall (plate 3) showed evidence of stone remains which were perceived as being a continuation of the nave. Drawings of both plans and sections were compiled in order to illustrate the purpose of the stones.

Plate 3: View of west wall
