# Crowsley Park House, Shiplake, Oxon

ARCHAEOLOGICAL AND PHOTOGRAPHIC RECORD  
IN ADVANCE OF BUILDING WORKS

OXFORD ARCHAEOLOGICAL UNIT  
AUGUST 1998

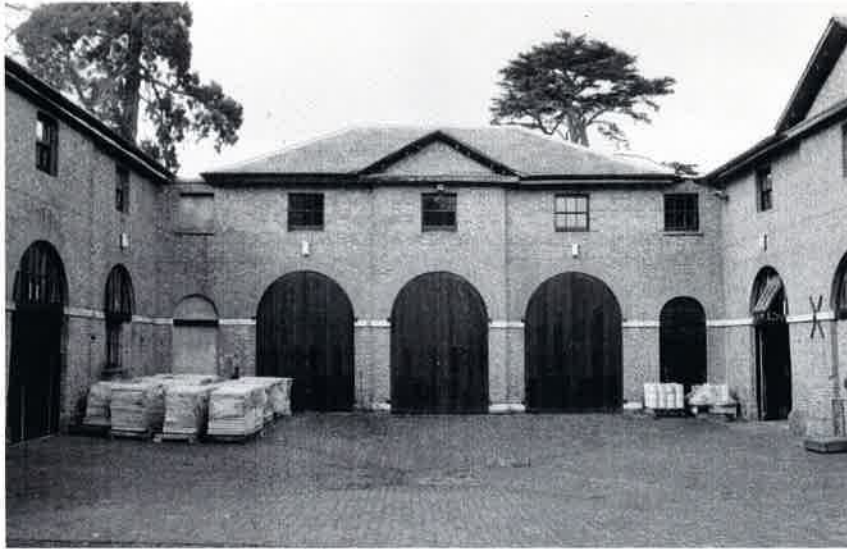
Plate 1: Courtyard. Coach house to rear.

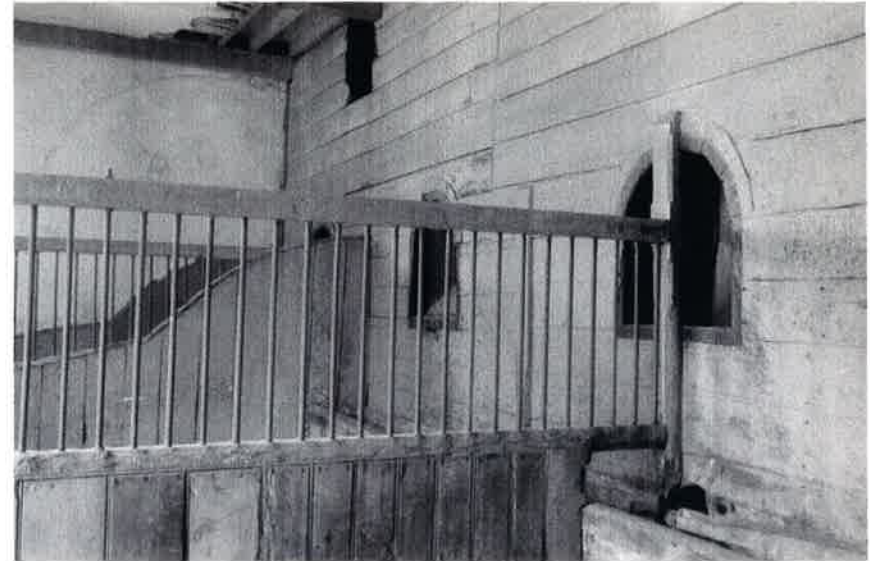
Plate 2: Secondary partition to front, original angled partition to rear. G3

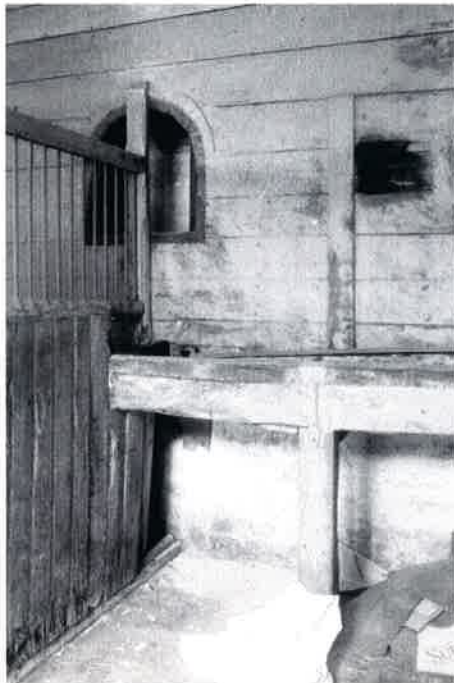
Plate 3: Chute exit, trough and secondary partition wall

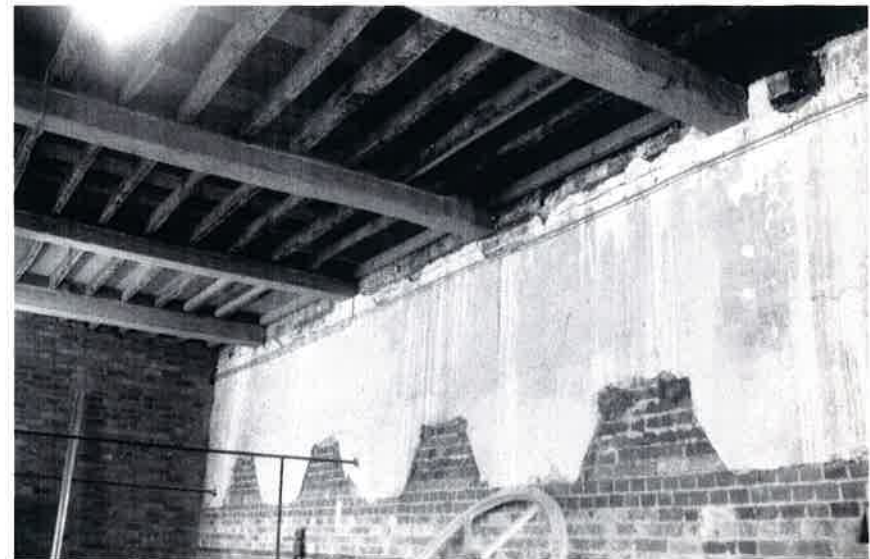
Plate 4: Castellated effect on west wall within G8

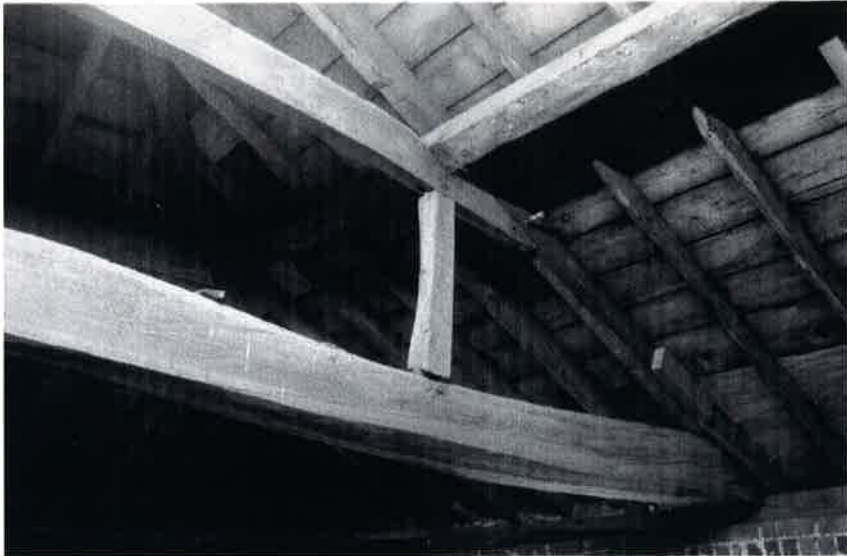
Plate 5: Roof truss detail at SW corner of F3. Note more slender timbers than in west wing.

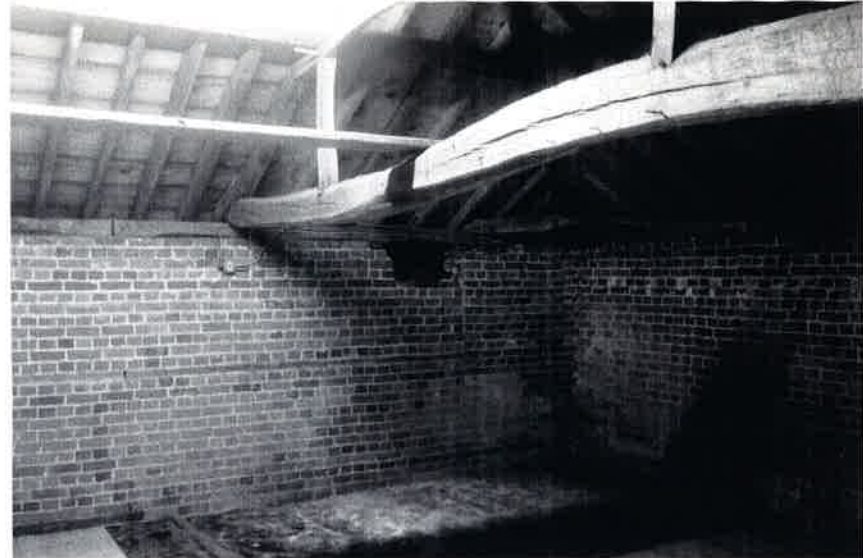
Plate 6: Warped tie beam to north of F3

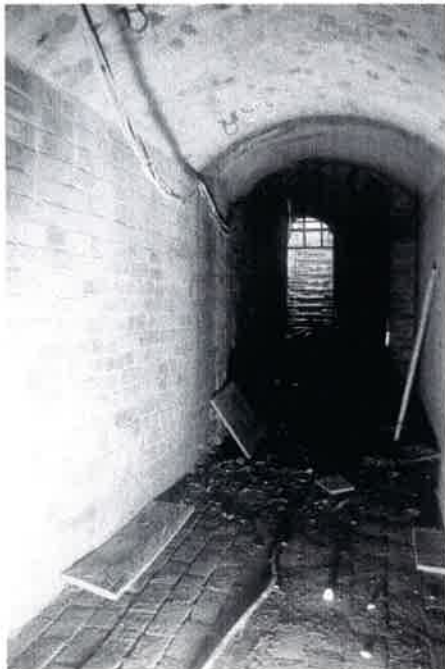
Plate 7: View south within cellar

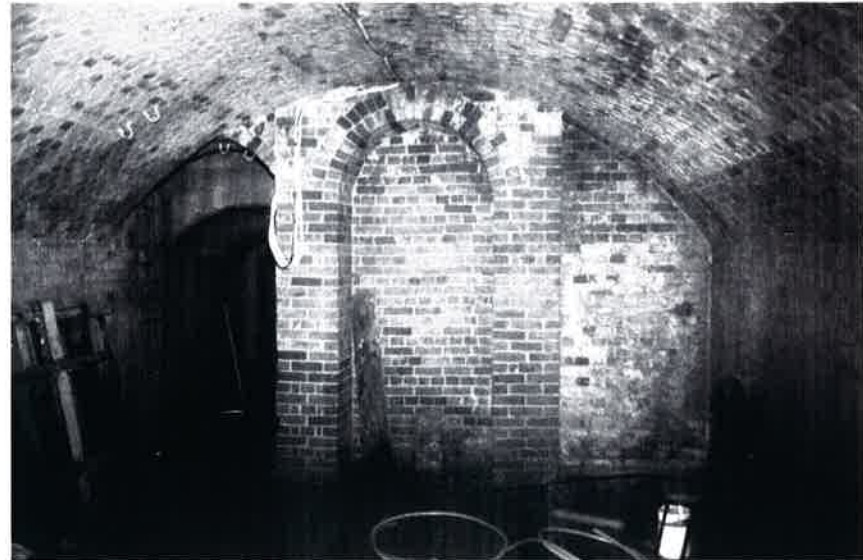
Plate 8: Brick arches in first cellar space

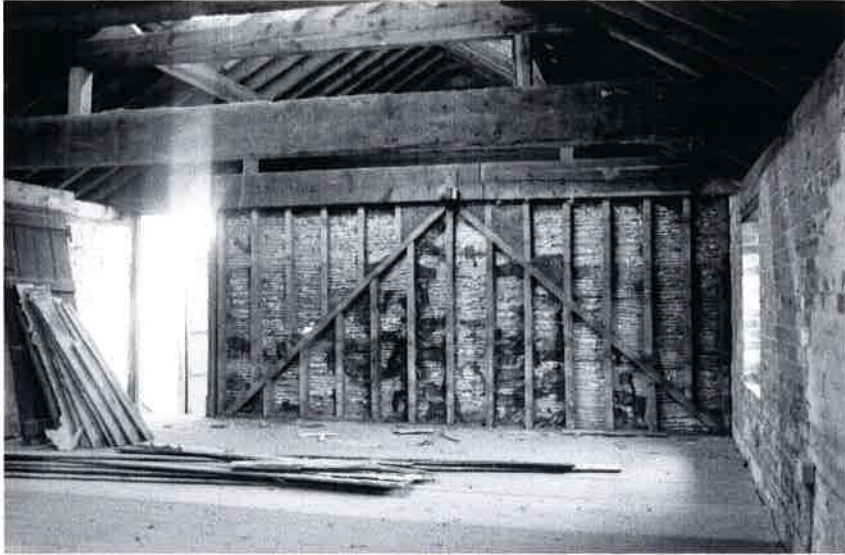
- 4.6 The field work was undertaken when the refurbishment work had just begun and the plastered south side of the central partition, directly beneath the third truss from the south, had been removed. This reveals vertical, timber studs (at 36 cm centres) braced by a pair of diagonal studs forming a triangle. A

Plate 9: Exposed south side of stud partition within F2

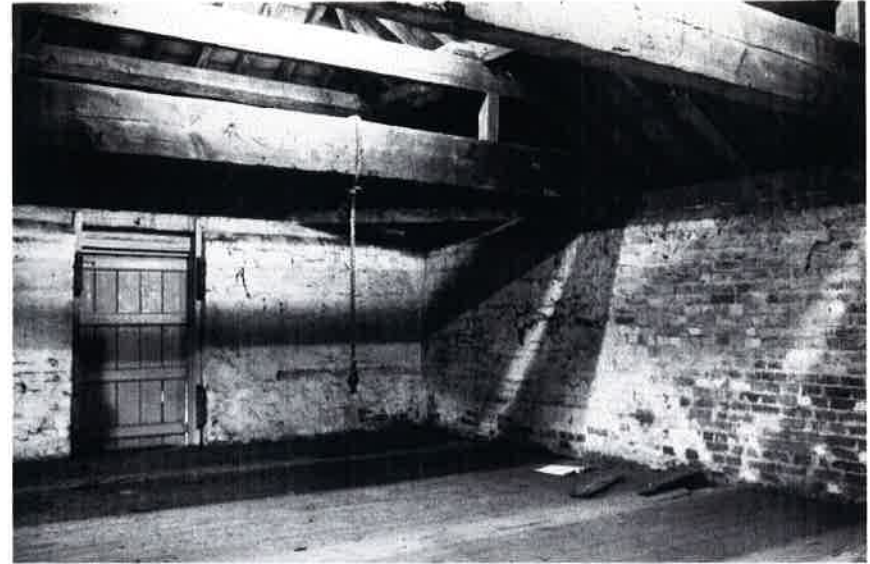
Plate 11: General view of F2

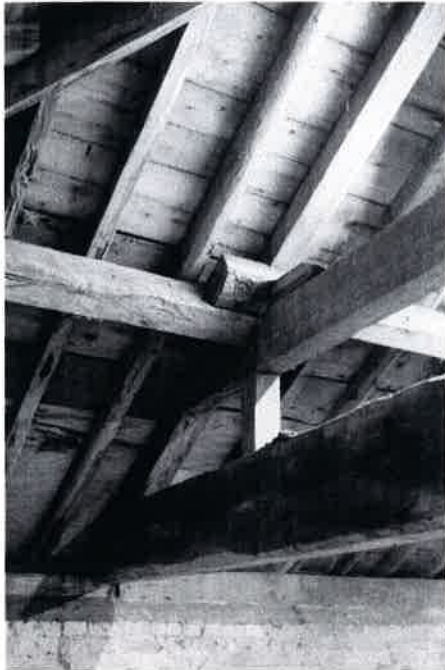
Plate 10: Truss detail with F2 showing overlapping clasped purlins and squat post between collar and tie beam

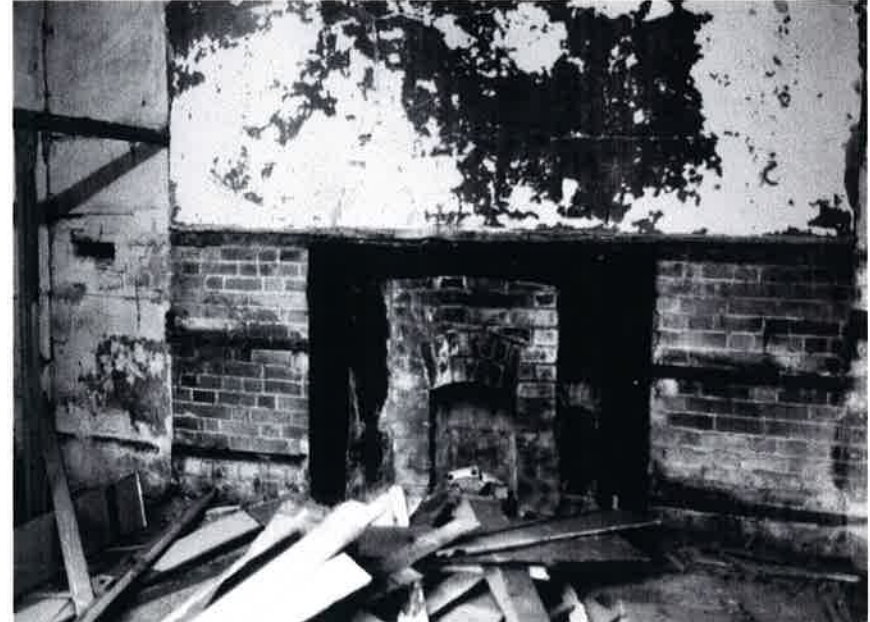
Plate 12: Exposed fireplace within tack room

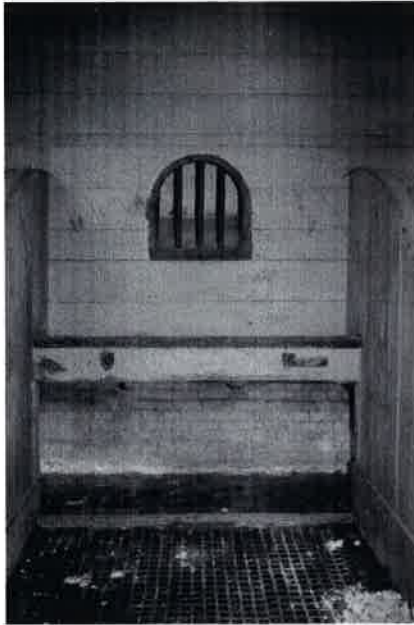
Plate 13: Third stable pen from south in G2

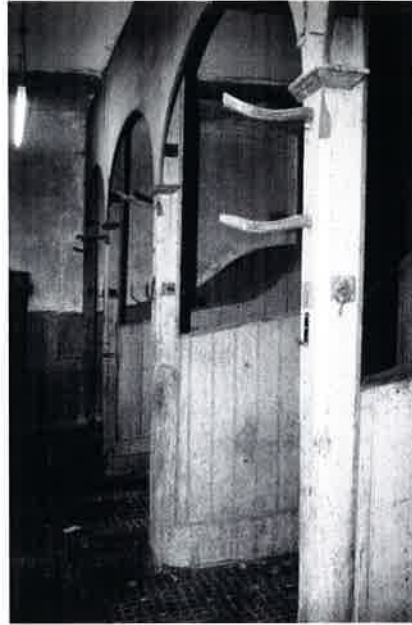
Plate 14: Arched fronts to stables within G2

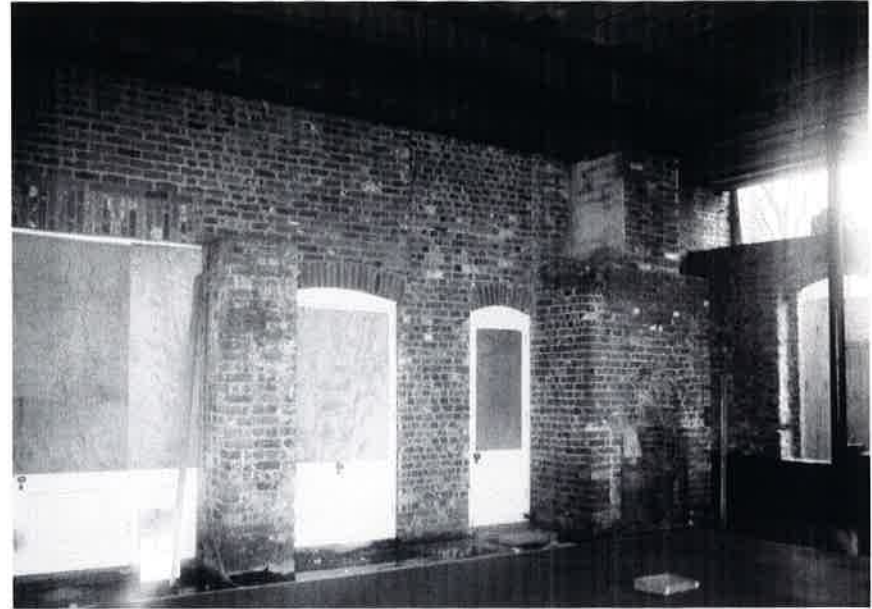
Plate 15: South wall of house during construction of conservatory

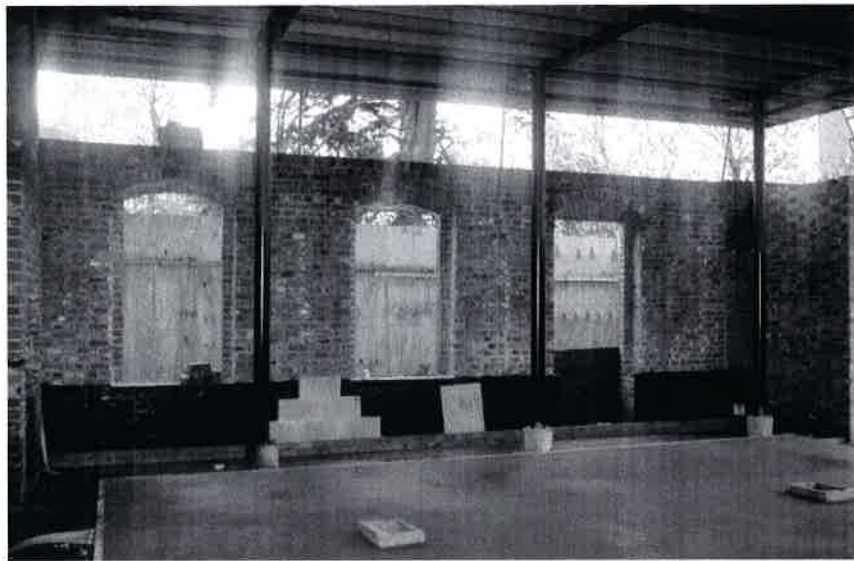
Plate 16: Retained wall from previous structure to form east wall of conservatory

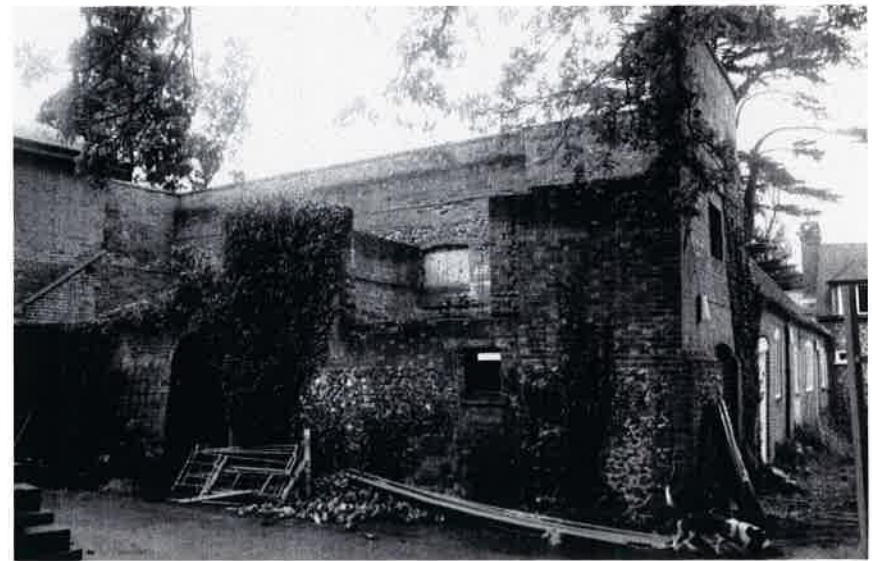
Plate 17: Ruined cottage. Note tapered wall front wall to left

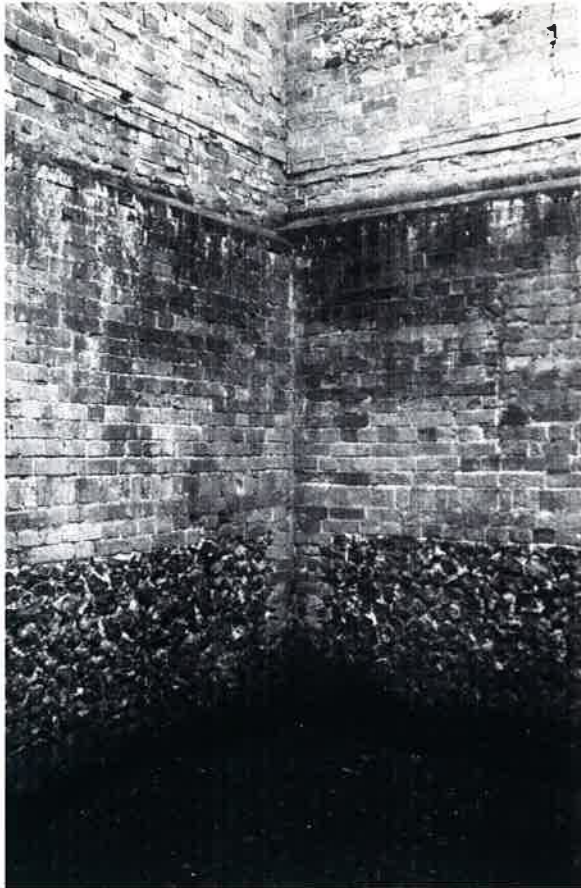
Plate 18: North-west corner of cottage showing flint below brick construction

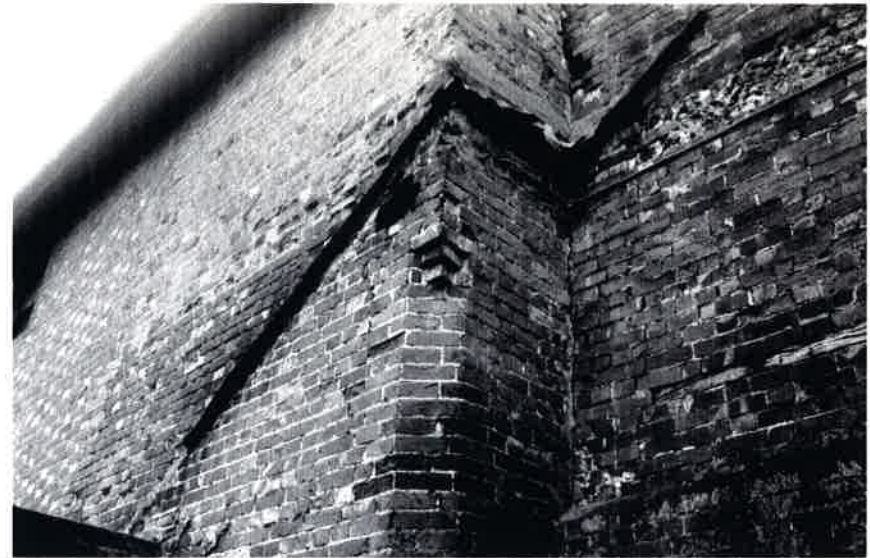
Plate 19: Flashing showing former roof covering cottage

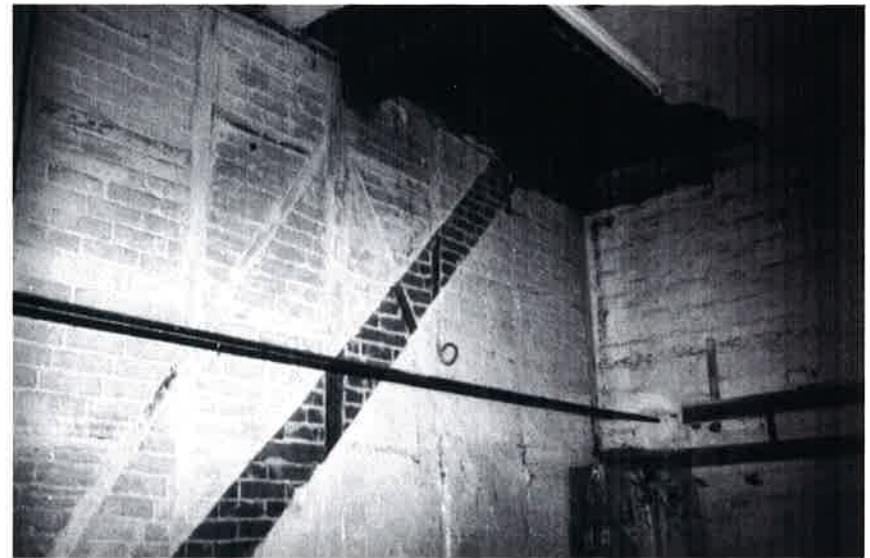
- 4.14 The exposed wall behind the former stairs demonstrate its brick nogging construction and the outline of the timber frame is visible beneath the painted surface, including a pair of diagonal members rising to support the perpendicular binder. The opposite wall, adjoining G5, is of similar brick nogging construction. Sections of plastered ceiling have been removed in the north-west and south-east corners of the room to reveal modern softwood joists inserted alongside original joists. The floor is generally covered with twentieth-century quarry tiles but the section, which would formerly have been hidden by the staircase, retains older brick pavers.

Plate 20: Imprint of former stairs within G4 adjacent to wall with timber frame and brick nogging
