English Farm Nuffield Oxfordshire

Historic Building Assessment

Oxford Archaeological Unit
December 2000

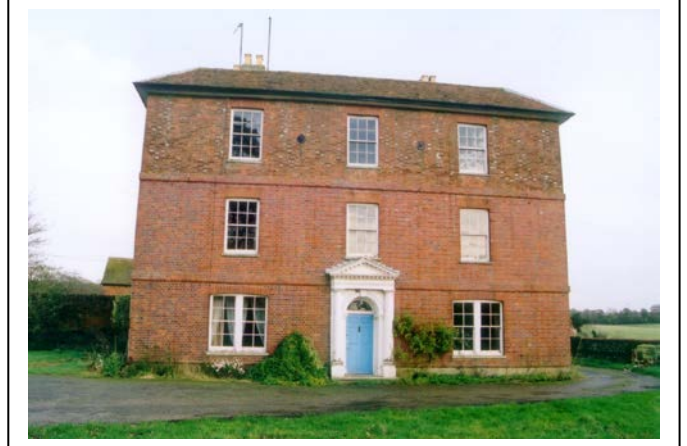
Plate 2: South front of house

- 3.2.2 **South elevation (front)** (Plate 2): three bays wide with central pedimented doorcase to ground floor. Apparently Georgian brickwork (Flemish bond) facing second floor but later (probably C20th) brick (English bond) facing lower two storeys. Two ground floor windows (paired 8-light) beneath segmental brick arches. Three 12-light sash windows (C19th?) to ground and first floor beneath gauged brick lintels. All windows with stone sills, ovolo glazing bars and probably of late 19th-/early 20th-century date. Straight joints of three bricked-up windows at second floor level immediately to west of each existing window. Projecting string course (3 bricks tall) between each floor. Set on rendered plinth recessed slightly behind the main plane of the elevation.

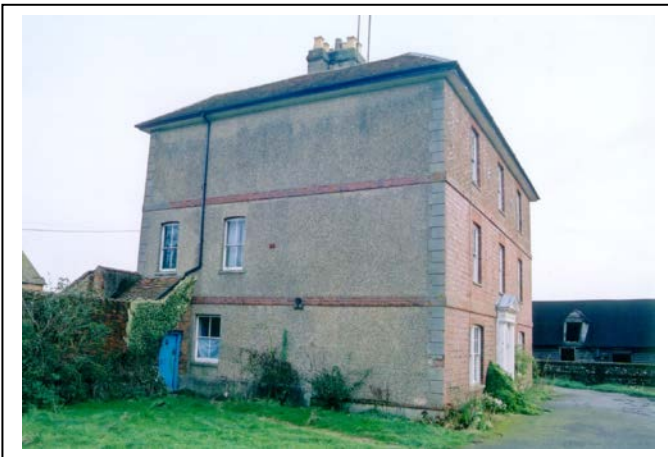
Plate 3: West elevation of house

- 3.2.3 **West elevation** (Plate 3): wall pebble-dashed other than projecting string courses (3 courses C20th? brick) and rendered quoins at both ends. Two four-light sash windows (C19th?) towards north end of elevation at first floor and one at ground floor. Similar plinth as south elevation to southern half of elevation with taller projecting rendered plinth to northern half. Shadow of former two-storey adjoining building with pitched roof towards the north end at first floor level, enclosing window. A strip of pebble dash was removed at 1.5 m above ground level and this revealed that the southern third of wall was formed of (or at least faced with) the same 20th-century brick as the south elevation and that the rest of the visible wall (as far as the adjoining building) was formed of small brick with a beige mortar.

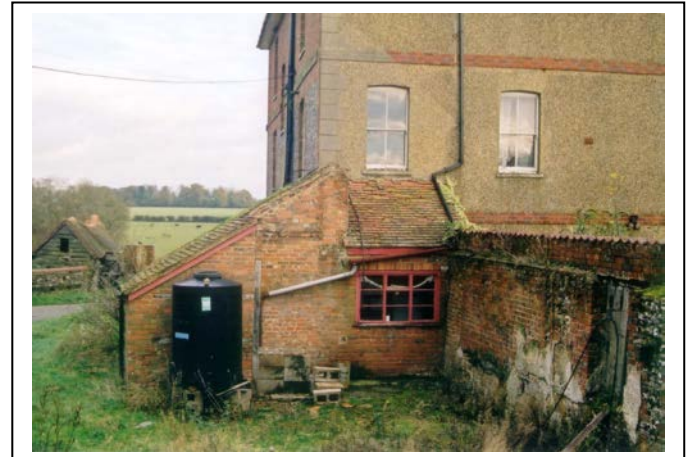
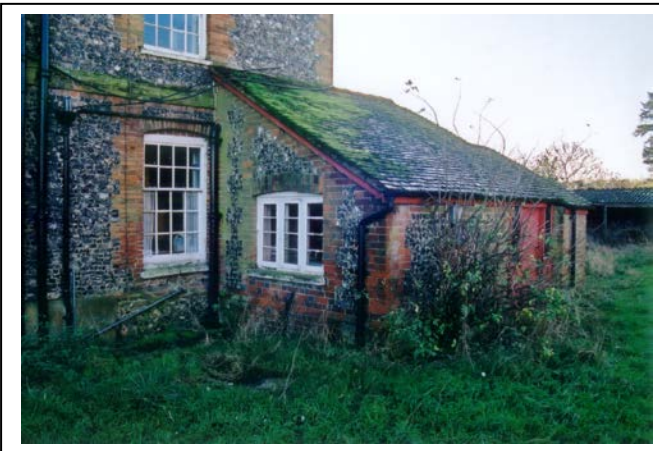
- 4.1.1 **Description:** Small extension to north-west corner of house. Washroom immediately to north of house, built of flint with brick dressings and with single-pitch roof sloping to north. Log store of brick and also with single-pitch roof sloping to north but west wall of southern corner of Building 2 formed of later brick and with lean-to roof

sloping west. This is clearly the reformed, truncated stub of a formerly much larger building although the washroom was added later.

4.1.3 **Significance:** Building 2 is not of great significance but the older part, which appears to partially survive from a formerly larger building, is of some historical interest and provides evidence of the former building within this area.

4.1.4 **Proposal:** small existing extension to be demolished and replaced by large single-storey extension within Area 3 (see below).

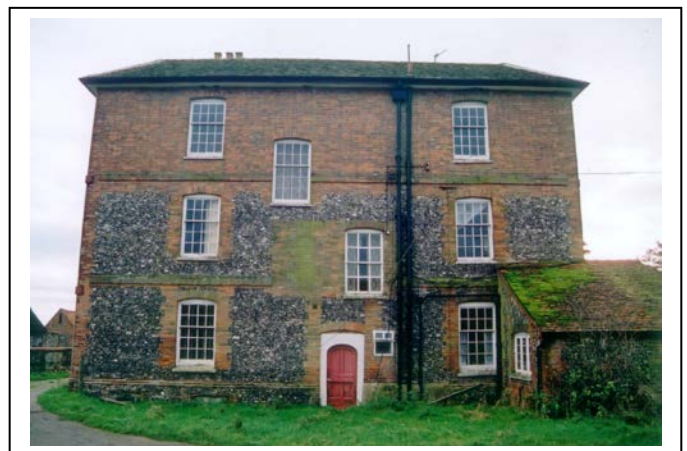
Plate 6: North elevation of house

- 3.2.5 **North elevation (rear)** (Plate 6): second floor of apparently Georgian brick with lower two storeys of flint with brick dressings to quoins and openings. Brickwork in lower two storeys formed of small bricks (c.5 cm tall) and strongly appears older than that to second floor (possibly reused brick). Two possibly primary windows to each floor (each one 20-light sashes) with slender glazing bars. Two further windows between floors which illuminate the staircase. That between first and second floor the same as other windows to elevation that between ground and first with thicker glazing bars and 12-lights. All windows beneath brick segmental arches. Small, low central ground floor doorway with arched head. Existing door apparently secondary and brickwork to each side of door continues up to landing window suggesting that the doorway may originally have had a fanlight or similar feature. Projecting string courses (3 courses brick) between floors but at slightly higher level than those to side elevations.

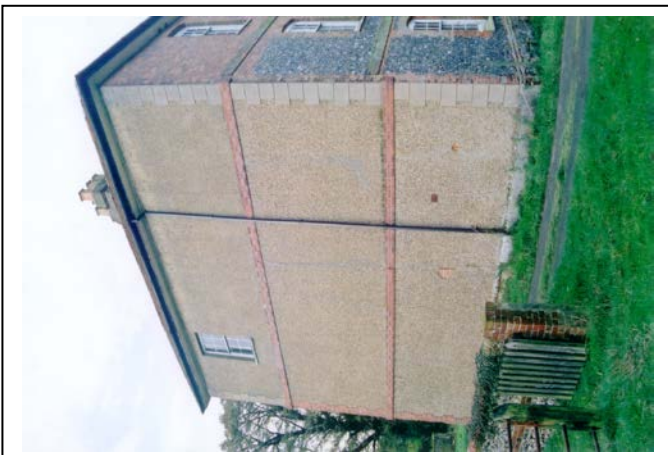
Plate 7: East elevation of house

- 3.2.4 **East elevation** (Plate 7): pebble-dashed other than 3-brick string courses at each floor level. Full height render quoin at north end and similar feature at southern end of second floor; projecting brick quoins beneath at ground and first floor. Recessed rendered plinth to southern half of elevation with projecting rendered plinth to northern half. A strip of the pebble dash was removed at c.1.5 m above ground level together with the northern render quoin beneath first floor which revealed that the external face of the southern half of the wall was formed of the same 20th-century brickwork as the southern facade. Immediately to the north of this was a bricked-up doorway which would have opened onto the side of the chimney stack. The northern half of the wall was formed of old, small bricks with what appeared to be a bricked-up window towards the centre. Beneath the render quoin at the northern edge of the wall the corner was formed of brick but there strongly appeared to be a constructional break between it and the brickwork immediately to the south. The corner brickwork was stepped in and out every 3 courses in a similar form that that immediately to the west of the corner. It therefore appears likely that the east wall was formerly of flint with a brick corner (same as the north elevation) and that this was refaced in brick, possibly in the 18th Century.

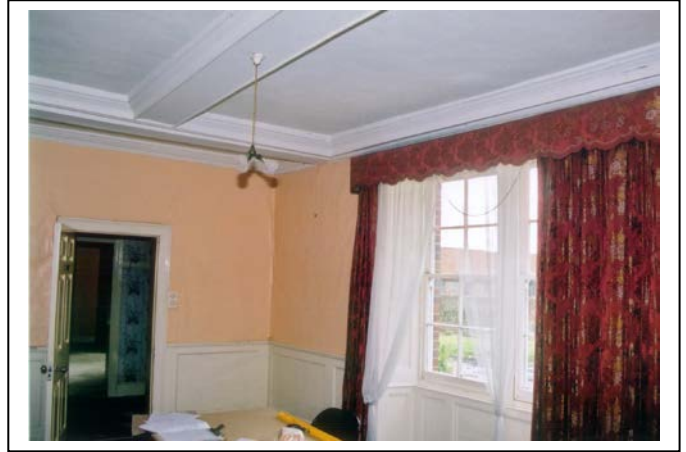
Plate 10: dining room

- 3.2.10 To the west of the entrance hall is the **Dining Room** (Plate 10) which has plastered walls above possibly primary mid-height panelling which was extended when the hall was narrowed and the room enlarged. Two boxed-in floor joists project beneath the ceiling which suggest that there is an N-S principal joist (at the east edge of the primary room) and an E-W bridging joist. A cornice continues around each of these joists and around the room but that to the east of the N-S joist (originally within the hall) is of slightly different design. The fireplace is a secondary replacement. To the east of the chimney stack there are two cupboards. The dado and panelling continue into the western cupboard to suggest that this formed a doorway through to the kitchen.

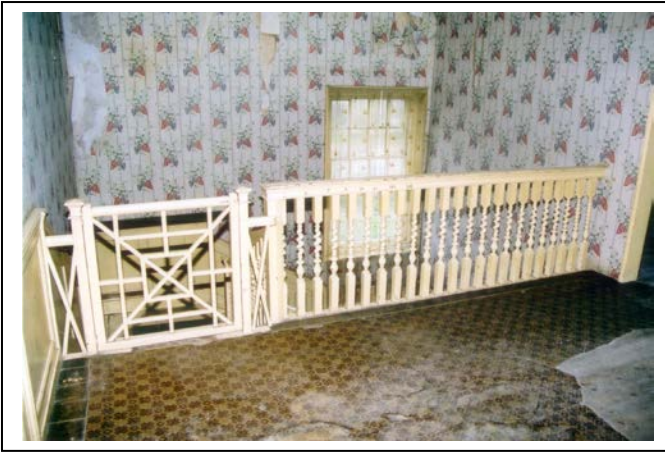
Plate 17: Landing at second floor level

- 3.2.25 A small gate has been added at the head of the stairs (possibly of late 19th/early 20th date) (Plate 17).
- 3.2.26 **Roof** (Plate 18): it has not been possible to make a full assessment of the roof structure but a limited inspection was possible through a hatch in Bedroom 4. The roof appeared to be largely of secondary softwood with some oak and elm and was probably rebuilt in the late C19th/early C20th). It consisted of simple raking struts resting on simple ties and supporting a single purlin to each slope with notched common rafters. A fuller investigation of the roof should reveal evidence of the primary roof.

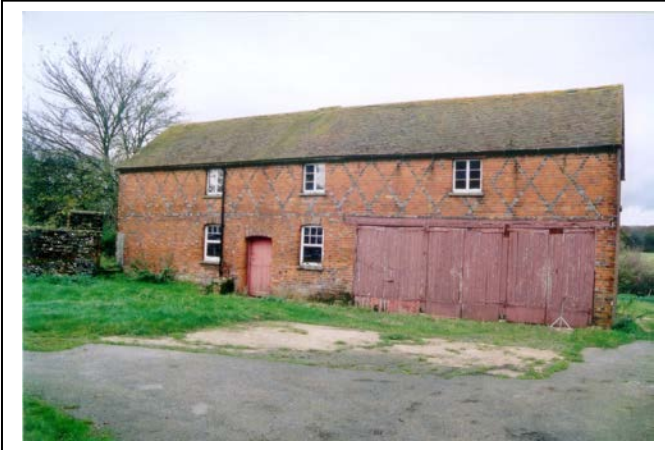
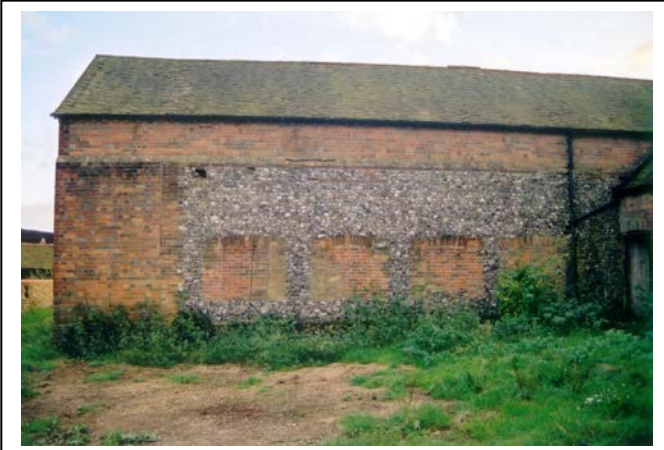
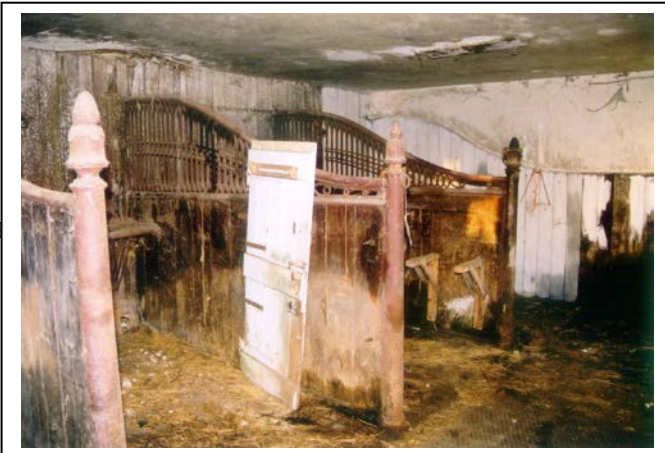
4.3.1 **Description:** Rectangular plan building with short secondary projection towards western end of north elevation. Gabled tile-covered roof. South elevation (facing house) of brick with diaper work at first floor and dentil course at eaves. Three large

double doors towards east end of elevation. A door and two windows beneath segmental brick arches. Most of northern elevation of flint with brick dressings and clearly incorporated from older building. To allow its incorporation the wall was extended vertically and towards the east in brick. Four bricked-up openings in older flint wall beneath brick segmental arches. East wall of brick. West wall of brick above low level of flint (with brick piers) incorporated from earlier building. Gabled northern projection with flint and brick west wall and brick north wall. Ground floor divided into two main areas. Stables to west and coach house (no access possible) to east. Three small horse boxes towards east end of stables with cast iron posts and ornamentation. Two larger boxes at west end. Groom's accommodation on first floor with skirting boards, plastered walls/ceilings and panelled doors with architraves. N secondary projection has domestic fireplace, tongue and groove panelled walls, plastered ceiling and boarded floor.

4.3.3 **Significance:** although the building is a relatively late addition to the farmstead (apparently of late 19th-century date) it is a prominent and attractive building which contributes to the overall character and form of the farm complex. The first floor was accommodation.

4.3.4 **Proposal:** Building to be retained and refurbished in development as coach-house and stores with staff flat over. The eastern half of the ground floor plan (garage and central stables) will remain little altered but the stables at the west end of the ground floor and the existing plan of the northern projection will be lost to allow the area's conversion to a utility room and staff flats. The first floor plan will also be substantially altered to allow its conversion.

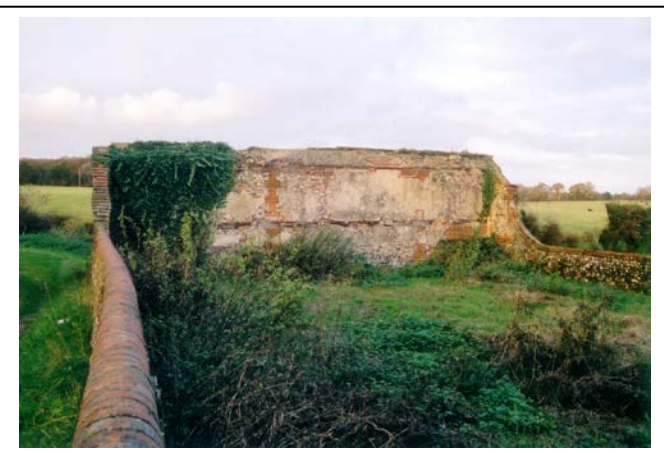
Plate 22: Area 6 from south

- 4.5.1 **Description:** small walled garden to north-east of house. Low walls to east and west (flint with brick coping) with tall flint and brick wall at north end which clearly formed one side of a small single pitch structure. Some roof tiles survive on sloped wall at west end and along the ridge of the rear (north) wall. Small shelter survives at south end of area with gabled tiled roof and weatherboarded walls. Very poor condition and roof almost collapsed towards east end.

- 4.5.3 **Significance:** area of limited intrinsic significance but of interest as part of the overall farm complex.
- 4.5.4 **Proposal:** create glass house at north end of area, renovate shed at southern end (as potting shed) and use area between as a cutting garden.

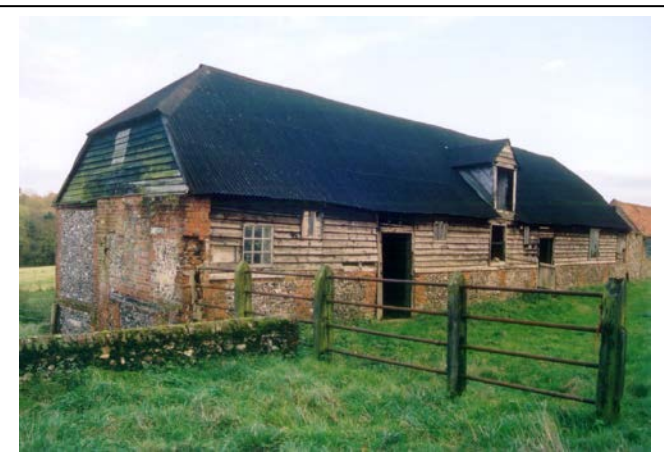
Plate 24: Building 7 from north-west

- 4.6.1 **Description:** Two storey farm building immediately to east of house with half-hipped corrugated iron-covered roof. Six bays wide. W wall of weatherboard over base of flint with brick piers (c.1.2 m tall); Other walls wall of flint with brick piers (and quoins) to eaves height; weatherboard above to each end wall up to half hip of roof. Beige mortar in brickwork. Simple stables and feeding boxes against east wall on ground floor. 14 N-S common joists tenoned into principal joists. 2 replacement principal joists inserted. Underside of joists painted. Only very limited access into upper floor but roof apparently entirely/largely rebuilt - some parts reused but mostly modern. Trusses with collar, tie-beam, principal rafters and additional raking struts parallel to the rafters and sandwiching the purlins (1 to each slope).

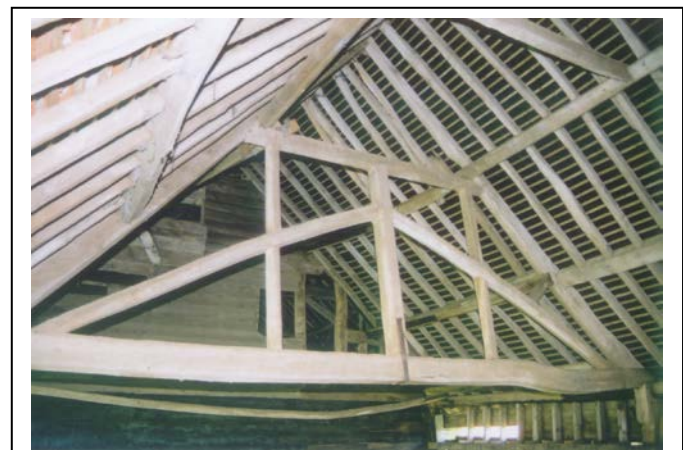
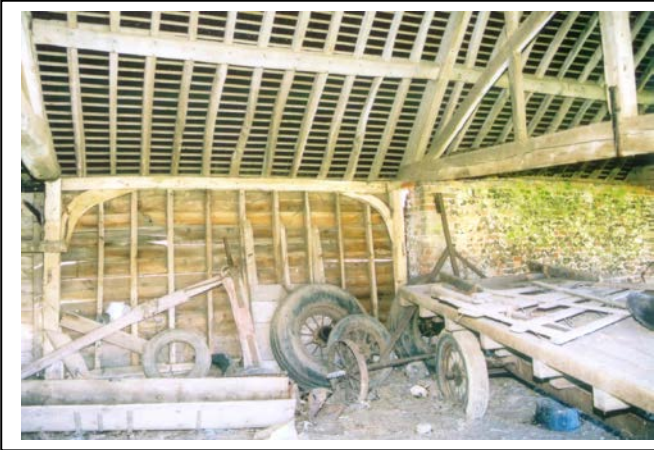
- 4.9 Building 10** (Plates 31, 32)
- 4.9.1 **Description:** Five bay wide cart shed adjoining to the south of aisled barn (building 9). Gabled roof with clay tiles to west and corrugated iron cover to south and east.
West elevation: open fronted and supported by timber posts (post 2 replaced by brick pier).
South elevation: random flint and brick '50-50' (ie all mixed in).
East elevation: southern two-thirds the same as south wall (with 2 brick buttresses) but northern one-third weatherboarded (supported by secondary studs - ie northern two bays probably originally open to both faces to allow carts to pass through).
Interior: 4 trusses, northernmost 4 of distinctive form with tie-beam, collar, king-post (secured to tie by iron strap), slightly arched braces between tie and king-post and two queen struts cut through by the arched braces. Sections of arched brace within Trusses 2 and 3 removed to create doorways. Southernmost truss a conventional partition formed by vertical members but without arched braces. Two purlins to each slope, the upper one clasped, the lower abutting principal rafter. No ridge-piece, primary rafters almost entirely in-situ. Quality of joinery and current condition of timbers good. Many members chamfered including purlins chamfer stops either side of principal rafters. There was a first floor relatively recently in bay 2 and there was almost certainly also a first floor in bays 3 and 4 (suggested by 'door' openings in trusses). Although the condition of the roof members is relatively good the posts and sections of the walls on which they are supported lean perilously and are in need of strengthening.
