Oseney Abbey Oxford: The Scheduled Monument

Historic Building Survey

November 2008

Client: W.H.Munsey Ltd

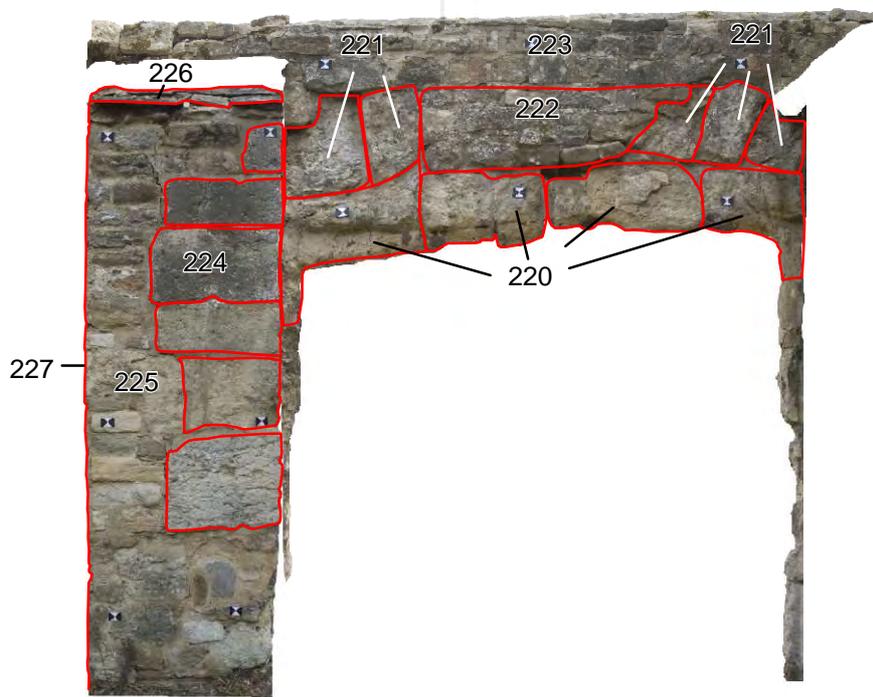
Figure 14: West elevation of arch

- 3.3.20 The elevation shows the back of the arch head and the north jamb, the south jamb on this elevation is hidden behind the abutting brick wall. The arch head itself is only one course of stones wide and much narrower than the wall to either side. Therefore the lower and upper voussoirs seen on this side (220 and 221) are the same stones as seen in the east facing external elevation (115 and 116 respectively) and there is little to add to the description of them, except to say that from this side the deterioration of the arch is even more evident. This is especially true of the weathering of the inner faces and opening up of joints in the lower voussoirs. The rubble infill in the upper voussoir course (222 corresponding to 118) is also very clear.

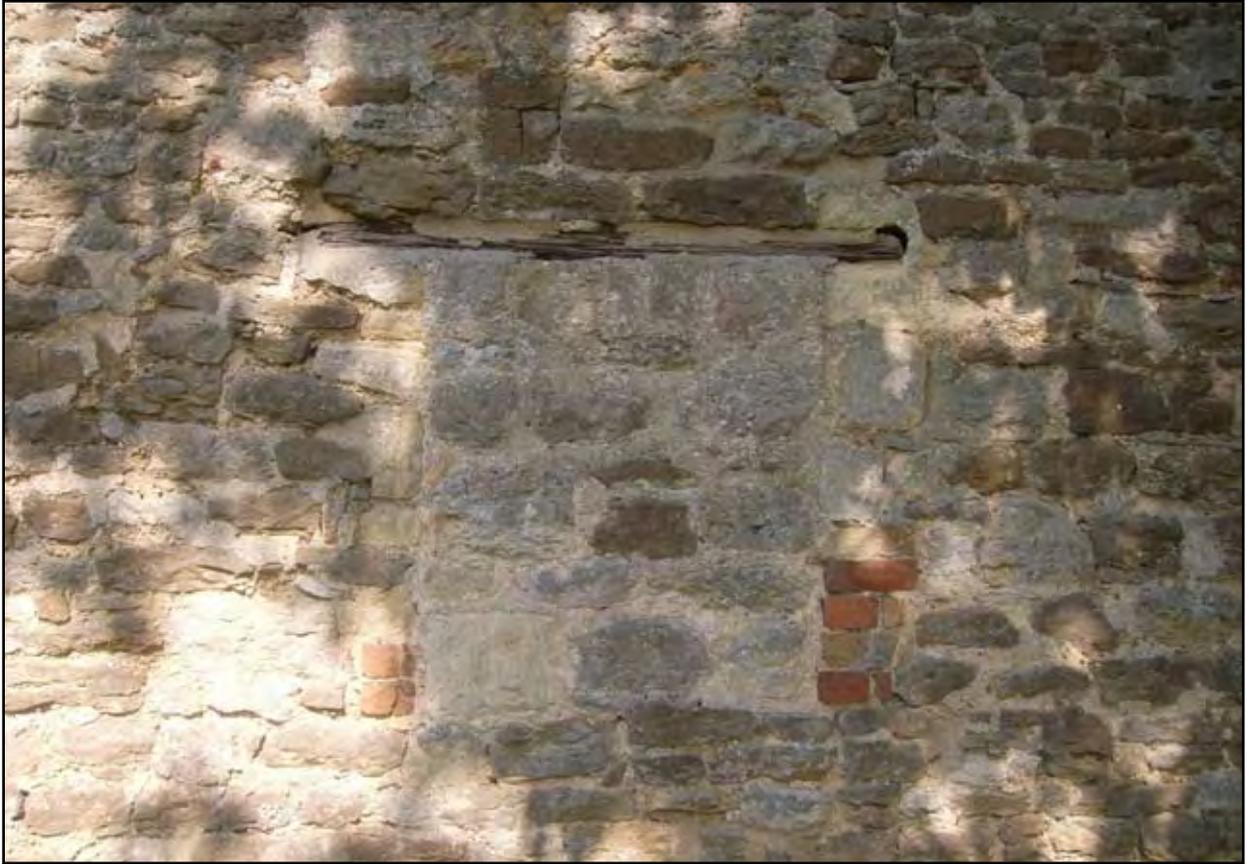
- 3.3.12 Just south and below the centre of the wall is a square window opening with a timber lintel (206) (plate 5). The opening has been blocked in stone rubble masonry flush with the rest of the wall (207). The window is a later insert or the jambs are rebuilt; they are of rubble and some brick fragments and are out of sequence with the courses of the wall and bonded with a different coloured lime mortar (208). The window is shown in Burghers' 1720 view. The inserted south jamb of the window is in line with the irregular joint (205) above so may be part of a larger repair or alteration.

Plate 5: Blocked inserted window in west wall

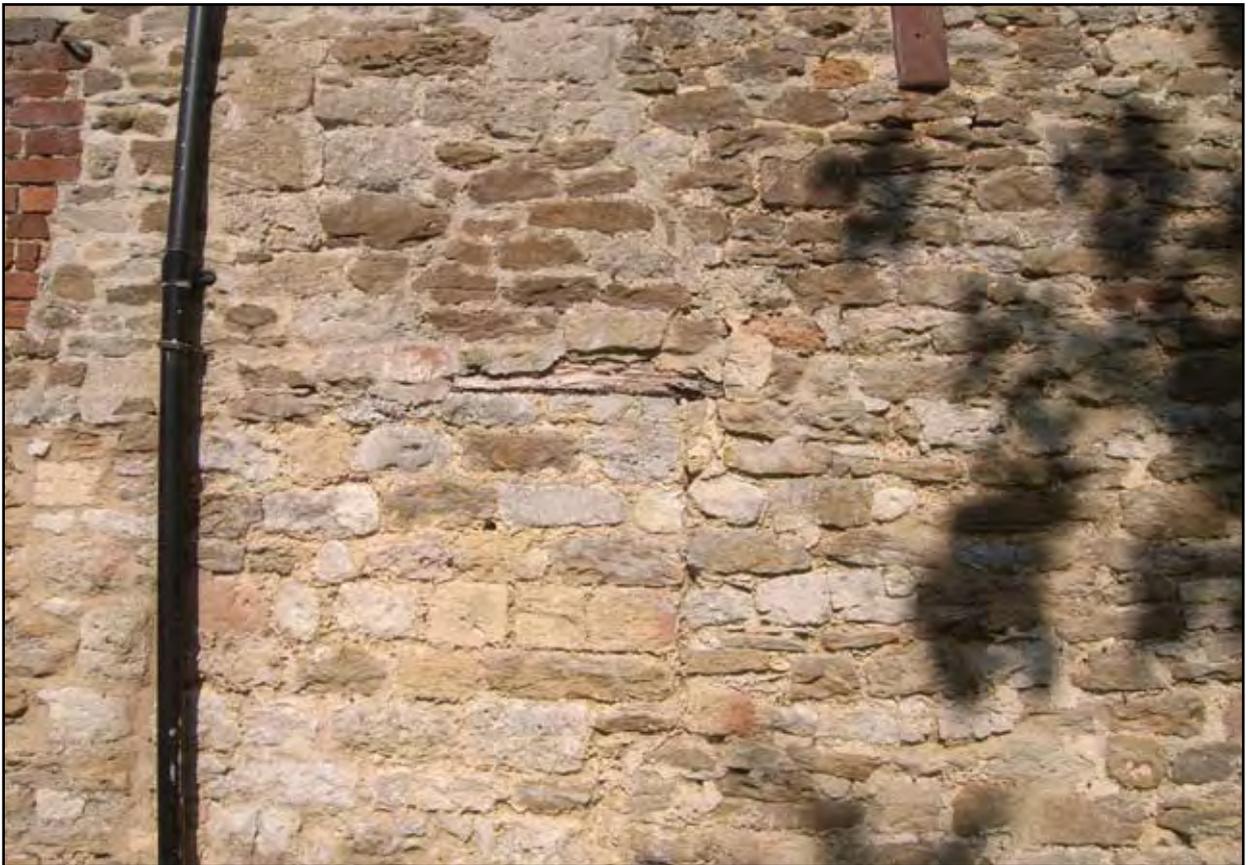
Plate 6: Blocked openings and rebuilt masonry in west wall

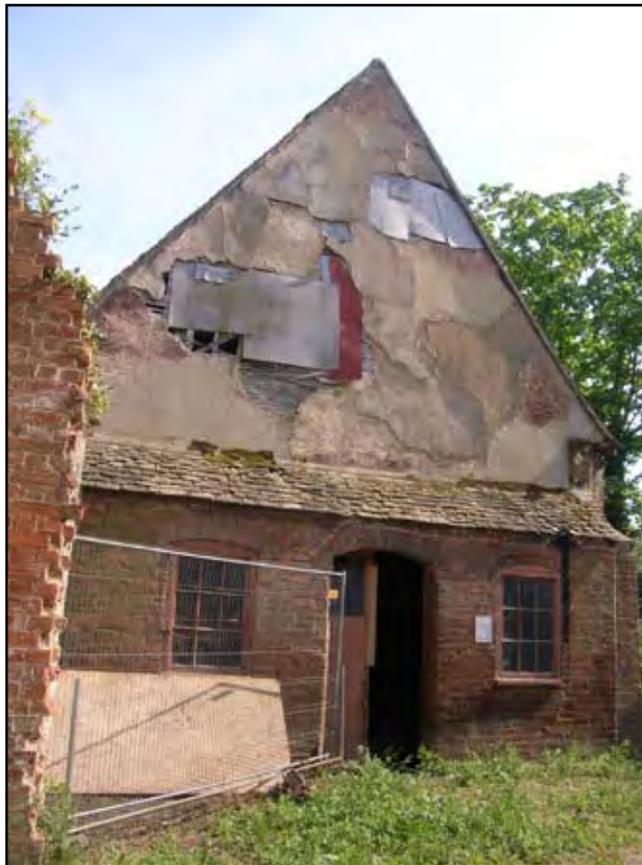
- 3.3.32 The gable wall above the brick façade is in poor condition and in need of repair, it is currently a patchwork of different render repairs and pieces of plywood covering holes in the render and exposed areas of laths (409).

Plate 8: View of north elevation of wall and gable

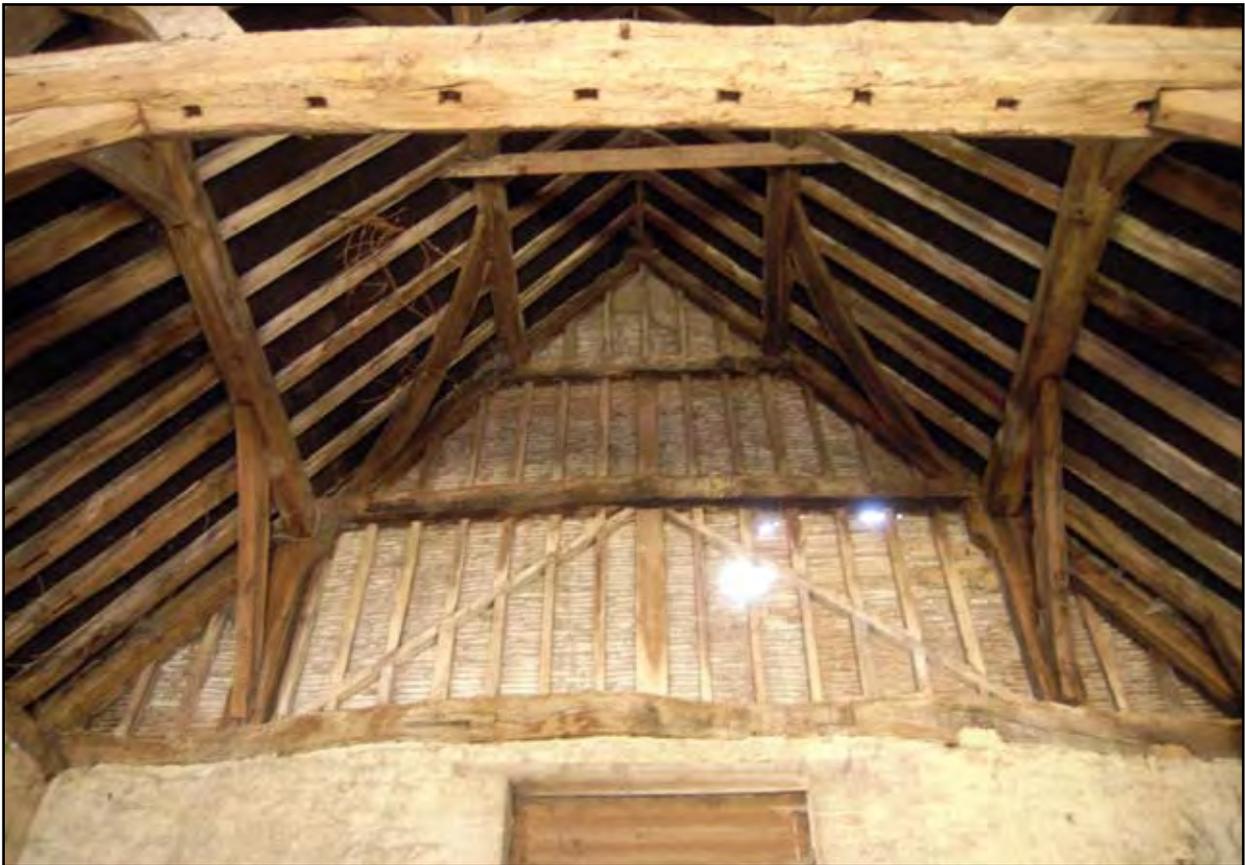
Plate 10: South roof truss with later infill

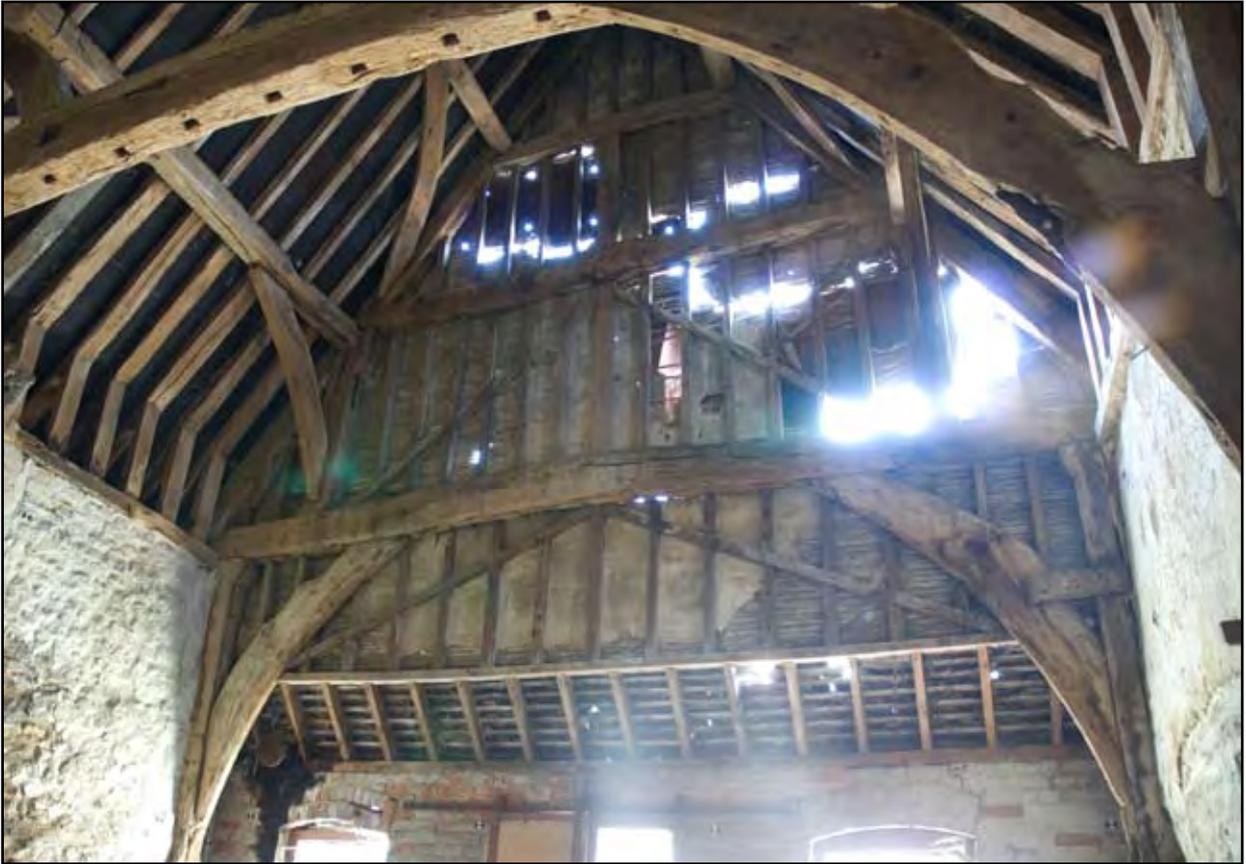
Plate 11: North roof truss with studwork infill
