ADKIN LTD & THE ABINGDON BAPTIST CHURCH

## 35 OCK STREET, ABINGDON, OXON.

ARCHAEOLOGICAL RECORDING PRIOR TO REFURBISHMENT

OXFORD ARCHAEOLOGICAL UNIT  
JANUARY 1997

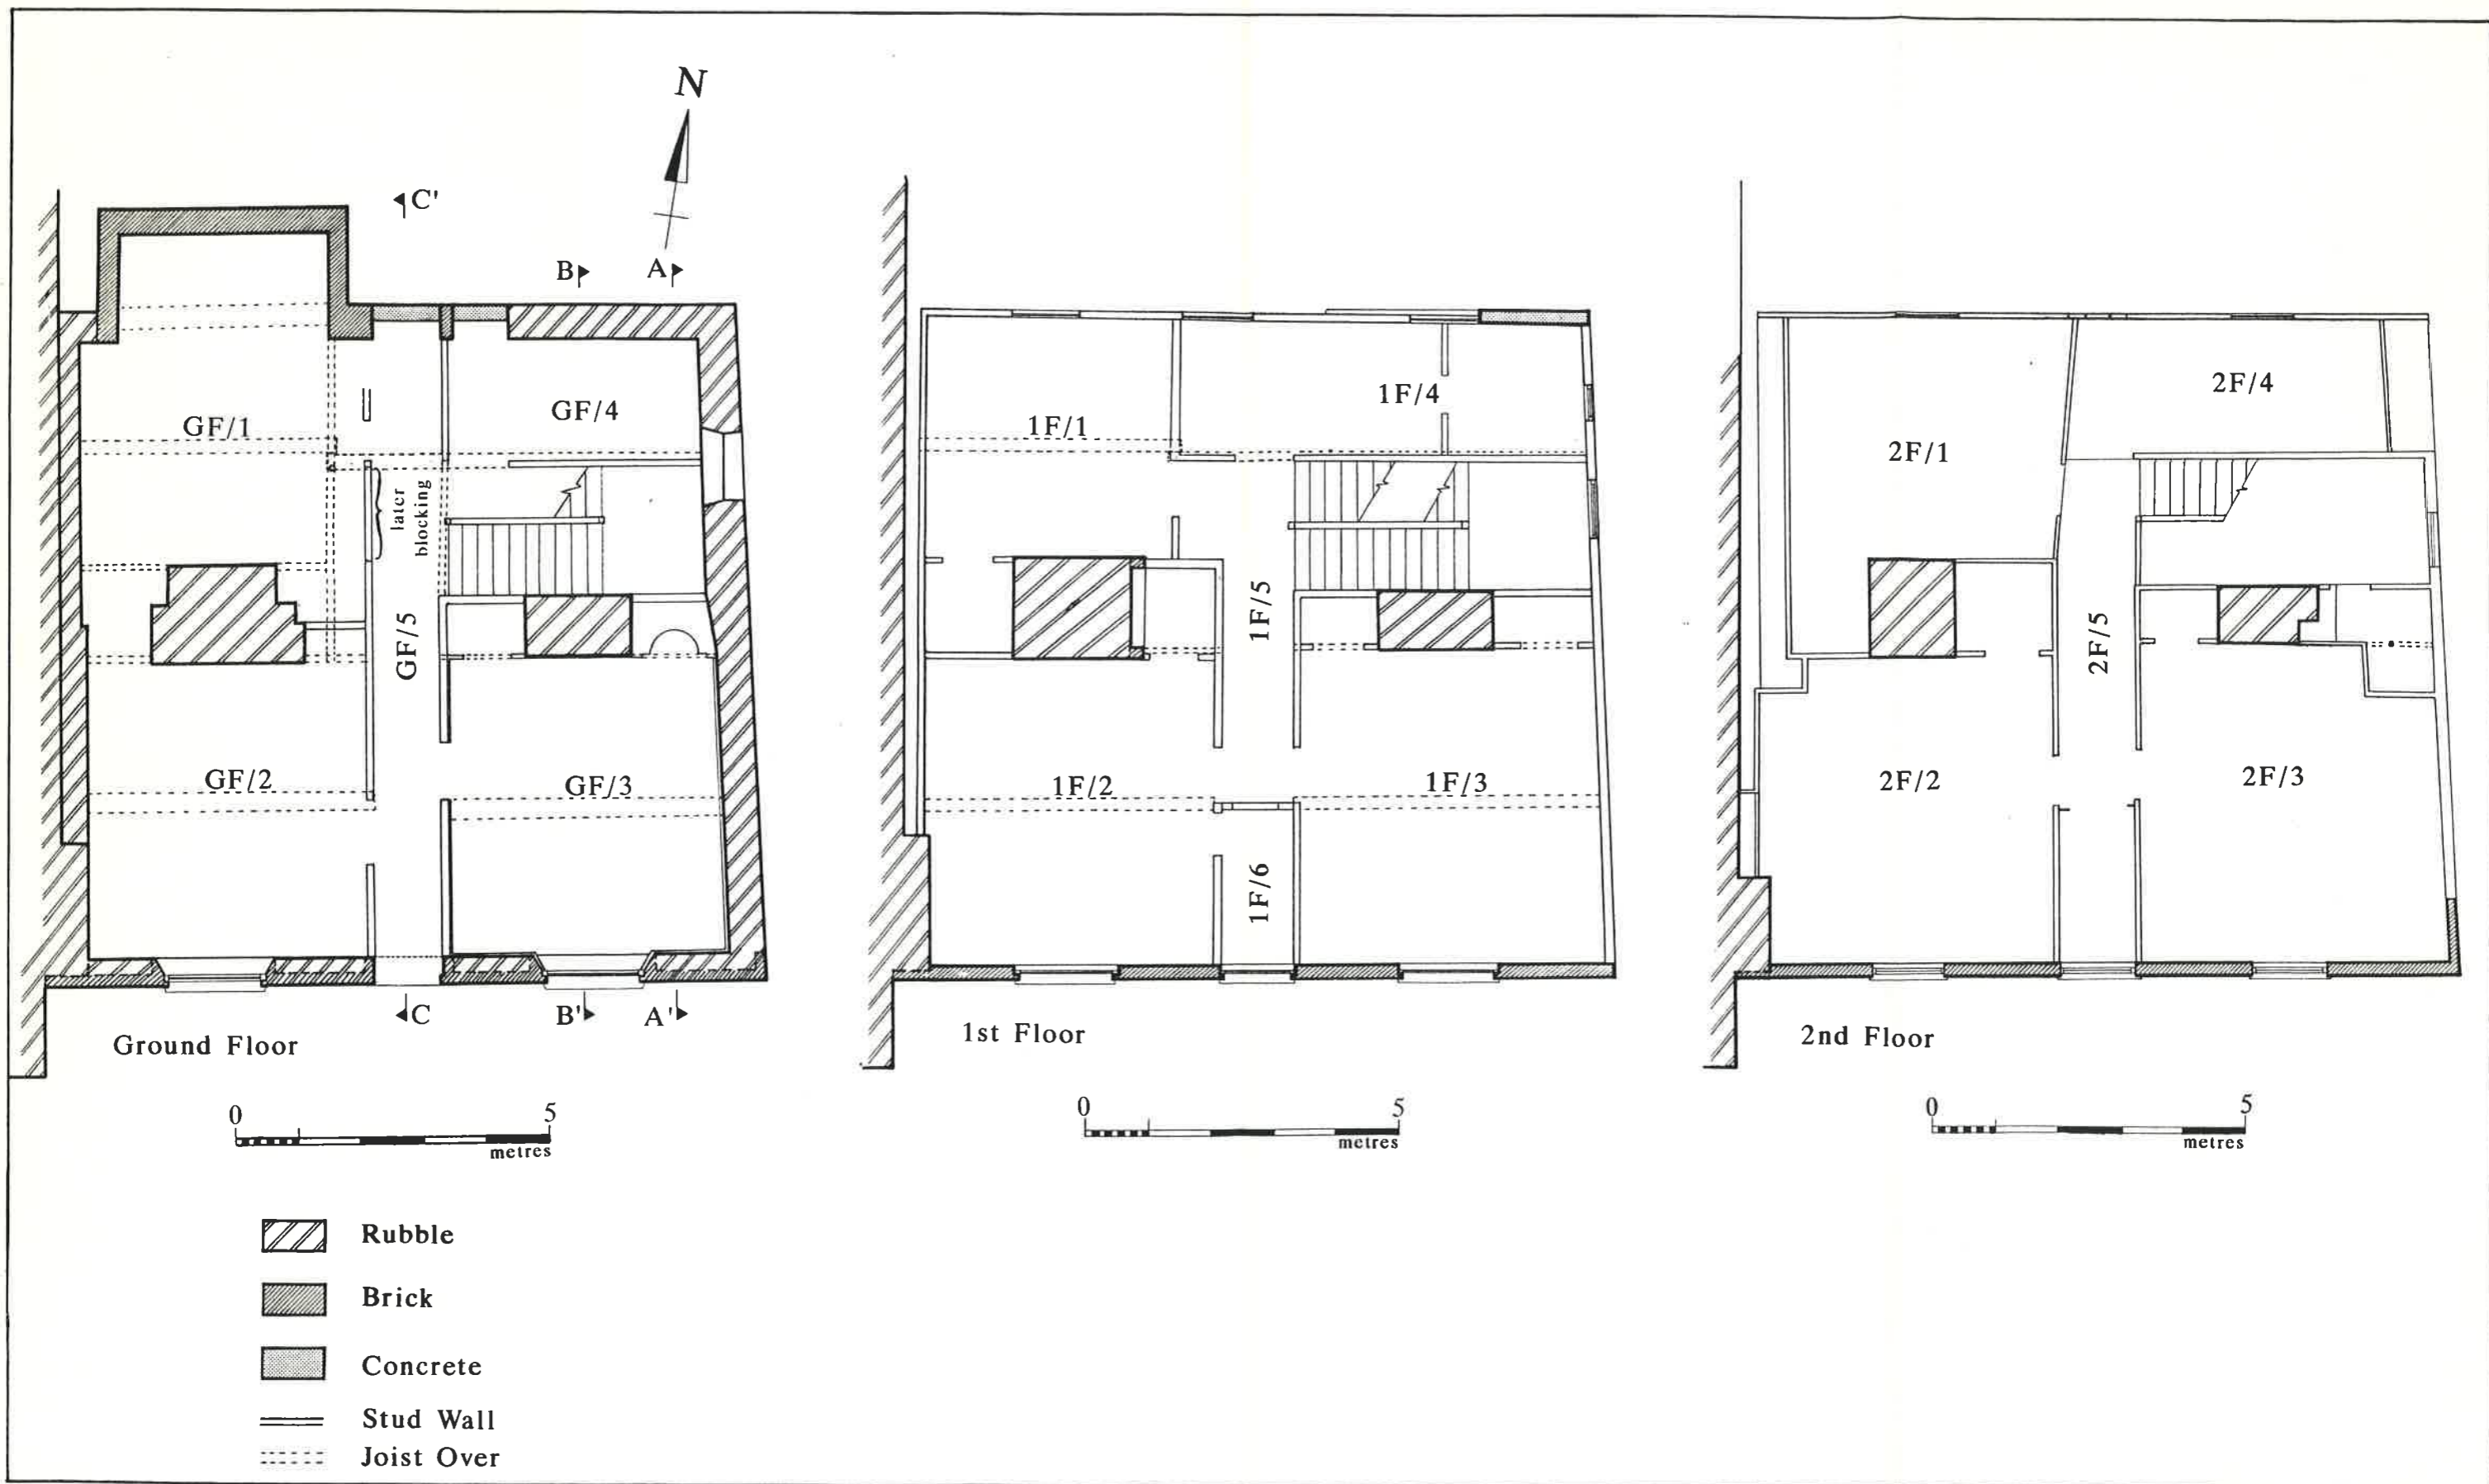
Figure 3:  
35 Ock Street, Abingdon  
Floor Plans (schematic)

The house was built against an existing building on the west, whose stone chimney stack is respected by the west wall of No. 35. The walls are of rubble, with brick surrounds to the windows and door in the front wall, and some rebuilding in brick and concrete block in the N wall. The chimney stacks are also of rubble, with brick arches and jambs (GF2). The plan is of two rooms one either side of a central passage entered from the front door. The room on the E (GF3) is panelled, with an alcove and cupboard on each side of the fireplace, and stud framing flush with the rear of the stack (pl. 10). The stair is at the rear on the E side (GF4), and if primary may have been moved, since it cuts across the window in the east wall in a manner that does not look intentional; however, the lack of a fireplace in the rear of the chimney would equally suggest that it was intended to be here. The solid balusters are probably of early 18th-century date (pl. 11, fig. 5 detail). The NW room (GF1) has a fireplace (blocked) and had a brick bay window of 19th-century date; an earlier door to the passage (S of the present one) had been blocked (see fig. 3).

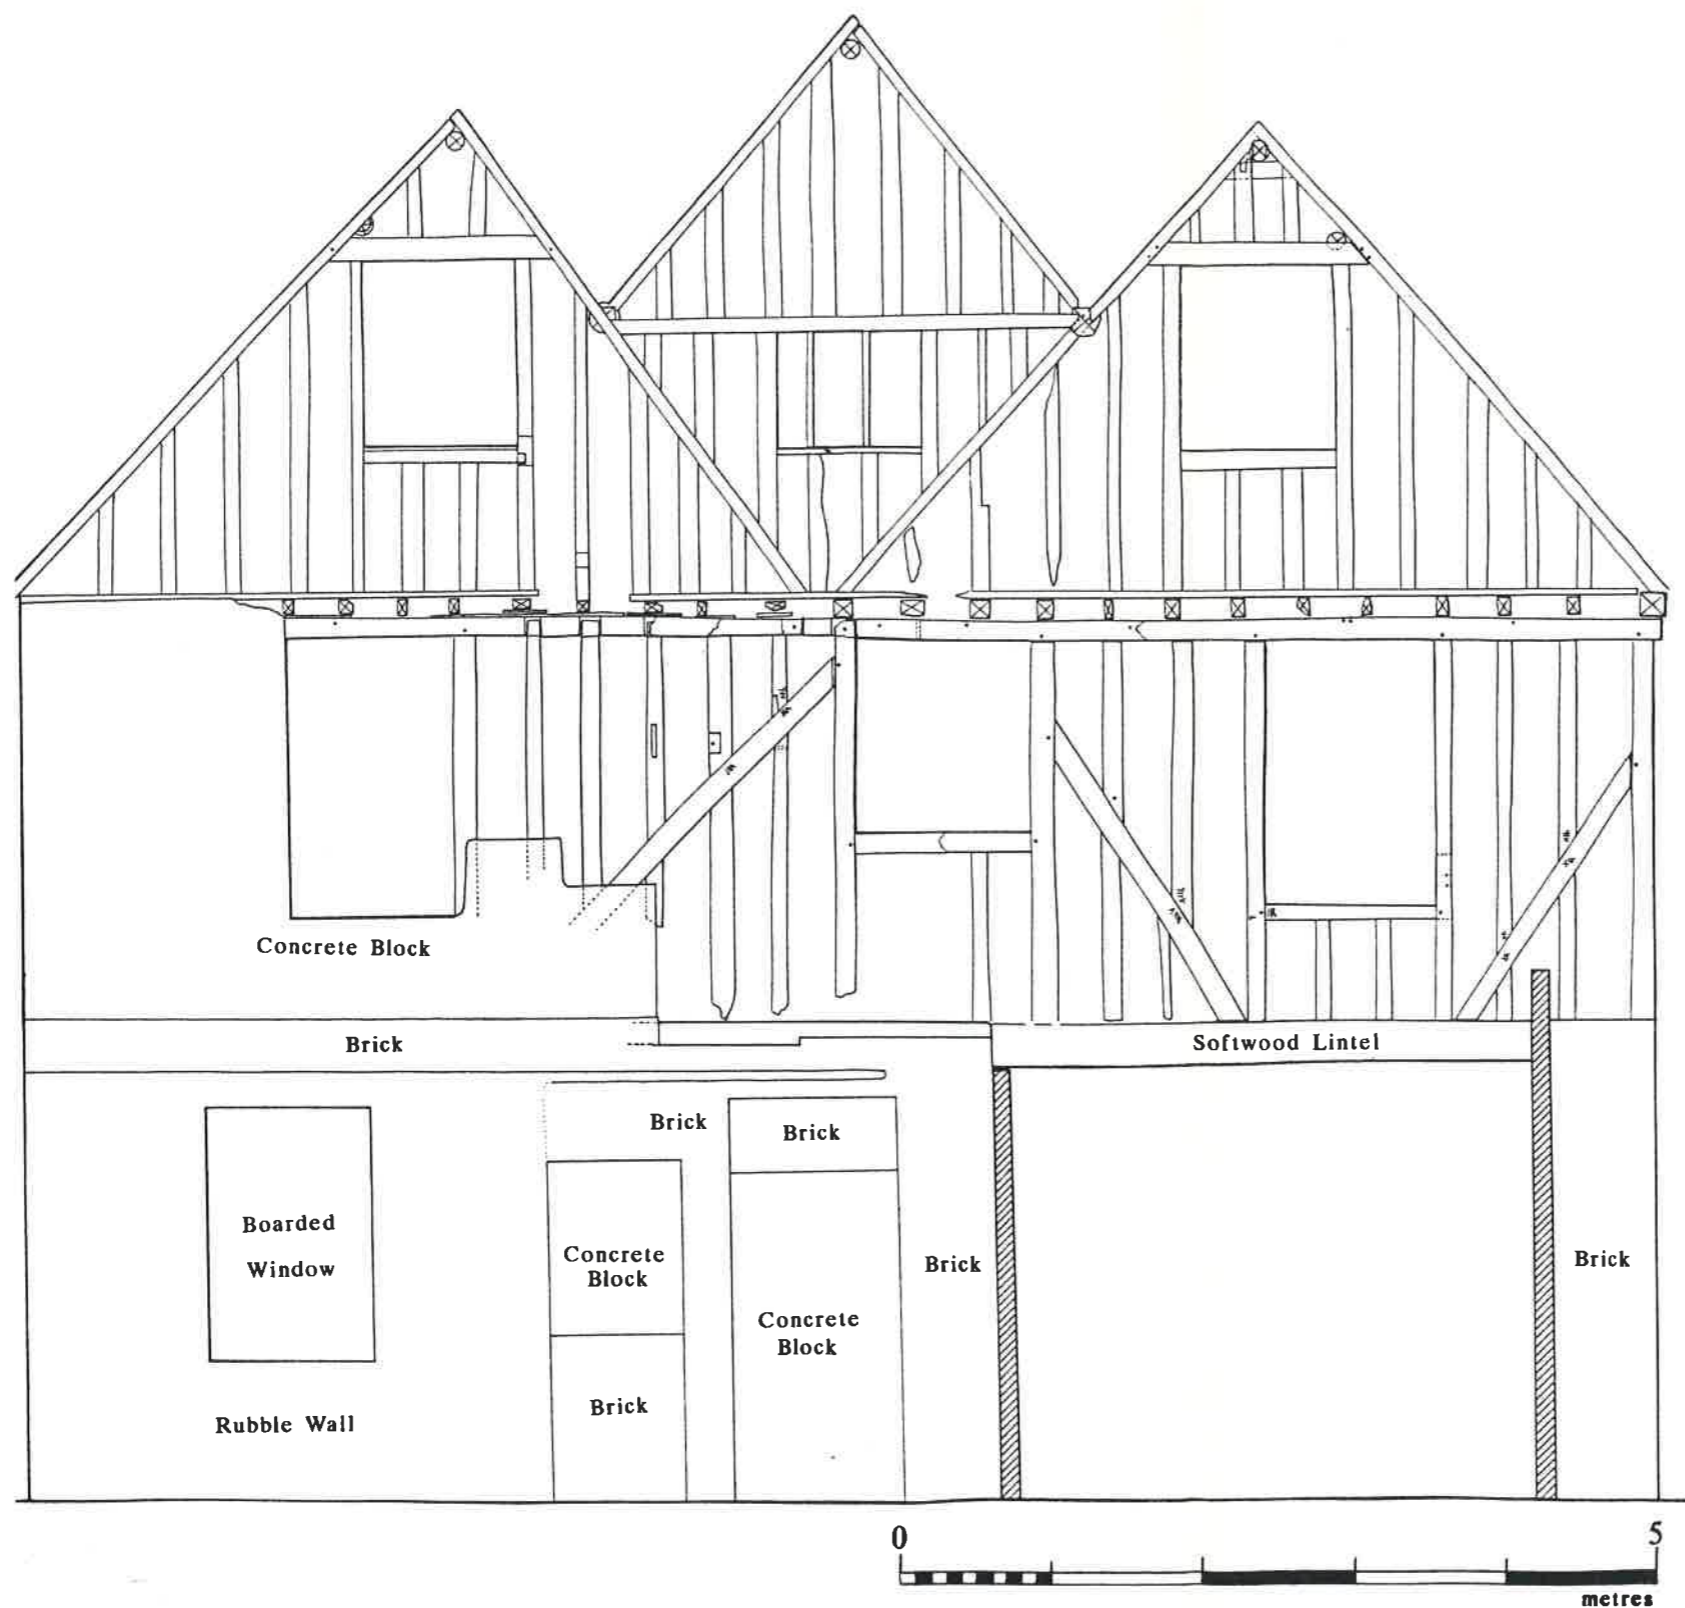
Figure 5:  
 35 Ock Street, Abingdon  
 North Elevation  
 Detail of turned stair baluster

The *rear roof* may initially have had a similar single roof, and the top plate of the rear wall (i.e. at attic floor level) has pegged mortices for uprights (fig. 5) that may have carried dormer windows. It is clear that the rear attic floor has always rested on the rear plate rather than being tenoned into it, and given the similarity to the floor of the front part is presumably original. This does not alone decide the sequence of roof structures, but the present gables are placed on the floorboards in a manner that suggests they are secondary, and that an earlier roof was replaced with a gabled roof at right-angles to the front part. It was thought at first that the middle gable might be additional, but there is no significant difference between that and the other two, and so it is probably part of the same build. The rear gables rise from the front ridge line, and the central one being higher has a hipped gablet (pl. 24). They are all of fairly light construction, using poles and some reused timbers, and with one possible mast timber in the E gable (pl. 26). The rafters of the outer sides descend to the wall plate, and the inner ones to two valley plates that run back to posts beside stack (and provide for internal headroom).

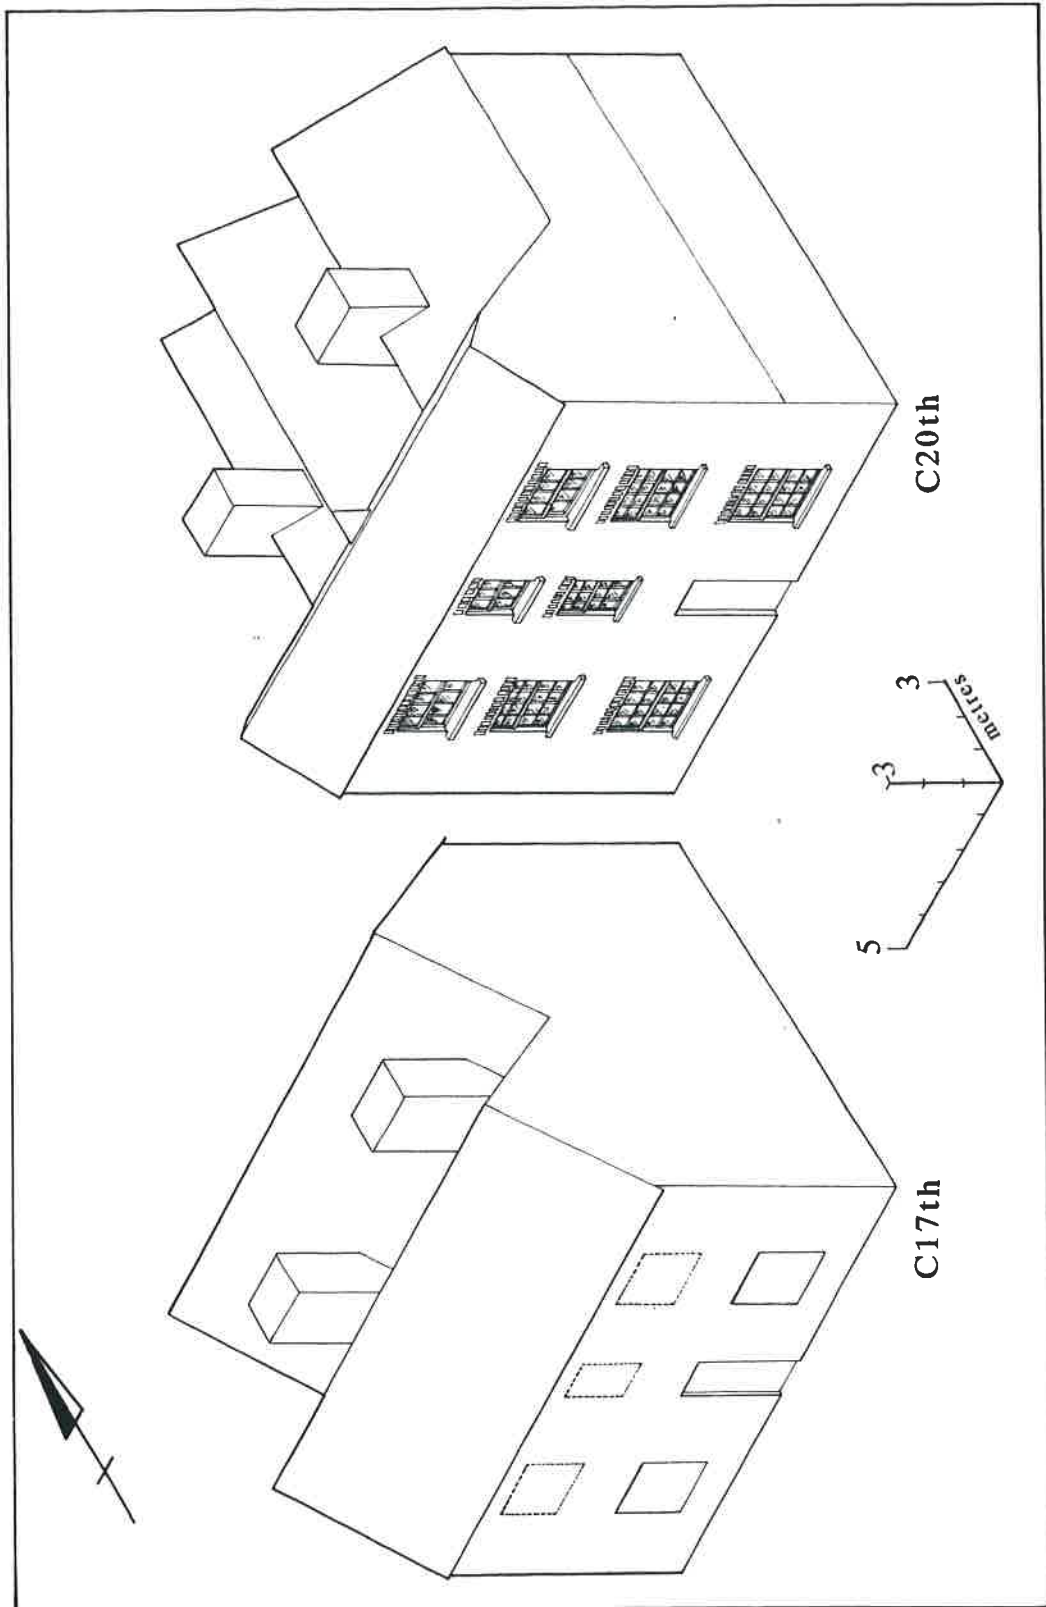
Figure 6:  
35 Ock Street as first constructed (reconstruction)  
35 Ock Street prior to the recent alterations

- 4.1.1 A detailed description of the observed features is given in the following section (§4.2), the salient points of which are here summarised.
- 4.1.2 *Phase I:* As constructed (fig. 6) the house was double fronted, with a central passage and two chimney stacks, and a stair in the rear part. Of two storeys with attics, it was of rubble walling on the ground floor, and was timber framed on the first floor. There was a double gable roof, of which some of the trusses of the front half survive, while the rear wallplate suggests that there may have been dormer windows.

*Phase III:* In the third phase (fig. 6) the front roof was reconstructed, converting the front attic to a full second floor by extending up the front wall (now rebuilt in brick) and replacing the existing roof with a low-pitched gable.

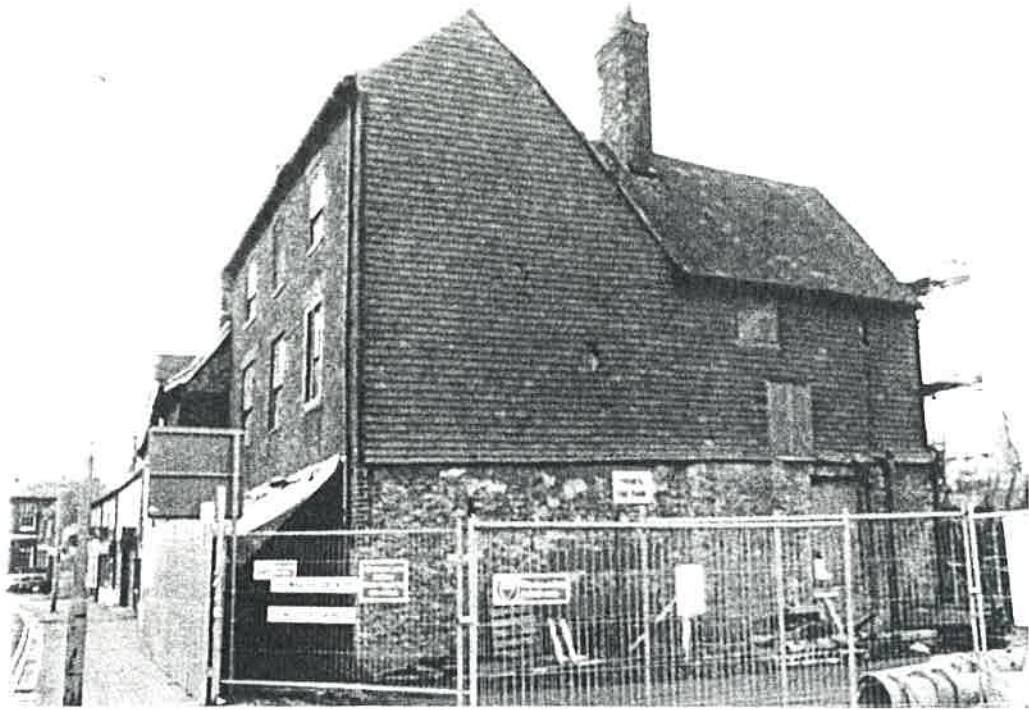
Plate 1: 35 Ock Street from the south-west

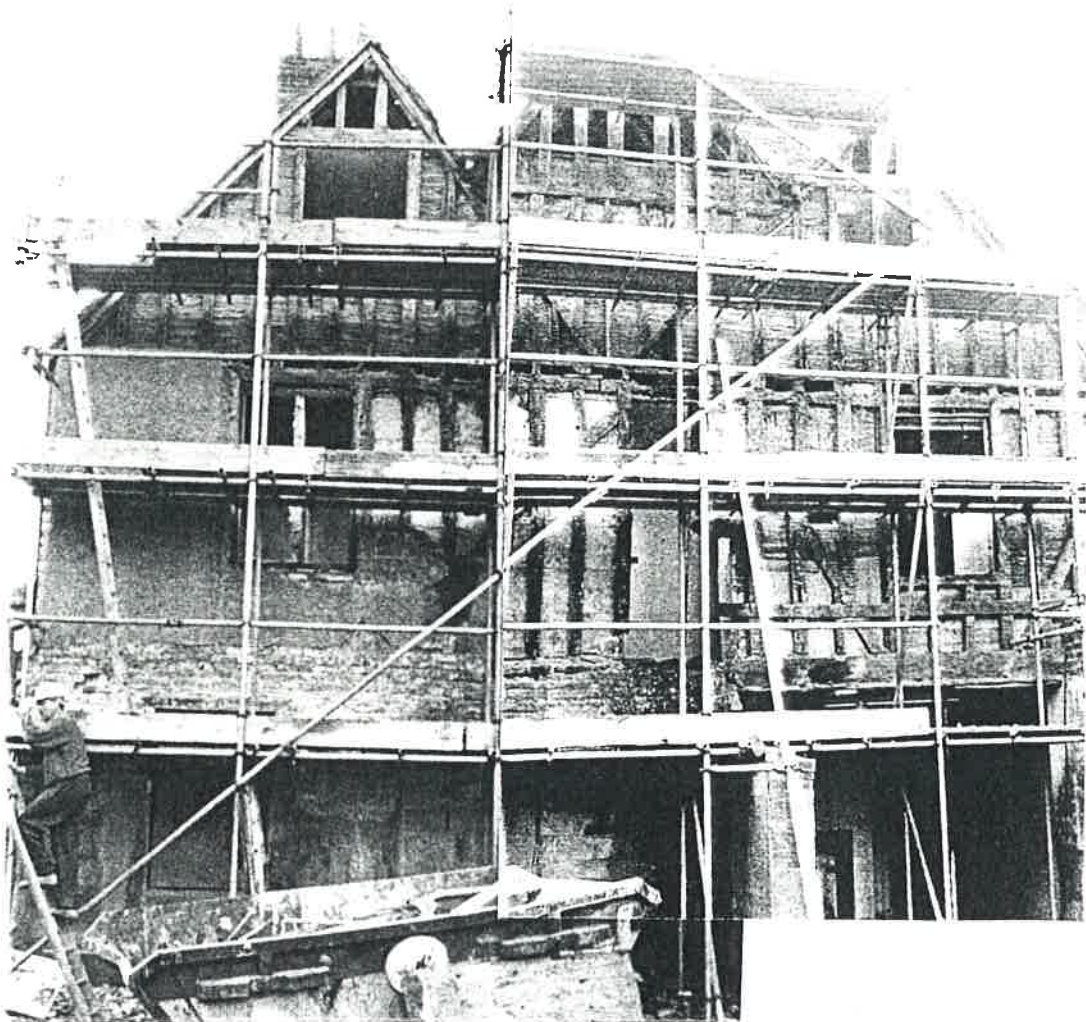
Plate 2: North elevation after removal of brick lean-to

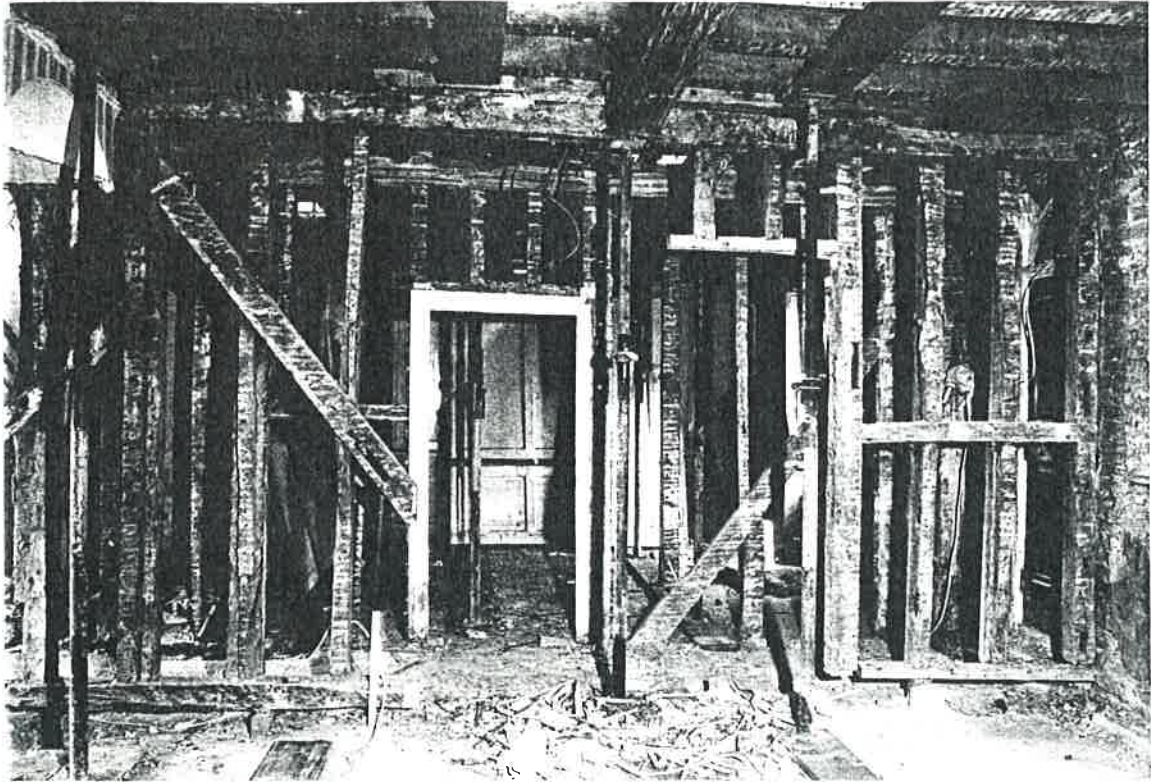
Plate 7: Room GF/2 - partly dismantled passage wall supporting principal joist

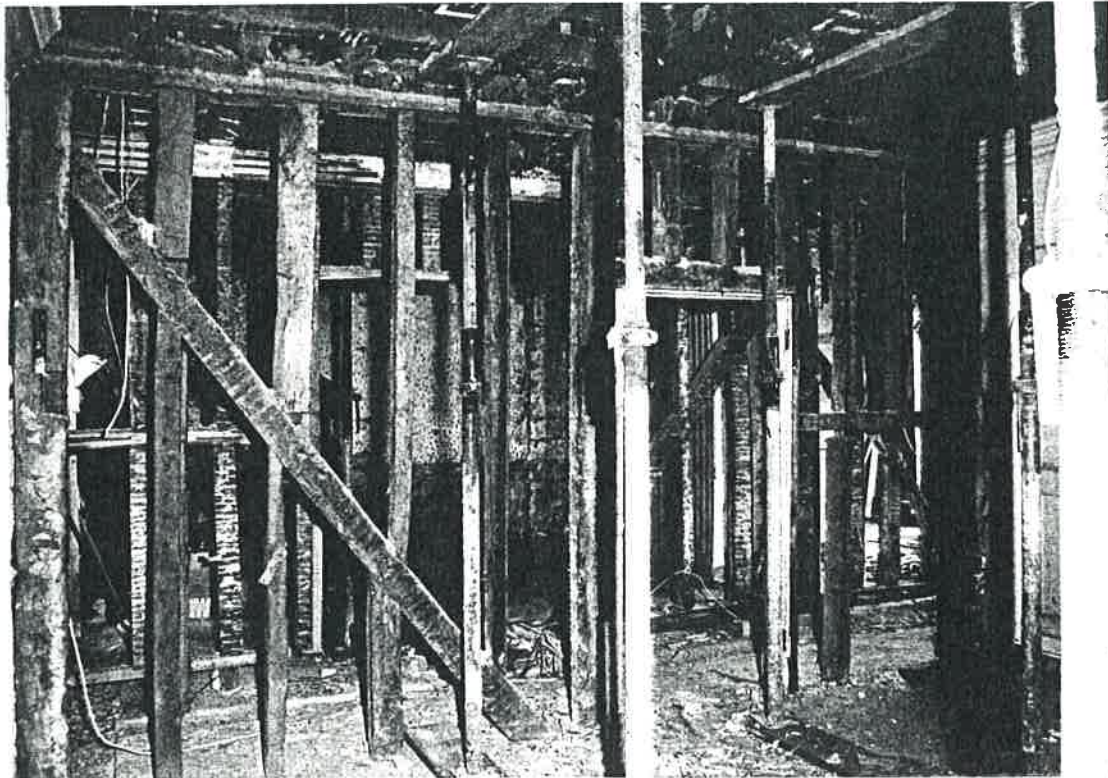
Plate 3: Room GF/3 - passage wall supporting principal joist

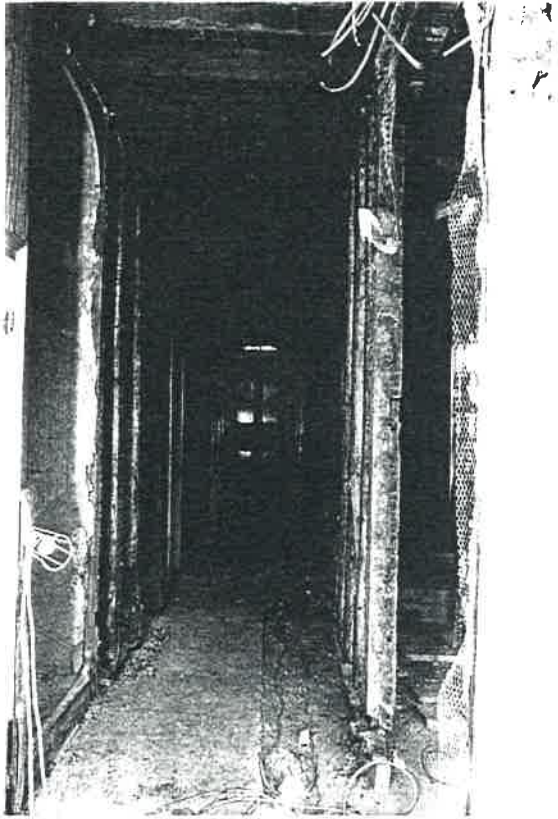
Plate 9:  
Passage GF/5 - common joists resting on the passage walls

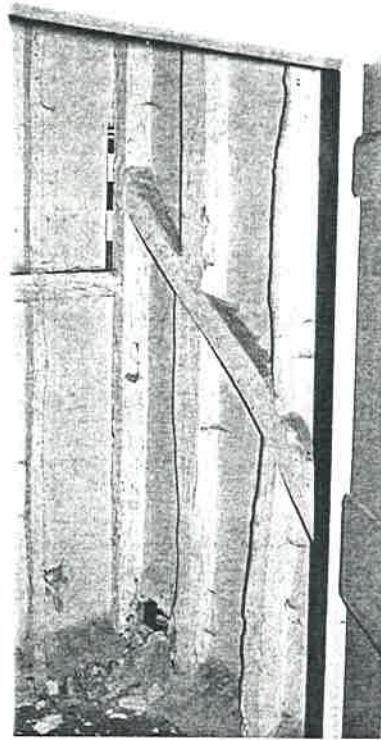
Plate 10:  
Room GF/2 - cupboard showing back of passage wall on right

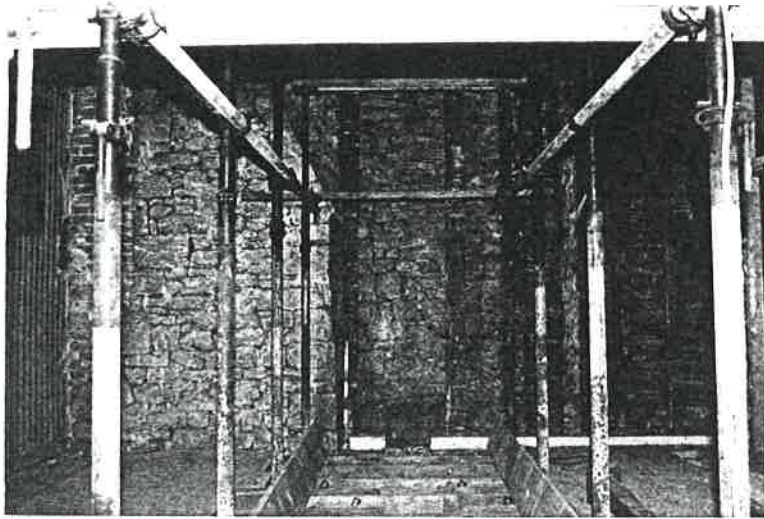
Plate 12:  
Room 1F/2 - showing west wall abutting chimney stack of adjacent property

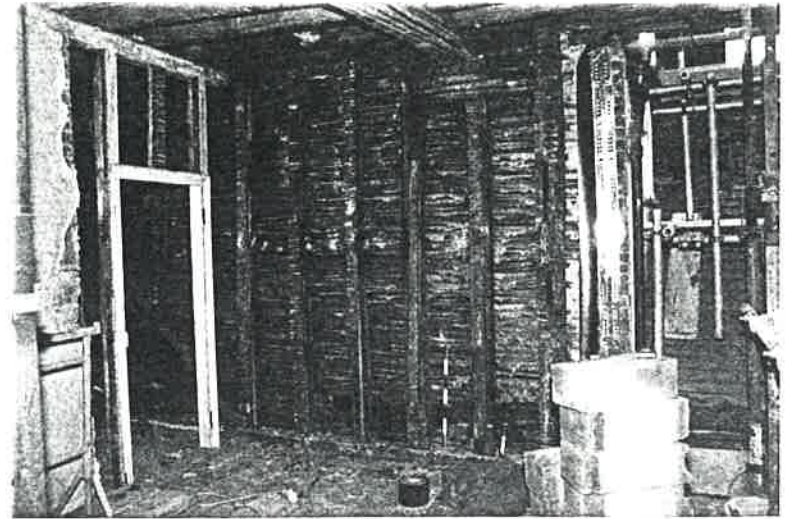
Plate 13:  
Room 1F/1 - continuation of west wall with principal joist detail

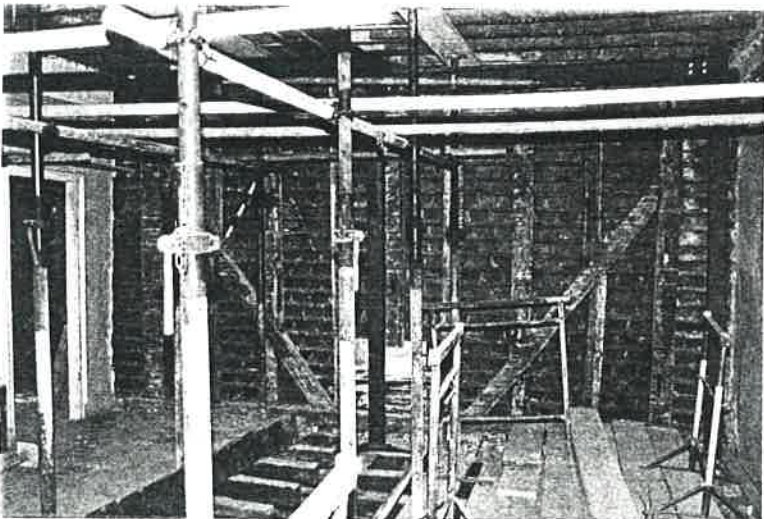
Plate 14:  
Room 1F/3 - east wall (after removal of principal joists and insertion of steels)

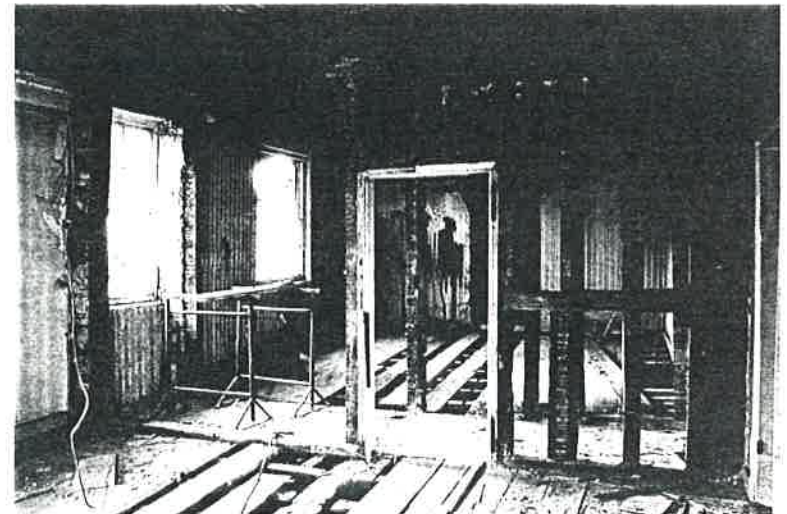
Plate 15:  
Rooms 1F/2/3/5/6 - showing relationship of principal joists to passage wall (after partial removal of passage walls)

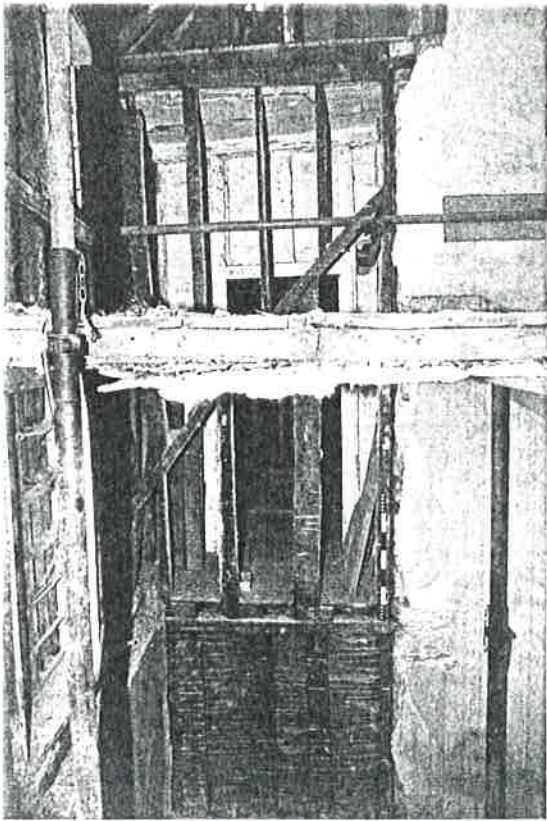
Plate 16:  
South wall of staircase showing relationship of stud walls  
to chimney stack

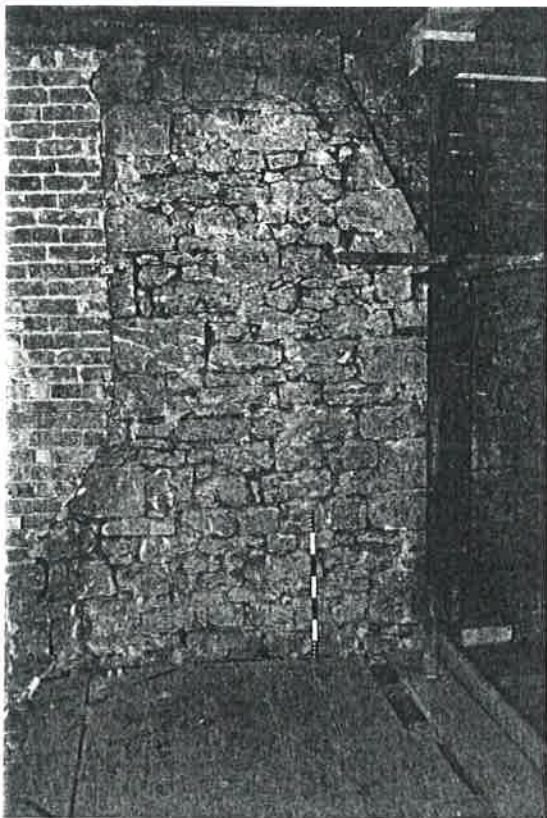
Plate 18:  
Room 1F/2 west wall - detail of chimney of adjacent property

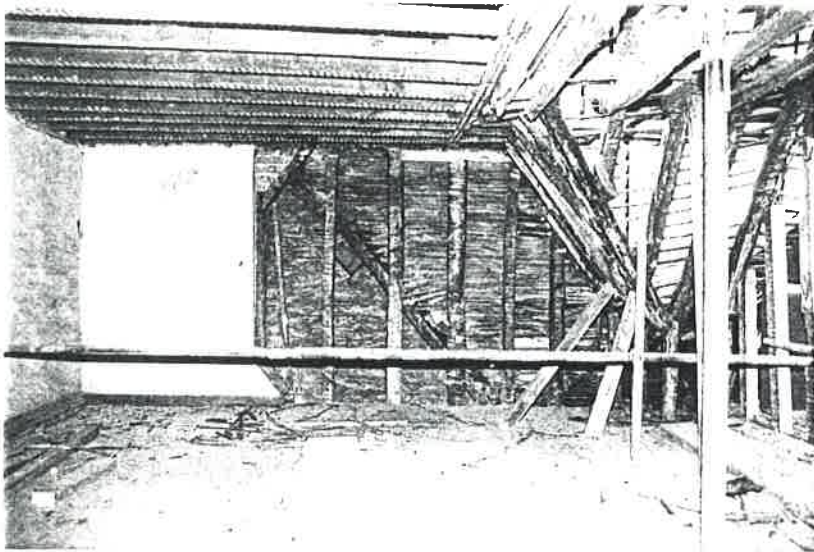
Plate 20:  
Room 21/3 west wall - former gable and chimney stack of adjacent property

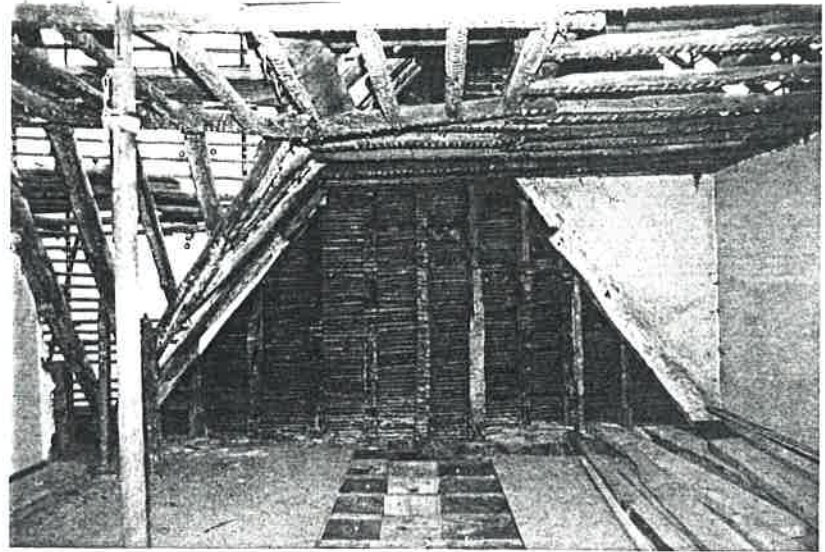
Plate 21:  
Room 21/3 east wall - former gable-end truss showing site of clasped purlins

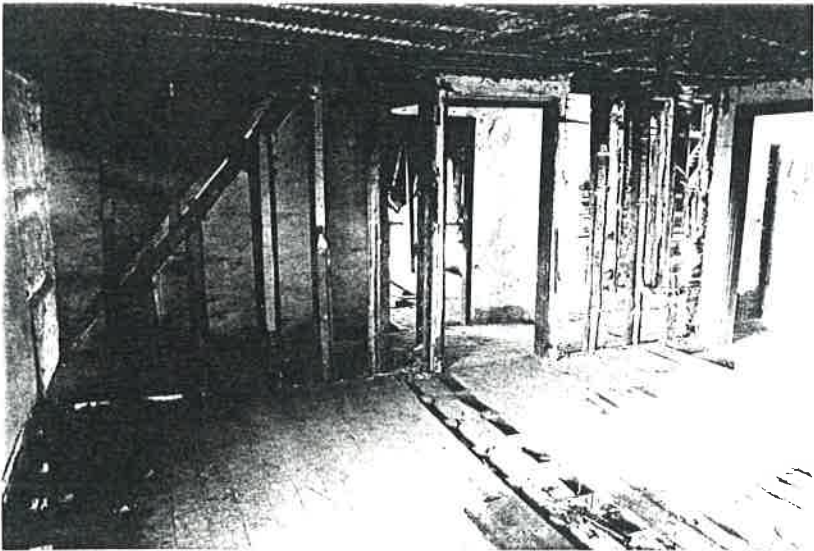
Plate 22:  
Room 21/3 - west wall (now removed) showing incorporated common rafter

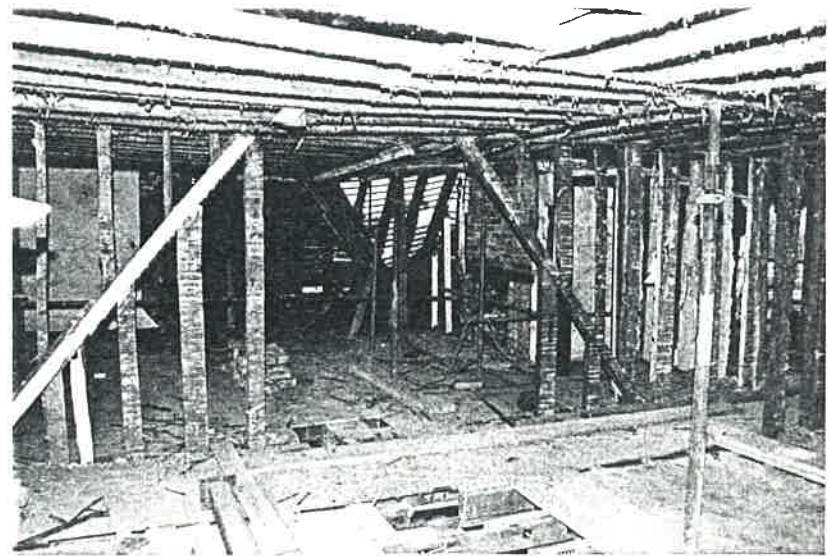
Plate 23:  
Room 21/2 - east wall from east showing incorporated common rafters

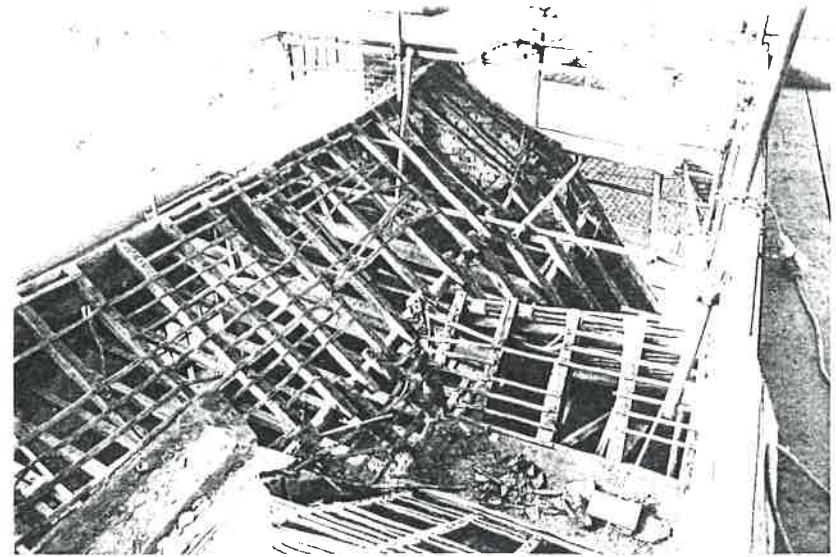
Plate 25:  
Southern roof showing change of pitch at former ridge

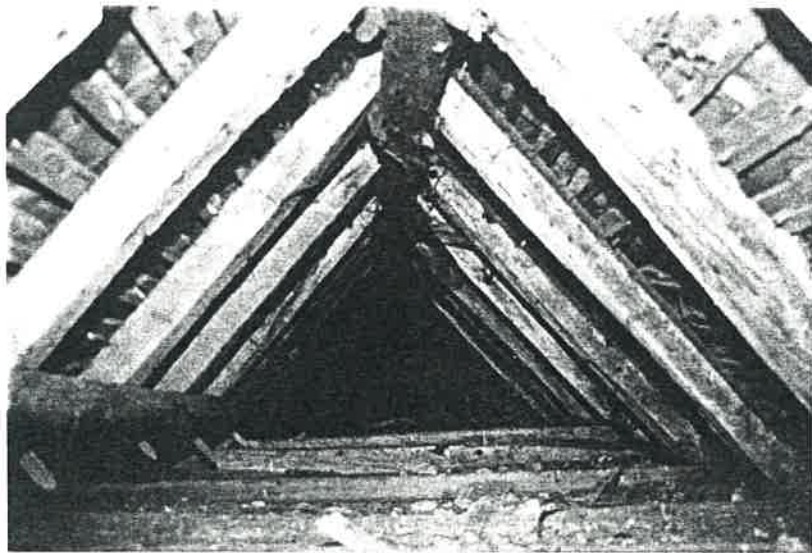
Plate 26:  
Northern roofs, east ridge - rafters pegged to round purlin
