Wardington Manor Wardington Oxfordshire

Historic Building Investigation: Roof Structure - Southwest Wing

November 2004

Document Title: Wardington Manor, Wardington: Examination of surviving elements of south west wing roof structure

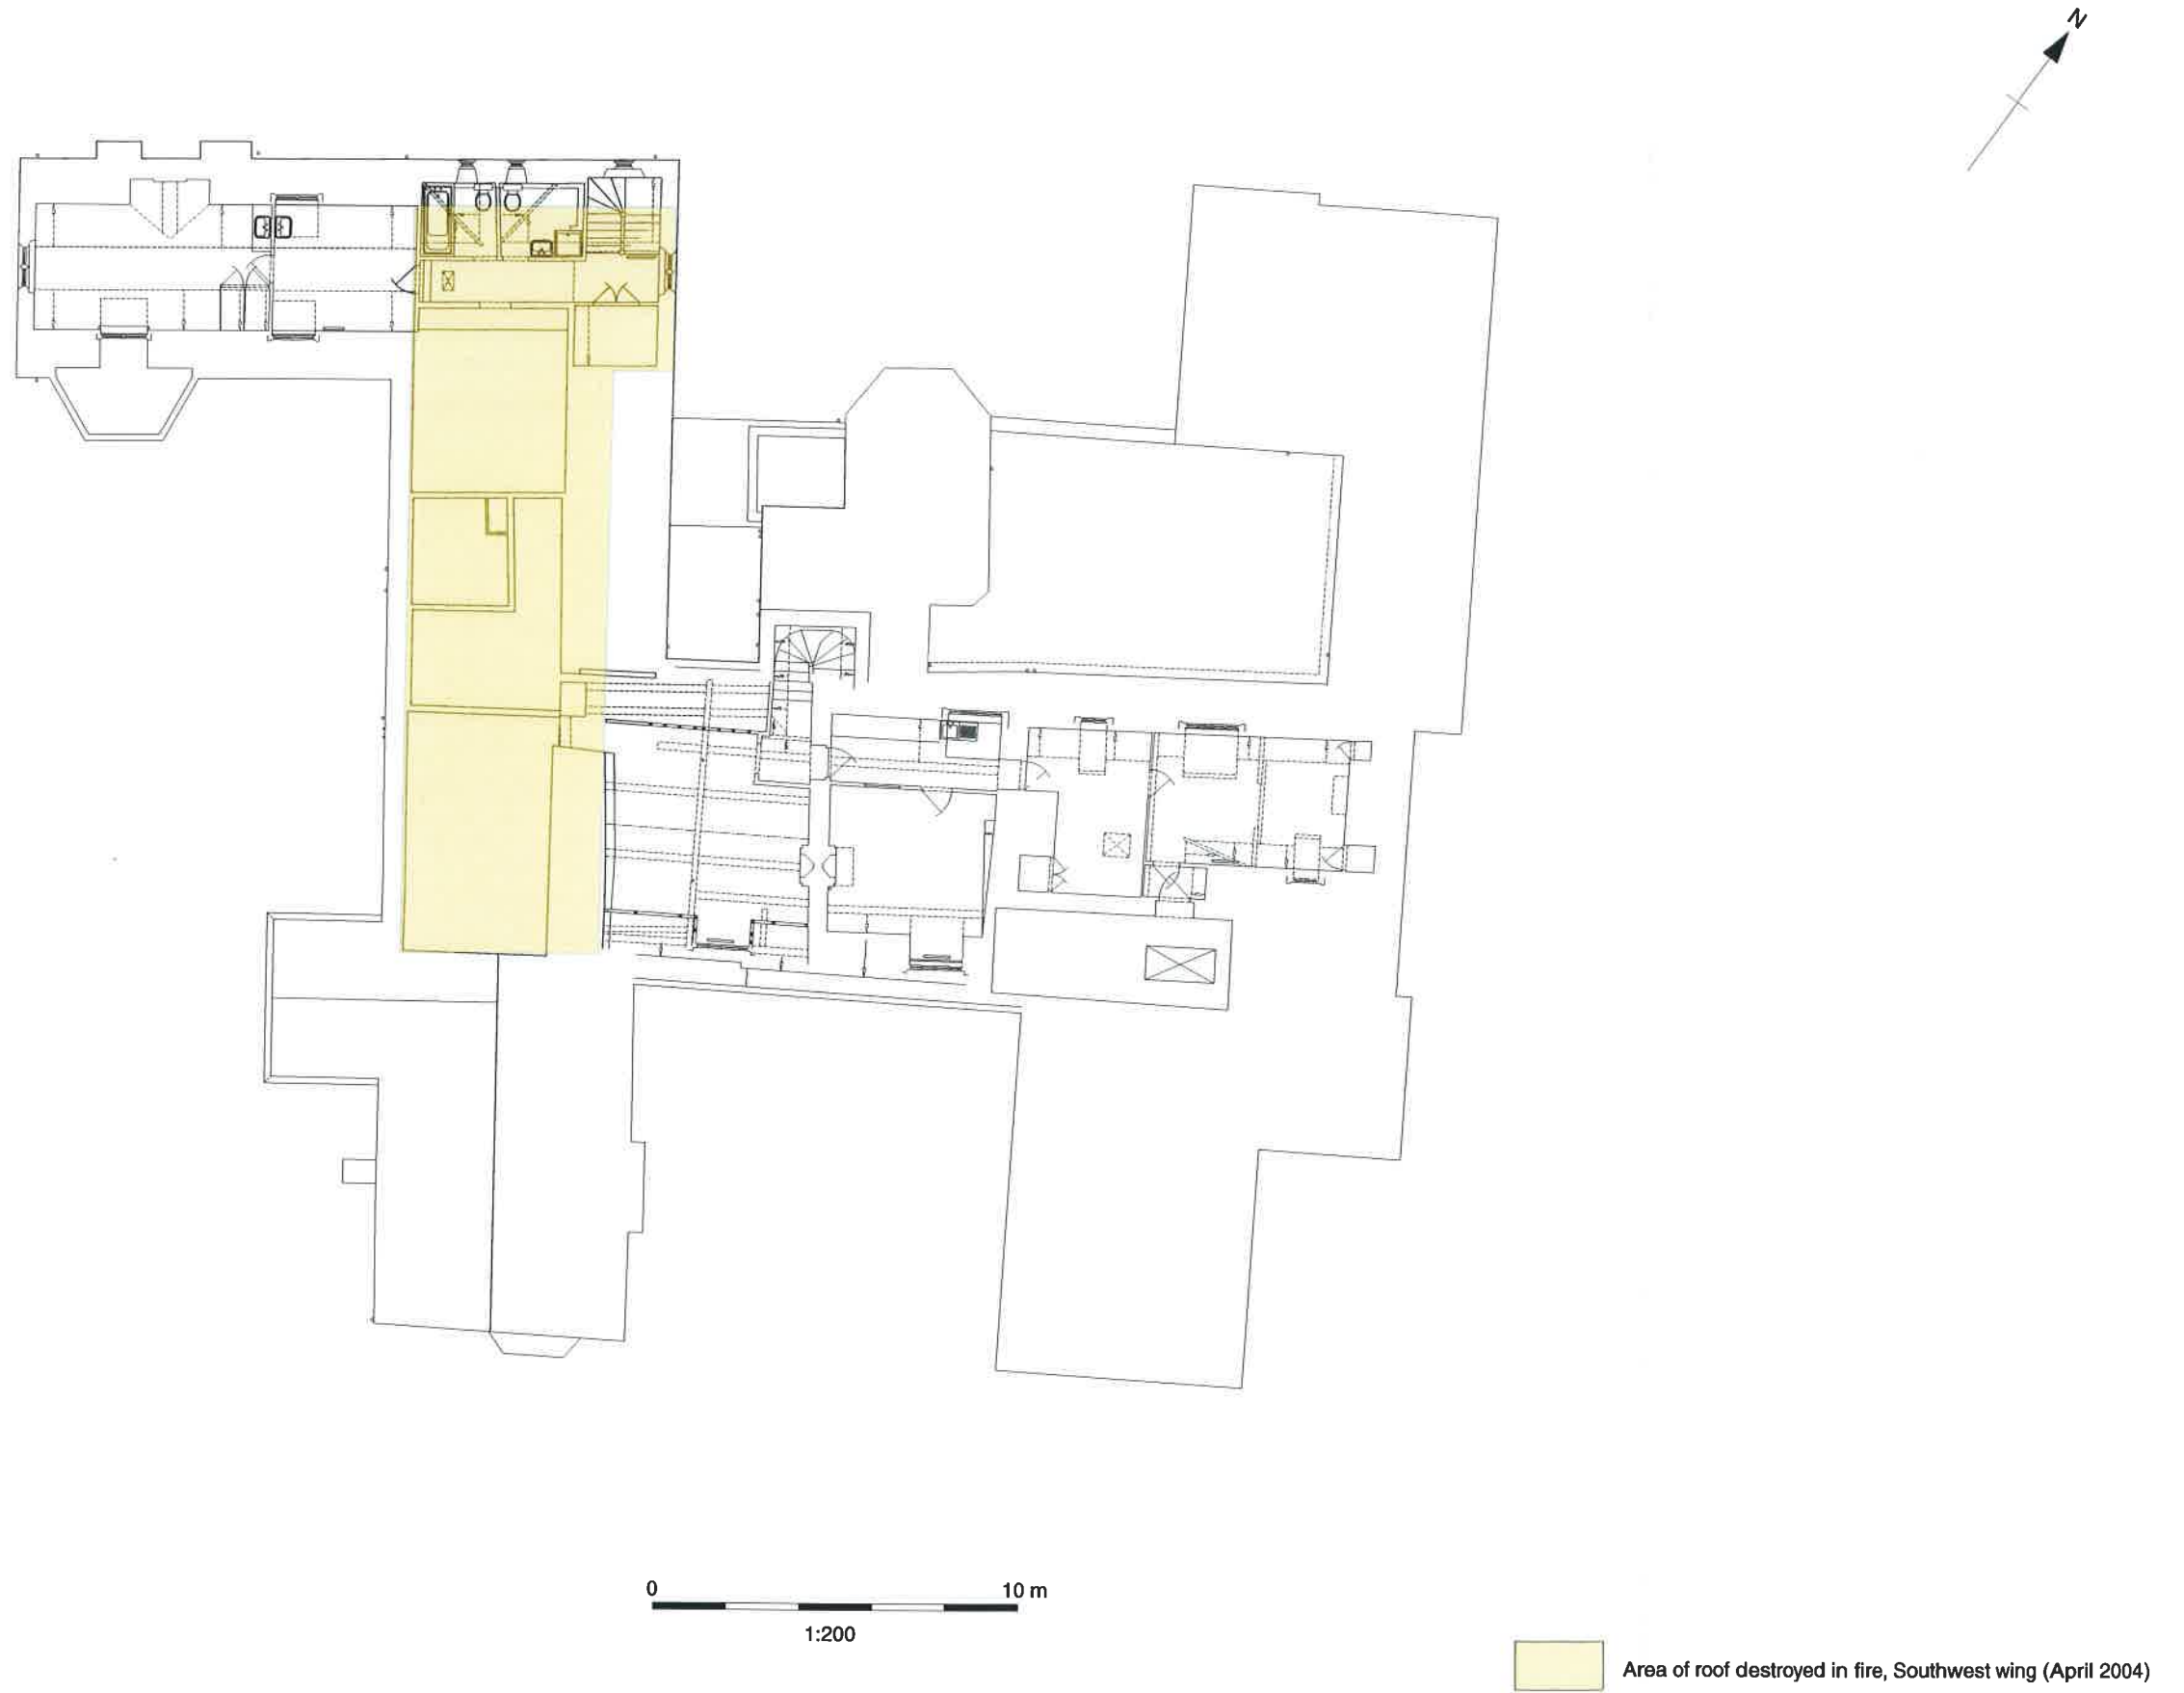
Figure 3: Second Floor

- 4.1.1 The fire of April 2004 destroyed approximately 90% of the roof covering and timber structure below in the south west wing (Figure 3). The area of the house covered by this section of the roof extended to approximately 100 m². Little is known about the roof structure in this part of the house prior to the fire.

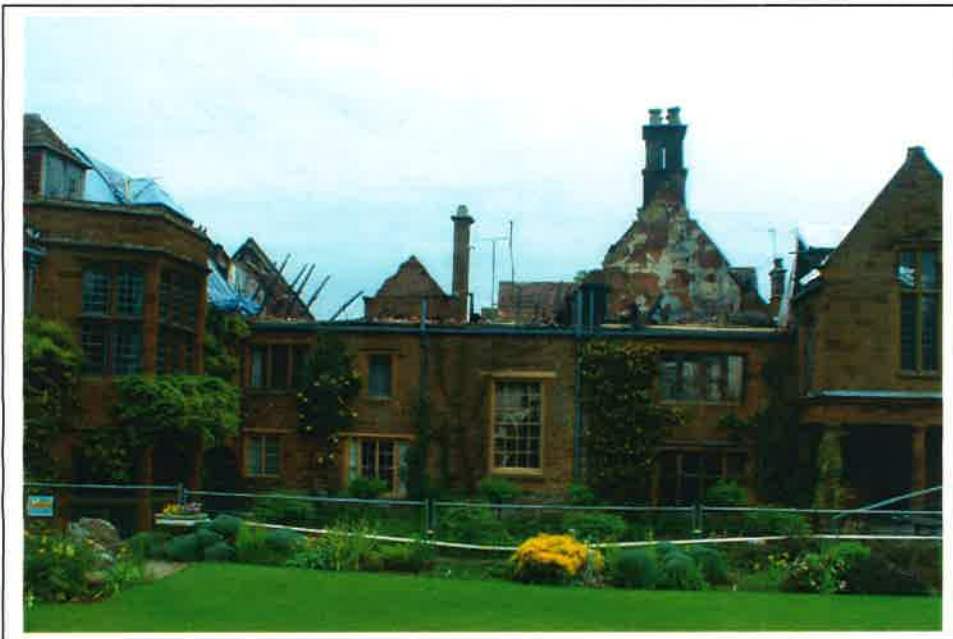
Plate 3: View north east - fire damage to roof on south west wing

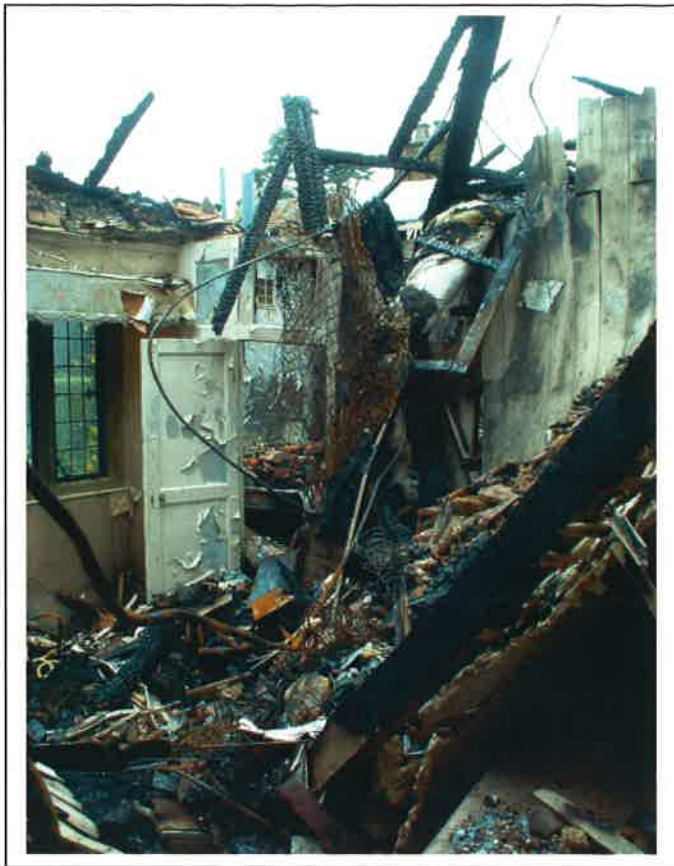
Plate 5: View west - collapsed roof above 1st floor

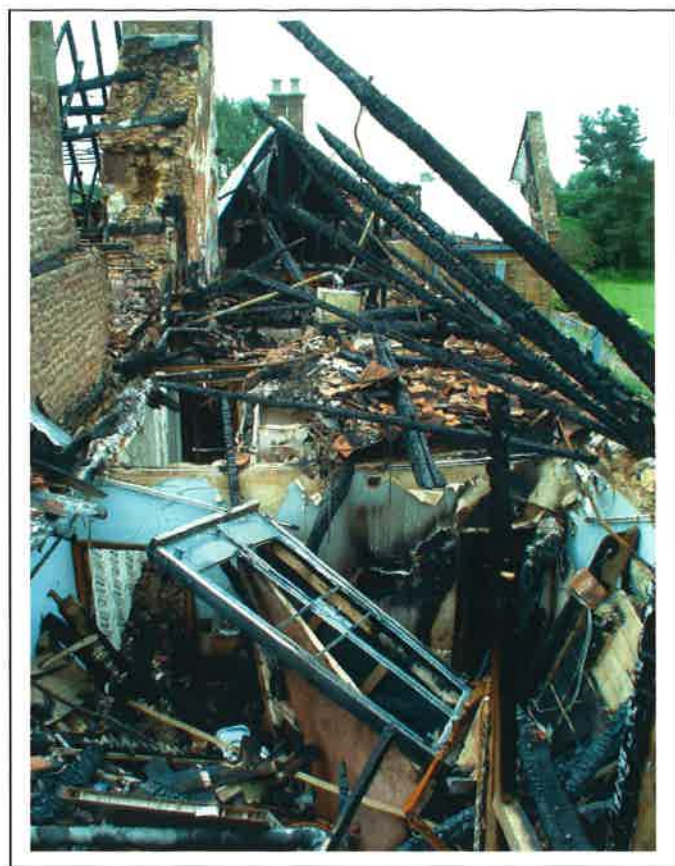
Plate 6: View south east - collapsed roof

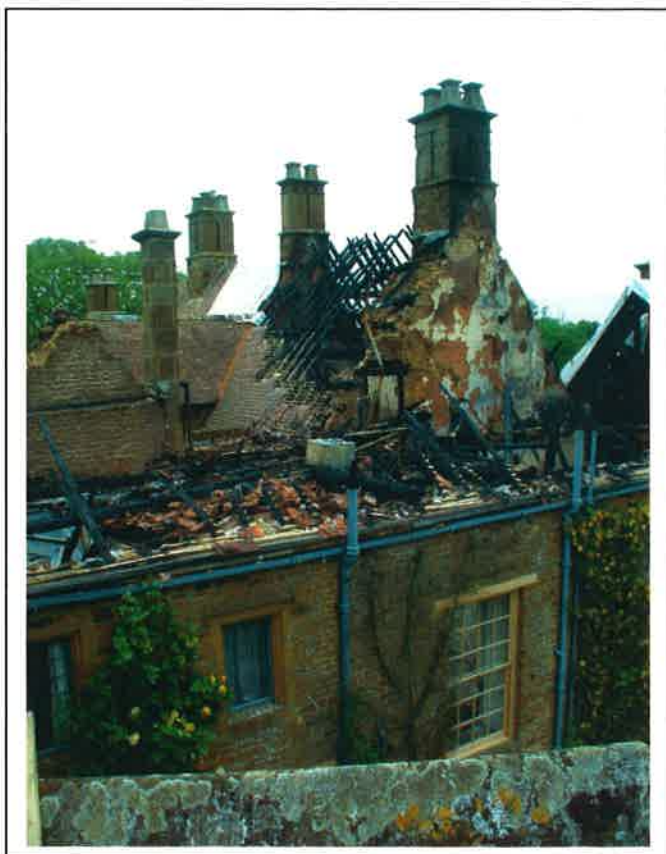
Plate 7: View east - fire damage to roof structure

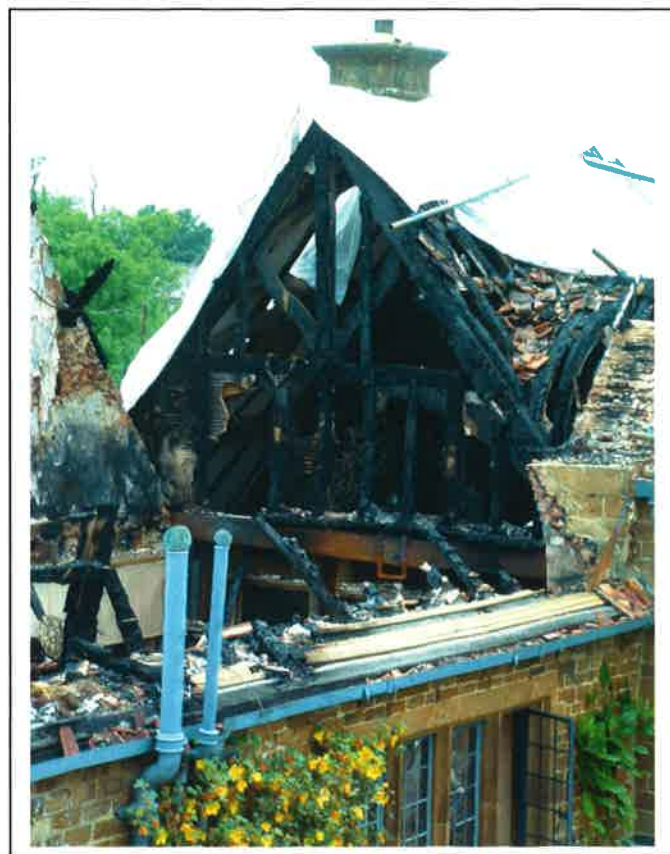
Plate 8: View east - fire damage to roof structure

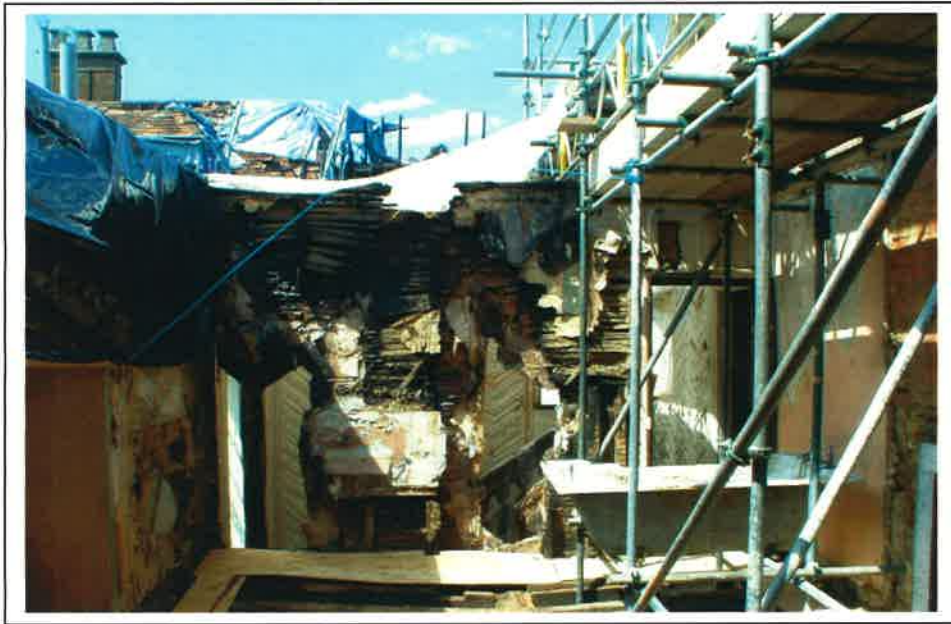
Plate 9: View south east - 1st floor after clearing of roof debris

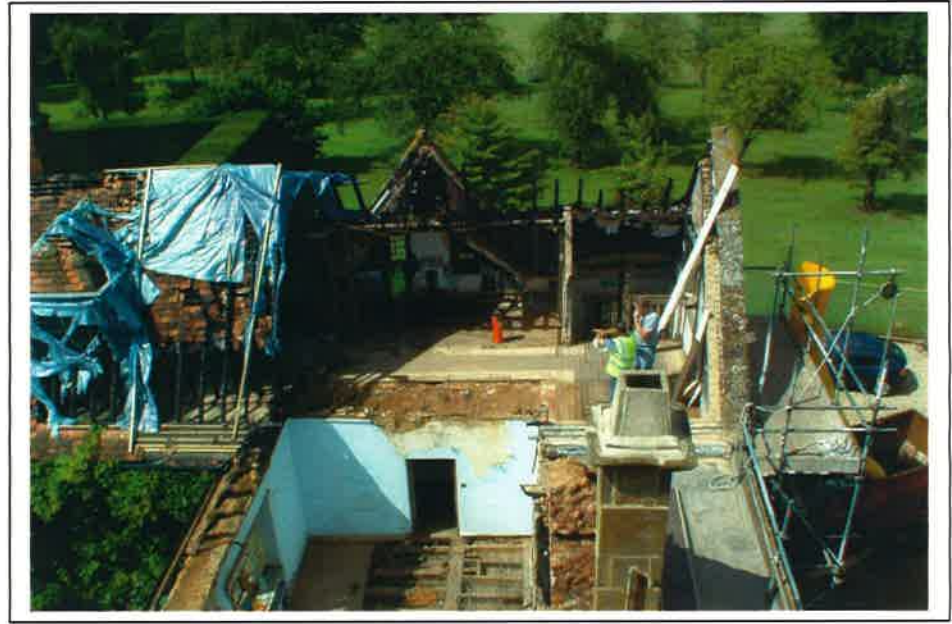
Plate 10: View north west - Extent of fire damage at north west end

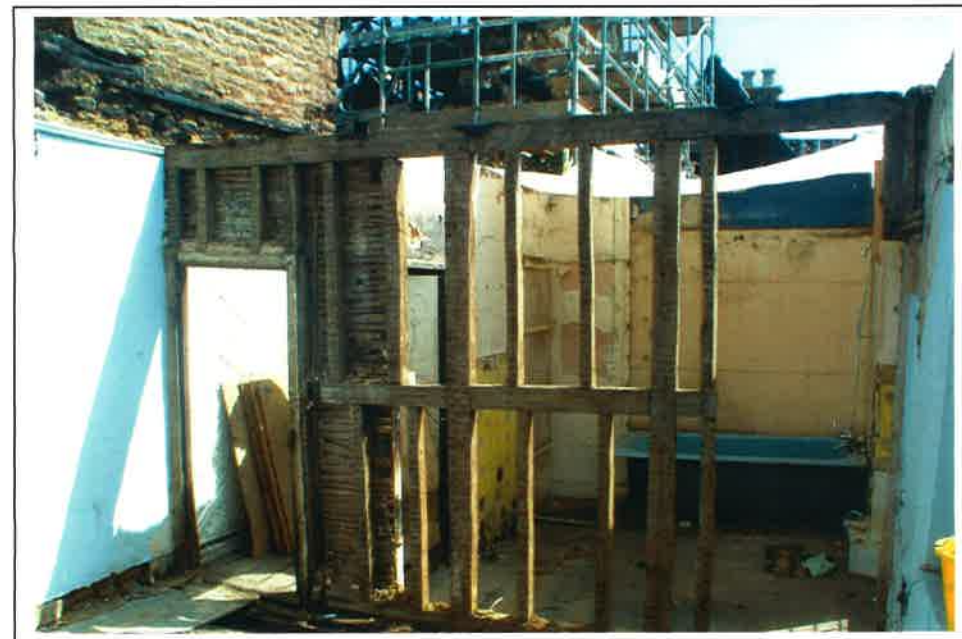
Plate 11: View south east - 1st floor after clearing of roof debris

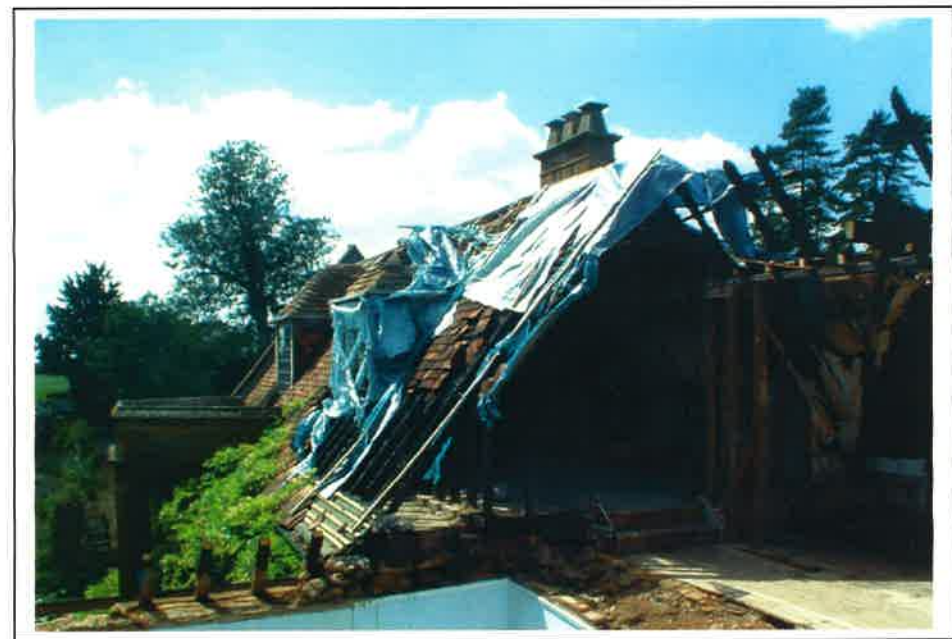
Plate 12: View south west - Extent of fire damage at north west end

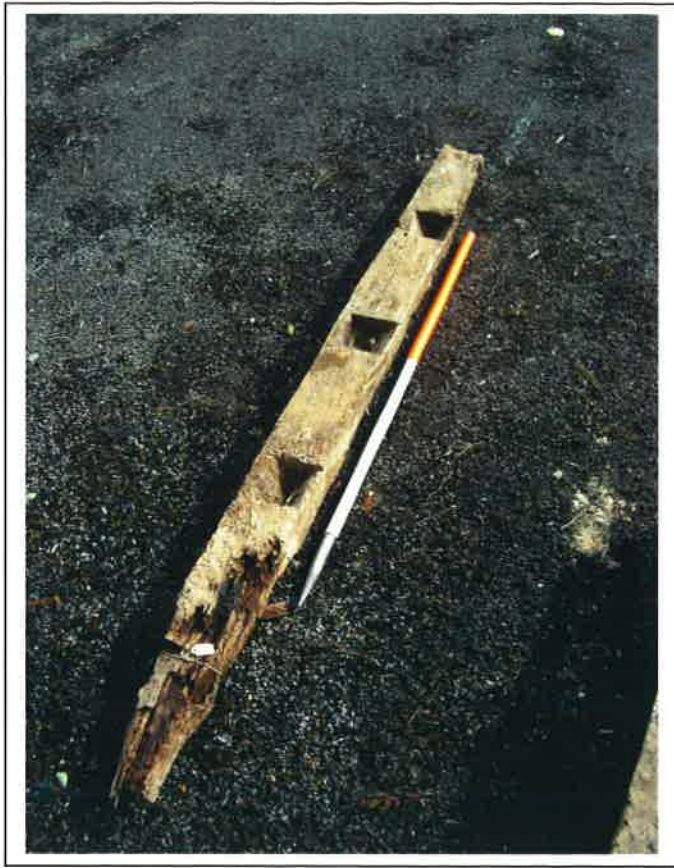
- 4.2.2 Principal floor joists
- 4.2.3 At least 4 (104, 114, 116, 148) sections of primary floor joist were recorded measuring from 17 by 12cm and 2.52m long to 20 by 21cm and 3.26m long. All had mortices for floor joists on both sides and retained elements of the laths that were originally affixed to them. Preservation appeared to be

Plate 13 : Damaged ceiling beam - south west wing

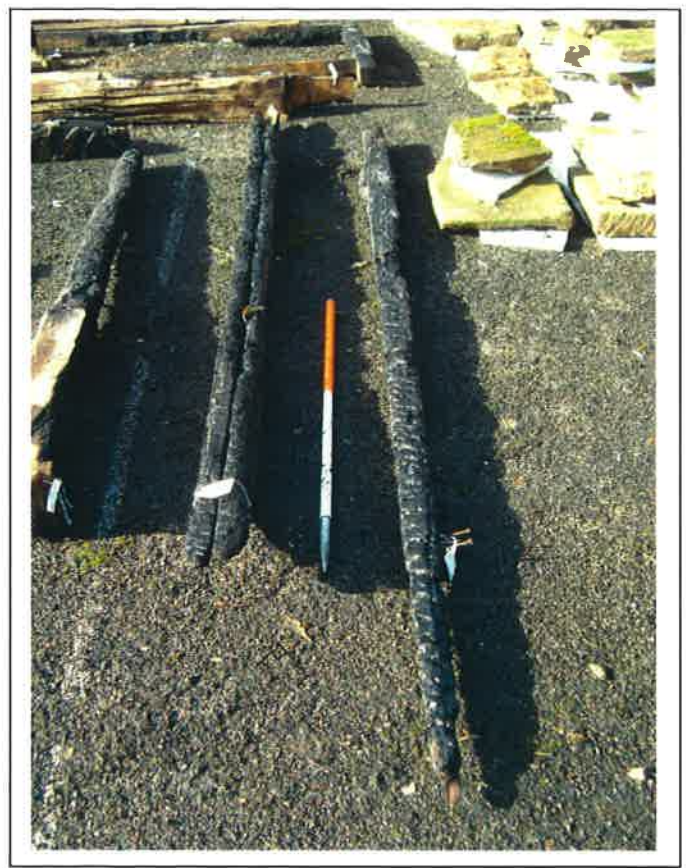
4.2.7 At least three principal rafters were identified amongst the charred material (nos. 102, 103, and 149), with possibly another two also found but too charred to be positively identified. Measurements ranged from 16cm x 17cm x 1.82m to 20cm x 18cm x 2.30m. The slots and mortices were clearly visible still on at least two of the examples. Two of the examples had suffered considerable burning at both ends and along their length although the third example had survived relatively unscathed. The rafters were in too poor a condition to be certain, but it seemed likely that they were from a post-medieval roof.

Plate 14: Charred rafters from south west wing

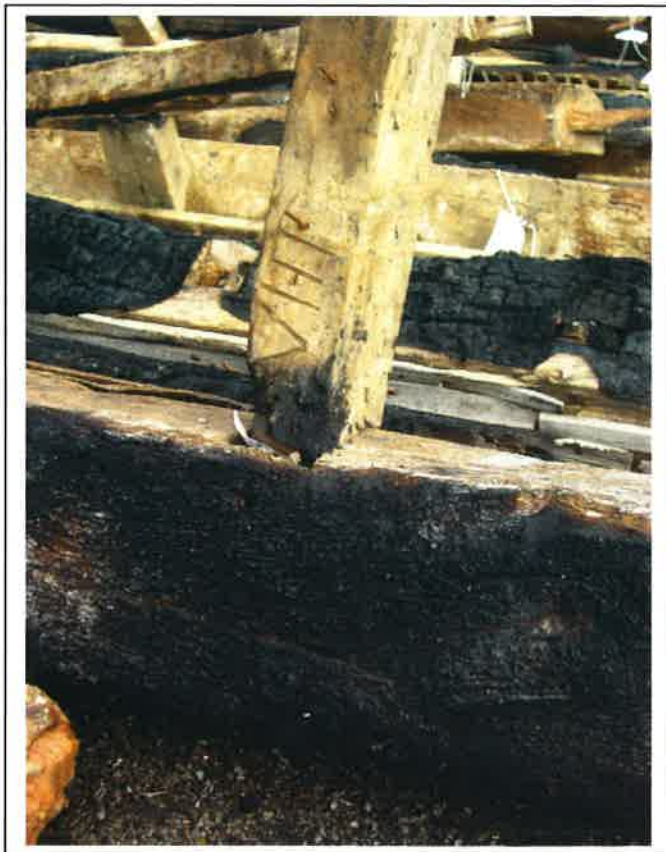
Plate 15 : Construction numbers on ceiling joist

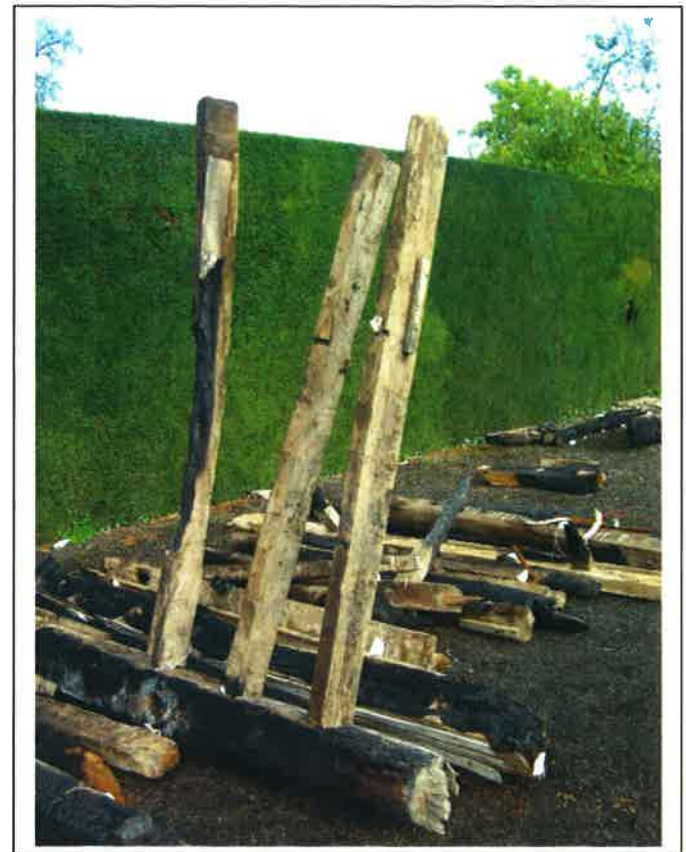
Plate 16: Reconstructed section of ceiling

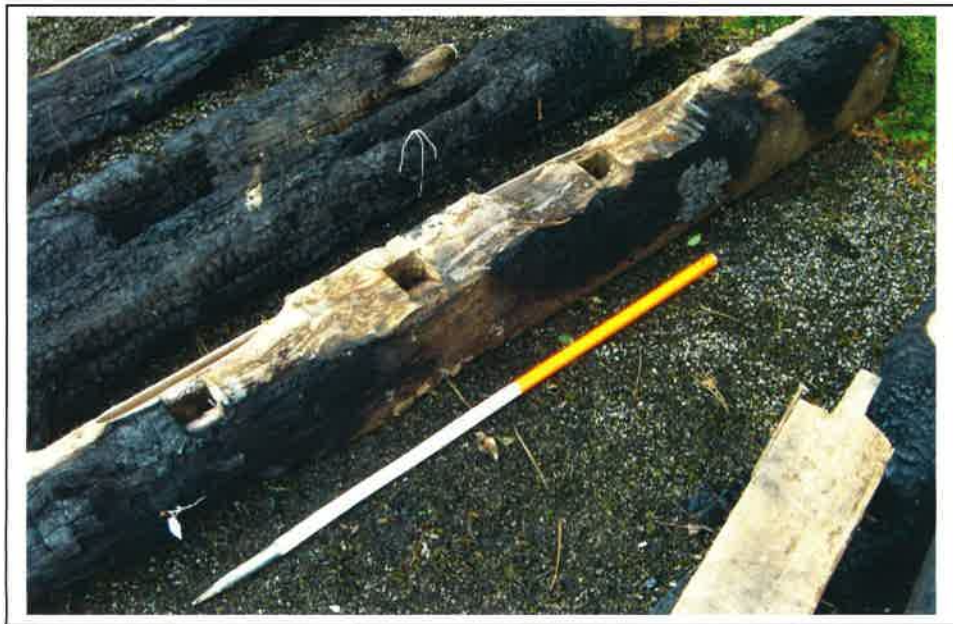
Plate 17: Deatial of charred primary beam - south west wing roof

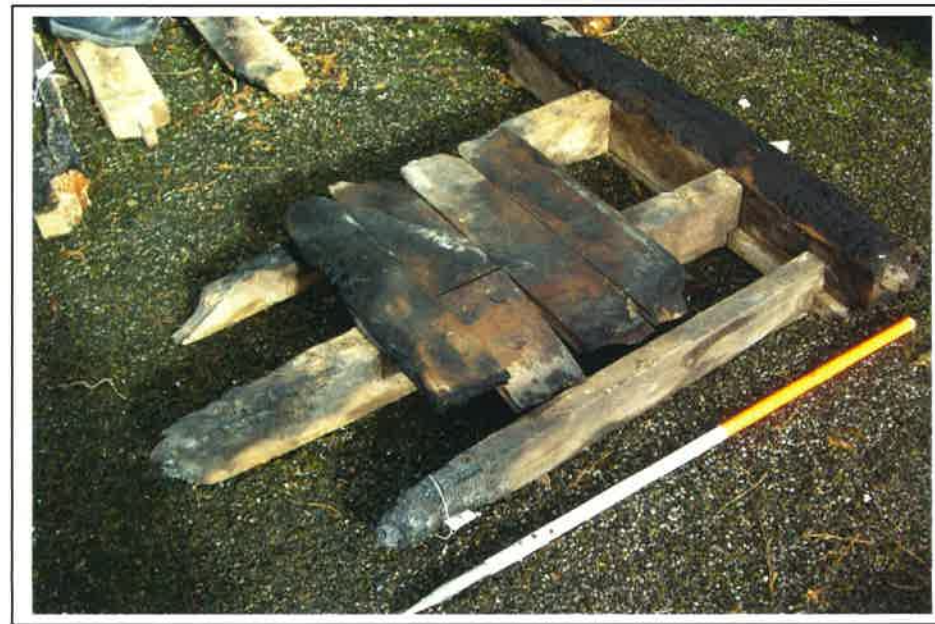
Plate 18: Surviving section of ceiling - south west wing roof

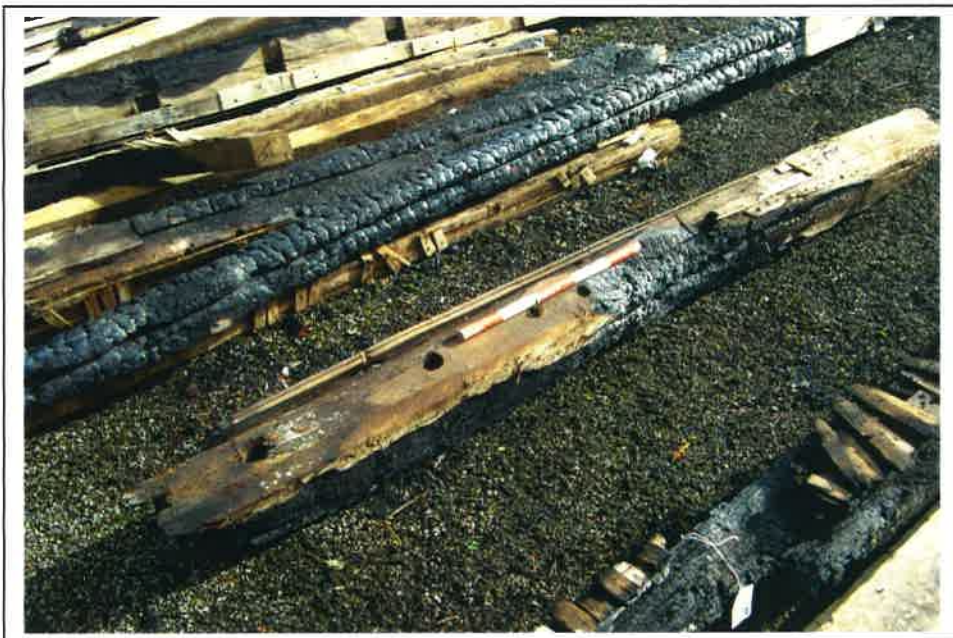
4.2.15 Three substantial timbers (129, 137, and 140) were picked out on a site visit by Julian Munby (JM) as possibly being of medieval origin. The three pieces were 15 by 16 cm and 2.40m long, 14 by 24 cm and 2.32m long, and 14 by 18 cm and 2.61m long respectively. All had a series of long chase mortices and elongated oval peg holes on their sides, and they had two heavily chamfered edges when viewed in section. In all instances the elongated peg holes were covered by the remains of lath and plaster and had clearly been reused. At the

Plate 19: Detail of possible reused medieval timber

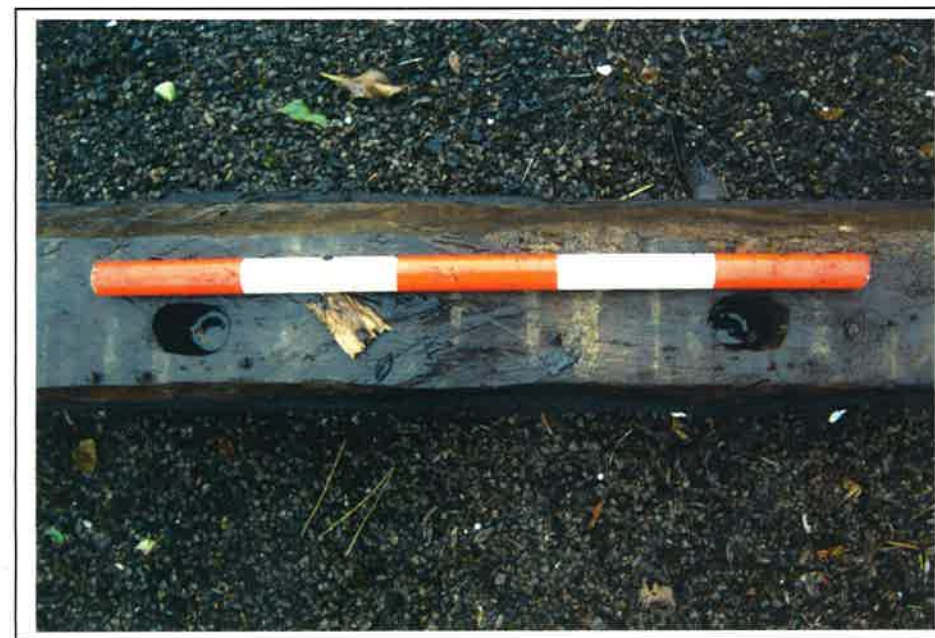
Plate 20: Detail of possible reused medieval timber.
