Client Name: Rt. Hon. Lord Wardington
Client Ref No: -
Document Title: Wardington Manor, Wardington: Examination of stud wall and medieval floor joists
Document Type: Historic Building Investigation and Recording
Issue Number: 1

Prepared by: Andy Miller
Position: Research Officer - Building Archaeology
Date: November 2004

WARDINGTON MANOR, WARDINGTON:
HISTORIC BUILDING INVESTIGATION AND RECORDING

HISTORIC BUILDING INVESTIGATION AND RECORD

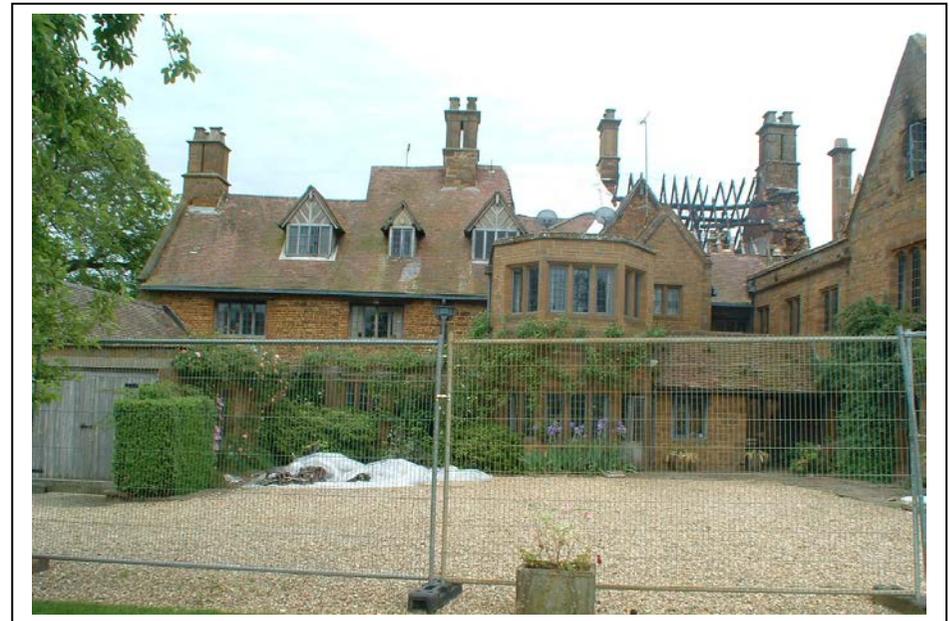
- 1.3.3 During April of 2004 the fire destroyed approximately 90% of the roof structure over the south west wing and the attic ceiling below. Much of the burnt debris collapsed onto the floor of the two rooms below that are subject to this preliminary report.

Plate 3: View north east - fire damage to roof on south west wing

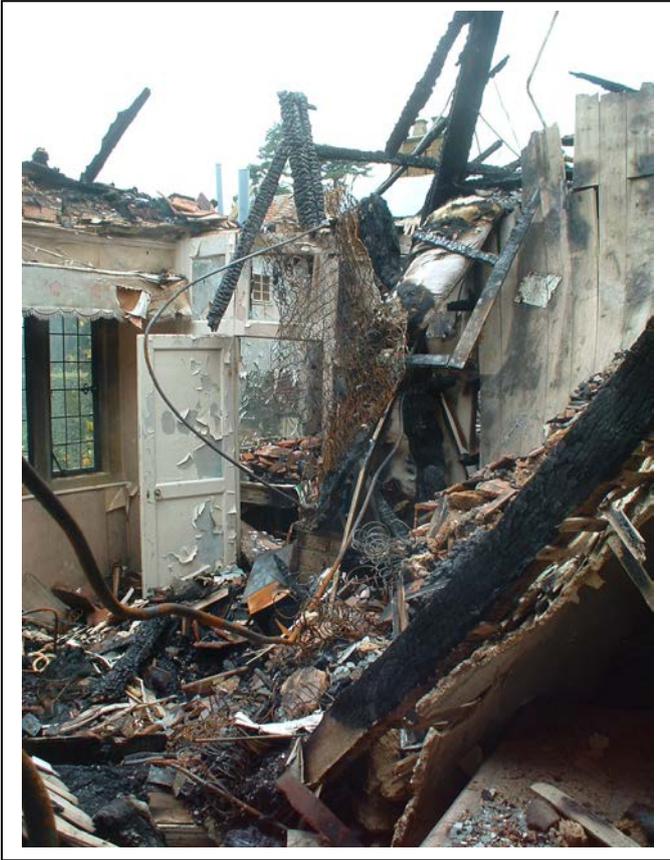
Plate 5: View west - collapsed roof above 1st floor

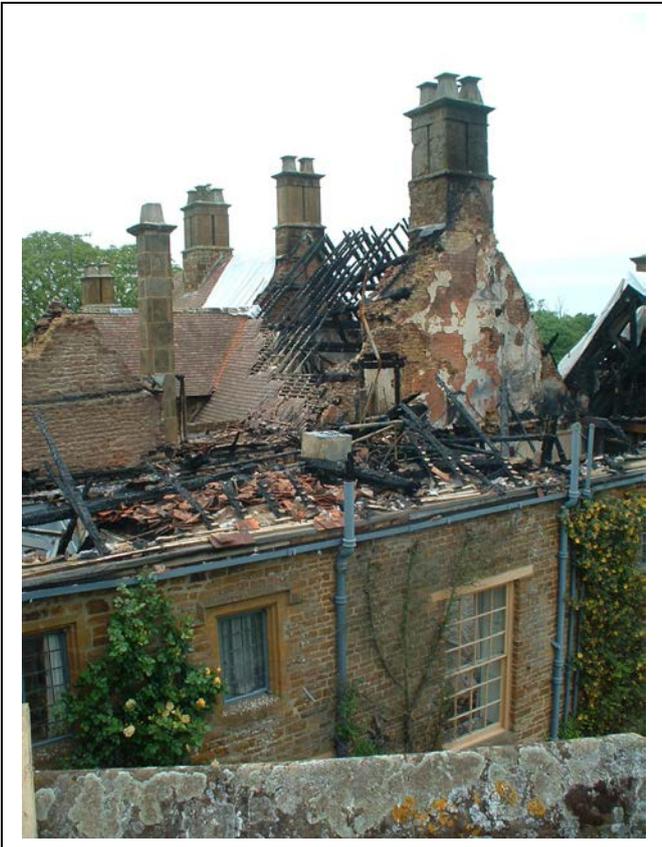
Plate 7: View east - fire damage to roof structure

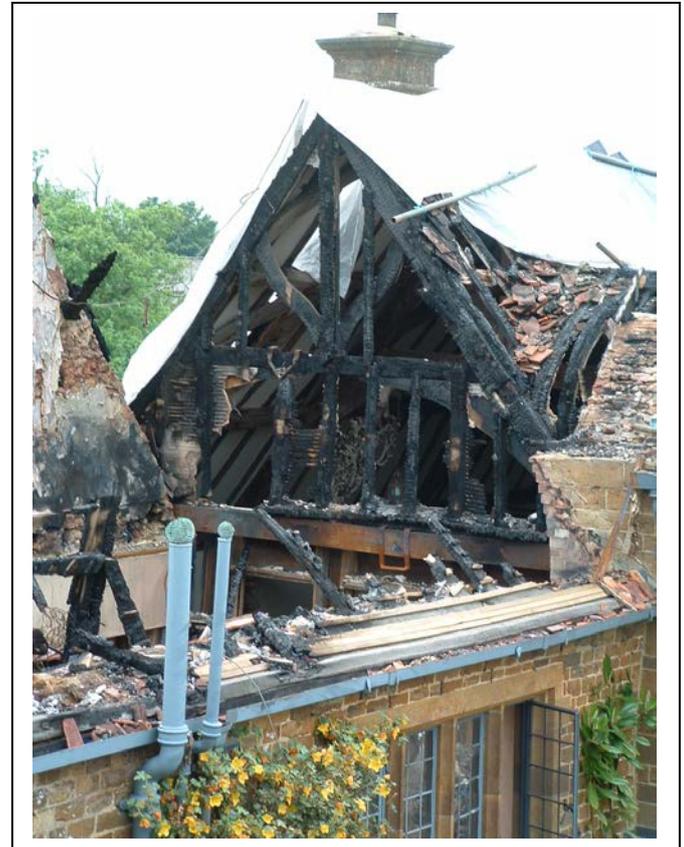
Plate 8: View east - fire damage to roof structure

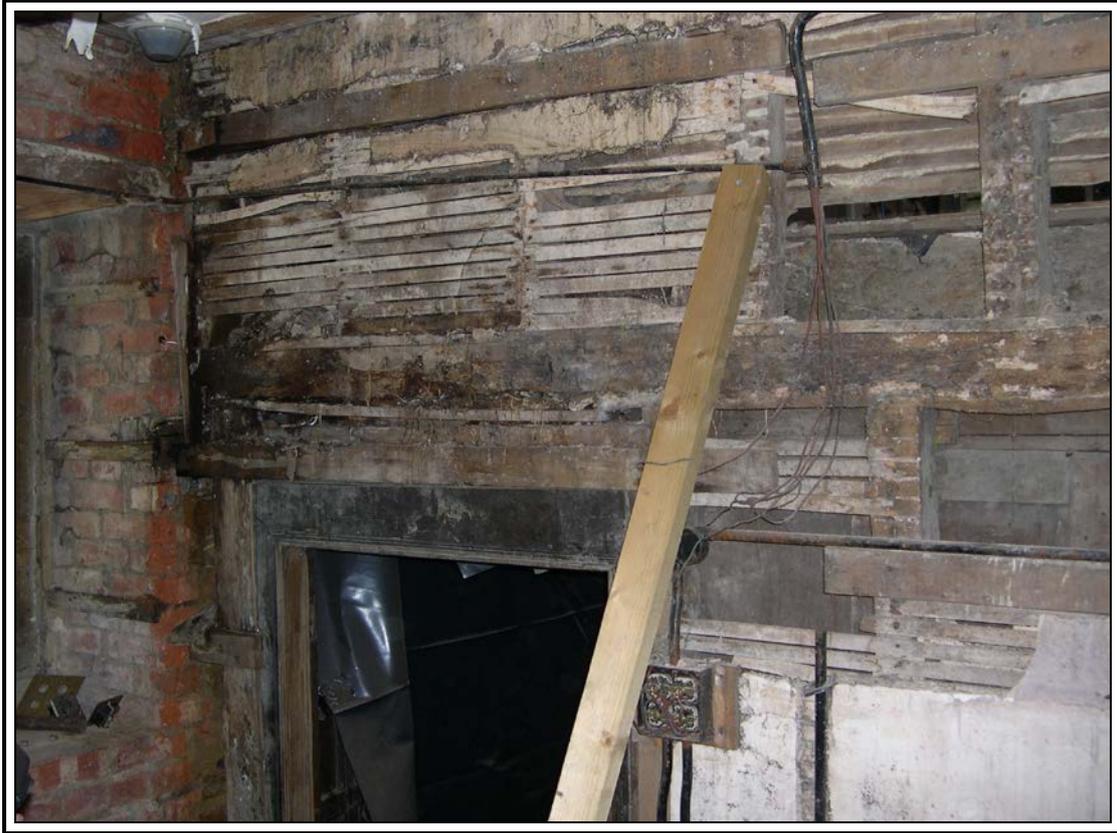
- 4.1.4 The stud wall at ground floor level was not directly effected by the fire at the house. However, during the initial course of stabilisation works it has become apparent that there might be a question over the structural integrity of the wall in its current state of repair (Plates 13 & 14).

4.2.9 The stud wall, which is generally in a poor state of repair and appears structurally compromised, also currently bears much of the weight of the southern end of the first-floor frame in the room to the north.

Plate 13: View north west - stud wall between library and smoking room

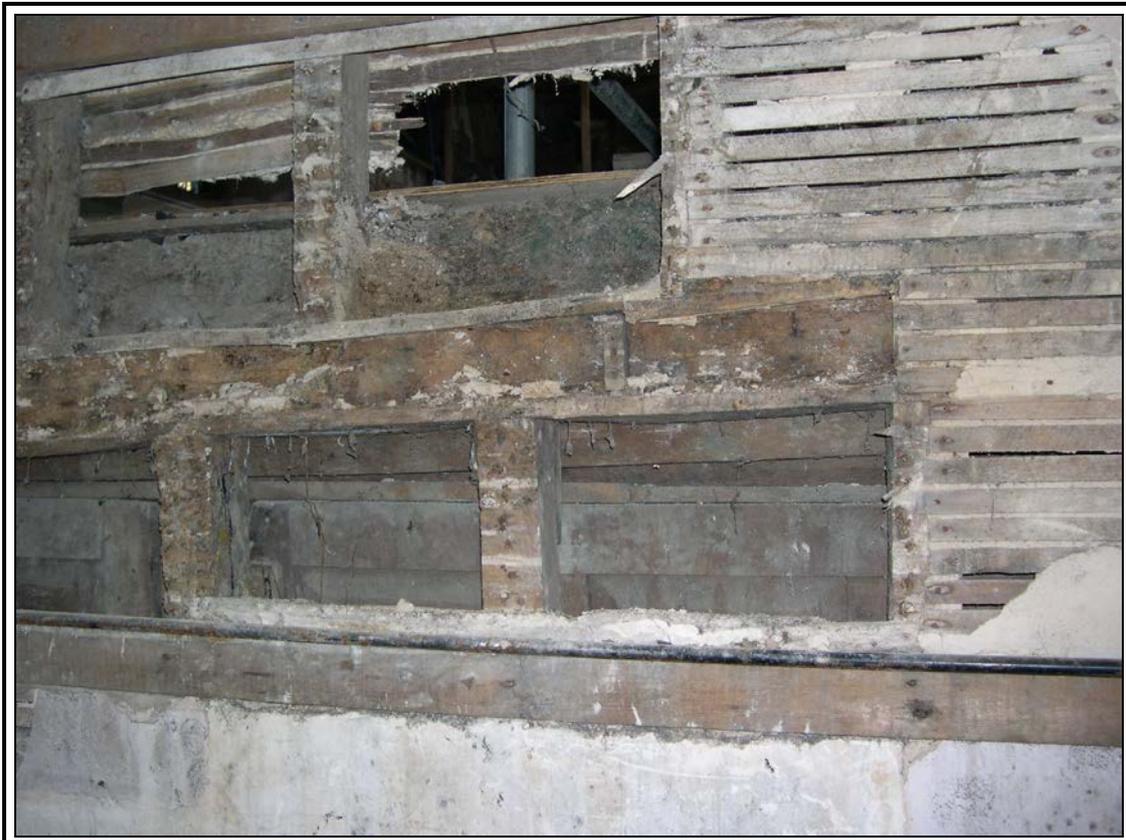
- 4.2.5 The plaster render had become detached from the stud wall in several places, presumably as a result of the general degradation of the fabric, which allowed a closer examination of the structure beneath. Several smaller areas of plaster were also carefully removed by William Sapcote and Sons Ltd, again to allow a fuller observation of the structure beneath.

Plate 14: View north west - stud wall between library and smoking room, detail

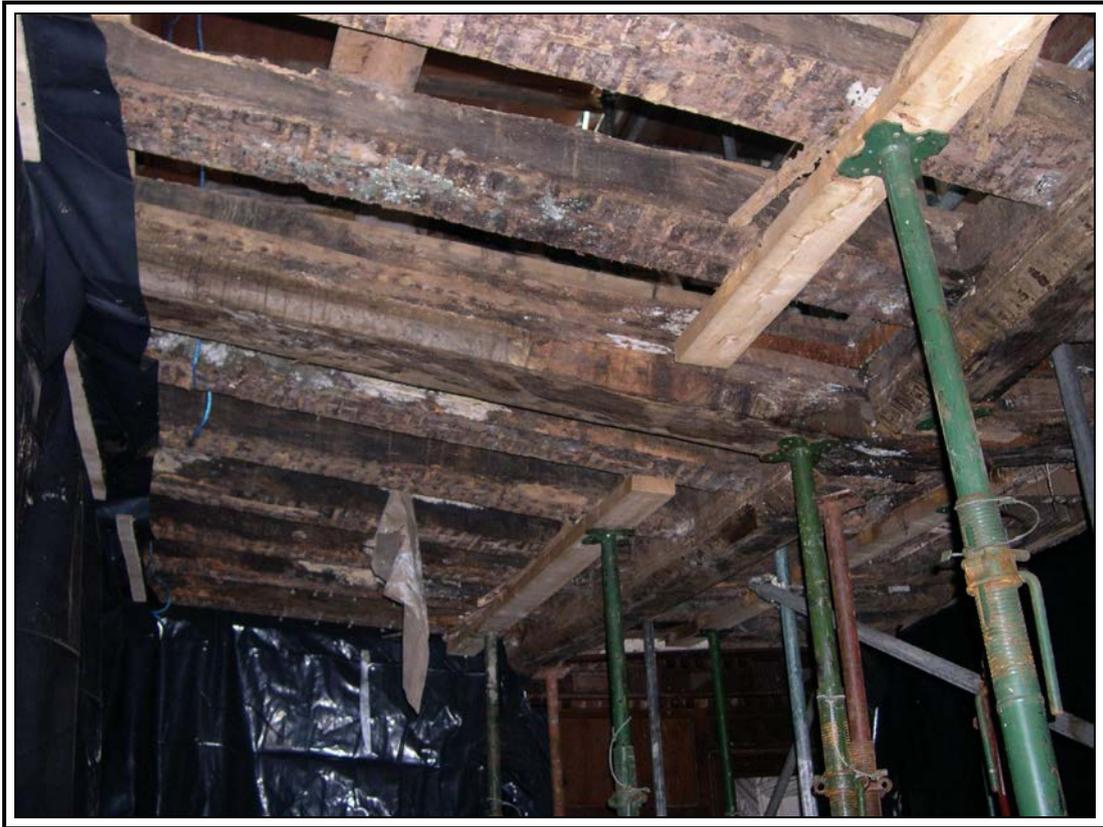
Plate 15: Underside of floor joists - southern room, south west wing

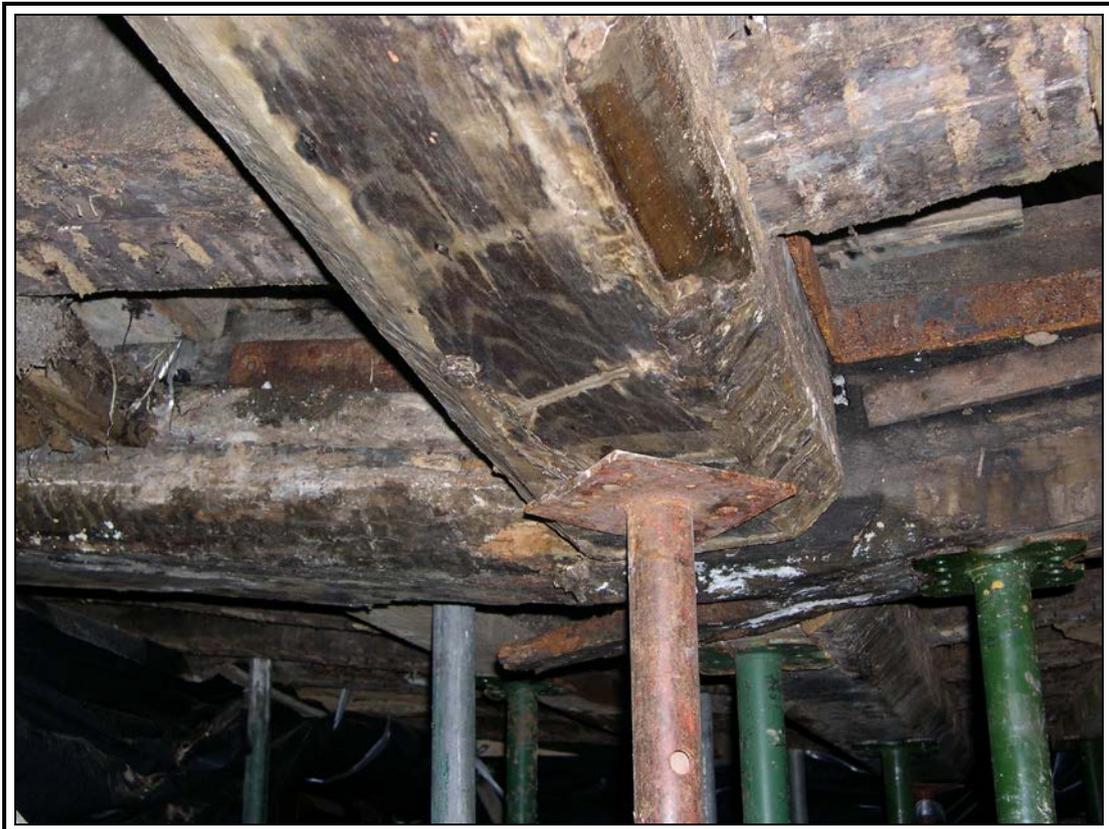
- 4.4.5 It was observable that the fabric of the principal joist had failed at some point in its history, around the central point, and four iron brackets had been attached to each right angle formed by the principal joists and bridging joists. As noted however, this remedial work has not stopped the floor from dropping further from its original position.

Plate 16: Underside detail of failed principal joist - southern room, south west wing

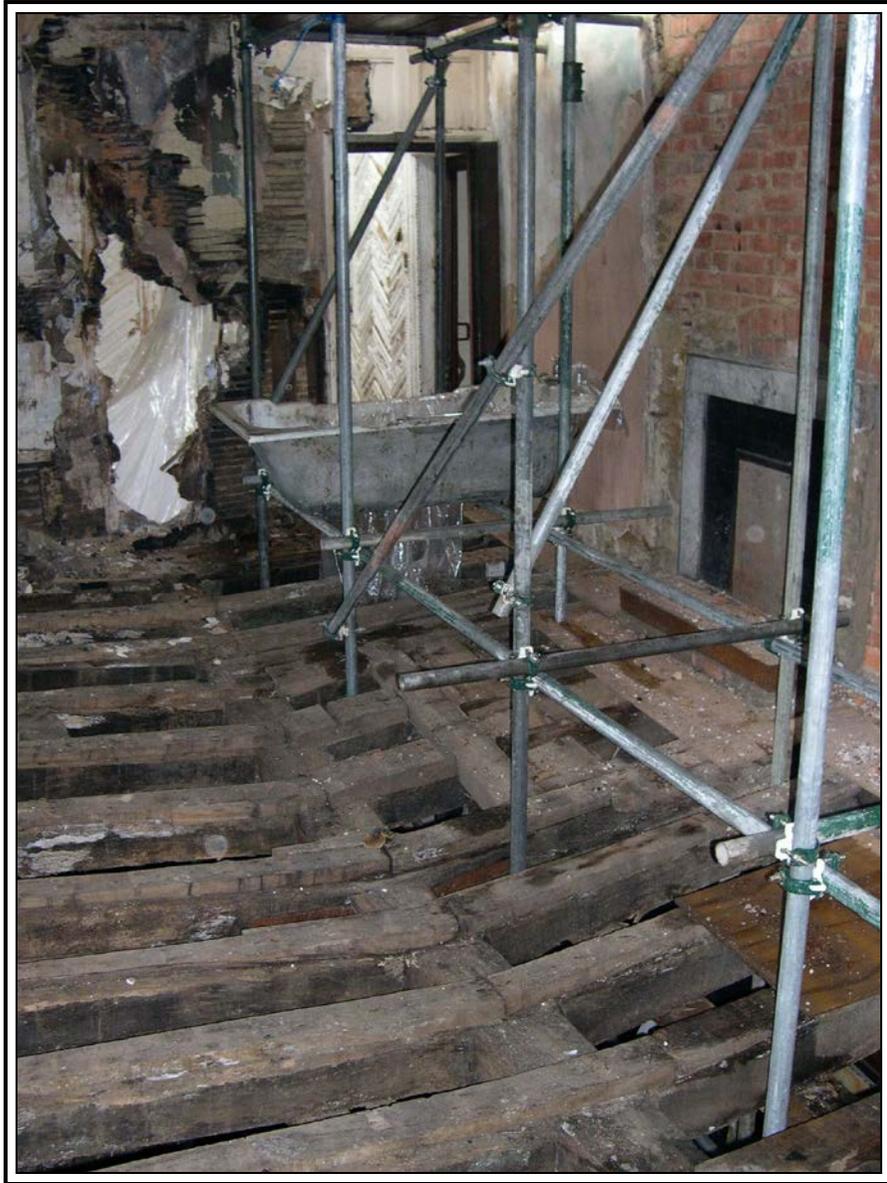
Plate17: Detail of dipping floor joists - southern room

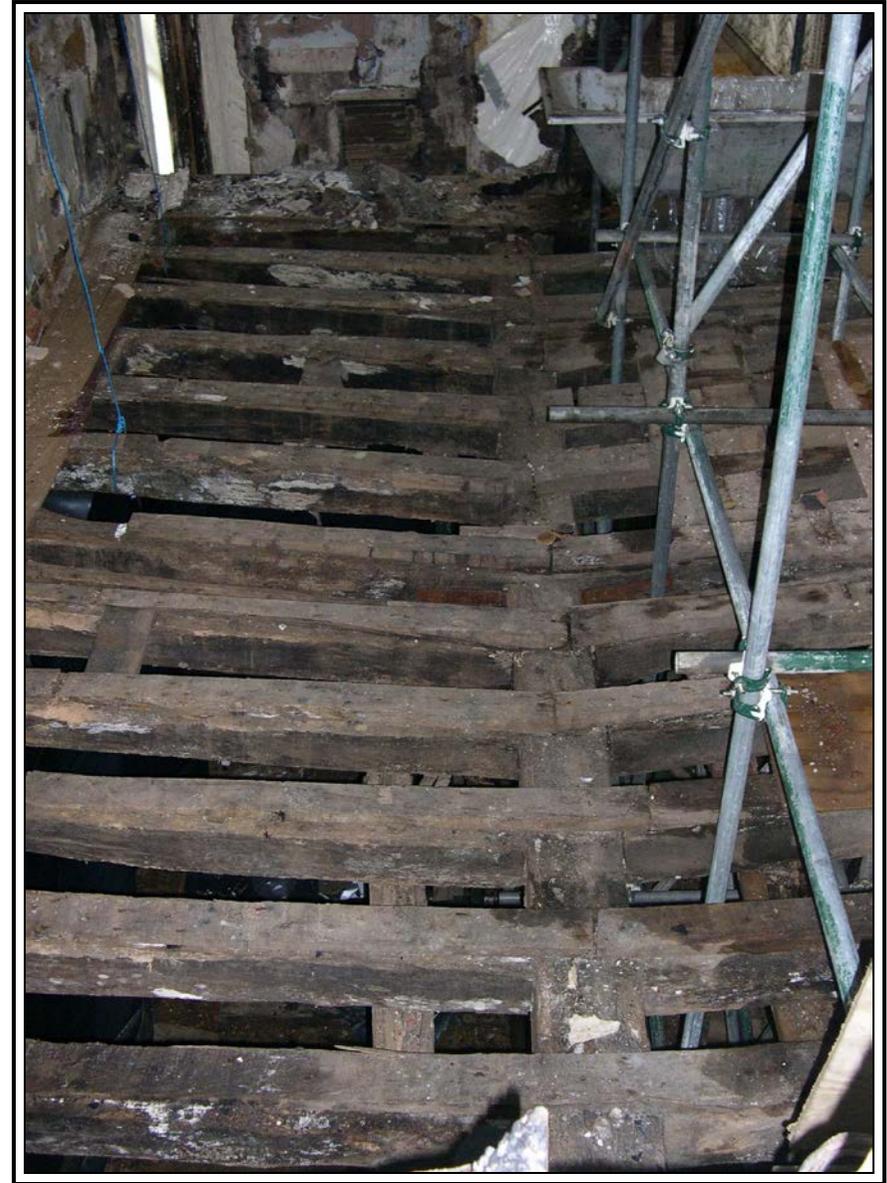
Plate 18: Detail of dipping floor joists - southern room

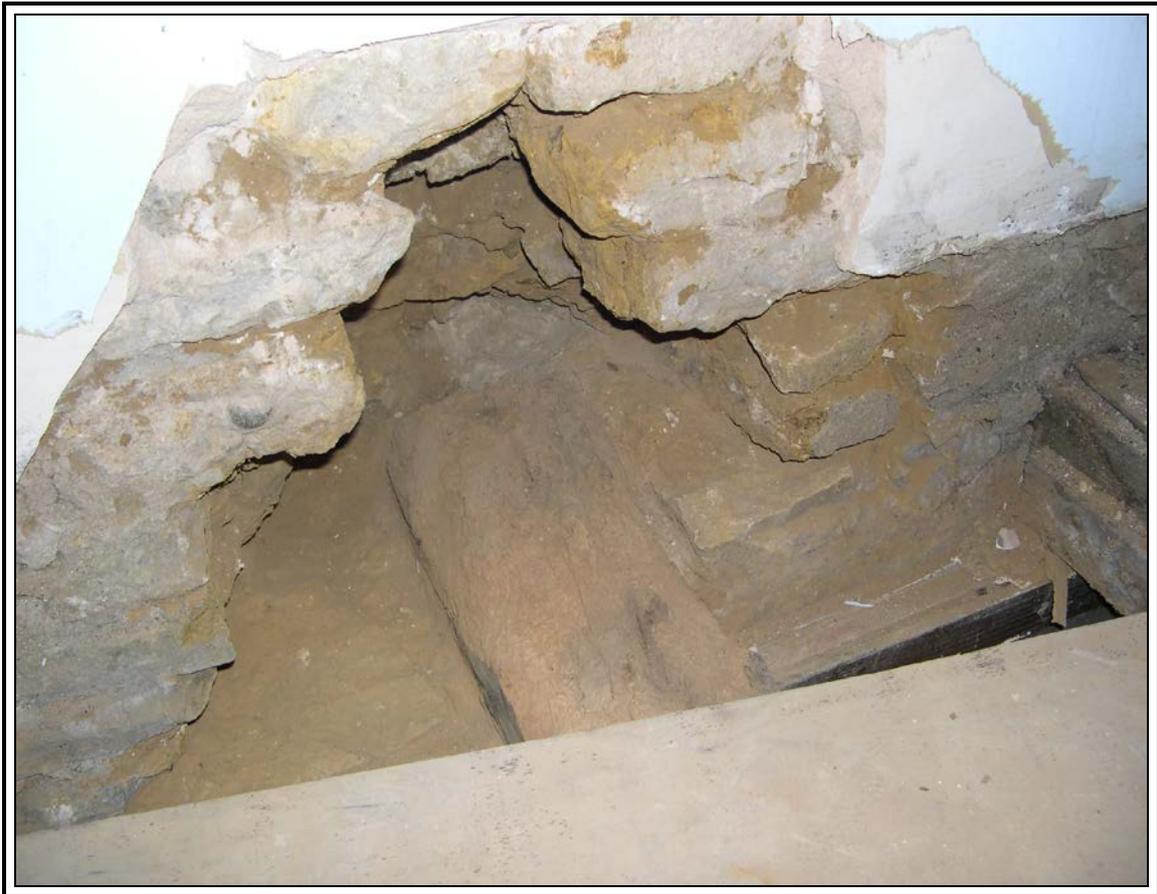
- 4.7.4 In terms of the structural integrity of both sets of floor joists, the ends of a number of the common joists in the north room were rotten and would require repair in the near future. Although the ends of the joists within the walls in the south room were not available for inspection by OA it is reasonable to suggest they are likely to be in a similar condition. It was also very apparent by both the presence of the many packing strips on the surface, the extreme dip of the floor and the observation of the failed principal joist at ground floor level that there are serious ongoing problems with the structural capability of the floor in this room which are to be addressed as part of proposed repair and restoration works

Plate 23 : Detail of floor joist in north east wall - northern room, south west wing

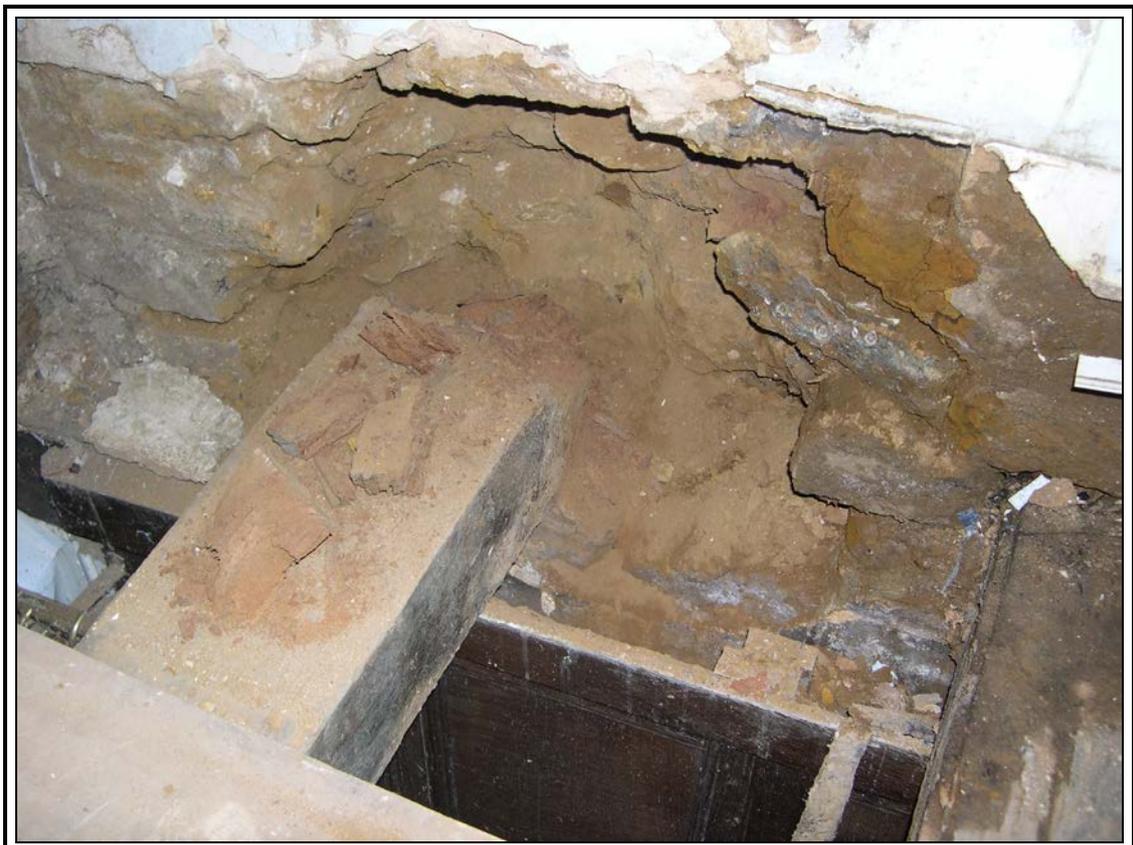
Plate 24 : Detail of floor joist in south west wall - northern room, south west wing
