Client Name: Rt. Hon. Lord Wardington
Document Title: Wardington Manor: Chimney Base, Bathroom 1.7
Document Type: Historic Building Investigation and Recording
Issue Number: 1

WARDINGTON MANOR, WARDINGTON: CHIMNEY BASE,
BATHROOM 1.7

HISTORIC BUILDING INVESTIGATION AND RECORDING

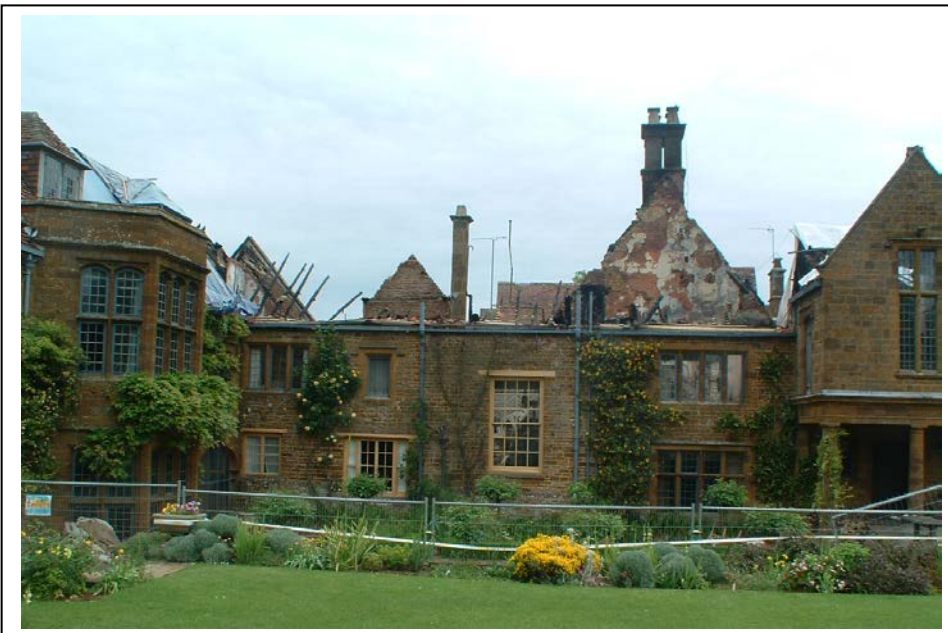
4.1.2 As a result of a substantial episode of burning in the roof space of the south west wing in April 2004 much of the roof structure collapsed on to the first and partially the ground floors. The extent of the damage to this area of the house has necessitated temporary removal of the floorboards and joists, panelling, and permanent removal of the plasterwork from the ground and first floor rooms of the south west wing. This specifically included the removal of the plasterboard lining and associated fixtures and fittings in bathroom 1.7. revealing the structure of the chimney base supported by the plasterboard. As a result of the fire damage the base has become inherently unstable with no significant means of vertical support and has been temporarily propped. In addition to issues of failing structural stability, it may also be necessary to remove the chimney base and associated Acrow to facilitate further restoration

Plate 3: View north east - fire damage to roof on south west wing.

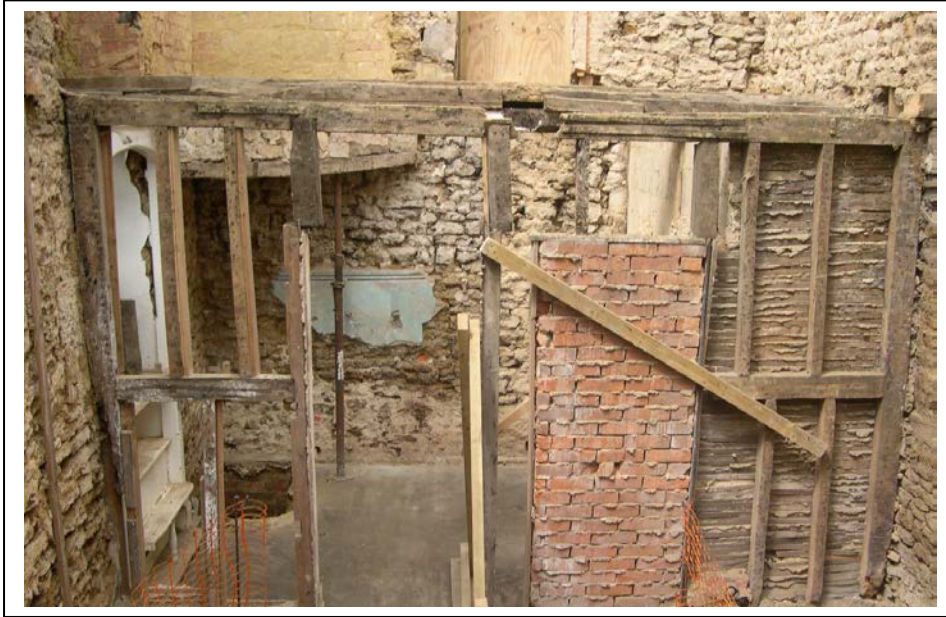
Plate 5: View north west - stripped bathroom 1.7 beyond the Oak Room.

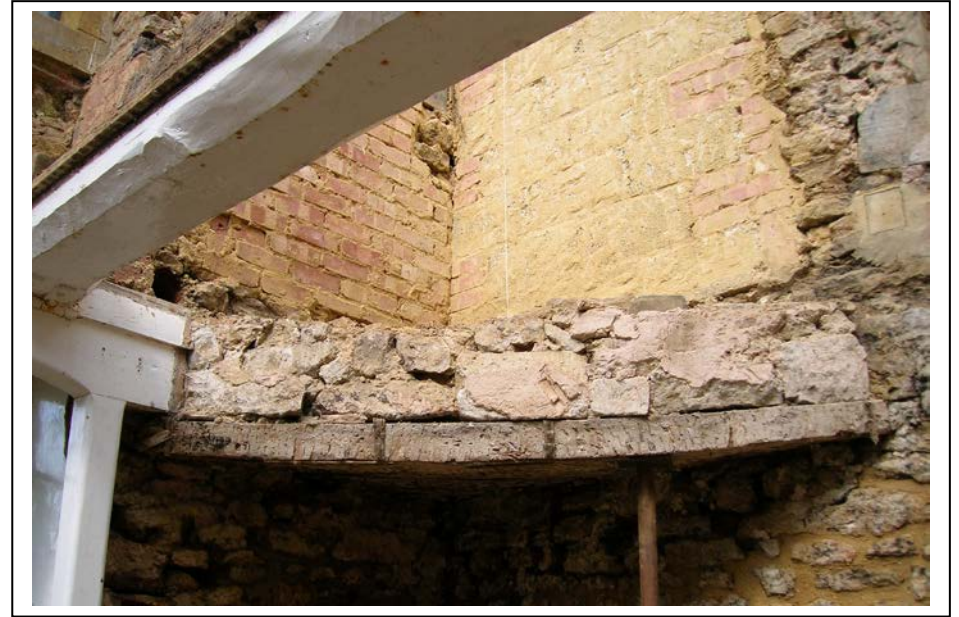
Plate 6: View west - timber and stone elements of the chimney base.

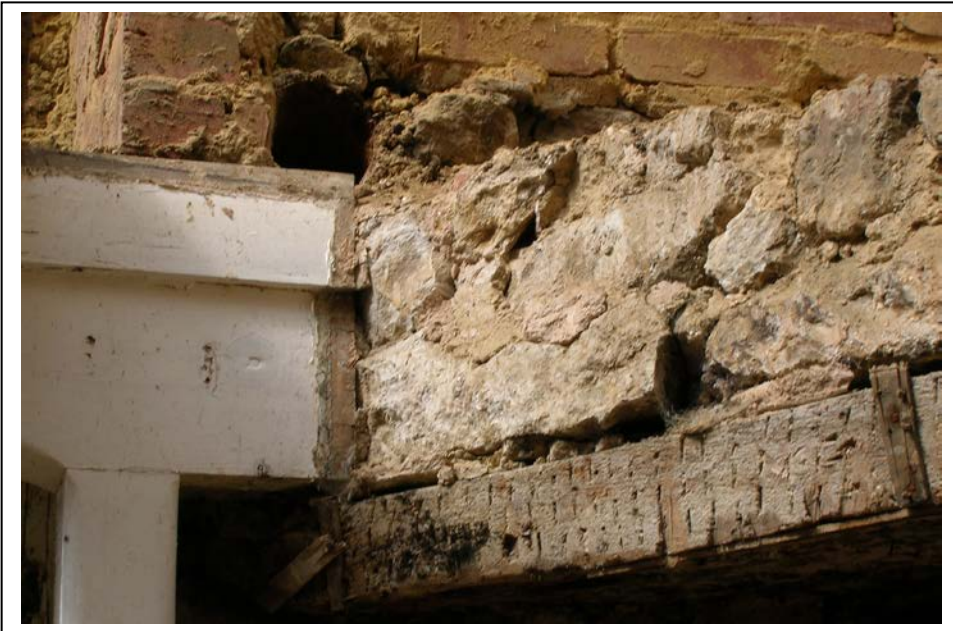
- 4.1.5 Both the stone and the timbers below appeared to be keyed into the respective elevations but with no further bonding observable. On the left hand side of the chimney base (south west elevation of the former bathroom) it could be observed that the window frame (window W 1.10) partially overlapped the structure and hence could be identified as a later feature or insertion (Plate 7).

Plate 7: left side of base - note it extends behind the window frame.

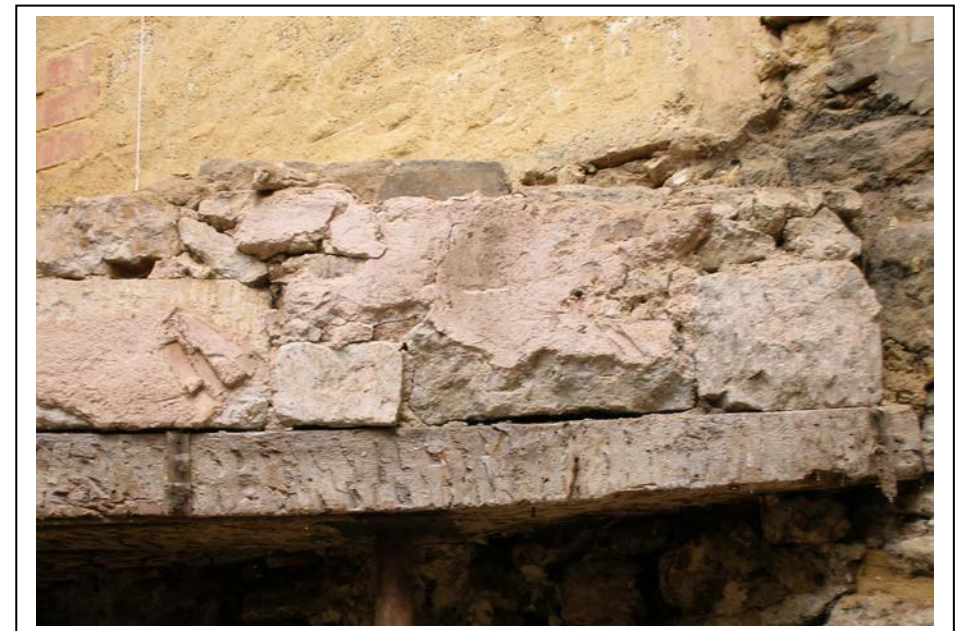
- 4.1.3 The chimney base survives as a triangular corner piece constructed of two courses of rubble local limestone laid on top of an oak platform. The timber base has been constructed in four sections with the widths of oak (front to back) as follows, 0.33m, 0.18m, 0.24m and 0.25m. The height of the timber visible at the front is 0.18m. The width of the front timber stretching from the south west elevation to the north west elevation is 2.08m and the width from the front of the base to the corner is 1.06m. The front timber appeared to be heavily tooled and has five thin wooden strips attached for the possible fixing of panelling, removed after the fire (Plates 7 - 11).

Plate 8: Right side of base showing timber and rubble construction.

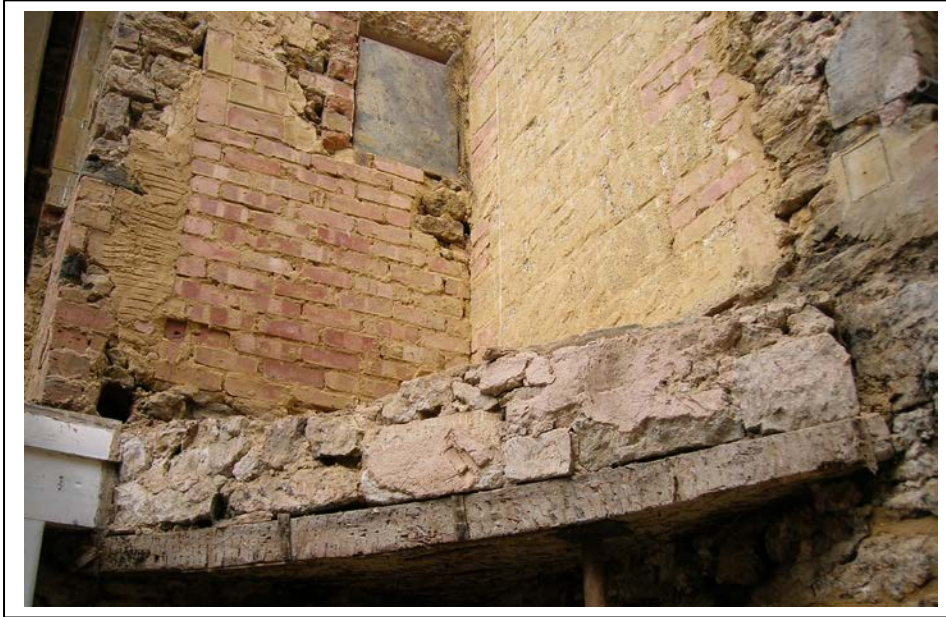
Plate 9: View west - chimney base with brick repairs to first floor walls.

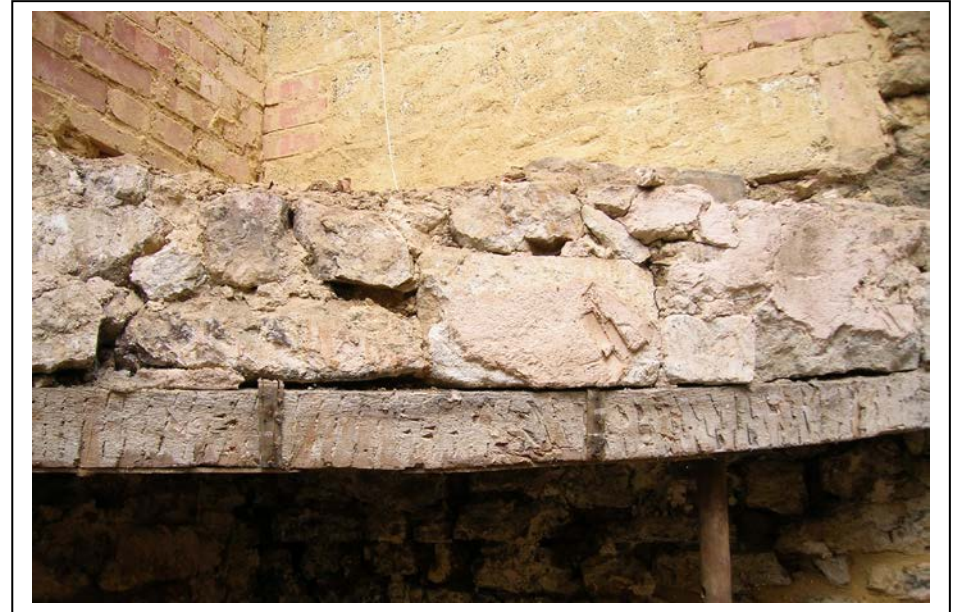
Plate 10: View west - detail of chimney base structure.

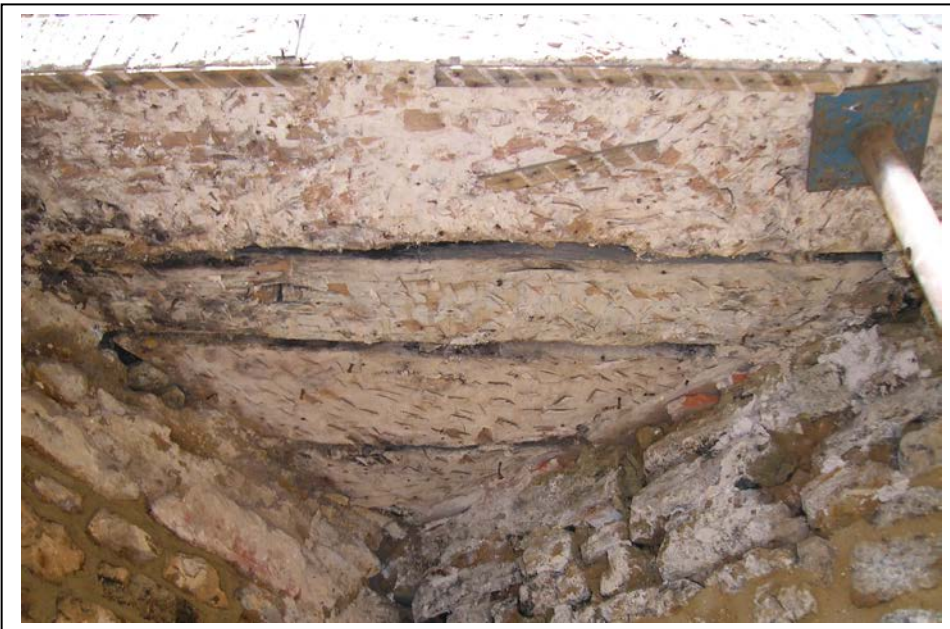
Plate 11: Underside of the four timbers forming bottom element of the base.

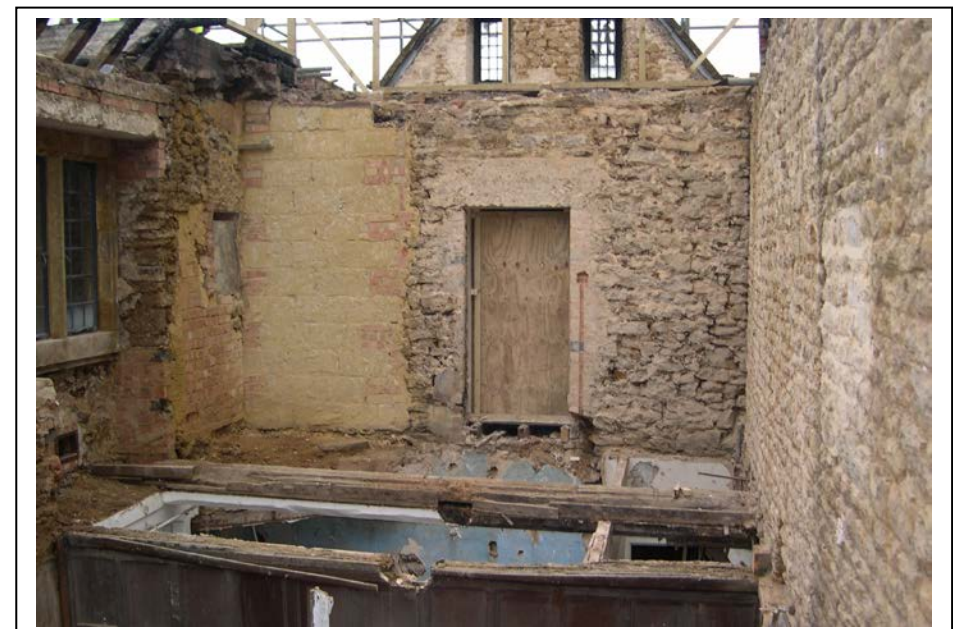
Plate 12: View north west -first floor with base location to the left.

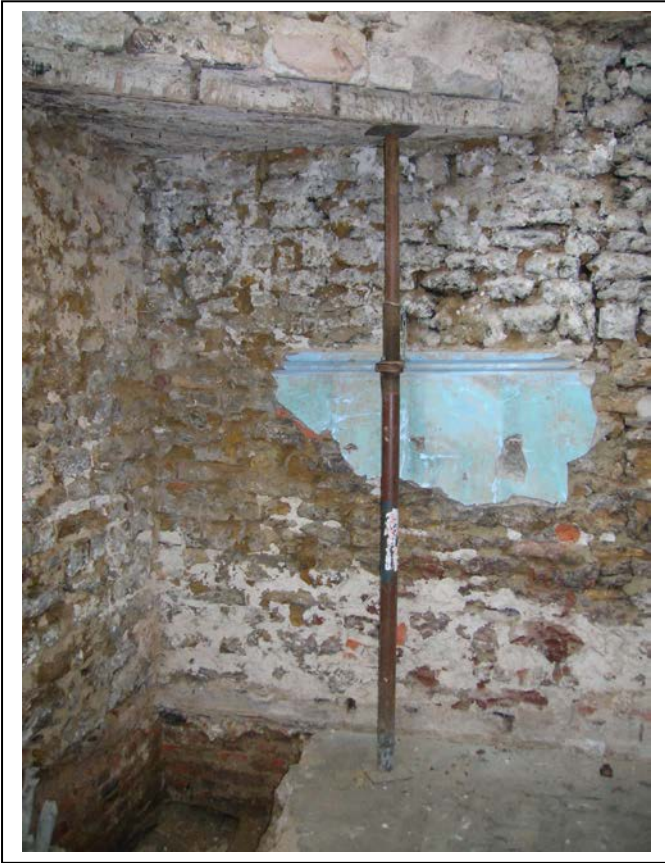
- 5.1.2 No medieval elements were readily identified within the structure observed, although the accurate dating of the feature on the evidence available is inconclusive. Due to its current poor state of repair and obvious structural instability the removal of the chimney base is essential and will not significantly effect the historic integrity of this area of the house. It is noted that the temporary Acrow is the only visible means by which the base is

Plate 13: View north west - stripped walls of bathroom 1.7 below chimney base showing support.

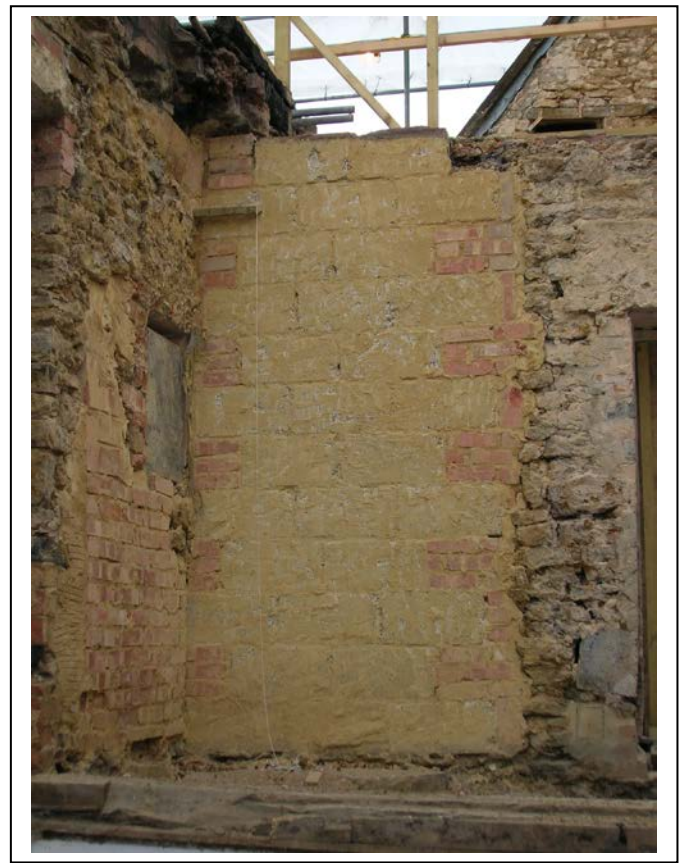
Plate 14: Blocked alterations / repairs adjacent to the chimney base at first floor level.

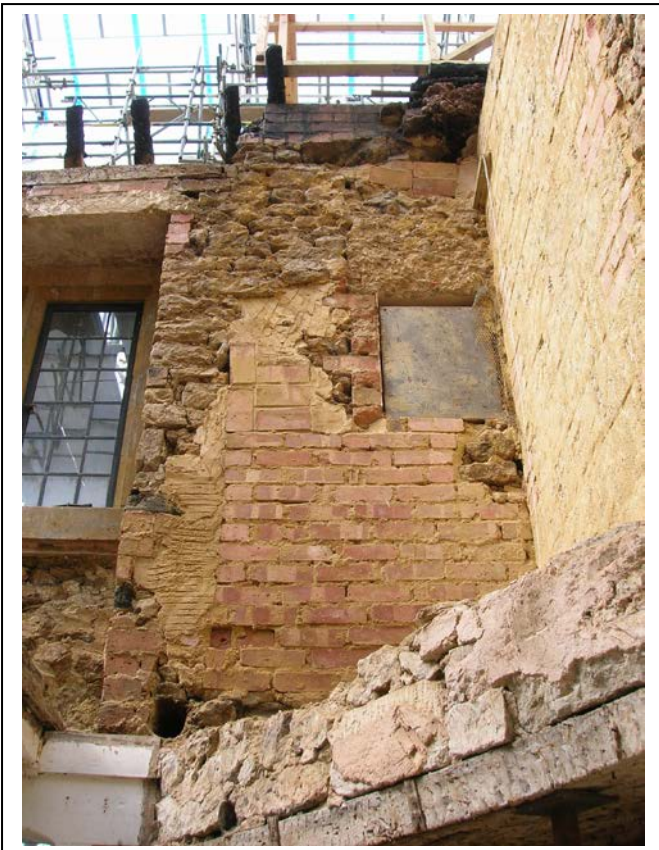
Plate 15: View south west - repaired area at first floor level adjacent to the chimney base.

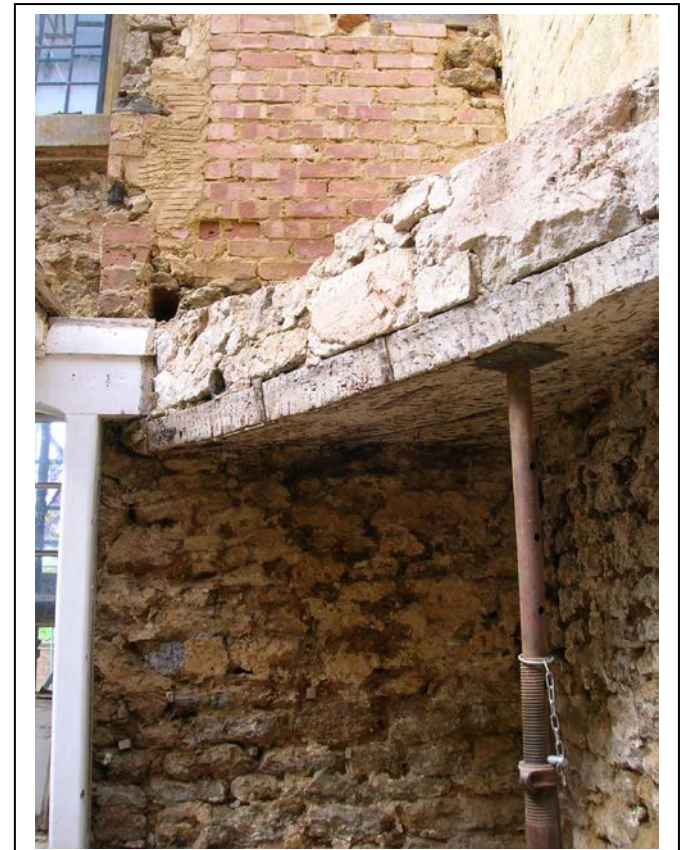
Plate 16: Detail of chimney base and support below.

- 5.1.3 It is suggested that a member of OA historic building staff be present during its demolition to observe and record the nature of the fabric and any further historical information that might be gleaned from its removal. Should further more substantive dating evidence be required it would be possible to arrange a dendrochronological assessment of one or all of the timbers retrieved from the base. This may enable an idea to be given of whether the structure is part of the original medieval core of the building.
