**Document Title:** Wardington Manor: 'Blue Window', Landing 2.6

**Document Type:** Historic Building Investigation and Recording

OA Job Number: 2394  
Site Code: WAMA04  
Invoice Code: WAMABS

Building Name: Wardington Manor  
Building Location: Wardington, Oxfordshire

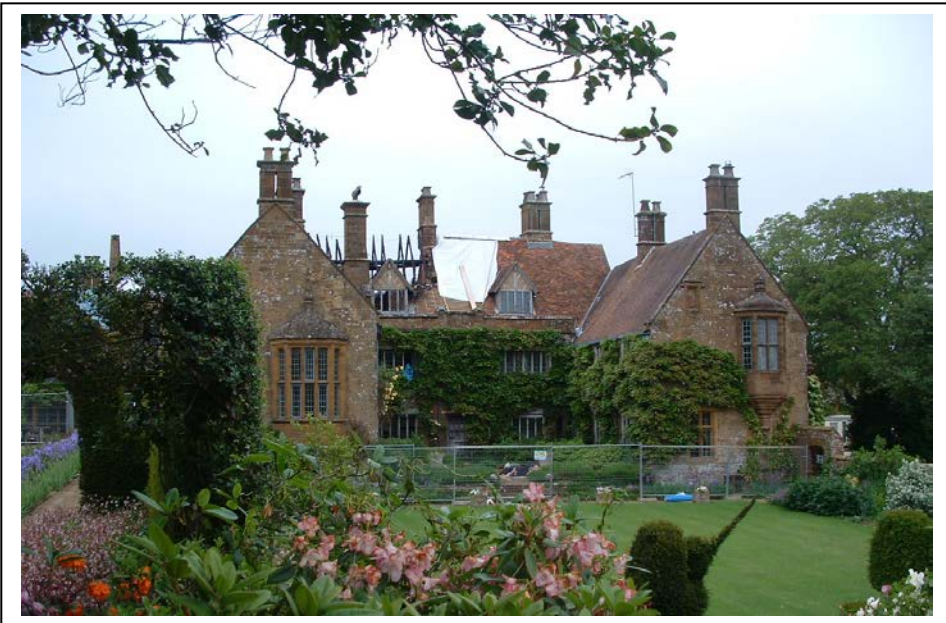
- 1.3.3 As a result of the fire in April 2004 (Plates 1 - 4), an extensive programme of restoration and conservation work has been proposed by Rodney Melville and Partners, Architects, details of which are currently being finalised and are likely to run until the latter part of 2005. Alongside this a programme of archaeological investigation and recording is being undertaken to ensure that the works are informed by an understanding of the historic fabric, and that significant information about the history of the Grade II\* building is not lost.

Plate 1: View north west - general view of house.

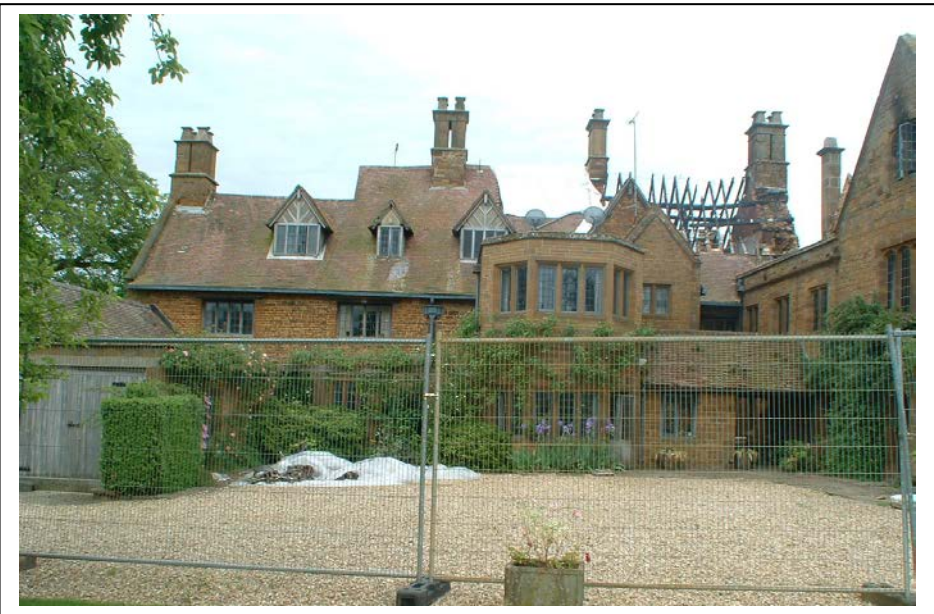
Plate 2: View south east - general view of house.

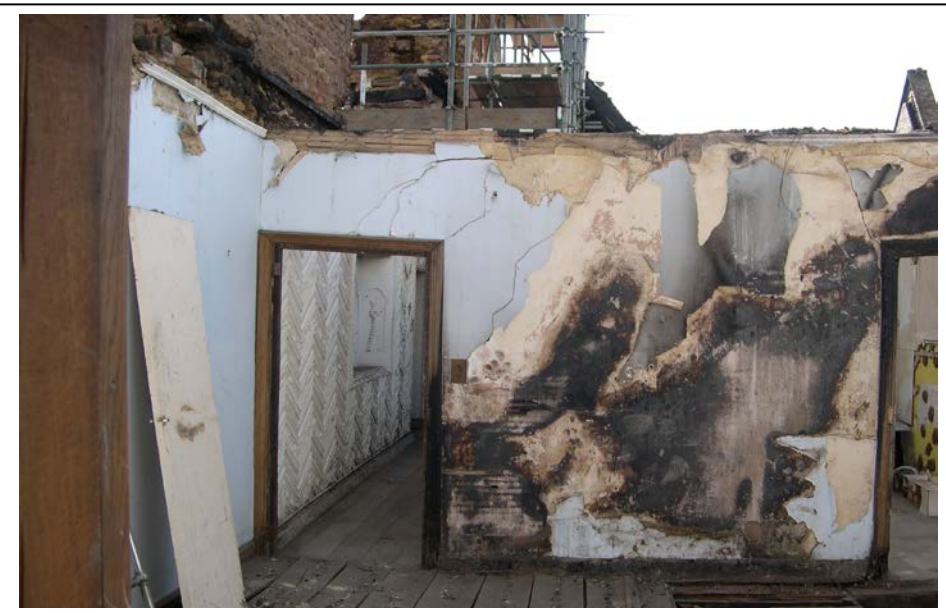
- 4.1.2 As a result of a substantial episode of burning in the roof space of the south-west wing in April 2004 much of the roof structure collapsed on to the first and ground floors (Plates 1 - 4). The extent of the damage, particularly to the first floor and landing, has necessitated the removal of the floorboards and joists, panelling, and permanent removal of the plasterwork from the ground and first floor rooms of the south west wing. The corridor along the landing on the first floor had been covered with a decorative plaster that was used extensively elsewhere in the house (Plates 4 & 5). This cast fibrous plasterwork decoration was designed by Molly Cochrane (Mrs. Randall Wells) between 1919 - 1923, and was described by Pevsner as "*the most extraordinary decoration in the house ..... the luscious plasterwork by Mrs. Randall Wells*".

Plate 3: View South east - general location of the decorative plaster bay.

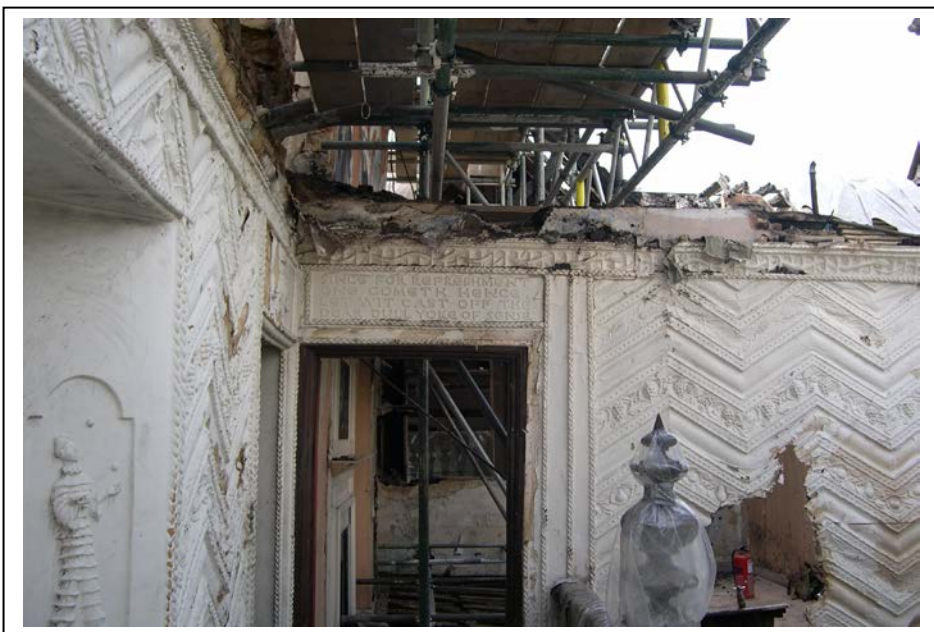
Plate 4: Decorative plaster at the top of the Yellow Staircase.

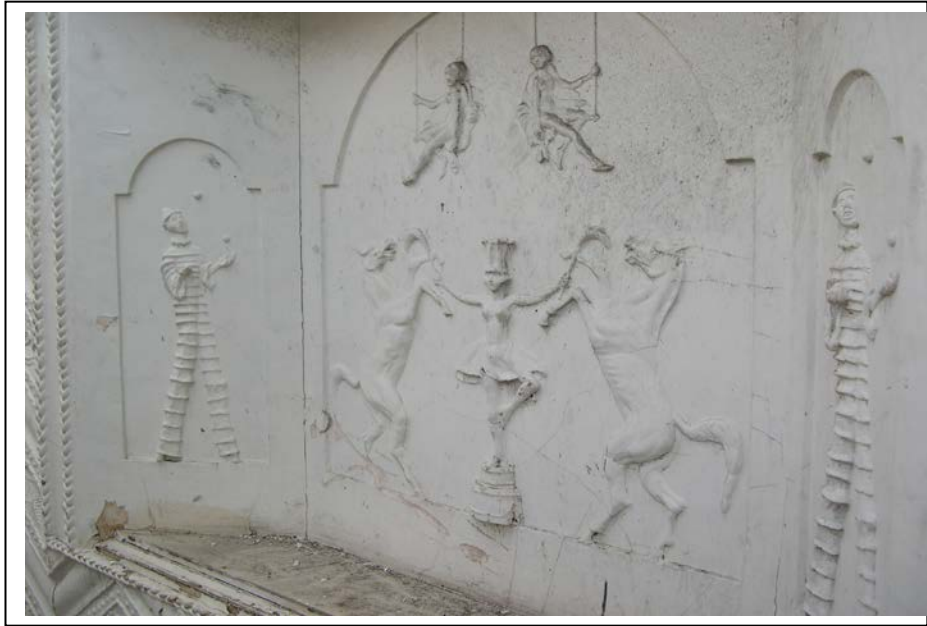
Plate 5: View north - Fibrous decorative plaster within the bay on Landing 2.6.

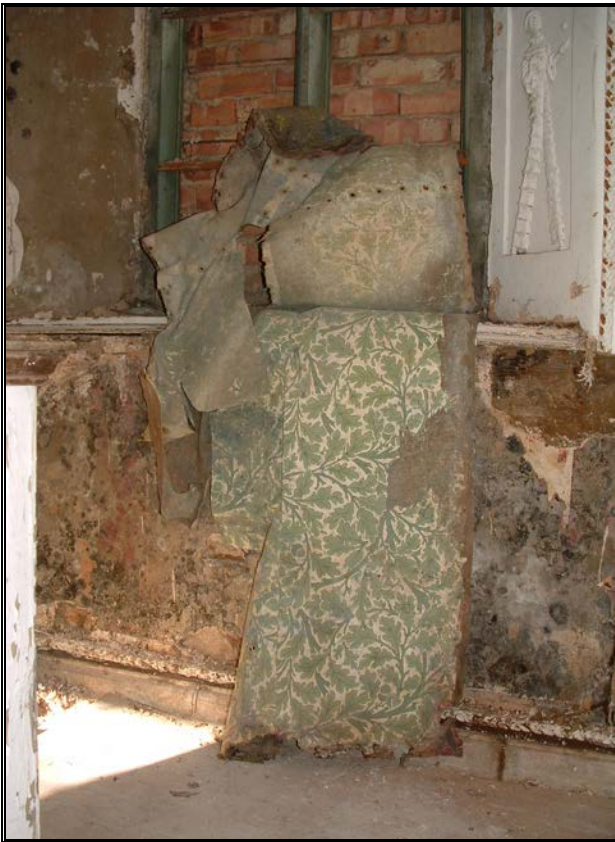
- 4.1.3 On removal of the plasterwork a green oak leaf pattern wallpaper was observed covering the frame, indicating that there was likely to have been an intermediate stage between the brick blocking of the window and the installation of the fibrous plasterwork. The style of wallpaper has been identified as being 'Oak Tree', designed by J.H. Dearle (1860 - 1932) for William Morris's company Morris & Co., first produced in 1896. As many Morris & Co. papers continued in production throughout the 20th century, first through Jeffrey and Co., and later through Sanderson, it is not possible to give an exact date for the wallpaper.<sup>2</sup> (Plate 6).

Plate 6: View north - Green oak leaf wallpaper revealed under the fibrous plasterwork.

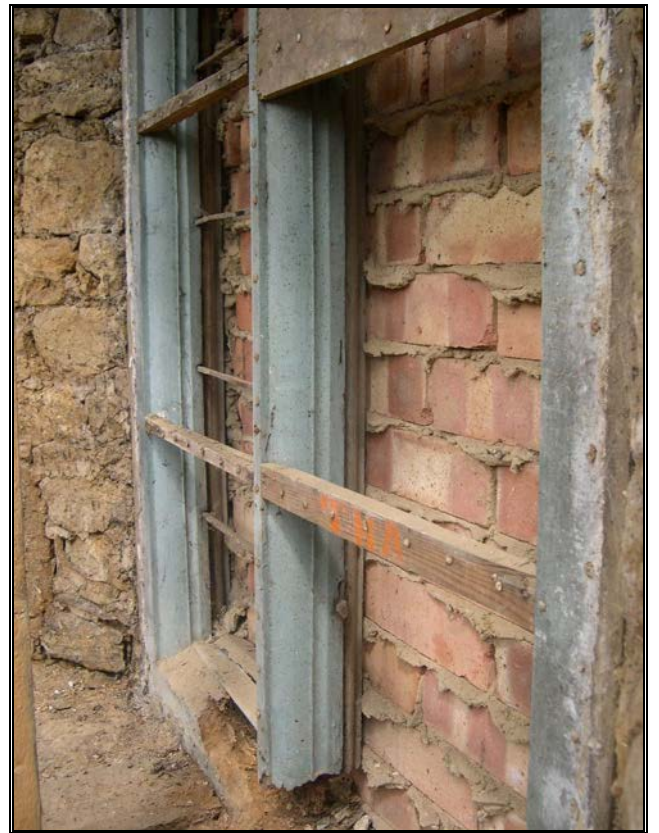
- 4.1.4 The frame was 98 x 122 cm of timber construction with a central mullion (11 cm wide) forming a 2-light window. The depth of the frame was 10 cm. The right hand light had two surviving machine cut laths (42 x 8 cm and 42 x 3 cm) fixed horizontally across it whilst the left hand light had one (40 x 2 cm). These were presumably the remains of fixings for covers over the disused window. The left hand light also retained four iron bars (33 x 1 cm) spread evenly and horizontally between the central mullion and the left hand side of the frame. These are likely to be saddle bars designed for fixing lead glazing, providing additional horizontal strength to hold the glass panes in place. The glass would usually have been attached to the saddle bars using copper wire ties, loops and wedges or in some instances coils of lead. The mullion retained many of the nails down its length that had been used to affix boarding of some description to it on what would have been the inside of the window. The window frame was painted with a thin wash in pale blue. It was not possible at the times of inspection to clearly to identify whether there were any further layers of paint underneath (Figure. 4, Plates 6 - 9).

Plate 7: View north west - detail of frame and mullion from the side.

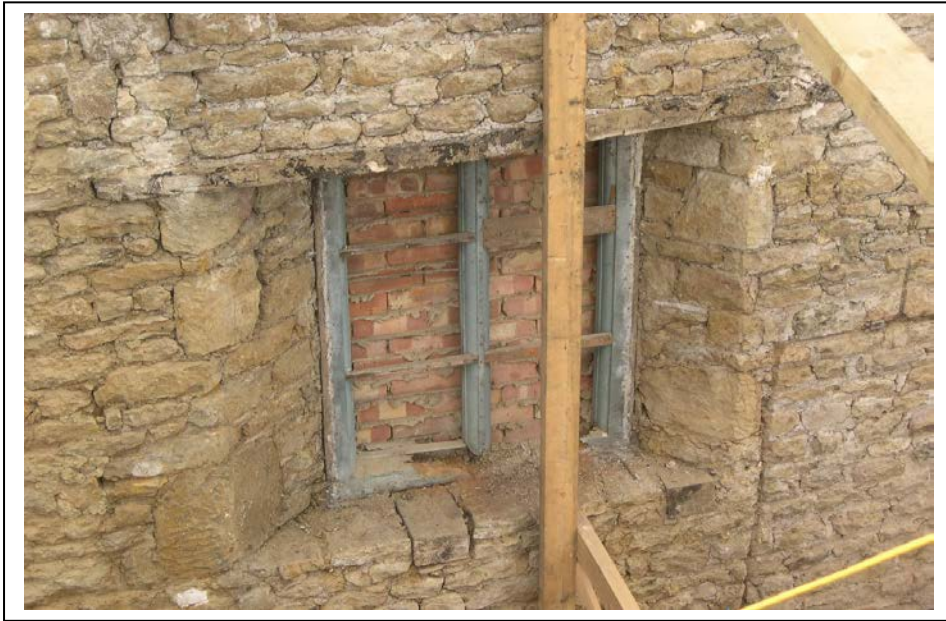
- 4.1.8 The outer side (NE) of the frame had been bricked up (red brick, 22 x 7 cm) prior to addition to the building to the north east, (currently corridor and staircase 2.12). The brickwork is similar in composition and size to that found in other areas of Wardington Manor where Randall Wells had intervened, notably the brickwork in the north-west wing. This would date the blocking up of the window to the period 1917 - 1923.

Plate 8: View north east - structure around the hidden window.

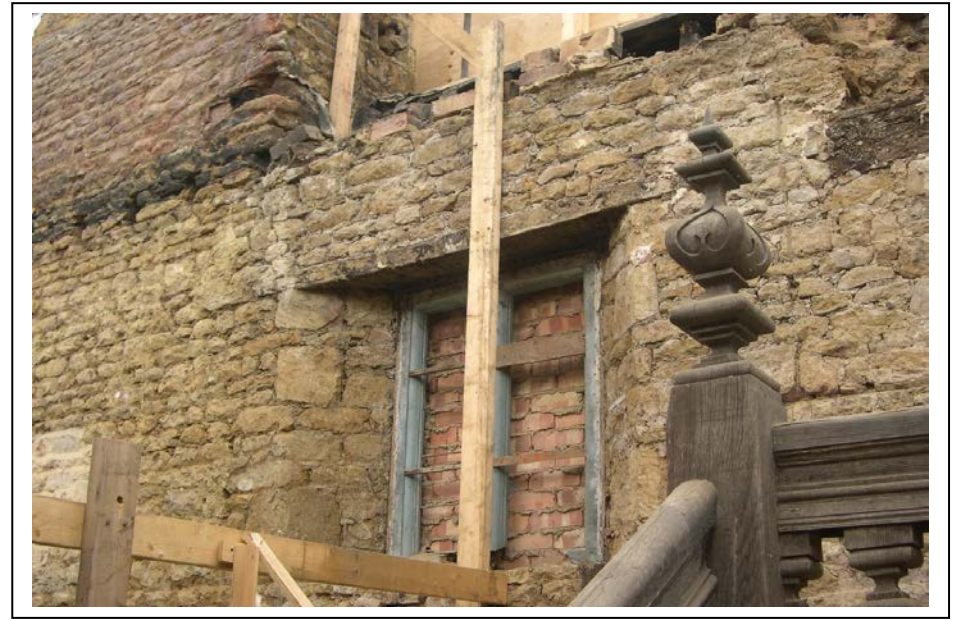
Plate 9: Location of window (after stripping) at the top of landing.

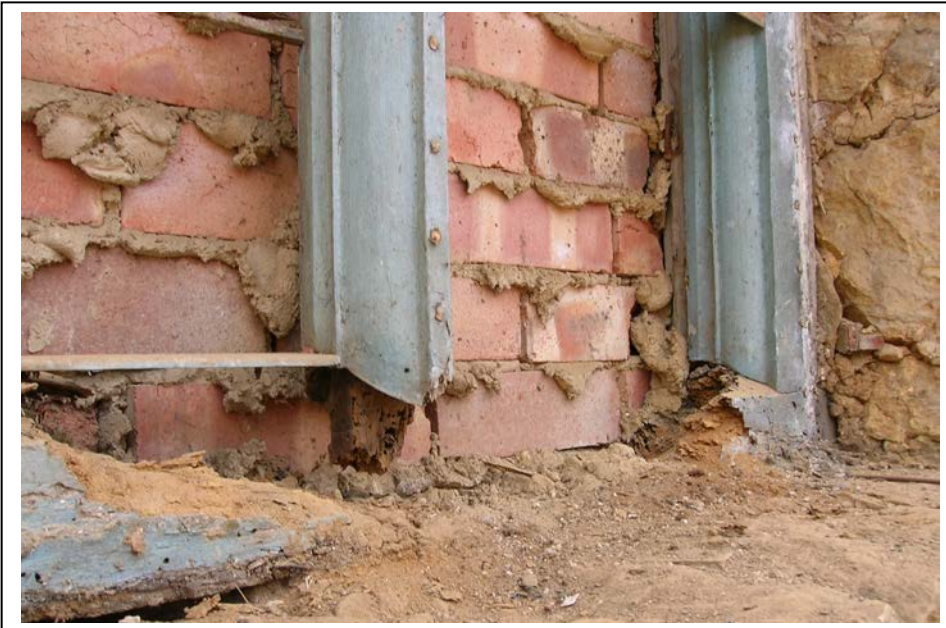
- 4.1.5 The window frame was generally in a poor state of repair with some of the paint missing on both sides. The base of the frame had approximately 65% of its timber missing and there was further decay visible on the surviving elements of the lower framework and underneath the base of the mullion (Plates 10 & 11).

Plate 10: View east - detail of decay in lower element of window frame.

be possible to make a feature of this in the reinstated corridor although current plans put forward look to re-cover the window as was the case prior to the fire. If the window is not to be removed then it is likely it will need to undergo a degree of restoration and conservation, (specifically the lower section of the frame), prior to being resealed. As referred to in 4.14 the lower structure has partially rotted away and this would need to be addressed. It would be possible to reconstruct and replace this lower element if necessary. Dependent on advice taken on the degree of decay present within the timber frame, it may be deemed appropriate to completely remove it, as originally proposed.

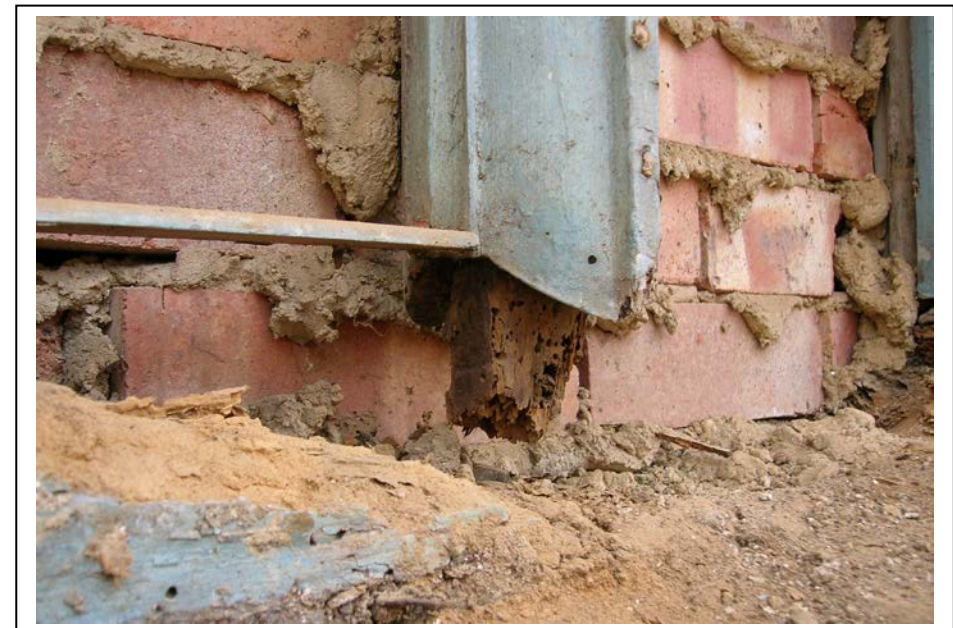
Plate 11: Detail of decay in lower element of window frame.
