No 40-41 Church Lane West Wycombe Village Buckinghamshire

Building Recording and Investigation

Client: The National Trust

Report on Historic Building Investigation

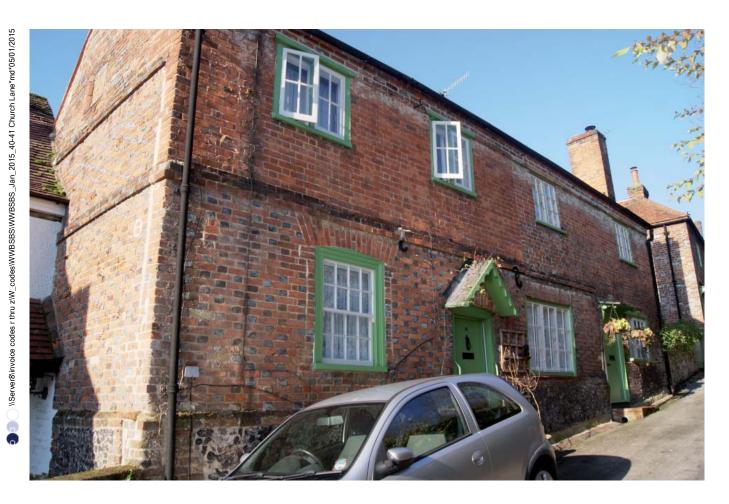
- 2.2.4 The *east elevation* is the main front of the building facing Church Lane and from here the complex evolution of the house is apparent from the patchwork of different brick types and constructional phases (see Fig 5 & Pl. 1-2). The elevation is set on a flint plinth with brick dressings and sloped shoulder at the top and due to the sloping ground there are two steps in this plinth, adjacent to each front door. The main plinth is assumed to be part of the 18th-century refacing of the building rather than the possibly primary timber-framed 17th-century building and we know that the section in the northern bay must be secondary as this whole bay was an 18th-century extension. This type of plinth with moulded capping is an unusual feature to West Wycombe.

Plate 1: East elevation facing Church Lane (after conservation work)

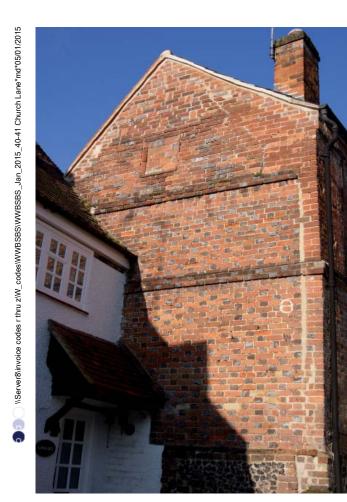
- 2.2.8 The gabled *south elevation* (Fig 6) is constructed from red brick (largely Flemish bond with glazed blue headers) and has slightly projecting string courses at first floor level and close to the original eaves height. This brickwork appears to be the same as the earliest phase of walling in the east elevation (discussed above). There is a possible infilled window in the gable (discussed further below) and a large patch of flint walling at ground floor.

Plate 5: South elevation showing phasing in brickwork (after conservation work)

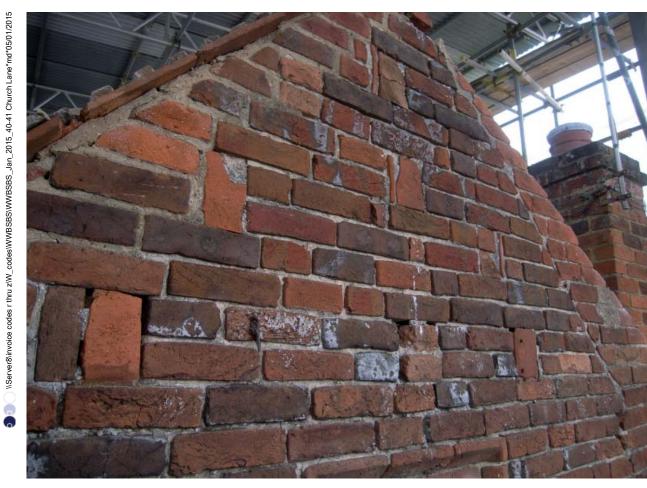
- 2.2.11 The gable includes a distinct stepped pattern of what appears to be seven small infilled holes (c.15 cm²) in the primary brickwork, similar to what would be found in a dovecote or dove loft. However, there is no real evidence of there ever having been any nesting boxes within the roofspace for doves and the thin nature of the wall, a single brick thick, makes it unlikely that these 'holes' were ever open. The bricks above do not always span over the infilled 'holes' and if the holes were open then the gable would probably have collapsed. There is some possible evidence in the roofspace which is suggestive of a dovecote in a reused pole purlin in the south section of the roof and also one of the rafters in this area which has a series of holes either side which may relate to a small ladder or frame of some sort. It seems most likely that the holes in the gable was some sort of a decorative feature rather than ever having been a dovecote. The pattern formed by these infilled holes is also shown on the 1907 photo and although it is not possible to see this area in detail on the photo it strongly appears that the pattern was more prominent than it is today. It may be that there was originally a pattern formed in the gable with a distinct material (different coloured bricks or stones) but that these were removed, possibly in the 1930s works, and the holes infilled with red brick.

Plate 7: Infilled holes in south gable

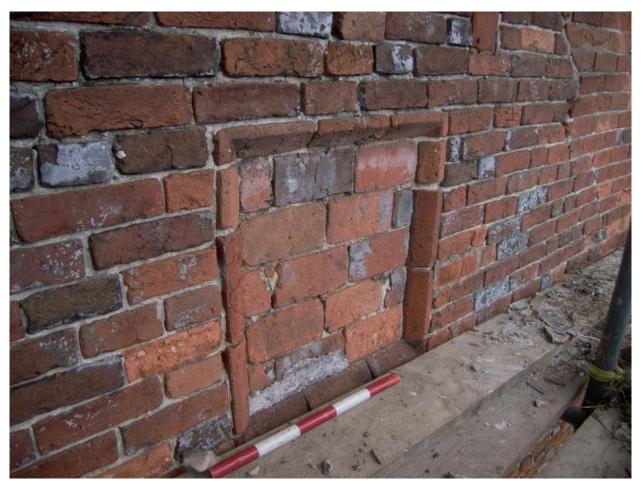
Plate 8: Blind window in south gable

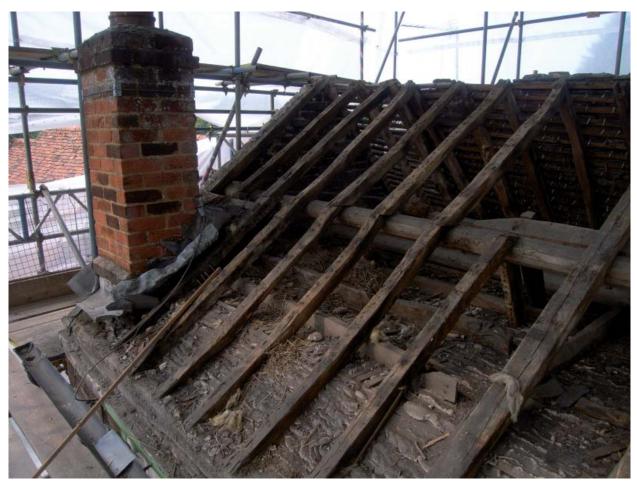
- 3.2.9 As outlined above the alignment of the east slope of the primary roof was altered in the 18th century to raise the eaves and there is much evidence in the roof relating to these changes. The primary purlin has been entirely removed and replaced by a new purlin on a raised alignment formed from a crude 'pole' type timber. This has sagged towards the cruck at the north end of this bay and it is now supplemented by a later purlin (1930s?) which has been added from the mid point of the bay to the cruck .

Plate 12: Re-profiled east slope of Bay 1 at south end of building

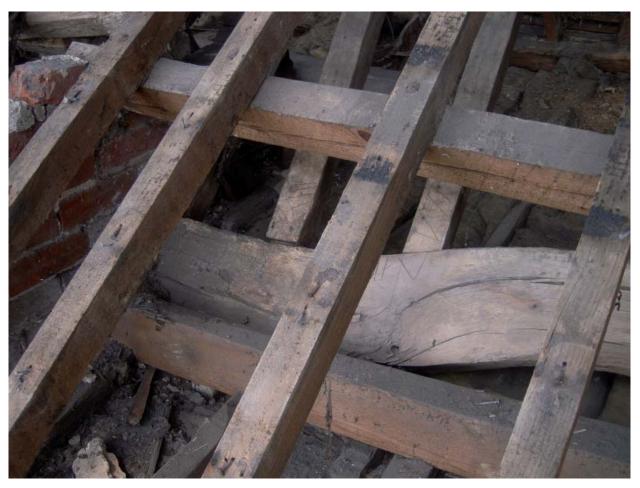
Plate 22: Primary purlin in east slope (Bay 3)below secondary rafters from higher roof line

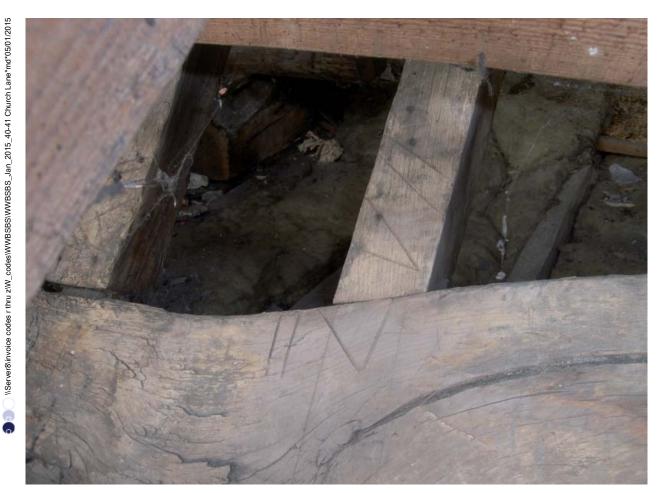
Plate 23: Carpenters marks in primary purlin and rafter below secondary higher roof line

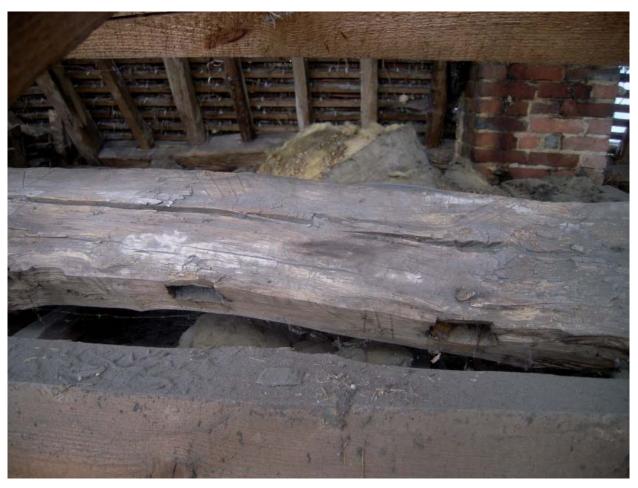
Plate 24: Empty mortices in purlin from former abutting rafters (Bay 3 from south)

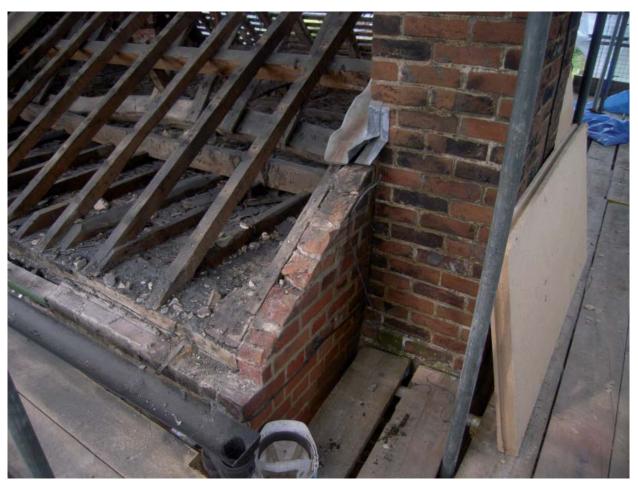
Plate 30: Secondary chimney at north end of east slope
