ARCHAEOLOGICAL AND PHOTOGRAPHIC RECORD
IN ADVANCE OF BUILDING WORKS

OXFORD ARCHAEOLOGICAL UNIT
AUGUST 1998

Manor Farm, South Stoke, Oxon

ARCHAEOLOGICAL AND PHOTOGRAPHIC RECORD IN ADVANCE OF REFURBISHMENT

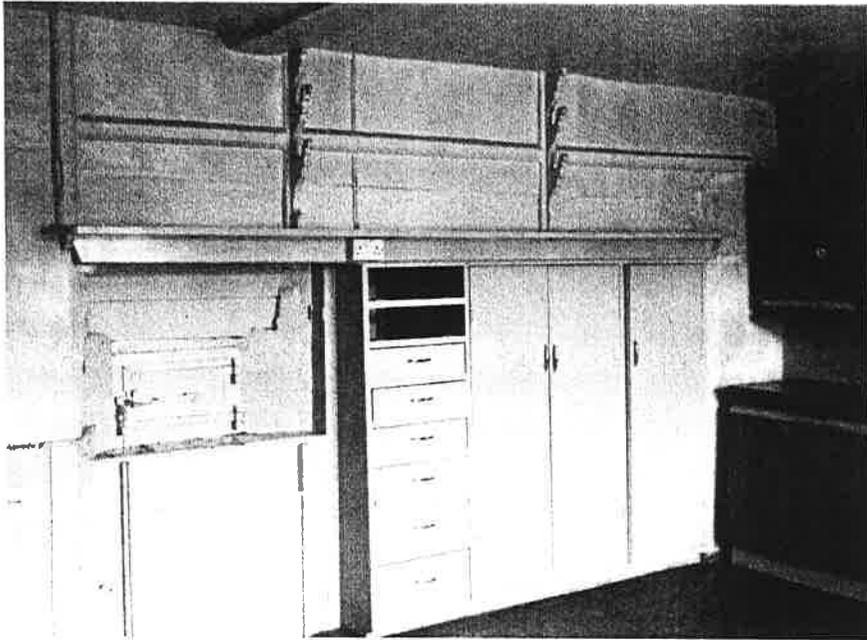
Plate 1: Modern kitchen units prior to removal

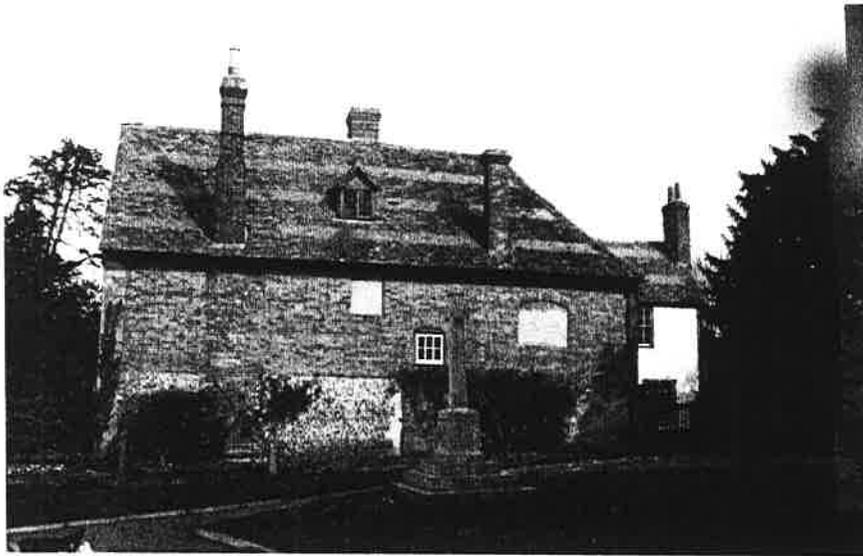
Plate 3: General view from churchyard (south)

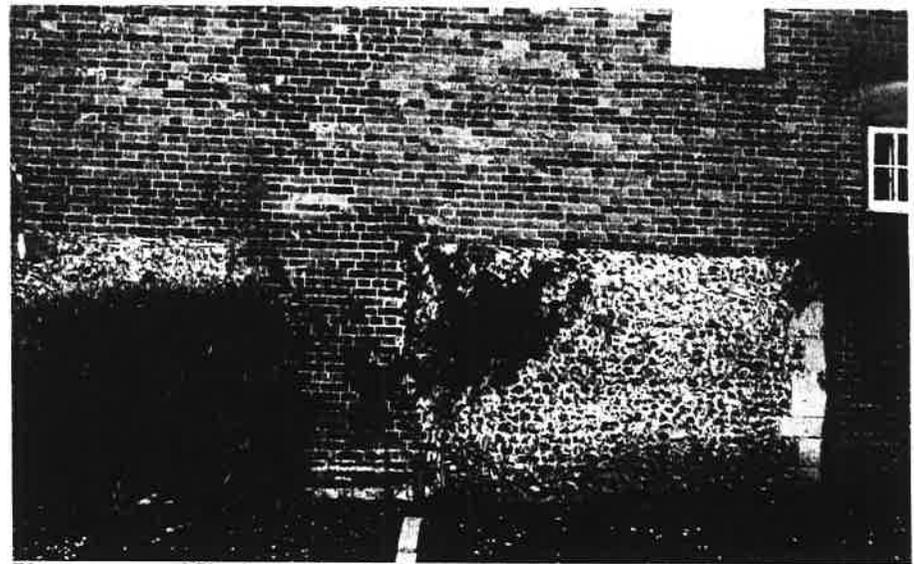
- 4.5 The part of the farm house believed to constitute Phase 1 is the south-west wing of the present house, measuring c 7.5 x 7 m. As existing the south facade is exposed brick at first floor while the ground floor is formed by two large patches of flint walling divided by brick infilling. There are stone quoins either side of the flint (rising to eaves level at the west corner) indicating the extent of the original building in contrast to the longer existing facade. The two other facades are covered with a white render partially obscuring their construction but they appear to be solid at ground floor level with timber framing above.

Plate 4: Areas of flint in south wall of ground floor of Phase 1, dressed quoins differentiating between Phases 1 and 2

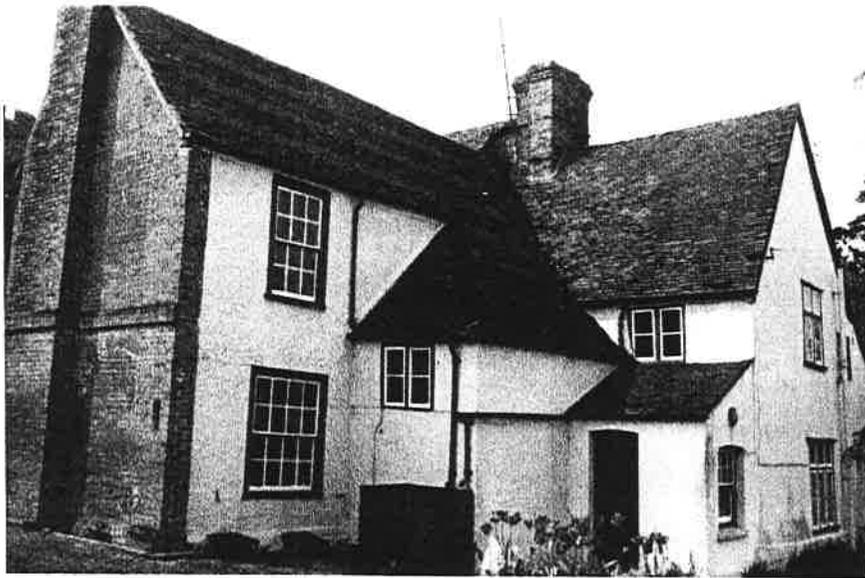
Plate 5: View from north-east

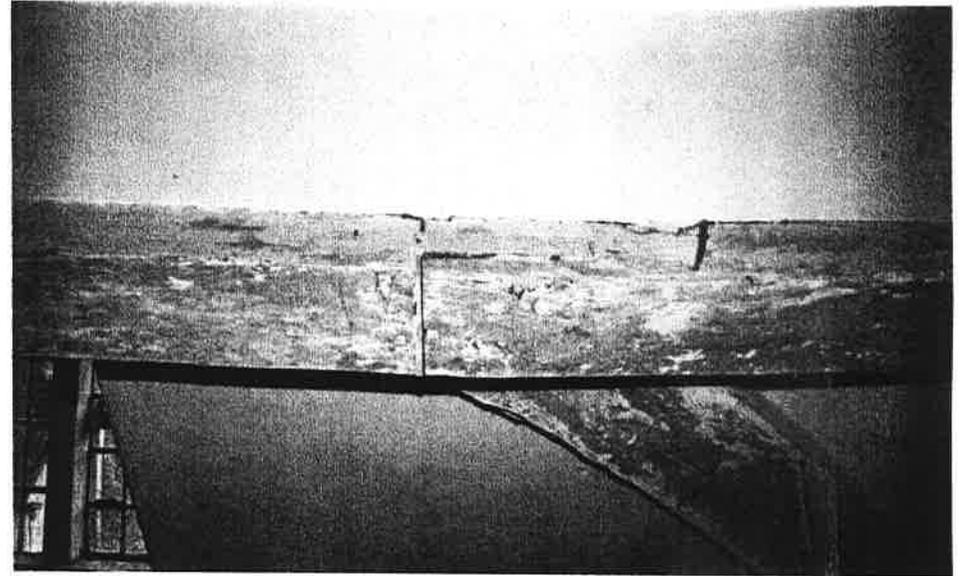
- 4.11 Phase 1 is the only part of the house with an attic intended for use. It also appears possible that the roof has not been substantially rebuilt and retains original timbers. There is a single truss supporting a pair of purlins and beneath each are two pairs of arched timber members supporting the sloped ceiling. Each purlin is scarfed with a late medieval joint suggesting a sixteenth-century date. The full depth of each purlin is not visible from within the Phase 1 roof space but their chunky section is clear from within Phase 2, adjacent to the chimney stack (of thin bricks 5 cm high).

Plate 6: Late medieval scarf joint in purlin in S3 (Phase 1)

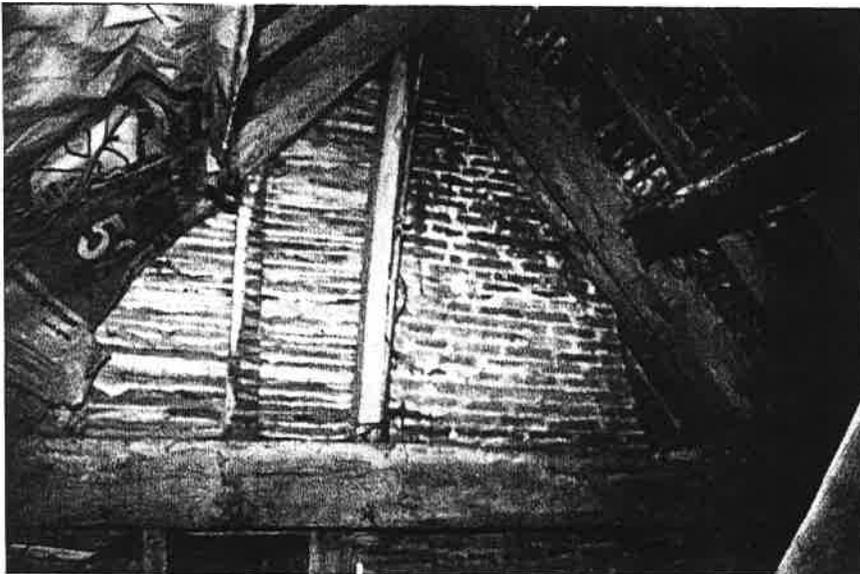
Plate 7: Brick chimney stack in roof (S4) adjacent to timber

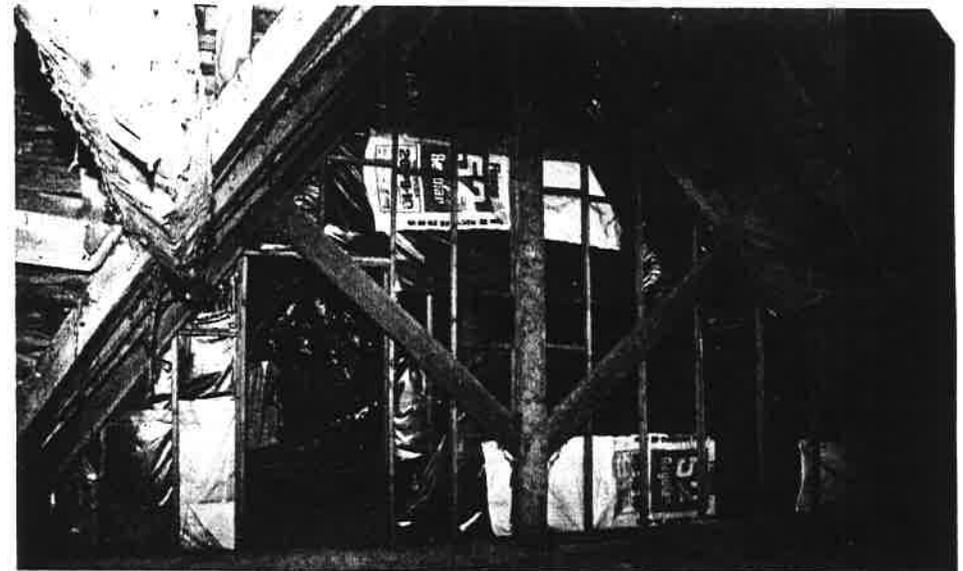
- 4.19 The roof of phase 2 has been rebuilt with reused timbers and the present structure probably dates from the C18th-19th. There is no evidence of plaster or lime wash within the roof space of Phase 2 and was presumably never intended for accommodation or other use. The basic structure is of two king post trusses supporting a single purlin to either pitch. Each king post is formed from a reused oak purlin (with notches) probably of C17th -C18th date. The purlin present to the east slope, within the central bay, shows tenons extending at each rafter and is blackened, contrasting with the matching purlin on the opposite slope without blackening or tenons. The king post is strapped with an iron cotter to the underside of each tie beam (this is confirmation of the structure's later date). The higher roof profile of Phase 2 than 3 results in an infilled strip of bricks laid at the angle of the roof, where the two phases meet.

Plate 8: King-post truss between Phases 2 and 3

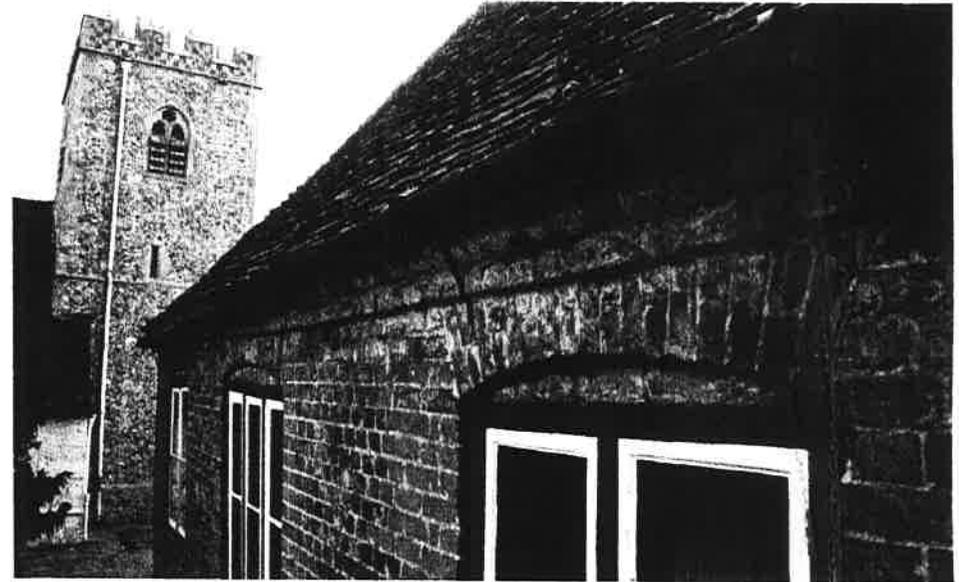
- 4.12 The addition of the hall to the east of the existing house (probably replacing an earlier structure) would have created an L shaped building with staircase and fireplace ideally located between the two wings. Evidence suggests that the extension dates from the sixteenth or seventeenth-century and that it was subsequently refaced in brick in two phases. The brick of the east facade suggests an eighteenth-century date but is very different in style to the plainer south facade which is probably of earlier origin. The east facade is Flemish bond between floor with vitrified blue headers and red stretchers. There is also a projecting, curved brick course at the eaves.

Plate 10: Ovolo moulding at eaves of refaced east elevation of Phase 2

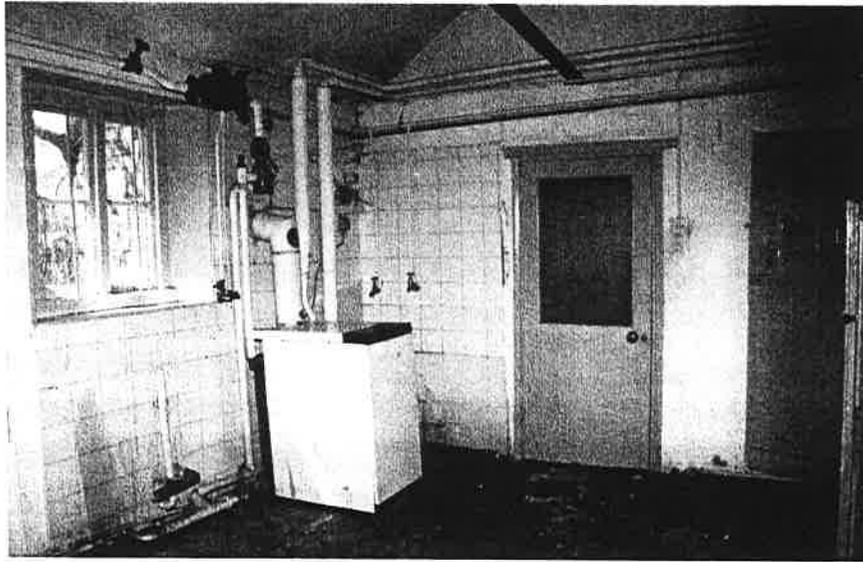
- 4.32 Phase 5 is a lean-to added to the west of Phases 2 and 3 and continuing its roof line. G2 is the boiler room which is being converted to a family room involving the removal of the existing quarry floor tiles (to allow underfloor insulation and a new slab), enlarging a window opening in the west wall to allow new double doors.
- 4.33 Plaster has been partially removed from the east wall (adjoining the kitchen) to reveal a rough combination of flint, brick and rubble towards the northern end. G3 is a larder which is being converted to a play room, involving the removal of the existing quarry tiles. The walls are all of plastered masonry and there is a single two light window, with splayed jambs and diagonally set, square sectioned timber bars behind the glazing.

Plate 11: Boiler room (G2) prior to alteration

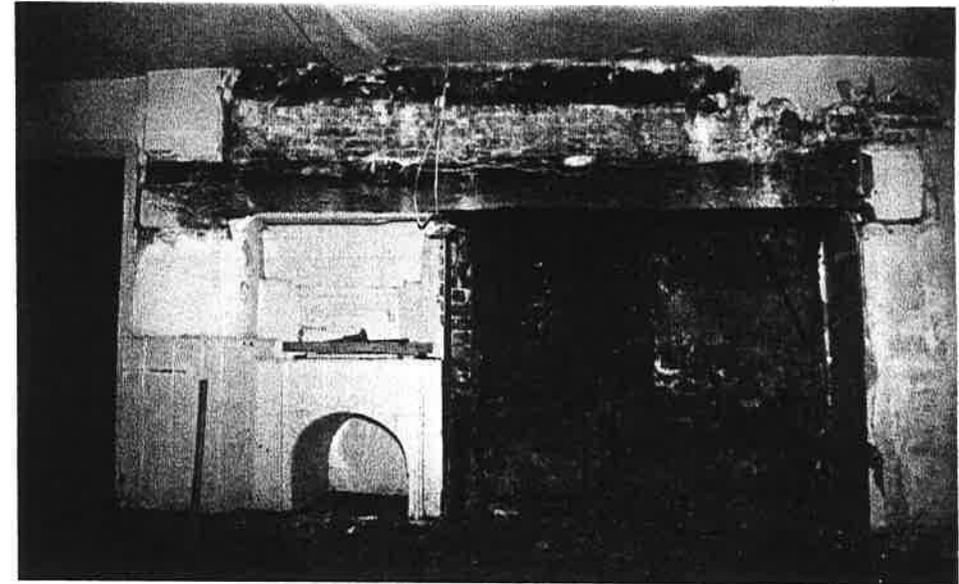
- 4.21 The current refurbishment project in the kitchen (G1) involves removal of the quarry tiled floor (to allow underfloor insulation and a new slab) and the exposure of the large fireplace which had been obscured with mid-twentieth century cupboards and kitchen units. When exposed the timber lintel of the fireplace could be seen to be 420 cm long and marked several times with WB and a triangular triple C design along its length. The lintel is 26 cm high between supports and 38 cm high where supported to either side. It is 17 cm deep to its underside and 24 cm deep at its top, thus the rear of the beam is angled to match the slope of the inner face of the chimney breast.

- 4.22 The bricks to the rear of the chimney (laid in a non herringbone pattern) and above the lintel visible in the front face of the chimney breast are unusually thin (average 23 cm x 5 cm) suggesting an early date for Phase 3. The bricks on either side of the fire place (including the side of the bread oven) are formed with

Plate 12: Exposed fireplace within G1

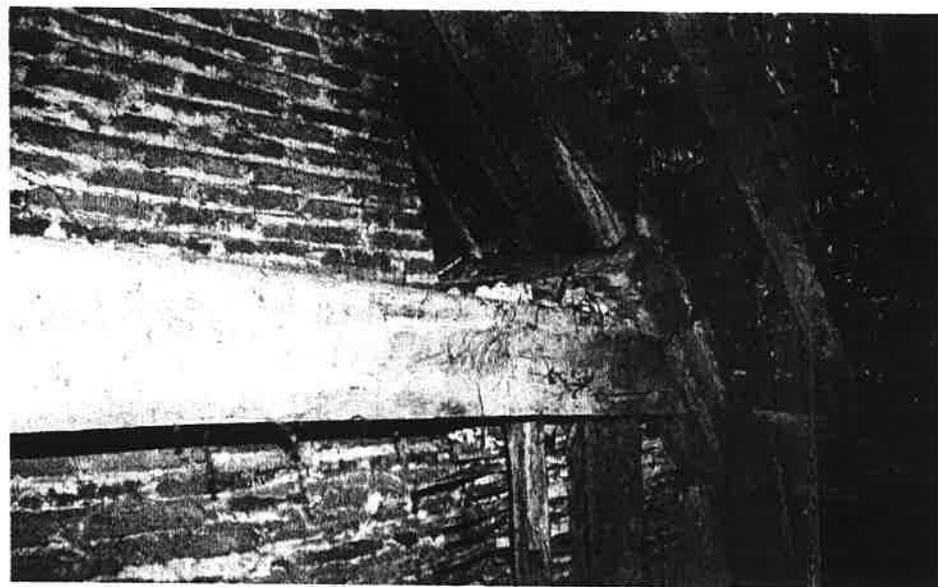
Plate 14: End of chunky purlin visible, adjacent to chimney in S4

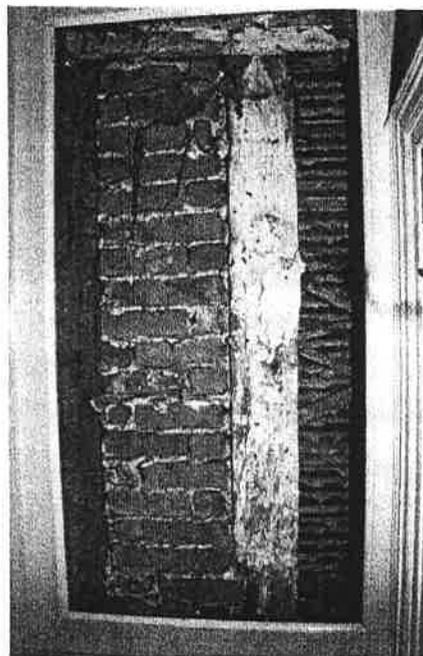
- 4.8 The current project originally proposed removing the panelling in F1 to allow treatment of the timbers behind and although this plan was abandoned three small sections of panelling were removed revealing the north wall's construction. The wall is constructed of close studding, with posts c 16 cm wide x 10 deep, at 20 cm centres and with vertical grooves down either edge facing one another. The rear of horizontally set laths are visible supporting the rendered external surface. Three diagonally set diamond mullions remain of a former window in the north wall of F1, c 1 m wide and 1 m from the west wall. At the eastern end of the wall, 75 cm from the a cupboard in the corner

Plate 15: Removed panelling to east side of north wall in F1 (Phase 1) showing diagonally-laid laths remaining *in situ*, behind later horizontal laths

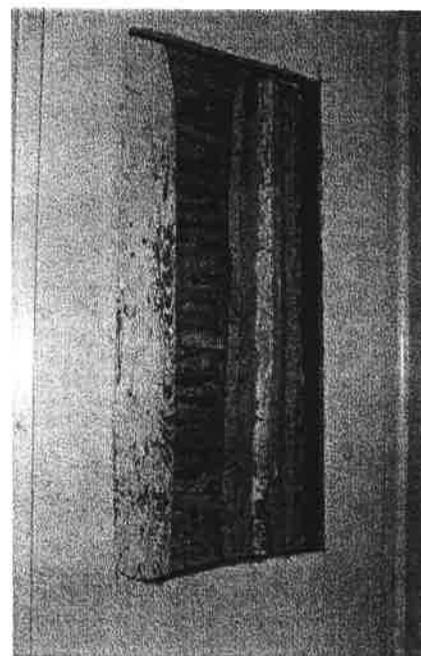
Plate 16: Square-sectioned, diagonally-set mullion exposed by removal of panelling to west side of north wall within F1
