The National Trust
(Thames and Chilterns Region)

Osterley Park, Isleworth, Middlesex.

Notes on watching briefs during construction work,
Stable blocks, January-March 1994.

Oxford Archaeological Unit
November 1994

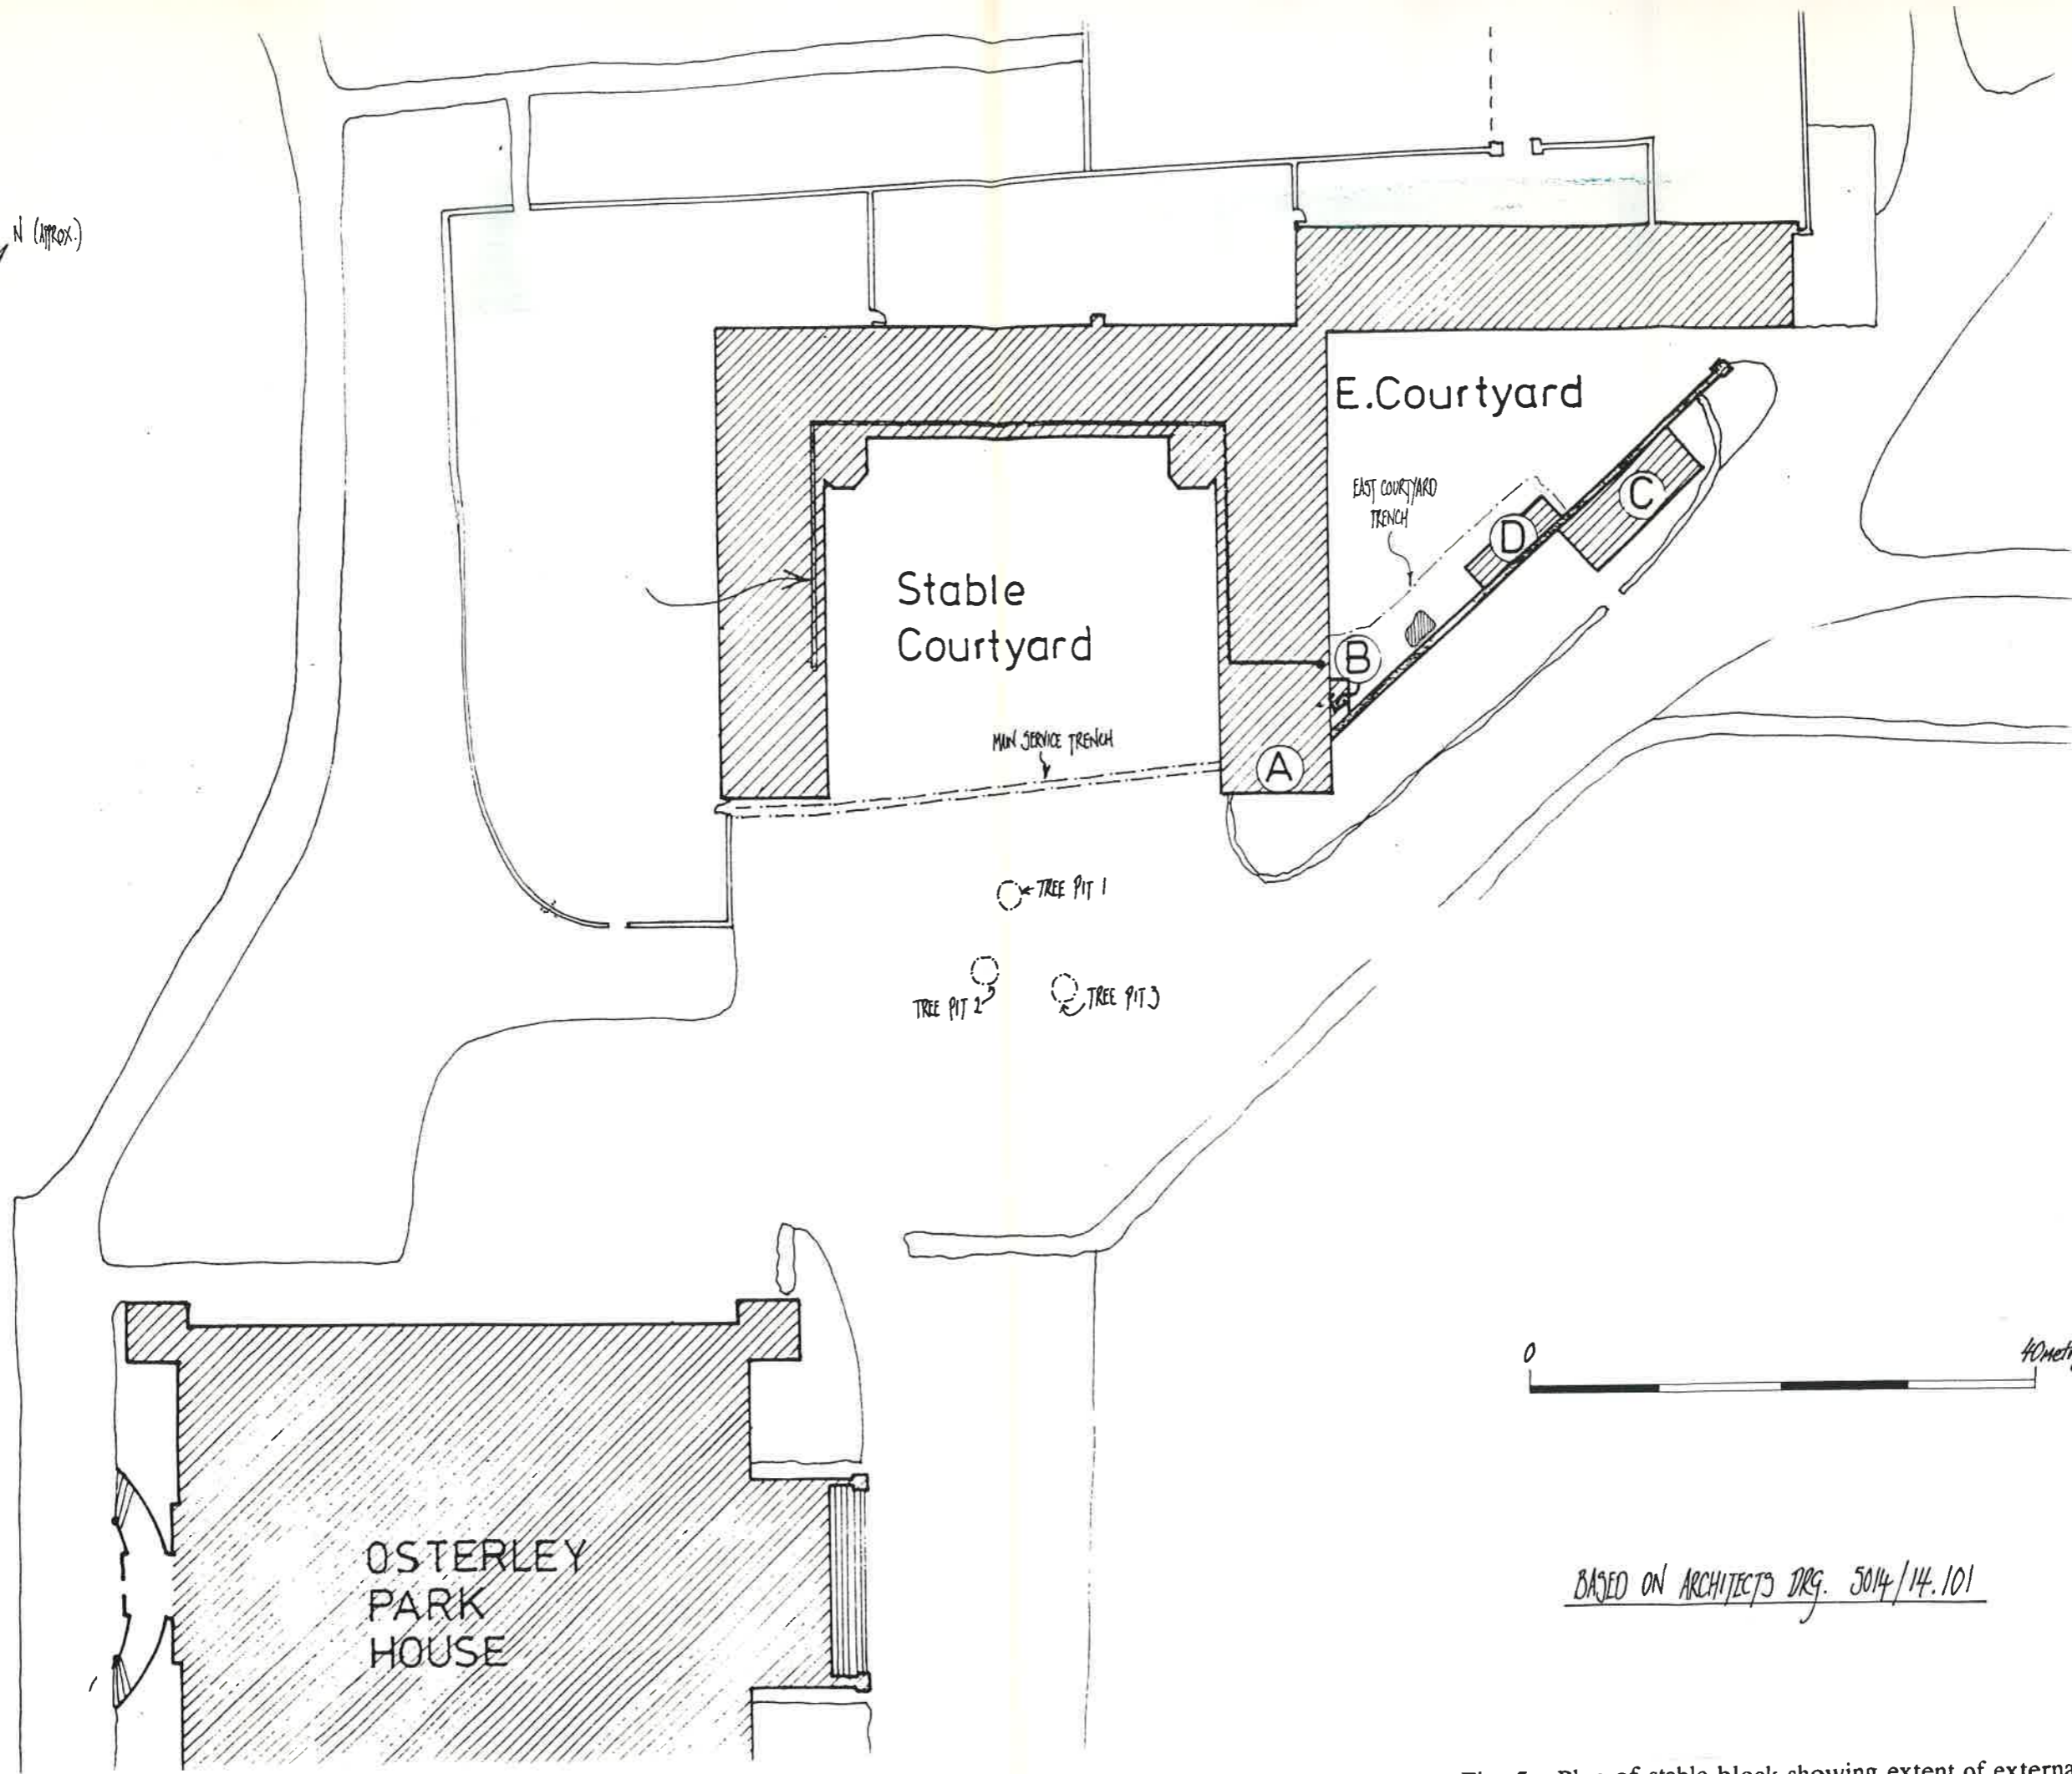
Fig. 5: Plan of stable block showing extent of external construction work.

- 3.1.3 A small area (max. dimensions: 2.1m x 1.2m) of brick paving was encountered adjacent to the garden wall c.7.5m east of the east wing of the stable block and at a depth of c.0.12m below current ground level (see fig. 5). The paving comprised both complete and partial bricks and was of an uneven and well weathered appearance suggesting an exterior surface rather than an internal floor. The long axes of the complete bricks (dimensions: 0.23 x 0.1 x 0.06m) were laid parallel to the garden wall which the surface abutted. The surface is therefore either contemporary with or post dates the existing garden wall which is first depicted in the enclosure map of 1818 (see fig. 3). The bricks used in the paved area are of a similar size to those in the original east wing wall and are distinct from those in the garden wall which have dimensions of 0.20 x 0.06m. The surface is possibly a former east stable yard utilising bricks reused from the original east wing at a time when minor alterations were in progress.

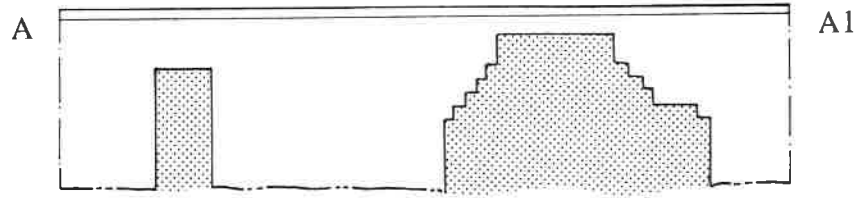
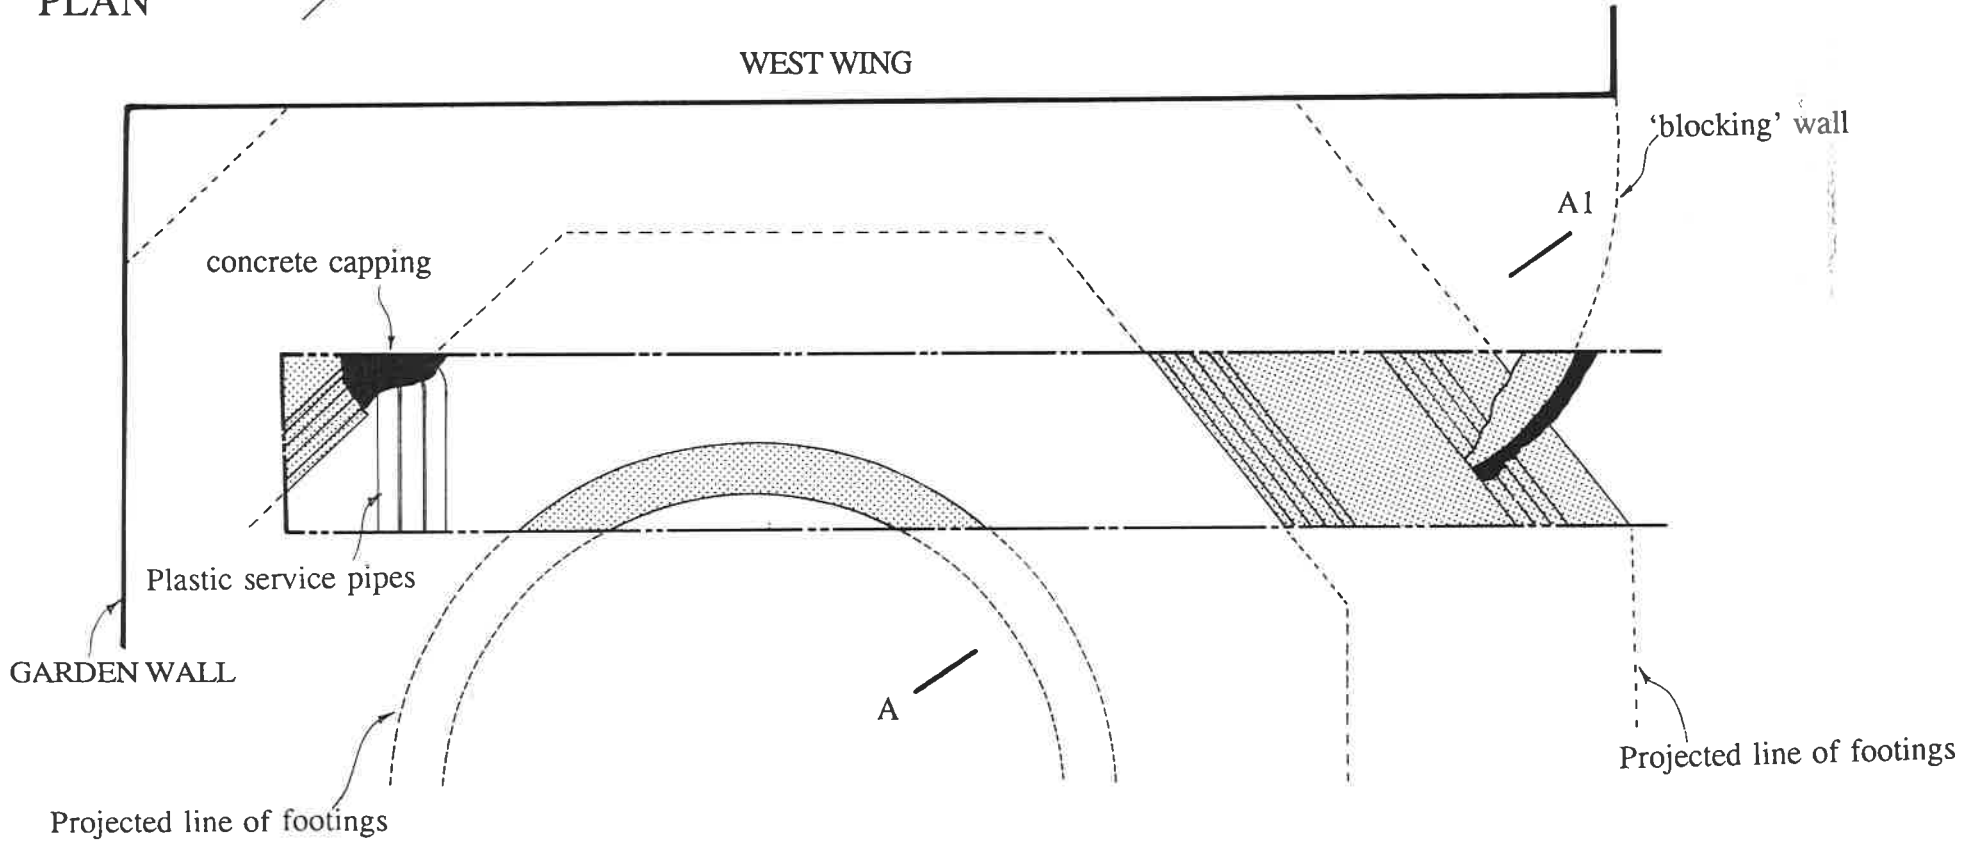
Fig. 6: Plan and representative section of exposed water tower footings.

- 3.2.2 At the western end of the service trench, south of the gable wall of the west wing, substantial wall foundations were exposed (see fig.6) which correspond to walls depicted in the drainage plan of 1879 (fig.4) and tie in with footings recorded by Angus Wainwright during previous watching briefs (1992). The footings represent the remains of an octagonally based water tower extant until at least the later 19th century. Truncated by the laying of the current tarmac yard surface, the footings comprise three courses of wall 0.61m wide built up from a series of five offsets each

one course deep forming a spread foundation with a maximum width of 1.40m. The fourth offset was more substantial to the exterior of the structure. Two related walls of similar construction were located projecting from the gable end of the west wing at angles of 45° and 135° respectively forming two sides of an octagonal structure. Contained within these walls was a circular wall 0.24m wide and extending the full 1.0m depth of the trench in nine courses. To the west, these footings were cut by the insertion of a series of six modern plastic service pipes (0.11m diam.) backfilled with clean sand and capped with concrete. The brick was of a uniform orange/red colouration and dimensions were 0.22 x 0.10 x 0.07m throughout. Built from the eastern of the exposed tower walls was a 'blocking' wall which curved on a line which, projected, would appear to link up with the south-east corner of the west wing. This wall only survived to one course and was built from the level of the first spreader offset.

- 3.2.3 Immediately north-east of the water tower foundations was a small area of cobbling directly below the present tarmac surface and overlying the construction trench for the water tower wall. The cobble sets appeared to be laid perpendicular to the water tower wall and represents a former yard surface, contemporary with the water tower. The full extent of the cobbling was not seen due to disturbance to the north east by services (see 3.2.4).

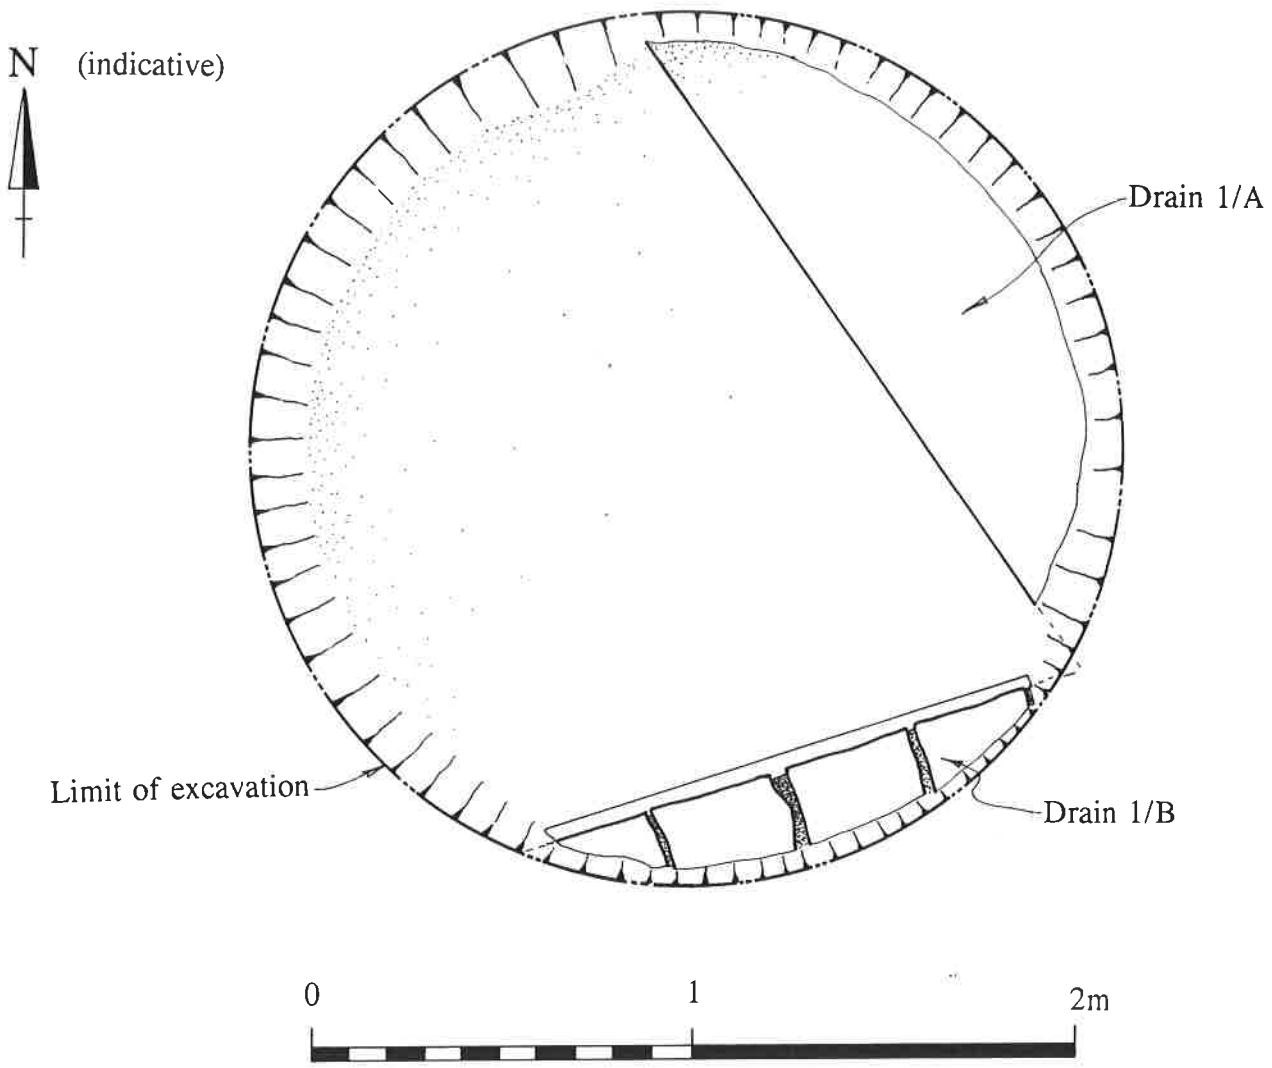
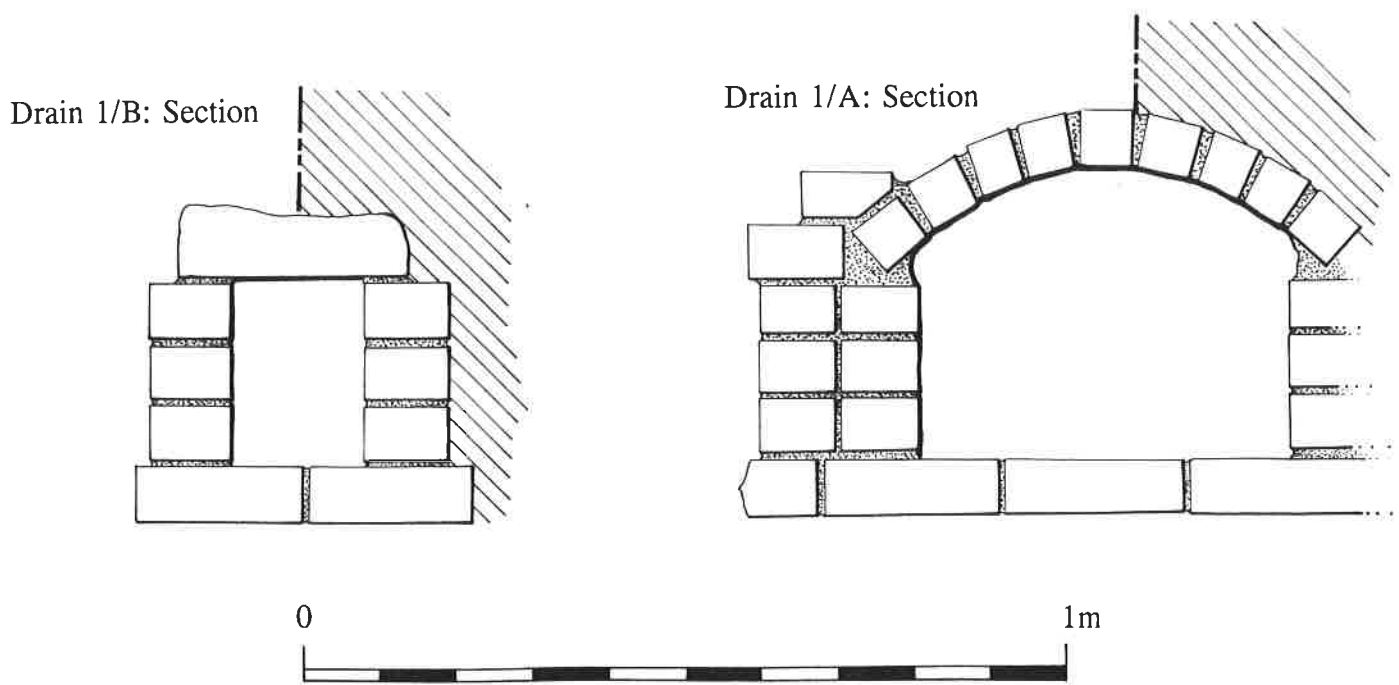
Fig. 7: Tree Pit 1: Plan and comparative drain sections.

Two interconnecting brick-built drains were exposed within the pit at a depth of some 1.24-1.45m below modern ground surface. Drain 1/A was aligned approximately NW-SE draining away from the western stair turret of the stable block (location of the brewhouse). Of brick construction, its internal dimensions were 0.4m (h) x 0.48m (w) and its top was vaulted from a height of 0.24m above base. The brick employed in its construction was of av. size 0.235 x 0.11 x 0.06m and the top of the drain was at a level of 1.24m below modern ground surface. Drain 1/A is the same feature as the drain exposed within the main service trench and drain 3/A exposed in tree pit 3 (see 3.3.3 below). Drain 1/B was partly exposed within the trench and was aligned approximately south-west/north-east. Its internal dimensions were 0.24m (h) x 0.17m (w). The drain walls were again of brick construction (av. size: 0.22 x 0.10 x 0.07m) rising to three courses. Drain 1/B differed from 1/A however, in that its capping comprised various re-used architectural fragments: these included an inverted limestone stair treader and two sculpted greenstone blocks (see fig. 10). Decorative motifs employed on these blocks were Tudor Rose and strapwork stylistically 16th - 17th century. The nature of the stone and high quality preservation of the sculpture, in the Tudor Rose fragment especially, suggest an original internal as opposed to external usage. The divergent angle of mouldings at the base of the Tudor Rose fragment suggests a possible original function of a doorway or fireplace surround, while the strapwork fragment probably formed part of a decorative frieze. Drains 1/A and 1/B were noted to be inter-connecting. Both were partially dismantled and recorded prior to planting and backfilling. The architectural fragments were salvaged and have since been returned to the National Trust at Osterley Park House.

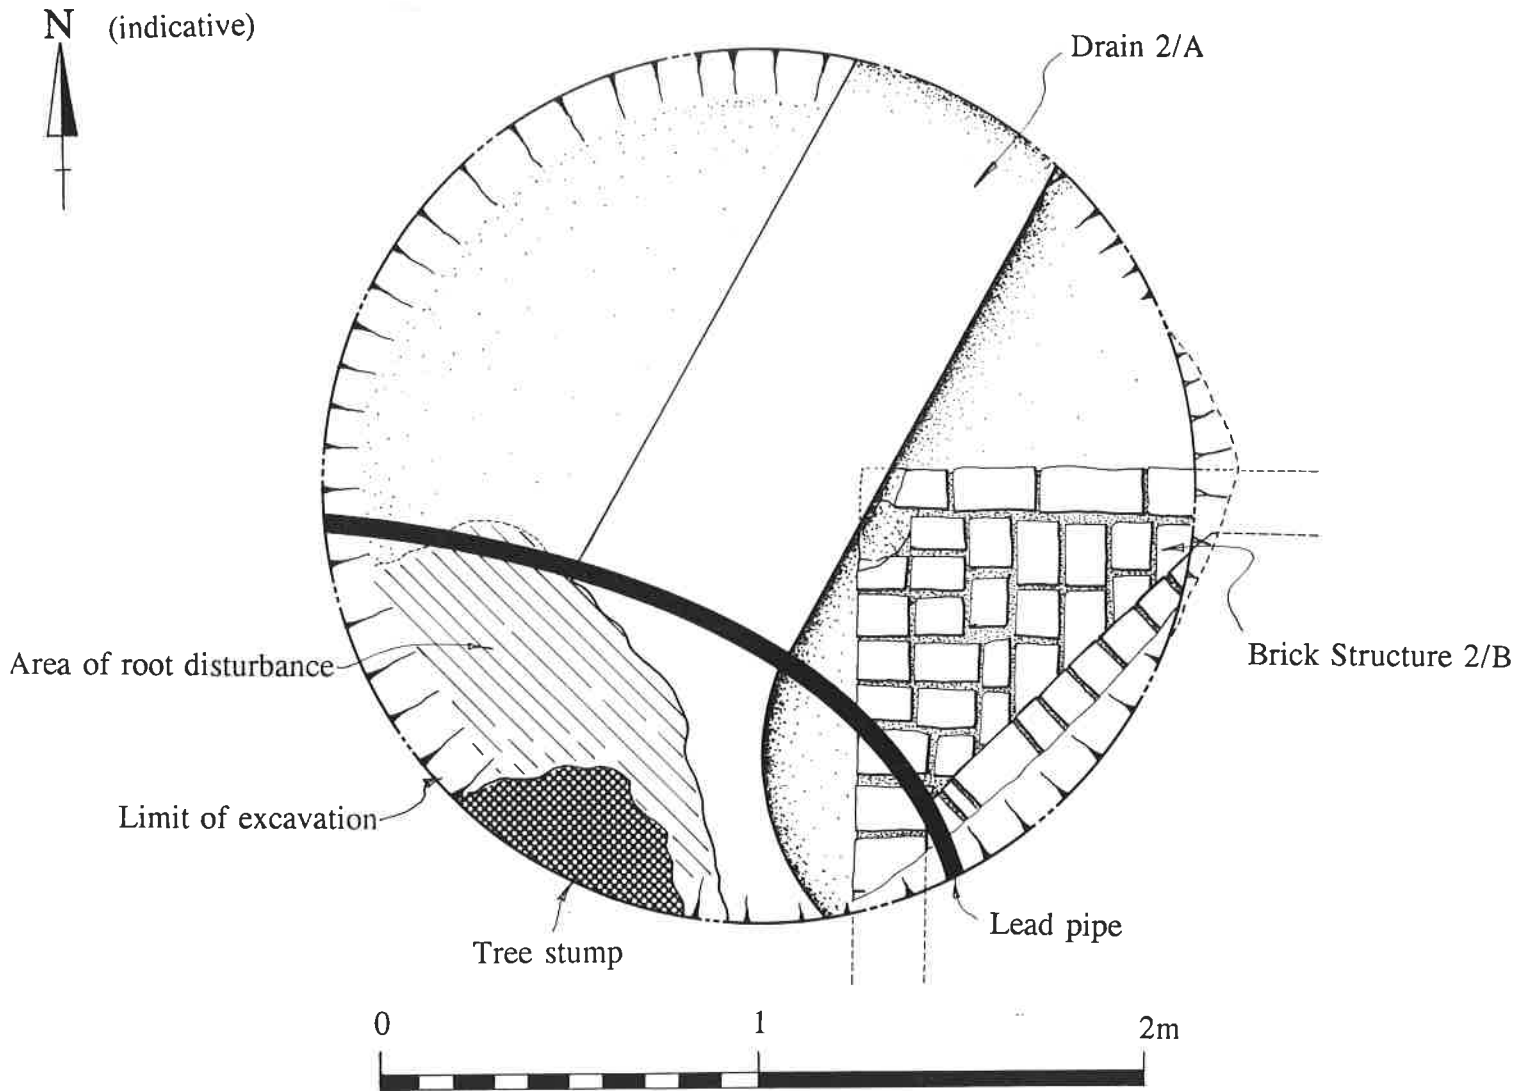
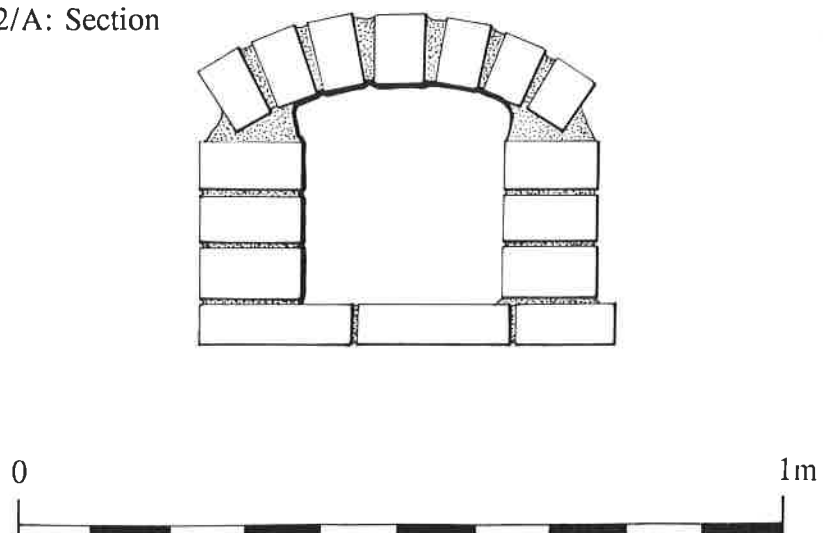
Fig. 8: Tree pit 2: Plan and drain section.

A brick built drain 2/A ran across the pit aligned approximately N-S at a depth of -0.69m below ground surface. To the southern side of the pit, the drain curved eastwards though it had been disturbed at this point by lead piping and as a result of extensive root action (see fig. 8). The drain had internal dimensions of 0.26m (w) x 0.27m (h) with straight sides of three courses and a vaulted top from a height of 0.23m above base. The brick size was av. 0.22 x 0.14 x 0.07m. Drain 2/A was recorded and dismantled prior to planting and backfilling. Drain 2/A in turn cut a large brick built structure (2/B) to the east. This structure comprised a square or rectangular brick base atop which was constructed a solid brick built platform surviving to three courses in height. The face of the platform exposed within the trench was set at an angle of 45° to the rectangular base suggesting a possible octagonal plan. Unfortunately, the partial exposure of this structure within the excavated tree-pit does not allow for full interpretation of its nature and extent, though the possibility exists that it may represent some form of decorative garden feature located near centrally within the mouth of the stable yard. Structure 2/B was left *in situ* prior to planting and backfilling of the pit.

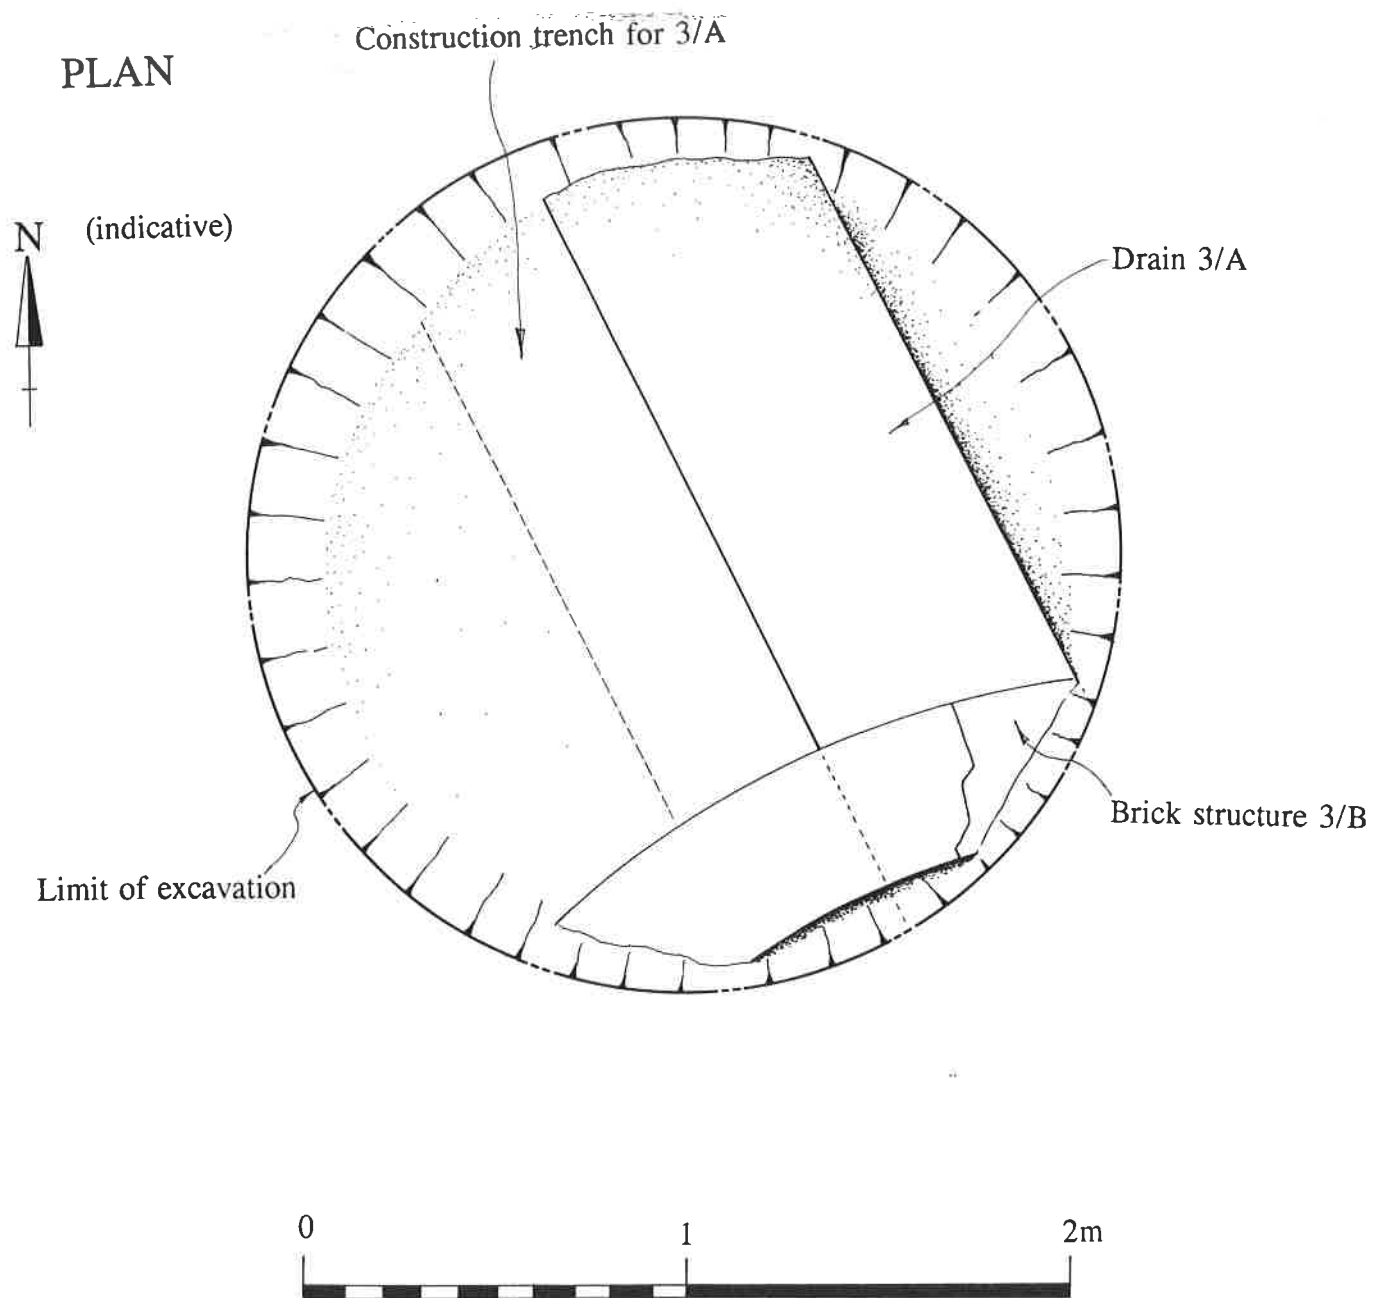
Fig. 9: Tree pit 3: Plan.

At a level of -0.42 m from yard surface, a straight brick built wall comprising only one course was encountered running across the tree-pit on a NE-SW alignment. This feature was in isolation and no related deposits were identified. Its function is unclear. At a level of -1.40m a brick built drain 3/A was exposed running NW-SE and was seen to be the same feature as drain 1/A and the brick drain exposed in the main service trench. Comparative levels at the three exposed sections of the feature confirmed that it drained away from the stable blocks. The construction trench for the laying of drain 3/A was clearly discernible to the W and rubble infill of this trench formed the fill of much of the tree-pit. At the SE of the tree-pit, drain 3/A was seen to run below a small section of curving (?circular) wall (structure 3/B) extending beyond the excavated pit to both S and E (see fig. 9). This footing survived to a maximum of two courses. Again, due to limited exposure within the excavated pit, interpretation was not possible. Features 3/A and 3/B were left *in situ* prior to planting and backfilling of the pit.

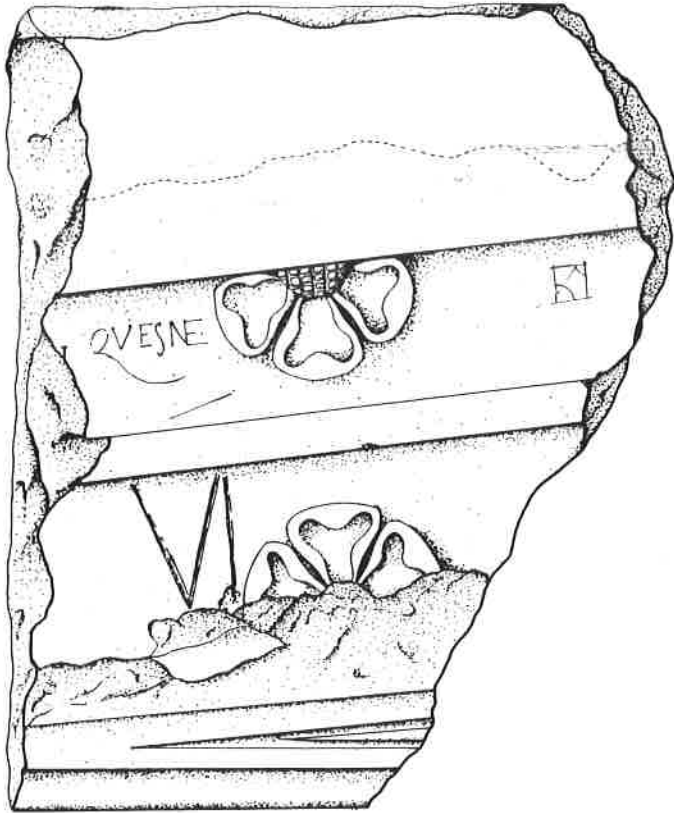
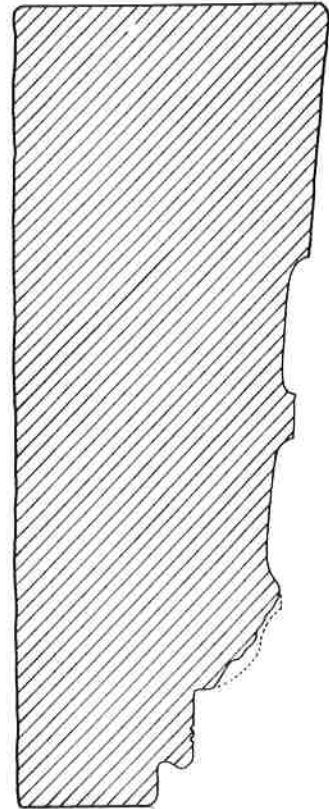
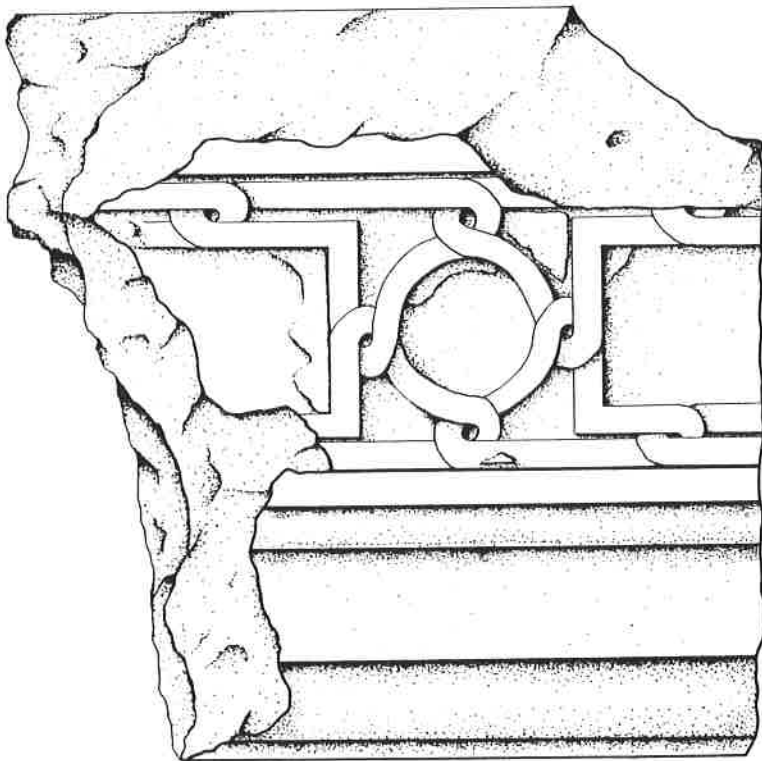
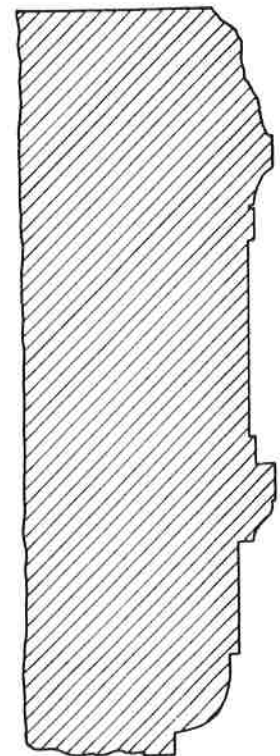
Fig. 10: Details of architectural fragments (capstones to drain 1/B).

- 4.2 The series of hard features and deposits described in 3.3 above appear to represent a former drainage layout to the stable blocks, probably dating to the late 17th or 18th centuries. The discovery of (?)16th century architectural fragments used in the capping of drain 1/B is of particular interest, these possibly originating in the main house, being re-used at a time of internal renovation, though not necessarily at the Adam stage.
- 4.3 The uncovering of the greenhouse footings (3.4 above) in the walled kitchen garden serves to highlight gaps in our understanding of the development of this part of the stable grounds. Further interventions should be monitored closely to clarify the layout and development of this area which is not well documented.

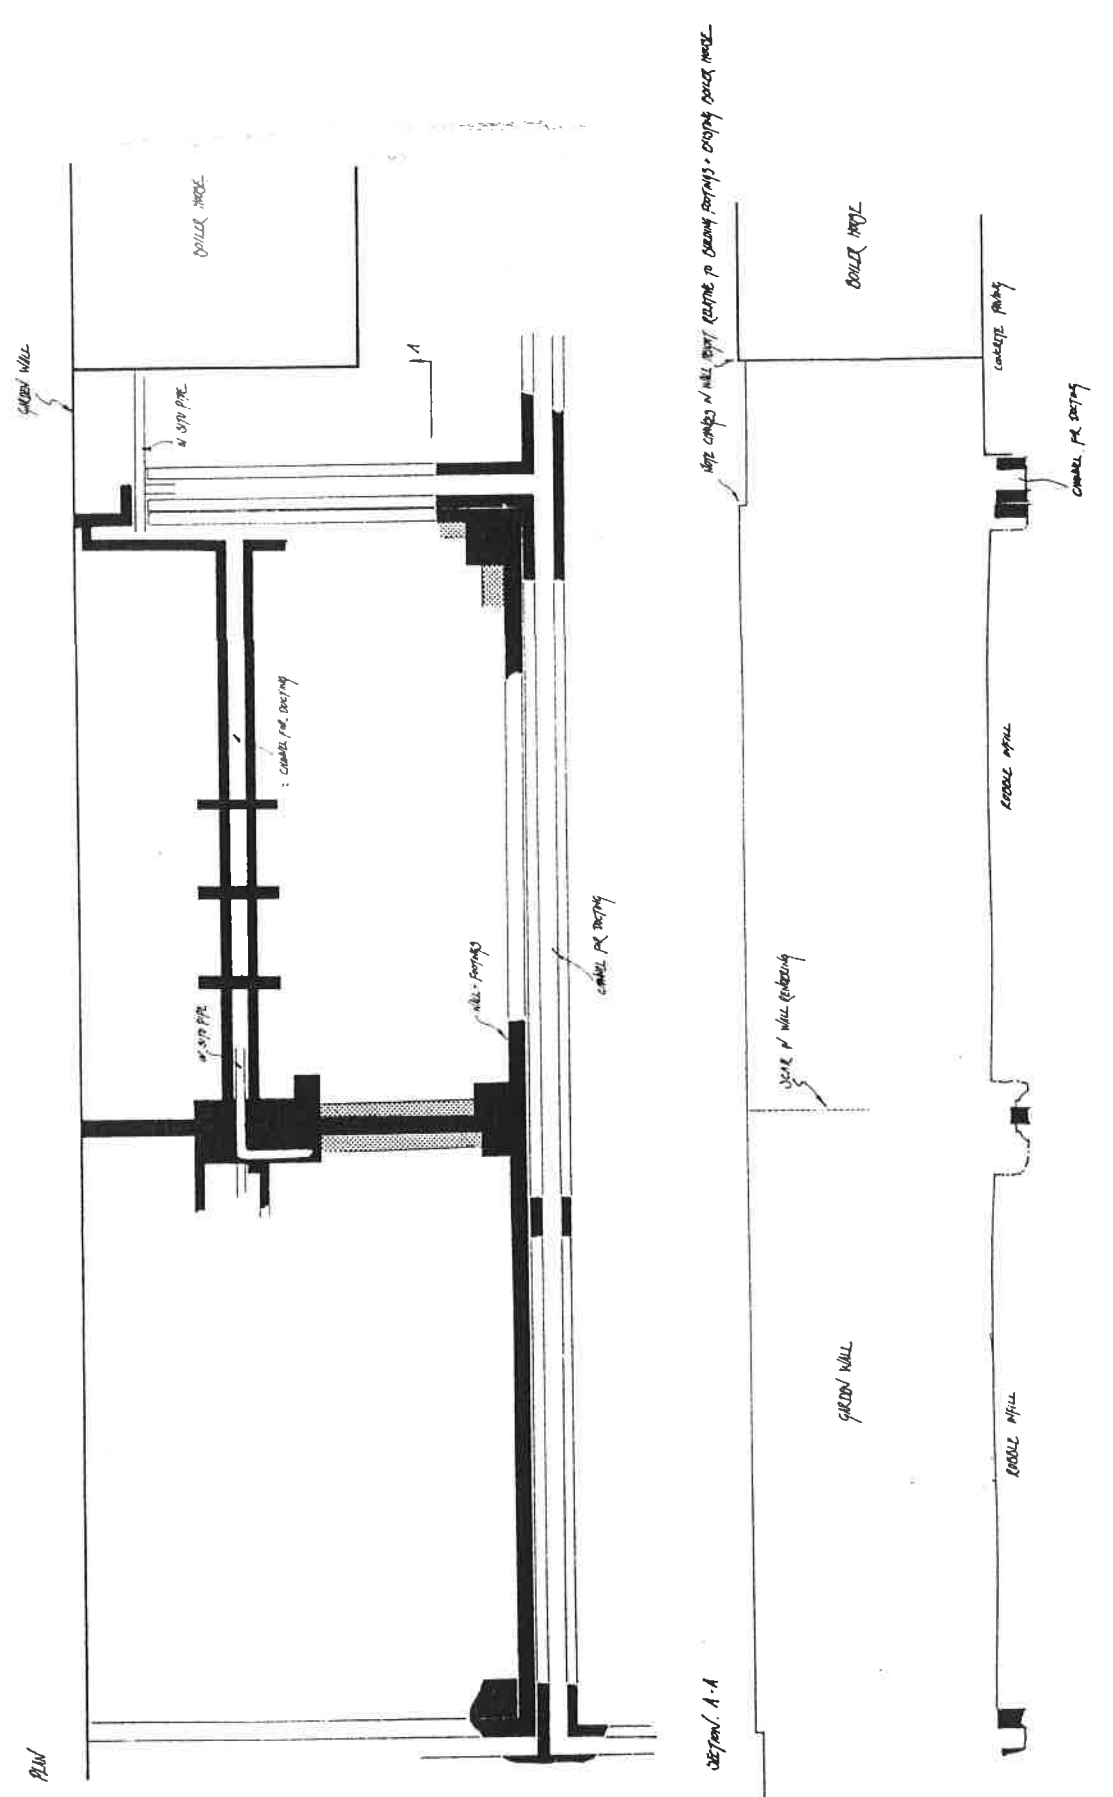
Fig. 11: Plan of exposed greenhouse footings.

- 3.4.2 The footings represent the remains of a building 5.8m x c.16m against the east wall of the walled garden to the north of the existing boiler house. Around the exterior of the building runs a brick built channel for warm air ducting (fragments of pipe survive *in situ* in places) which runs to the boiler house though it is not connected to the present boiler. A second ducting channel runs up the interior of the building. At the northern end of the building the exterior ducting channel appears to divert westwards, so the possibility exists of another greenhouse or related building to the west of the exposed footings. The walls, footings and ducting channels survive in places to a depth of 4 or 5 courses. The two east-west walls appear to abut the main garden wall which suggests that the greenhouse was a later addition. It was noted that changes in height of the garden wall appear to relate to the presence of buildings built against it (in the case of the standing boiler house and the exposed footings) and for this reason it seems reasonable to suppose that another building existed to the north of the exposed footings where a further rise in wall height was noted.

- 3.4.3 During the excavation of the foundation trenches it was confirmed that a further greenhouse or related building existed to the west of the exposed footings (as was suggested by the diversion of the ducting channel at the north western limit of the greenhouse), brick built footings being exposed in the southern foundation trench section. The full western extent of these additional footings was not exposed within the excavated trench.
