**St Marys Church, Bletchley
Buckinghamshire**

Report on Watching Brief

THE OXFORD ARCHAEOLOGICAL UNIT

January 1996

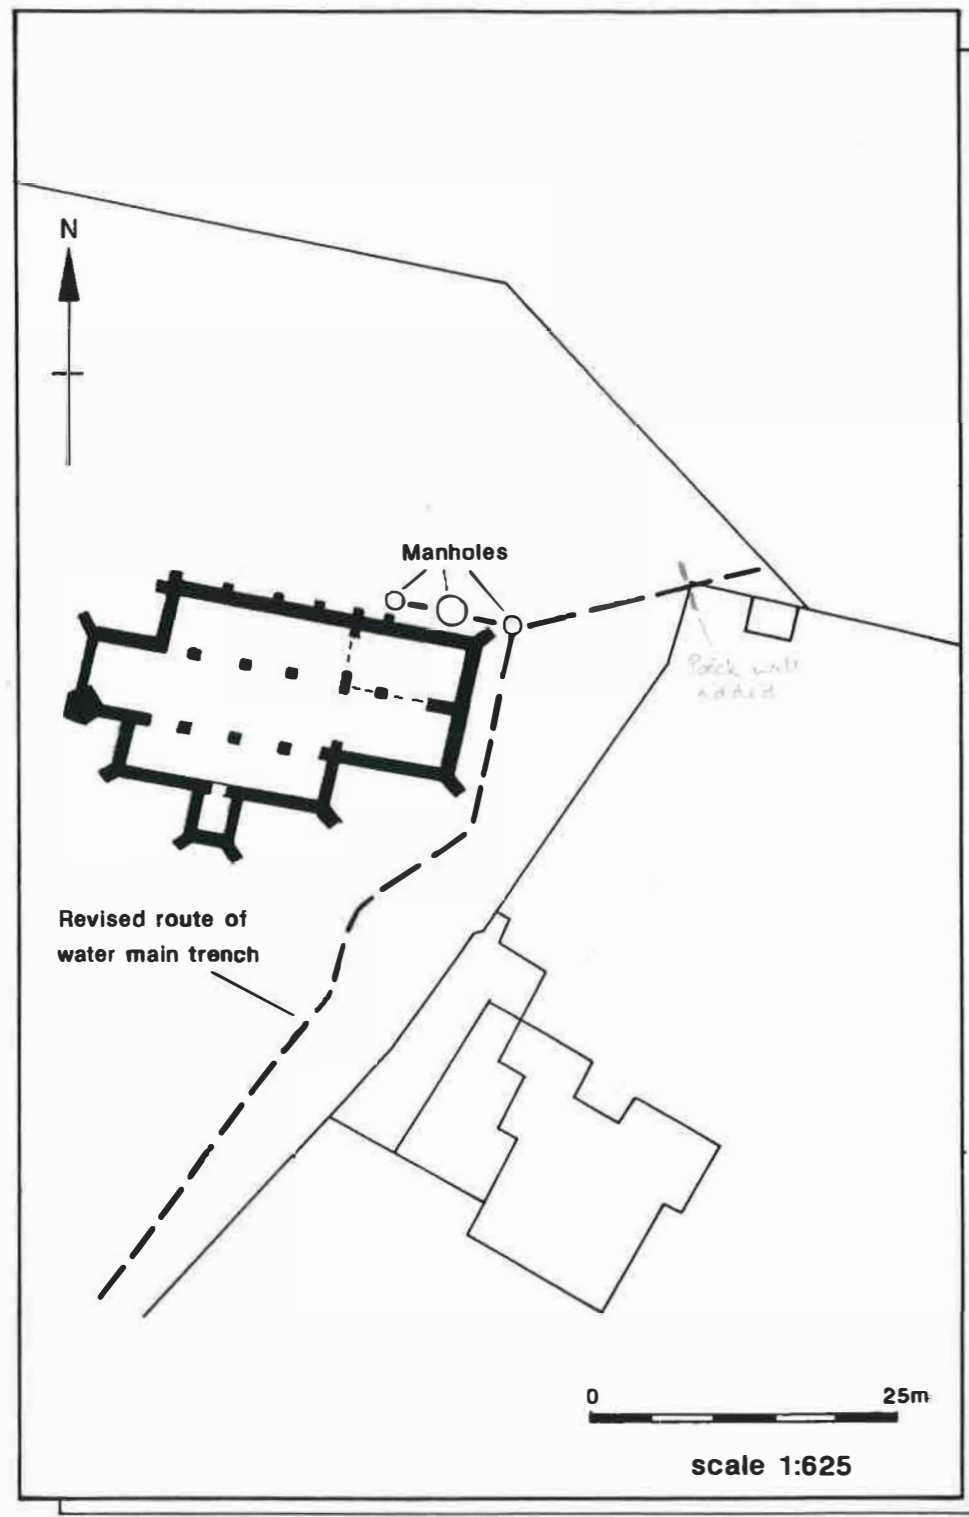
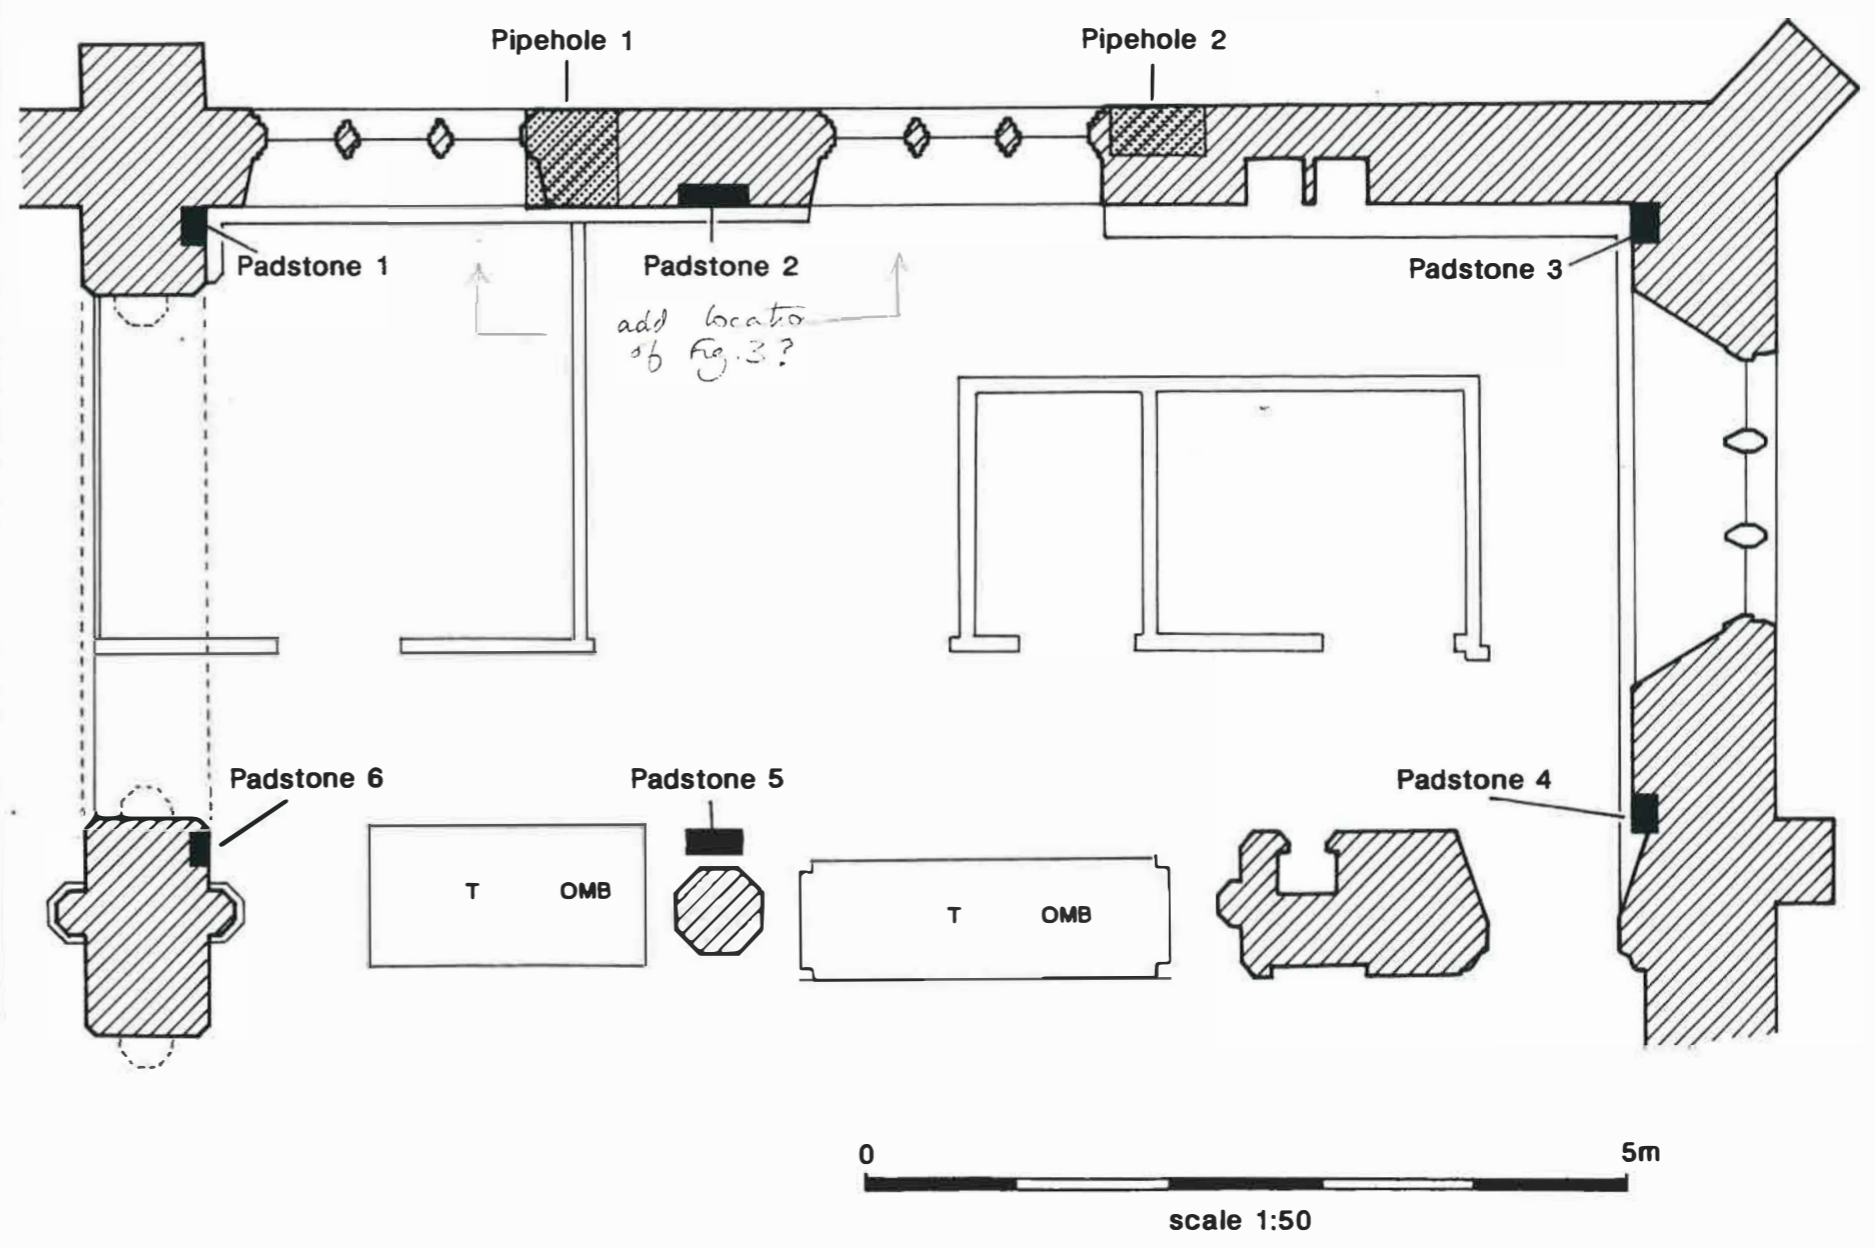
Figure 2

The Chapel (see Fig. 2 for location of padstone and pipeholes)

External Service Trenches (Fig. 2)

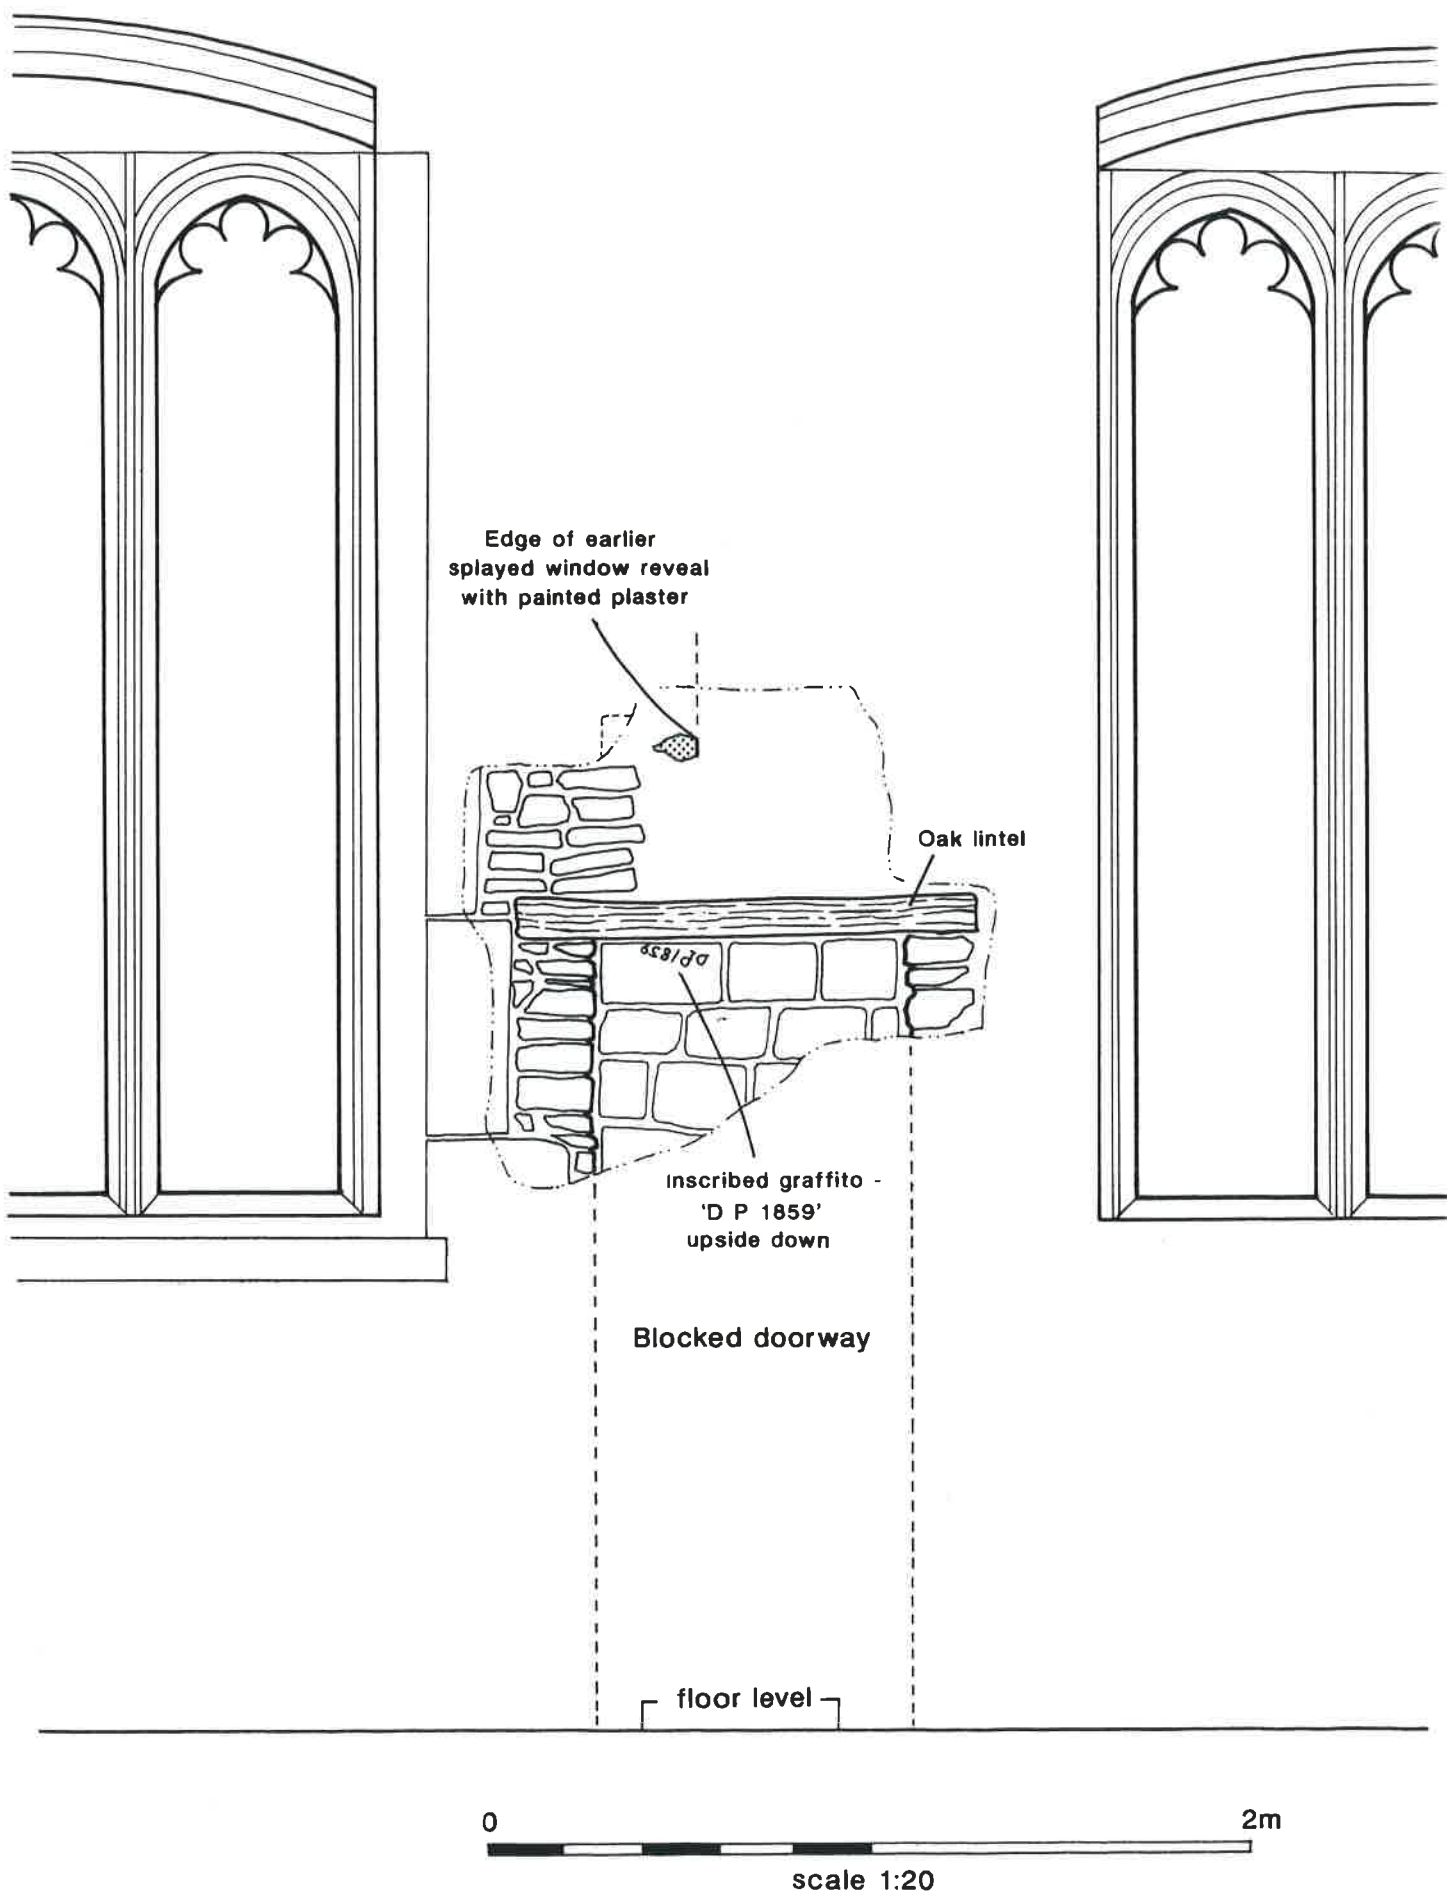
Figure 3

Padstone hole 2 (Fig. 3)

This hole was positioned between the two existing windows in the north wall, and in addition to the actual padstone hole, an area of plaster was removed around it to exposed a surface area approximately 1.2m x 1.2m in size. The creation of this hole revealed the existence of an oak lintel built into the wall some 2.10m above the present floor level, and in the stonework beneath the lintel were two straight joints, 800mm apart. This features therefore appeared to be a blocked in doorway and it is noticeable that this feature is centrally located between the two existing windows. One of the stones used in the blocking was inscribed with graffiti depicting the inscription D.P. 1859 (Fig. 4). However, the inscription was upside down, and therefore the stone was obviously reused, revealing that the blocking up of the doorway must have occurred after this date.

In the area of wall exposed above the doorway another vertical straight joint was visible in the stonework, and in the gap between the straight joint it was just possible to observe an area of red, black and white plaster work covering the west facing section of the joint. This feature is almost certainly the remains of an earlier, splayed, window, a small remnants of which can also be seen in the stonework on the external face of the wall.
