ST Michael and
All Angels Church
Letcombe Bassett
Oxfordshire

Historic Building Recording

December 2005

Document Type: Historic building investigation and recording
Issue Number: 1

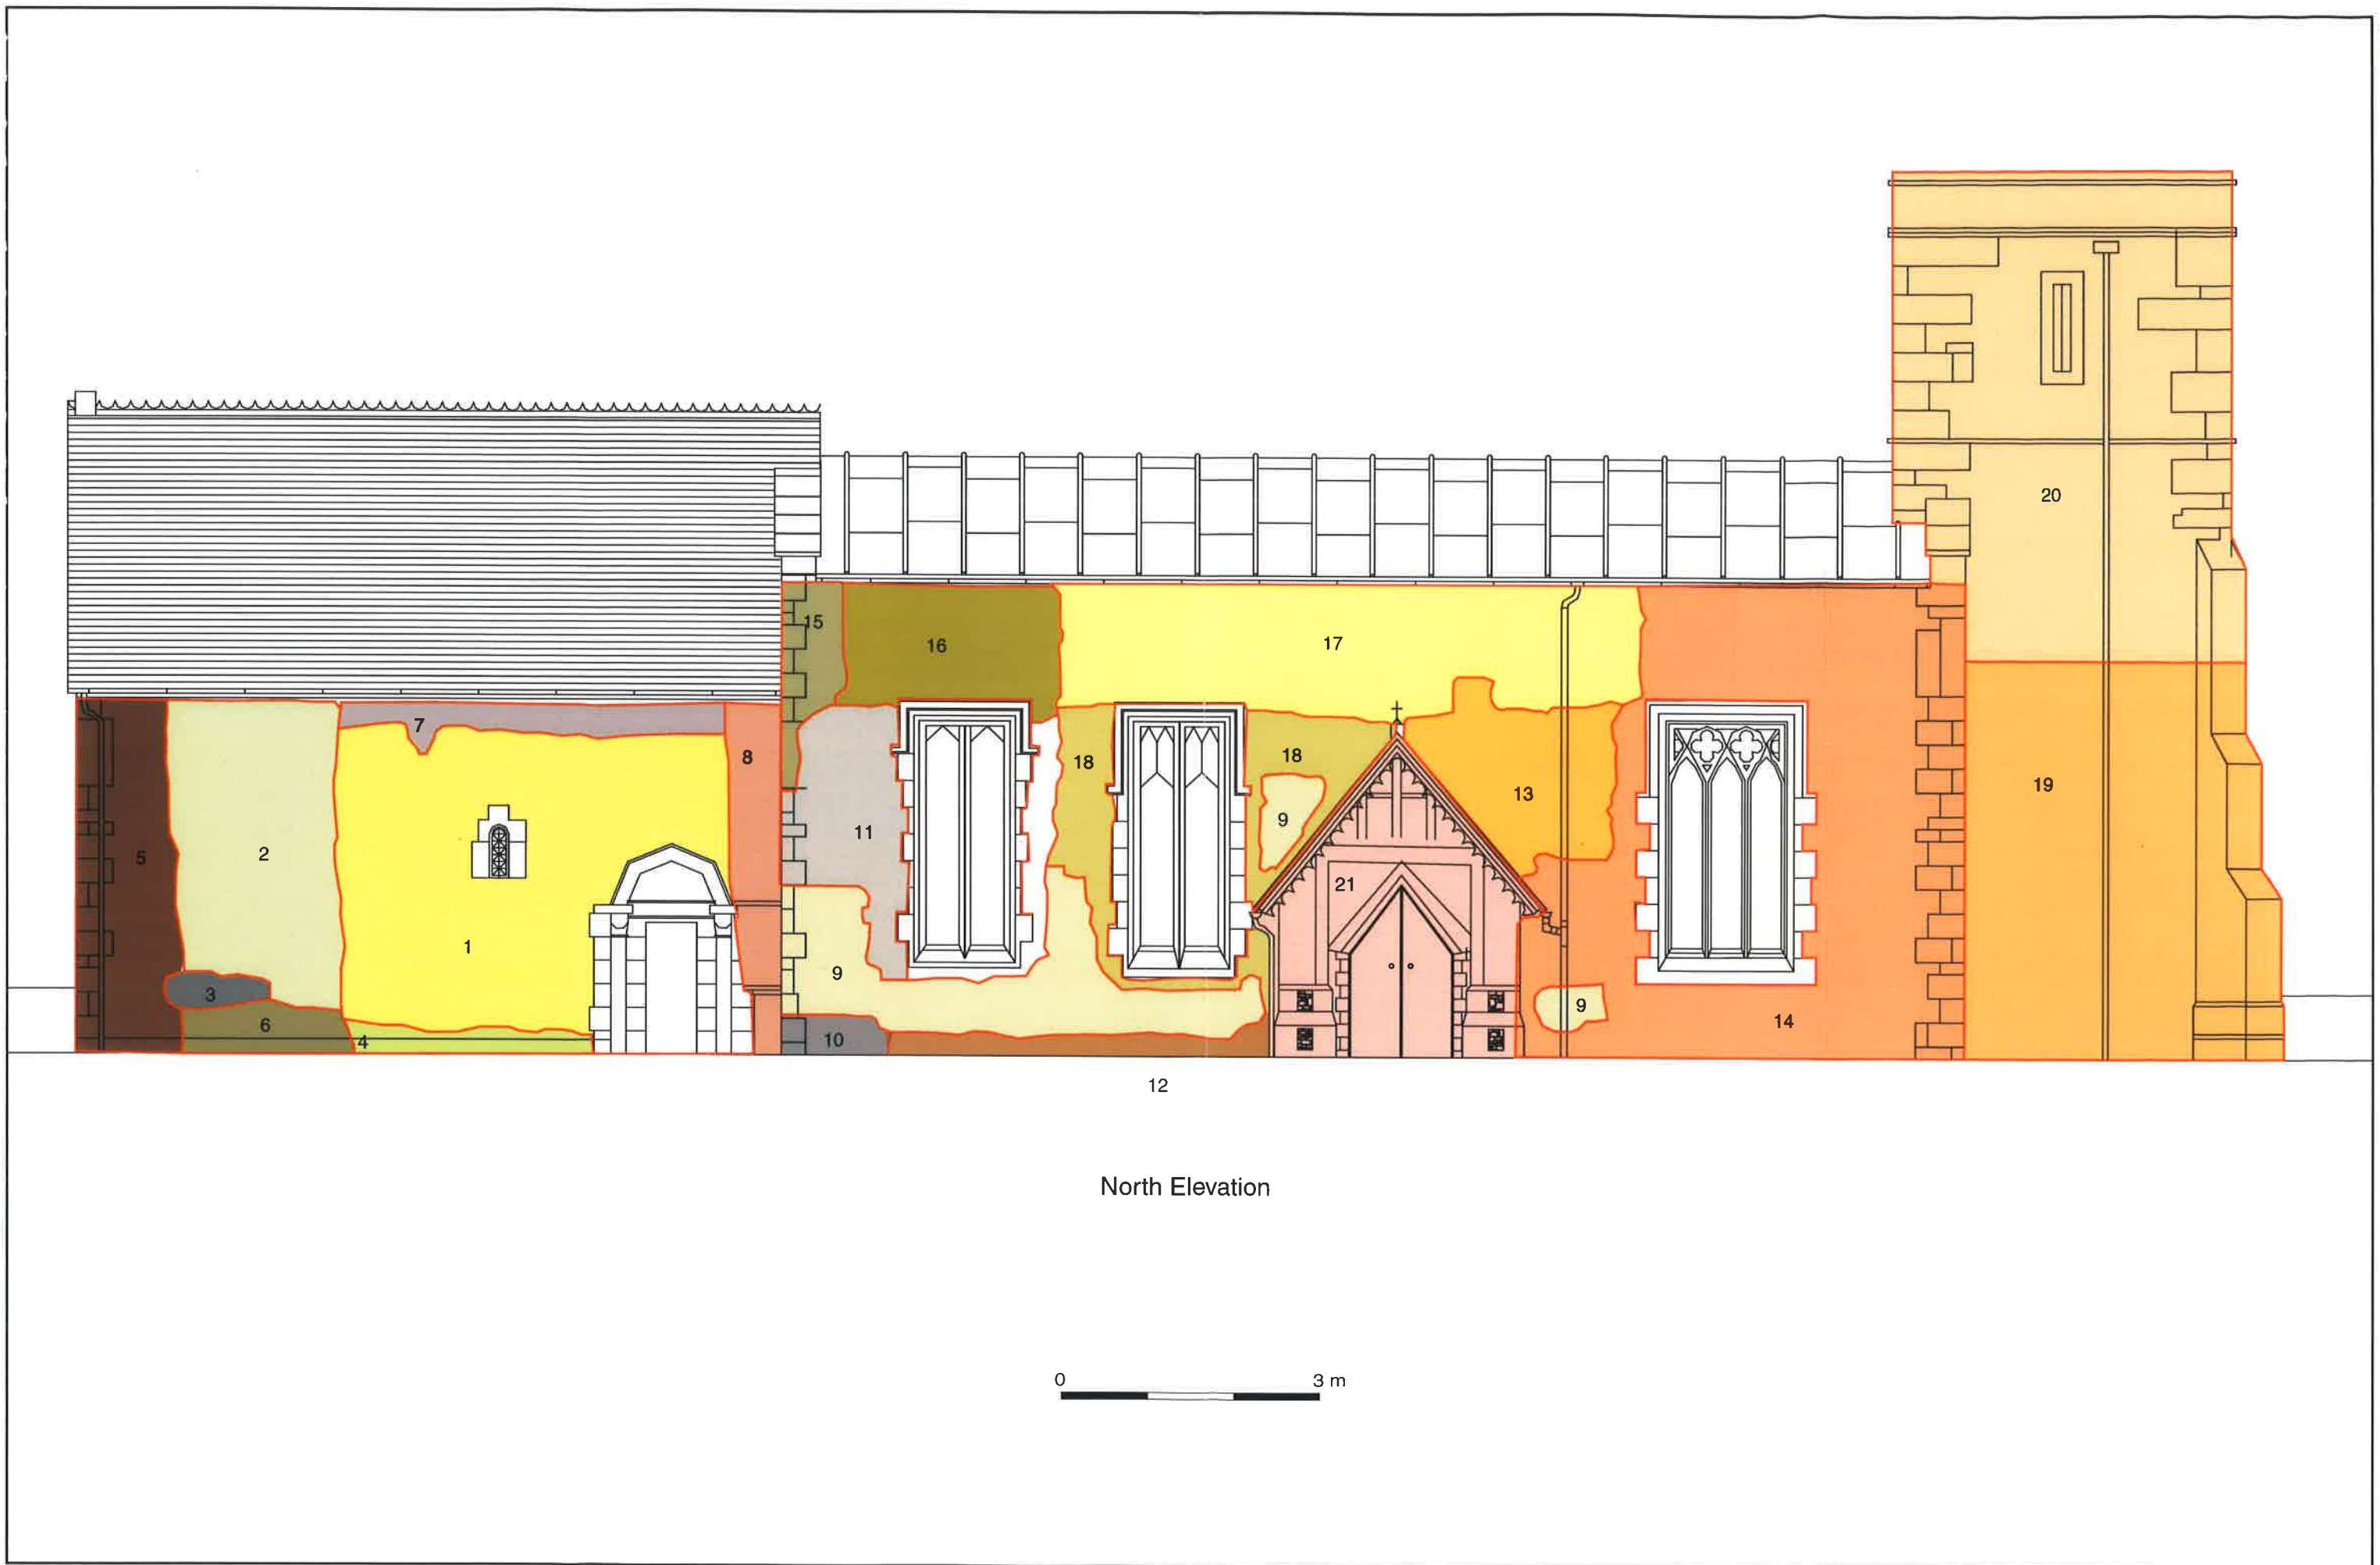
Figure 3: North elevation showing wall contexts

- 3.2.4 ***Evidence revealed by render removal:*** The clearest and most significant evidence revealed by the removal of render from the chancel wall is a straight joint two-thirds of the way along the wall towards the east. The older part of the wall (the western two-thirds containing the 12th-century window and door) is formed of flint set in a dark ochre coloured soft mortar with flint speckles and some hairs but no straw [1]. The flint is not squared or faced and is of various sizes (average c.15 cm x 10 cm). It is generally roughly coursed but uncoursed in patches and it contains a number of chalk blocks apparently randomly mixed in. The 12th-century door and window are of the same phase as this wall. The lower c.40 cm of the wall is of a distinct construction (although there is not a clearly defined horizontal joint) with a lighter mortar [4]. The flint construction is similar to the wall above and it is likely to all be primary but having used a different mortar mix for the base.

- 3.2.9 The north elevation of the nave is more complicated and has more distinct contexts than the chancel. The most significant feature of the elevation is the fact that there are three distinct patches of the wall [9] which appear to be identical to the primary wall of the chancel, both in terms of the main construction material (uncoursed flint) and the mortar used to bond it (soft, ochre coloured). This implies that the nave is contemporary with the chancel although it has been much altered since its original construction.

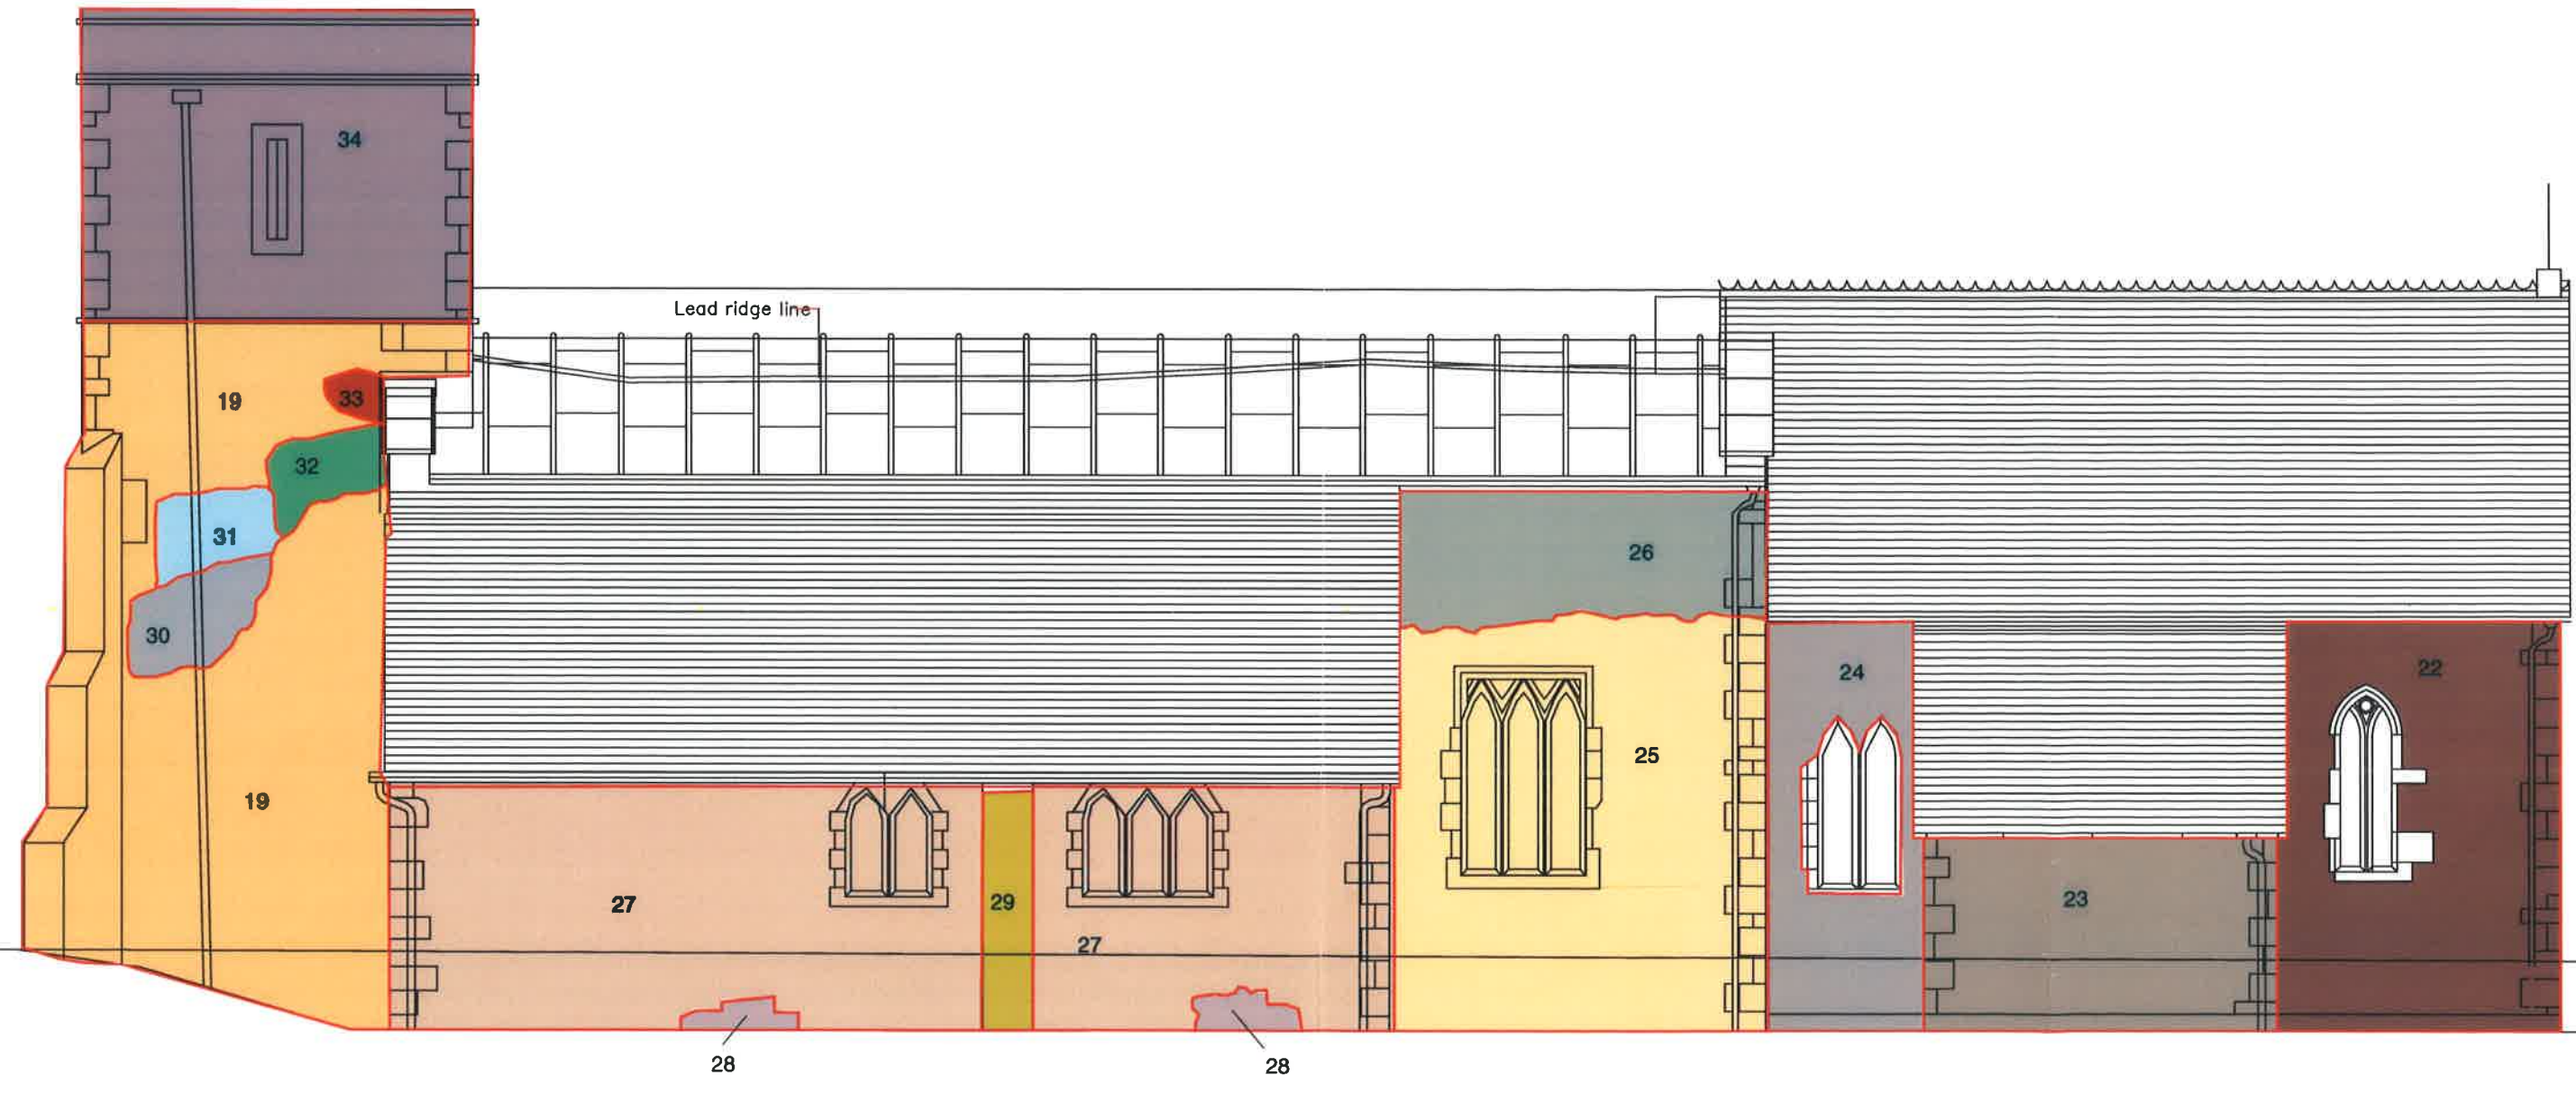
Figure 4: South elevation showing wall contexts

- 3.3.4 ***Evidence revealed by render removal:*** As detailed above the eastern third of the chancel is known to be a later addition (possibly in the late 13th century) and this is confirmed by the removal of render from the south wall of the chancel to the east of the vestry lean-to [22]. This has shown that the construction of this wall is the same as the east elevation of the chancel and the eastern part of the north wall with relatively regular chalk blocks of various sizes (eg 20 cm x 15 cm).

- 3.3.7 Immediately west of the chancel is the only surviving (and externally visible) section of the primary nave wall. Removal of render from this c.4 m wide section has shown that there is a clear constructional division between the main lower part of the wall and the upper c.1.5 m. The lower part of the wall [25] appears to be substantially the primary wall (albeit heavily patched up) and is of similar construction to the north face of the chancel. It comprises non-squared and non-faced flint nodules roughly coursed and laid with a soft ochre colour mortar. Although the wall is believed to be largely primary it is obscured in several areas by later patching including many bricks, stones and reused flint mixed in and with a later mortar (light grey/white) which bonds the later elements and hides much of the primary mortar. The upper part of this section of the wall or context [ie upper part of 25] has a large patch of flints very roughly compacted together without any attempt at coursing which suggests that the top of the original wall may have collapsed and it was roughly rebuilt reusing the same flints but without the original coursing. The window within [25] has a number of chalk infill blocks surrounding it and although there is surprisingly little mortar immediately around the window

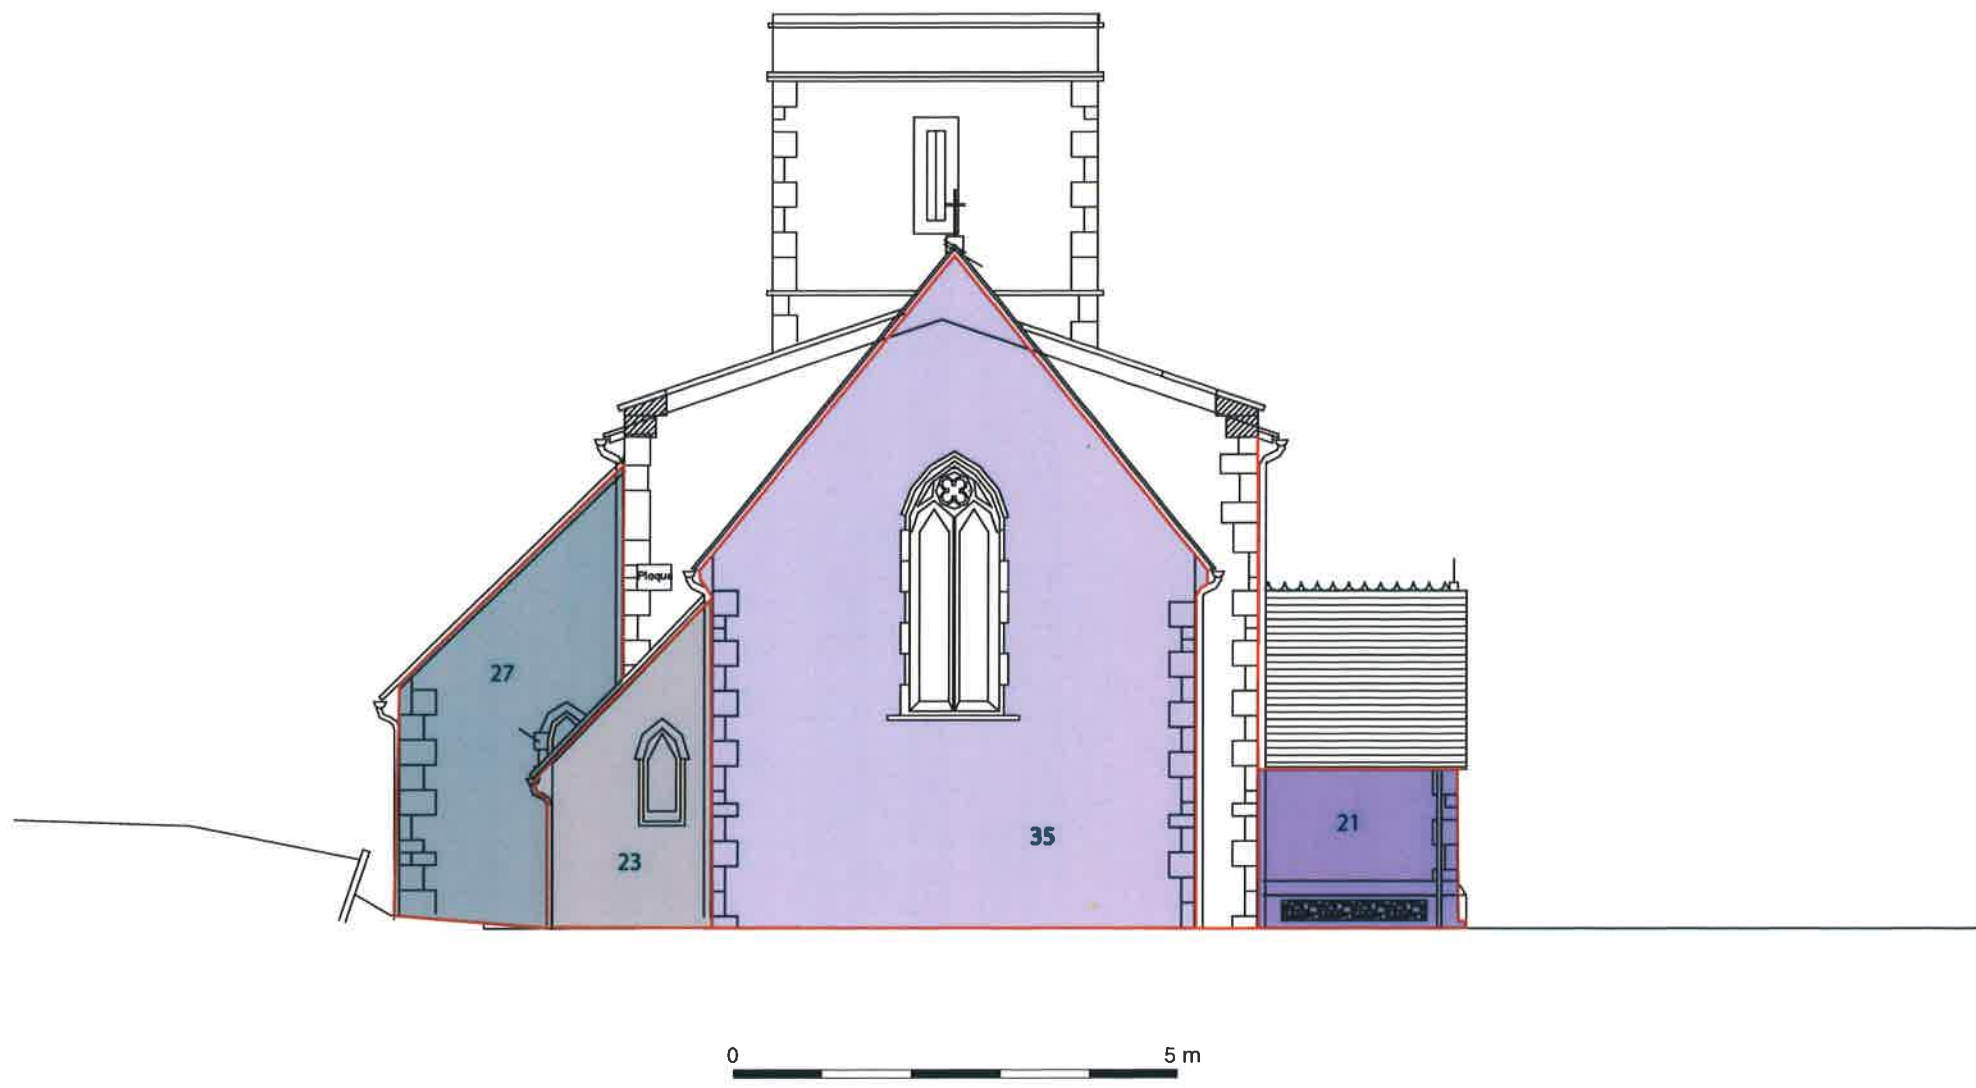
Figure5: East elevation showing wall contexts

- 3.4.2 **Evidence revealed by render removal:** Beneath the 20th-century render the east elevation of the chancel is almost entirely of a single phase construction [35] the same as the eastern end of the north and south elevations. It clearly dates to the extension of the chancel referred to previously possibly undertaken in the 13th century. It is of chalk blocks of various sizes roughly coursed in some areas and uncoursed in others. The blocks are roughly squared but as elsewhere many of the blocks have lost their faces (possibly frost damage). The main distinction in the sizes of the blocks is that those in the lower part of the elevation (beneath the window) are generally larger to make the wall more stable. In addition those stones at the northern and southern ends of the wall are generally larger to increase the stability of the corners of the building so therefore there are 'panels' of smaller, flatter stones either side of the window and towards the apex of the gable. From the construction and mortar of the jambs and sill the window appears primary to this wall. The only secondary features in the wall are a few isolated holes (some put logs) which have been infilled with bricks and cement mortar. Unlike those at

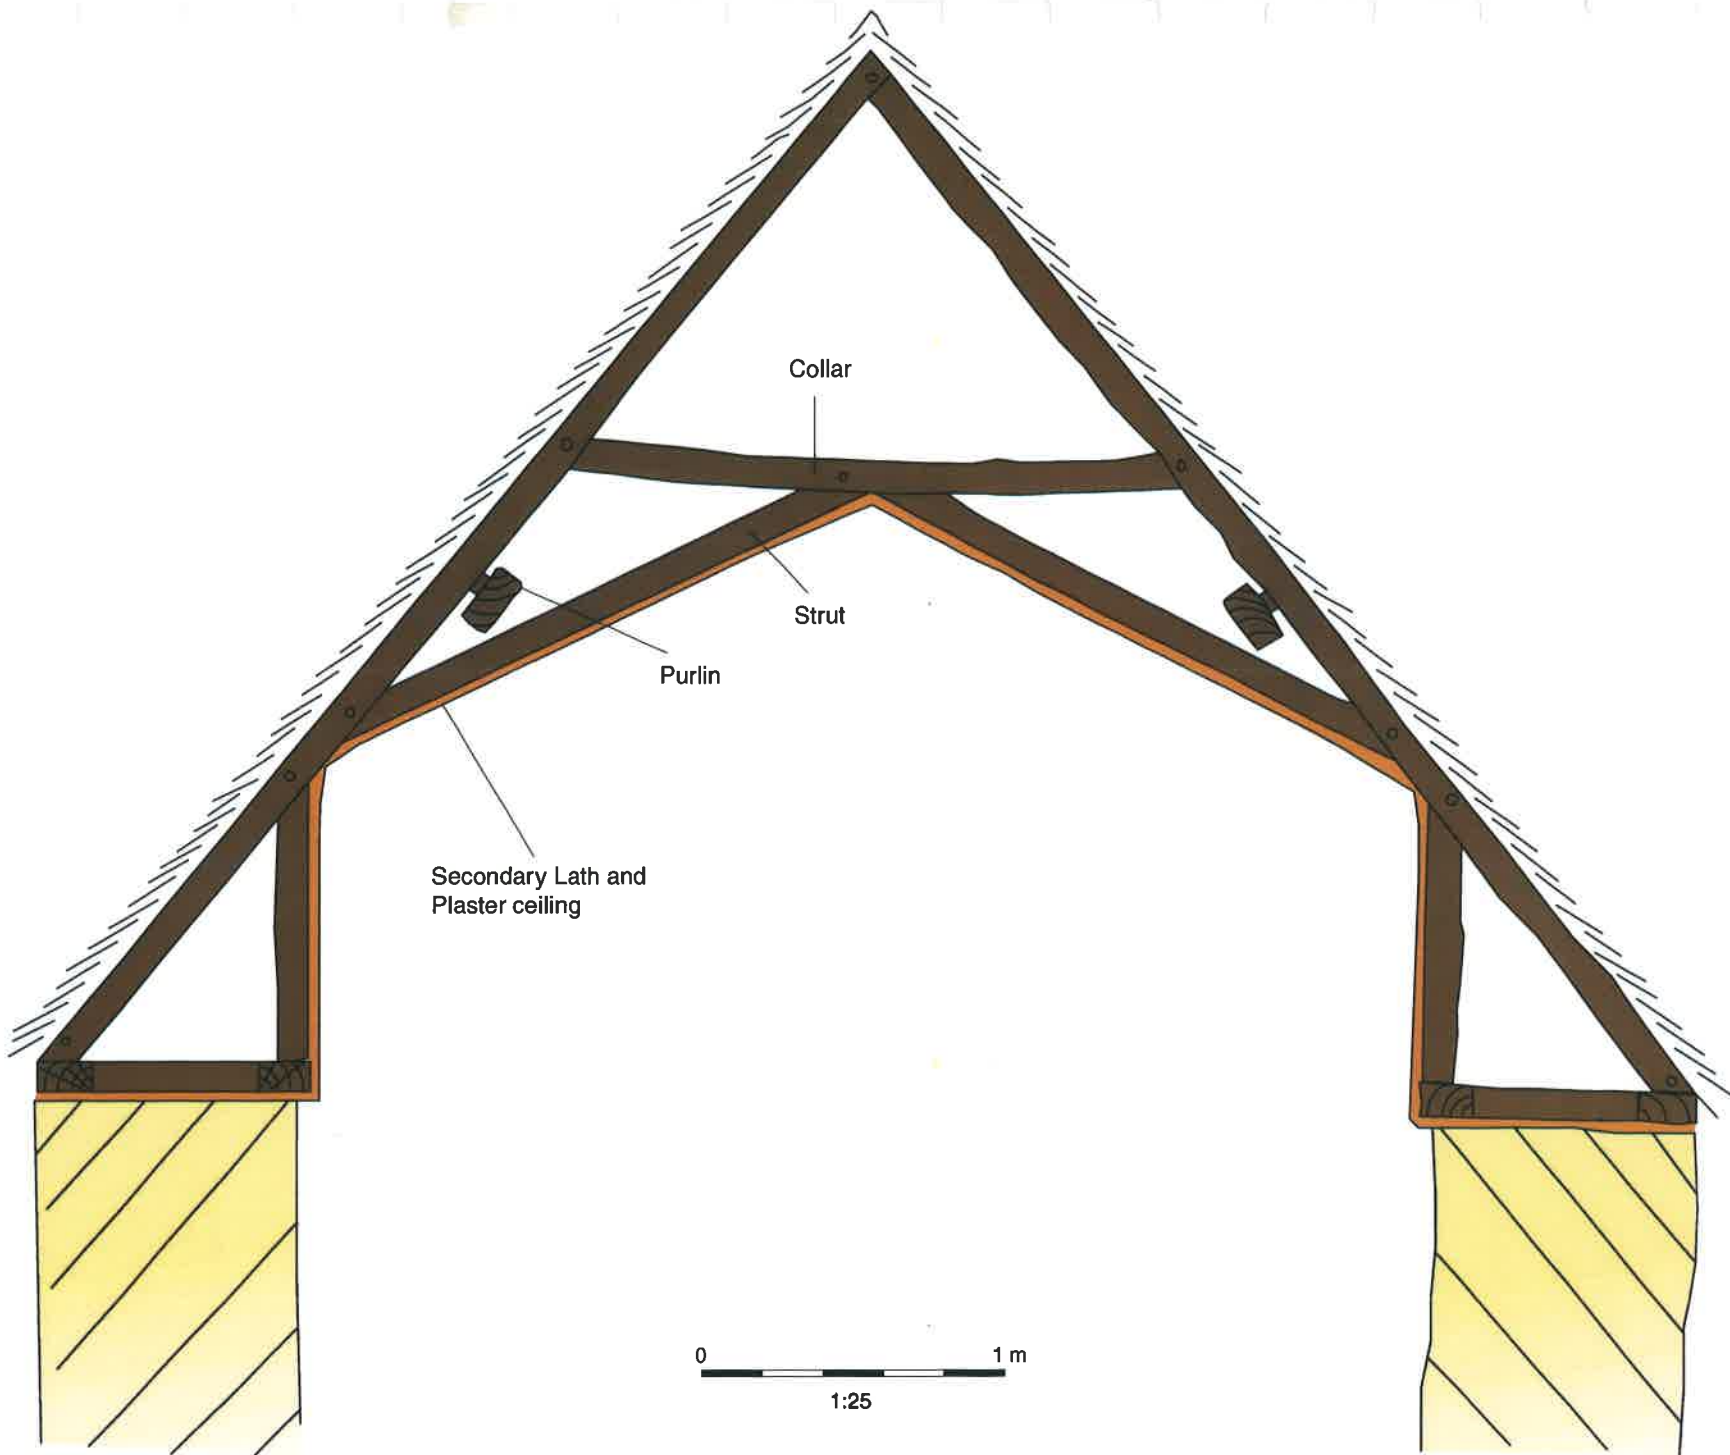
Figure 6: Section through channel roof, Letcombe Bassett Church

- 3.6.2 Although the roof structure is in a moderately poor condition the historic form and fabric is substantially intact and it has not been greatly altered since its construction, possibly in the 14th century. It is a common rafter roof with no full trusses but 18 pairs of coupled rafters (including two pairs which are built into the east gable wall). Each pair of rafters (11 cm x 9 cm) is braced by a collar (11 cm x 9 cm, 130 cm below apex) and by two raking struts the upper ends of which meet at the centre of the underside of the collar and the lower ends of which are pegged

- 3.6.4 The roof members are pegged, they are largely of elm and they have long, scratched carpenters marks typical for a medieval roof. The main members are all primary. The rafters are laid flat and there is little clear evidence of reused timbers. The timbers used are of good quality (although the purlins are waney) with each one roughly squared although some sections have now worn away and a small number of edge sections have been used. The roof has clearly been recovered at least once since its original construction and a relatively small number of secondary props and supporting timbers have been added. Several of these are towards the feet of each primary rafter to add support to the lower part of the roof and in various areas the purlins have sunk so battens have been added to their upper faces to directly support the rafters. In addition on the north side of the roof additional ashlar posts have been added as the primary posts have started to spread or diverge.

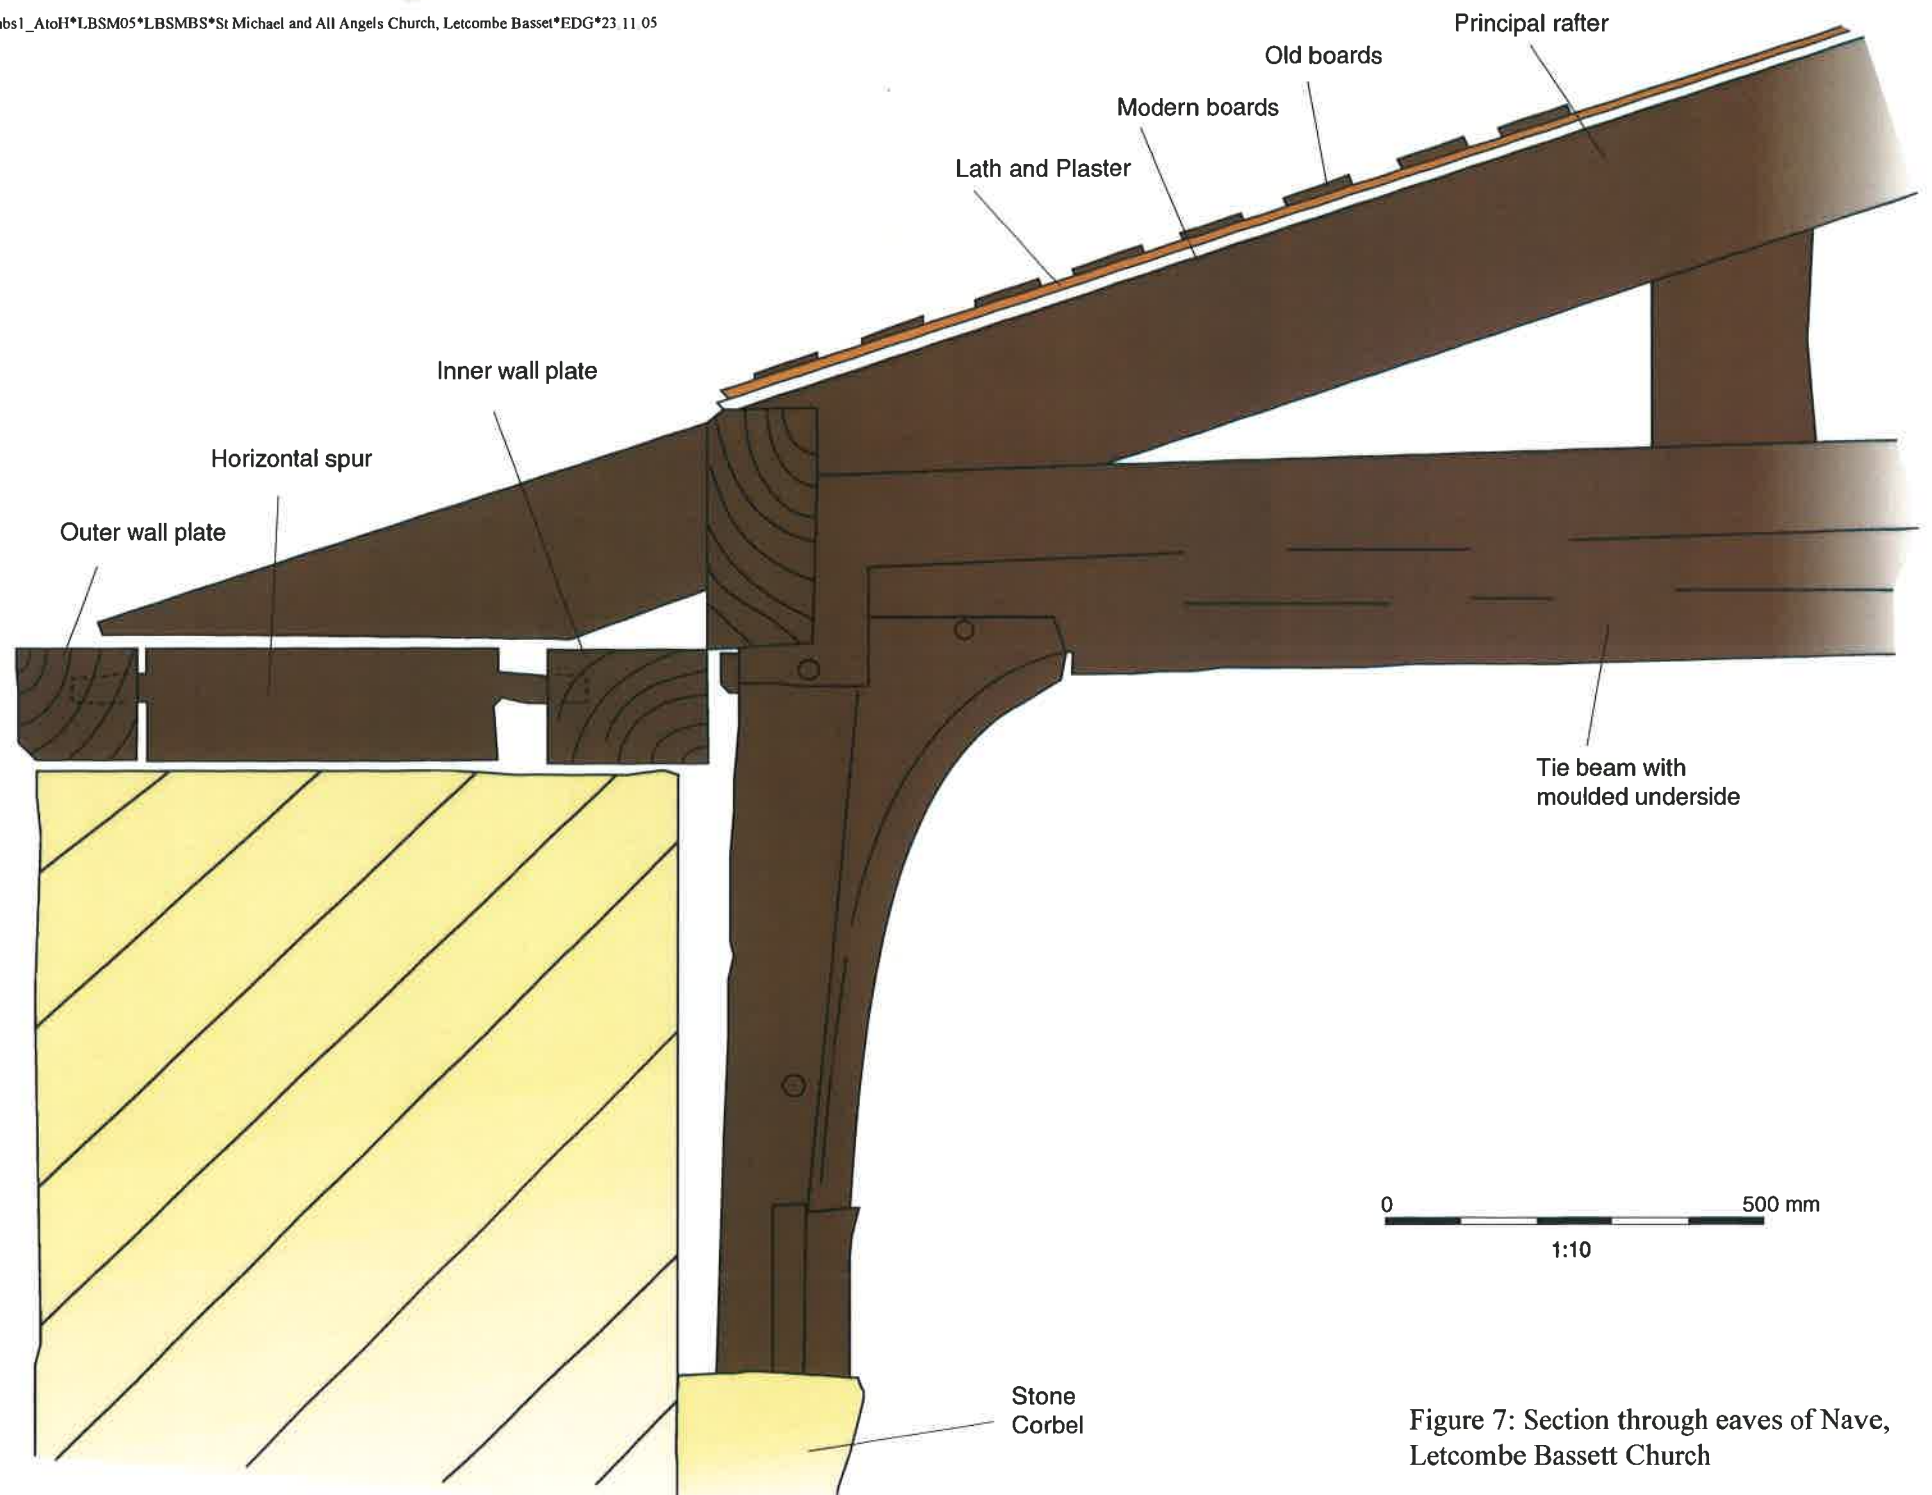
Figure 7: Section through eaves of Nave, Letcombe Bassett Church

3.7.1 The roof above the nave is later and distinctly different to that above the chancel. Its modern profile (prior to the current works) dates to 1952 when a softwood rafter roof with tile cladding was added above the previous roof. However the structure of the older roof remains substantially visible within the church and the current works to return the roof to its previous lower profile have revealed that much of the upper part of the structure also remains intact. It is in very poor condition (worse than the older roof above the chancel) and there is a considerable sag between each truss. The substantially surviving historic roof above the nave is likely to date to the 17th century although the VCH speculates that it may be of 15th-century date.

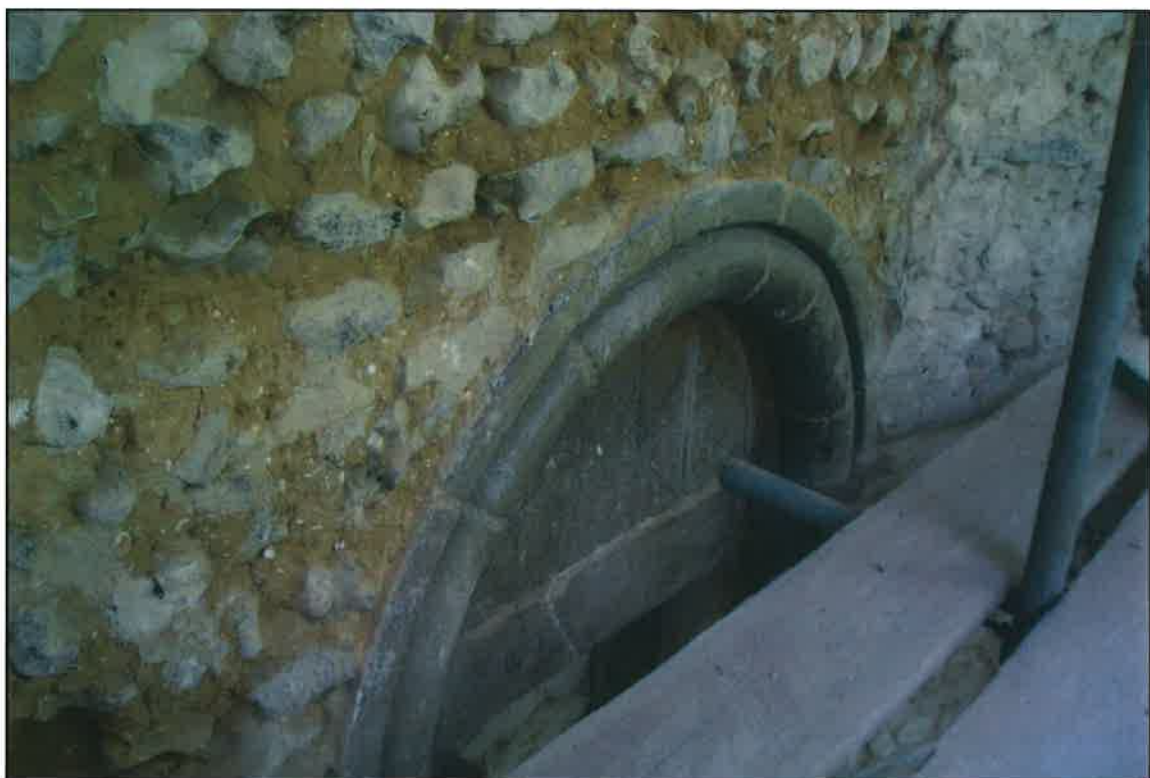
Plate 6: Arch over door after removal of cement render

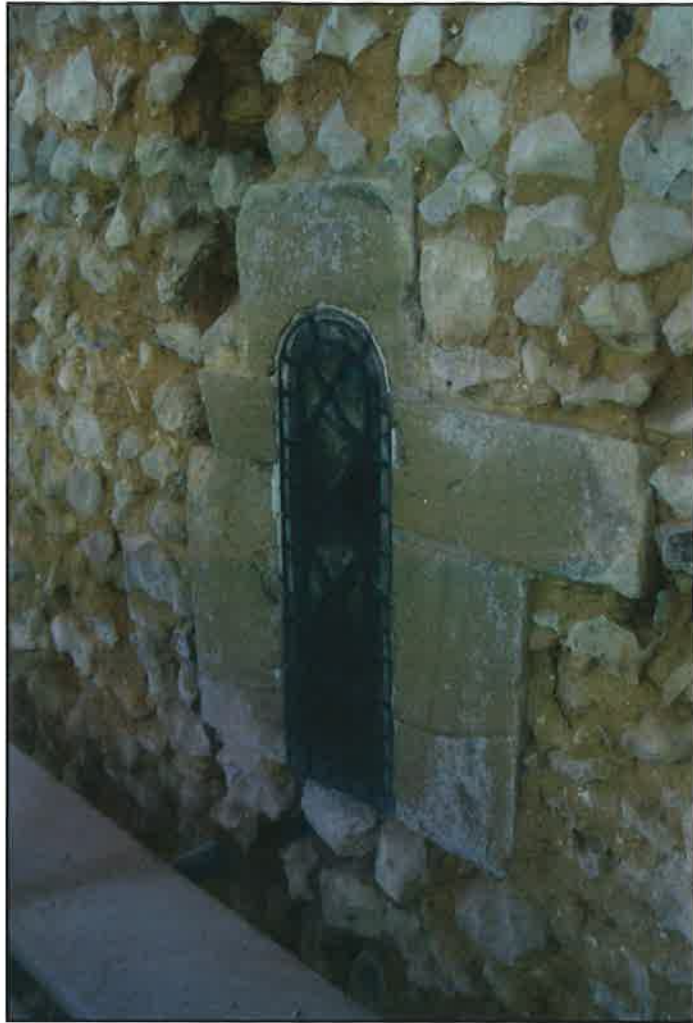
Plate 7: Primary window in north wall of chancel after render removal

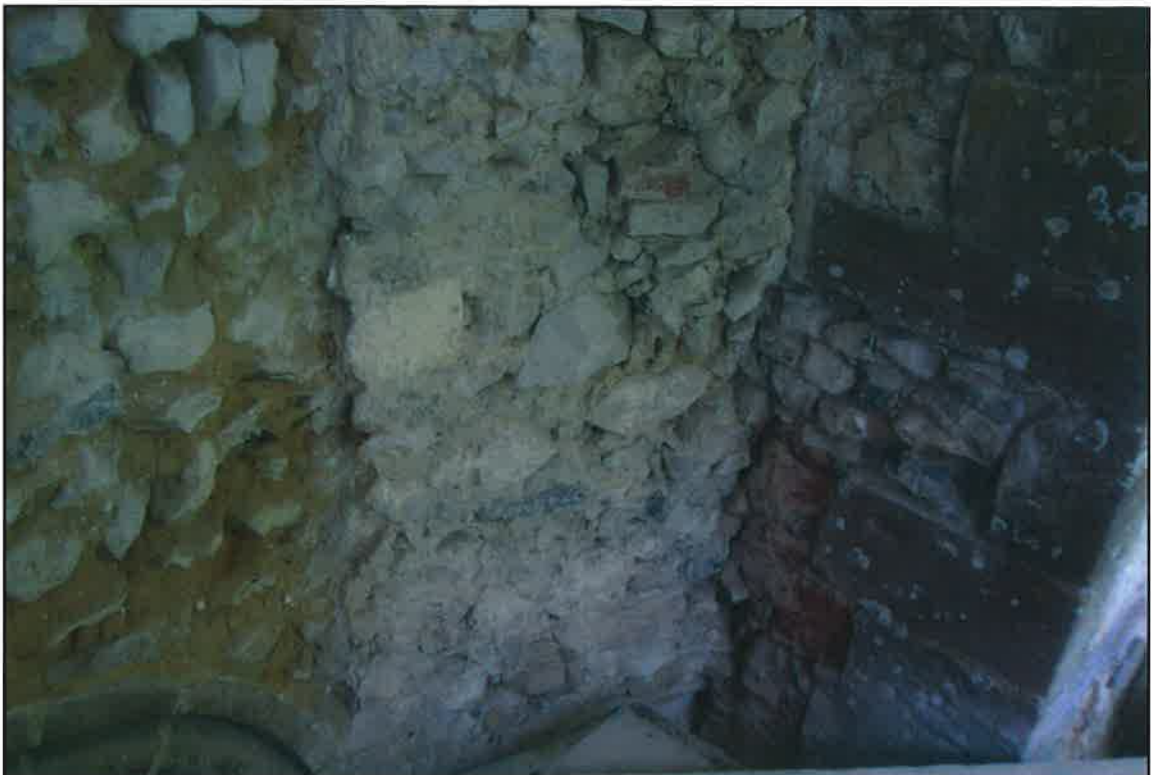
- 3.2.6 There is also an interesting feature at the west end of the primary wall, at the point where it adjoins the nave wall. At this junction the upper part of the chancel wall steps out with two flat, stone 'corbels' at c.80 cm and c.1.9 m above ground level. The wall was rendered but the removal of this has revealed that the stonework is partly built over the jamb of the primary door and is clearly later than the main wall. It has a soft, light grey mortar and the main material is a mixture of chalk, flint and a small number of bricks [8]. At its top it partially overlies the small fragment of surviving primary render.

Plate 8: Patching at west end of chancel adjacent to nave

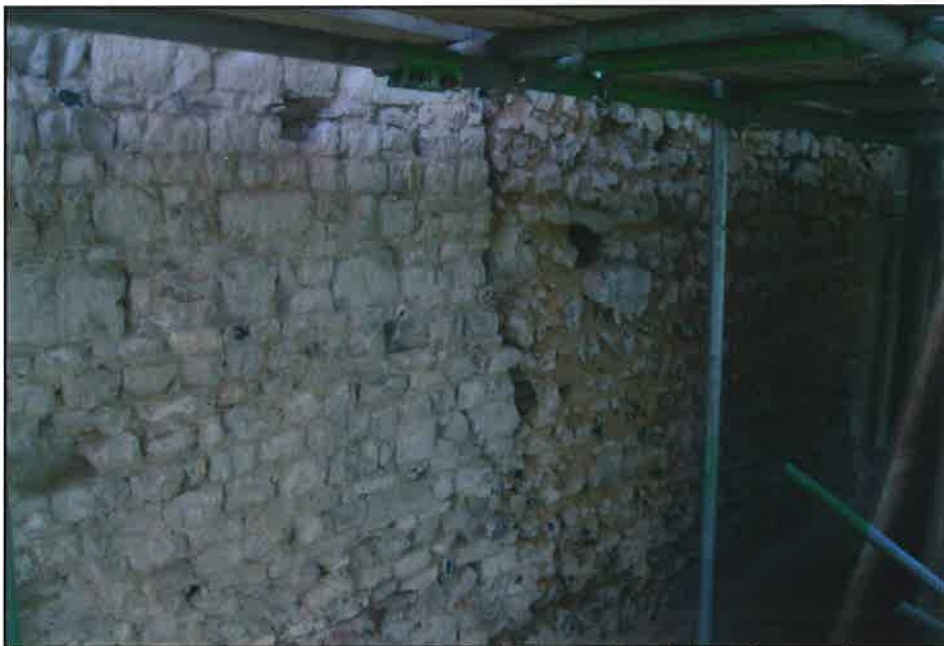
Plate 9: North wall of chancel showing primary wall to right and extension to left

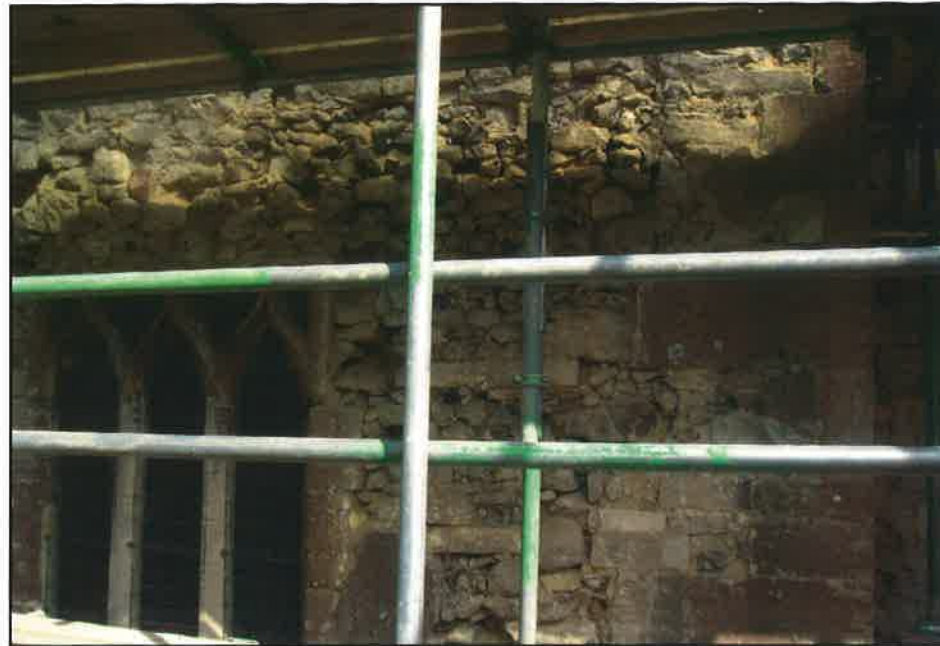
- 3.3.8 The upper part of the wall [26] has clearly been rebuilt and it comprises chalk blocks with a light beige, medium hard lime mortar. The blocks are roughly coursed similarly to elsewhere. This corresponds with evidence in the north wall of the nave showing that when the roof was rebuilt (possibly in the 17th century) the walls of the nave were raised by c.1.5 m and that they would originally have been of the same height as the chancel walls.

Plate 10: Partially rebuilt south wall of nave

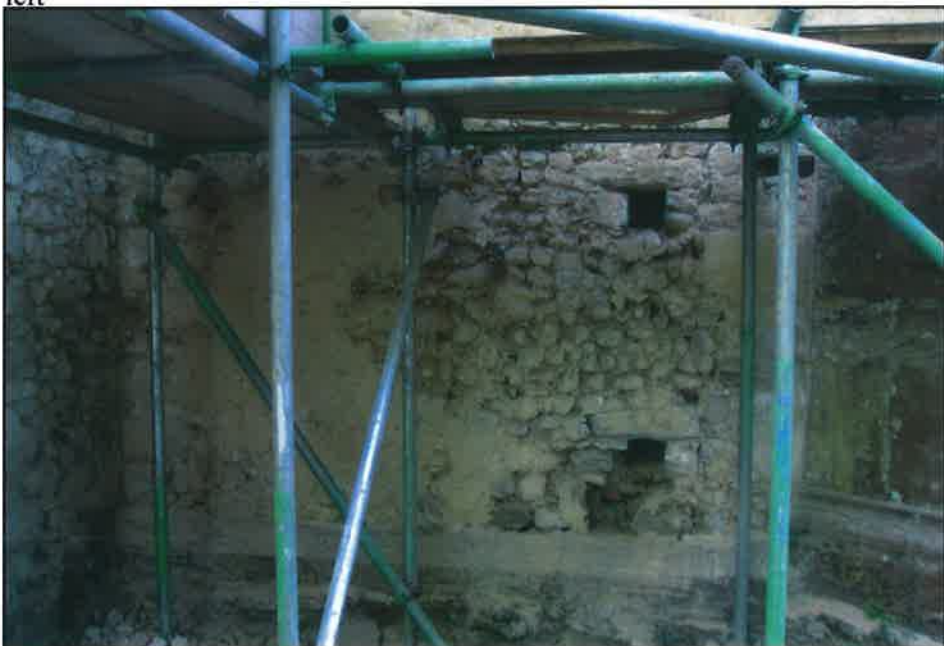
- 3.2.15 Among the interesting features revealed in the western half of the nave elevation and the tower are a series of put-log holes which would have been used to erect scaffolding when the tower was first constructed and rendered. There are two clear levels of holes in the north face of the tower (c.1.75 m and c.3.5 m above ground) and two further levels at the same height in western half of the nave wall. The lower two holes in the tower are particularly well constructed with clear 50 cm long lintels over the 15 cm² holes and lined by chalk blocks (although the main walling is of flint nodules).

Plate 11: North wall of tower showing put-log holes

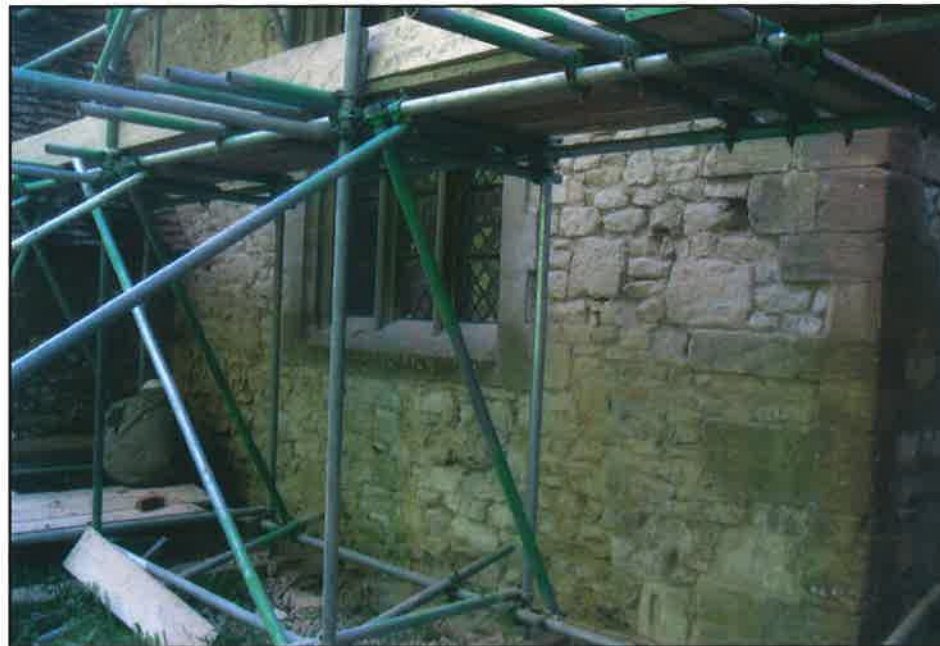
- 3.2.13 It is interesting to note that the uppermost c.1.5 m of the wall (above the height of the windows) has been rebuilt for much of its length [16, 17] suggesting that the wall was raised, presumably when the roof was built, possibly in the 17th century. It is also worth noting that the main horizontal line above which has been rebuilt is the same height as the eaves of the chancel strongly suggesting the walls of the nave were originally of the same height as the chancel. The central section [17] (above the porch and the central window) is constructed of regular coursed chalk blocks of a similar form to the construction of the whole of the western end [14] of the wall although with a darker mortar.

Plate 12: Rebuilt wall at north-west corner of nave

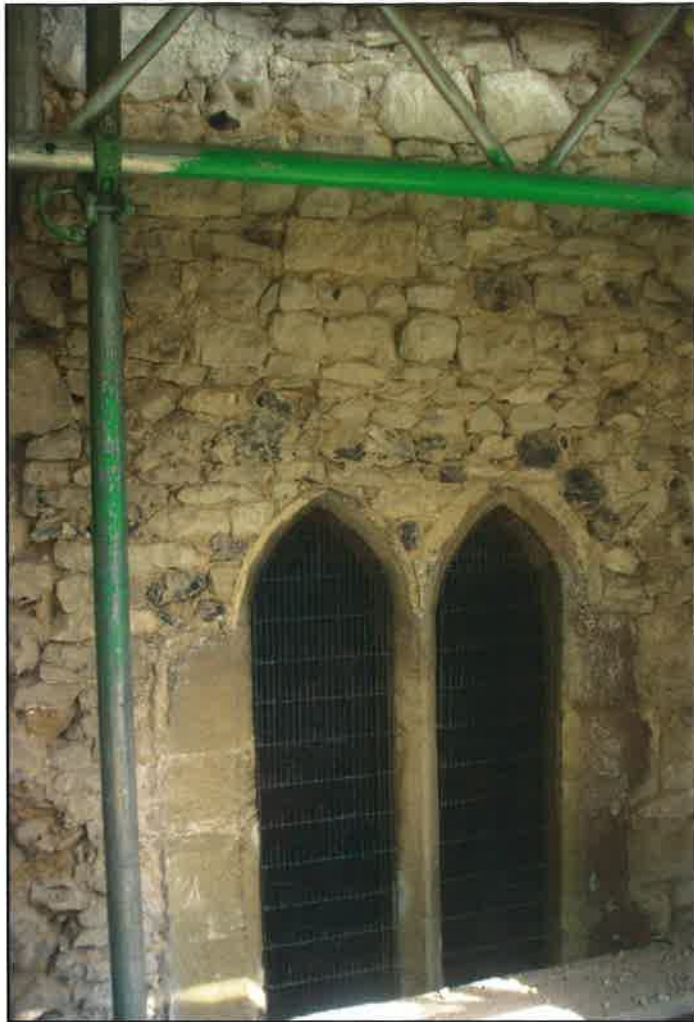
Plate 13: Inserted window in south wall of chancel
