ST Michael and
All Angels Church
Letcombe Bassett
Oxfordshire

Historic Building Recording

December 2005

Document Type: Historic building investigation and recording
Issue Number: 1

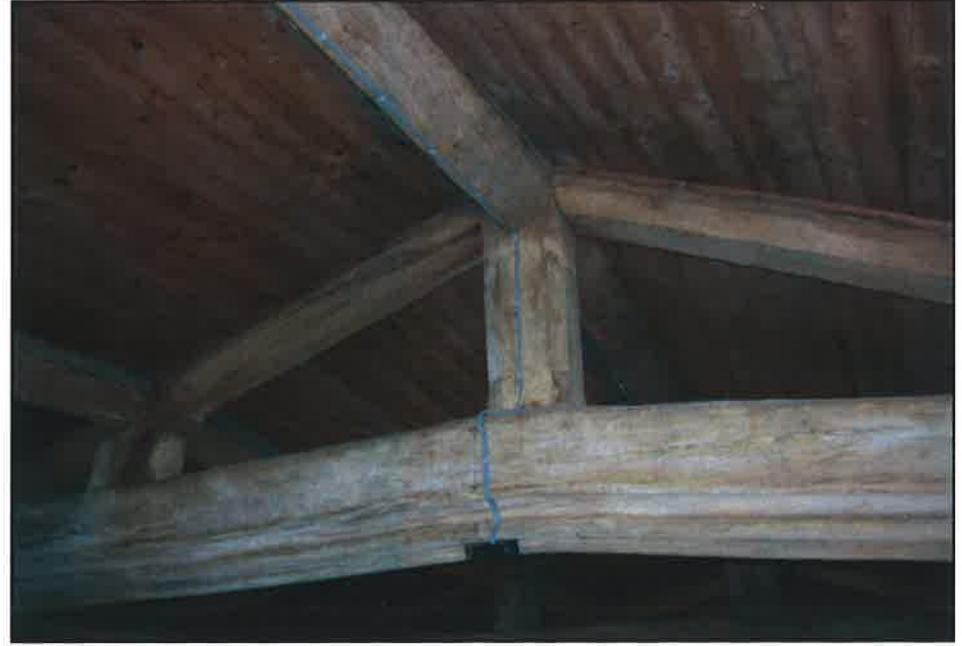
Plate 16: Roof truss above nave (possibly 17th century)

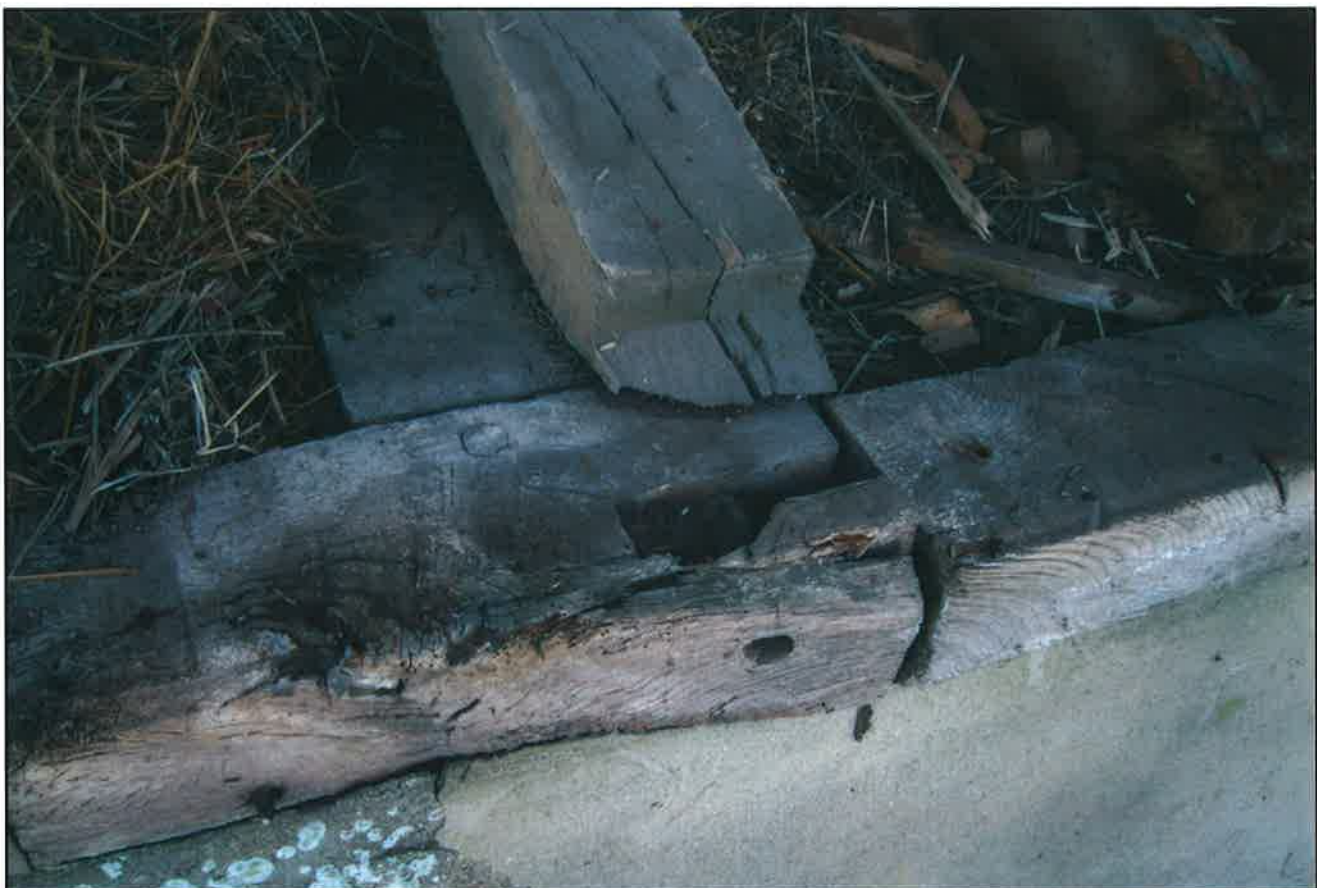
Plate 24: Scarf joint in wall plate on north side of nave
