The Bull Stanford Dingley Berkshire

Buildings Analysis / Recording

ARCHAEOLOGICAL ANALYSIS

December 2001

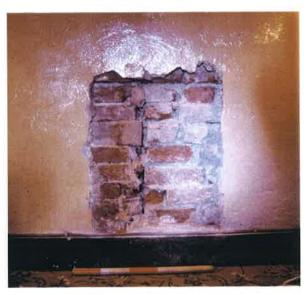
Plate 1 Internal Wall Plaster Removal

To facilitate analysis a small section of render was removed from the surface of the brickwork in the bar area. This sample revealed very fragmentary brickwork, with bricks from various periods, the latest of which being mid 19th century.

Running down the centre of the sample section a vertical joint in the brickwork was observed.

The covering render was hard cementitious mortar, obviously recently applied.

The main feature of interest is the covered vertical joint exposed in the sample section of render removal. The joint may represent some form of opening, though given the disturbed nature of the brickwork it may be that it is an anomaly.

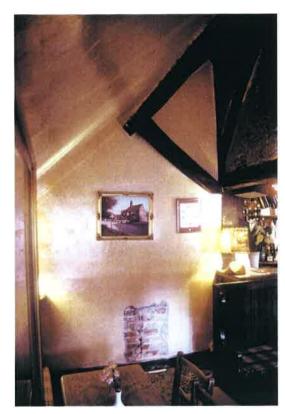
Plate 2 Internal Wall General Shot

The wall is outwardly entirely featureless, apart from a single timber tie for the roof, the fabric being covered by render in the bar area, and modern board in the kitchen.

There is one timber purlin exposed in the ceiling of this extension, which is roughly converted, with simple chamfers to its lower edges. This timber ends shortly before the wall in question, and is replaced by a more evenly converted timber.

The junction between these two timbers is supported by a brace that runs back to the tie within the wall; the brace is converted in a similar manner to the replacement purlin above.

The main exposed purlin could be 16th century in date, though it is not associated with the dividing wall that it is proposed to remove.

At least the base of the wall is 19th century in construction, a date which would not be inconsistent with the smoothly converted timbers with which it is associated.

The wall and timberwork all appear to be part of a later alteration and subdivision of the earlier extension.

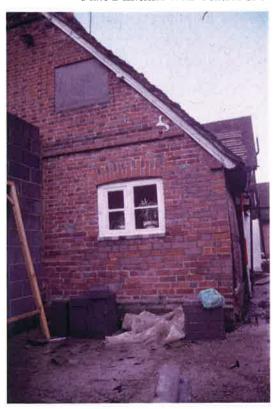
Plate 3 External Side Wall

The side section is entirely brick, though elements of the timber frame may remain behind the façade. Much of the work is Flemish bond with flared headers, forming a regular polychrome pattern.

This general pattern continues into the arch above the small window, and to some extent into the plinth. In-between these points the pattern has been disturbed and mostly removed by later work. This work continues to the limits of the proposed works, which coincide with the internal division of the property.

There have been considerable changes to the small window, possibly including shortening.

The side section of wall is complete to the period at which the building was faced, up to the top of the window. Below the window, the wall has been extensively rebuilt.

The rebuild does not include the plinth, though it does correspond with repairs to the window and a modern sill.

The major rebuild within this section of wall is firmly dated by an inscribed brick, which reads TP 99. It is uncertain as to the depth of this rebuild, however its coincidence with the internal division suggests that it is full thickness.

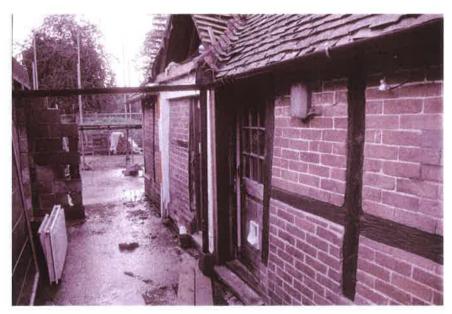
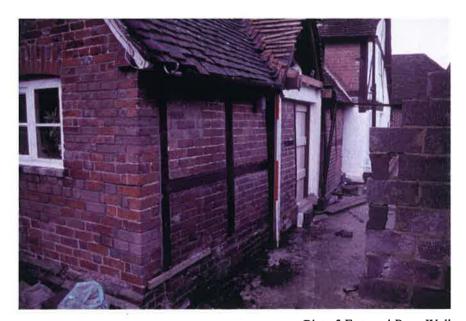
Plate 4 External Rear Wall

The rear wall consists of a plain, pegged timber frame, with a wall plate and eight uprights (two of which were obscured). The ground beam has been removed and replaced with brickwork.

The uprights have been horizontally braced, however the third and fourth braces from the northwest have been removed to introduce modern doorways.

Generally, where it remains, the timber is in sound condition, however it has been repaired, in several places, with a cementitious grout. An abundance of thick brown stain / paint obscures the boundaries between the repair and the sound timber.

Red bricks 220mm by 60mm, with yellowish lime mortar; much of this type has been re-pointed with cementitious mortar.

A great deal of the masonry of both types has been rebuilt with modern mortars, and the foundations below the brickwork have been excavated and replaced with concrete.

The simple form of the oak frame and its limited and incomplete nature make an assessment of its date difficult. It is certainly possible that the frame is preeighteenth century, however there is no direct evidence to suggest this.

The brickwork is all 18th century or later, and has been considerably altered in recent years. The presence of the two modern doors and the concrete foundations strongly suggest that much of the lower section of the wall has been reconstructed.

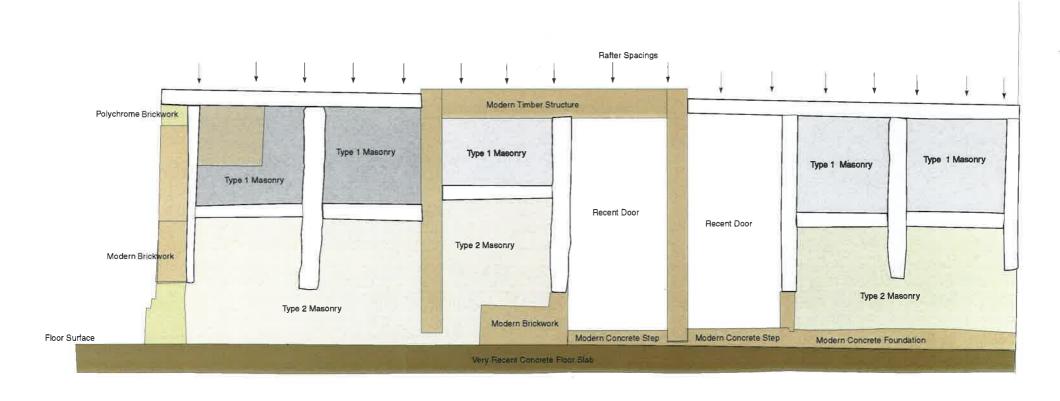
Figure 1 External Elevation Of The Back Wall Of The Bull

Type 1 is almost exclusively limited to the upper panels, while type 2 forms the body of the masonry below the centre braces, including that which lies below the line of the old wall plate.
