LEEDS PRIORY DOVECOTE ABBAY FARM, LEEDS, KENT

ARCHAEOLOGICAL BUILDING RECORDING AND
WATCHING BRIEF DURING CLEARANCE WORKS

Oxford Archaeological Unit
December 2000

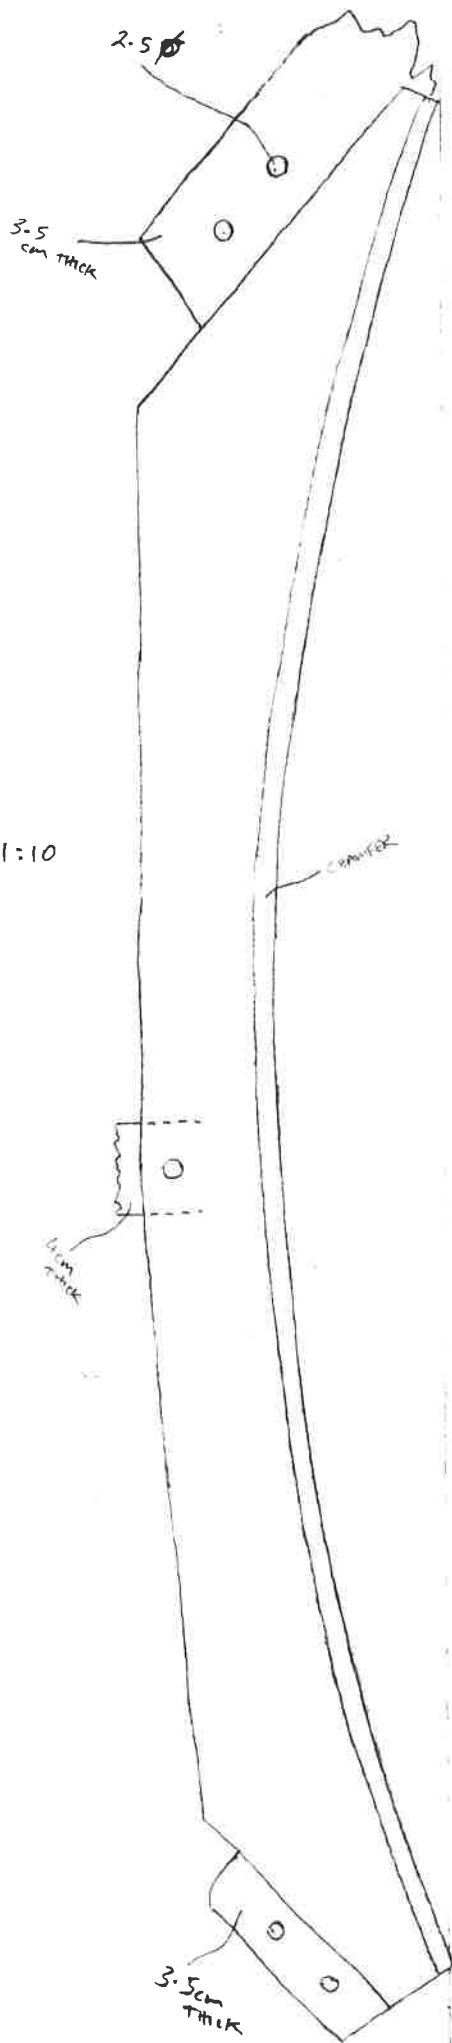
ARCHED BRACE

- 2.5.4 Four oak **arched braces** were identified with one in Bay B (B36) being in the best condition (Fig. 3). It was 2.65 m long by 12.5 cm thick with arched (by 22 cm at mid-point) and chamfered soffit. There were long tenons (3.5 cm thick with two peg holes) in the two sloped ends and there was a mortice in the upper face, towards the central point of the brace with the end of a 4 cm thick tenon which remained in-situ. This tenon would have secured the principal rafter to the brace.

CONDITION GOOD - 8/10

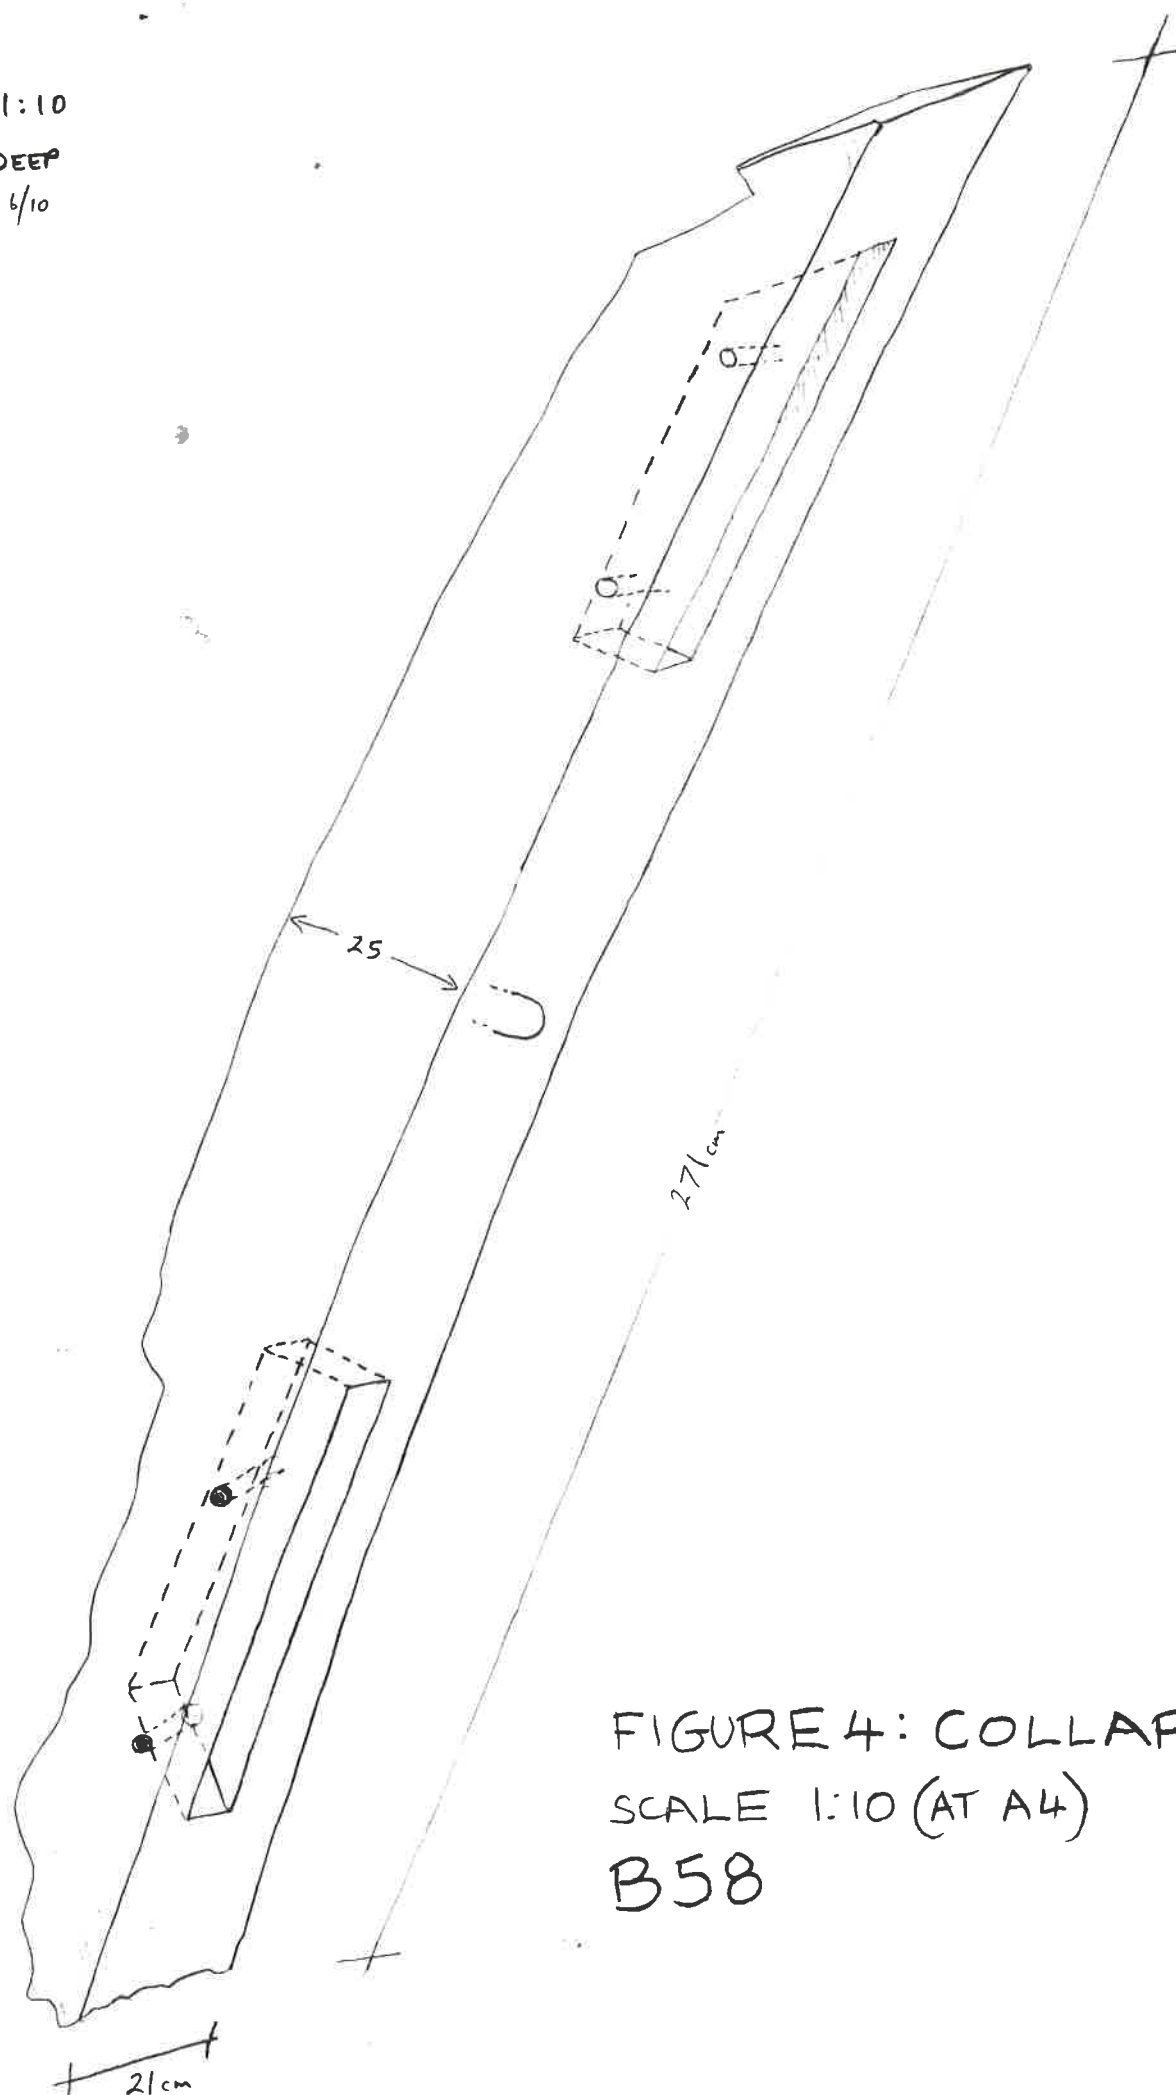
FIGURE 4: COLLAR

- 2.5.5 Four oak **collars** were identified and again one in Bay B (B58) was in the best condition (Fig.4). The collar was 2.71 m long, 25 cm high at its mid point and 21 cm deep. It was slightly cambered and there were two mortices (60 cm long x 12 cm deep x 5 cm wide) towards each end of the underside. There were two peg holes to either side of each mortice and there was an iron loop projecting from the underside of each of the collars.

CONDITION - 6/10

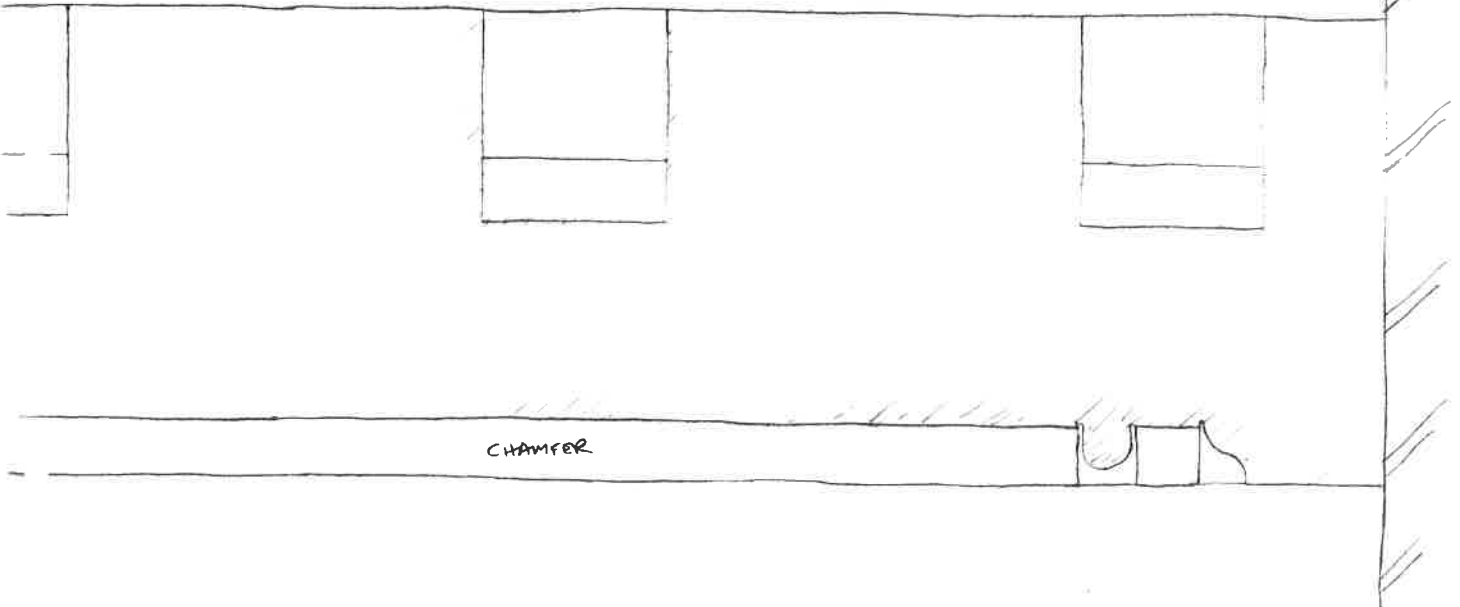
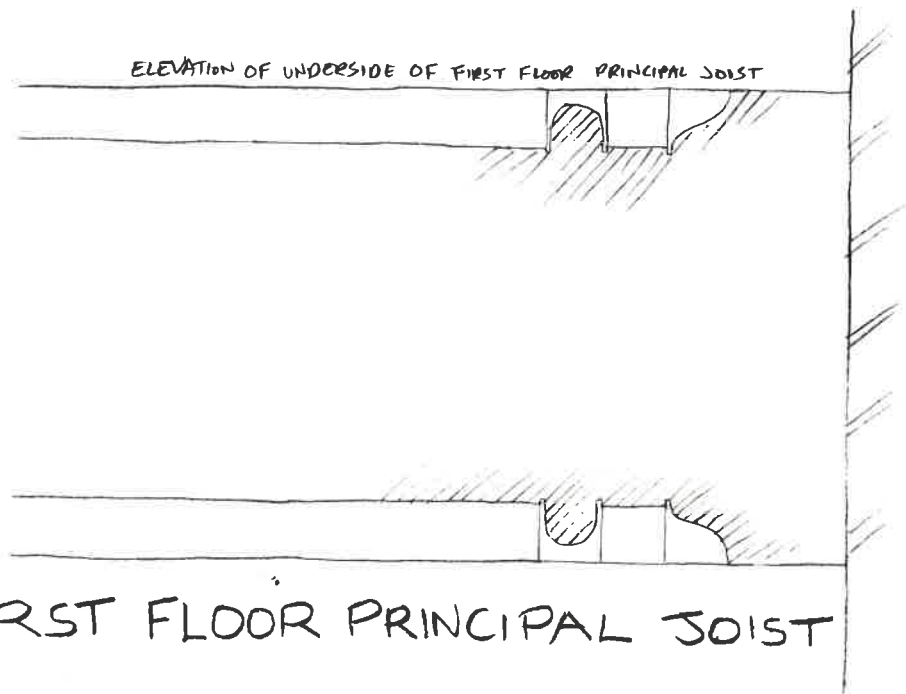
FIGURE 5: FIRST FLOOR PRINCIPAL JOIST

- 2.5.12 The only **first floor principal joist** to remain fully in-situ was that between Bays C and D, although one end of each of the others remained in place with the other end fallen to the ground. They were 31 cm by 31 cm and had mortices and peg holes for 13 common joists at 39.5 cm centres. The lower edges of each principal joist were chamfered and had moulded stops (scroll stops with bar; see Fig. 5). The first floor common joists were 13.5 cm high by 11 cm wide and also had chamfered lower edge with plain stops (Fig.7).

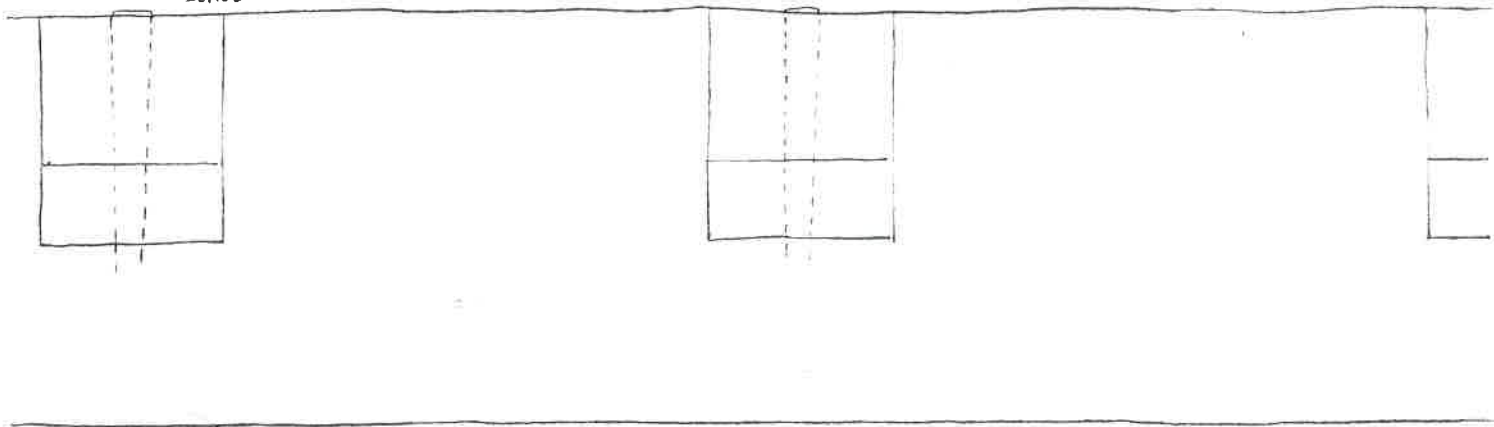
FIGURE 6: GROUND FLOOR PRINCIPAL JOIST

- 2.5.10 No sections of purlin, wall plate or jack-corbel survived which could be positively identified.
- 2.5.11 Each of the **ground floor principal joists** remained at least partially in-situ although in parts some had largely disintegrated (Fig.6). The principal joist furthest north (between Bays A and B) was the best preserved and had mortices for 12 common joists (at 44 cm centres) within each side face with circular peg holes above each. The principal joist was 27 cm high by 28 cm wide. The **ground floor common joists** were 14 cm high by 11 cm wide by c.2.50 m long and they had soffit tenons with diminished shoulder to each end (Fig.7).

ALL GROUND FLOOR JOISTS V. SIMILAR BUT ONLY THAT BETWEEN BAYS A+B INTACT, INSITU + FULLY VISIBLE - THIS ONE HAS 12 MORTICES EACH SIDE FOR COMMON JOISTS

GROUND FLOOR JOIST AT WEST END OF BAY.
WESTERNMOST JOIST IN BAY. SOUTH END
INSITU, WITHIN MORTICE.
12TH JOIST FROM EAST.
OAK
N. END OF JOIST BROKEN BUT PIECE
247 cm LONG.

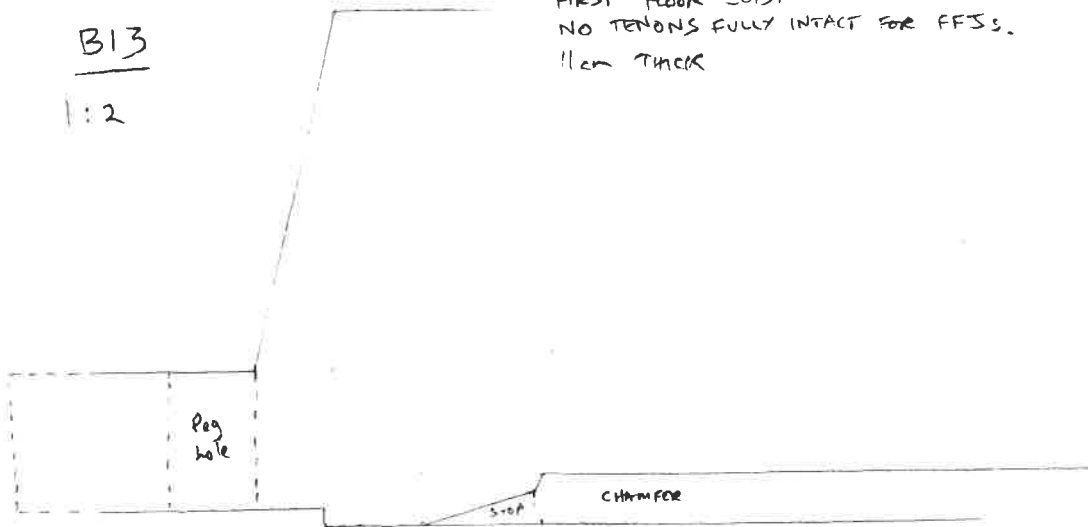
FIGURE 7: COMMON JOISTS

FIRST FLOOR JOIST
NO TENONS FULLY INTACT FOR FFS.
11cm THICK

BOTH FACE (KERN) LARGELY
DISINTEGRATED BUT MAXIMUM
EMSTING DEPTH 8cm

① PROB PRINCIPAL RAFTER WITH
MORTISES FOR WIND BRACE + PURLIN?

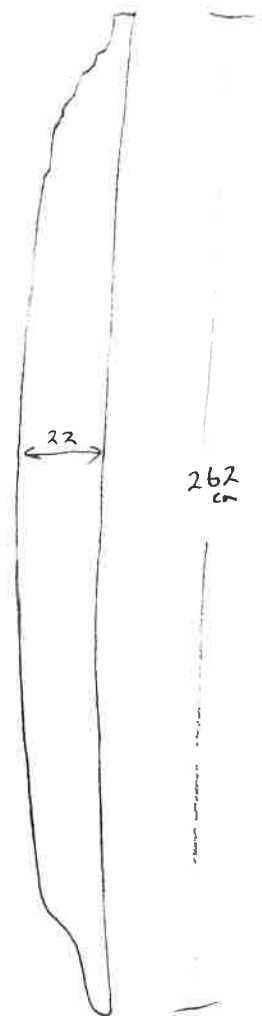
FIGURE 9: OTHER ROOF MEMBERS
SCALE 1:20

- 2.5.9 Two further roof timbers of interest were identified. One of these (C2) was of similar dimensions as the collars and with the same cambered form but there were no mortices to its underside. Also of interest was a beam 3.59 m long by 17 cm x 15 cm (E6). It had a mortice in its underside (13 cm long x 9 cm deep) and there appears to have been a mortice and peg hole in each of its two angled, upper corners.

14 CM DEEP
SAME CAMBOR
AS COLLAR
NO MORTICES

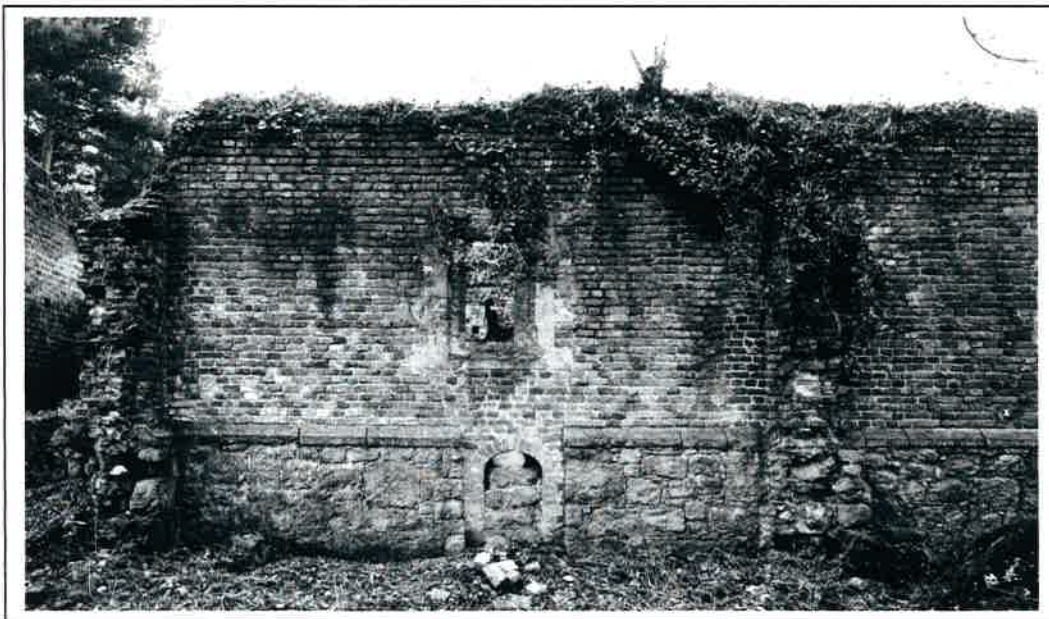
Plate 1: East elevation of larger dovecote showing buttresses and secondary openings
Plate 3: North elevation of larger dovecote

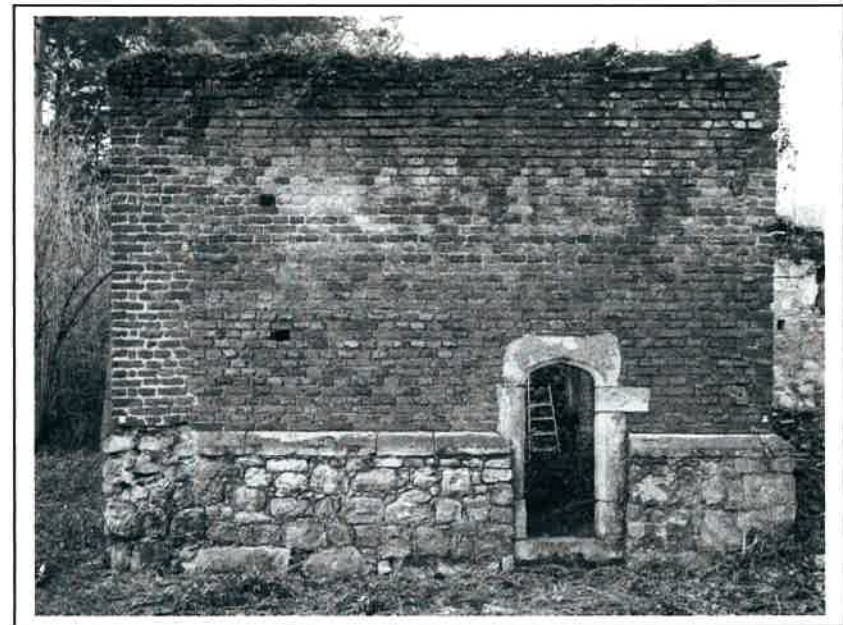
Plate 2: East elevation of smaller dovecote. Note rebuilt corner to left.
Plate 4: Interior of smaller dovecote. Secondary wall to left

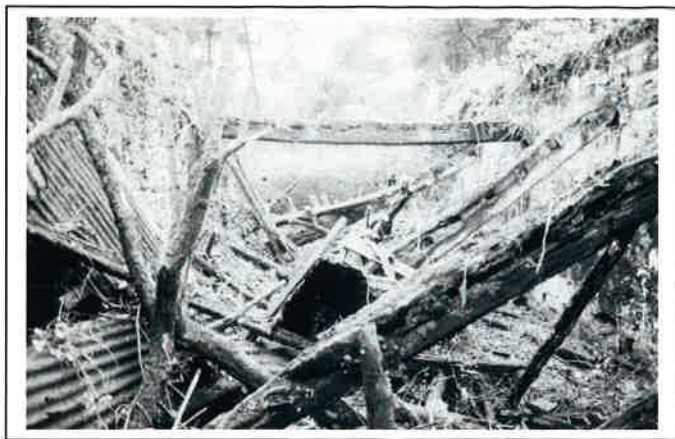
Plate 5: Interior of large dovecote before clearance

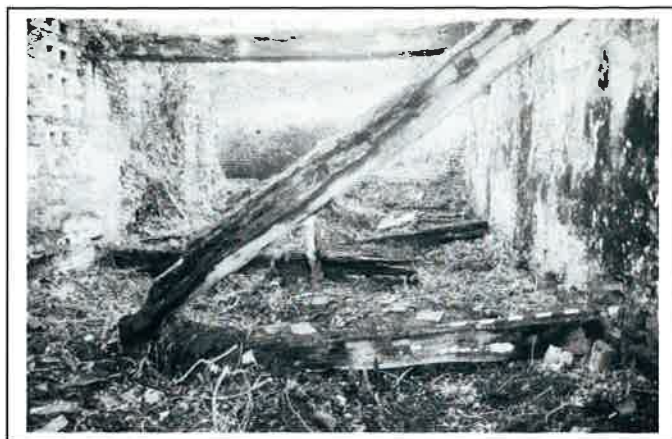
Plate 6: Interior of large dovecote after clearance

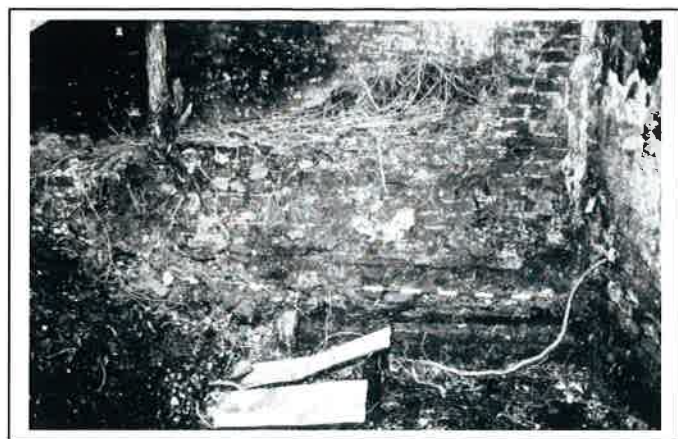
Plate 7: N face of surviving section of wall between Dovecotes exposed by current works

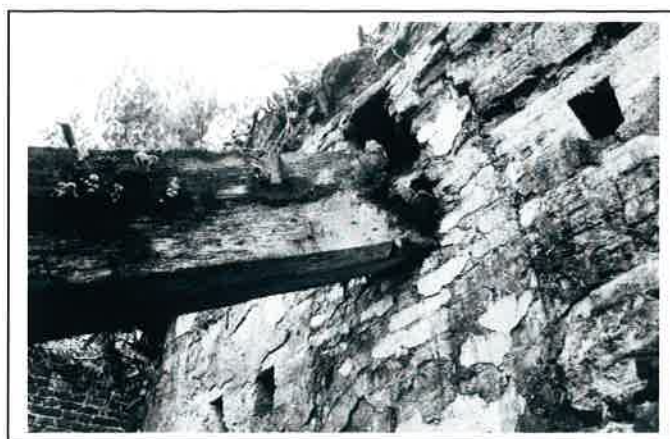
Plate 8: Chamfered underside of first floor principal joist

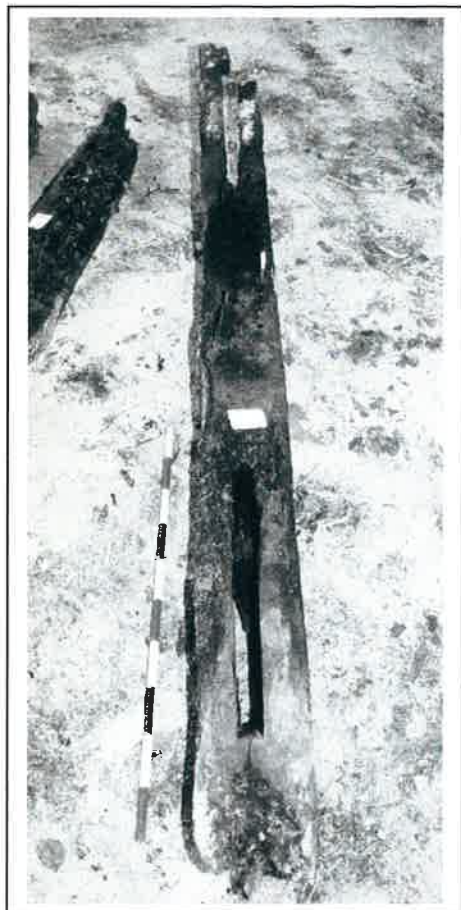
Plate 10: Detail of ground and first floor joists

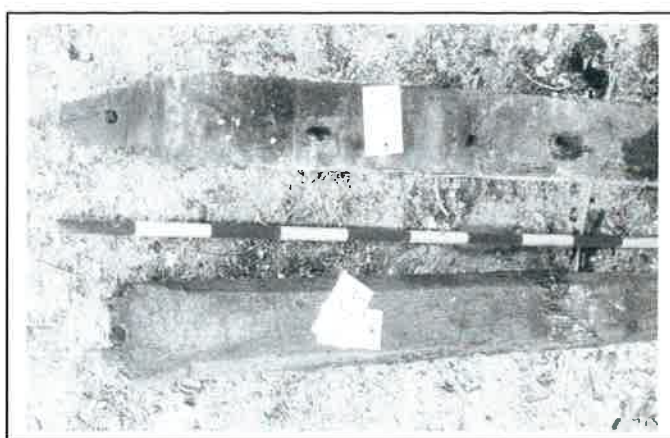
Plate 11: Three collars

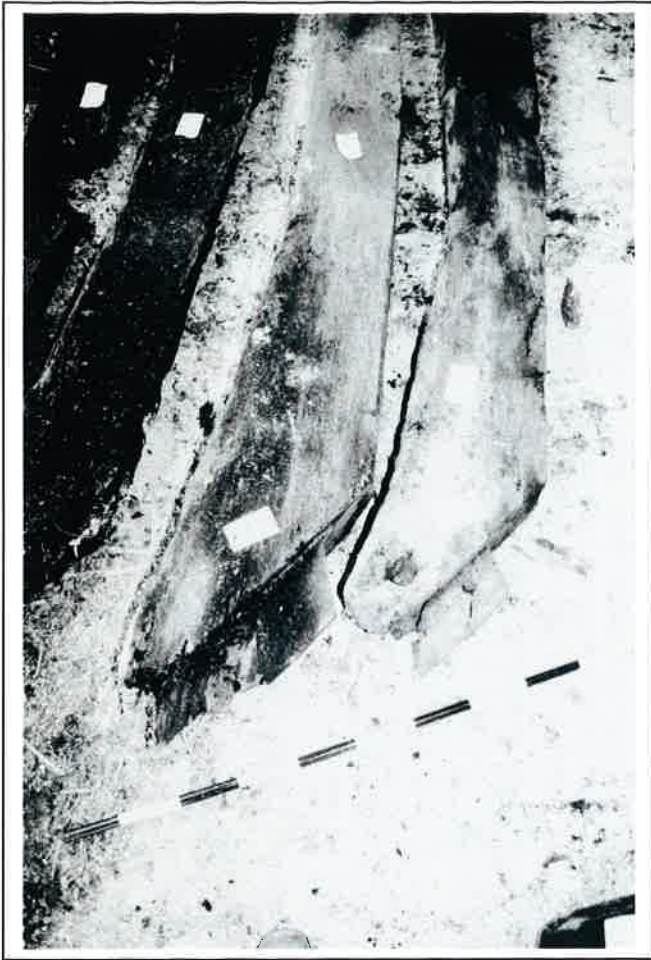
Plate 12: Tenoned ends of arched braces

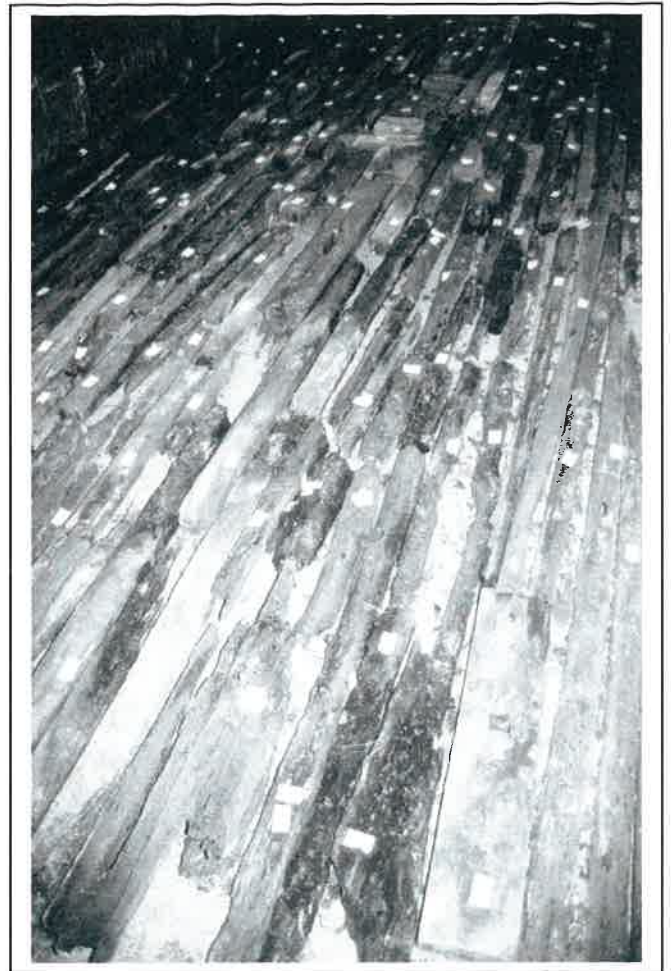
Plat 13: General view of labelled timbers
