Longwick Mill
Longwick
Buckinghamshire

Historic Buildings Recording

Oxford Archaeology

July 2002

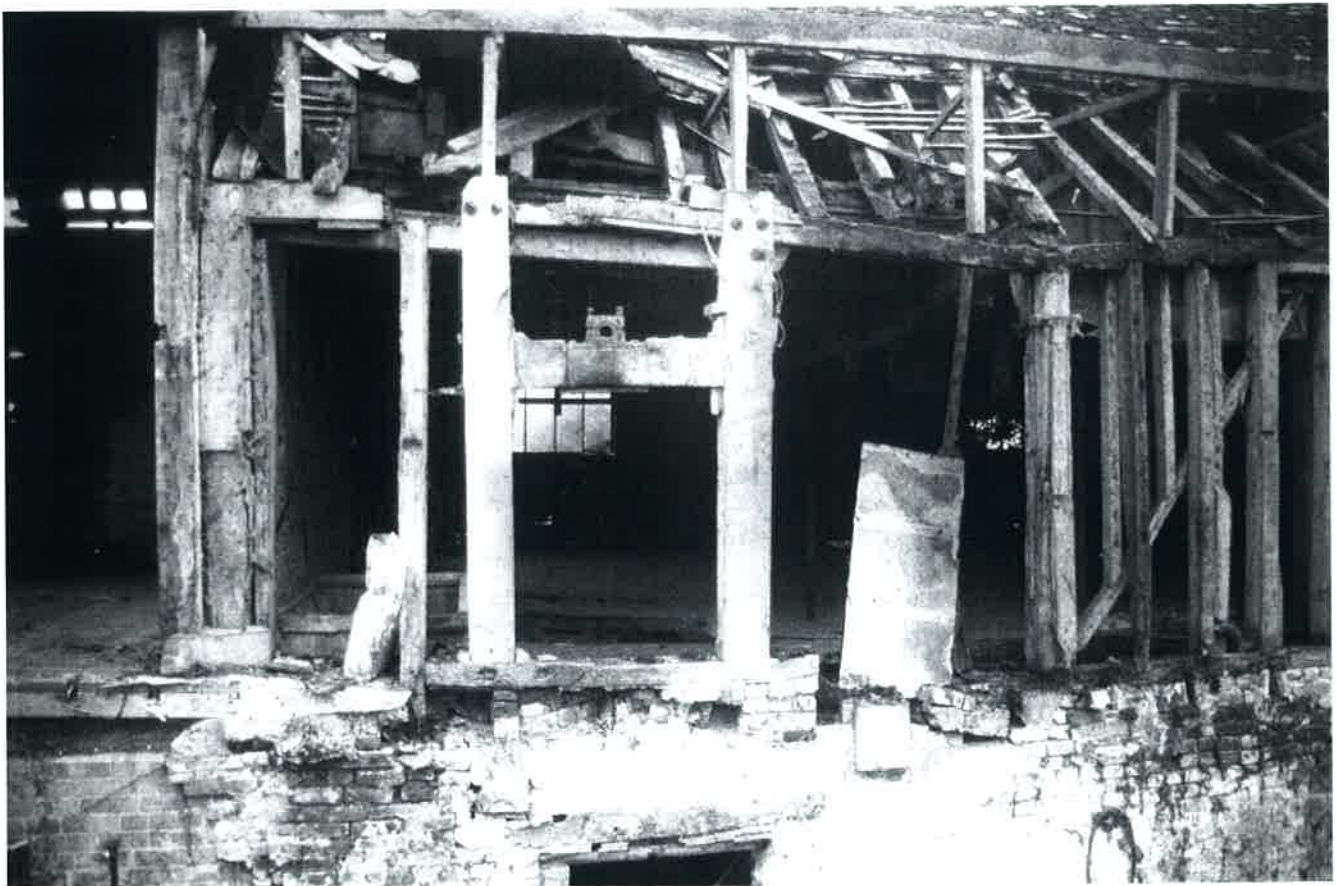
Plate 4 Power shaft bearing frame in east wall of mill.

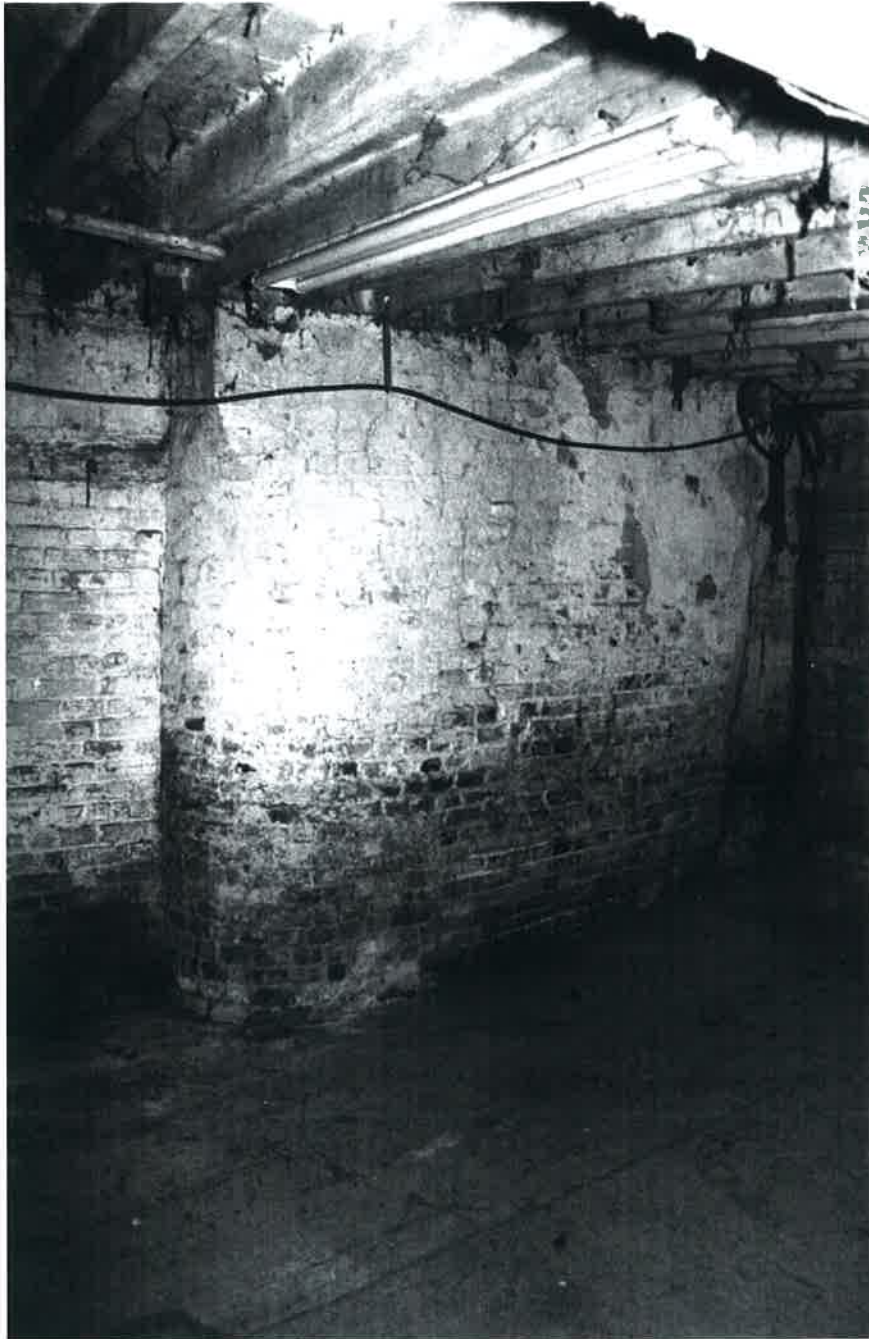
Plate 9 Primary chimney stack within G9

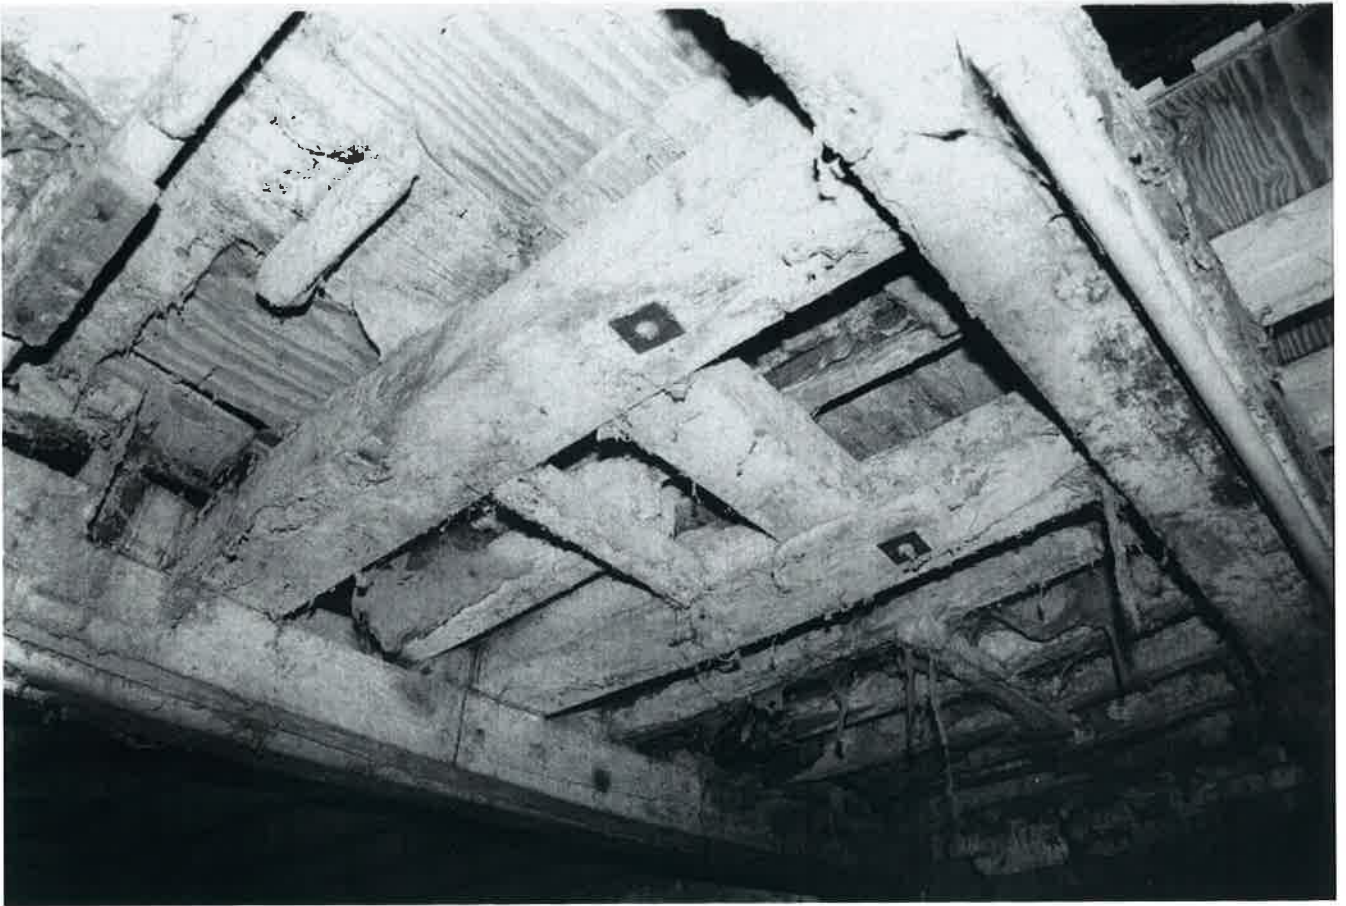
Plate 10 Underside of mill stone bearers within mill.

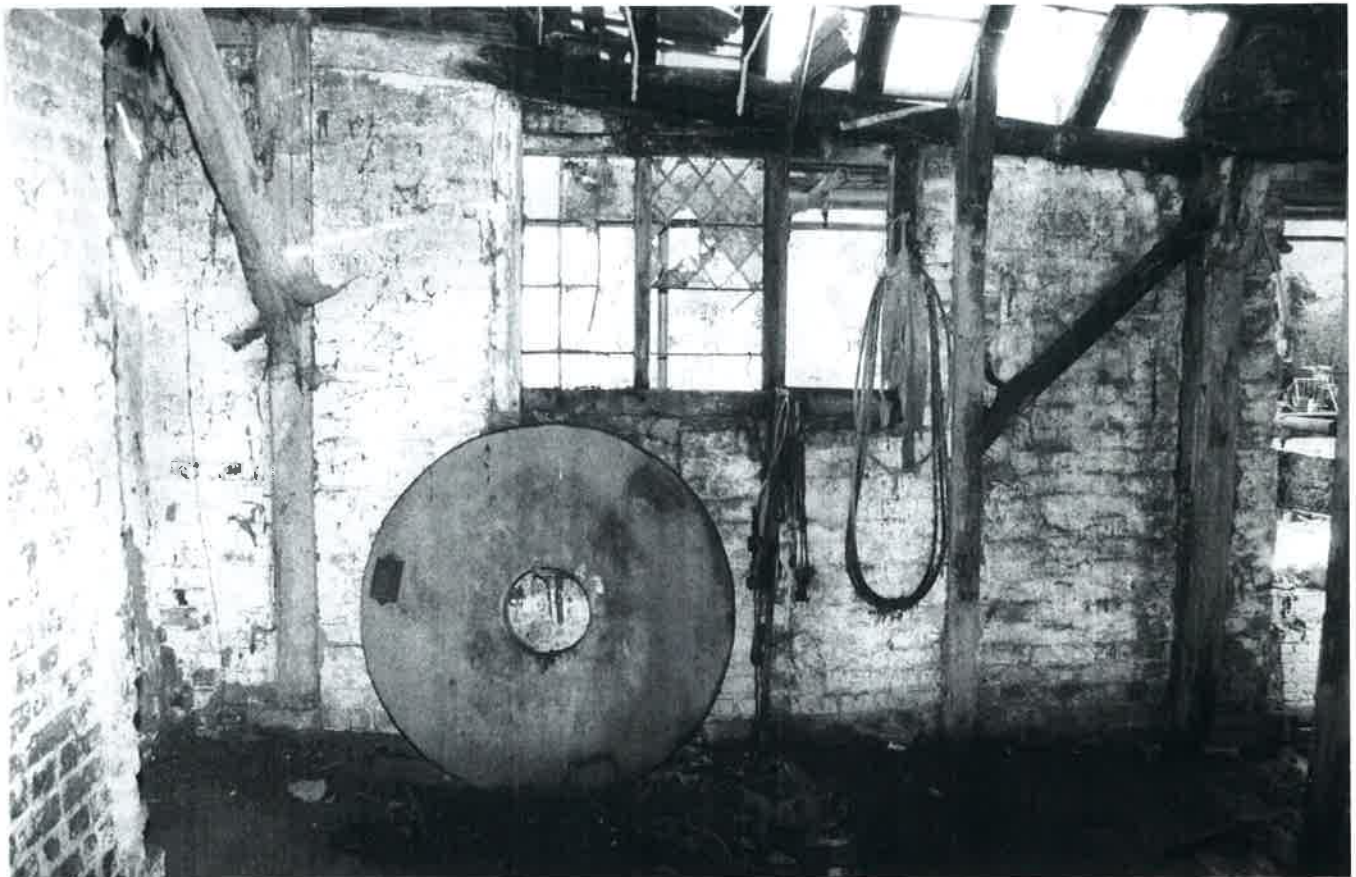
Plate 13 Mill stone and window in F9.

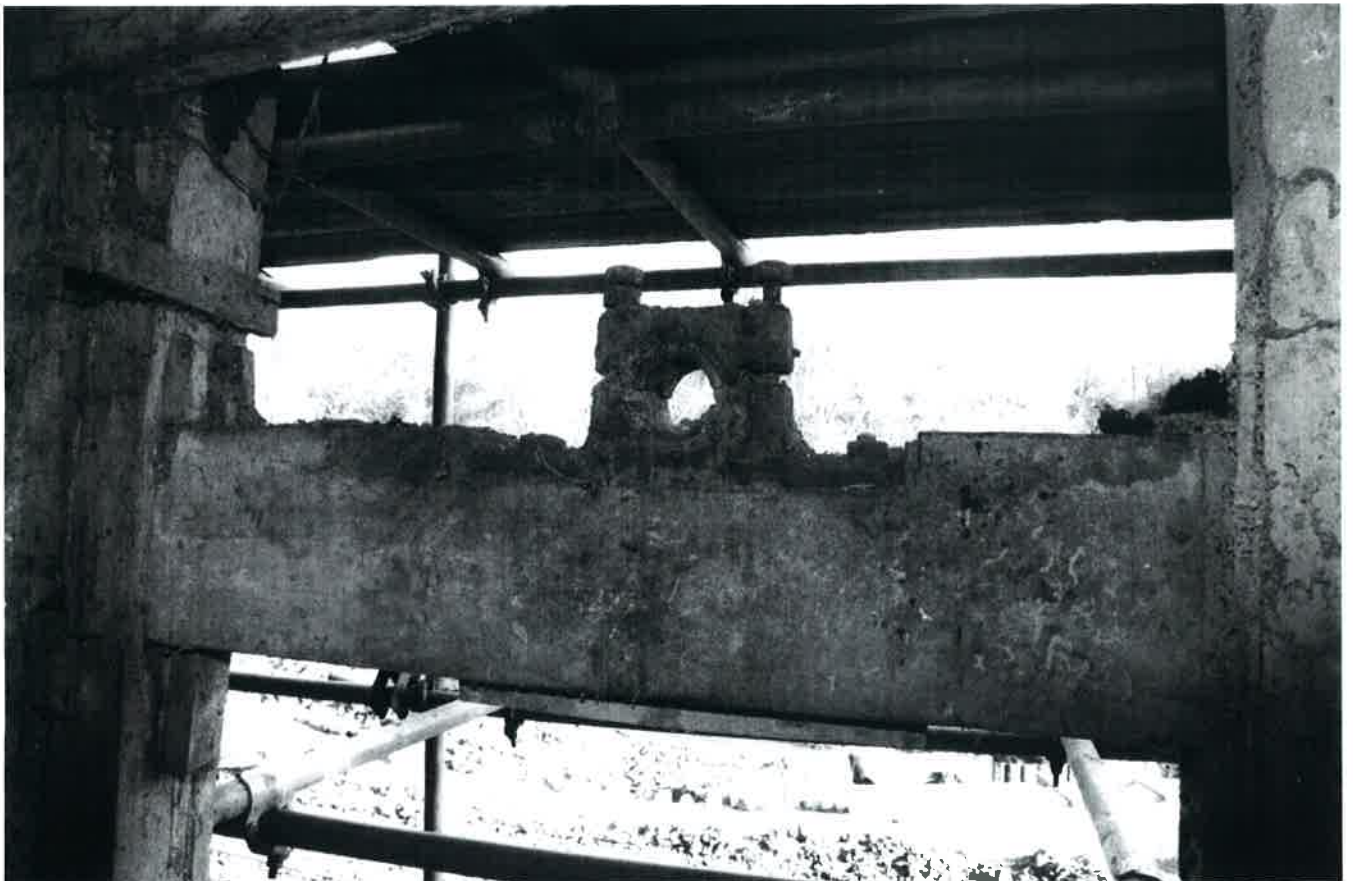
Plate 15 Power shaft bearer in east wall of F9.

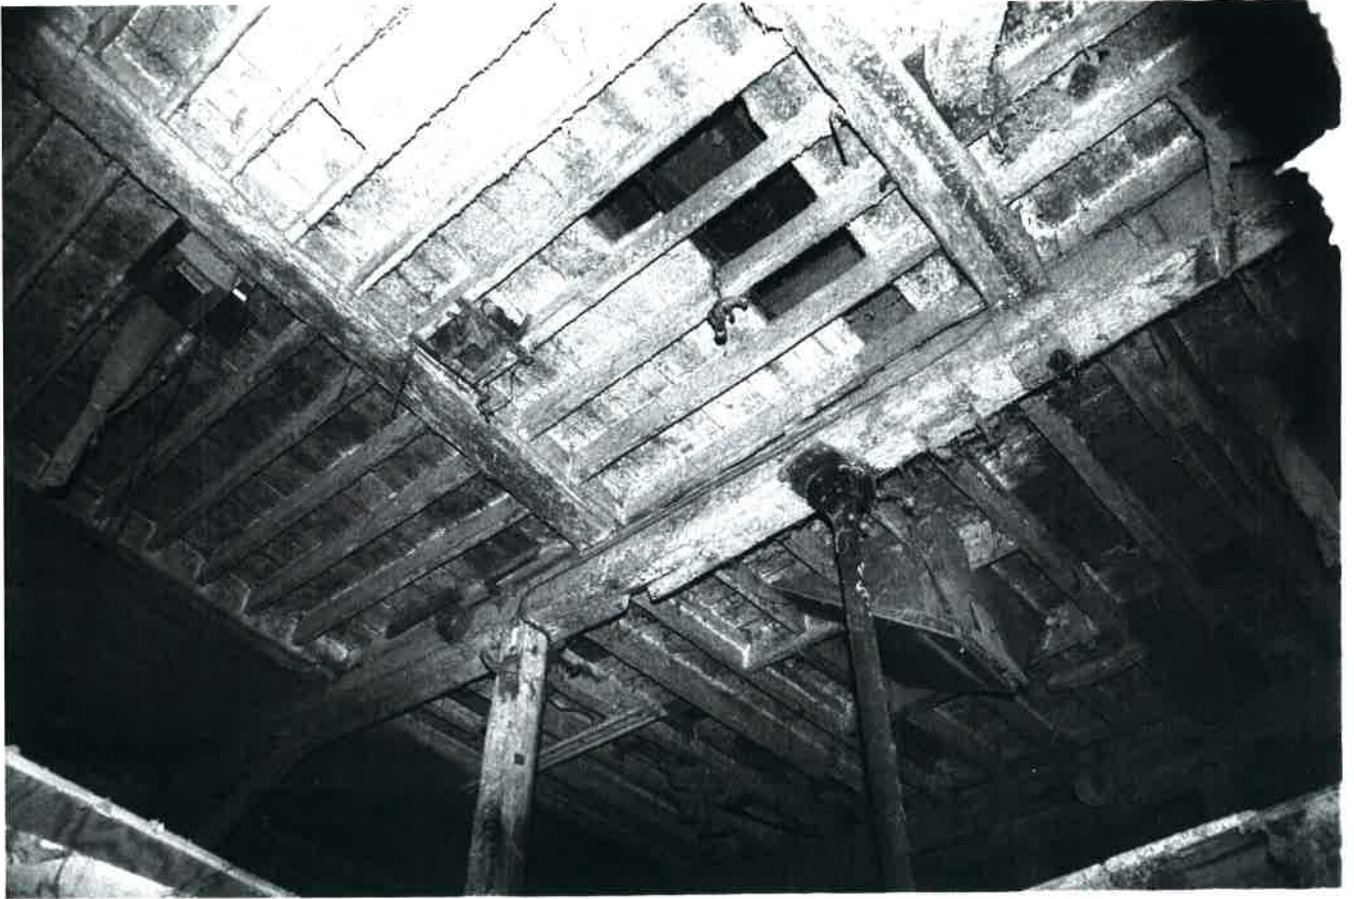
Plate 16 Underside of second floor of mill. Note top shaft reused as prop.

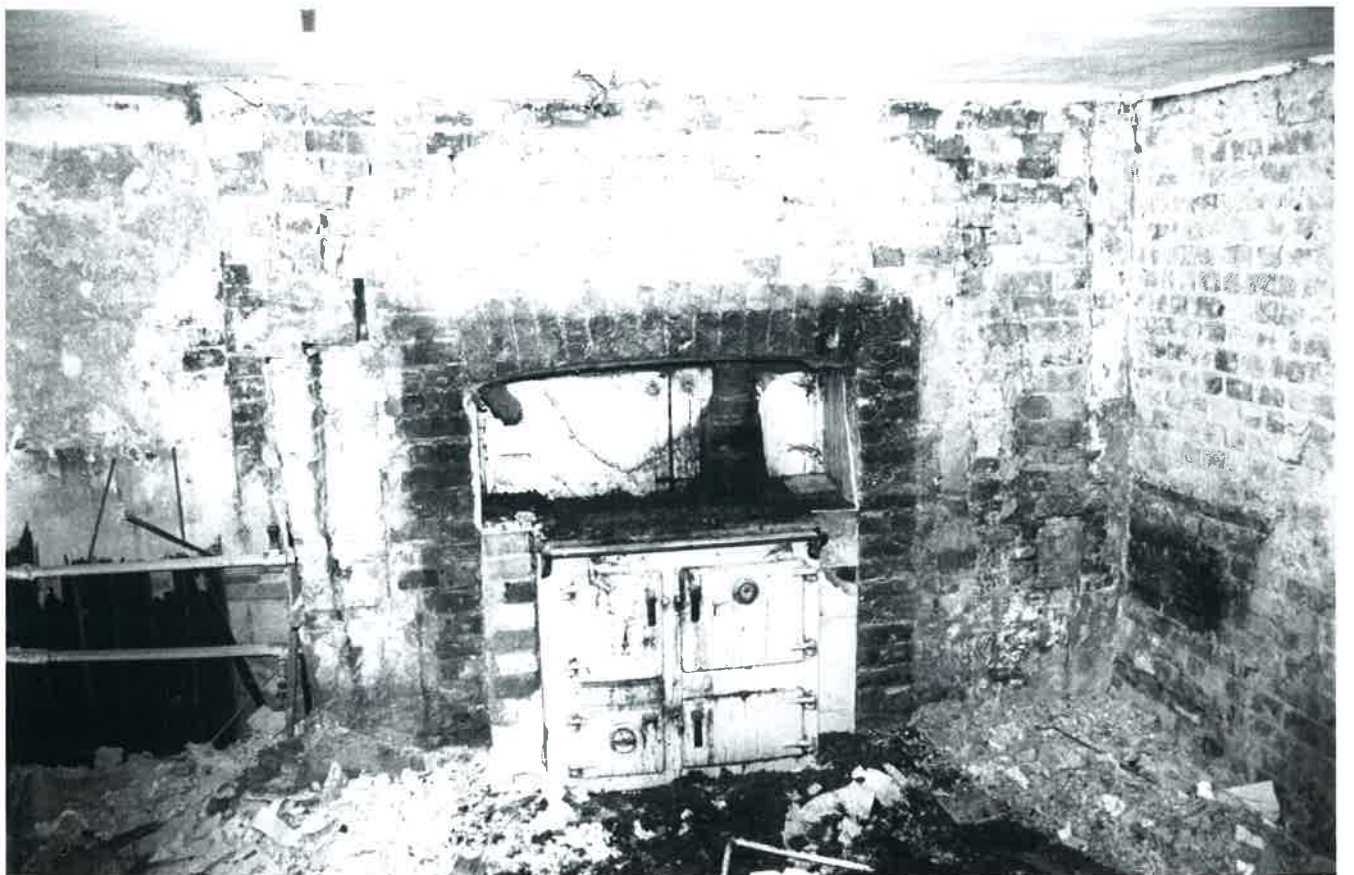
Plate 20 Secondary range in primary stack in G6

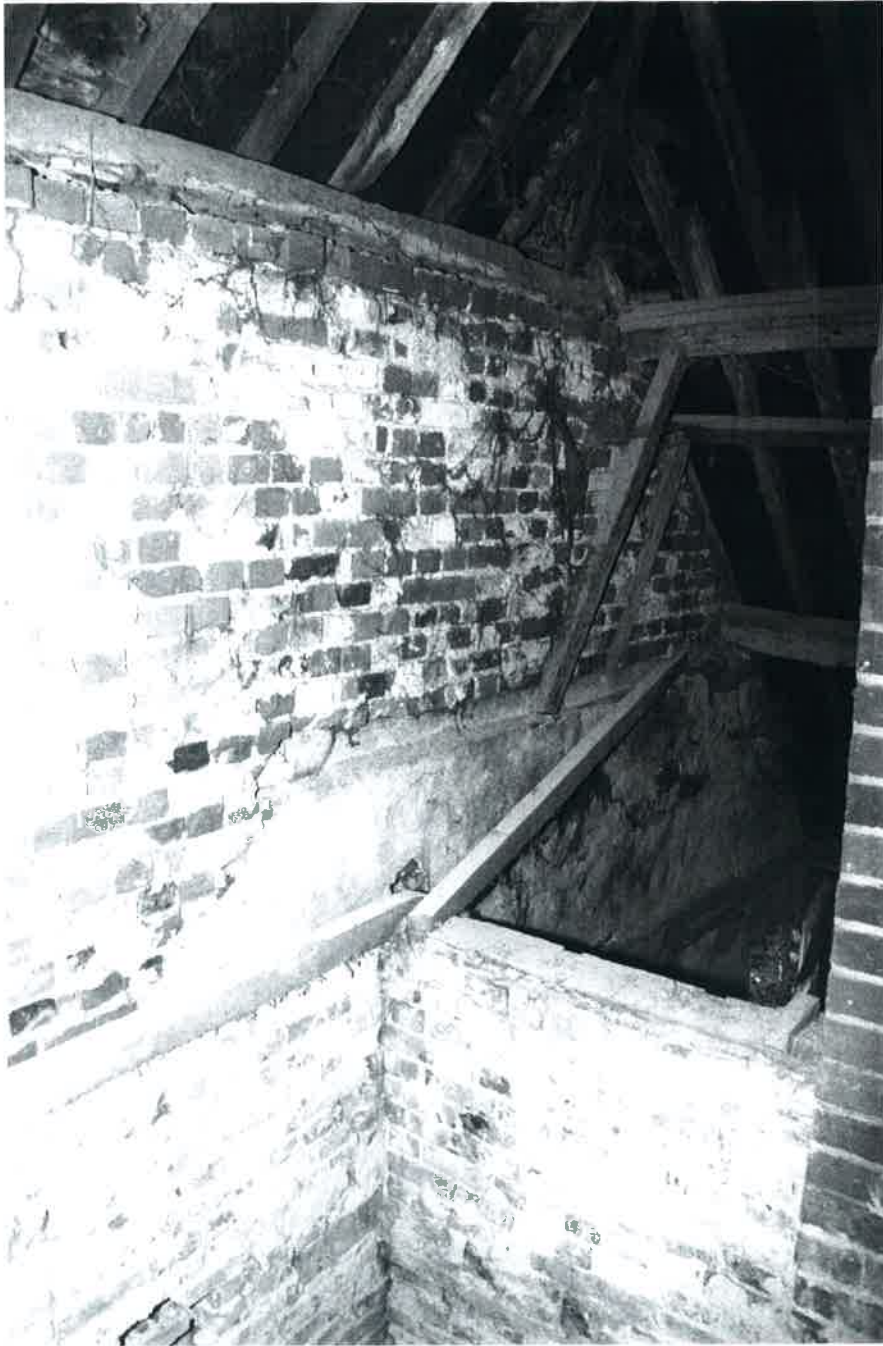
Plate 21 Imprint of former roof on north wall of mill house.

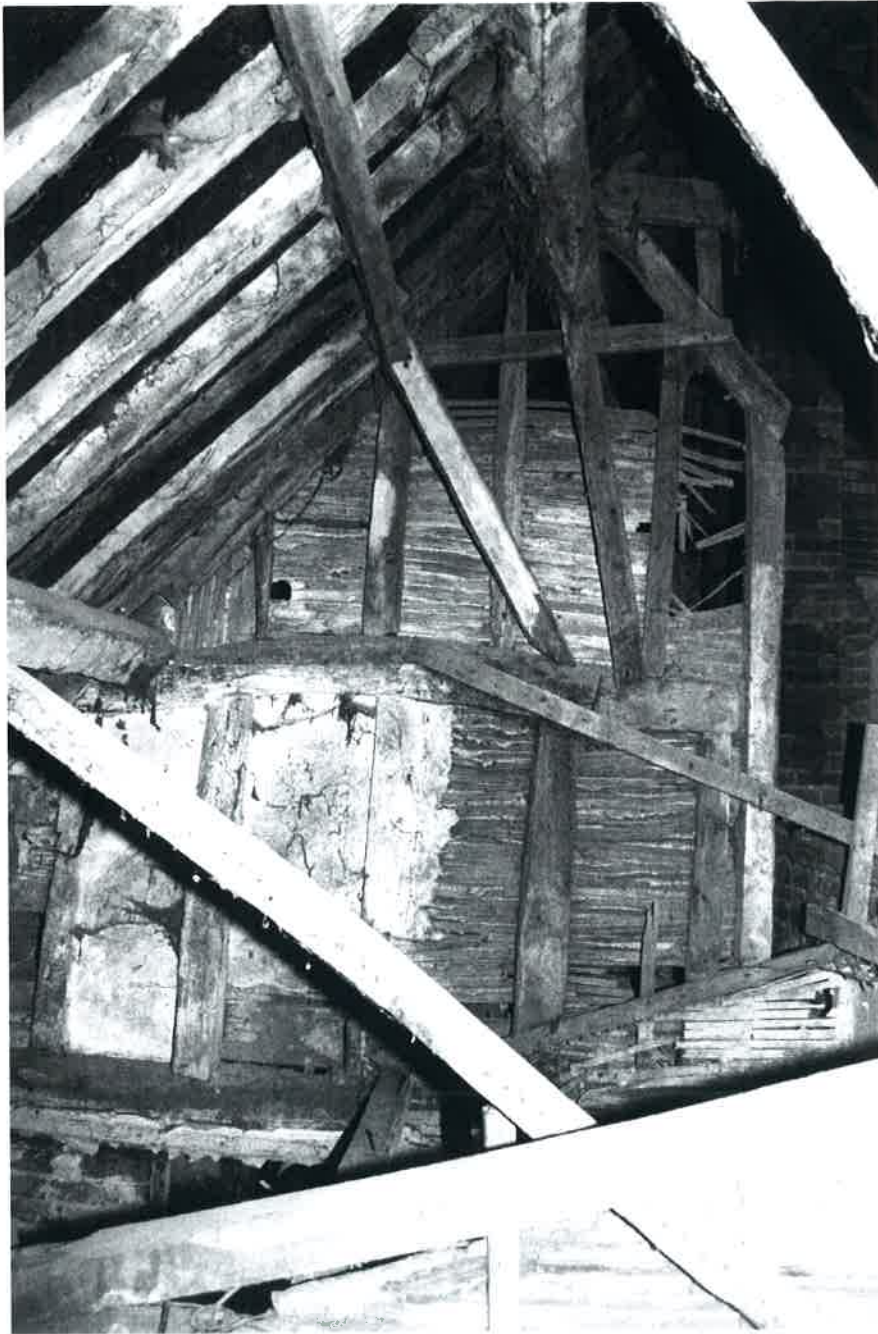
Plate 22 Surviving truss and cross frame above wall between F7 and F8.

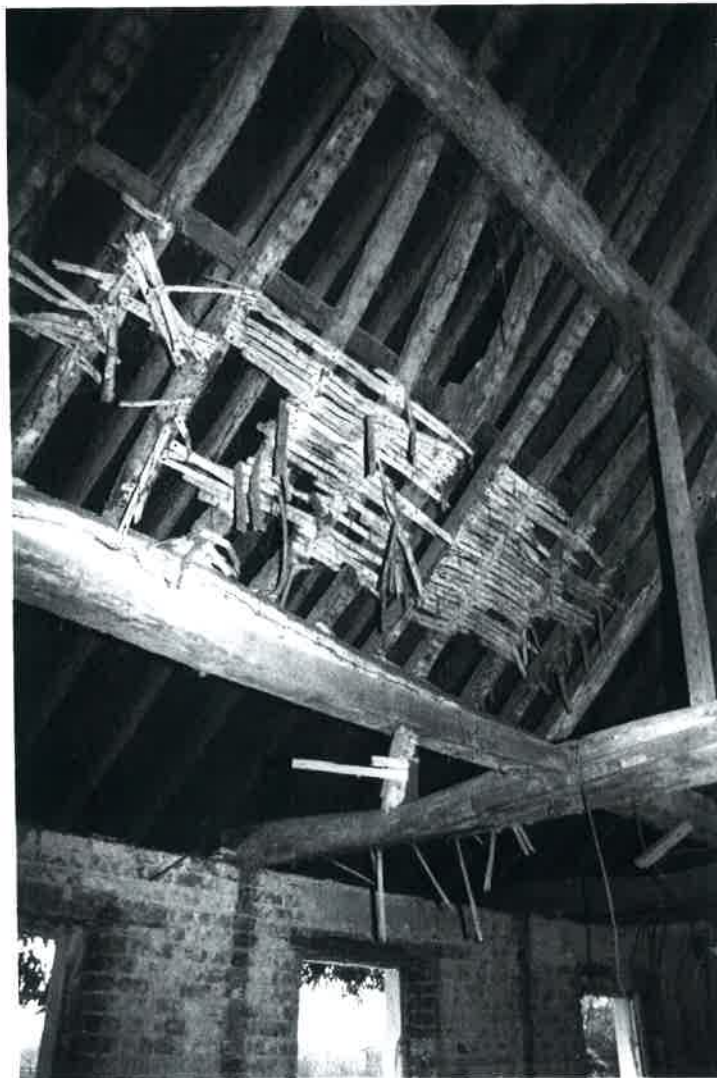
Plate 24 Rafters of earlier building enclosed within roof of mill house

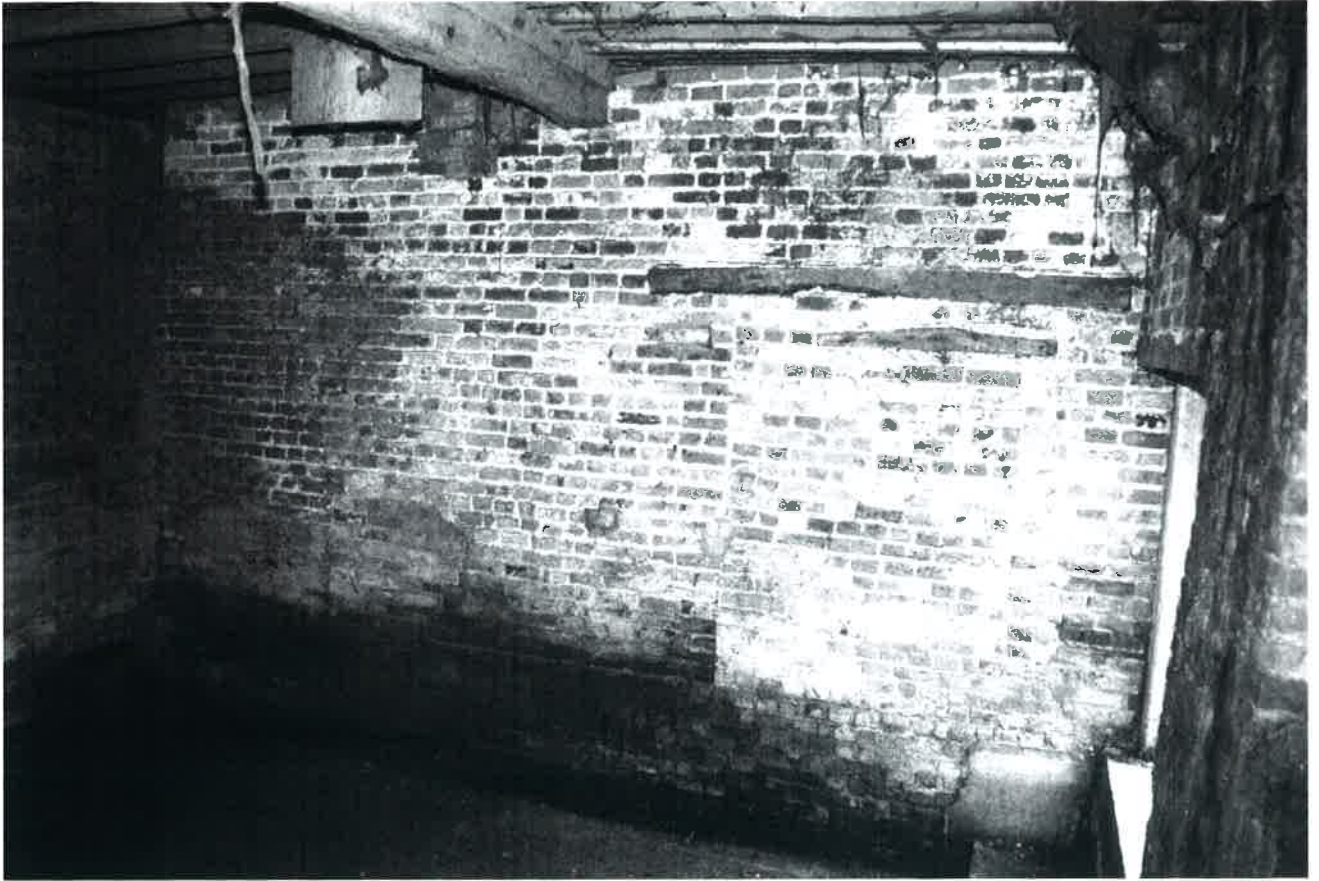
Plate 25 South wall of former wheel house (G10).
