CLAYTON HALL

Archaeological Evaluation and Fabric Survey

Oxford Archaeology North

January 2002

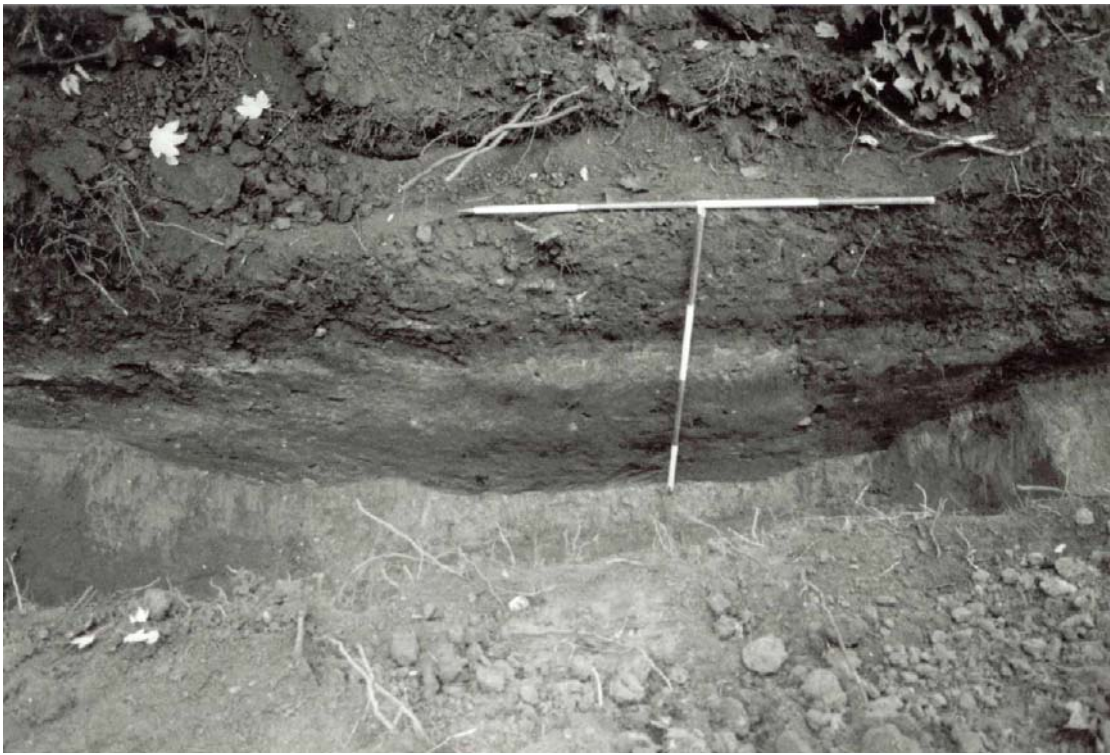
Plate 1: West-facing section of Trench 15, showing the profile of the moat

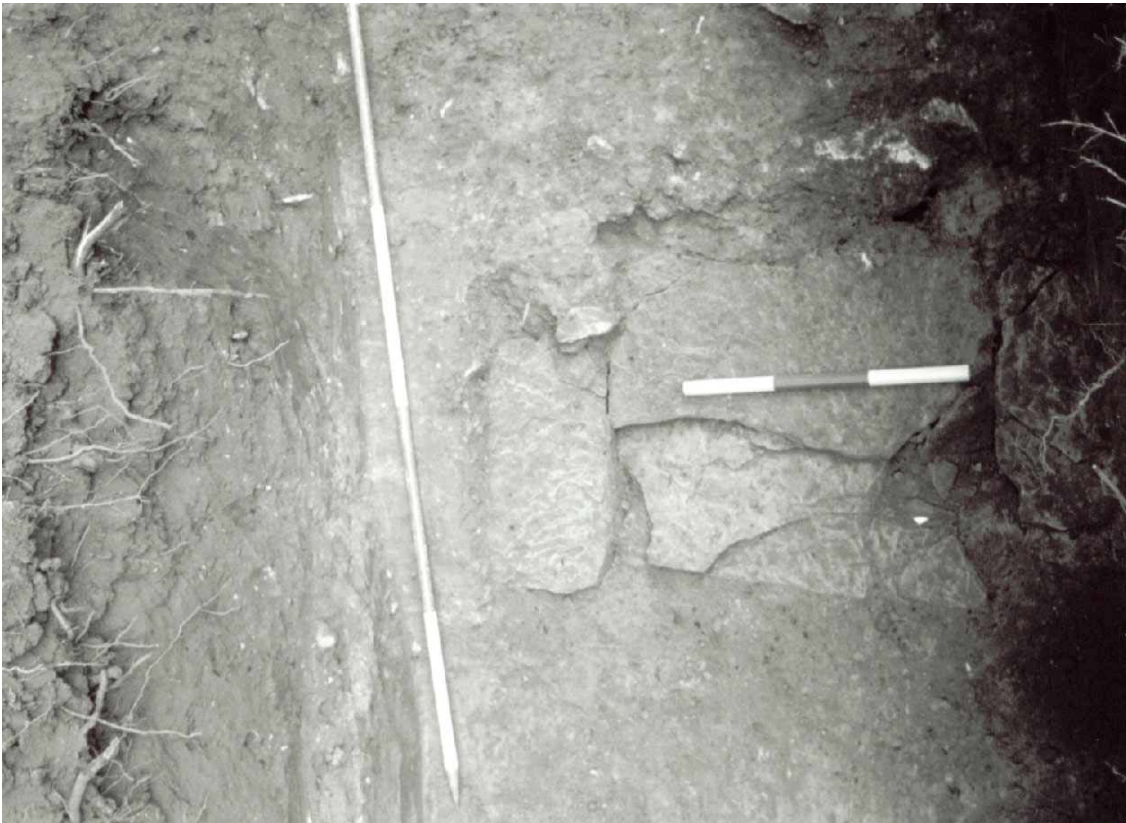
Plate 2: Vertical view of stone culvert **25** in Trench 17

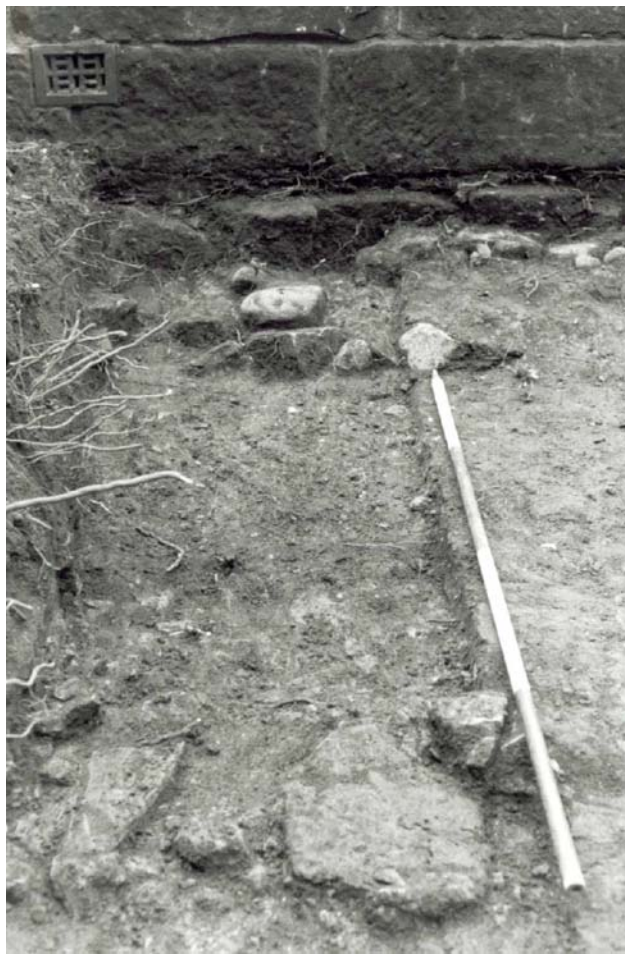
mottled iron-rich sand, **219**, similar to **211**, was encountered, representing drainage in antiquity. Fill **204** was sealed by a clay layer, **202**, in the north, which was not present in the south; this may represent a deliberate attempt to backfill the cut and create a surface. This clay layer was probably contemporary with an adjacent clay deposit that bonded an uneven spread of sub-rectangular stones, **201**. This deposit, **201**, extended between linear feature **203** and the foundations of the eastern wall of the Hall, and could perhaps be the remains of an earlier wall, with an associated clay floor. On the east side of ditch **203** was a deposit of clay, **205**, which was comparable to the clay deposit within **201**, but without the stone component. Overlying **205** was an orange sandy layer, **209**, at the northern side of the trench.

- 3.3.5 East of **203** was a further linear feature, **208**, on a similar alignment, comprising a disturbed flat stone structure, which was 0.56m wide and had a section of what would appear to be a wall with facing stones on both the east and west sides. This would therefore appear to be the decayed remains of a wall or wall foundation. The structure was set within an approximately parallel-sided foundation cut, **207**. A large sandstone capping, **206**, topped a second course of sandstone in the north part of the wall and the feature resembled a stone culvert. This putative culvert did not extend all the way across the trench, and at the southern end wall **208**, was overlain by thin micaceous sandstone tiles, resembling a surface. The feature was sealed by redeposited clay in the east and west.

Plate 3: Trench 19, looking west showing the contrast between the early foundations, *203*, and those of the southern extension

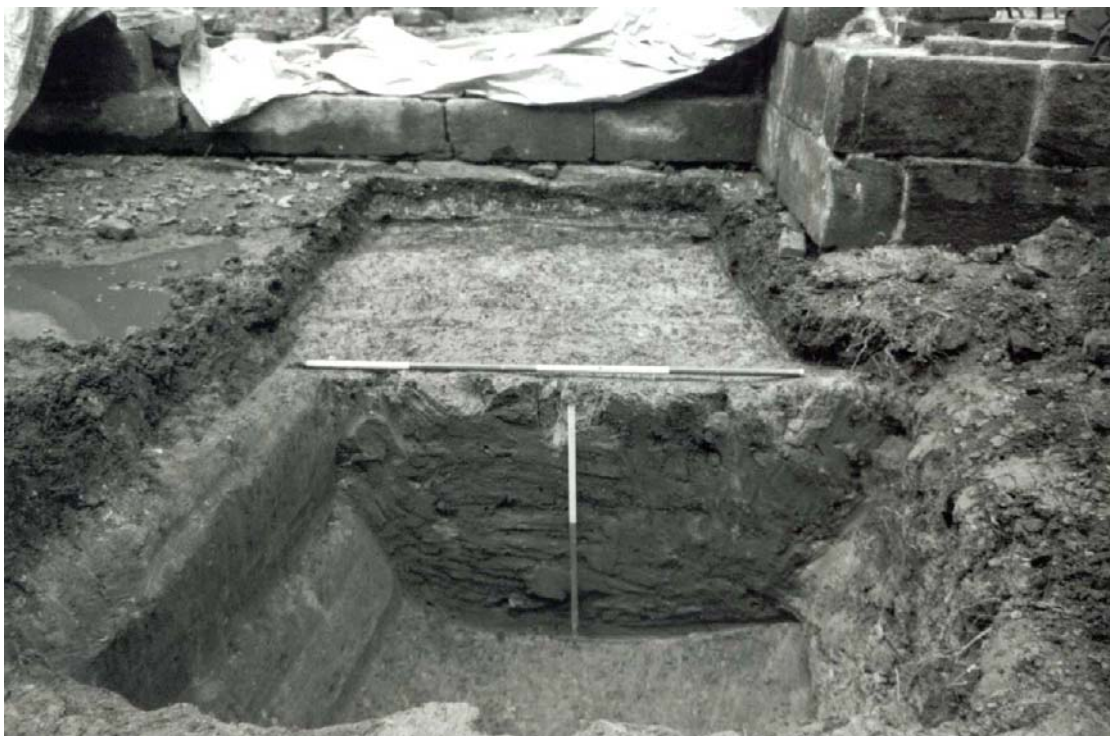
- 3.3.8 At the western end of the trench, two 100mm diameter ceramic water drains were visible, which ran parallel north/south, aligned with the extant foundation of the house, and were either contemporary with, or post-dated, its construction.

Plate 4: Trench 20, looking west, showing natural deposits beneath building

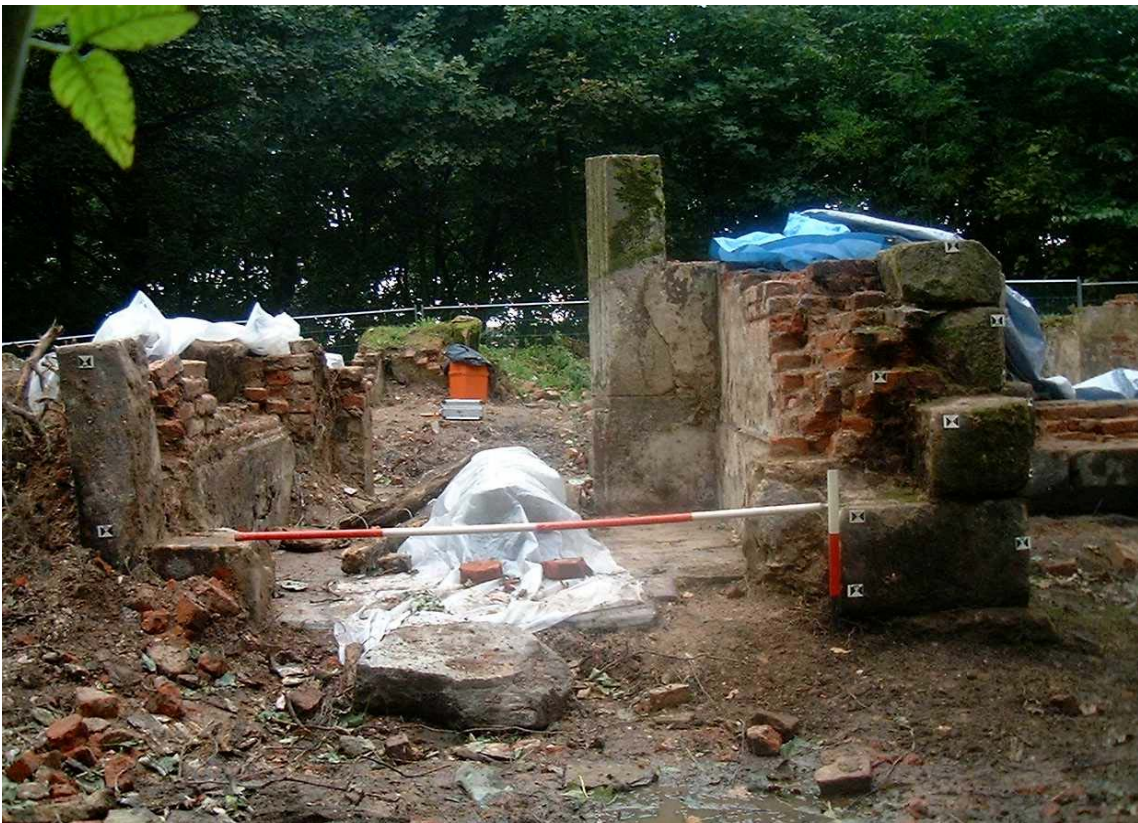
course of ashlar blocks is chamfered, suggesting that the ashlar plinth was at full height. The entry hall has an outer and inner doorway, both with stone fluted jambs, although the northern jamb of the external doorway is entirely missing, and the 1975 photograph shows that this door surround had been removed prior to demolition (*ibid*). Both this and the c1900 photograph shows that the porch had large, alternate, sandstone quoins, with longer quoins on the northern corner, than the southern corner. The photograph shows that above the entrance-way was a single stone mullioned window. Within the short porch is a stone flag floor, and the walls are finished with plaster, including a high skirting board. The internal jambs appear to have been inserted, or more likely repositioned, as the brickwork supporting them has been rebuilt.

Plate 8 View of the porch, looking west, at the outset of consolidation

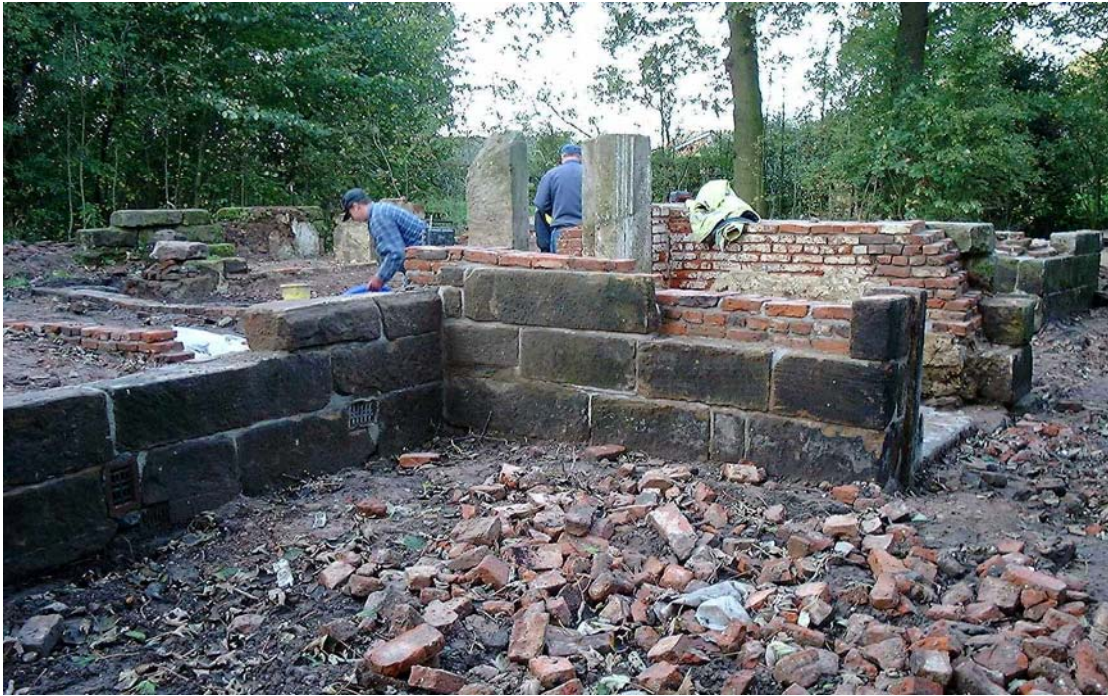
Plate 9: The porch following consolidation, viewed from the south-east

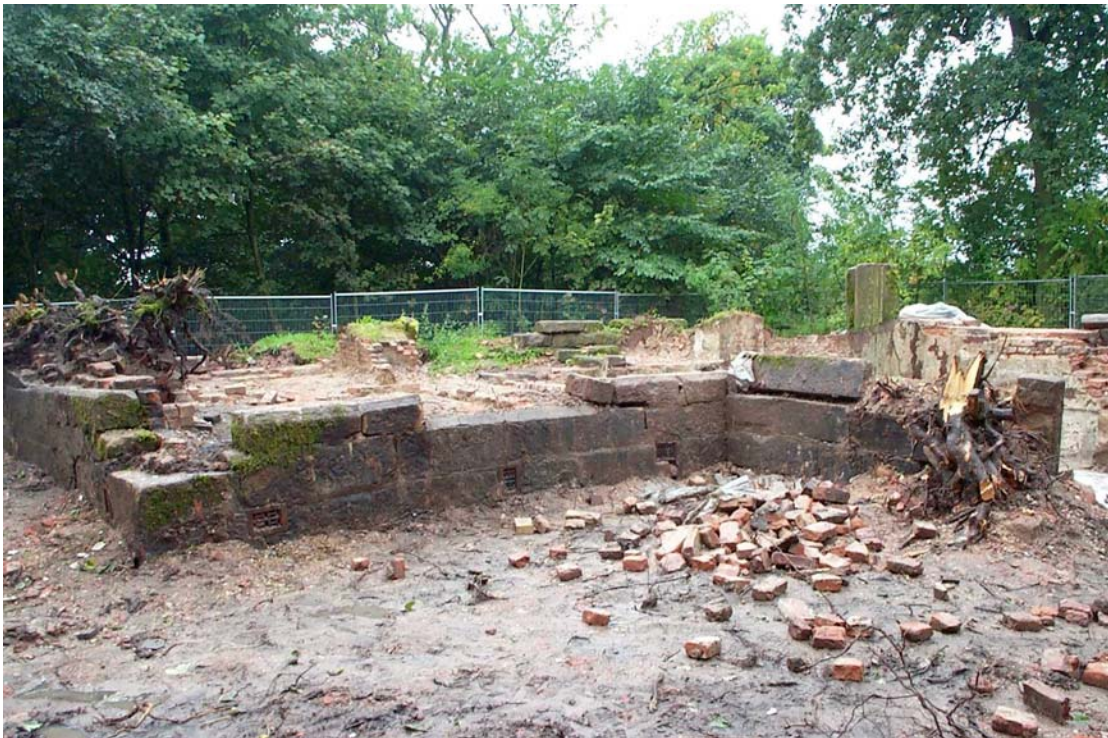
- 4.2.4 The southern section of the elevation, to the south of the porch, is constructed of a single skin of ashlar stone cladding, with only a single skin of brick behind; the mortar between the bricks is a dark charcoal / ash-rich mix, which is found only in this section, and in the southern elevation. The upper course of stone cladding is chamfered, but these are at a lower level than the chamfered blocks on the porch, and the c1900 photograph confirms that the upper level of the ashlar cladding is markedly lower in the southern section than that on both the porch and the northern section.

Plate 10: Southern part of Clayton Hall, including the porch, viewed from the south-east at the outset of the consolidation
