RAVENGLASS FORT

Watching Brief Report

Ravenglass Roman Fort
Cumbria

Report no 1999-2000/051/AUA8947

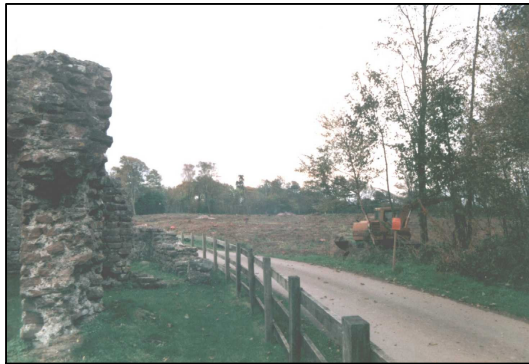
Plate 1 Cleared area of fort: bathhouse in foreground looking south

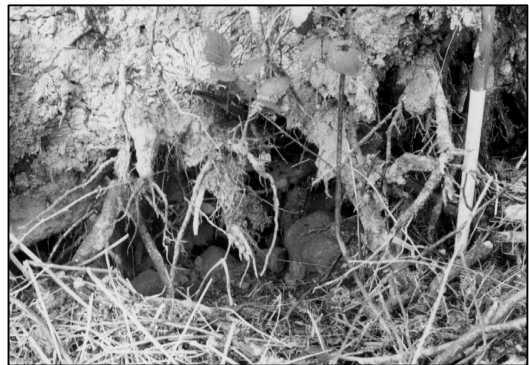
- 3.1.2 **Group 1:** four locations (Sites 9, 11, 12 and 14) had clearly visible stones associated with them. Site 9 was the remains of a tree which had blown over, and then been righted; despite this, one block of sandstone was visible beneath. Site 11 had one squared fragment of sandstone and three or four sub-rounded fragments. Site 12 revealed only one fragment of squared sandstone. Both Sites 11 and 12 were located in close proximity along the north side of the fort at the base of the rampart bank (Plate 3). Site 14 was to the north-west of Sites 11 and 12 and beyond the fort ramparts; it comprised several sub-rounded 'cobbles' visible through exposed roots (Plate 2).

Plate 2 Site 14 with stones revealed in cavity

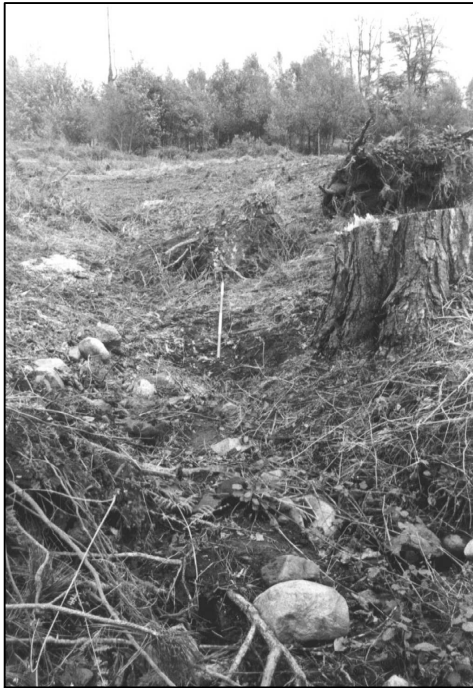
- 3.2.2 The masonry sites identified (M1, M2 and M3) consisted of a block of amorphous stones in the centre of the fort (M1), and two areas of loose stone on the surface along the northern edge, lying in the ditch (M2 and M3). Plate 3 shows the scattering of both squared and amorphous stones in the area of Sites 11, 12 and 13. These stones were in an approximate east/west alignment and were composed of granite and sandstone. To the north of this area was a collection of four fragments of mixed material. None of the stones appeared to be *in situ*.

Plate 3 Sites 11-13 and strewn stones, looking east.

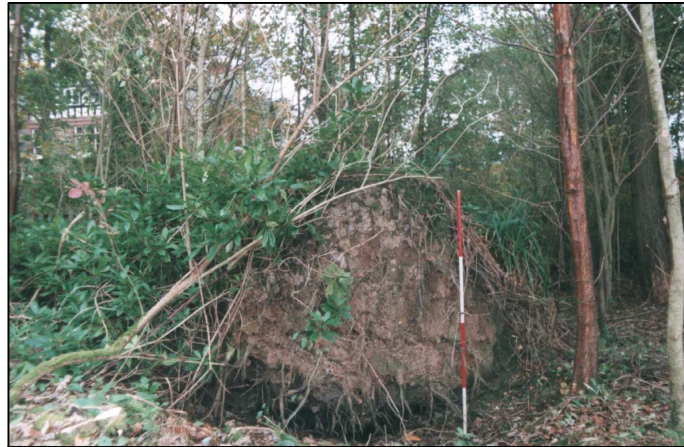
- 3.1.3 **Group 2:** this group revealed no signs of any masonry, stones or any other archaeological features. The tree hollows were all fully exposed, usually because the trees had been blown over and had not been righted, leaving the tree bowls upstanding (Plate 4). The remains, however, were not always visible due to the fact that, since the trees had fallen, their hollows had become overgrown. The sites in this group included 1, 2, 3, 13, and 15. They were scattered randomly across the study area although Sites 1, 2 and 3 were clustered together on the south side of the fort and all the trees had been blown to the south. Stump 13 had not obviously been blown over but there was significant disturbance from erosion and a section was visible including an horizon of humic material (0.2m), a greyish brown silt (0.12m) and, at the base, a reddish brown deposit (0.25m+). Site 15 revealed nothing.

Plate 4 Site 1, looking south

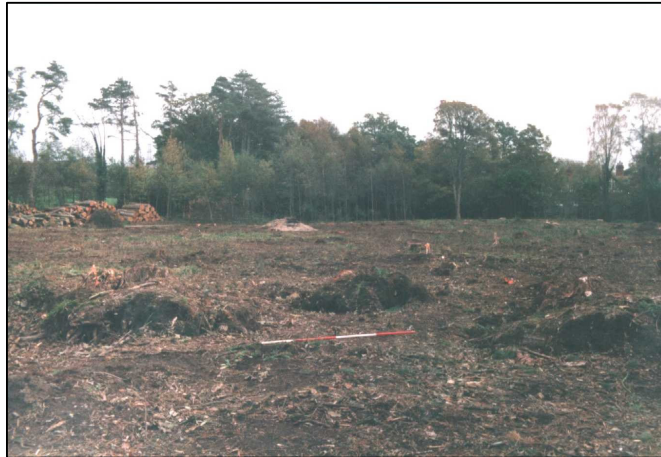
- 3.1.4 **Group 3:** this group consisted of those trees that had blown over, yet continued to grow, or their stumps had been righted by the Lake District National Park staff. This group comprised Sites 4, 5, 6, 7 and 8, and were all located on the central raised area of the fort itself. It was difficult to determine which way the trees had blown over and visibility within the hollows was minimal. Site 4 was clearly the oldest, having become completely earthfast. There were also two further stumps in the nearby area which may have been blown over or may simply have grown at an angle due to the prevailing westerly winds.

Plate 5 Sites 7-9 looking south-east
