# Cogges Manor Farm Witney Oxfordshire

**Historic Building Recording**

Cogges Manor Farm House, photographic recording

Historic building recording

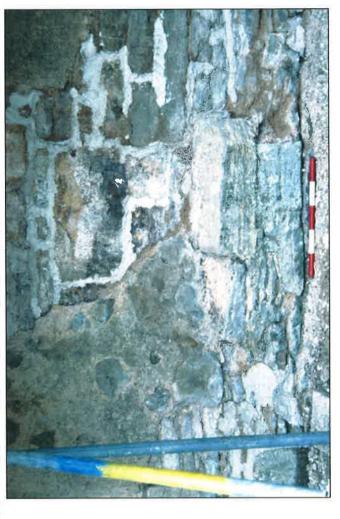
- 4.2.1 *Ground Floor:* the limestone render has been partially removed exposing some recent repair to the stonework with some areas of infill. Of particular interest is a plinth at the base, and it is likely that this extended further to the east as this has clearly been infilled (Plate 2). It is possible that there was an entrance to the house from the north range that was later infilled.

Plate 2: North elevation, ground floor showing plinth and infill

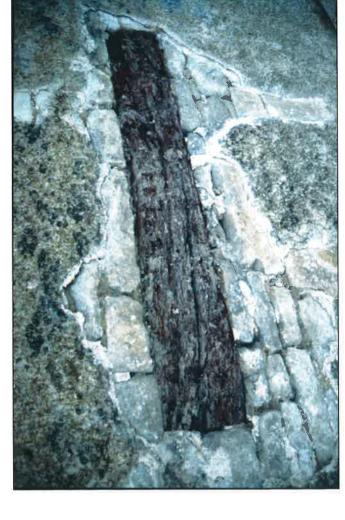
- 4.2.3 The removed render also exposed two timbers. An east/ west timber (1.70 m by 0.24 m) is evident 3.21 m from the western edge of the elevation (Plate 4). A further 0.41 m to the east an end section of a north/ south timber is visible. In section this measures 0.21 m by 0.22 m (Plate 5)

Plate 4: North elevation, first floor showing exposed timber.

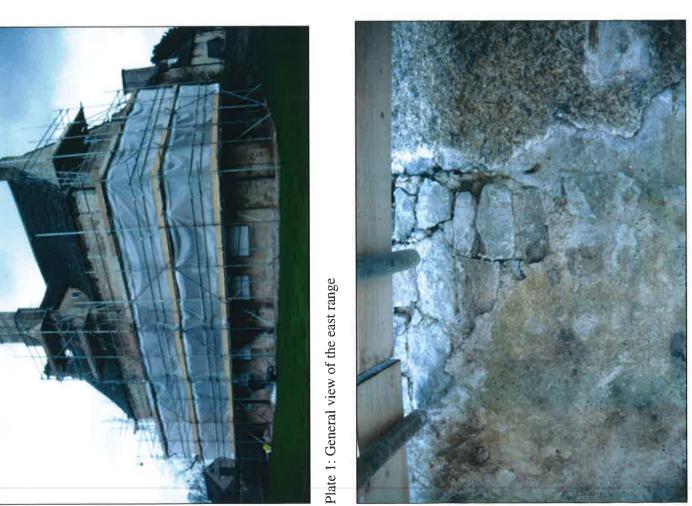
- 4.2.2 *First Floor*: areas of render were removed on the elevation, and it is evident from the remaining render that the most westerly third is of a different phase. The alignment also follows a break in the stonework, although it was not possible with the extant evidence to phase this change (Plate 3).

Plate 3: North elevation, first floor showing break in stonework at west end.

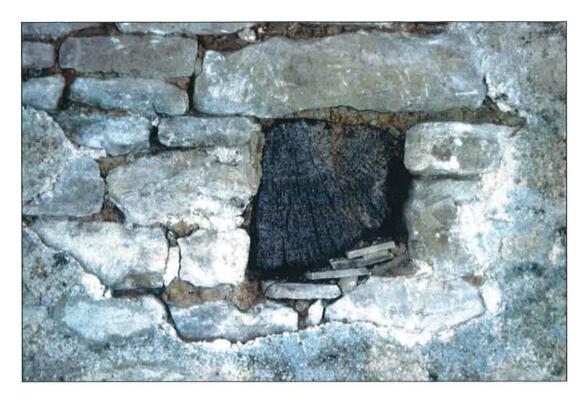
Plate 5: North elevation, first floor showing exposed cross timber

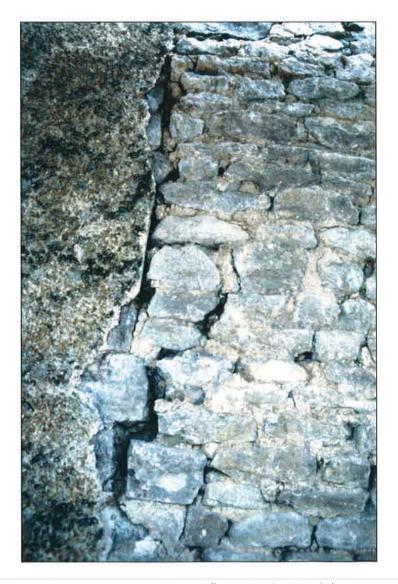
- 4.2.4 Second Floor: removal of render has revealed a clear break in the stonework to the west of the elevation. This extends to the west and has smaller limestone pieces which are irregularly coursed (Plate 6). This aligns with the break in the stonework found on the first floor and it would appear that the area to the west is a later extension.

Plate 6: North elevation, second floor showing break in stonework

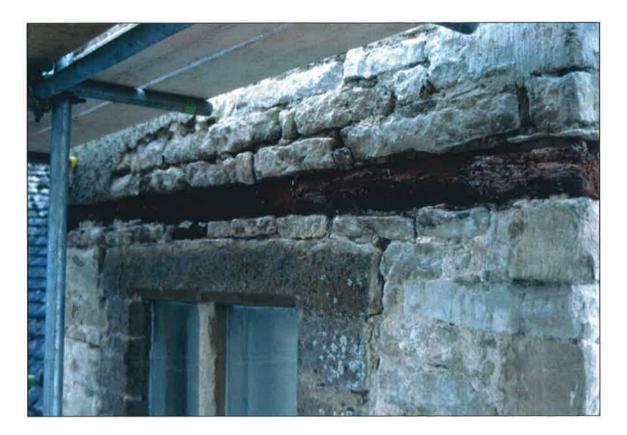
- 4.2.5 Third Floor: three north/ south timbers have been revealed. The most westerly measures 1.73 m by 0.67 m (Plate 7). The central timber is situated above a mullion window (2.25 m by 0.27 m) and is chamfered at the base and there is also an east/ west cross timber above this which is 0.16 in width (Plate 8). The third is a thin section of timber above a quoin that is 0.6 m in thickness (not possible to measure full length) (Plate 9).

Plate 7: North elevation, third floor showing exposed timber

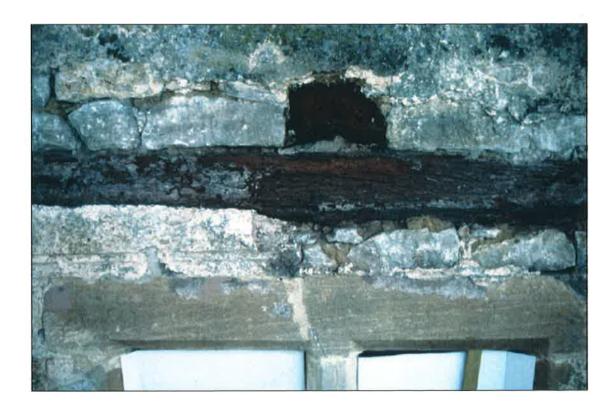
Plate 8: North elevation, third floor showing exposed timbers

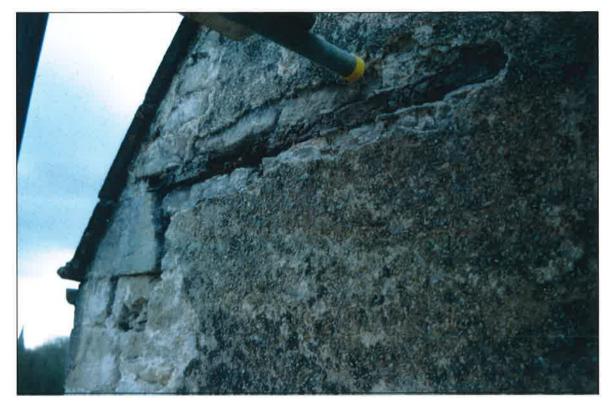
Plate 9: North elevation, third floor showing exposed timber

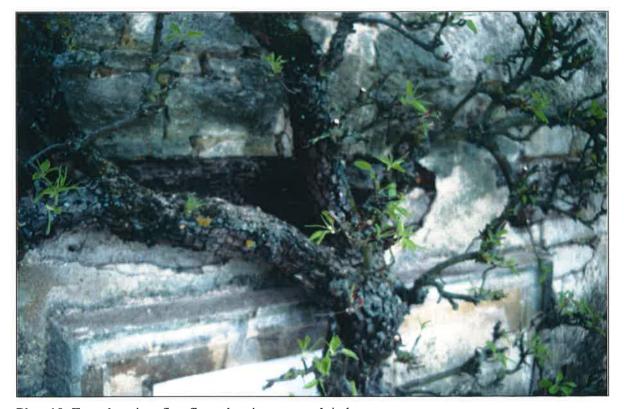
- 4.3.1 *First Floor*: some render has been removed revealing a timber lying above a window to the north (which is partial infilled). The full extent was not possible to measure but it is 0.21 m in thickness (Plate 10).

Plate 10: East elevation, first floor showing exposed timber

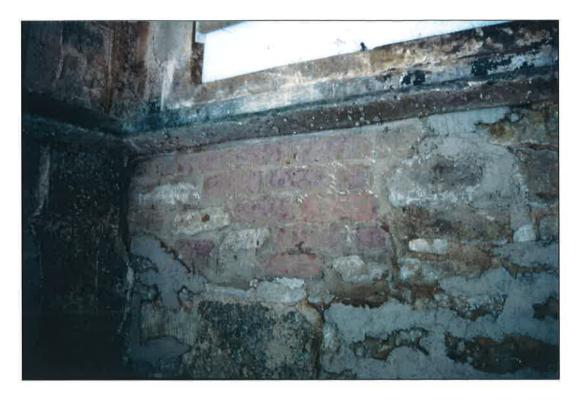
- 4.3.2 Above the second and third windows from the north patches of probable 19th century red brick are visible (Plate 11). To the south of the elevation, above the fourth and fifth windows from the north is an exposed timber is evident (0.21 m thick, not possible to measure length). This has been sawn off at the end indicating that this once extended further to the south (Plate 12). The face of the elevation steps in 0.05 m at this point. There is a different phase in the stonework and it would appear that an additional building once extended further to the south from this point. The south elevation of this earlier structure has been retained and the extant eastern range of the Manor House has been built on from this point. This confirms the findings of the building recording carried out by the Royal Commission of the Historic Monuments of

Plate 11: East elevation, first floor showing exposed red brick

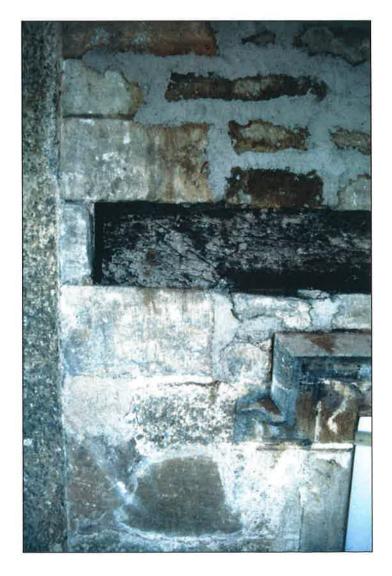
Plate 12: East elevation, first floor showing exposed timber

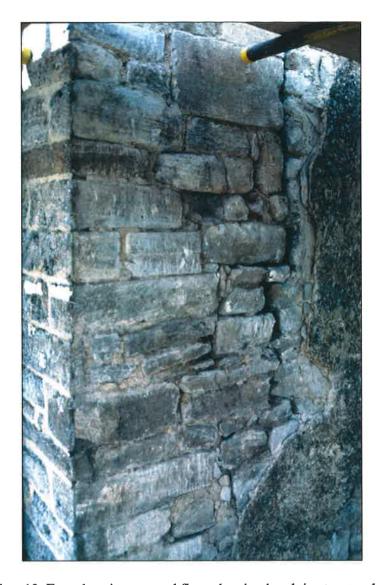
- England. Recording of the much rebuilt south range concluded that the east range originally continued to the south (Rowley and Steiner 1996 8)
- 4.3.3 Second Floor: a break in the brickwork is evident at the south end of the east elevation. The limestone is well dressed and of substantial build. There is a clear break here from the remaining structure projecting to the north and it is possible that this is part of an earlier building which once projected to the south (Plate 13). As above this confirms the findings of the Royal Commission (Rowley and Steiner 1996 8).

Plate 13: East elevation, second floor showing break in stonework

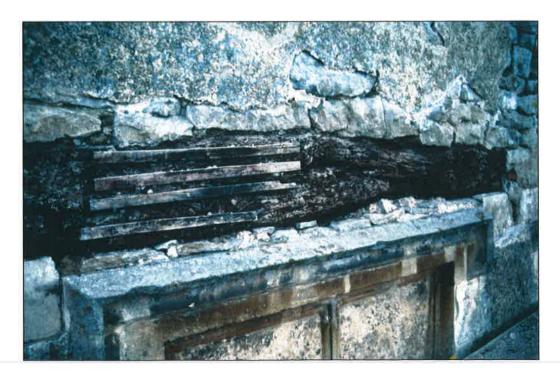
- 4.3.4 Third Floor: removal of render has revealed a north/ south timber above the most northern window (2.94 m by 0.30 m) (Plate 14). Overlying this between the window and roof level, the limestone is smaller and roughly coursed. Above the second and third windows from the north red brick infill is evident (Plate 15). This is c.5 courses and roughly constructed. It is probable that this occurred during the installation of the window or repair to the brickwork. As described above there is a break in the brickwork at the south end, suggesting the structure extended further to the south.

Plate 14: East elevation, third floor showing exposed timber

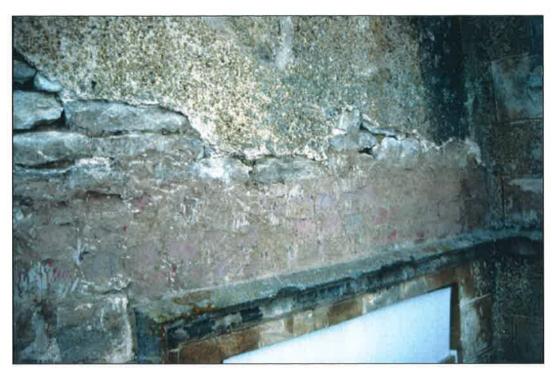
Plate 15: East elevation, third floor showing red brick repair

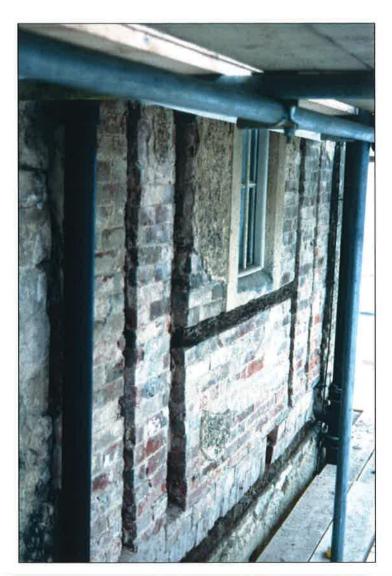
- 4.4.1 First Floor: the removal of the render has revealed a large area of brick multiphase rebuilding. It is possible that this dates from the 19th century, when much of the east range was rebuilt. It is thought that the bricks predate the 19th century and were reused. There is a four-light window roughly in the centre of this area, and seven timbers. This area is set between limestone (Plate 16).

Plate 16: West elevation, first floor showing red brick repair

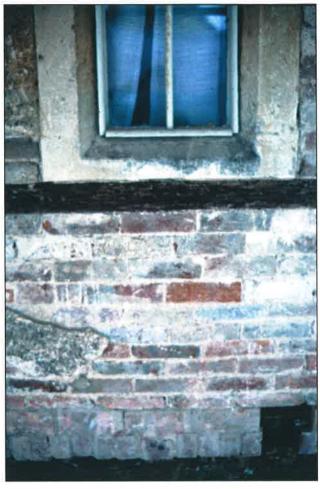
- 4.4.2 The lowest timber is horizontal, orientated north/ south, measures 0.17m (not possible to measure length) in thickness and is at the base of the first floor. Directly above this is a course of 20th century headers and footers Overlying this is an area of probable 17th-century brick, followed by a course of probable 18th-century brick and a further shorter north/ south timber (1.31m by 0.8m) situated just below the window (Plate 17). There are four vertical timbers; the most northerly is 0.18 m thick (2 pieces of 0.9 m placed together, not possible to measure length), one either side of the window (0.12 m and 0.19 m, not possible to measure length) (Plate 18) and the most westerly is 0.6 m thick (Plate 19). Between these timbers is probable 18th century brick.

Plate 17: West elevation, first floor showing red brick repair and exposed timber

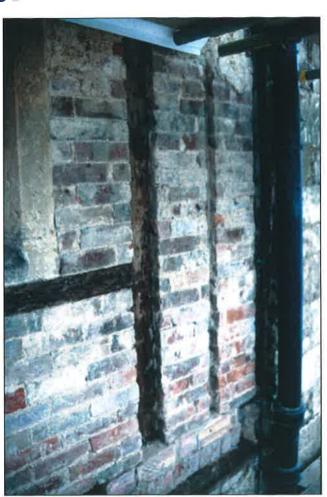
Plate 18: West elevation, first floor showing exposed timber

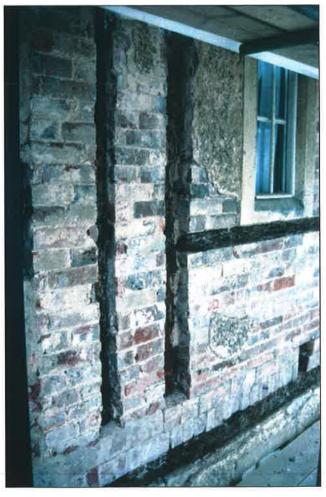
Plate 19: West elevation second floor showing exposed timbers to south

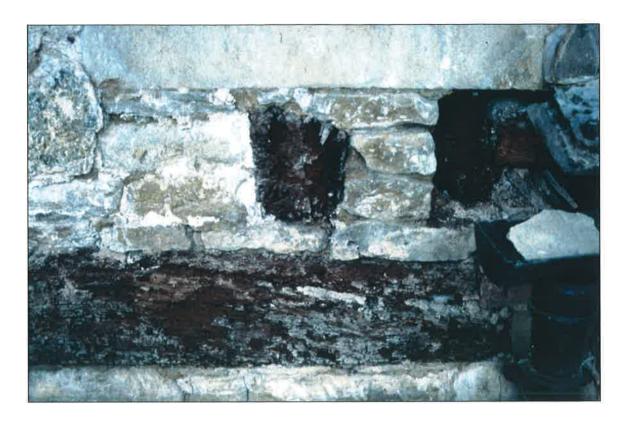
- 4.4.3 Second Floor: removal of render has revealed a north/ south timber (2.88 m by 0.20 m) above a window which is the second from the north. Directly above this are the ends of two east/ west cross timbers (0.20 m by 0.9 m and 0.16 m²) (Plate 20)

Plate 20: West elevation second floor showing exposed timbers

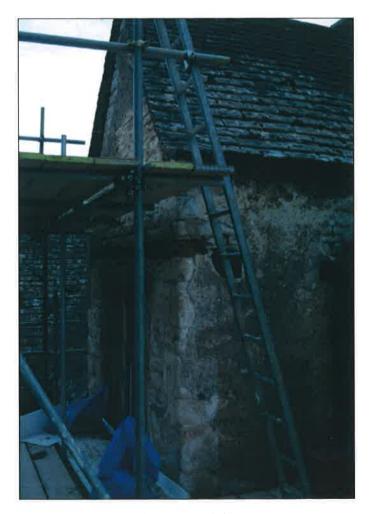
- 4.4.4 *Third Floor*: removal of render revealed a north/ south timber (2.71 m by 0.21 m) above a window to the south located in a gable projection (Plate 21).

Plate 21: West elevation, third floor showing exposed timber
