LANCASTER
UNIVERSITY
ARCHAEOLOGICAL
UNIT

RUFFORD OLD HALL
LANCASHIRE

FABRIC SURVEY REPORT

Watching Brief Report

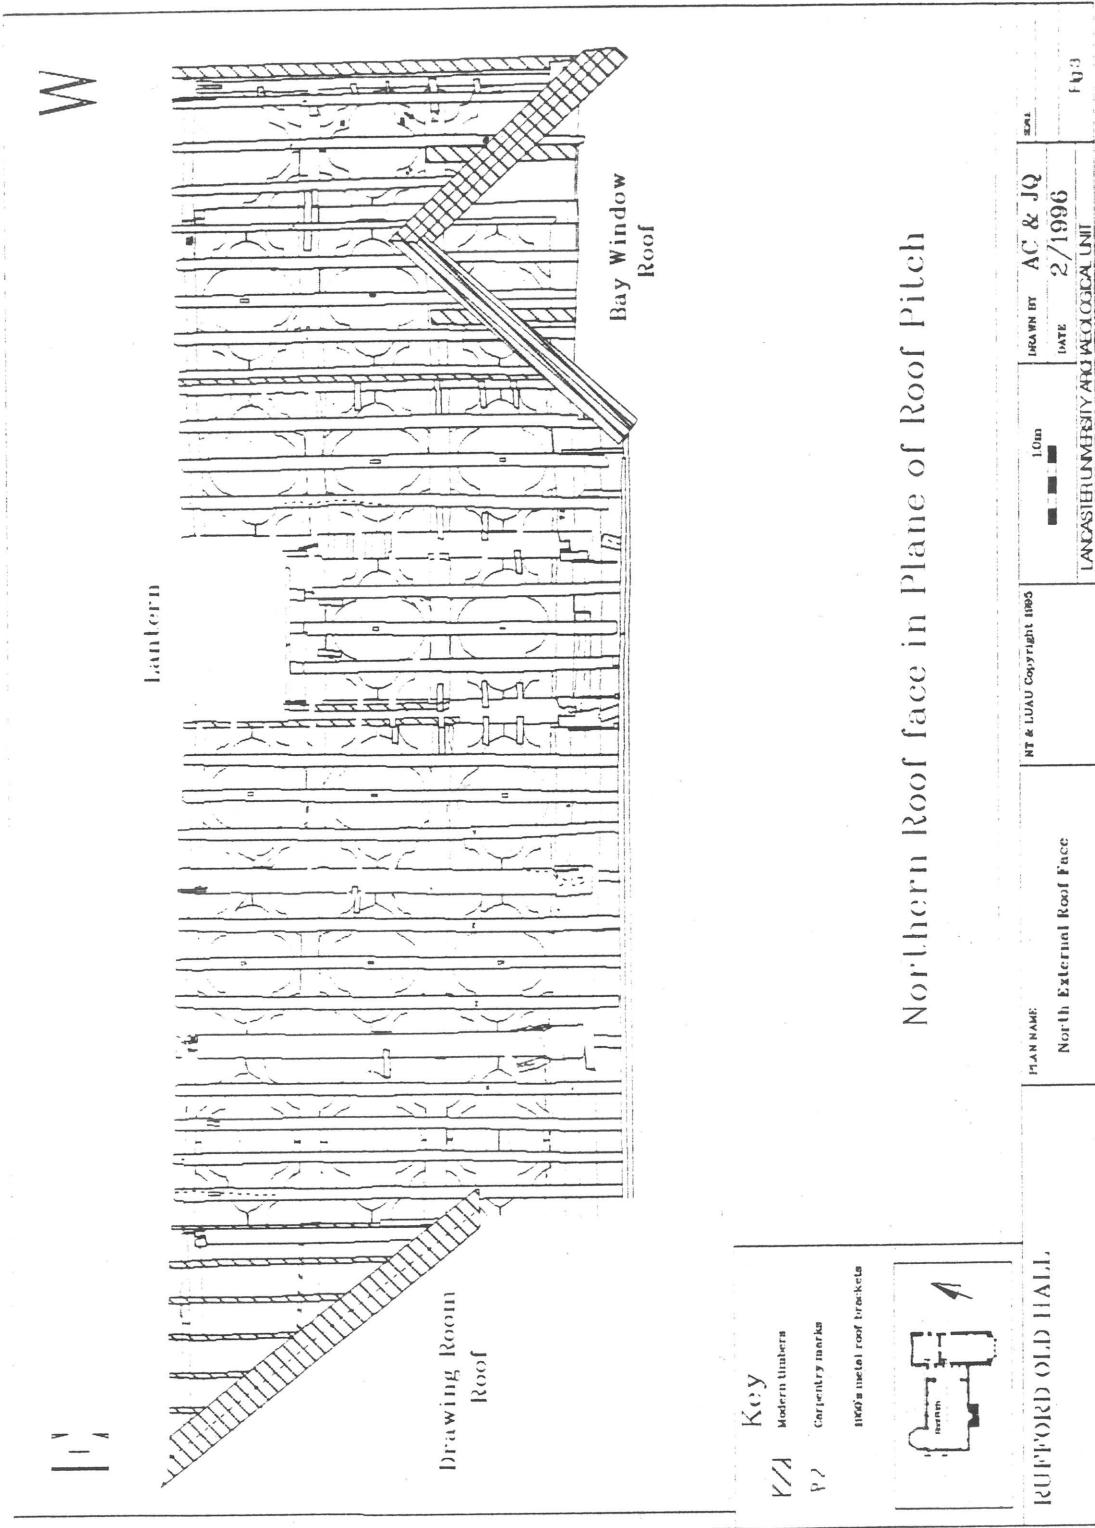
Fig 3 North Facing External Roof Structure

In particular, the extent of the repair programme of the 1950s became more fully apparent. Many of the wind-braces and rafters are connected by iron cramps, into which the timbers are bolted (Figs. 3 and 4); there do not appear to be instances in which the cramps are used in addition to the wooden pegs, but always instead of them. The arrangement of which timbers are pegged and which are cramped is eccentric and given that other parts of the hall have been reconstructed using pegs in new timber, no ready explanation can be suggested. However, it should be noted that the metal brackets are particularly concentrated in the central bays of the roof, in the trusses supporting, and adjacent to, the Victorian lantern. It may therefore be the case that the restorers of the 1950s were of the opinion that metal strengtheners would be a more effective means of supporting the additional weight carried by this area of the roof, than the traditional method of pegging the components of the frame together.

Comparison of the elevations of the east and west gables with one of the trusses supporting the lantern has shown that the pitch of the principal rafters beneath the lantern is dramatically shallower than at either end of the Great Hall (figs 3 and 4). This suggests that the trusses in the centre of the hall are experiencing deformation under the weight of the lantern. In this area, the timber-framed northern wall has also deviated from the vertical. Hammer-beam roofs place a lateral thrust on the wall-tops and are therefore more common in buildings with stone walls than timber-framed buildings (Lynn Courtenay *pers comm*). This effect is likely to be even more pronounced with the additional load of the nineteenth century lantern. Rectified photographs of the roof pitches also show that the ridge purlin has slumped considerably in the bays immediately east and west of the lantern (figs 3 and 4).

It was noted that two of the common rafters of the easternmost bay (above the cross-passage) on both the north and the south side of the building contained rectangular mortices close to the apex, while the irregularity of the rafters did not suggest that these were modern timbers (figs 3 and 4). It is possible that rafters from this site or elsewhere were salvaged for use in the construction of the Great Hall in the fifteenth or sixteenth century; however, an alternative hypothesis is that parts of the roof were remodelled in the post-medieval period. This bay contains four common rafters between the principals, as opposed to the three in all other bays. This arrangement has made it necessary for the decorative panels to be bolted at the four corners directly onto the rafters, rather than secured at the centre onto the central rafter, as in all other instances. The panels, however, are likely to be modern replacements.

The junction of the Great Hall and Drawing Room Wing was exposed during these works. It was evident from their regularity and scantling that the rafters in this area are not from the original structure but are relatively recent in date (figs 3 and 4). However, peg-holes in the principal rafter of the eastern closed truss of the Great Hall showed that the purlins continued east of the hall; the purlins that are still in place do not appear to be new timber and may have been the originals.

The exposure of the structure of the Bay window roof showed that all of the faces are supported by a central kingpost (fig 3). The timbers of this part of the building did not appear to be of any great antiquity and may possibly be of nineteenth or twentieth century date.

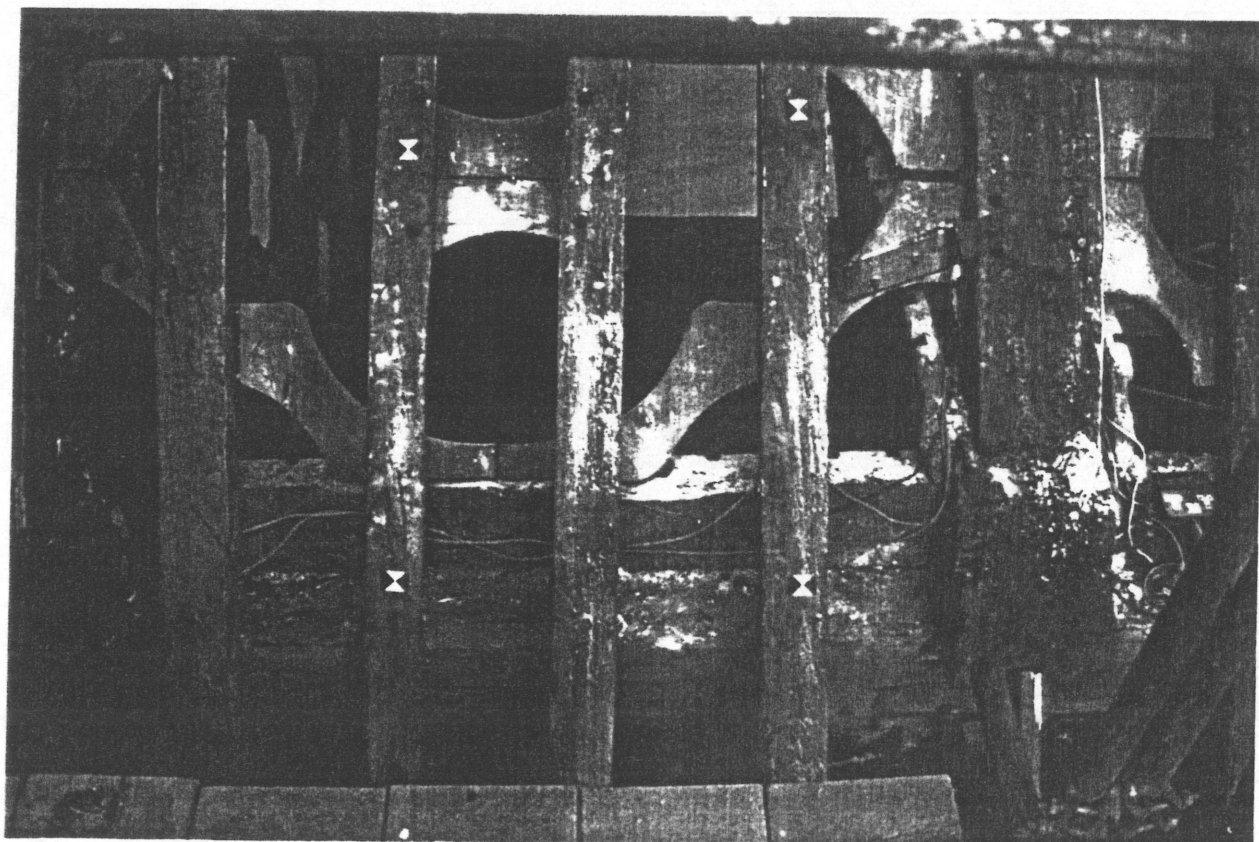
The form of the eaves on the north side of the Great Hall was examined for the first time and the information added to the cross-section record drawing prepared for the Great Hall in January 1995. It was shown that the principal rafters rest on the hammer-beams which are set in trenches in the wall-plate. As on the south side, the hammer-beams project slightly beyond the wall-plate and have dovetailed soffits. The common rafters have been the subject of extensive repairs and many of their ends are in new timbers. They are extended beyond the main wall-plate and meet the curving timbers of the coved eaves in an outer wall-plate of purely cosmetic function; this timber appears to be of nineteenth century date, but may replace an earlier timber. Where the main trusses meet the wall plate, the coving is connected to the back of the panelling by short tie-beams.

Plate 2. Roof detail on north side of roof pitch showing wall plate and hammer beam
