**DUNHAM MASSEY
STABLE YARD**

Greater Manchester

Archaeological Survey Report

The National Trust

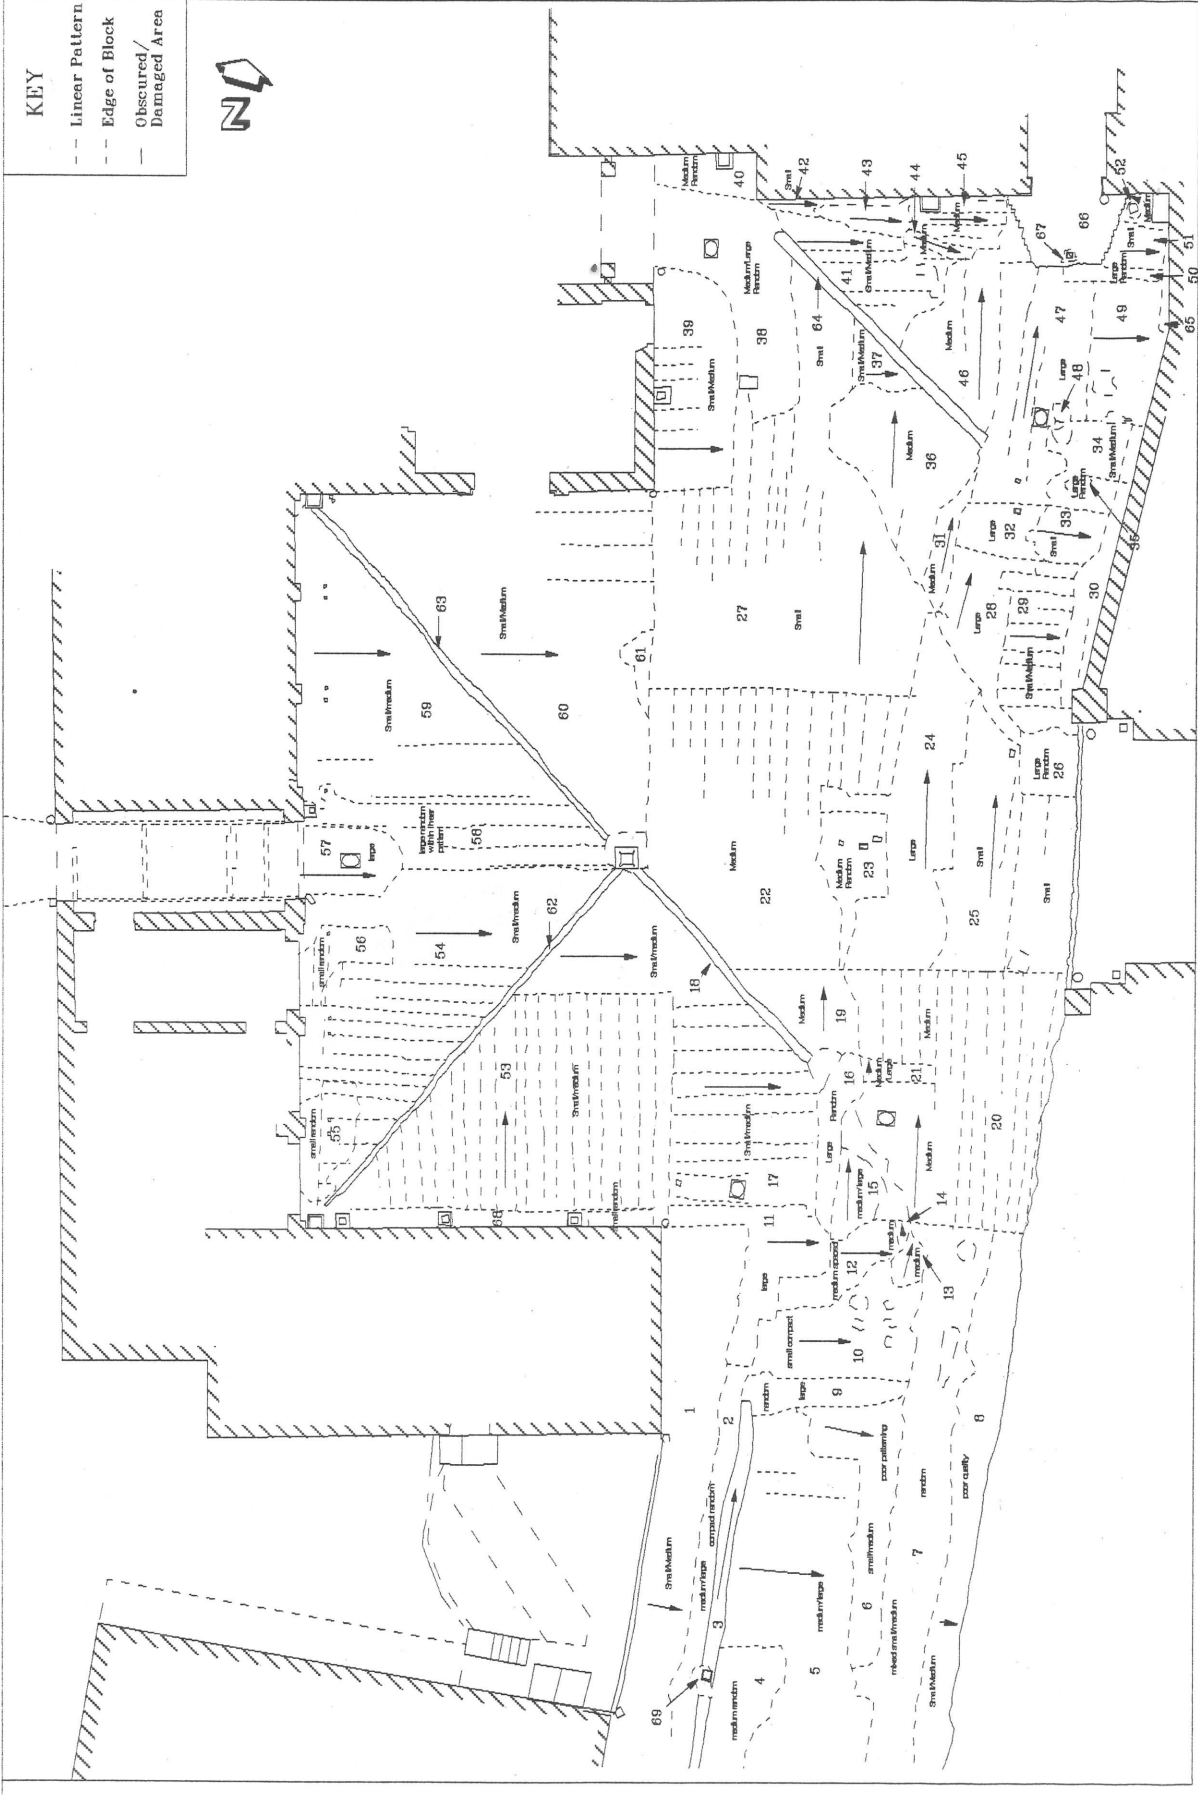
Fig 3 Analysis of Cobbled Surfaces

- 3.1.1 The aim of the analysis was to examine the different areas of cobbling, on the basis of rectified photographic evidence, and to distinguish the areas of repair from surviving elements of the original surface. It was thus possible to identify an earlier pattern of the stable yard surface. The patches of cobbling are shown on Fig 3 and are described in the gazetteer.

- 3.2.4 In the stable yard there are three particularly distinctive repairs (patches 57, 58, and 61). Patch 57 is the most striking, containing large cobbles in what appears to be a random layout. Patch 58 also contains mainly large cobbles, which distinguish it from the surrounding areas (patches 54 and 59), but in this area there are linear rows of cobbles on a spacing of *c* 0.5m as seen within other areas. However, the cobbles in between are randomly laid. Patch 61 is a small area of randomly laid small and medium cobbles on the eastern edge of the courtyard, and is clearly distinguishable from the linear east/west patterning surrounding it to the north, south and west. Two other patches of random cobbling are present in the stable yard: patches 56 and 68.

- 3.2.5 Many of the repairs on the drive area of the yard are easily identified by their random patterning. Patches 4, 7, 9, 16, 23, 26, 35, 38, 40, 48, and 50 all have these characteristics, and they all consist of mainly large cobbles, with the exception of patch 7 which contains some small and medium cobbles, and patches 4, 23, and 40, which contain predominantly medium sized cobbles. It is therefore possible to suggest that these repairs may all date from a similar period, but, with the general paucity of inter-relationships between the patches, it is not possible to prove this argument. There is, however, a clear relationship between patches 47, 49, 50, 51, 66 and 67. Patch 50 is a narrow band of large random cobbles which cuts through small linear cobbles and also through repair patch 47. This demonstrates that patch 50 is the latest feature of this area, and represents the cutting and refilling of a trench from the building immediately to the east, and is probably associated, with the localised repair (patch 67) in patch 66 around the service cover.

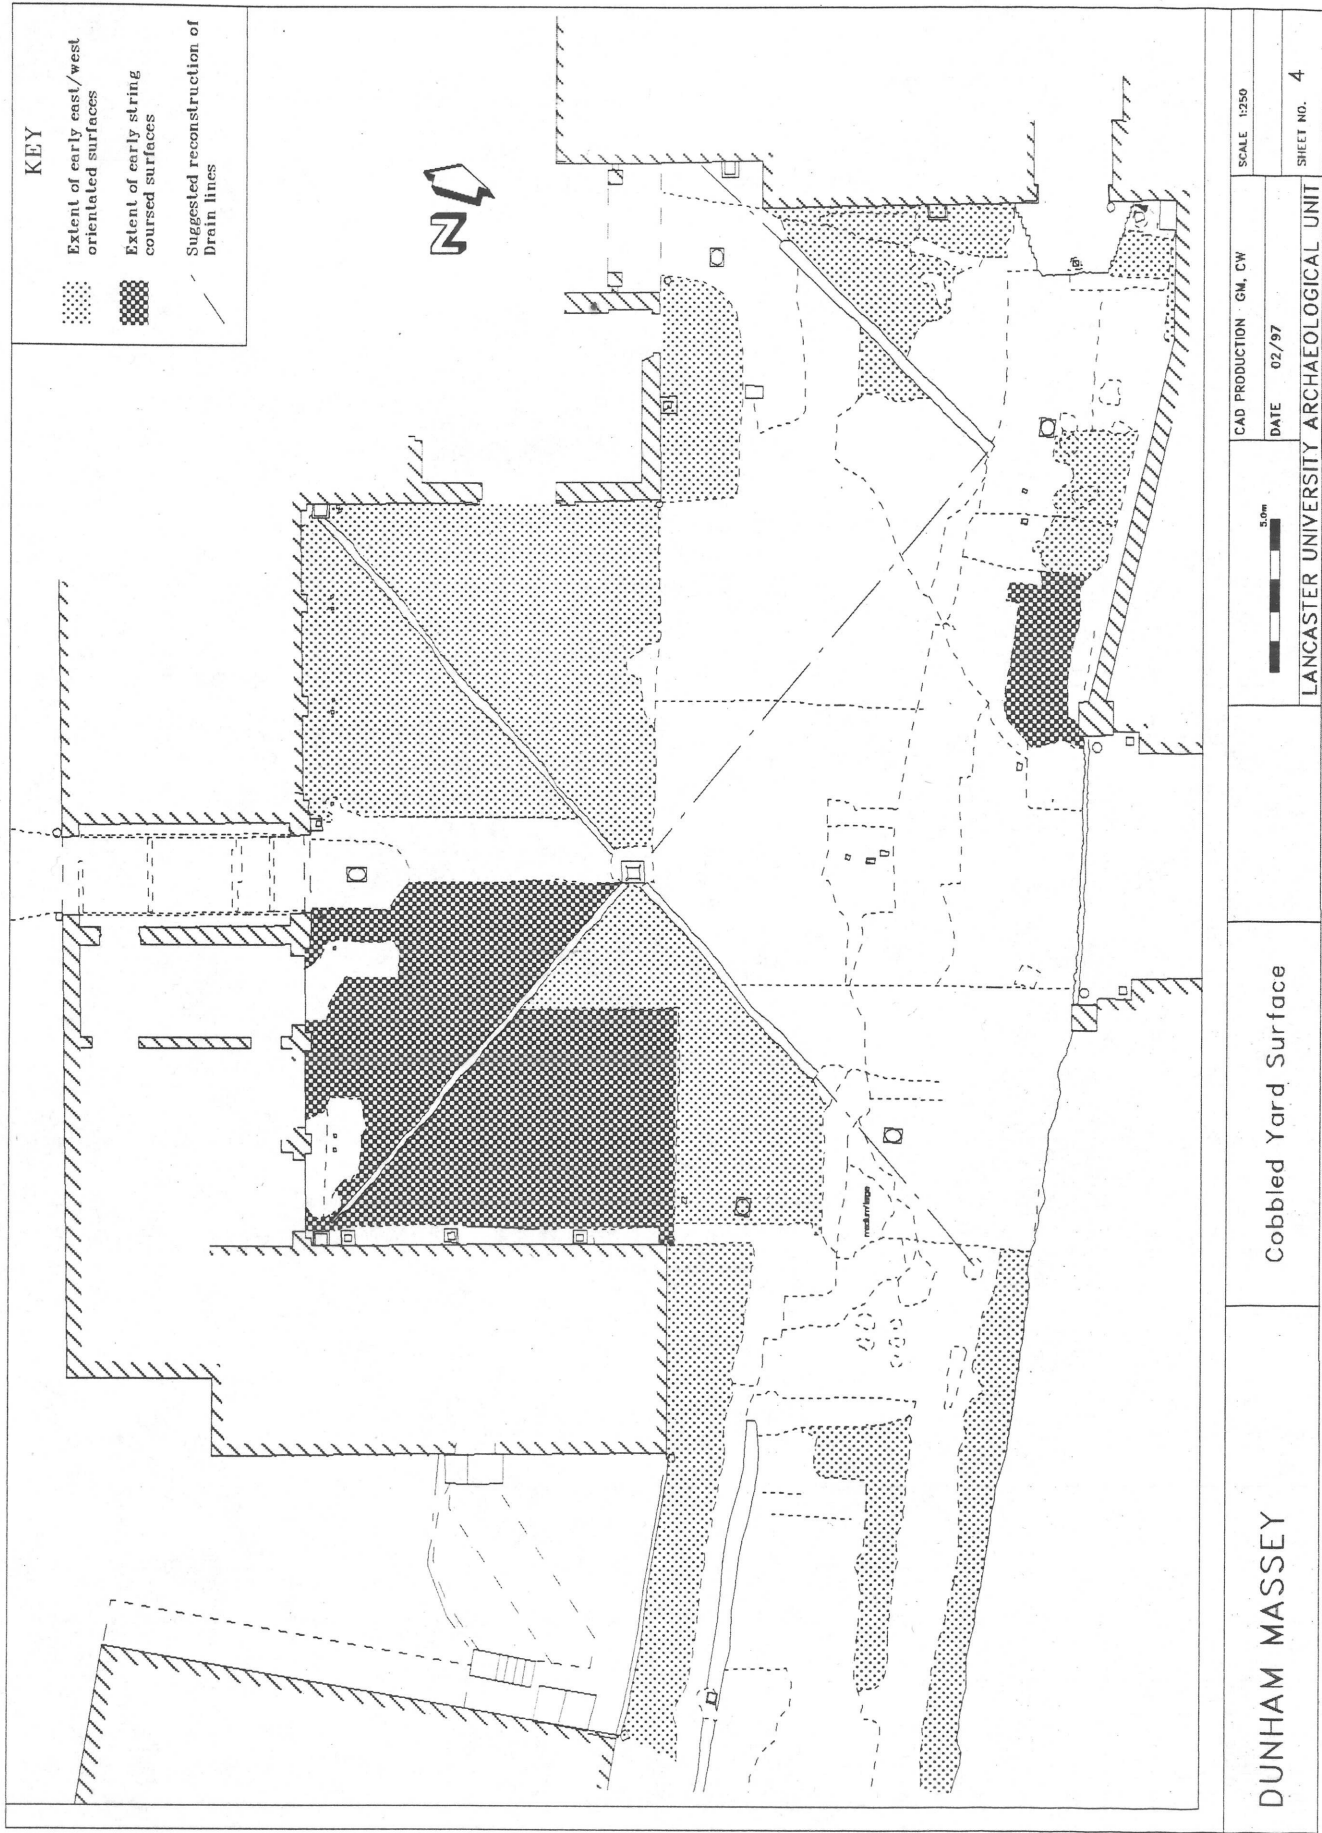
Fig 4 Extant patches of early cobbled surfaces

- 3.2.14 It is therefore suggested that there were two patterns of early cobbling, both of which comprised small and medium cobbles and these are presented as Fig 4. The regular string coursed cobbling comprise patches 53, 54 and possibly 29. Whereas

the east/west orientated cobbling, without regular string coursing comprised patches 1, 6, 8, 12, 17, 18, 30, 32, 33, 34, 37, 39, 41, 42, 43, 45, 51, 59, 60, 62, 63, 64, 65.

- 4.1 The survey has demonstrated that the stable yard has been subject to considerable relaying and repair of the cobbled surface. This was undertaken in a broad range of cobble orientations and sizes. The areas most affected by this work are in the centre of the driveway and to the south of the central drain, where a large area was relaid in a variety of styles and reflects the increased wear resultant from vehicular traffic. There are, however, the remains of early and possibly original cobbled surfaces, which survive best on the western side of the stable yard. This has two basic forms: one has regular lines of cobbles at a 400mm separation which reflect the constructional technique of laying cobbles in strips out from a string coursed line. The same technique is observed elsewhere, notably patch 17, but not to the same degree of regularity and consistency. The other pattern of residual cobbling has alignments, consistently on an east/west orientation, but only occasionally is it laid against string coursed lines. Both patterns are evidently early, but neither can be reliably ascribed as original. The extent of the suggested early cobbling is presented in Fig 4.

- 4.2 The framework for the original cobble pattern was a diagonal arrangement of drains, centred on a grid within the middle of the stable yard. A possible element (patch 64) of this drain system survives at the northern end of the cobbled yard, which runs parallel to the line of the diagonal drain runs, but is truncated at both ends. On the basis of identified drain runs and surface drain grids an interpretation of the original drain layout has been proposed (Fig 4).
