Old Dock Timbers, Liverpool

Condition Survey Report

December 2006

Oxford Archaeology North

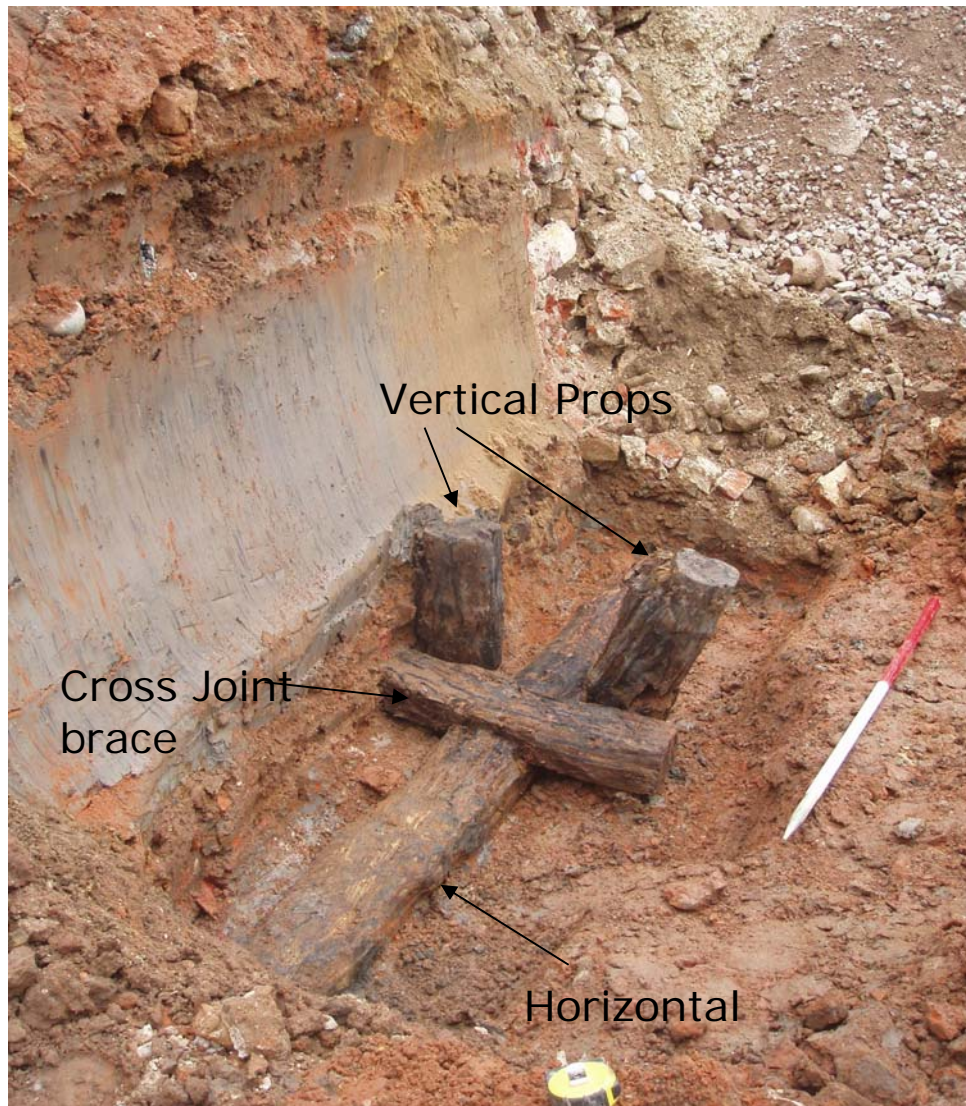
- 1.1.3 The timbers are part of a bracing support for the wall, and their typical configuration is shown in Plate 1, and comprise a Horizontal Brace that extends out from the wall, and then passes between two Vertical Props and is secured by a horizontal Cross Joint Brace. The condition and function of all of the timbers is defined below in Table 1.

Plate 1: Typical arrangement of wall bracing timbers

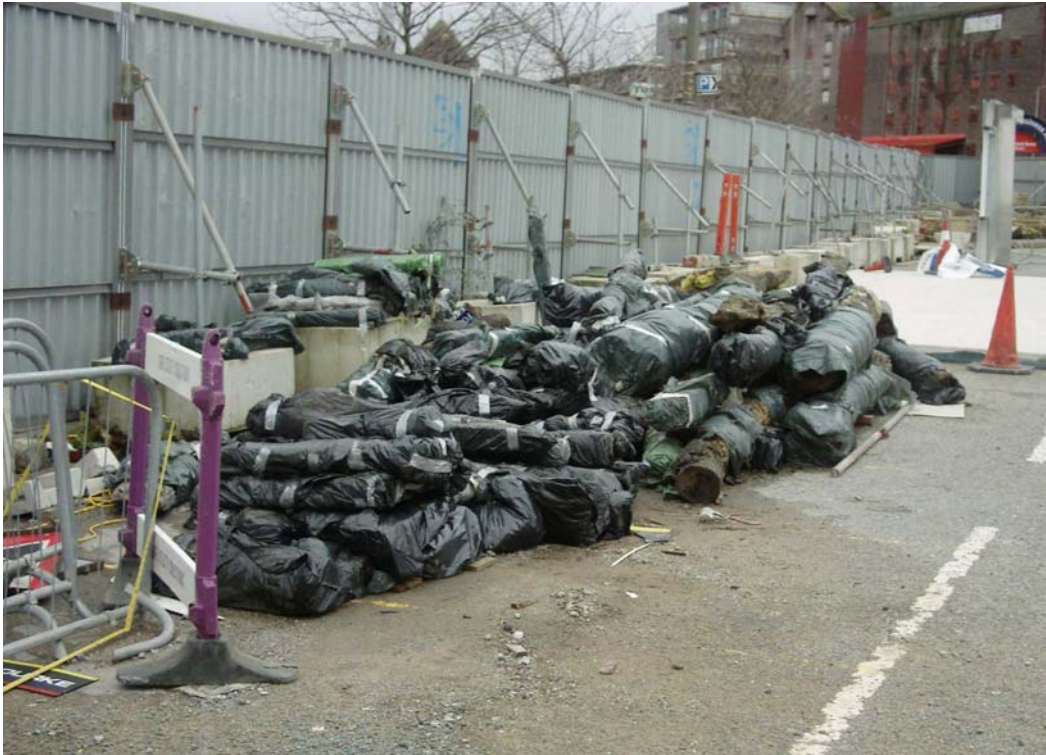
- 1.1.2 On the 14 Dec 2006 the timbers were checked again to determine their level of preservation, the results are set out below. The timbers have suffered an increase in deterioration due to the adverse weather conditions and the external nature of the storage area. This has been compounded by rodents tearing the plastic sheeting used to protect the timbers combined with the recent strong winds and exposing some of them to the elements. However the level of deterioration from September to December 2006 has been relatively moderate due to the damp conditions, reducing the drying out of the wood. The damp conditions have lead to an increase in the bark rotting and the infestation of insects which are present in the majority of the timbers. Some damage to the timbers was observed from the initial move from the museum and subsequent moving within the compound.

Plate 2: Timbers in their current storage at Site 17 (Dec 2006)

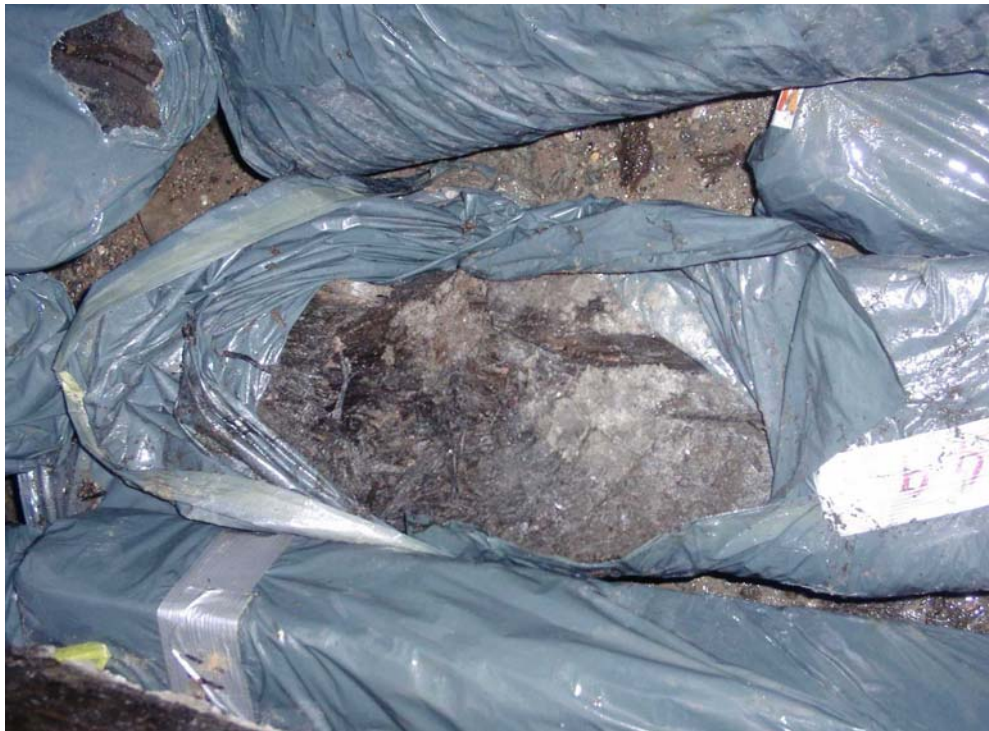
Plate 3: Timber 9649 in poor condition

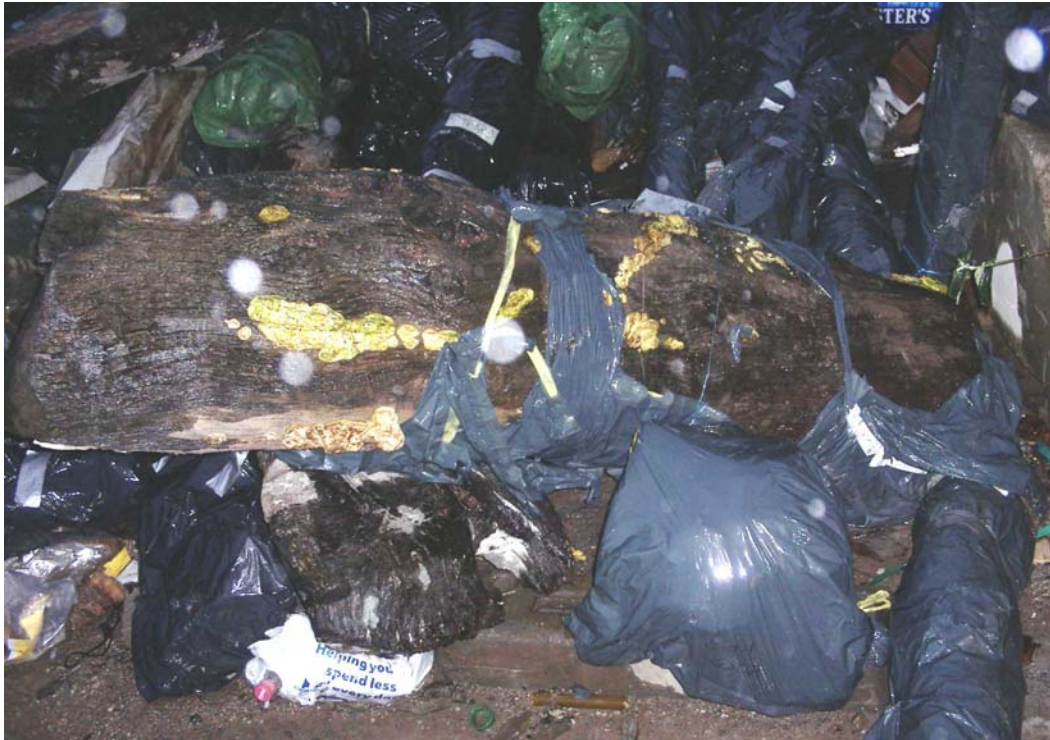
Plate 4: Timber 10709 affected by severe fungal growth

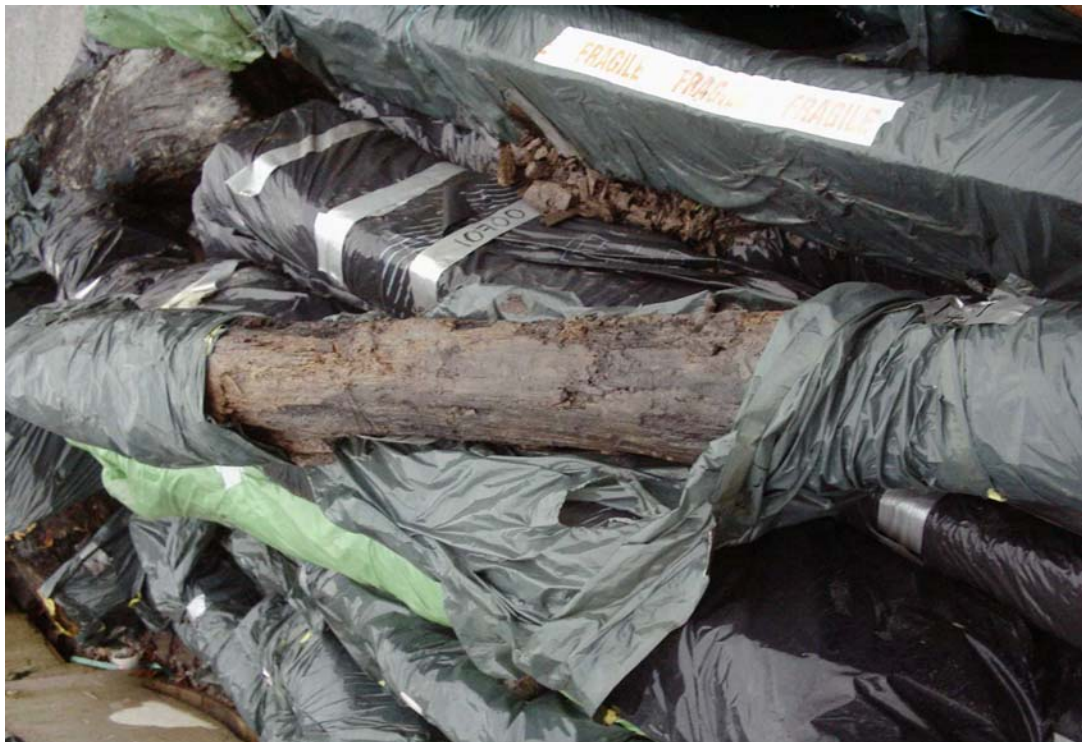
Plate 5: Timber 10710 in poor condition

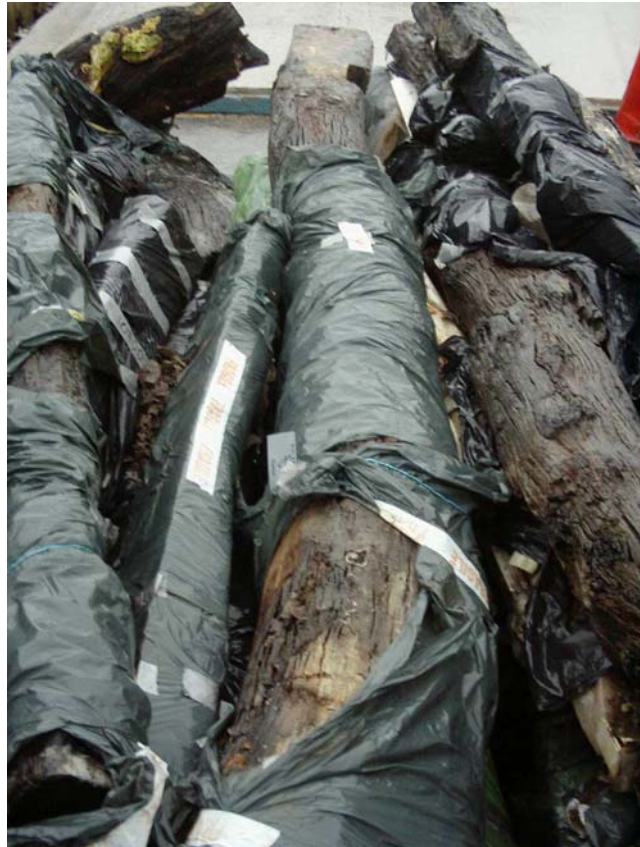
Plate 6: Timber 10716 in poor condition

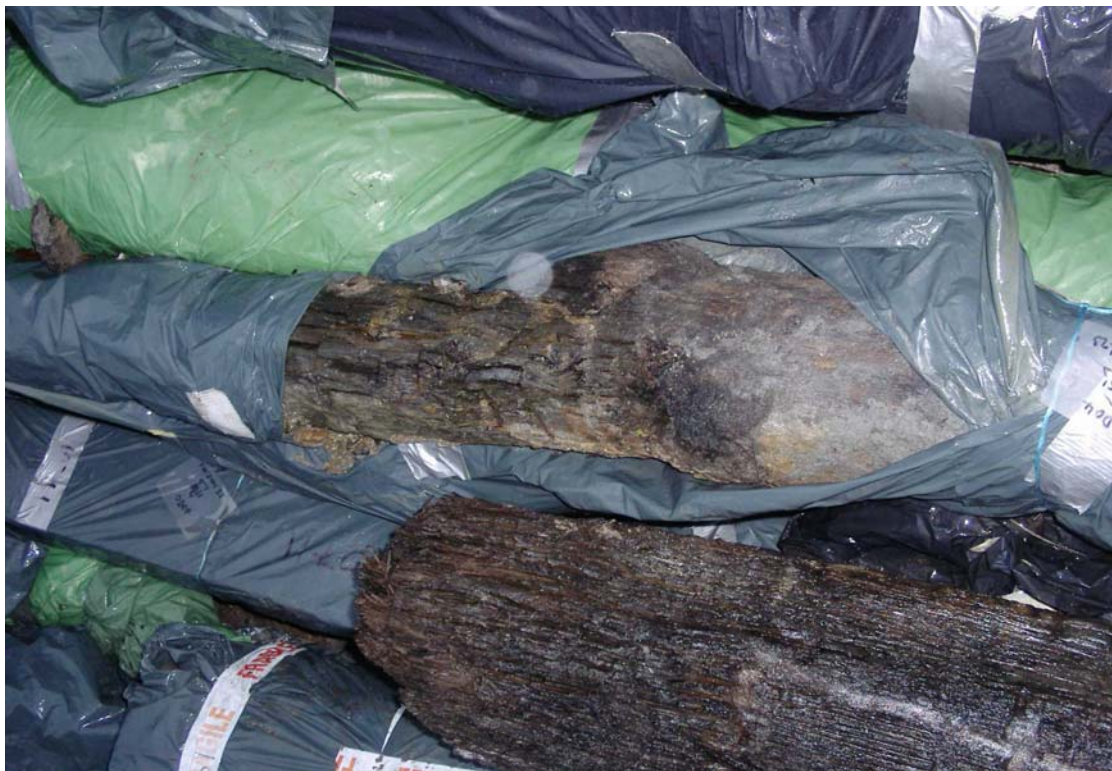
Plate 7: Timber 10751 in a very poor condition

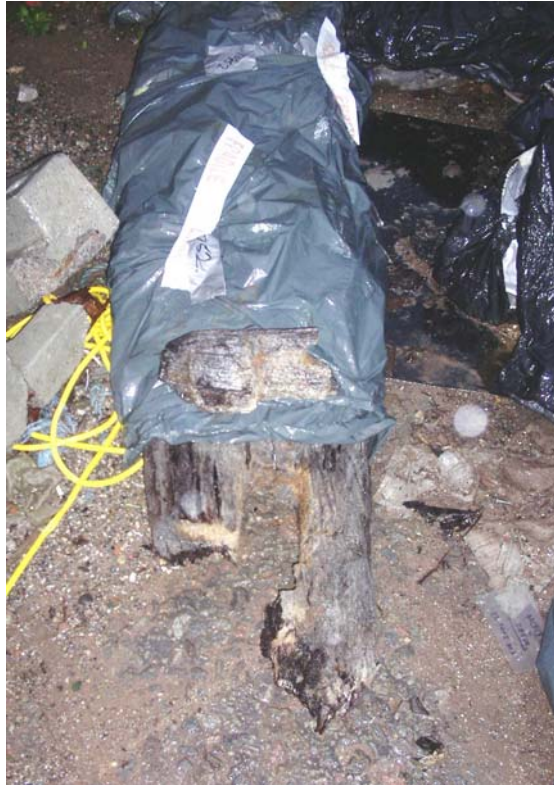
Plate 8: Timber 10752 in poor condition and damaged

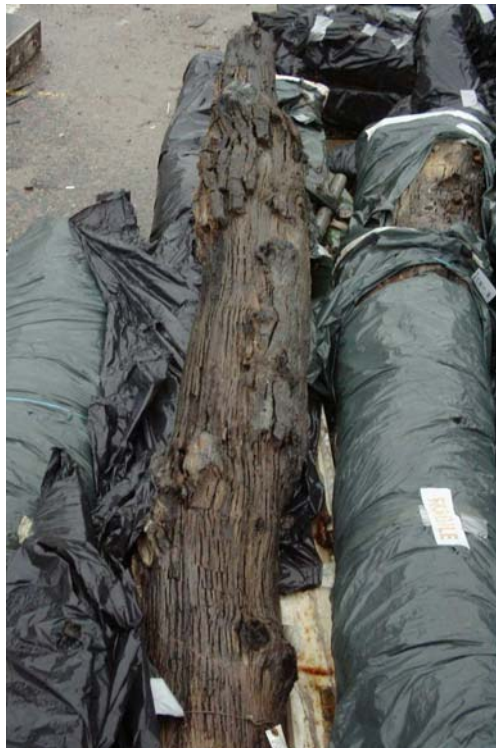
Plate 9: Timber 10833 in very poor condition

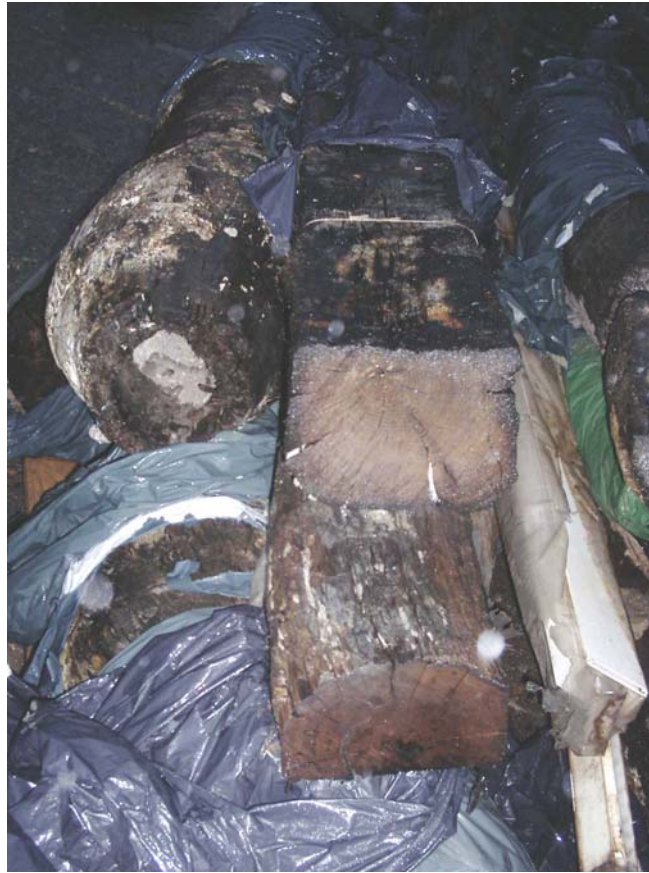
Plate 10: Timber 10969 in poor (cracked) condition

- 2.1.1 In general it is recommended that the timbers recovered from the later excavations on Site 16i be preserved, and this comprises timbers 10923 onwards (with the exception of 10969-70) along with some of the earlier timbers illustrated in the photographs below which appear to be in a stable state.
- 2.1.2 A complete non complex 'set' of timbers is made up of three components, the main horizontal brace a cross joint/ brace and two vertical props or stakes. The best surviving examples of the main Horizontal Brace timbers were 9576, 10830 and 10928. The best Cross Brace timbers were 10708, 10711 and 10713 being of

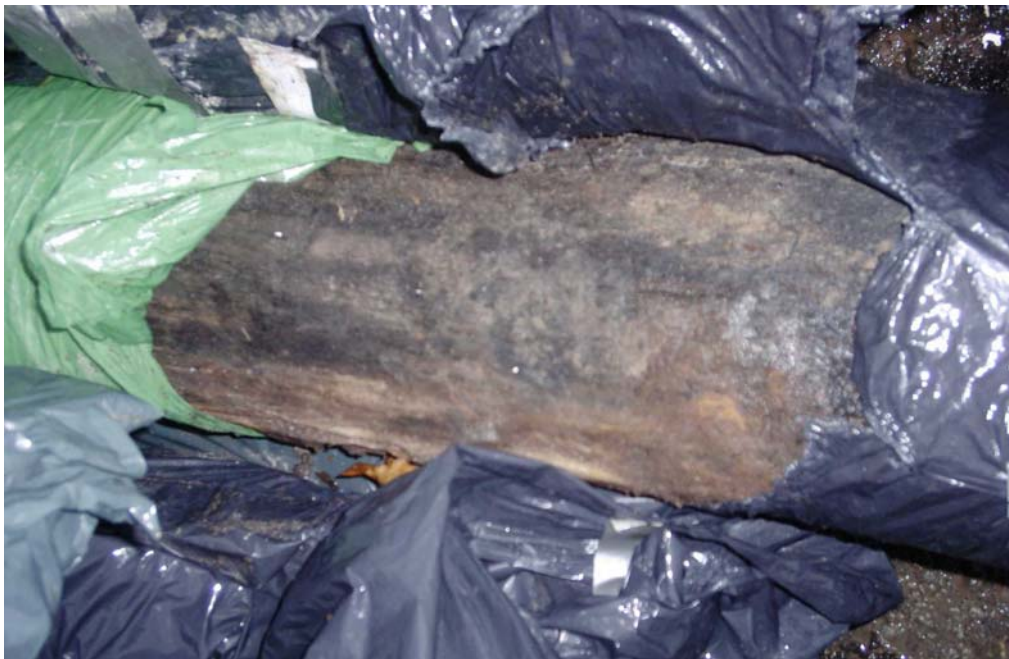
Plate 11: Timber 9576 in a Fair-Poor condition

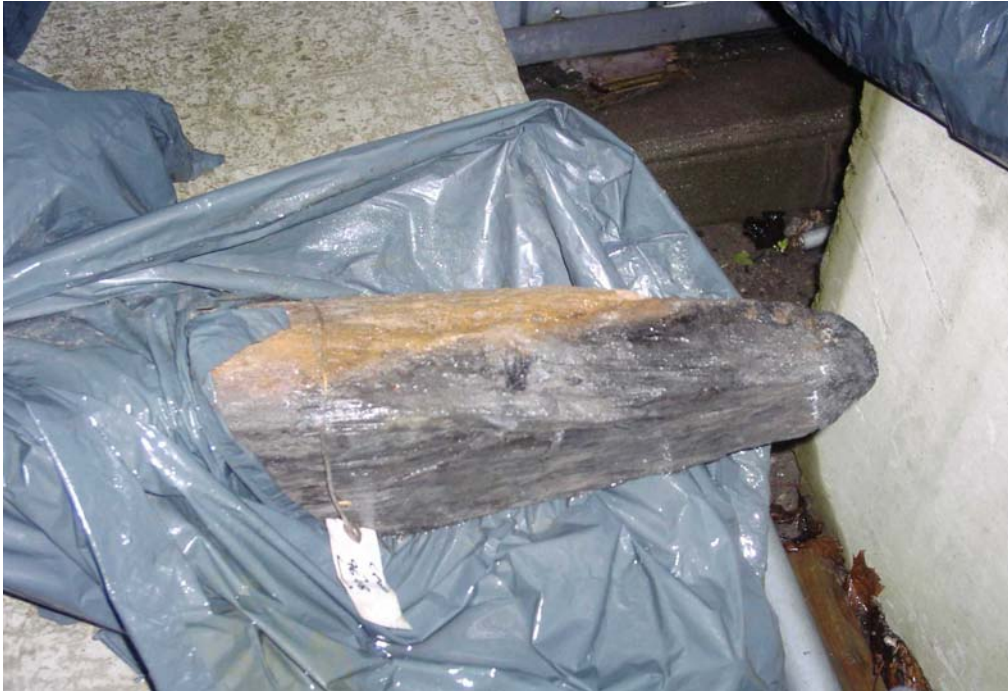
Plate 12: Timber 9648 in a Fair-Poor condition

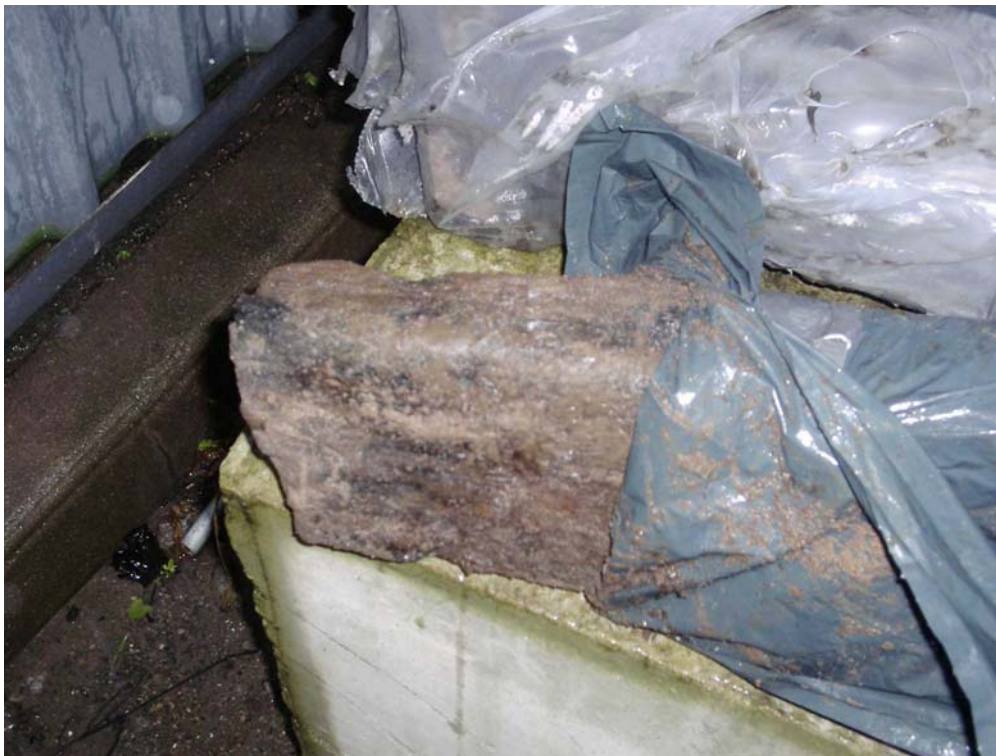
Plate 13: Timber 9878 in a Fair-Poor condition

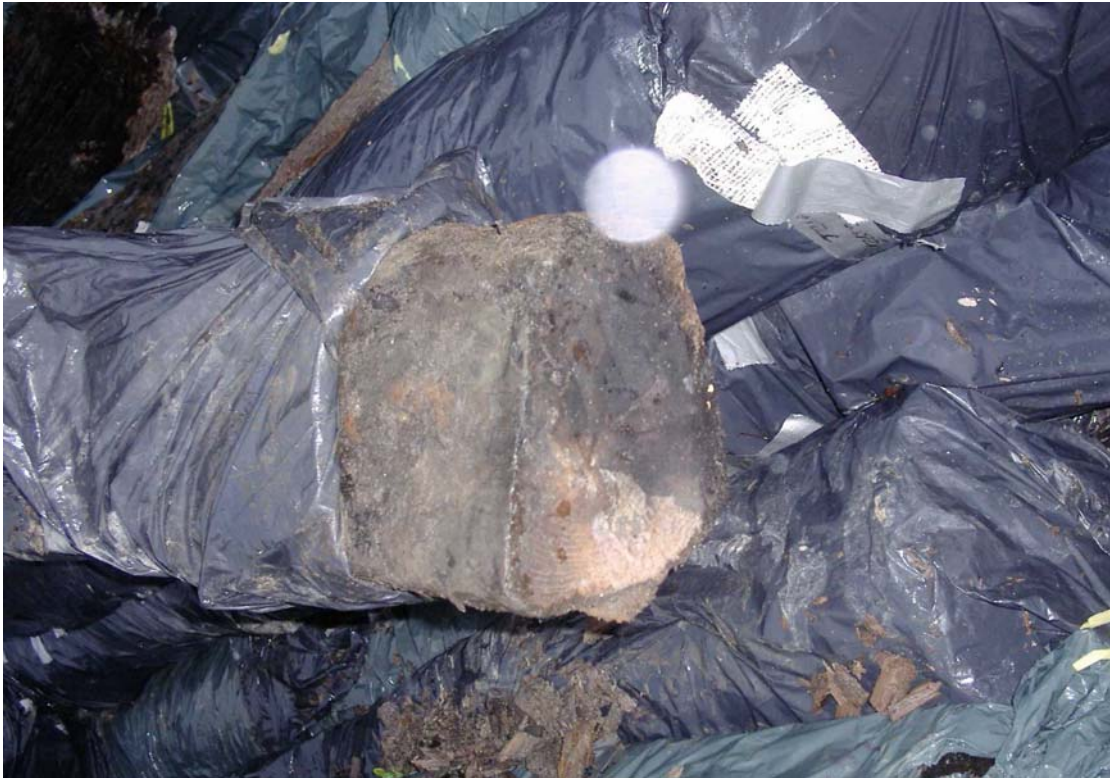
Plate 14: Timber 10700 in a Fair-Poor condition

a Fair to Fair-Poor category and timbers 10700, 10714, 10821 and 10933 were the best surviving Vertical Props.

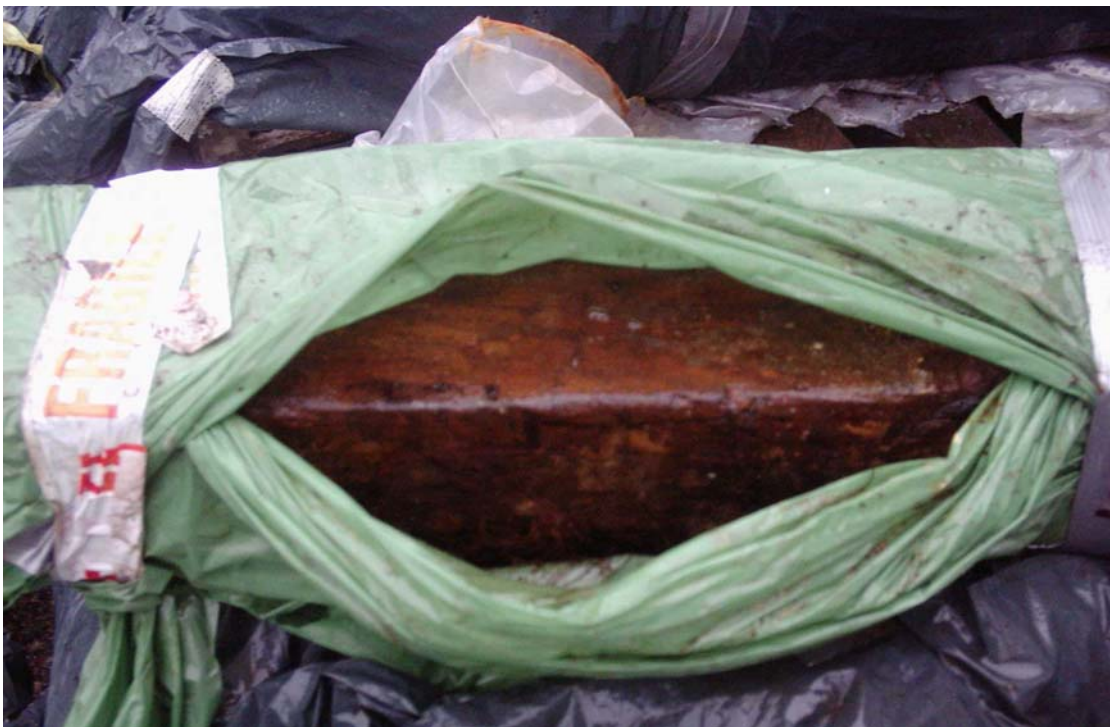
Plate 15: Timber 10708 in a Fair condition

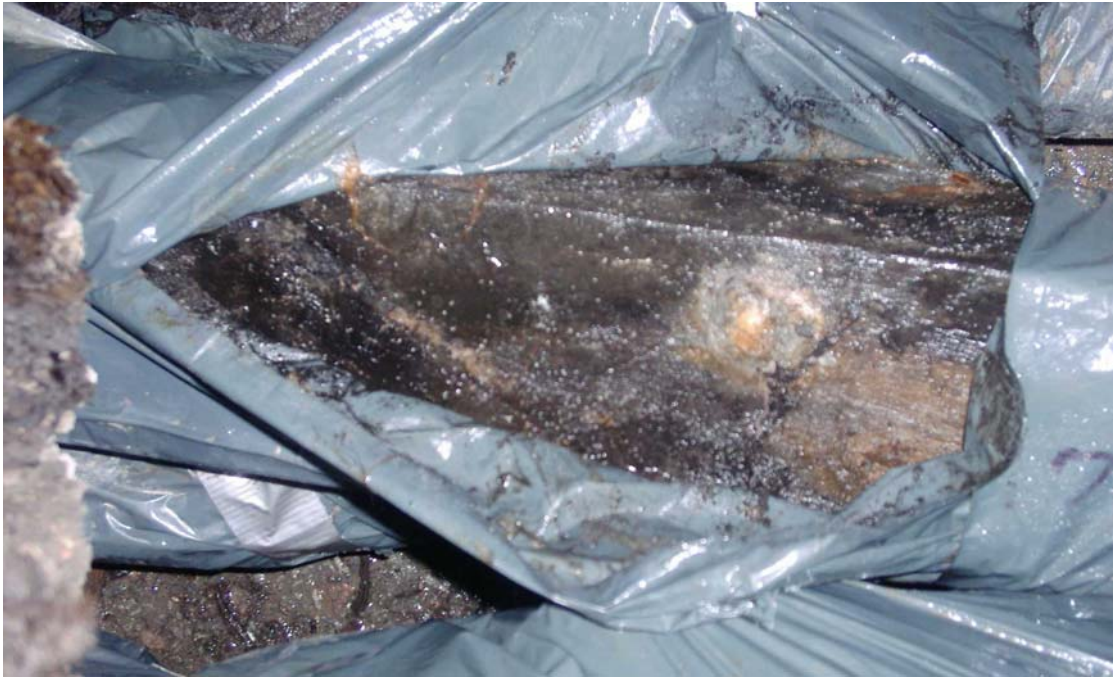
Plate 16: Timber 10711 in a Fair condition

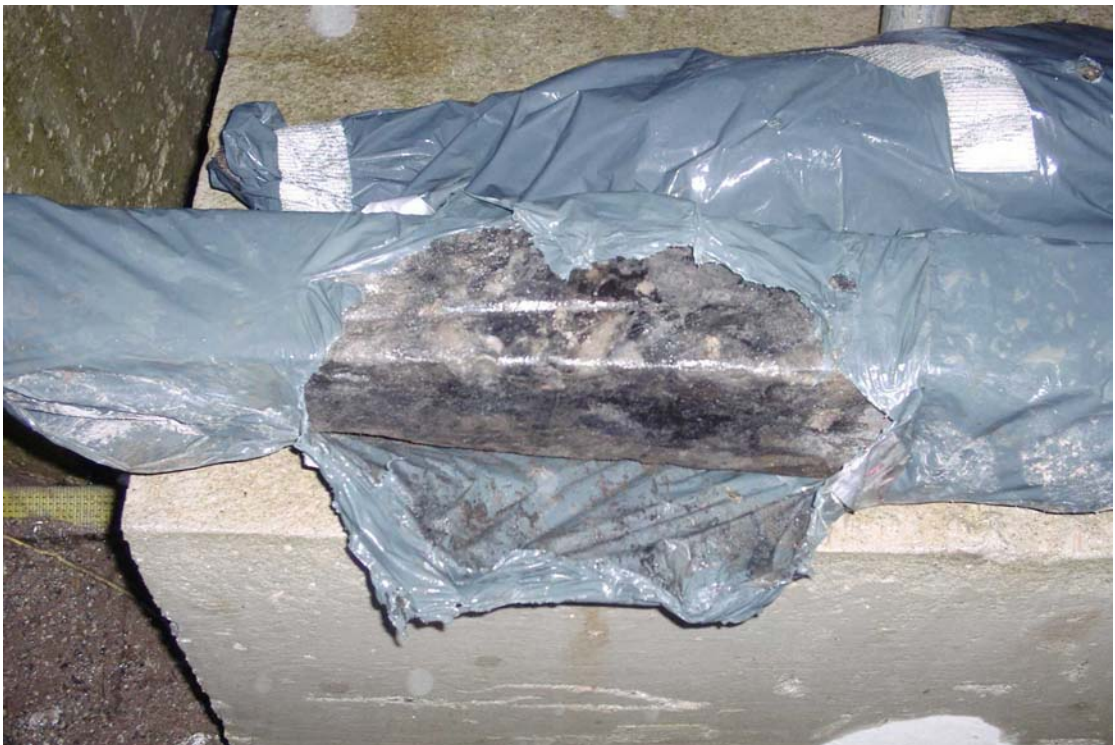
Plate 17: Timber 10713 in a Fair condition

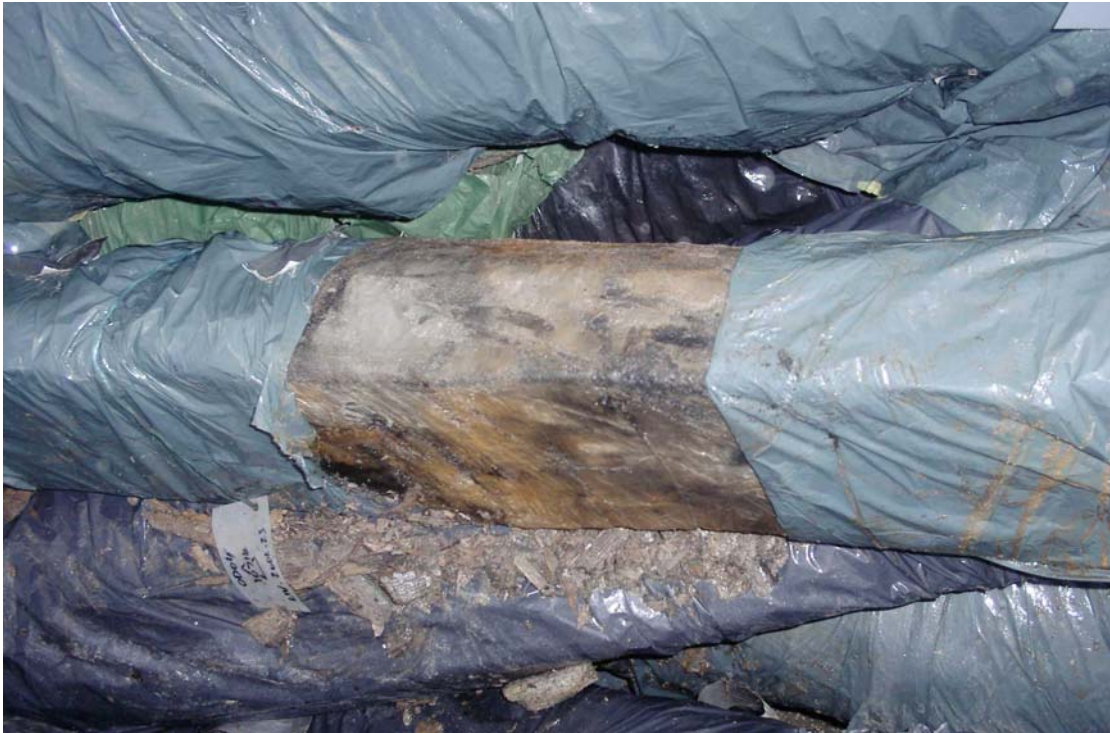
Plate 18: Timber 10714 in a Fair-Poor condition

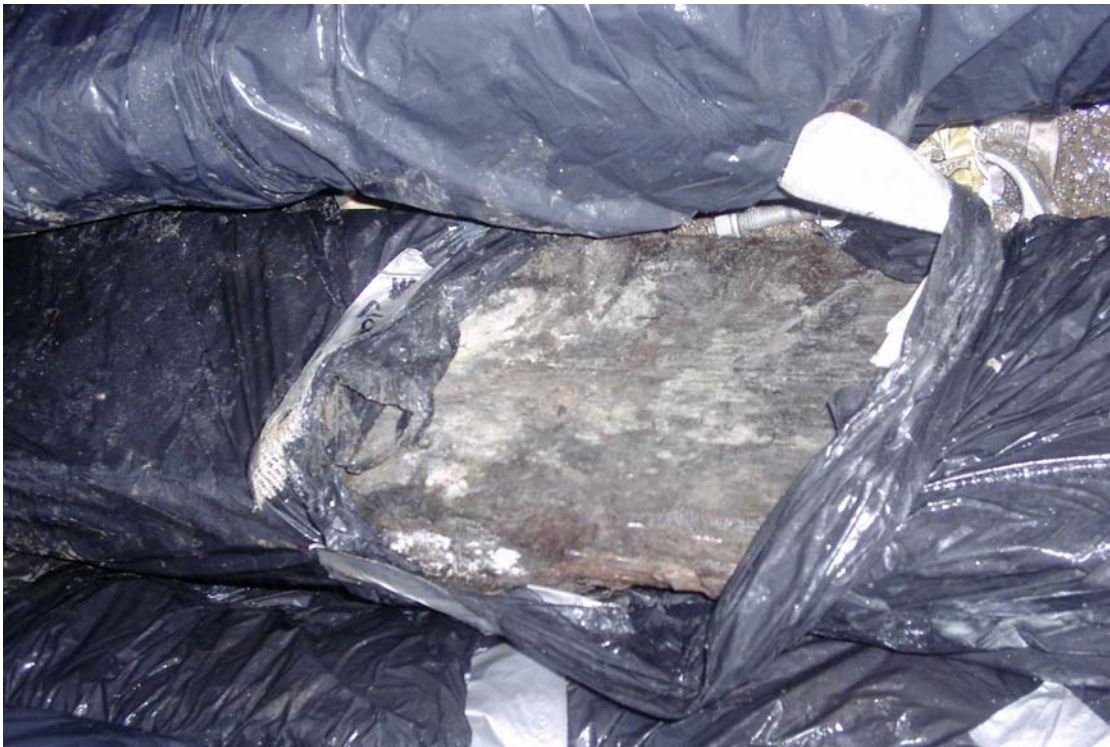
Plate 19: Timber 10821 in a Fair-Poor condition

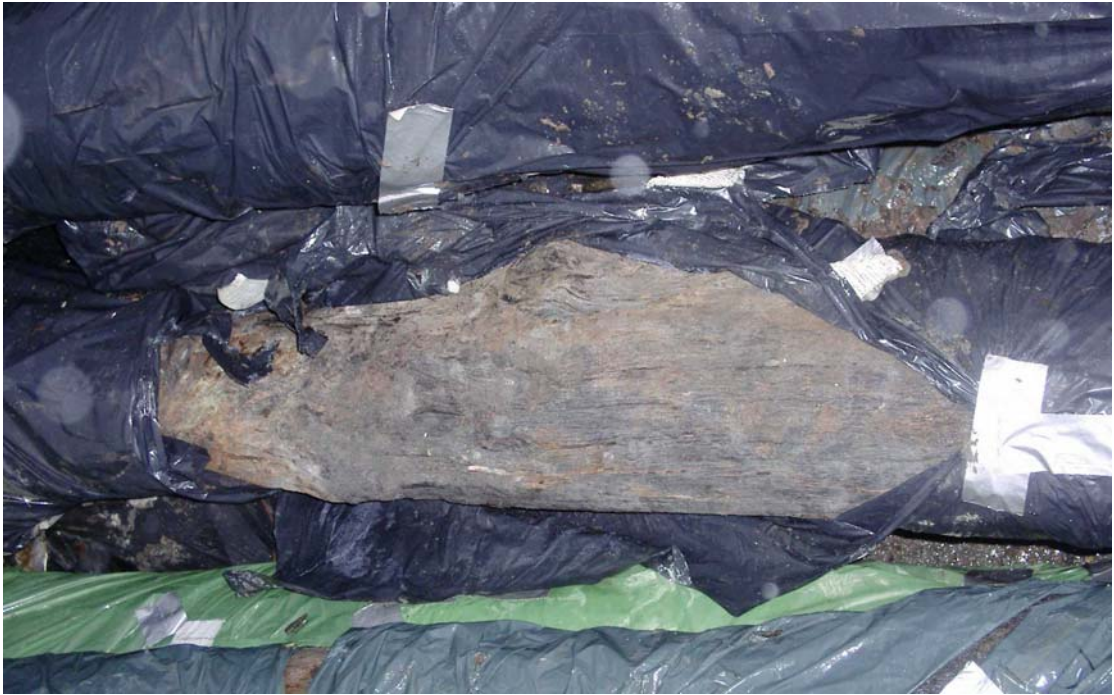
Plate 20: Timber 10830 in a Fair-Poor condition

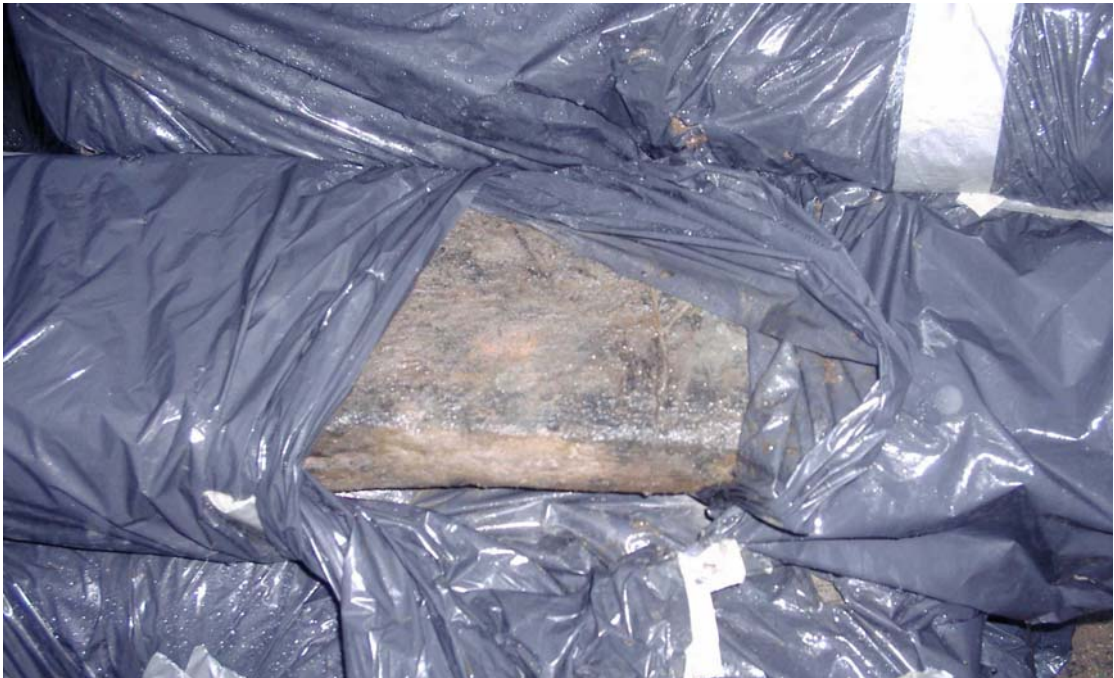
Plate 21: Timber 10927 in a Fair-Poor condition

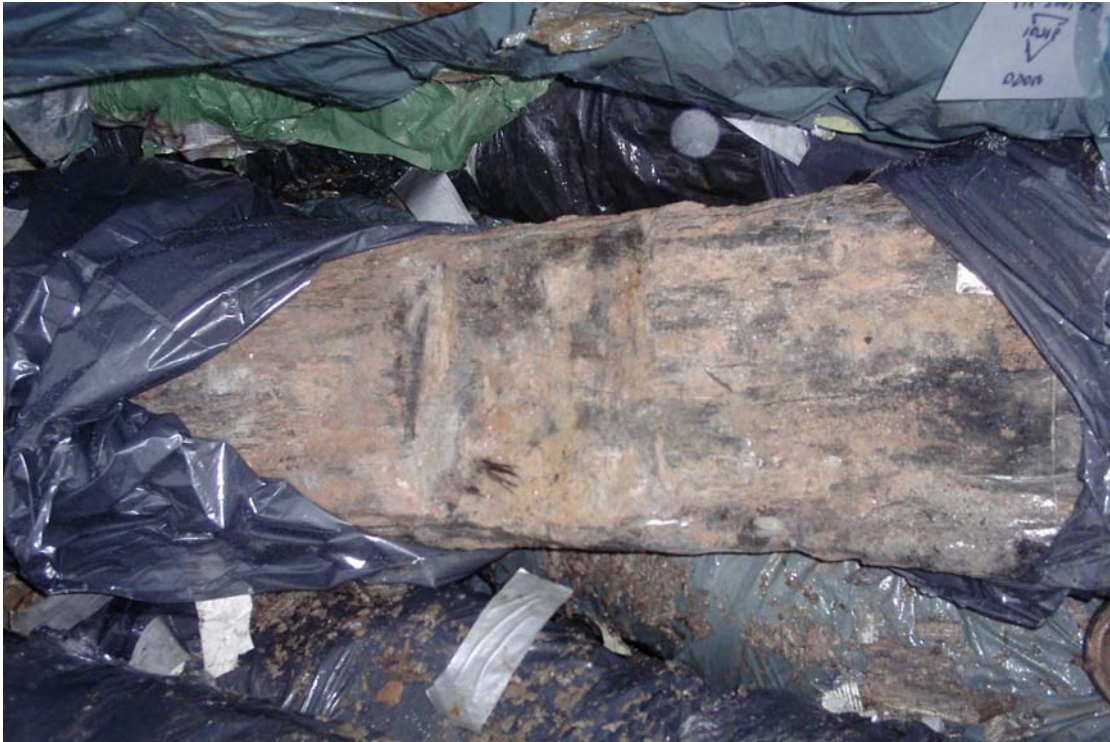
Plate 22: Timber 10928 in a Fair-Poor condition

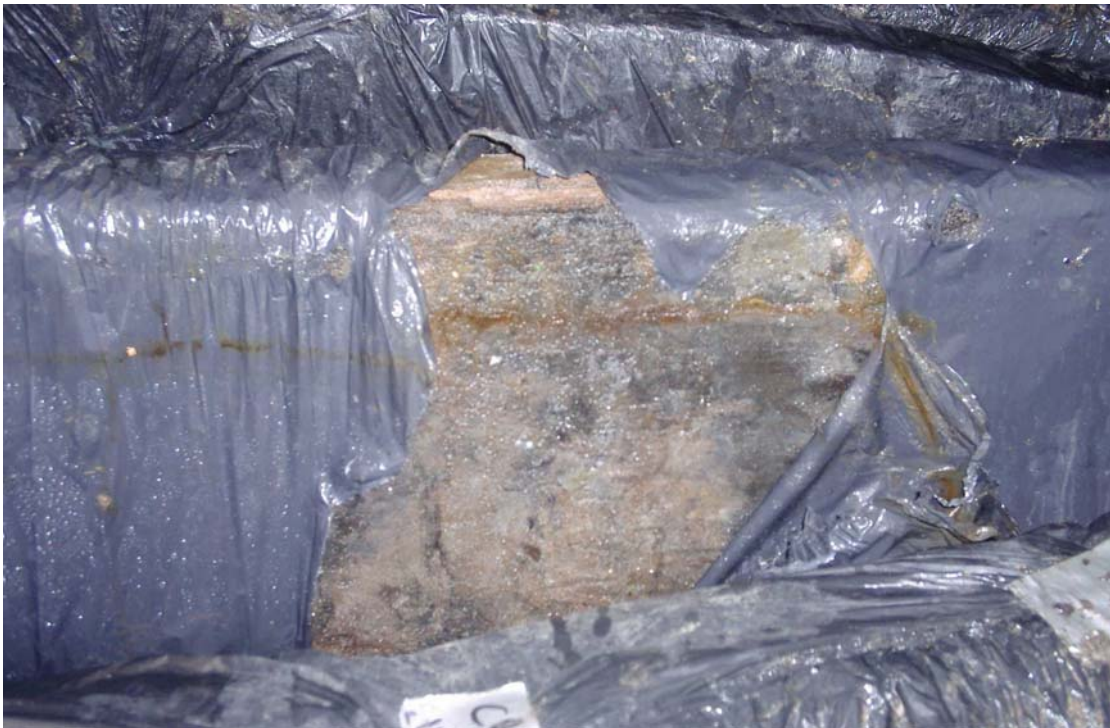
Plate 23: Timber 10933 in a Fair-Poor condition

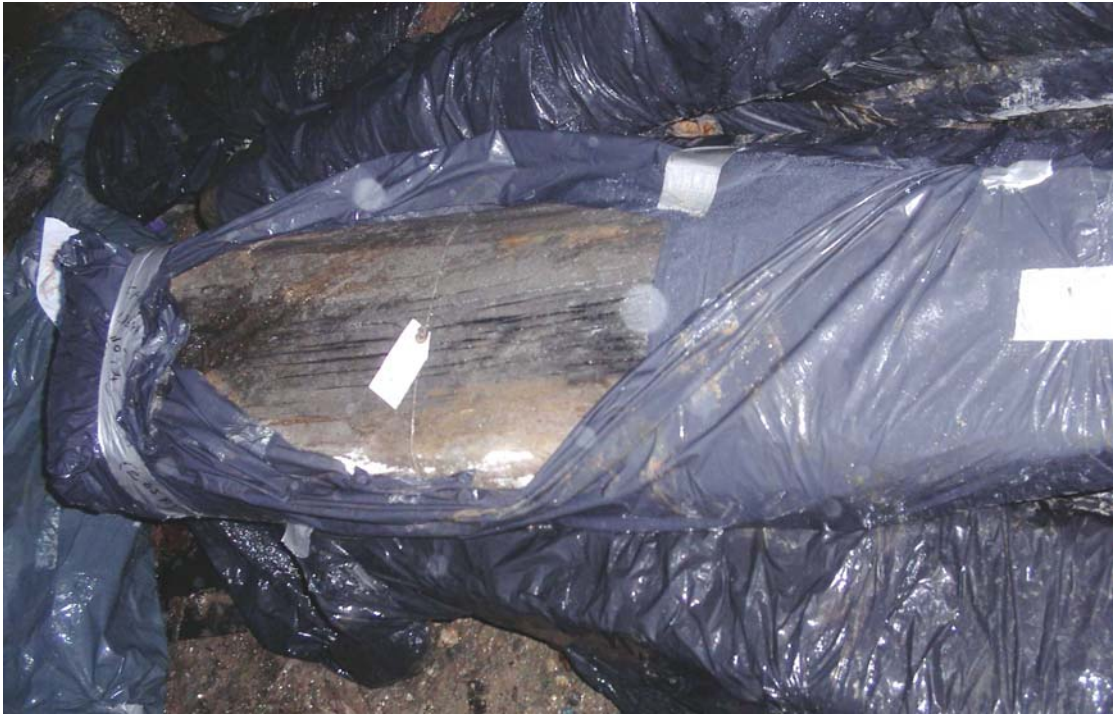
Plate 24: Timber 10934 in a Fair-Poor condition
