20 – 22 College Lane, Liverpool Fabric Survey - Interim Report

November 2005

Oxford Archaeology North

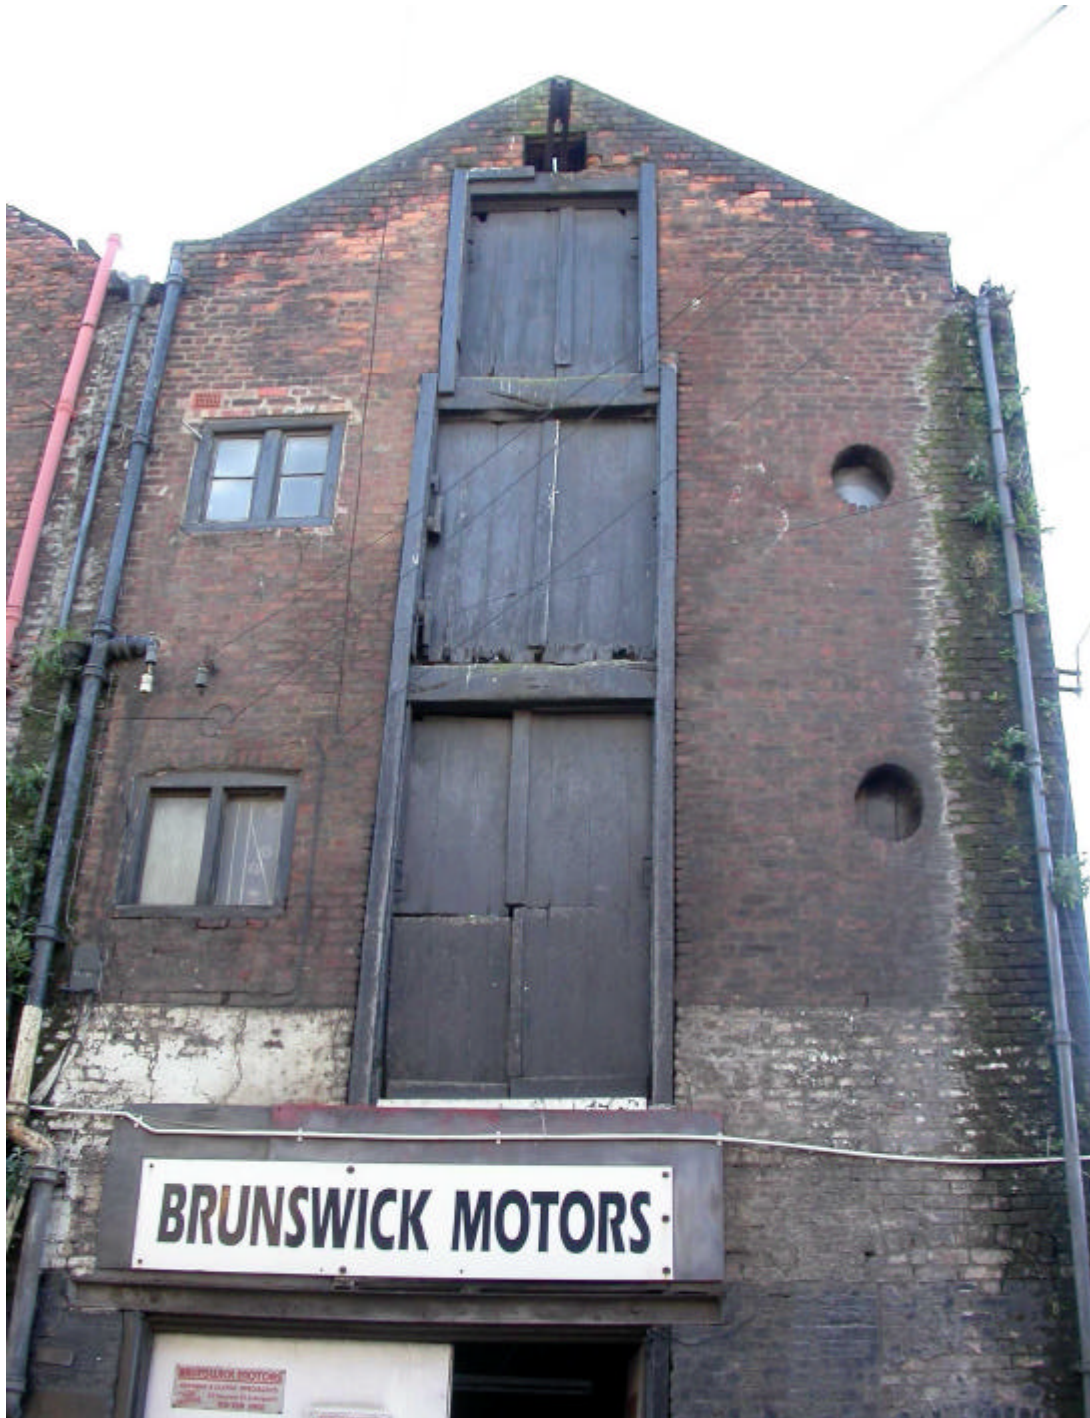
Plate 1: North-Facing Elevation

- 3.2.1 **Front/North Elevation** (Plates 1 and 2): this is the principle facade of the building that faces out onto College Lane, and all the original access points to the building were through this side. The first and second floors incorporate a small partitioned room in the north-eastern corner, which are each illuminated by a square timber mullioned window, which appeared to be original and therefore the partitioned rooms may also have been original components of the warehouse. The three upper storeys were connected by a stair tower at the north-west corner of the building, which was illuminated by oval/circular windows through the northern elevation.

- 3.2.5 **Loading Doors:** the warehouse loading entrances through the northern wall on the first, second and third floors survive largely intact (Plate 1). A winch mechanism was set within the top (third) floor of the building, which was made of cast iron and fed by a rope from a modern RSJ pulley support set above the upper loading entrance. The first and second floor loading doors are comparable in size and have a plain surround, and are divided from each other by a thick floor beam. The doors themselves are of plain panelled timber, and were potentially original features. The third floor loading door is narrower than those of the first and second floors and has a comparatively thin timber lintel. A square aperture through the gable above the top loading door allowed for a pulley beam, which would originally been of timber construction but is now a steel RSJ.

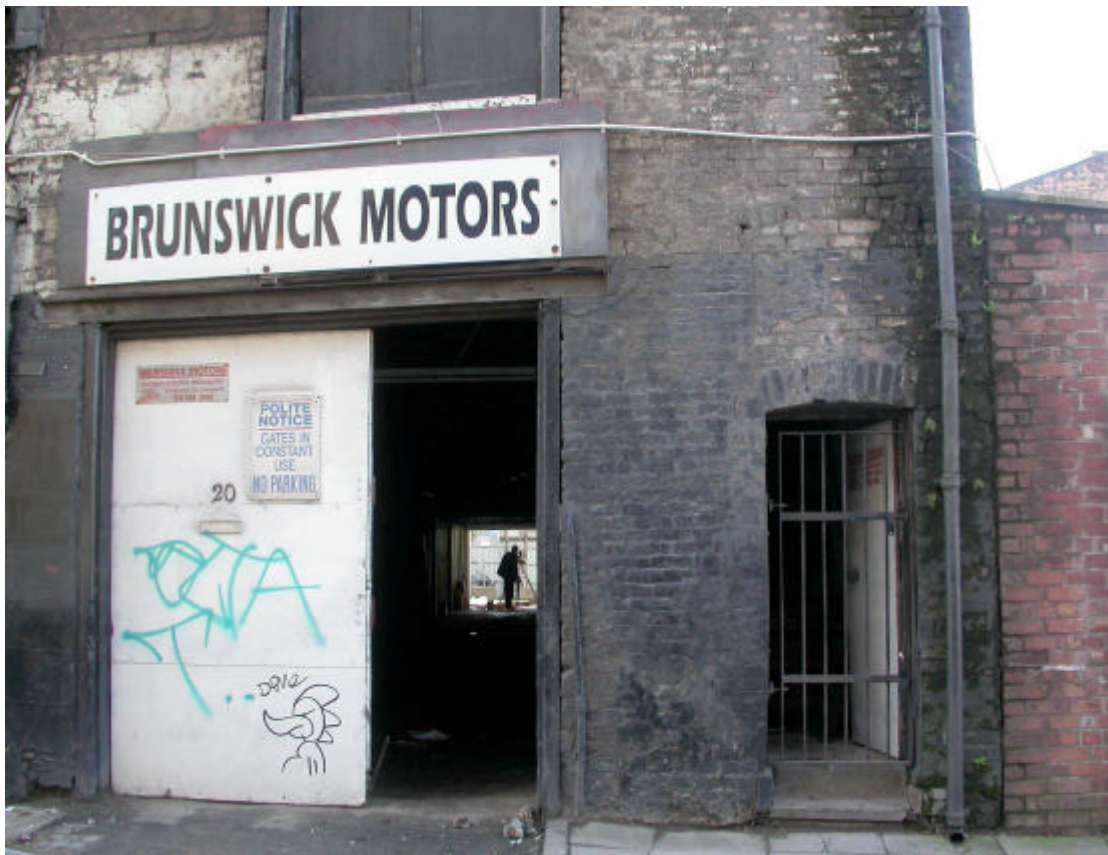
Plate 2: North-Facing Elevation of Ground Floor loading Doors

- 3.2.4 The main pedestrian access door is an original arched doorway (Plate 2), which is located at the north-western corner of the building. It has a modern plywood door with an iron grill. Steps lead up to the front door were originally in stone. To the east of this is a large double door, which is steel clad with a supporting RSJ lintel and was intended for vehicular access. It was a later insertion into a formerly narrower doorway and the western side of the modern door is seemingly original and is in vertical alignment with the eastern sides of the loading doors of the first and second floors. It is therefore probable that the original door matched in size and form the extant loading doors that are above it.

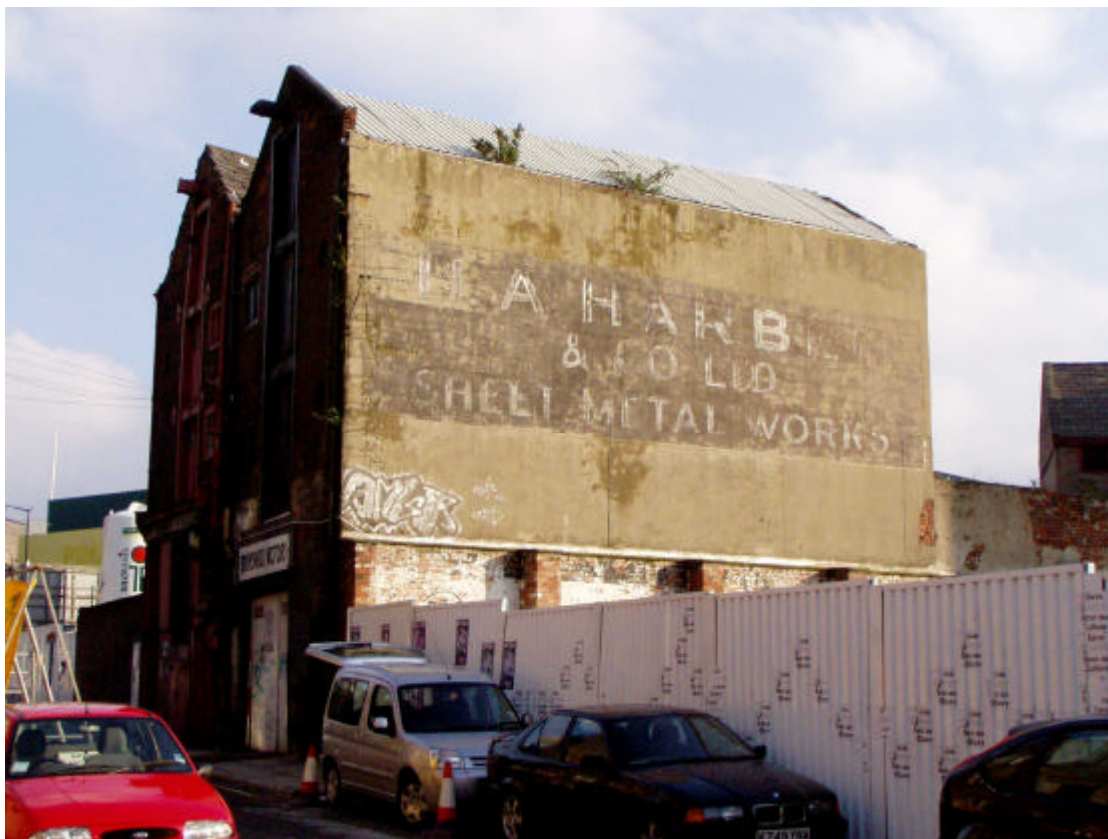
Plate 3: West-facing Elevation

- 3.2.9 **West Elevation** (Plate 3): the west elevation is rendered from the first floor up but the ground floor, external elevation reveals the original exposed brickwork.

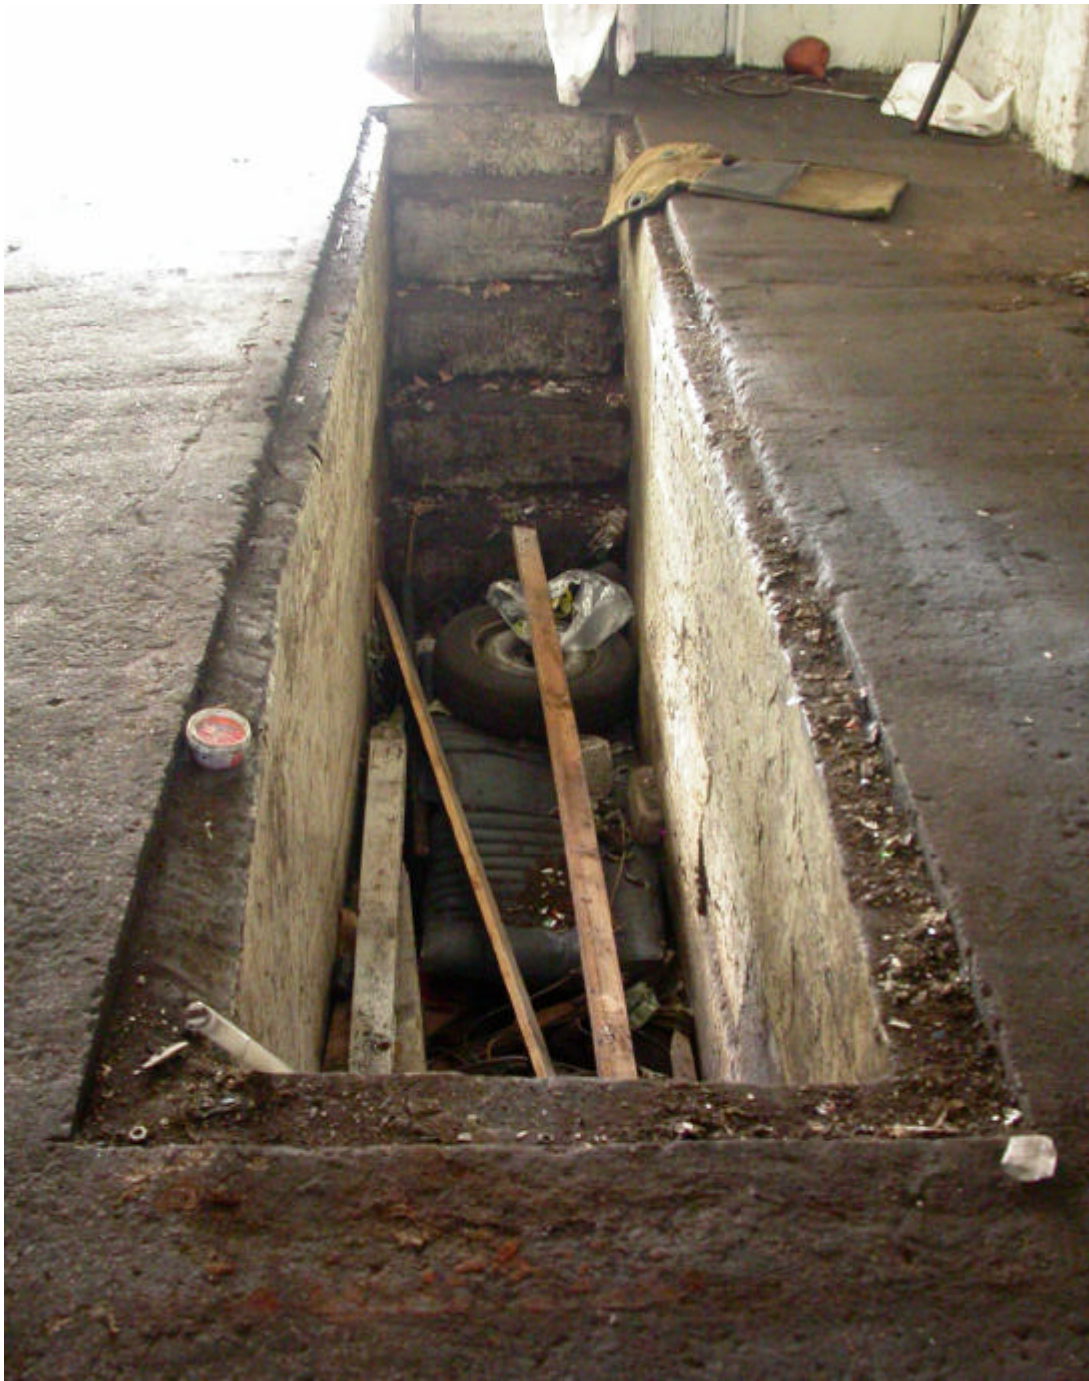
Plate 6: Inspection Pit on the Ground Floor

- 3.3.3 Within the long room is an inspection pit set into the floor in the south-west corner of the extension (Plate 6), which obviously reflects the most recent use of the building as a small garage. There is also an adjacent small office area (Room 20.G3) and toilet, built later at the extreme southern end of the extension (Room 20.G4). In the south-west corner of the northern, original room (Room 20.G1), are possible traces of a flue.

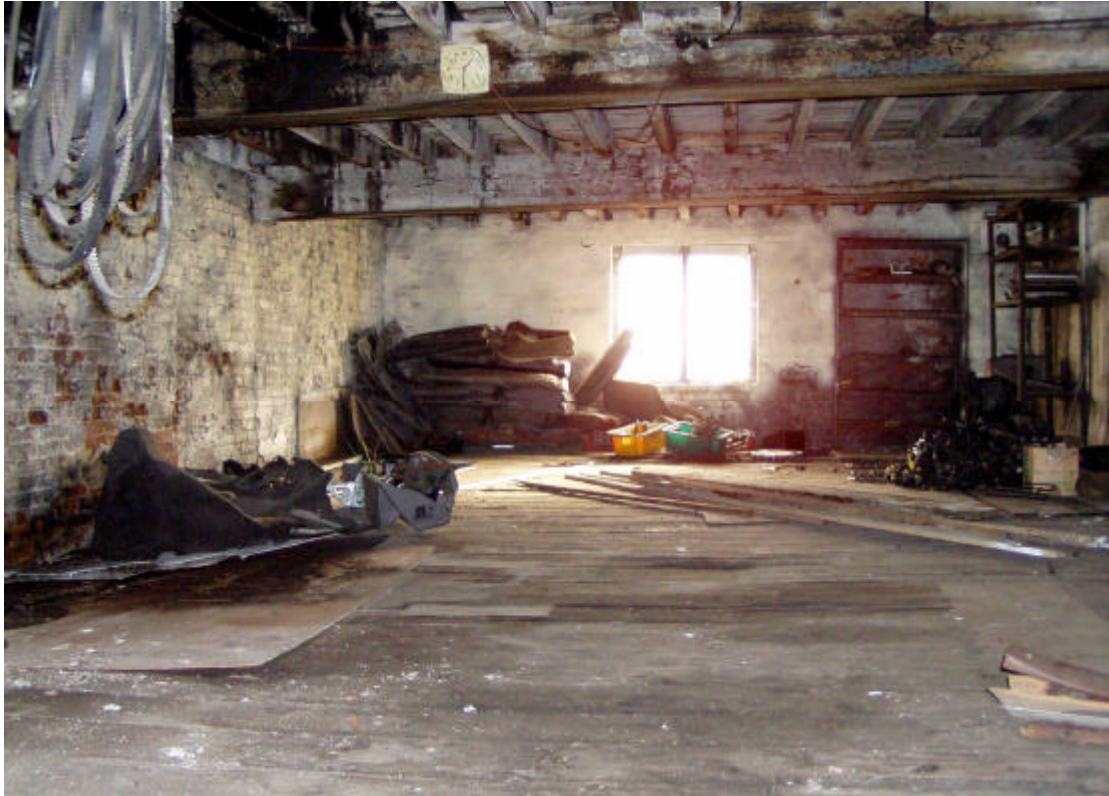
Plate 7: General Shot of the First Floor

- 3.3.5 There was one casement window in the south wall (Plate 7), which was possibly inserted during the twentieth century. In the north wall was a casement window and there was also an oval window positioned in the stairwell area. In the south-east corner was a single steel door, sealed shut. In the north

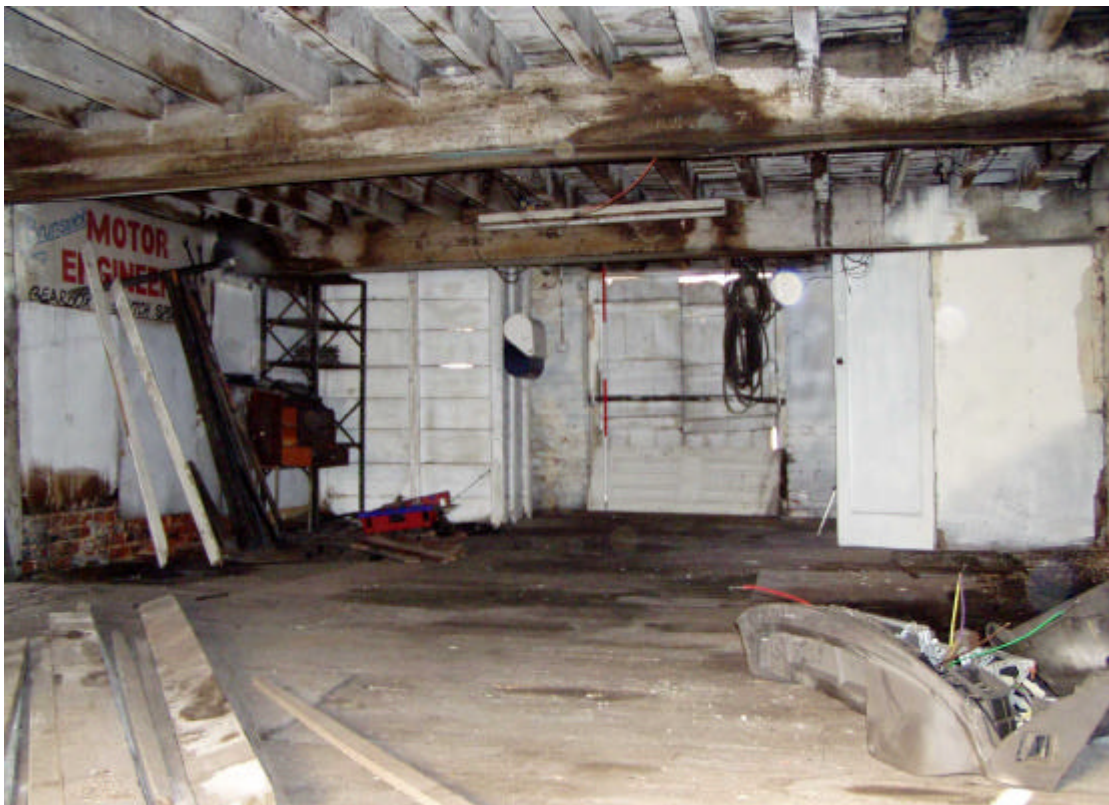
Plate 8: General Shot of the First Floor

wall were the original loading doors (Plate 8), which were blank and edged with wrought iron hinges and pintles and the original iron work for the bar is still present. The interior of the room was entirely painted, or white washed, including the ceiling. Other details including a possible flue in south-west corner, corresponded to the position of the one below, on the ground floor, and a small aperture in the south wall.

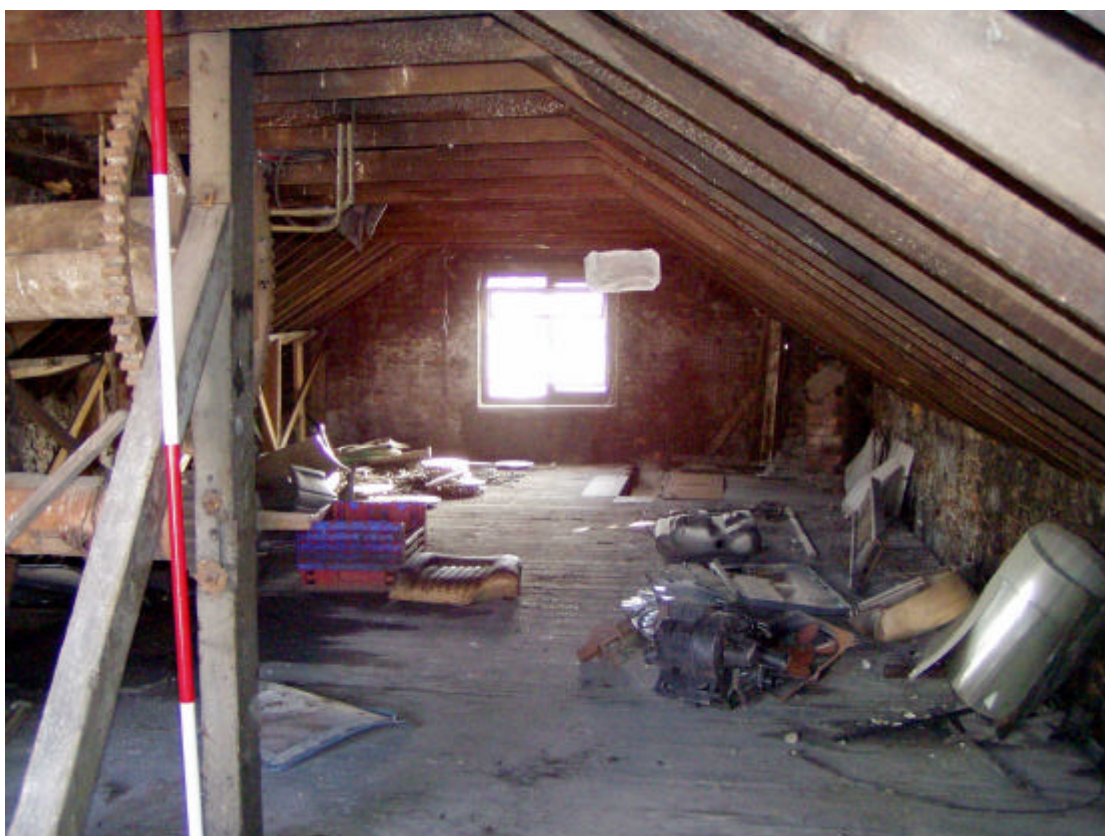
Plate 10: General Shot of Third Floor

- 3.3.8 There was a single timber window in the south elevation (Plate 10), which was probably inserted later, having a steel sill and timber lintel construction. At the northern end were the double loading doors which were plank and ledged and had the original screwed strap hinges and pintles. The roof structure comprises a later A-frame wooden truss, with later corrugated metal sheeting; this episode of reroofing may coincide with the establishment of the suspected later sandstone capping of the east and west walls. A hatch allowed access to the roof on the east side. The probable flue in the south-west corner and continuing vertically from the lower floors, and was truncated by the new roof covering.

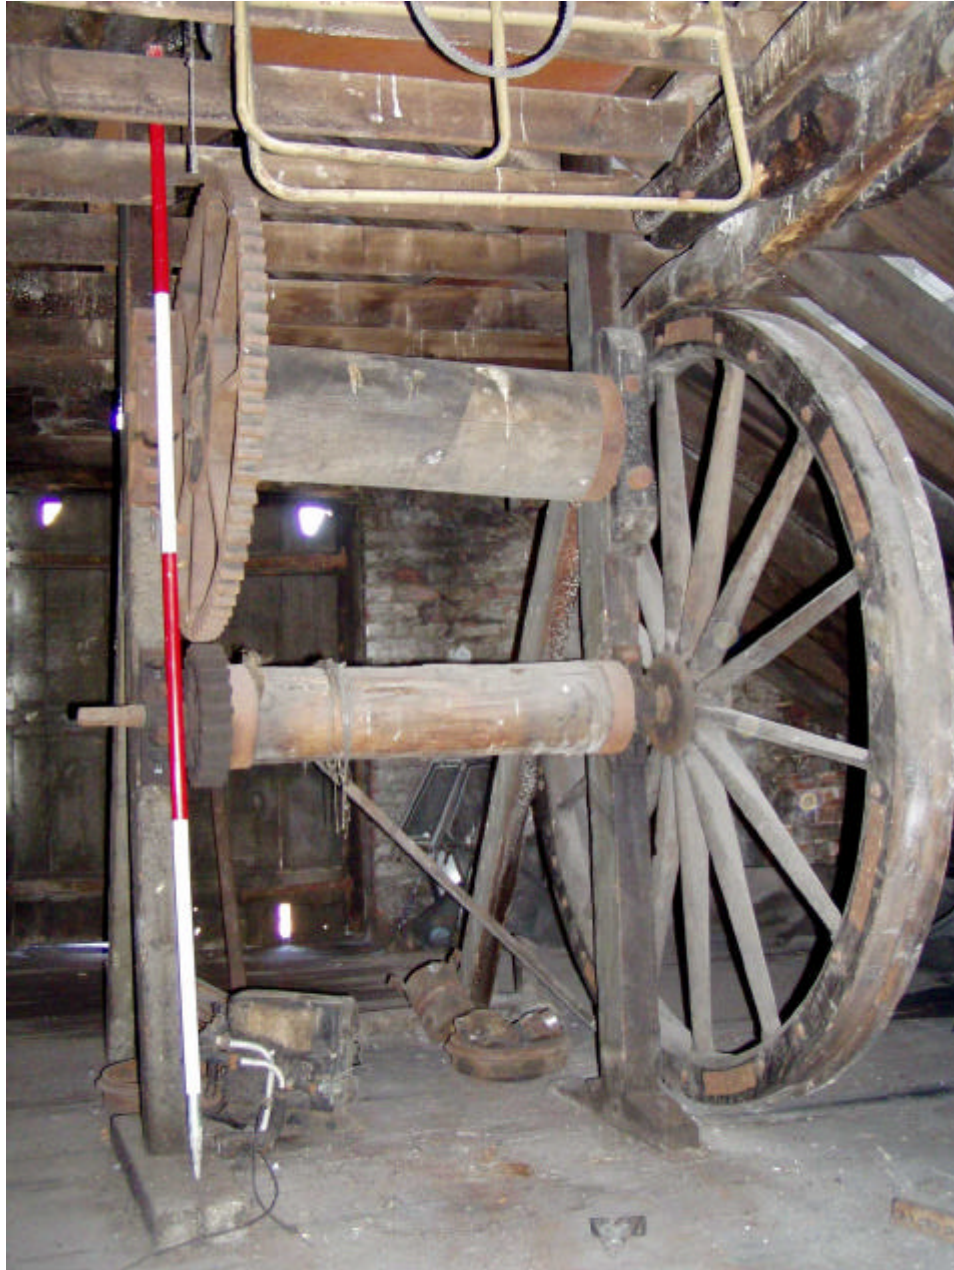
Plate 11: Detailed Shot of Winch Mechanism on the Third Floor

- 3.3.9 The main feature of this floor was the winding gear / winch which operated externally to the building (Plate 11). The winch is positioned 2m behind the loading doors and consists of a large wheel with brake on one side and the gears on the

other. The brake lever, intriguingly, has been repositioned to hold up the roof and therefore the building had gone out of use as a warehouse by the time the roof was replaced. The wheel has an iron hub, chamfered spokes and a sectional rim with a bolted section forming a 'V' groove for the rope. The larger of the two gears, present on the opposite side, is free wheeling while the smaller gear is directly attached to the fly wheel. Sliding brackets on the top wheel allow gears to be meshed/unmeshed. The gears were manually turned and there is no evidence to show that the winch had been provided with electrical power, which was a common practice by the 1920s. There are solid wooden cylinders around which the rope wound. The whole assembly is contained within a simple asymmetrical, vertical A-frame which projects out through the north wall with an iron pulley wheel at the end. The projection is formed from a symmetrical, horizontal A-frame made from two 1' section girders, with '*Dorman Long & Co Ltd for Middlesborough*' makers mark on both. All the elements of the winch are still in working order.

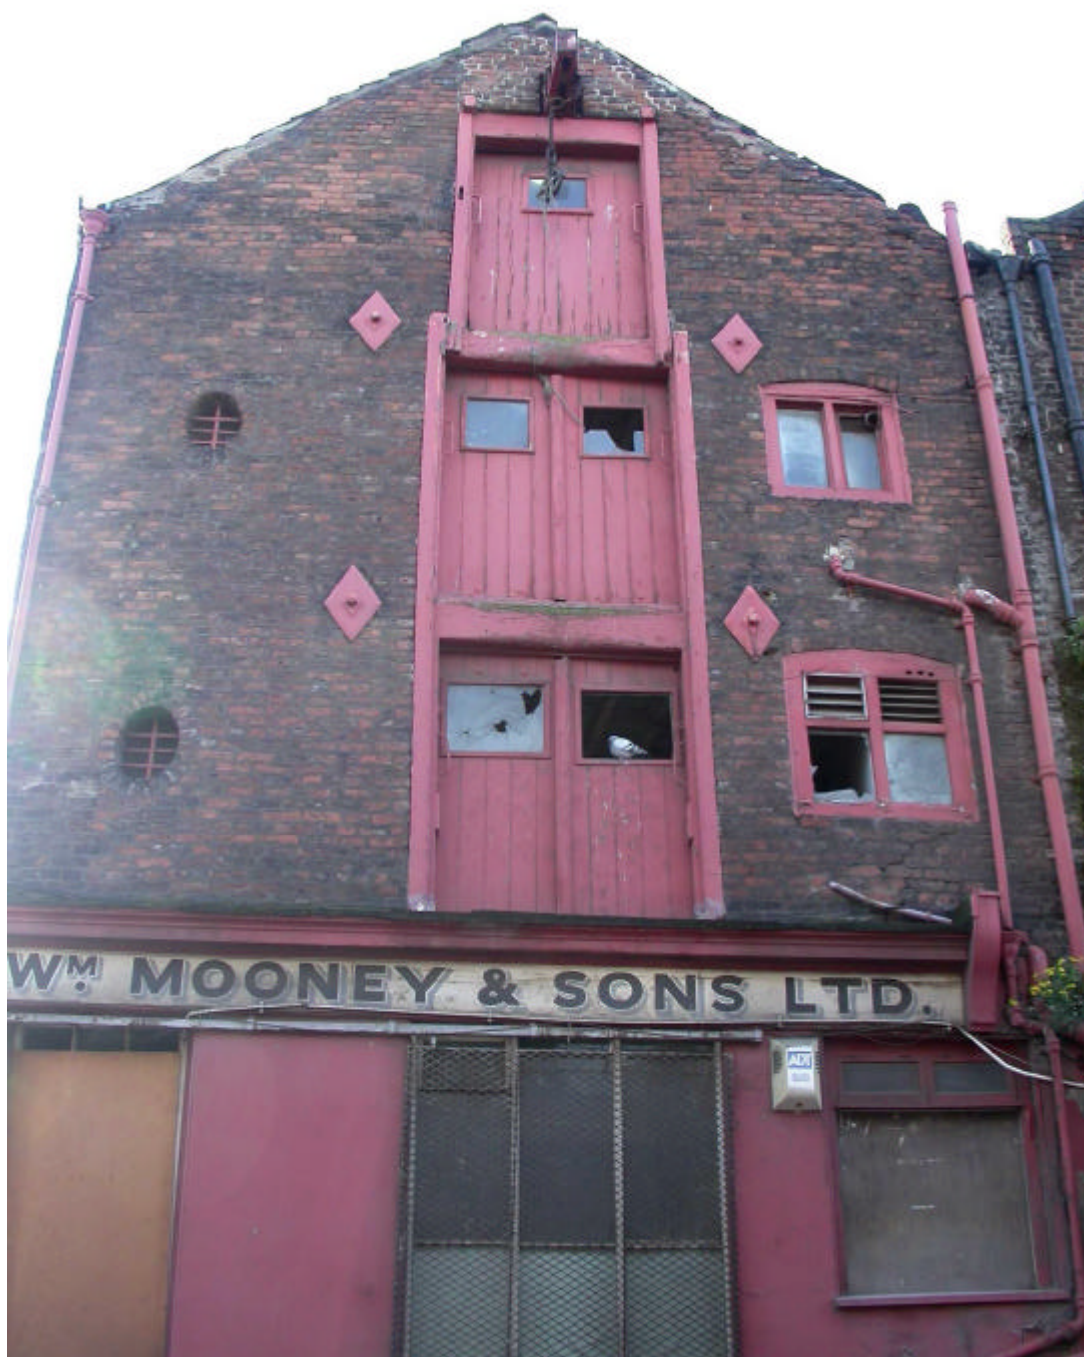
Plate 12: North-Facing Elevation

- 3.4.1 **Front/North Elevation** (Plates 12 and 13): this had the same general plan as No 20 College Lane but was originally longer than No 20. There is also a narrow passageway which runs along the western side No 22 and provided access to a small rear courtyard originally. Later, a two storey extension was constructed at the rear. As mentioned previously the storeys in this building differ slightly, due to the insertion of a basement, the level internally of the ground floor level is slightly higher than that of No 20.

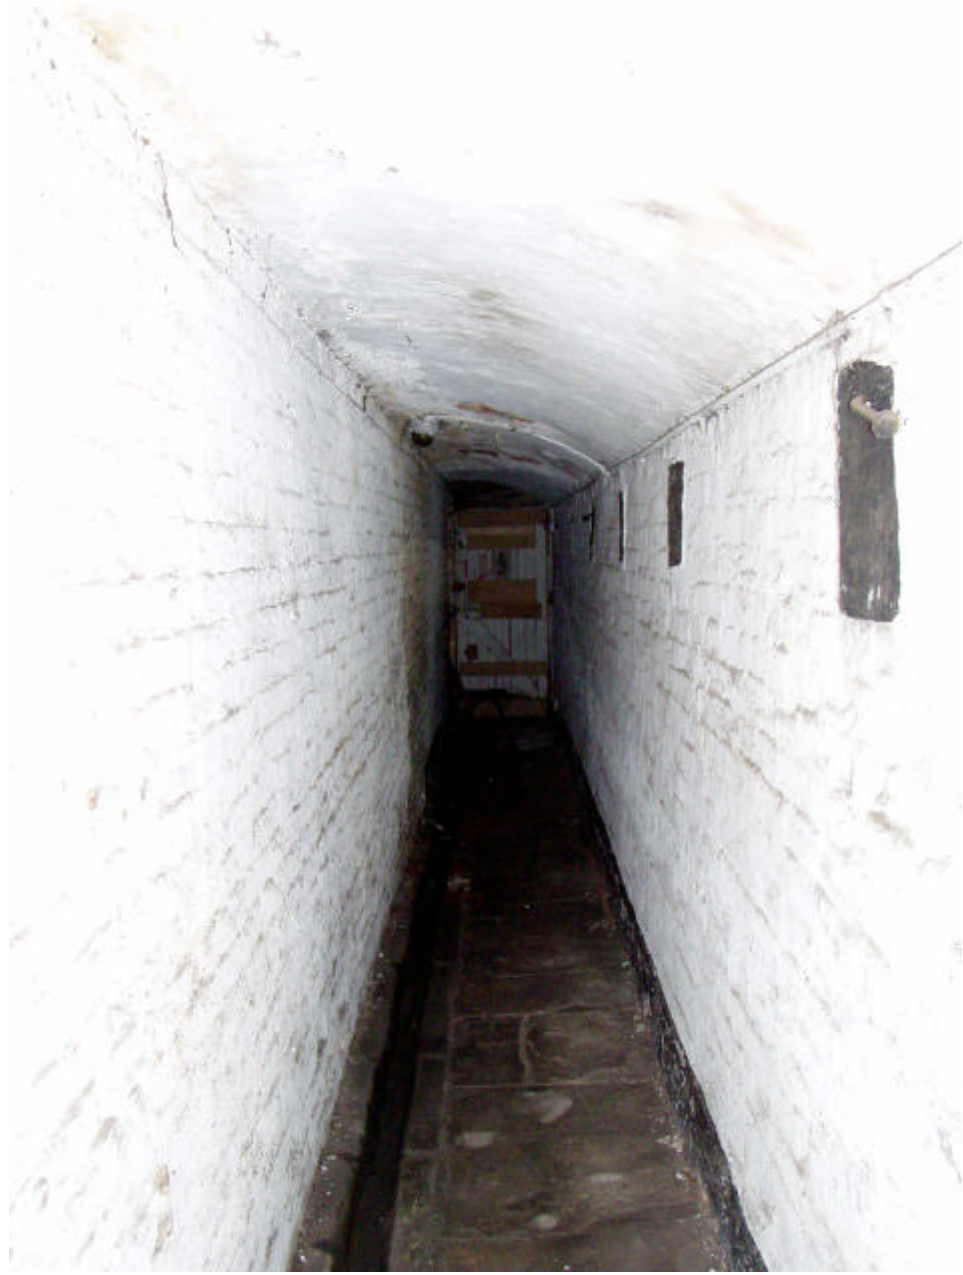
Plate 16: General Shot of Passage Way which Runs Alongside the Basement

- 3.5.4 The passageway was 2.08m in height and built of brick with a vaulted ceiling (Plate 16). It had a flagged floor with a sandstone drain running along on the west side that continued into the courtyard at the rear. The probable blocked door on the west side, at the south end, may have allowed access to the courtyard behind No 20 and there was a possible door into the basement at the northern end of the east wall. Six timber blocks (each measuring 10" x 12") were noted within the side wall, four of which have coach bolts sticking out. They are all at a height of 1.41m from the floor and are beam ends. The entire passageway is lime washed, again to lighten the area and increase visibility, although there were adornments which showed that it was once lit. The narrow width of the passageway demonstrates that it was only used for pedestrian access.

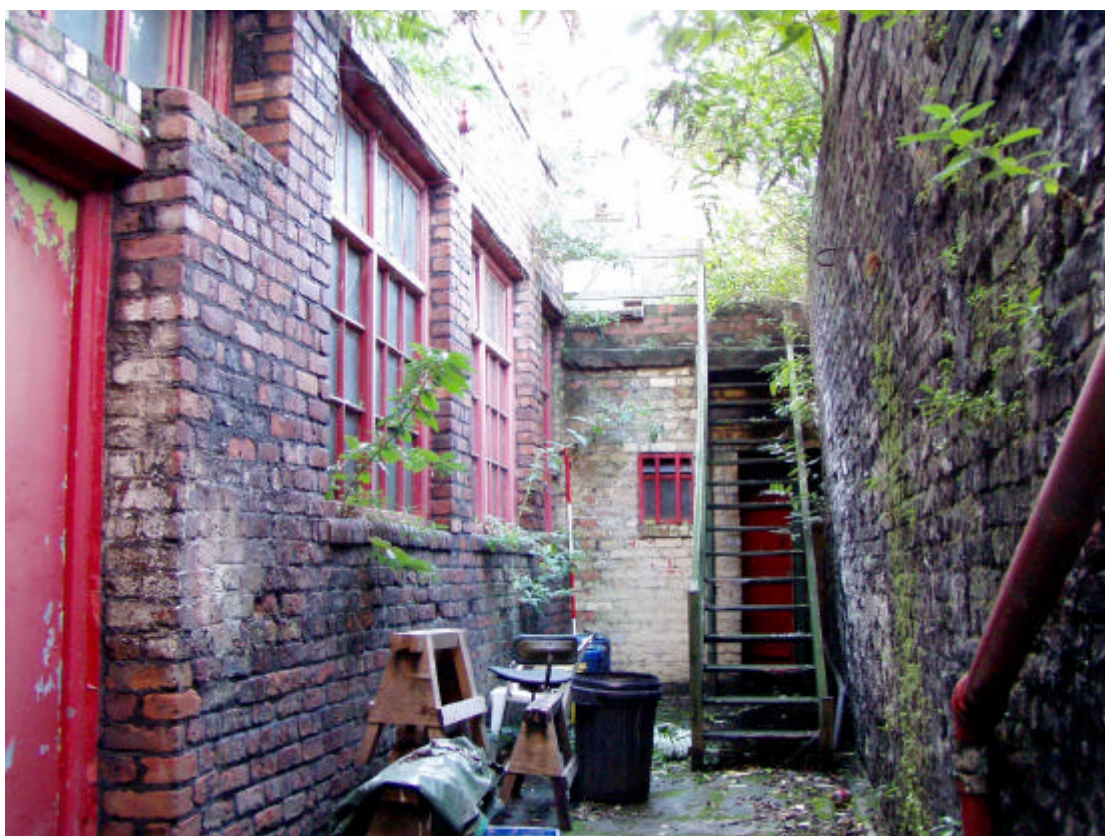
Plate 20: Shot of The Fire Escape From the First Floor to the Ground Floor

- 3.5.10 The toilet, attached to the south-west side of Room 22.G2, appears to be a later addition and is a small single storey building with stairs to the first floor running over the top (Plate 20).

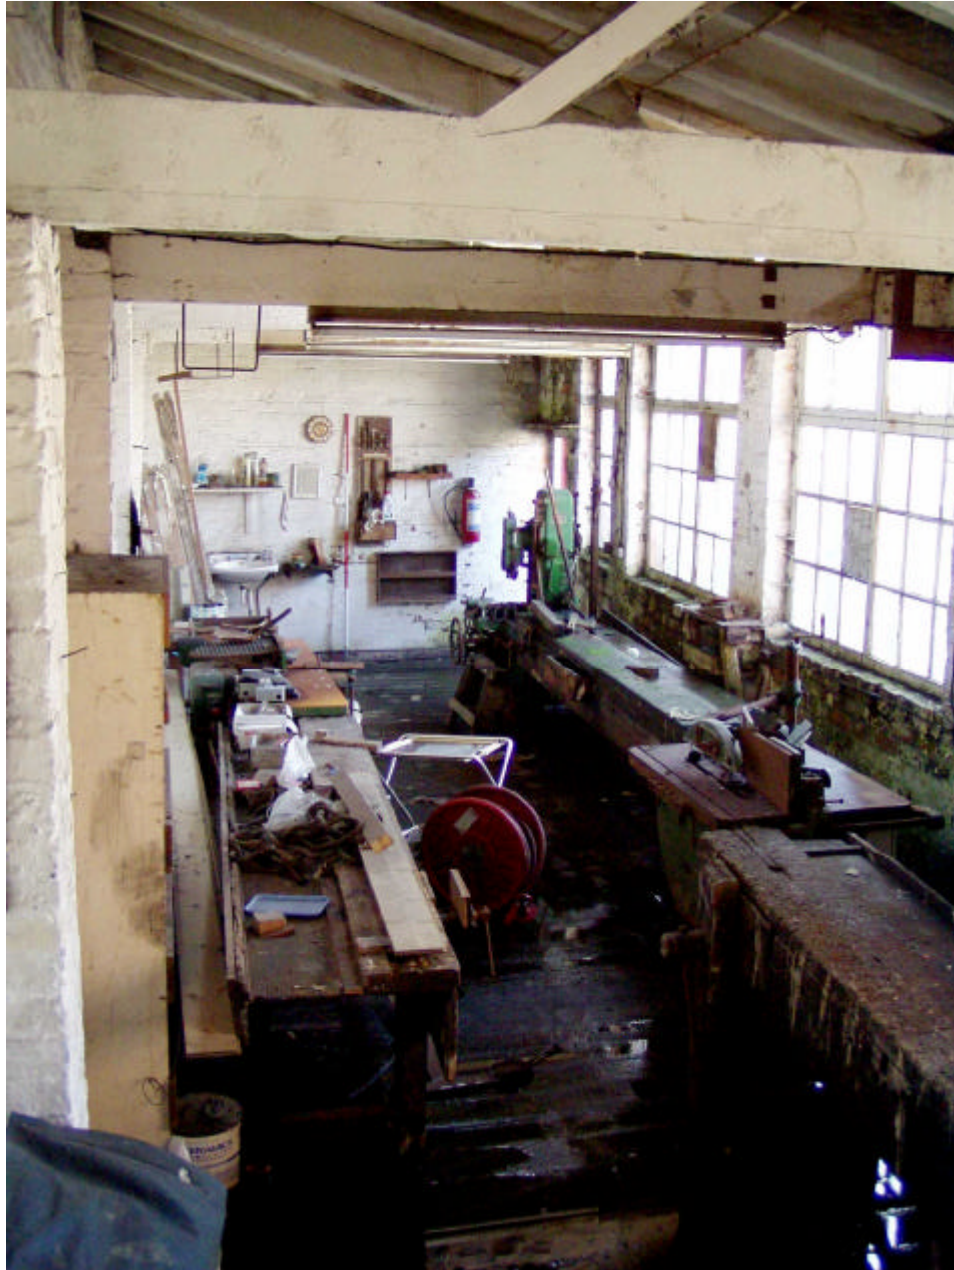
Plate 22: General Shot of Room 22.FF2 at the Southern End

- 3.5.13 The southern extension room, (Room 22.FF2, Plate 22), corresponds in layout to the room below (Room 22.G2 and G3). It has the same brick construction, timber flooring and window styles as the room below, and therefore are distinct from those in the original room (Room 22.FF1). There are two doors; that at the south end allows access on to the roof of the toilet and thence by an external stair to the courtyard. The other door is relatively wide and is positioned above the door in the room below and has riveted steel joints above for a hoist. The roof slopes to the west and is formed on what appears to be a half A-frame truss. There are a number of internal fixtures and fittings surviving in this room which include benches, saws, sink, drills and wooden shelving. The

equipment would have been used for wood working and indicates that this room was used as a workshop.

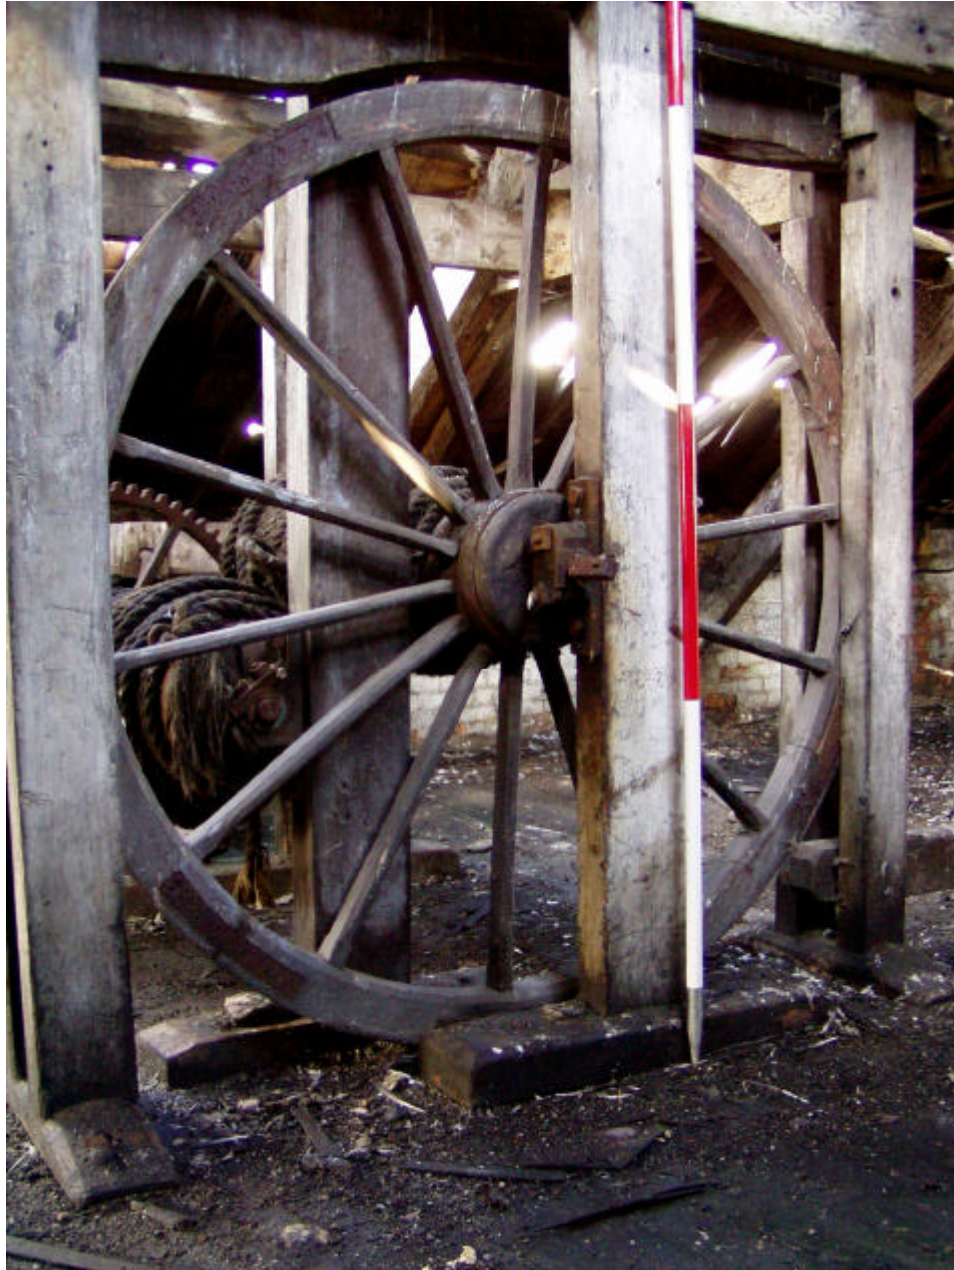
Plate 25: Detailed Shot of Winch Mechanism in Room 22.TF1

- 3.5.16 The hoist/winch is of the same overall design to that in No 20 and has similar components (Plate 25). It has the same brake wheel arrangement, with the brake wheel itself on one side and the gearing on the opposite side; between the two are the horizontal rope cylinders, onto which the rope wound and was still in place during the survey. The timber hubbed and iron strapped brake wheel still had the long brake lever in place. The entire arrangement is held in a square frame constructed from substantial timbers and on one of the uprights is inscribed Larme No 1. The frame is set further back into the room than in the adjacent arrangement in No 20. The pulley extends out through loading door and the pulley wheel has been attached to the apex of truss No 2 (Plate 24). Again, as with the equipment in No 20, the winch is in excellent working order with the rope still present.
