AUCHINDRAIN TOWNSHIP

INVERARAY

**Recording of the Architectural and Constructional
Detail of the Standing Buildings**

Report no 2000-01/ (025)/8016

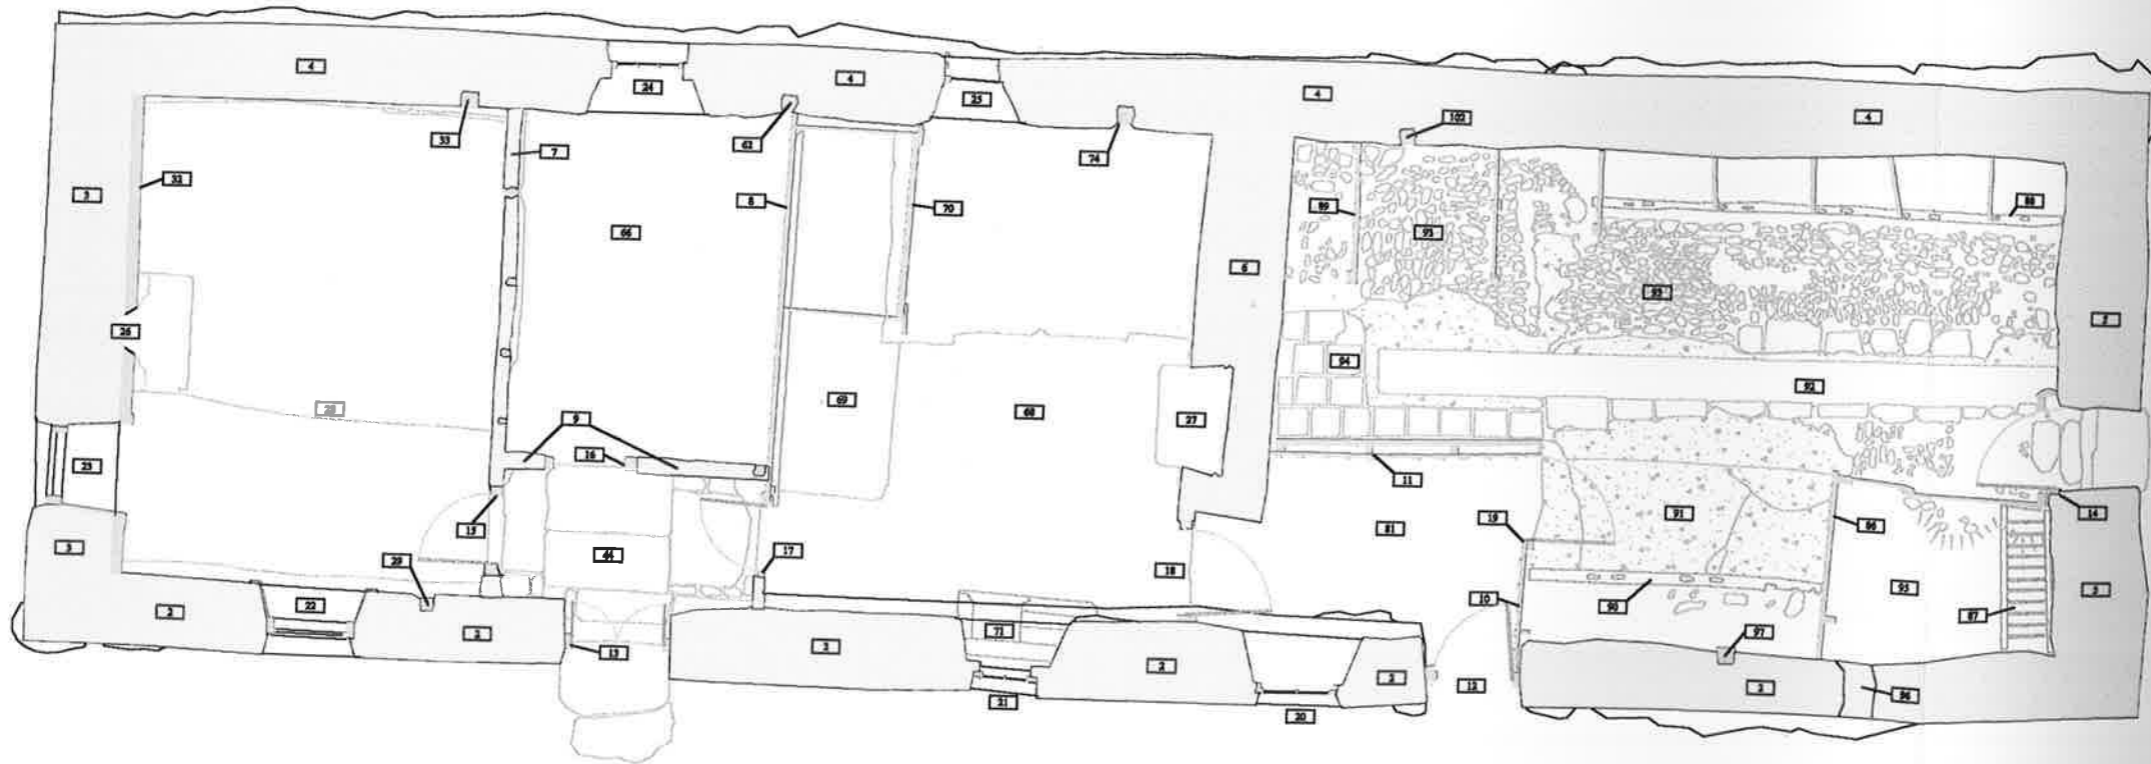
Fig 5: Plan of Building A

- 5.2.2 The original timber partition between byre and kitchen was replaced with a thick stone partition [6] with a fireplace containing a range inserted into the kitchen, and must date before 1904 as a central chimney is shown on the photograph of that date (Buchanan *et al* 1988). Running water was also added into the kitchen, with a sink [71] located in front of the southern window, to maximise the available light. All the windows, with the exception of the north window of the kitchen (which appears to retain its original frame but was modified slightly to allow for an opening light), were enlarged and had sash windows inserted. Those in the parlour also had panelled interiors to match the tongue-and-grooved panelling to the gable. The features described mark the achievement of a level of privacy, hygiene and decency that was considered basic to the housing of the rural poor elsewhere in Britain by the later nineteenth century.

- 5.2.4 The closet / dairy (Room 2) was separated from the kitchen (Room 4), parlour (Room 1) and porch (Room 3) by stud partitions which were not seen in the older buildings. That between closet and parlour [7] had roughly cut studs from floor to ceiling height with rubble stone nogging; it was butted by a wall of similar construction forming the north partition of the porch. The eastern wall [8] was of a different style, however, having a timber rail [44] which housed the original studs. The studs, and presumably the rubble nogging, were later replaced with a timber partition. It is unclear why two different techniques were used, and as no stratigraphic relationships exist between them it is not possible to deduce which was tried first, or whether they were contemporary attempts to ascertain the best method for previously unused stud partitions. It does, however, highlight the dynamic, *ad hoc* approach to the evolution of the structures within the Township.

- 5.2.5 Many of the original cruck-bases remain in-situ [29, 33, 62, 74, 97 and 102]. A loft was added over the parlour, closet and kitchen, the floor being supported on large (*c* 0.25m diameter) beams of roughly hewn pine trunks. A window in the upper eastern gable [5] was presumably blocked at this time. All trusses in this loft were replaced with modern trusses and were clad with tongue-and-groove boards beneath the tin roof, presumably for insulation.

- 5.2.6 Concrete floors were added throughout the building in several stages, although only partially in the byre which had a concrete drain [92] added.
- 5.2.7 The building is largely unchanged since being taken over by the Museum Trust, with only minor repairs, most notably to the eastern end of the north wall [4] of the byre, most probably carried out in the late 1960's, and the addition of mains electricity throughout the building.

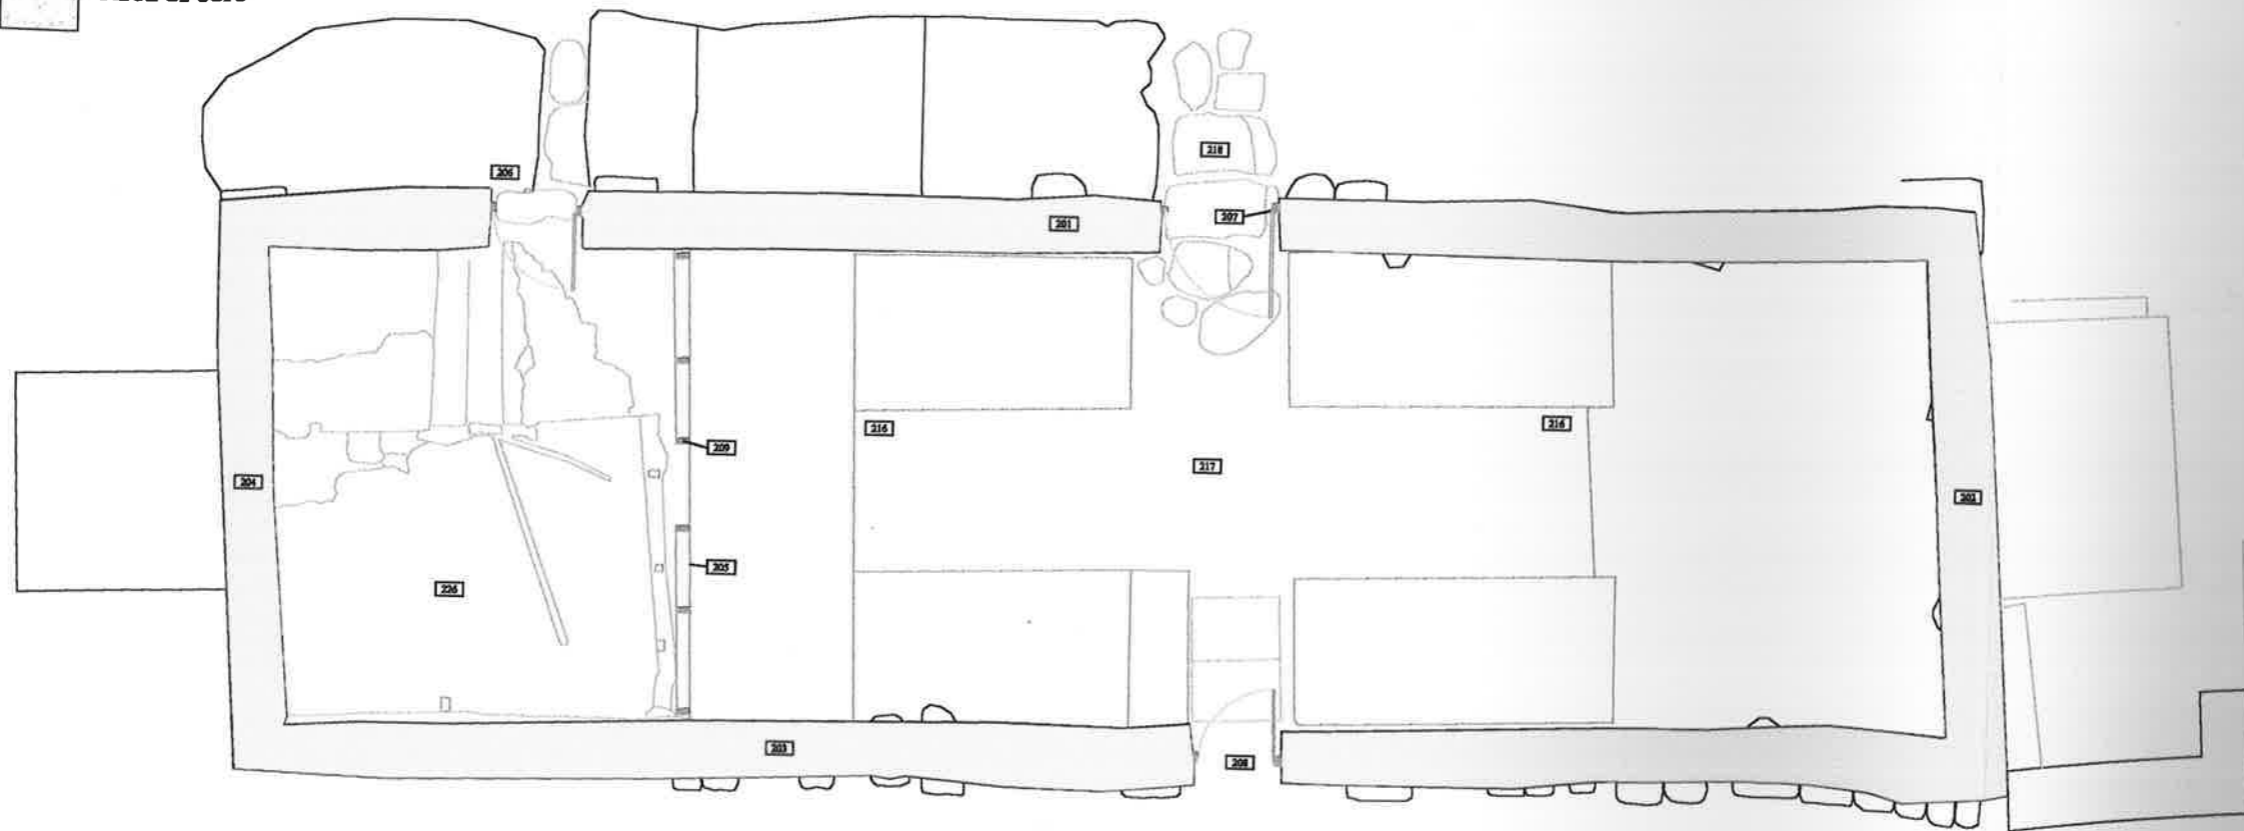
Fig 6: Plan of Building B

- 5.3.2 The walls have been rebuilt almost from the footings, with a mixture of triangular [215] and rectangular [210, 211 and 214] vents used. A timber panelled gable [202] was added above wall-head height at the southern end at the same time as the building was re-roofed in 1986. A cartshed shown in a photograph of 1904 (Buchanan *et al* 1988), also appears to have been rebuilt as a small tarred shed and pigsty, jointed to the south elevation of the barn with concrete mortar, and with a concrete floor. The original partition between barn and stable was also removed and replaced with a new timber partition [205] at the same time as the building was re-roofed.

- 5.3.3 The building has been consolidated at wall top height by the Museum Trust and several *ad hoc* episodes of repointing / repair have also been undertaken. This style of repair, using materials that were either nearest to hand or were cheapest is typical of the interventions made by the Museum Trust (Bob Smith pers comm), and it is due to such methods that the settlement has survived in generally good condition. Display boards / boxes have more recently been fixed throughout the barn.

- 5.3.4 A concrete platform observed to the north of building B may represent the base of a shed mentioned as having been removed prior to the Museum's management of the site (MacDonald pers comm).

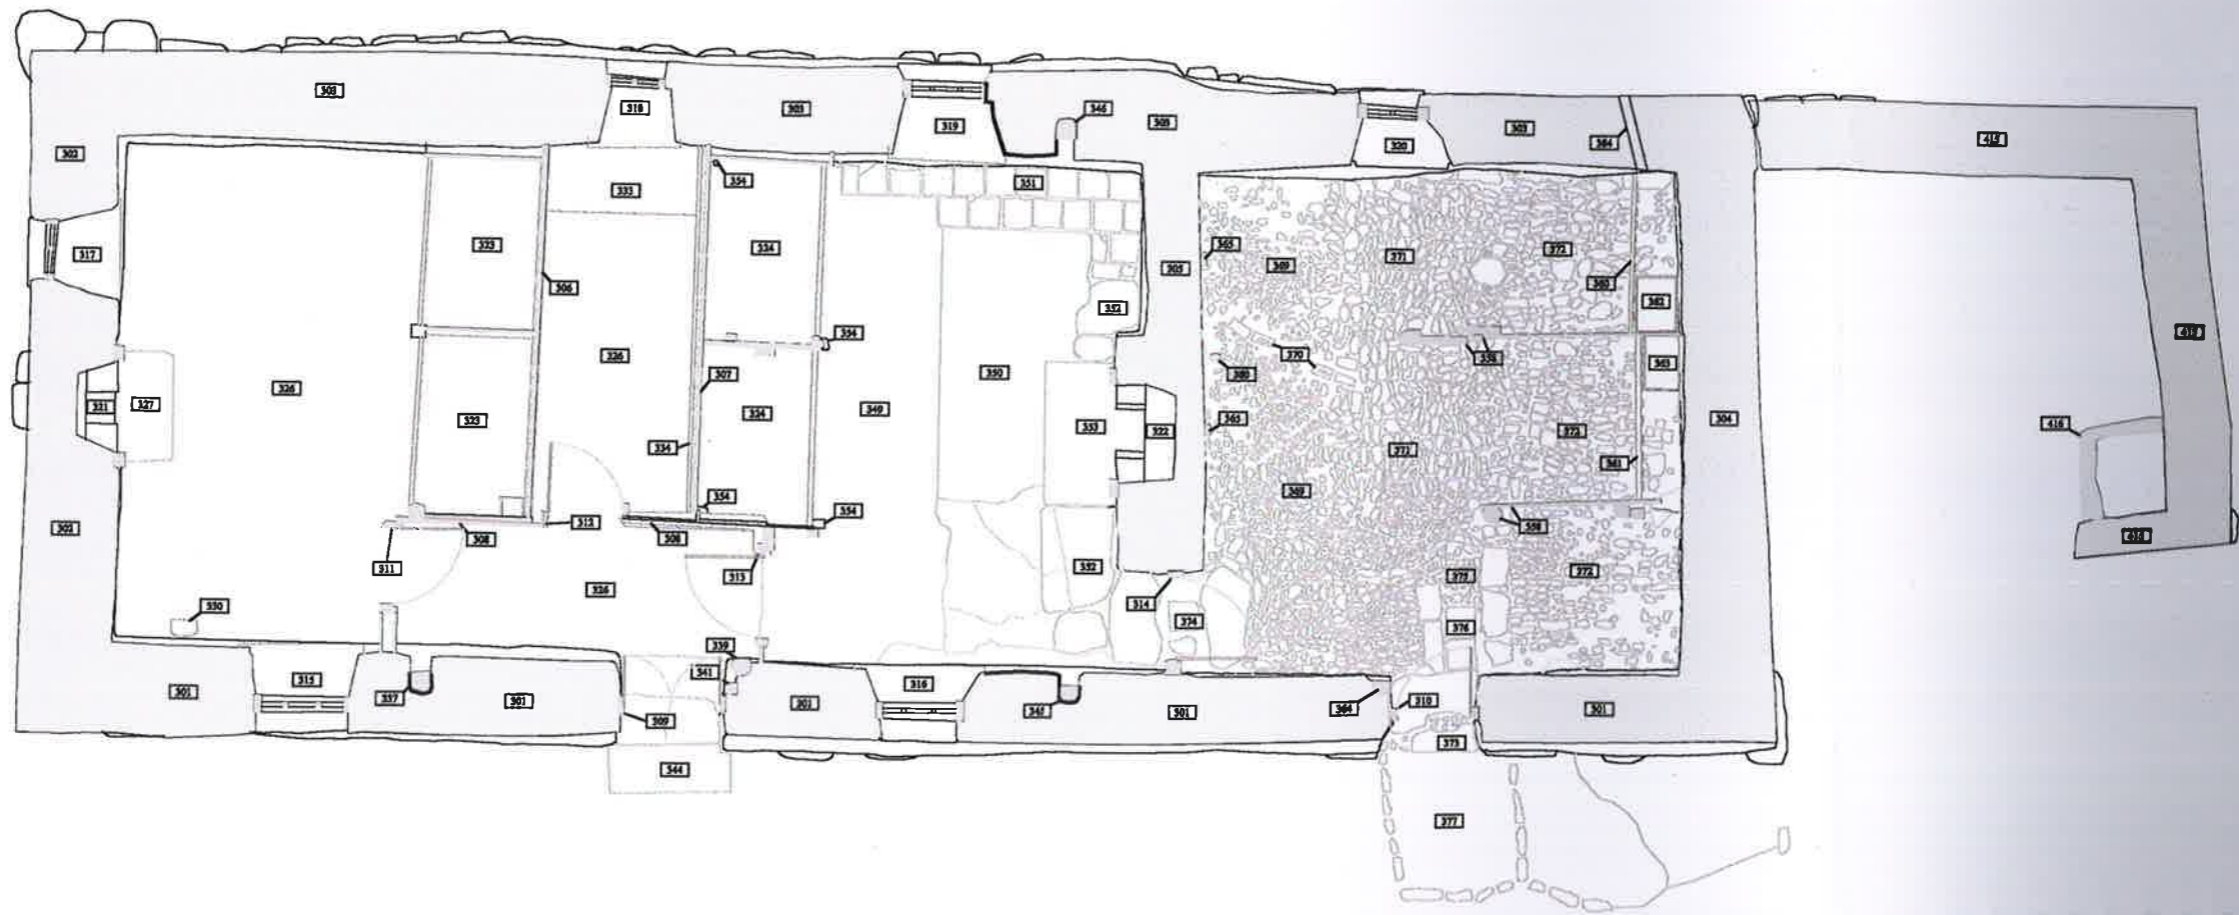
Fig 7: Plan of Building D

- 5.4.2 The building, like others within the Township is constructed of undressed local stone, probably originally with drystone construction, although the external walls [301 to 304] were all mortared during the massive renovation of the building, undertaken by the Museum Trust in 1992. This was carried out because the building had become unsafe and involved the rebuilding [367, 394, 395] of large sections of the external walls. The building is slightly unusual in that it is the only long-house not externally whitewashed.

original alignment to the east. The foundation course however is continuous in alignment, curving only slightly south, suggesting the original wall was straight. The bend in the wall was discovered during rebuilding, but might have subsequently become more exaggerated. The external foundation course also continues to the east, under a later? cart-shed wall, suggesting that there may have originally been an earlier structure, contemporary with the long-house, in this position. At the western end of the wall the foundation course is on a slightly more northerly alignment, up to 0.3m off-line with the present wall at its western return. This misalignment of the wall may relate to the Museum Trust renovation of 1992, when this corner was rebuilt, or possibly to an earlier rebuilding. Internally the wall is whitewashed, obscuring any detail.

- 5.4.7 A smoke hole [341] was observed within the thatch positioned centrally above the kitchen. The eastern and western edges are formed at the base by two machine cut timbers, set on edge, and resting on the two ridge purlins beneath. The rest of the cowl is formed by thin, presumably hazel, twigs, c 0.03m diameter, 'woven' around the rafters. The timber boards may be replacements.

- 5.4.8 The stone wall between kitchen and byre [305] is a later insertion, probably replacing an original timber partition. The thatch predates the construction of this wall, as it has a smoke hole, and the wall was built with a fireplace. However, the roof structure would have had to be modified at this time. The remains of a redundant cruck [364] were observed within the southern long-wall of the byre, but evidence for a northern terminal had been removed, with the insertion of a window [320] in its location.

- 5.4.9 There have been several other additions to the roof structure; the cruck stump immediately to the east of the dwelling doorway has been remodelled. It appears that the original cruck stump is the rear timber [341], recessed into the wall. The front timber [339], now supporting the base of the truss was presumably added when the original stump failed or became badly damaged. Extra collars [392] were added to the central two trusses, crudely bolted rather than pegged, with a second later collar added to the eastern of the two. It also appears that a post forming the box-beds in the kitchen was lap-jointed to one of these collars, further stabilising the roof structure [386].

- 5.4.11 The byre of the building remains relatively unchanged by the recent renovation. The half-loft, comprising roughly cut thin branches, is the only surviving example within the Township, and is probably broadly contemporary with the stone partition wall it butts. Half-lofts [379] would probably have been typical throughout the earlier Township buildings, only later being replaced by full lofts, as in Building A. The cobbling [369, 371, 372] of the byre suggests that there would originally have been stalls / tethers along the western side of the byre, as well as the east, with a narrow manuring passage [375] draining into a much larger central passage, only the southern end of which survives. It is likely that current layout dates from the conversion of the byre to a stable, as the use of horses within the Township grew, probably in the early / mid twentieth century. There is also a well preserved cobbled ramp [377] immediately outside the byre door, probably extending to the east, presumably constructed to prevent the cattle churning up the boggy ground.

- 5.4.12 Box-beds [323, 324] have been re-inserted in both the parlour and kitchen within the building. These have been located in the positions of the Township beds, observed in the parlour during excavation, and with the original footings still visible in the concrete floor of the kitchen.

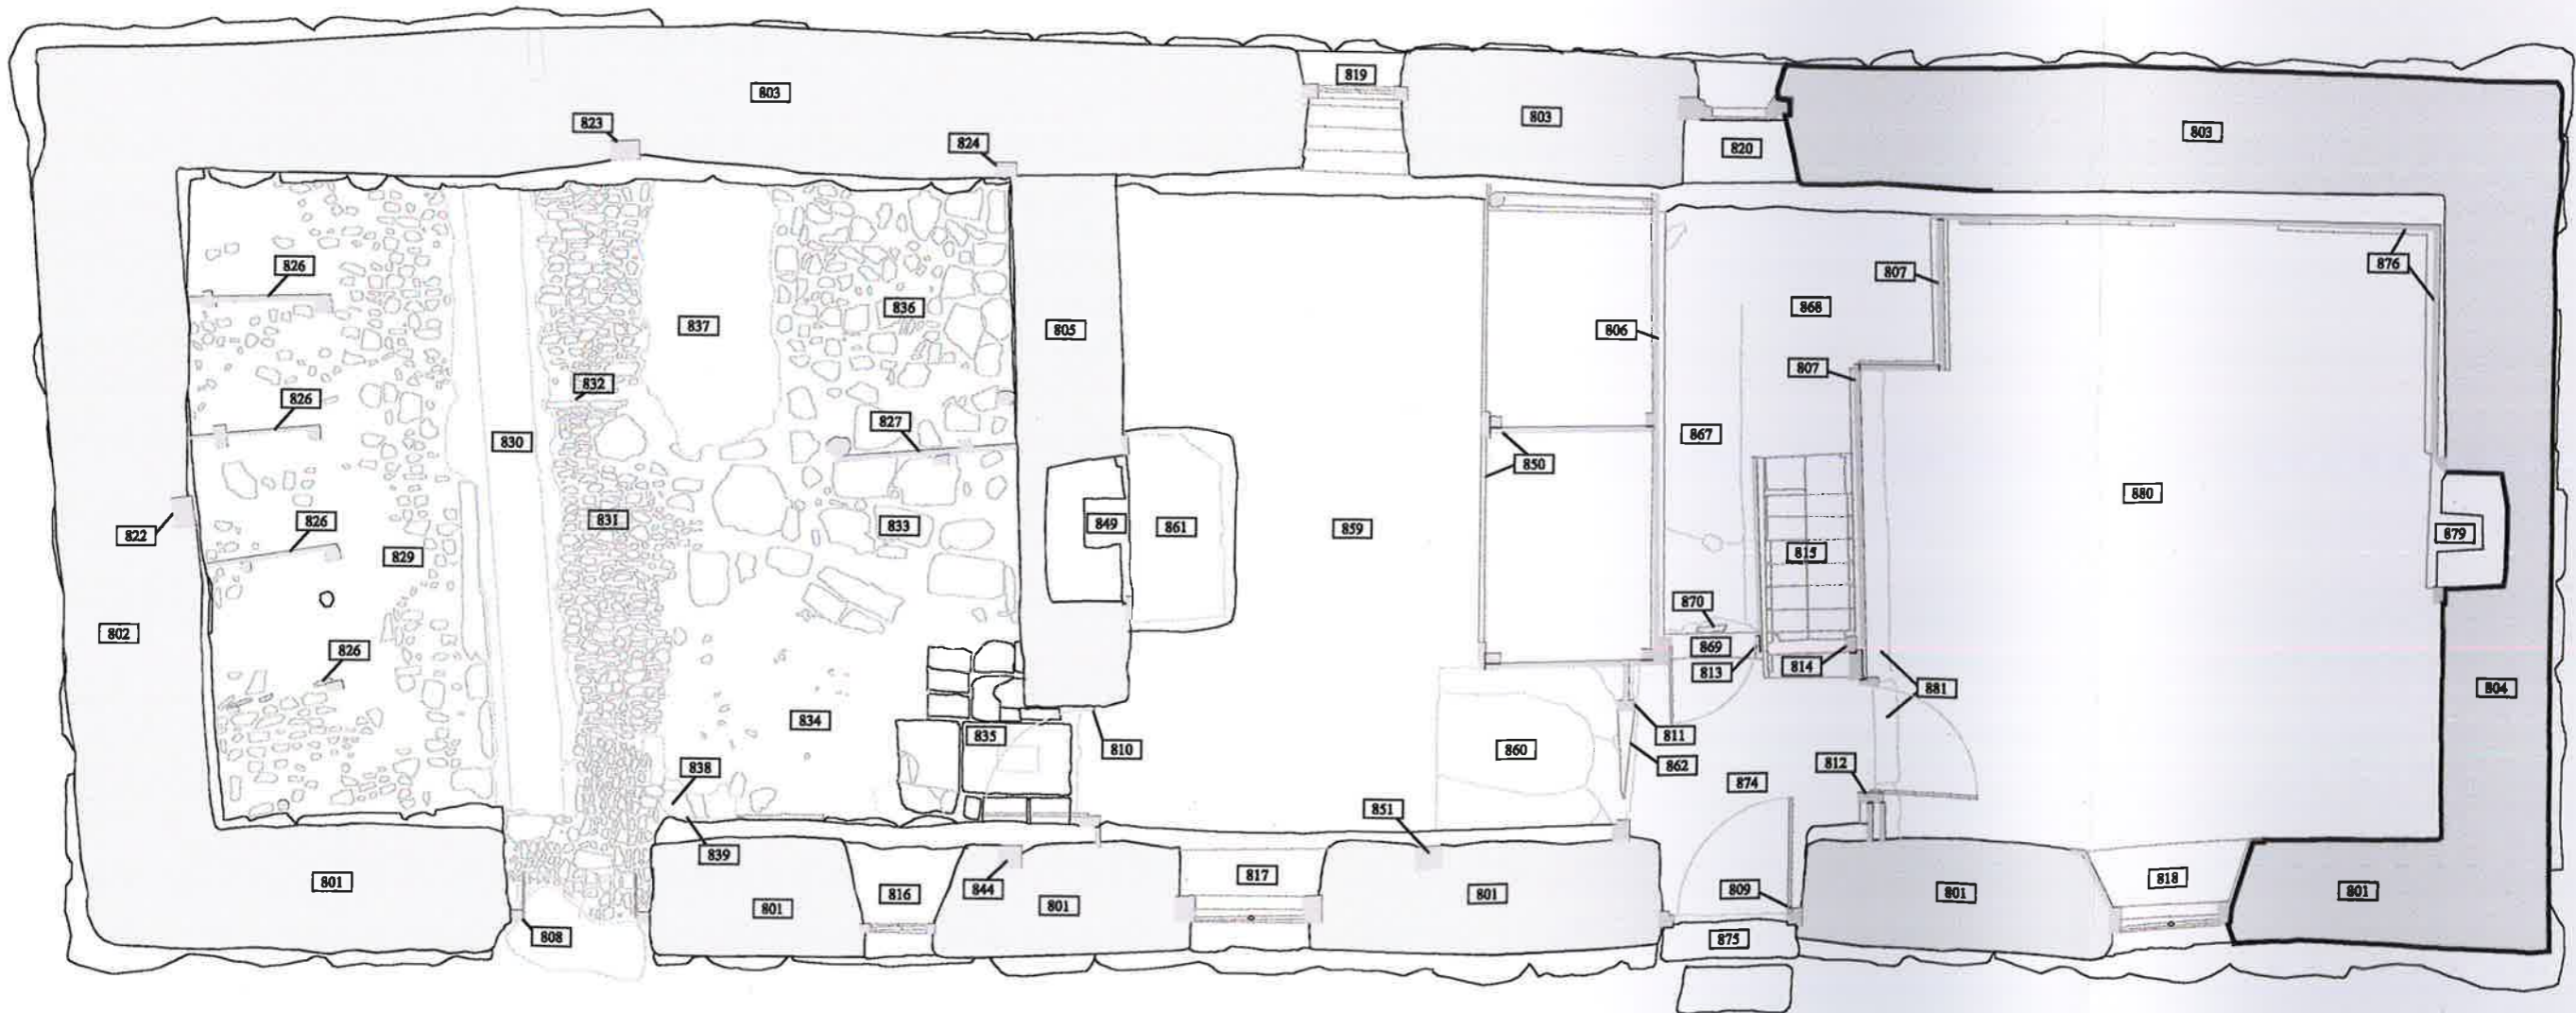
Fig 11: Plan of Building H

- 5.8.5 The attic floor [853] was inserted around 1907 (Dunbar 1965), with steep stairs [815] constructed within the closet. It would appear that the timber panelling [876] within the northern part of the parlour, some of which forms the eastern part of the staircase, dates from this same period. A repair within the concrete floor of the parlour [881] also suggests that either the position of the wall was also moved slightly to the west, or that the new wall was much thinner than the original, which may have been similar to that between the parlour and closet in Building A (7).

- 5.8.6 The stalls within the byre [826] are similar to those within Building A, but without the tether rail. Instead each stall had its own tether chain, showing a difference of stalling practices within the Township. Evidence of a secondary manuring passage [832] was also observed from the eastern stall [827].

- 5.8.7 The box-beds within the kitchen [850] are probably the oldest within the Township, although the slats forming the bed have been replaced, probably c 1950 when the attic was renovated, as they comprise the same timber.

- 5.8.8 The renovation to the attic involved the insertion of two timber partition walls [888, 889], creating two rooms either side of a central landing. The flues of the fireplaces have also been rebuilt [886, 887], possibly at this time, or earlier. It would appear that either the flues, or the junctions between chimney and roof, were leaking badly; the western beam in the kitchen has been repaired, with new floorboards above [890], and the attic floor by the western chimney has rotted and broken.

5.8.9 Several repairs have been made to the corrugated iron roof [903], by the Museum Trust since 1986. Extra sheets were inserted under the hipped ridge [908] of the byre, and also under the badly corroded lower sheets on the southern pitch of the eastern part of the roof [909]. There is an ongoing process of taping minor corrosion of the sheets on the northern pitch.
