31 Hanover Street, Liverpool

INTERIM FABRIC SURVEY REPORT

September 2005

**Laing O'Rourke and
Grosvenor**

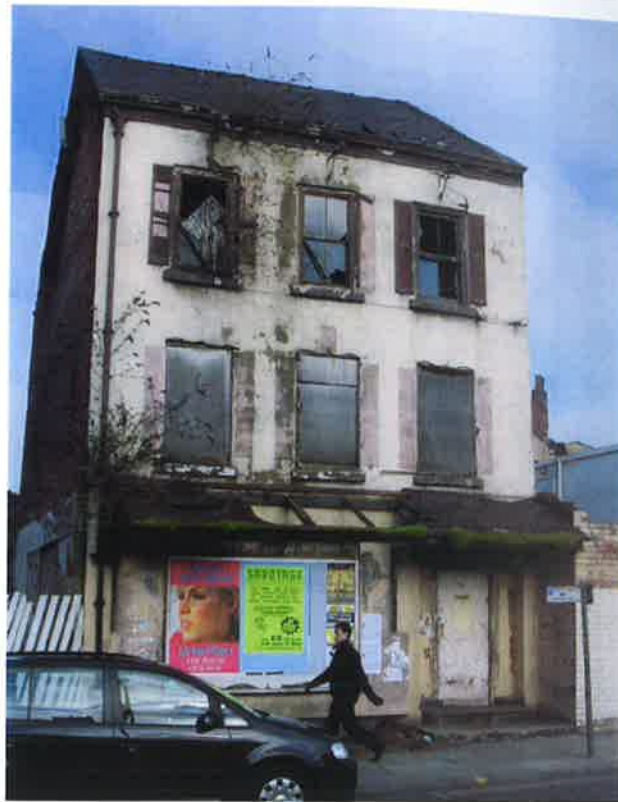
Plate 1: South-facing elevation of 31 Hanover Street

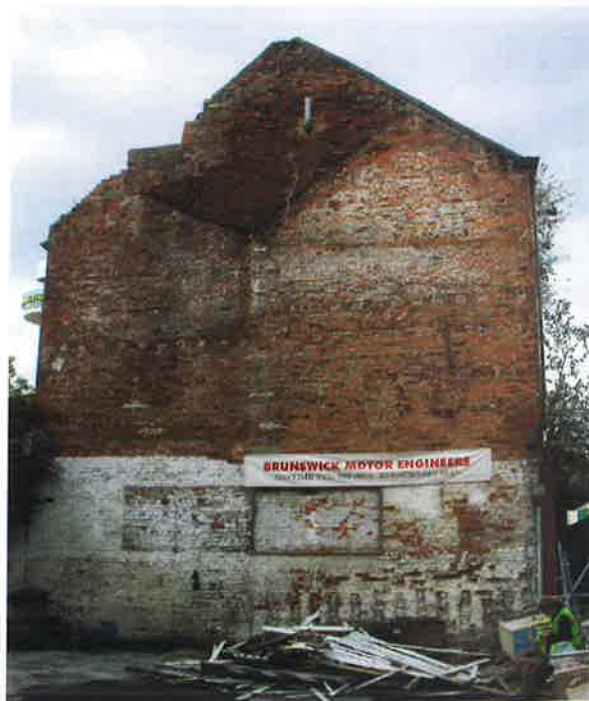
- 3.2.7 **Side / west elevation:** this is a high gable wall and has no evidence of any apertures, reflecting that it was originally a party wall with another building to the west that has subsequently been demolished. A single storey extension has been added to the north of the elevation in the mid/late twentieth century, and was constructed of red brick and had a sloping roof. The brickwork has been painted white to the height of the ground floor and there is much scarring and later infill indicating that this was once an internal elevation for the former building. There are the edges of a wooded rectangular notice board and wall scarring to the north from a former board within the centre of the wall. At the base of the ground floor, in the southern half, are thirteen vertical slots of infill (each c0.58 by 0.15m). The purpose of these are uncertain, but apparently acted as supports and relate to the now demolished western building. Above these is a rectangular patch of infill which is c0.65 by 0.65 m in size.

Plate 2: West-facing elevation of 31 Hanover Street

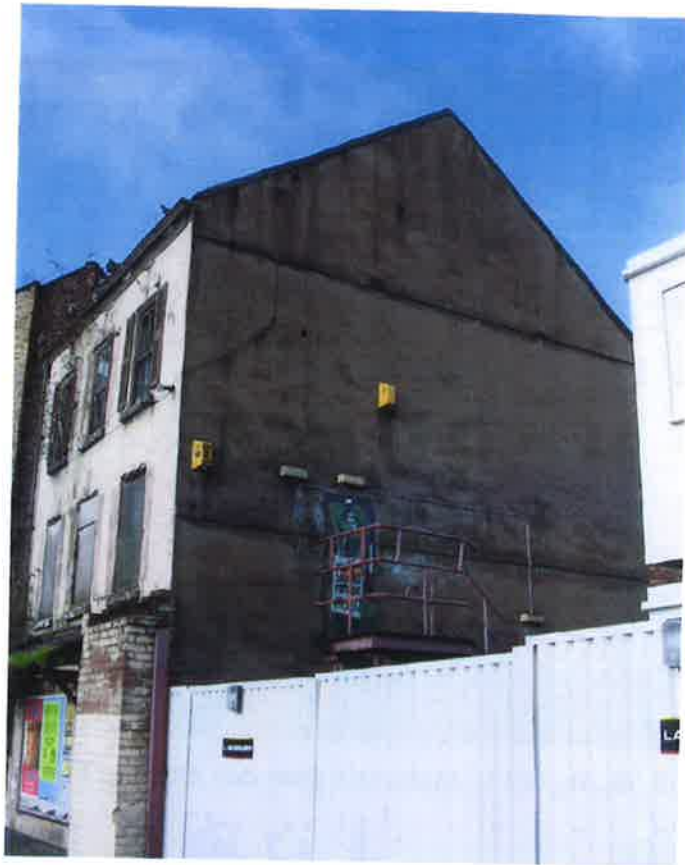
- 3.2.12 The alignment of the roof, relating to the earlier western demolished building, is clearly visible; the brickwork extends c0.40 m above the extant structure's roofline.
- 3.2.13 **East Elevation:** there are no windows or doors relating to the warehouse, and the elevation is entirely rendered with only a small patch of redbrick exposed below the southern pitch of the roof. A plain wood fire escape door is set at first floor level with a metal staircase extending from it; this construction and aperture evidently relates to the later use of the building as a public house.

Plate 3: East-facing elevation of 31 Hanover Street

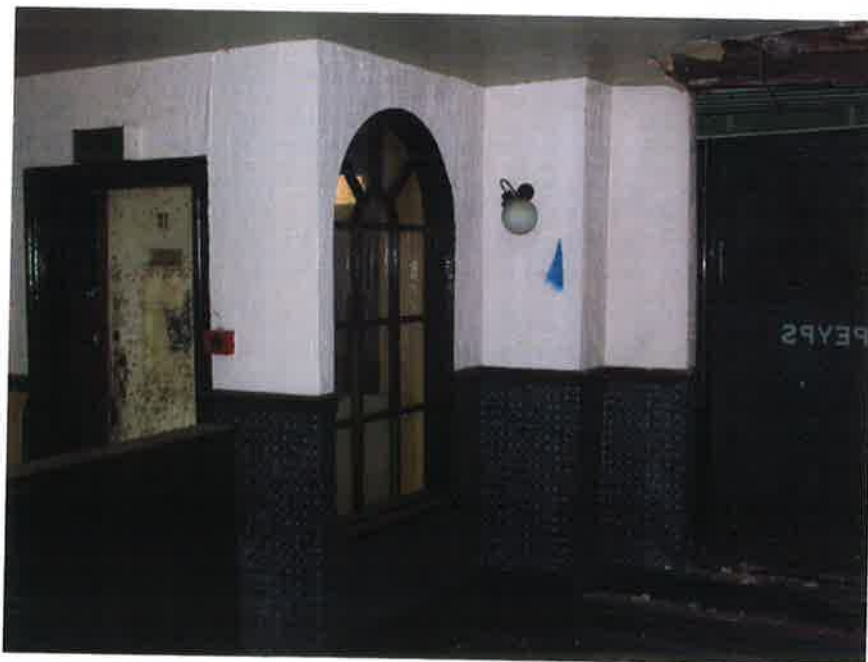
- 3.3.1 **Ground Floor:** the extant fixtures and fittings mainly relate to the structures secondary use as a public house. The main entrance door is via a mid to late twentieth century plain wood door which leads into an internal porch and beyond is a further glass and wood door. Between the two doors to the west is a segmented arched window with a black wood frame and is thought to be a later decorative feature added to the public house. Beyond the entrance door is a cloakroom.

Plate 4: The modern porch and front entrance on the south elevation of the ground floor

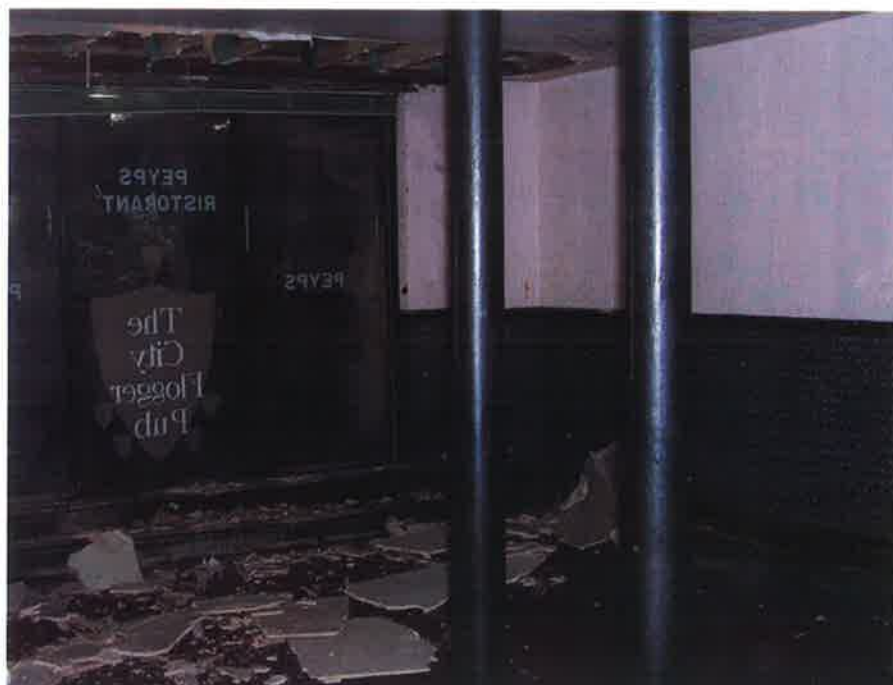
- 3.3.2 The south and central divisions of the ground floor have papered walls and a black painted dado rail running around sections of the walls. Wood seats, shelves and panelling are extant around the perimeter of the divisions. At the south end is a large glass window (as described in external south elevation section above). An RSJ has been inserted above this for structural support, and mid to late twentieth century north-east floor joists replace the primary timbers above this (c0.23m in depth). Situated between the south and central divisions are four metal pillars, painted black. These are nineteenth century in architectural style and may be contemporary with the primary phase, or more likely have been reused from elsewhere and were intended to provide an open aspect inside the public house.

Plate 5: The south and west elevations of the ground floor

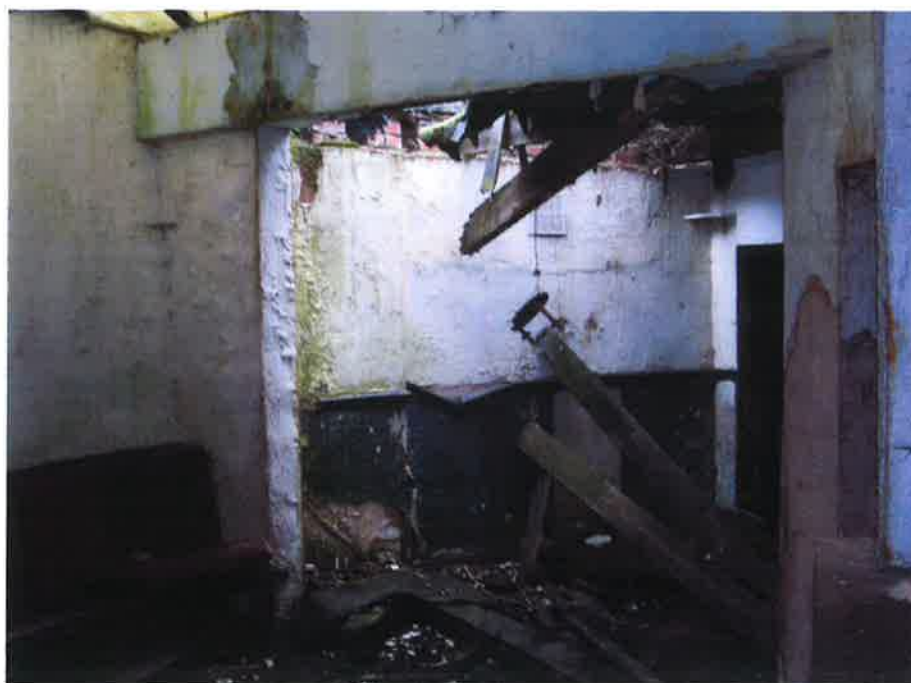
- 3.3.3 It was not possible to access the north division of the ground floor due to health and safety restrictions, as the floor was unsound. Therefore the following comments are made from visual observations as far as possible. In general this area retains much of the fittings of the public house as described above, which includes dado rail, panelling and seats. The west elevation curves in a north east alignment and the visible brickwork suggests this was a later extension. An RSJ has been inserted between the central and north divisions. There is a part angled glass roof above the RDSJ, and to the north of this the flat roof has suffered considerable collapse. The floor joists and boards are clearly visible.

Plate 6: The north extent of the ground floor

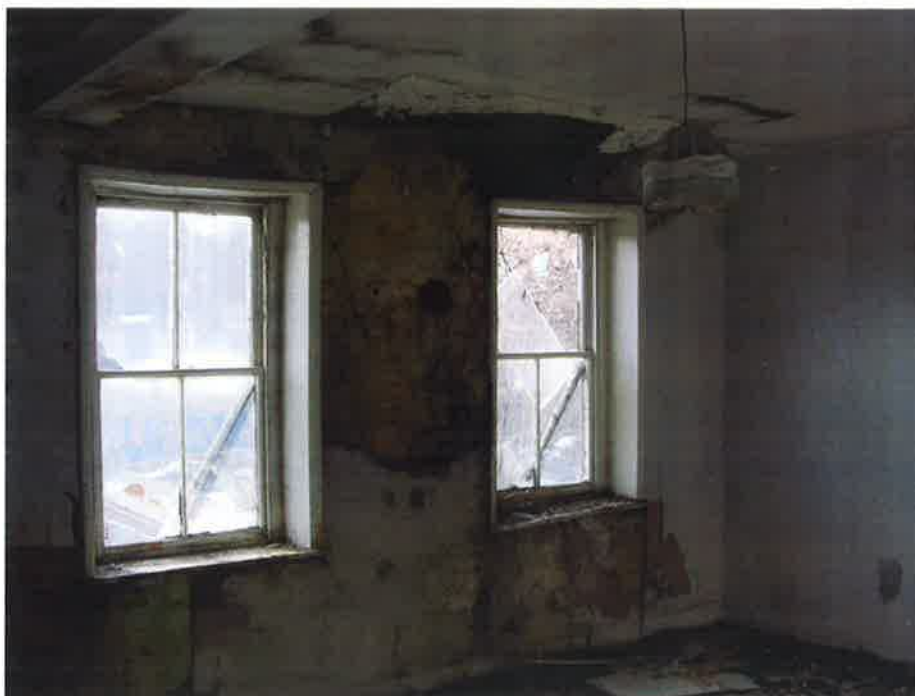
- 3.2.6 The second floor has a further three windows of the same alignment as those of the first floor, however these are not boarded up. They had sandstone cills with primary softwood moulded sash window and each division contains two lights. The two outer windows have extant wood louvered shutters on each side of the window, and were decorative rather than functional features. Above each of the window are twentieth century external flood lights, and were contemporary with the structure's secondary use as a public house. There are a further two spot lights below the most eastern second floor window.

Plate 7: The sash windows on the south elevation of the second floor
