Nos. 1-7 Longwall Street, Oxford

Historic Building Investigation and Recording

February 2022

Client: Magdalen College, Oxford

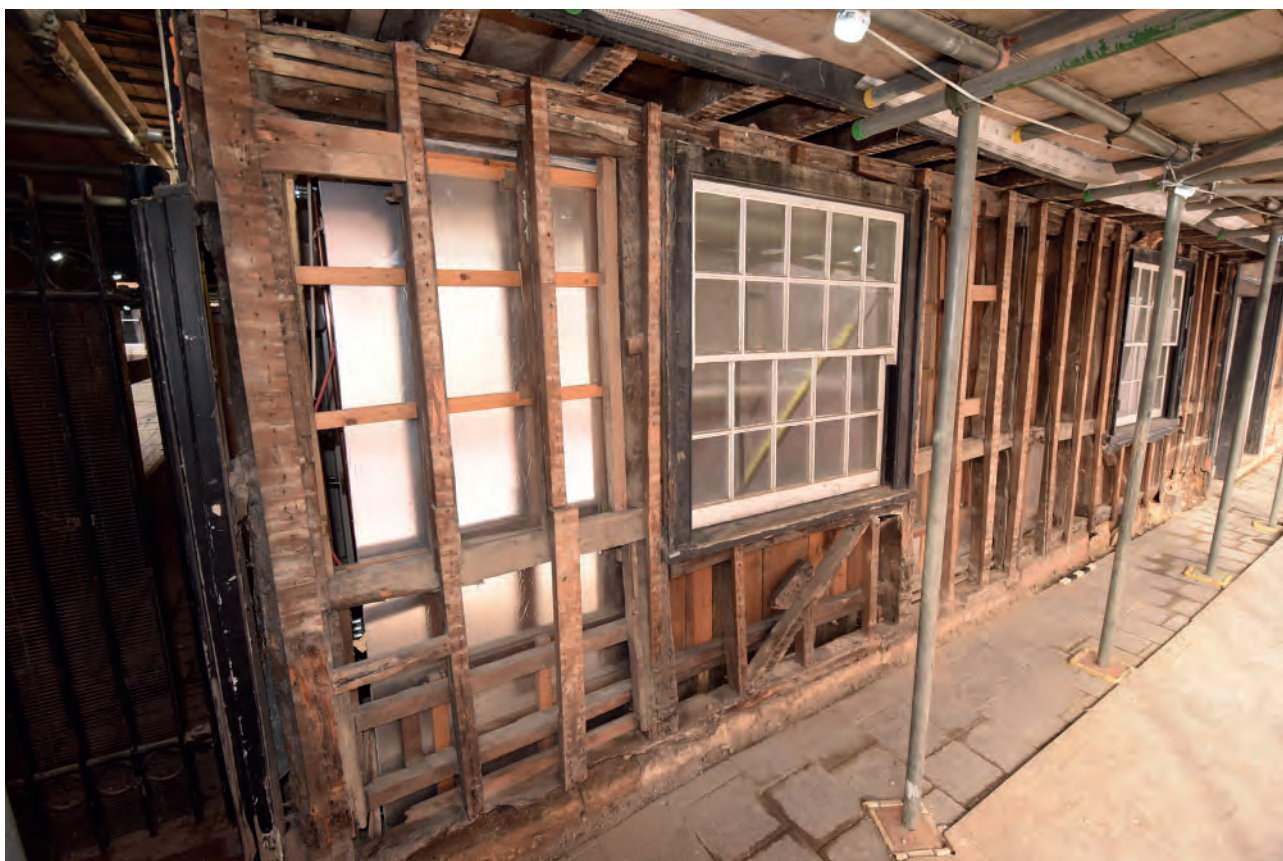
- 3.2.6 The ground floor was refaced in the late 18th or early 19th century by nailing new studs directly onto the primary face, preserving fragments of the original laths between (pls. 12 and 13). The sill beam rests on a degraded stone plinth (pl. 14) which has been partially replaced with 19th century brickwork (pl. 15). This foundation was replaced during the works and an opening beneath the north window was partially excavated. This was likely a coal chute and is blocked with 20th century bricks and cement mortar (pl. 16).

Plate 12: The refaced ground floor of Nos. 1-2

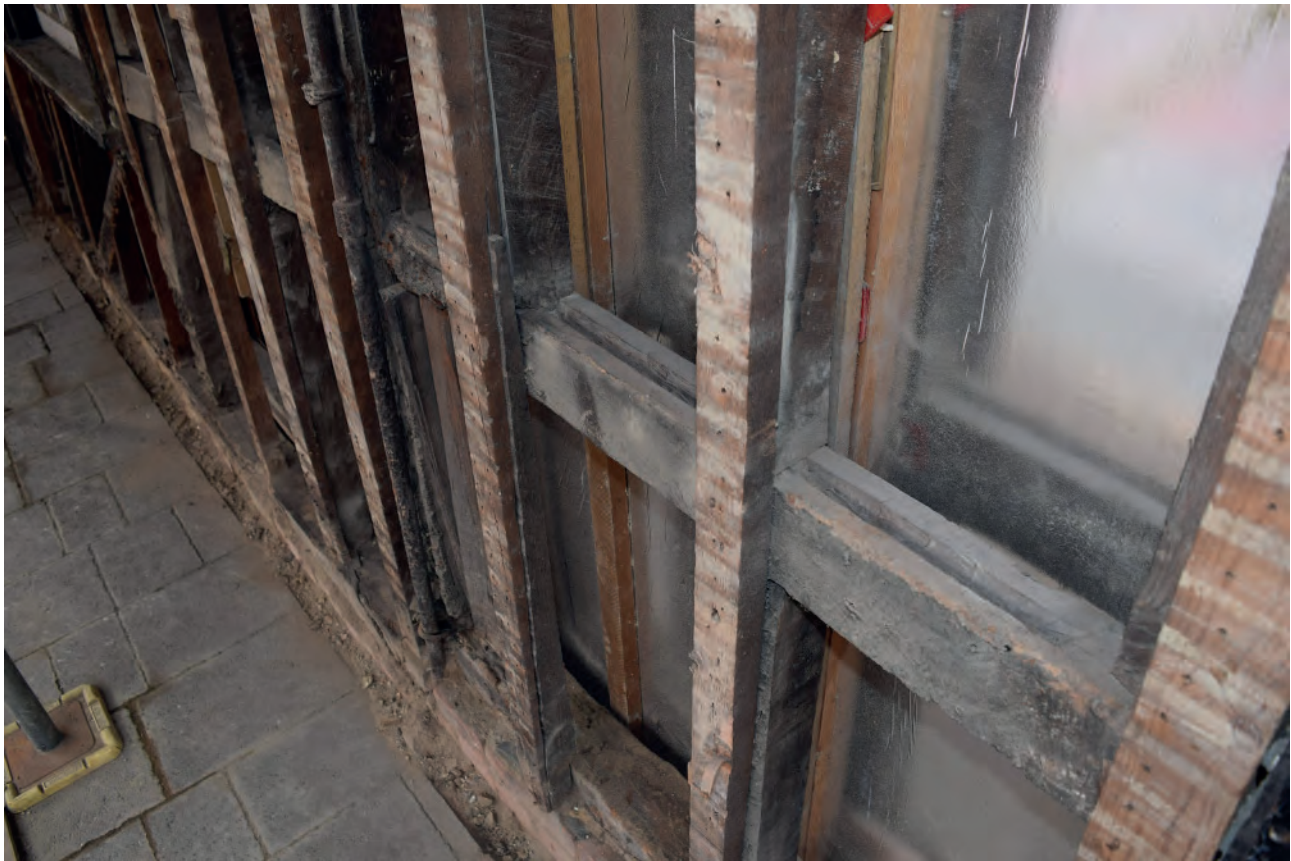
Plate 13: Refacing on the ground floor of Nos. 1-2

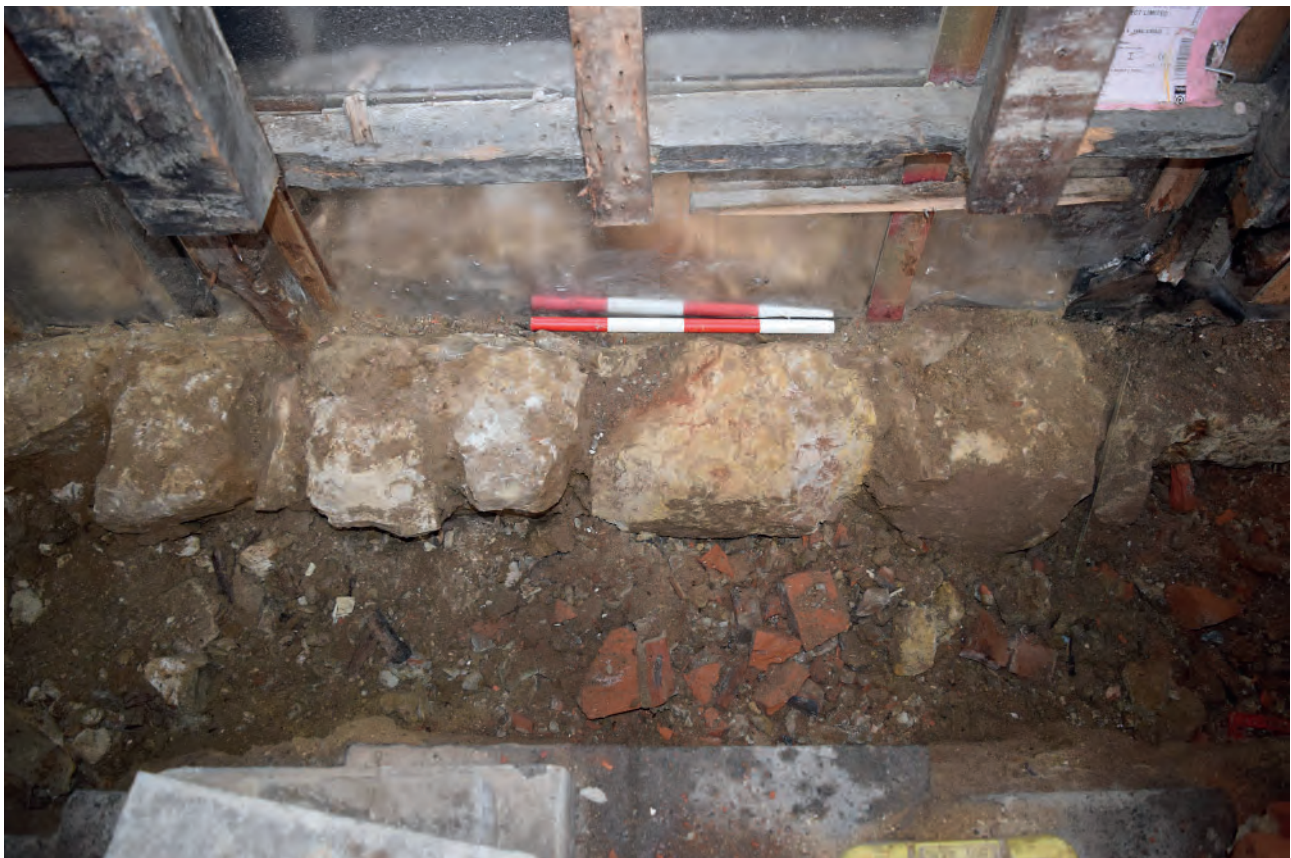
Plate 14: Stone plinth of Nos. 1-2

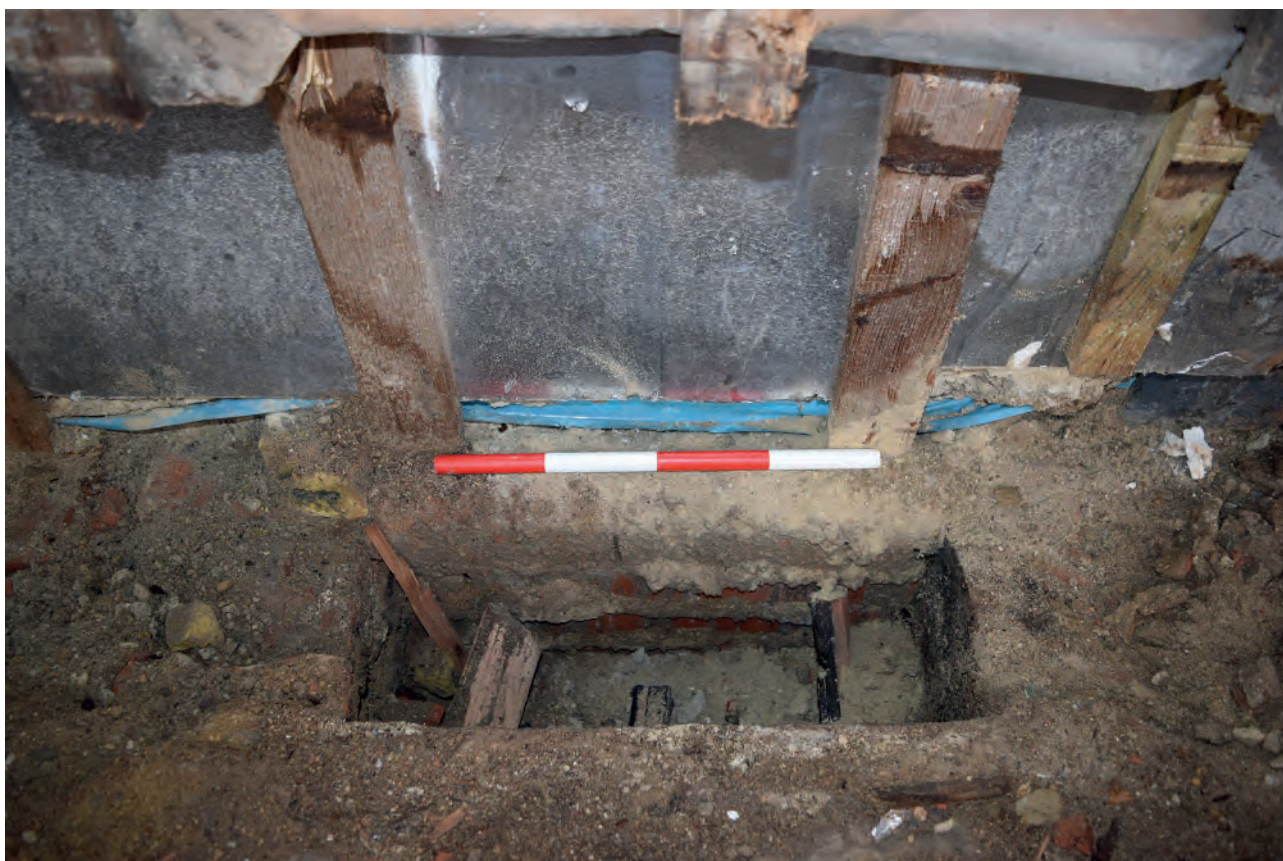
Plate 16: Blocked probable coal chute of Nos. 1-2

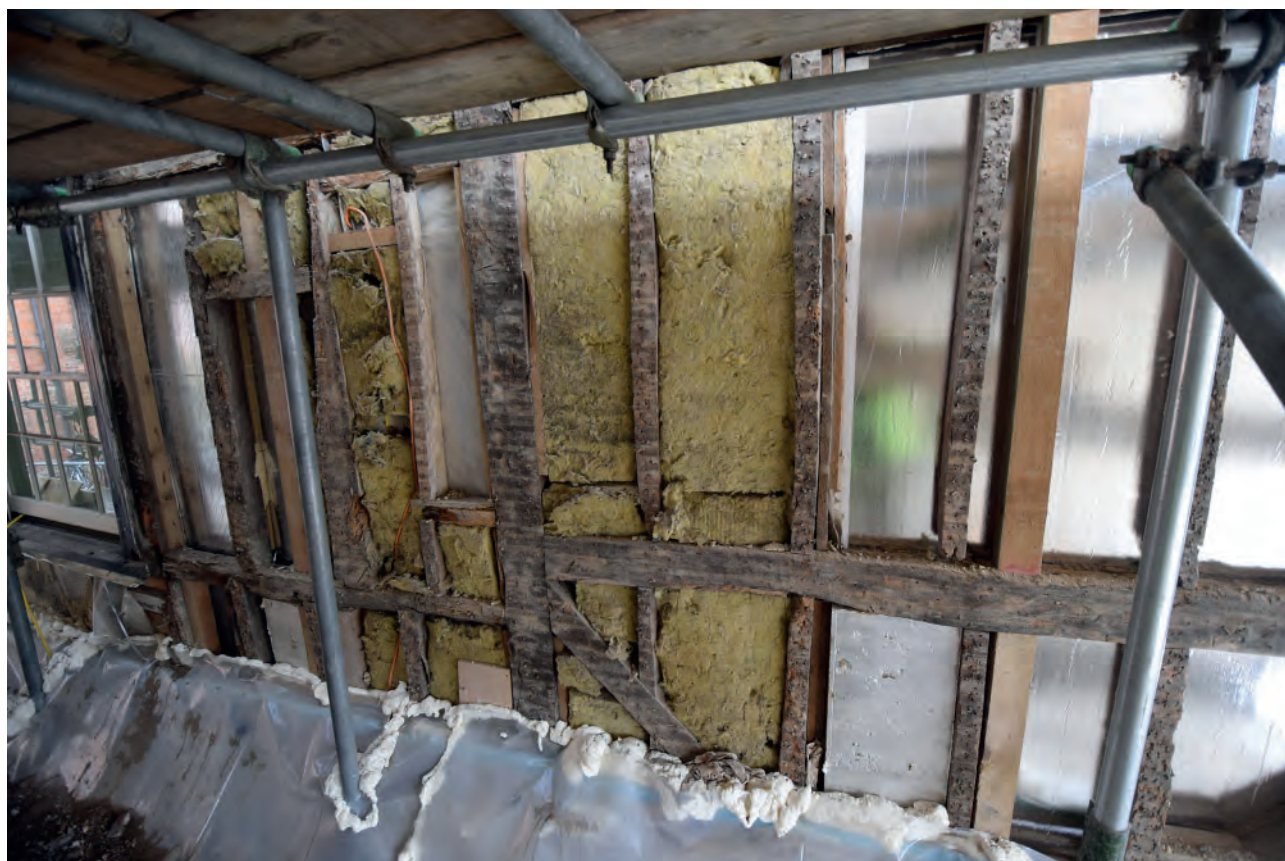
- 3.2.9 There is a visible distinction on either side of the central post, which looks like a former corner post, suggesting the western half could have been a secondary extension and the original building only 3.65m deep (pl. 22). However, the entrance below is primary, meaning an extension here is impossible, and the impression is likely due to the western half being significantly altered. The studs on the west side of the first-floor window are recent replacements, possibly dating to the work undertaken in 2004. Moreover, the west corner of the ground floor has been poorly replaced with brick in a stretcher bond, with slightly different brickwork underneath the window (pl. 23); both look late 19th or early 20th century and use cement mortar. The western corner post is truncated and sits on top of the brickwork. There is a scarf joint to the mid rail above the ground floor window, attaching it to a reused timber with empty mortices and a peg hole on its face (pl. 24). The west end of this timber has a half lap joint connected to the recent timbers on the first floor (pl. 25).

Plate 22: East elevation of Nos. 1-2 at first floor level

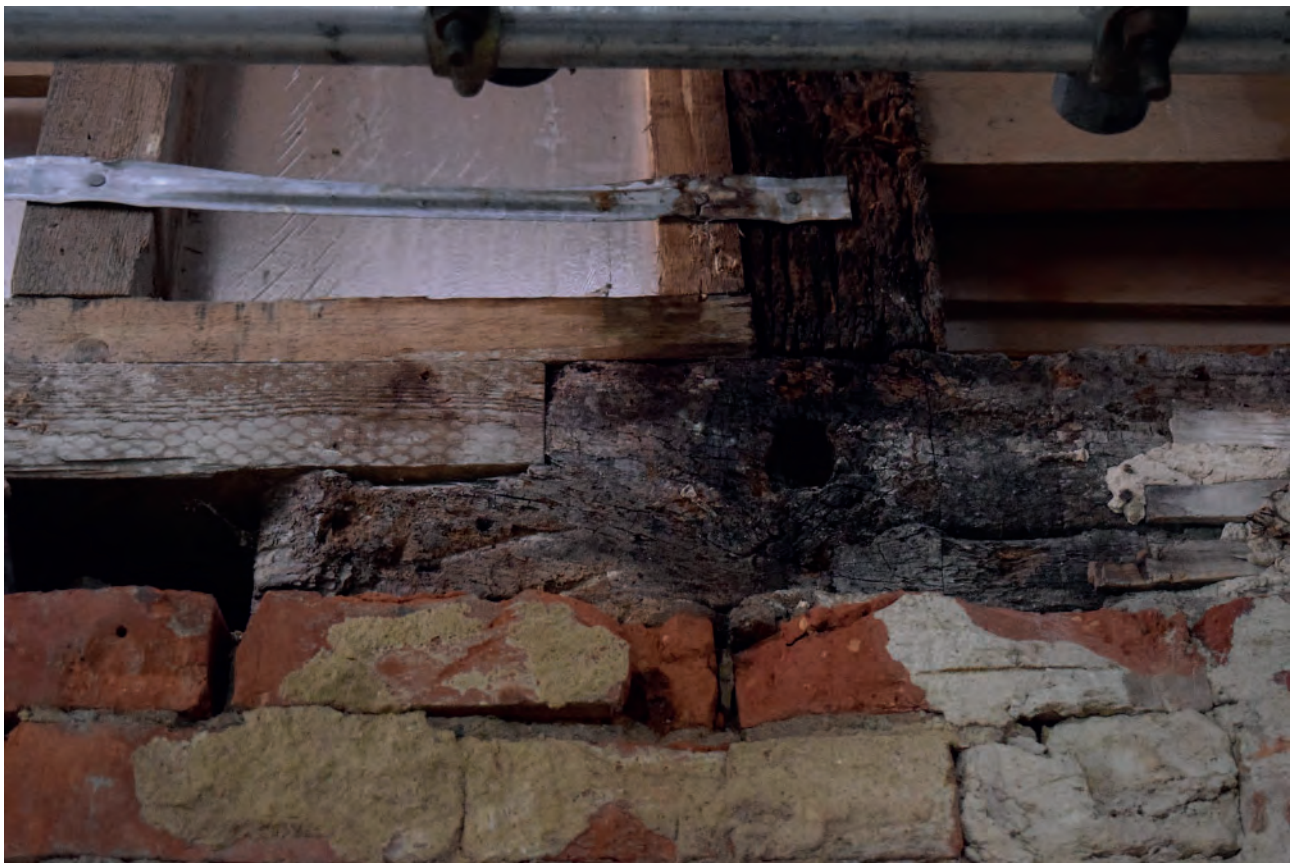
Plate 25: Peg hole and half lap joint above ground floor window of Nos. 1-2

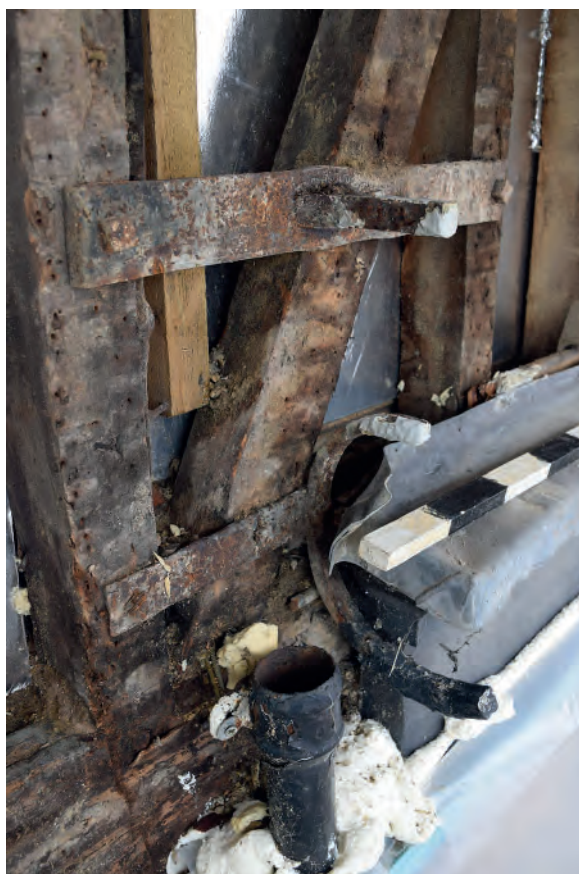
- 3.4.5 All the timbers are notched to help mortar adhere. The corner post does not join the sill beam but sits on the heavily degraded stone plinth. There is a truncated decorative bracket for a gas light between the ground and first floors (pl. 43).

Plate 43: Truncated gas lamp bracket between the ground and first floors of No. 4

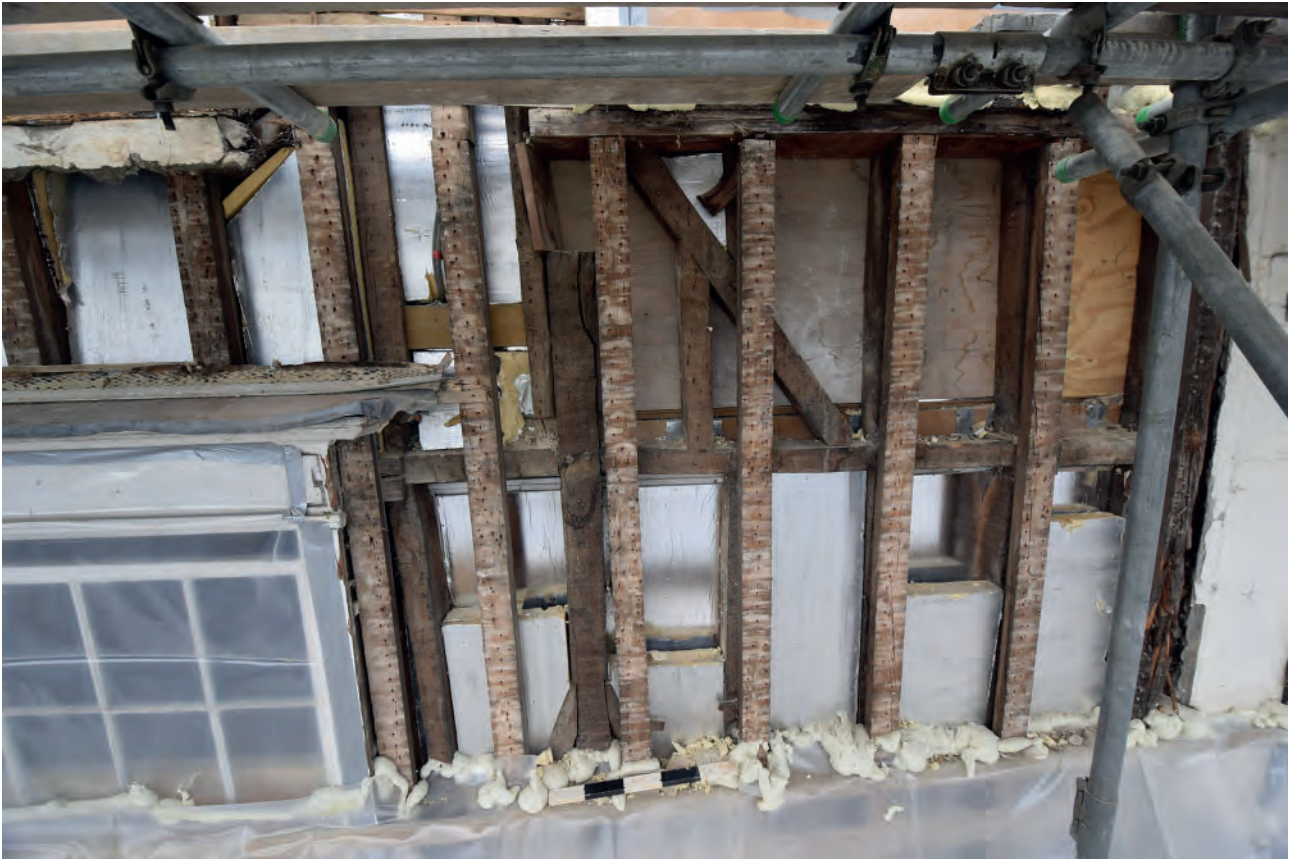
- 3.4.7 The first and second floors have been refaced by nailing tall studs onto the primary frame (pls. 45 and 46). In places, this has preserved small fragments of the primary laths and plaster behind (pl. 47). The removal of the channelled render on the ground floor revealed red brickwork behind in a Flemish bond with lime mortar (pl. 48). This is stepped forward to match the framing above and is assumed to encase the earlier lighter brickwork behind as noted above in No. 4. The remains of the northern corner post and original passage lintel were visible, as were timbers in the doorway (pls. 49 to 51). A row of header bricks shows where a coal chute or cellar light would have been before being blocked with stone (pl. 52).

Plate 45: Refacing on the first floor of Nos. 5-6

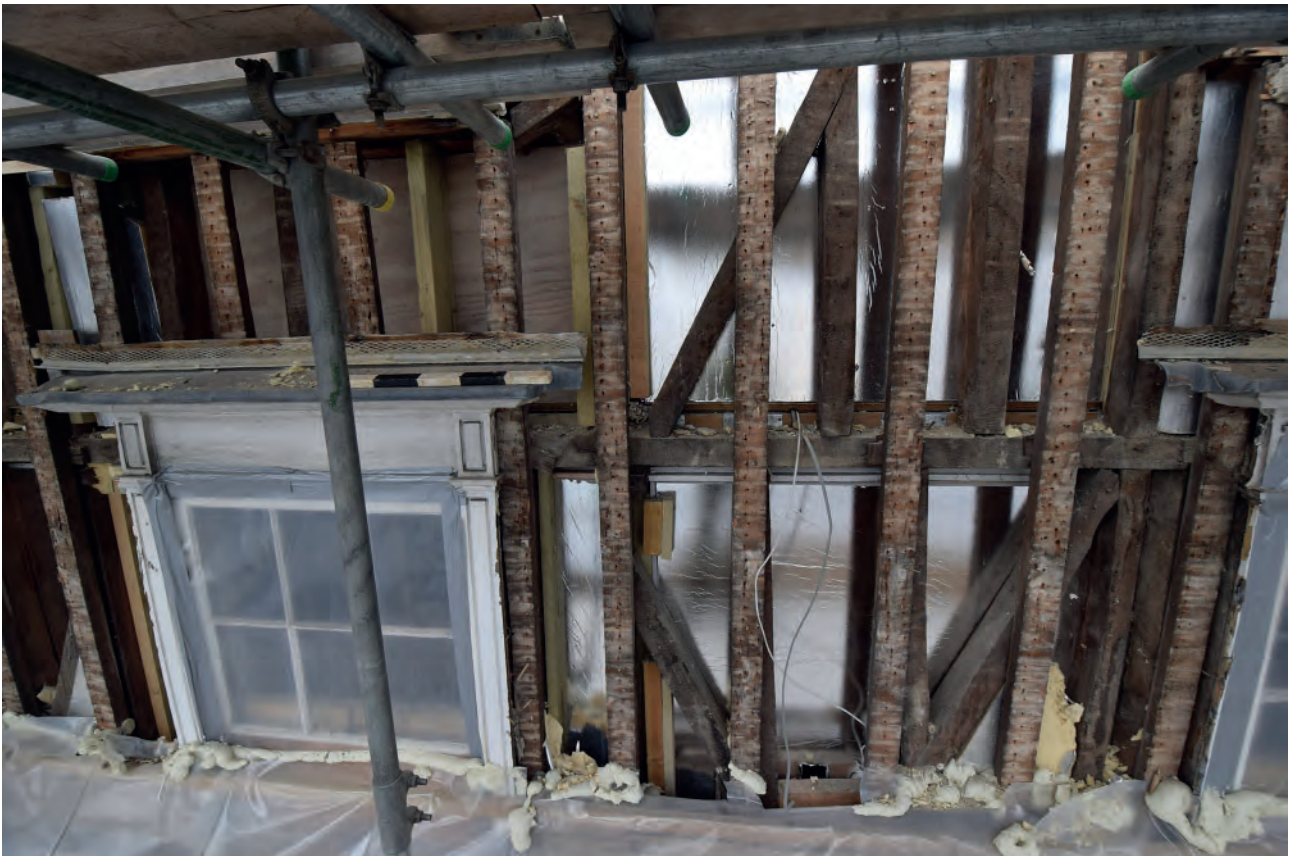
Plate 46: Refacing on the second floor of Nos. 5-6

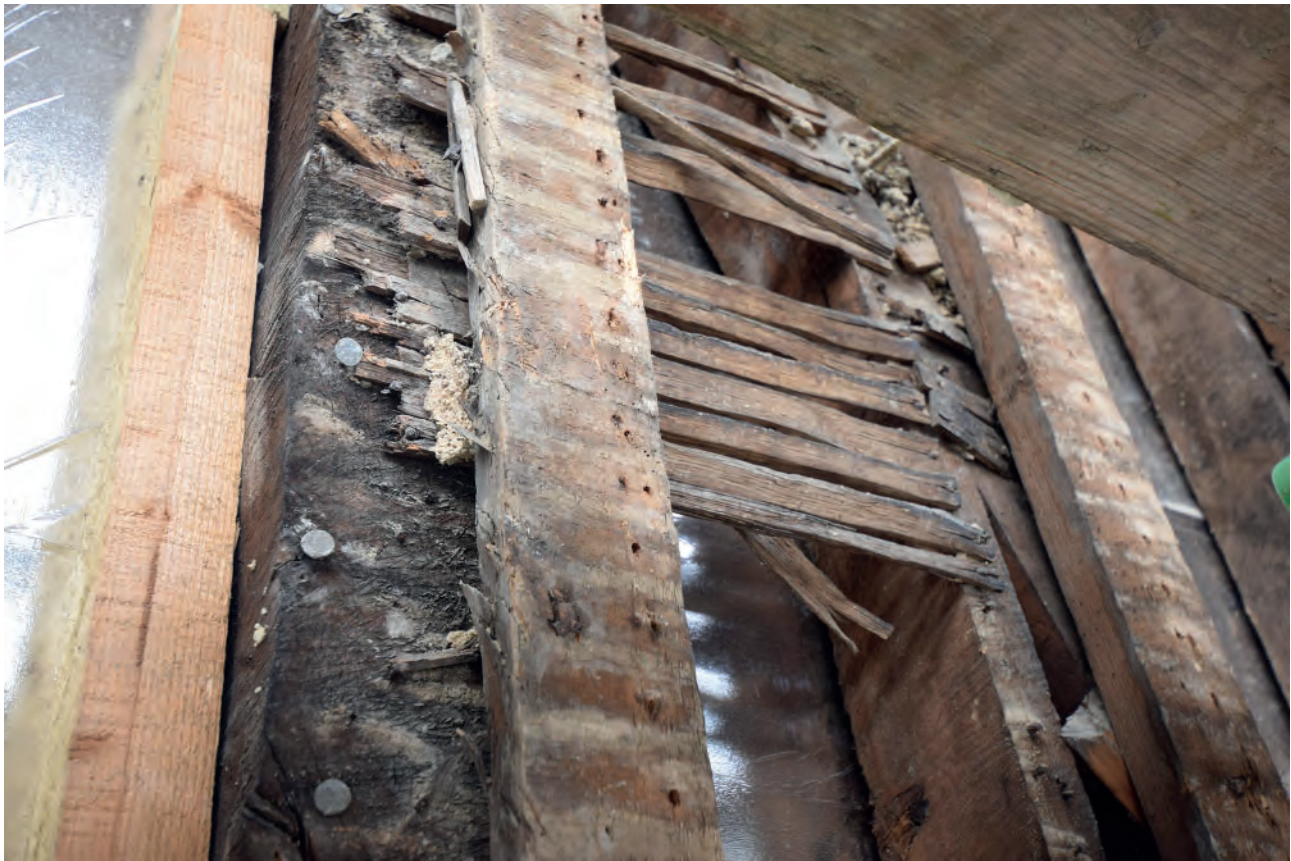
Plate 47: Laths preserved behind the reface of Nos. 5-6

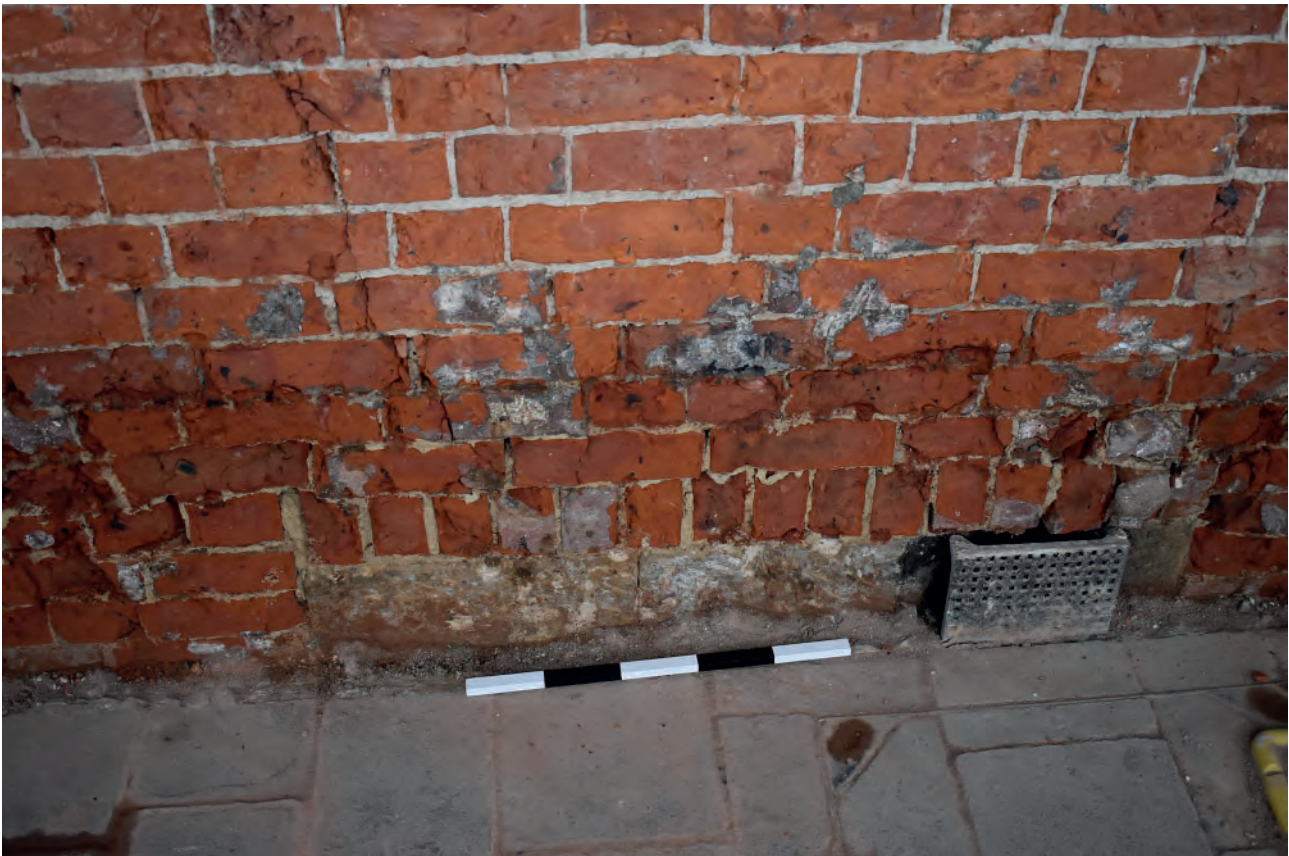
Plate 52: Block coal chute or cellar light on the northern side of Nos. 5-6

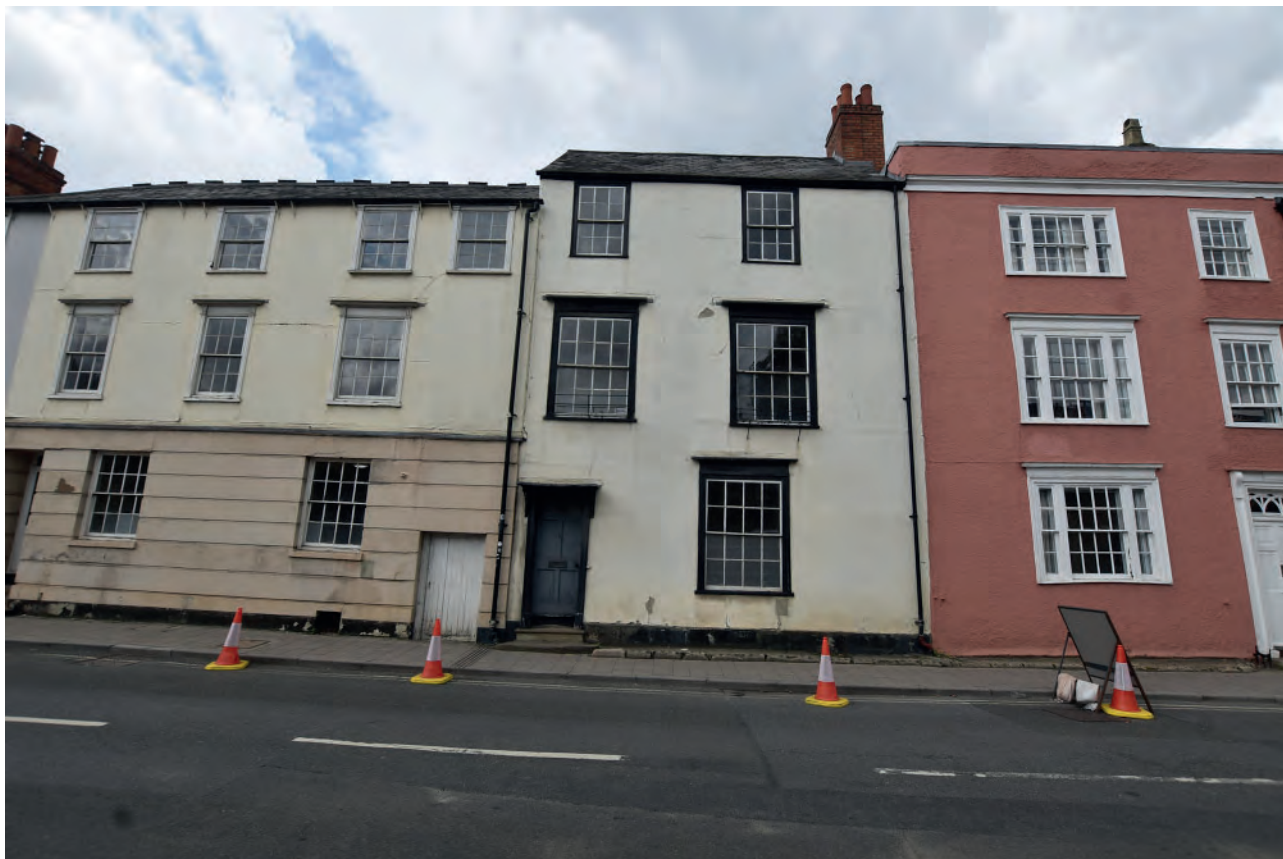
- 3.5.1 No. 7 Longwall Street (pl. 53) is a three-storey house with a pitched, slate-covered roof and it probably dates from the mid to late 18th century. The entire east elevation was timber framed with brick panels which appeared to be contemporary. Unfortunately, the condition of the softwood members had deteriorated to such an extent that much of it crumbled away when the render was removed. In places no more than a faint imprint survived from former framing (pl. 54).

- 3.5.2 The condition of the framing was so poor because it had been externally clad in cement render with the inner side sealed with a cinderblock skin. This trapped any moisture and prevented the frame from breathing.

Plate 53: East elevation of No. 7 Longwall Street before work commencing

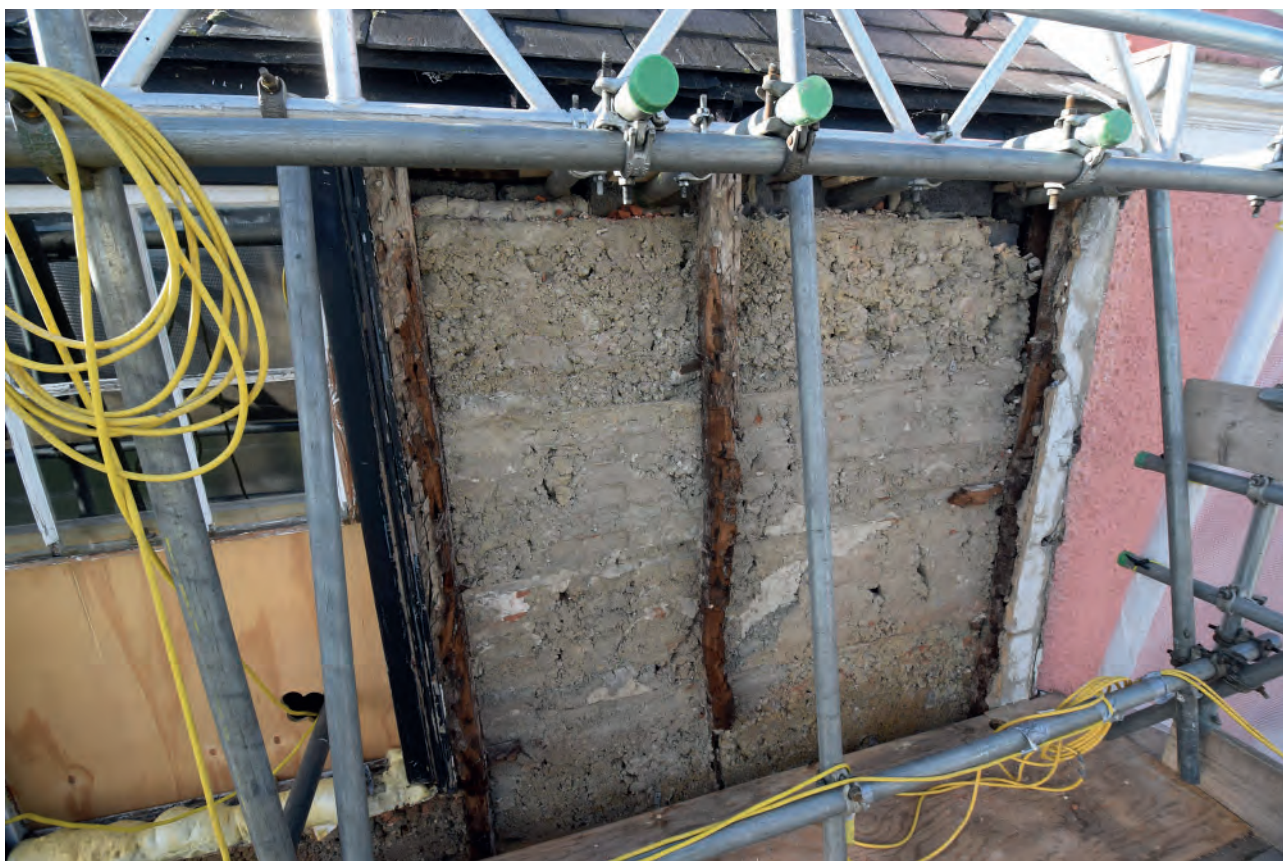
Plate 54: Imprints of lost rails of No. 7 on concrete

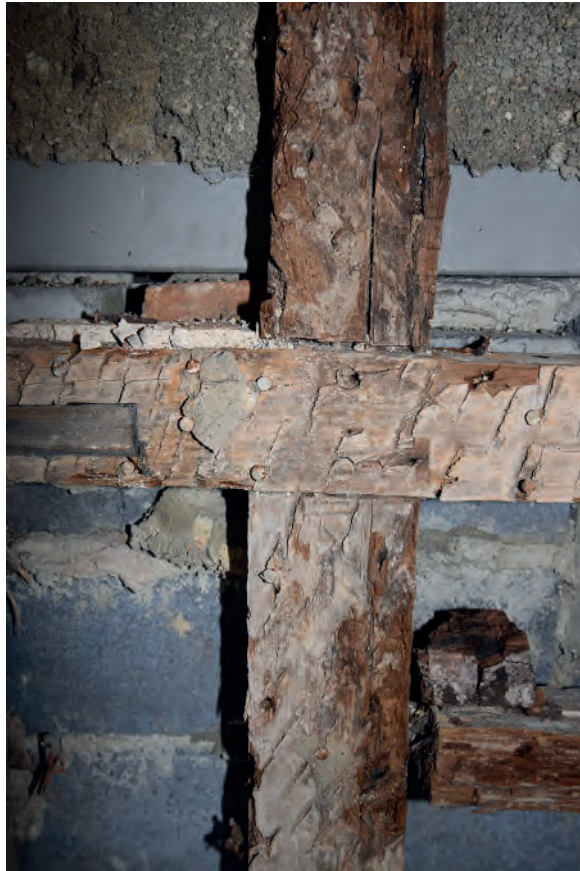
Plate 57: Scouring and nails on the framing of No. 7
