The South Terrace, Cliveden

Archaeological Investigations 2013-17

May 2018

Client Name: The National Trust
Client Ref No.: n/a
Document Title: The South Terrace, Cliveden
Document Type: Report on Archaeological Investigations 2013-17

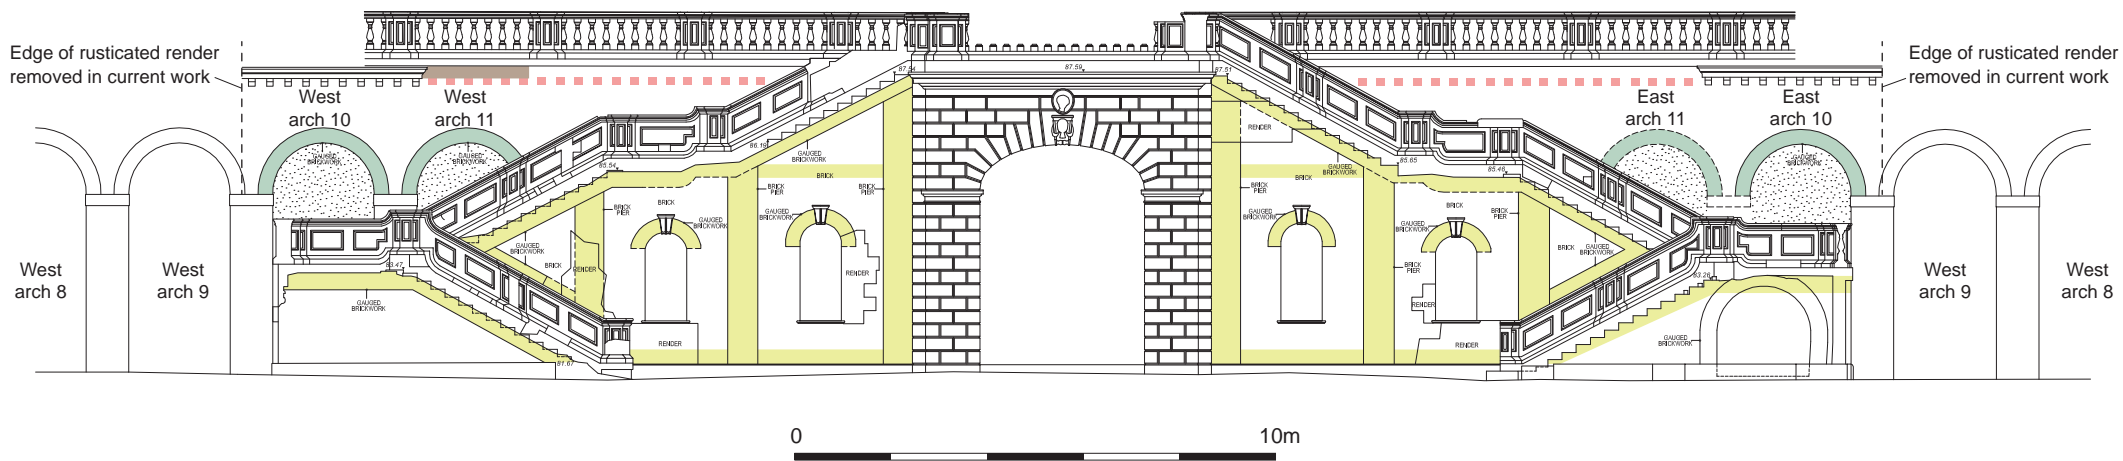
Figure A.3: Features exposed by removal of render from stairs and rustication from wall behind

- Fine joined facing brick revealed by removal of render from staircase
- Evidence of former brick brackets revealed by removal of rusticated render
- Blind arches revealed by removal of rusticated render - keystones and string courses truncated
- 19th century stock brickwork added to arches to hold rusticated render
- Truncated section of stone exposed. Possibly former cornice

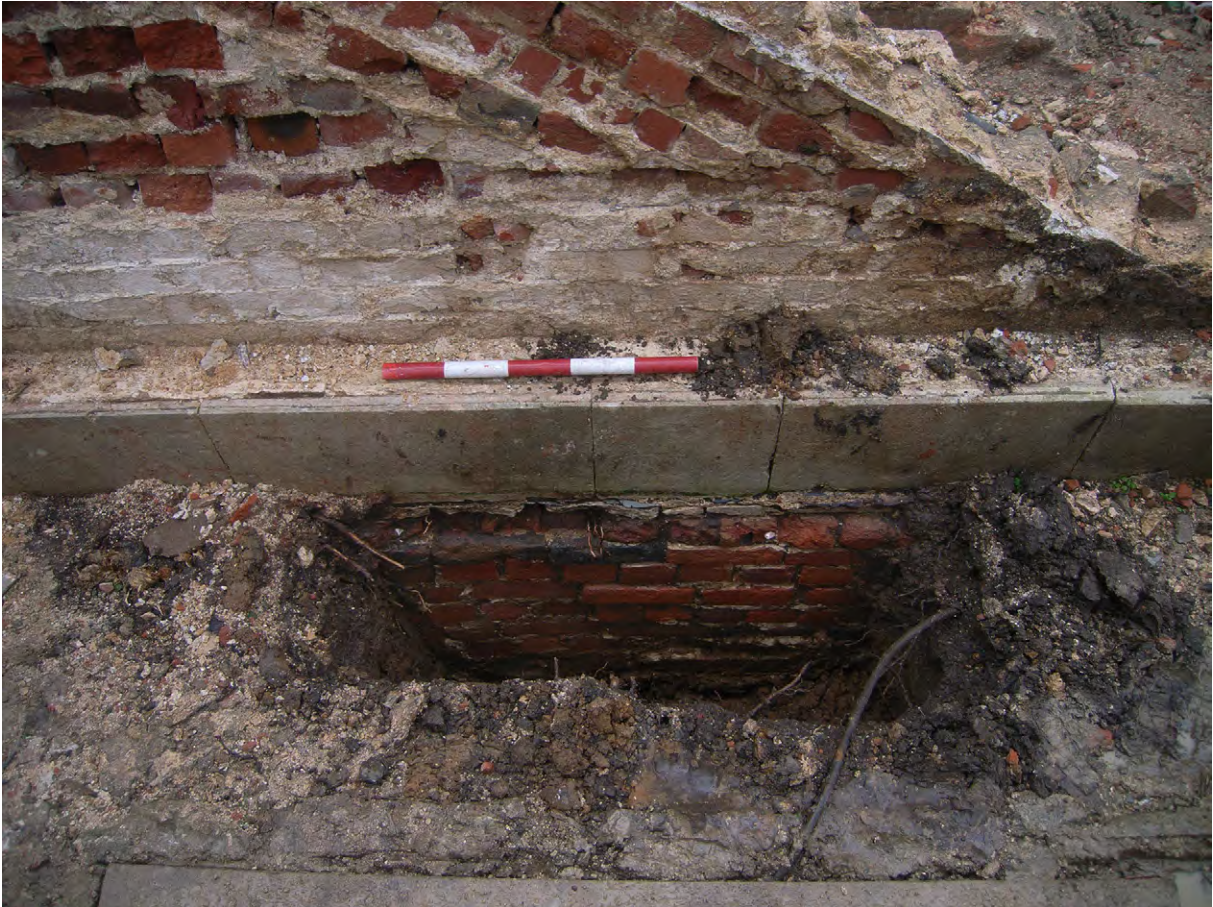
Plate A.29: Older foundations [A.4.3] beneath west flight of steps

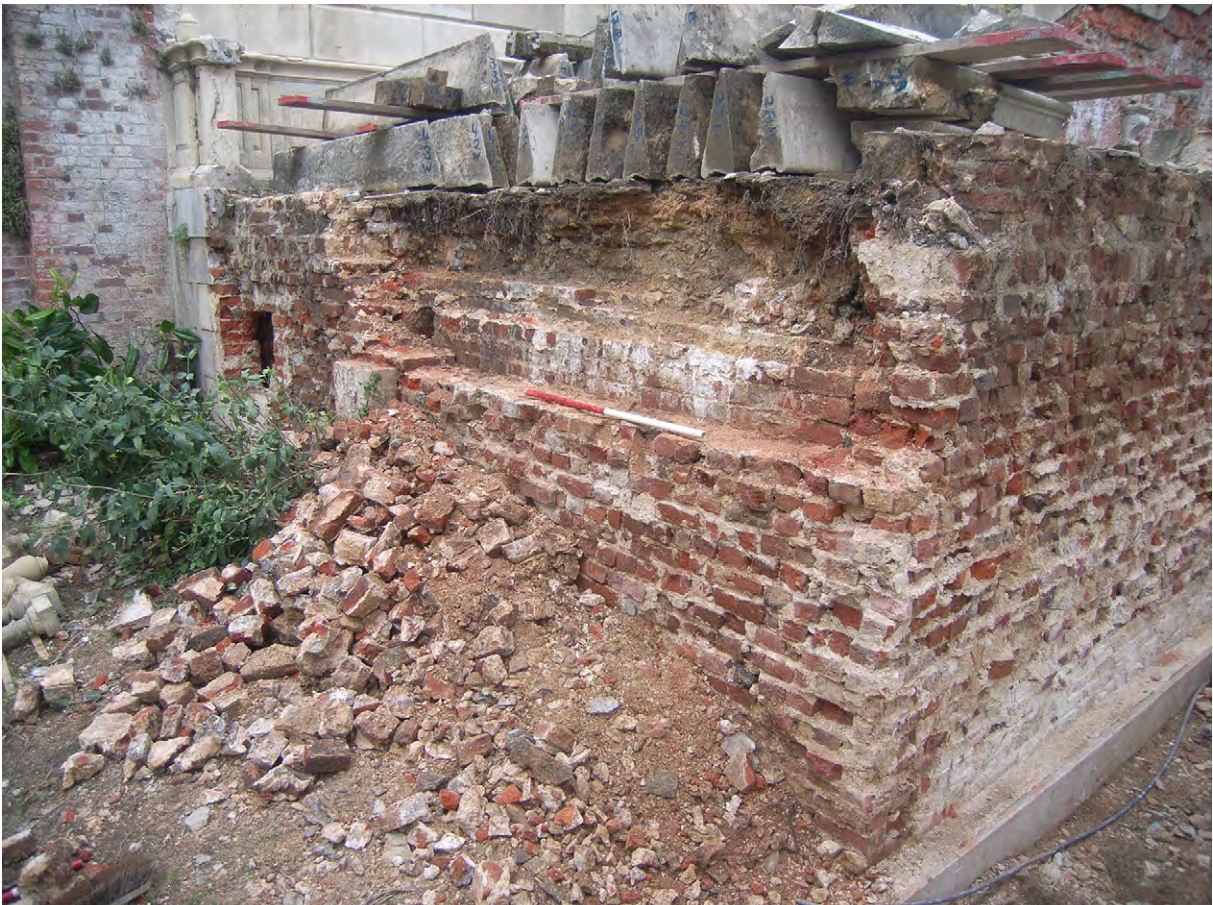
Plate A.30: West lower flight during dismantling [A.4.1 and A.4.2]

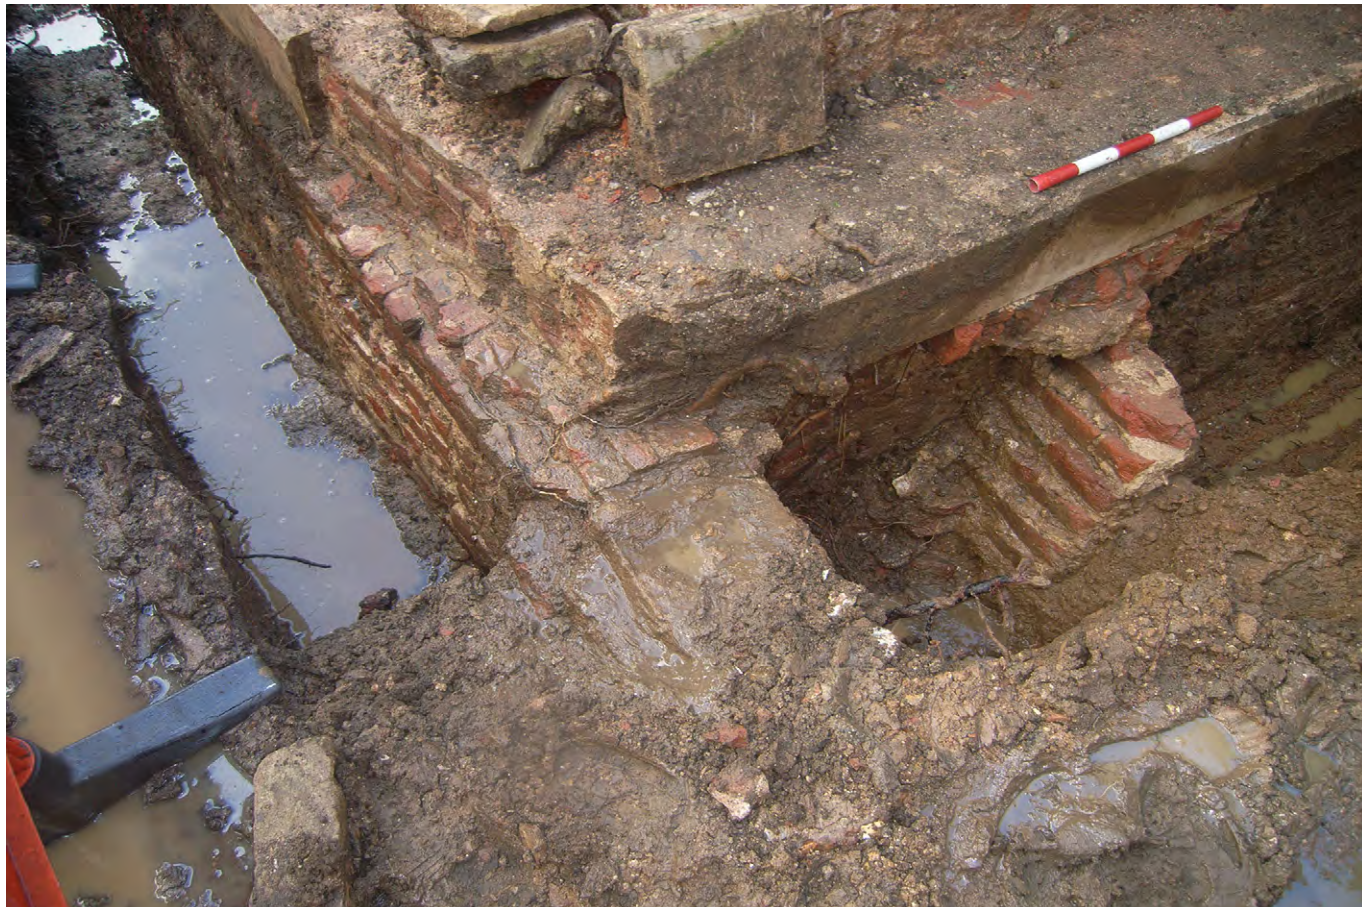
Plate A.54: Foundations beneath east side of stairs [A.3.3-A.3.5]

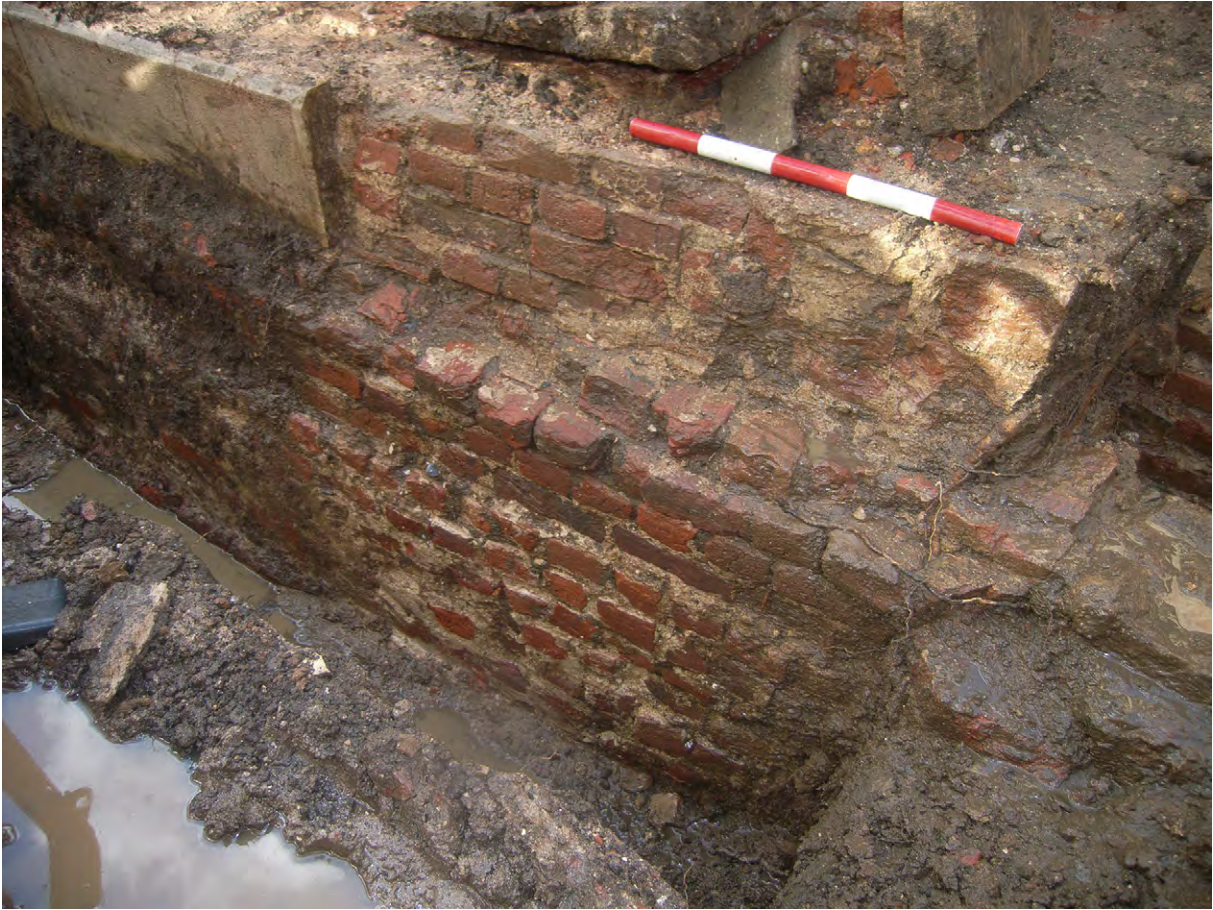
Plate A.55: Main foundation beneath east side of stairs [A.3.3]

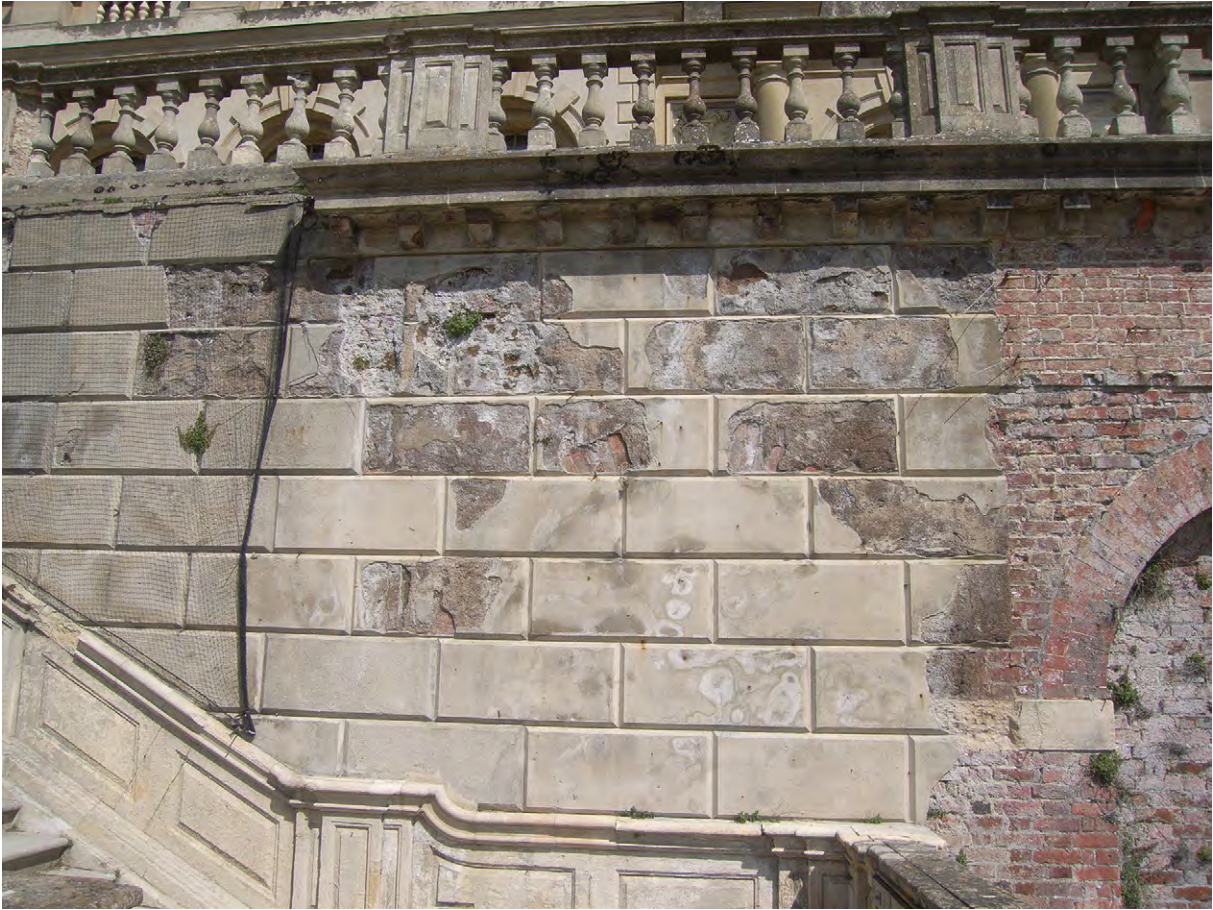
Plate B.7: Rustication behind east side of stairs

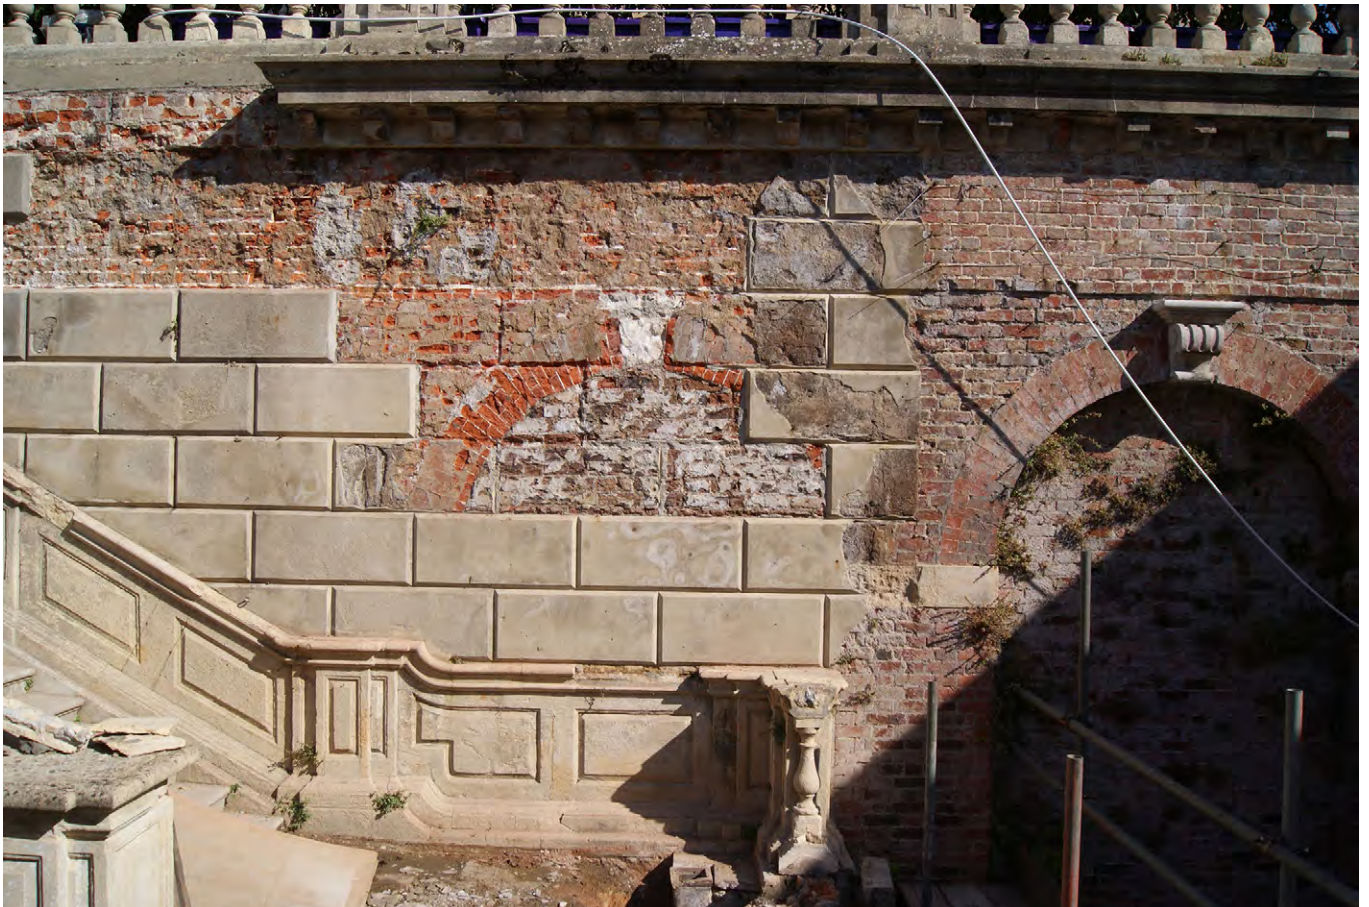
Plate B.10: Arch exposed behind rustication on east side

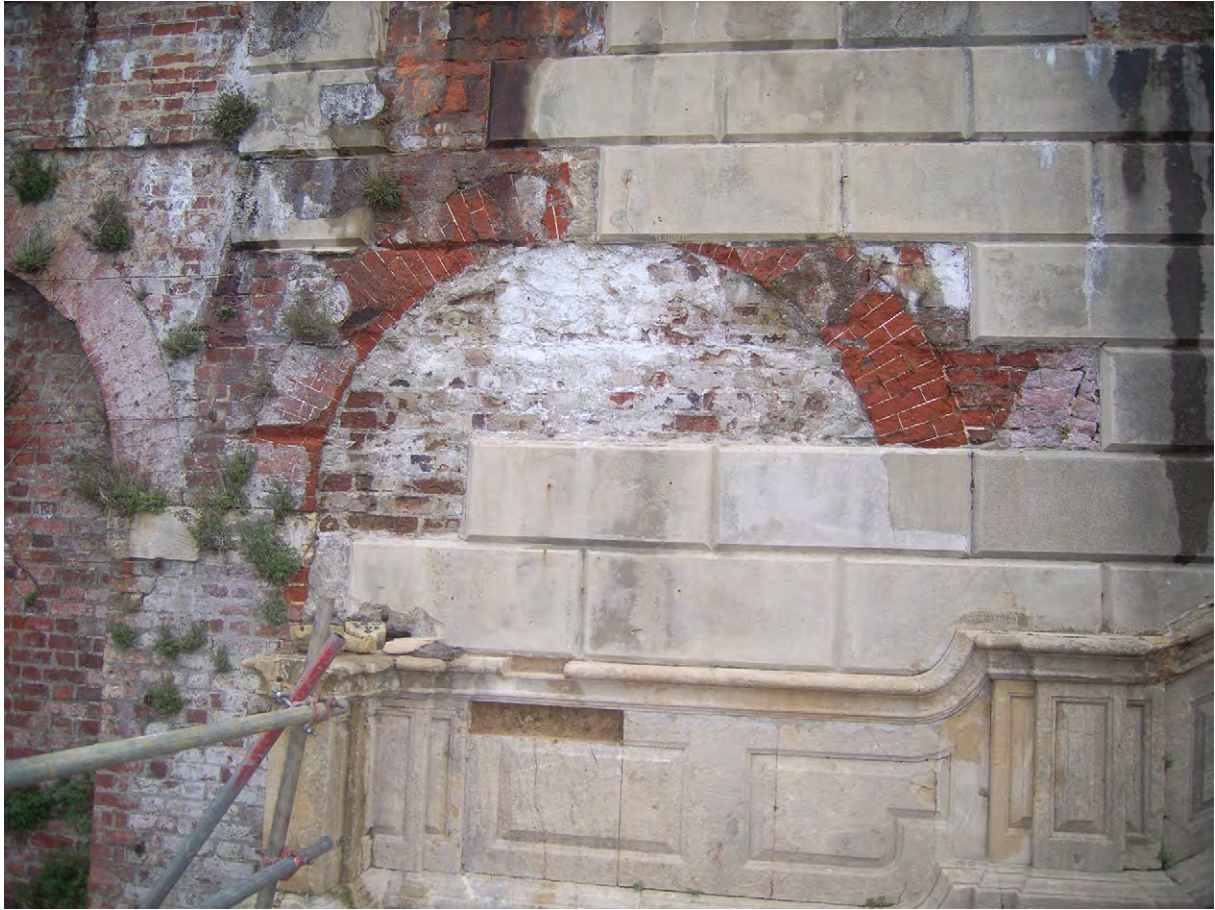
Plate B.11: Arch exposed behind rustication on west side

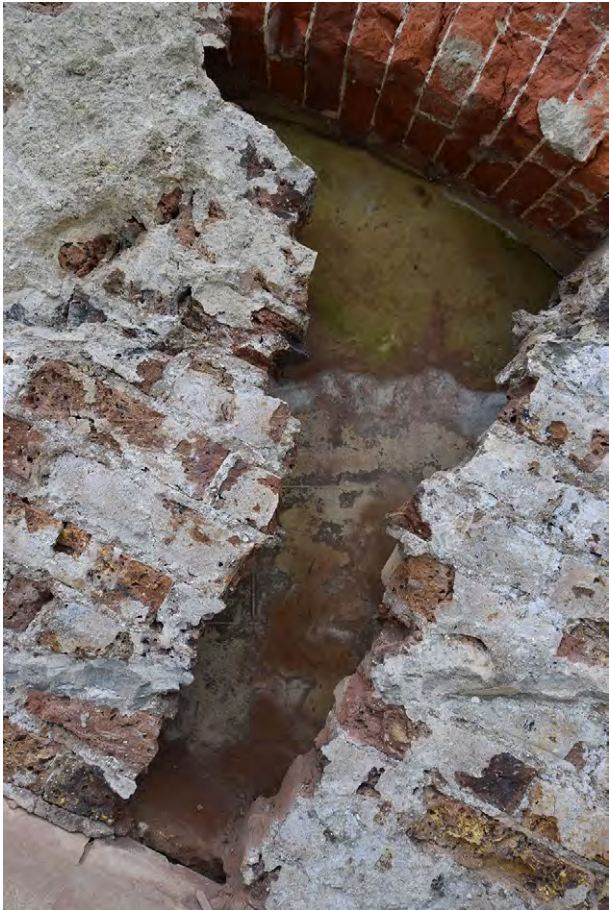
Plate B.16: Patch of removed brick in arch

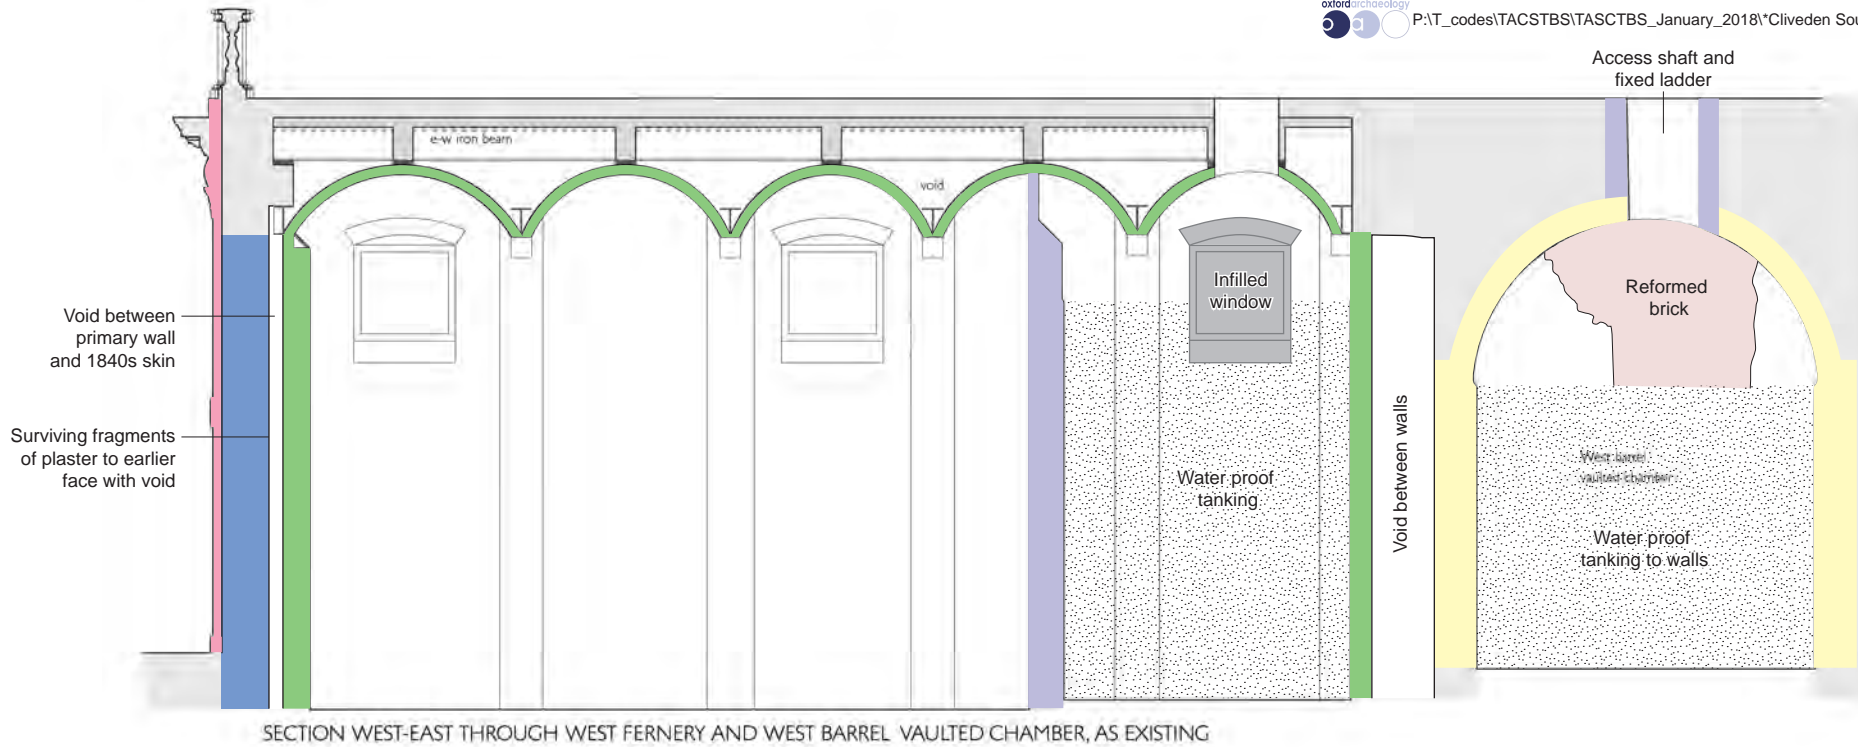
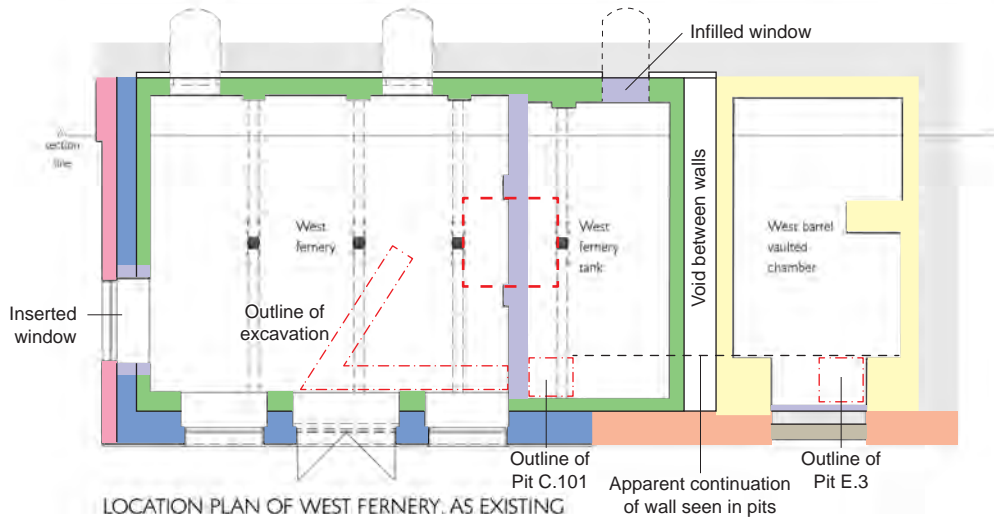
Figure C.1 Plan and section through West Fernery and tanks

- Late 17th century/early 18th century
 - 18th century
 - c.1760s-70s blind arches
 - c.1840 conversion to orangeries
 - 1895
 - 19th century render (1860s)
 - 19th century infill to arch
 - Approximate outline of former lantern rooflight
- 0 5m

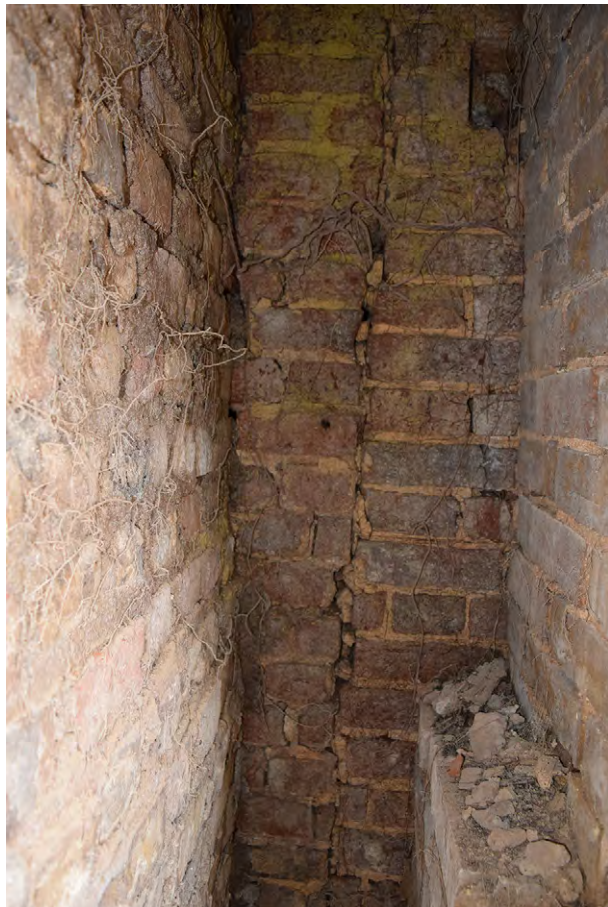
Plate E.2: Structural cracks in void between blind arcade skin and West Barrel Vaulted Chamber, looking west

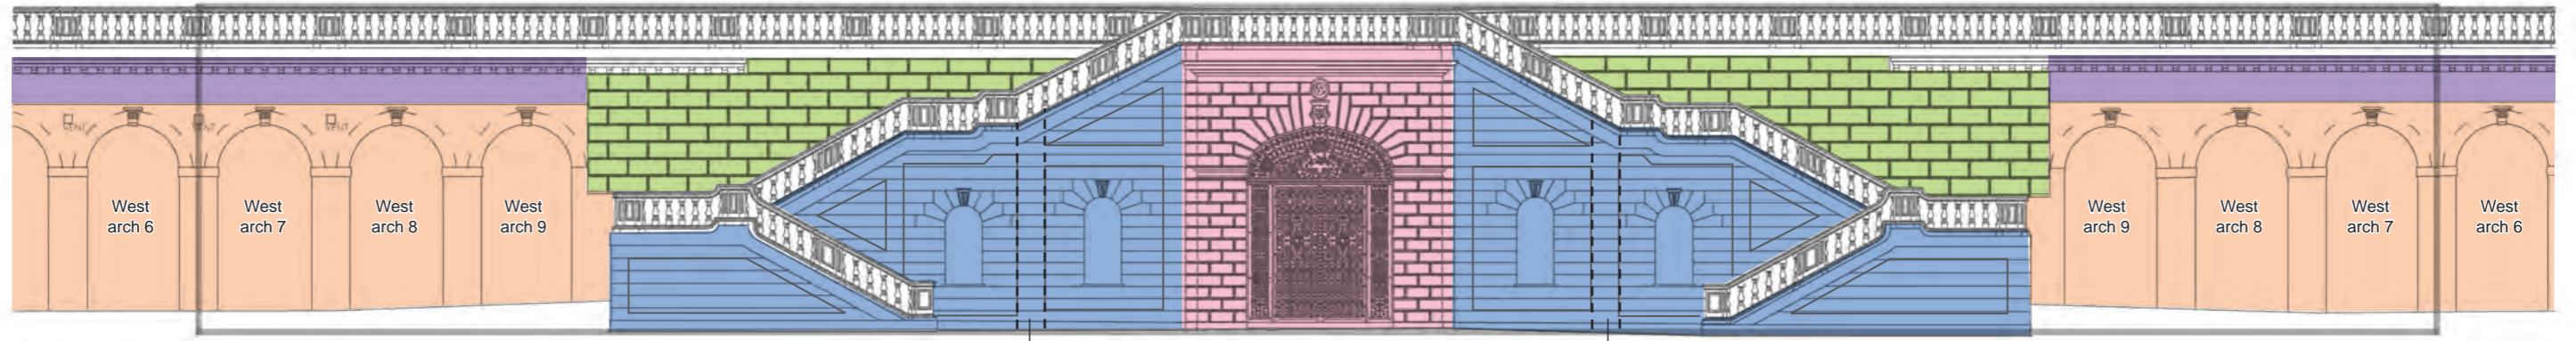
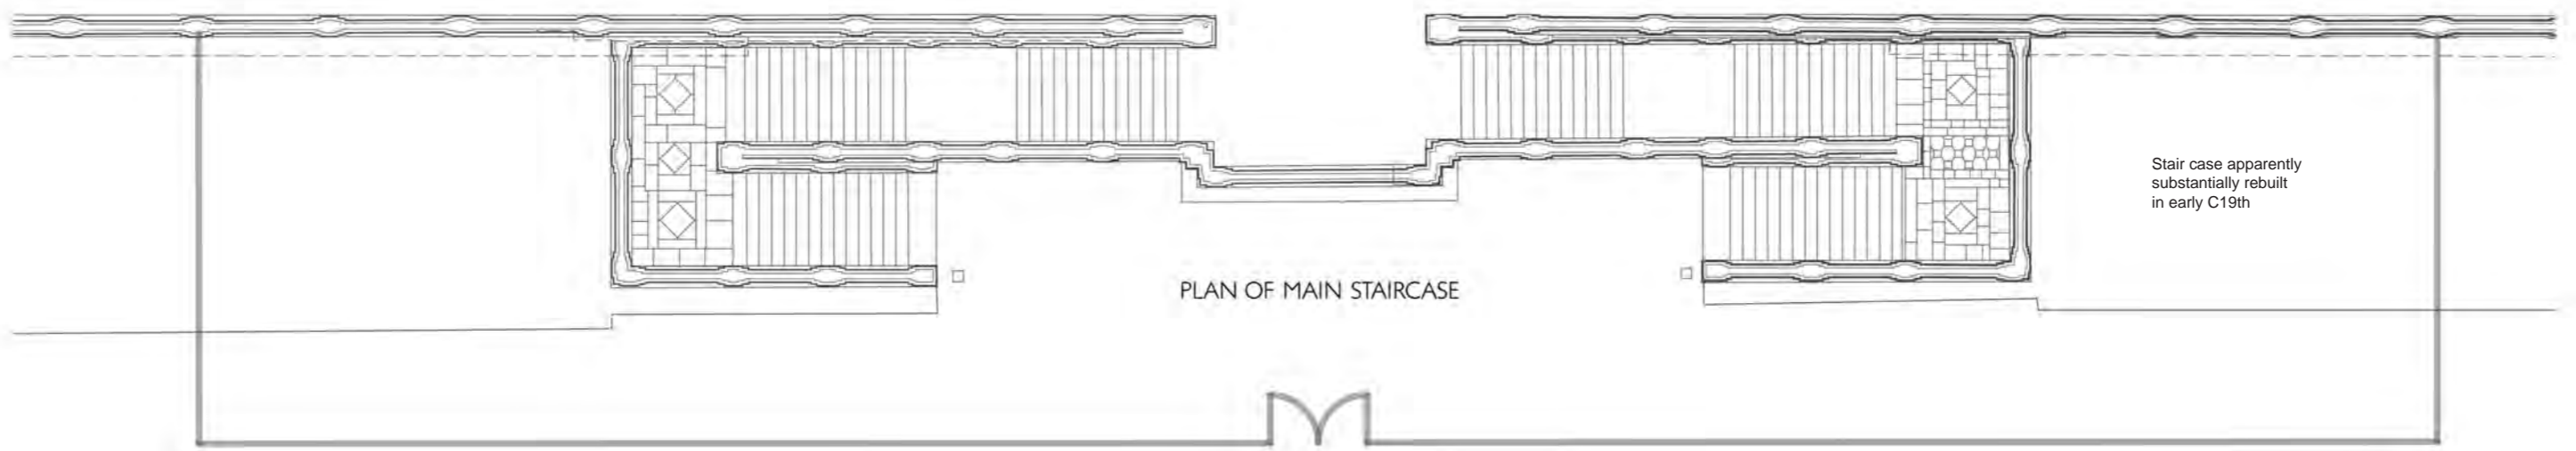
Outline of former pilasters SOUTH ELEVATION OF MAIN STAIRCASE Outline of former pilasters

- c.1760s-70s - Blind-arch front added to terrace
- c.1850 - Portico added by Barry
- Mid 19th century rustication
- Render of various phases (later C19th and 20th)
- Probably C19th brickwork. Rebuild or raising the height of the terrace

Stair case apparently substantially rebuilt in early C19th
