# Temple Room, Dining Room and West Corridor Stowe House, Buckinghamshire.

## Historic Building Recording

September 2022

**Client: Stowe House Preservation Trust**

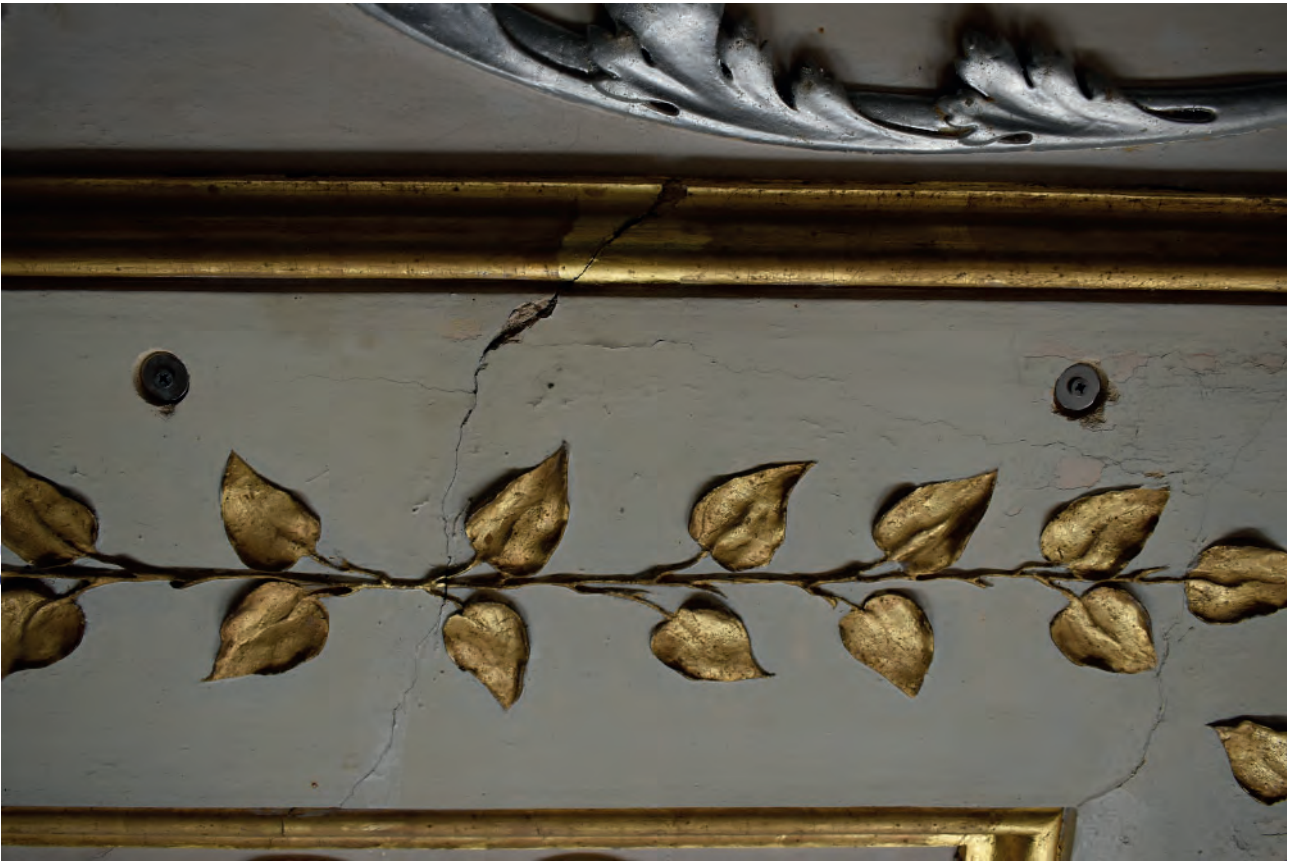
- 3.3.4 Cracks and flaking of finishes were observed generally due to movement of the building, humidity and water ingress from the bathrooms above (Plates 13 & 14). General cleaning of surfaces was also required where repairs were not necessary (Plate 15).

Plate 13: Temple Room, ceiling, example of cracking

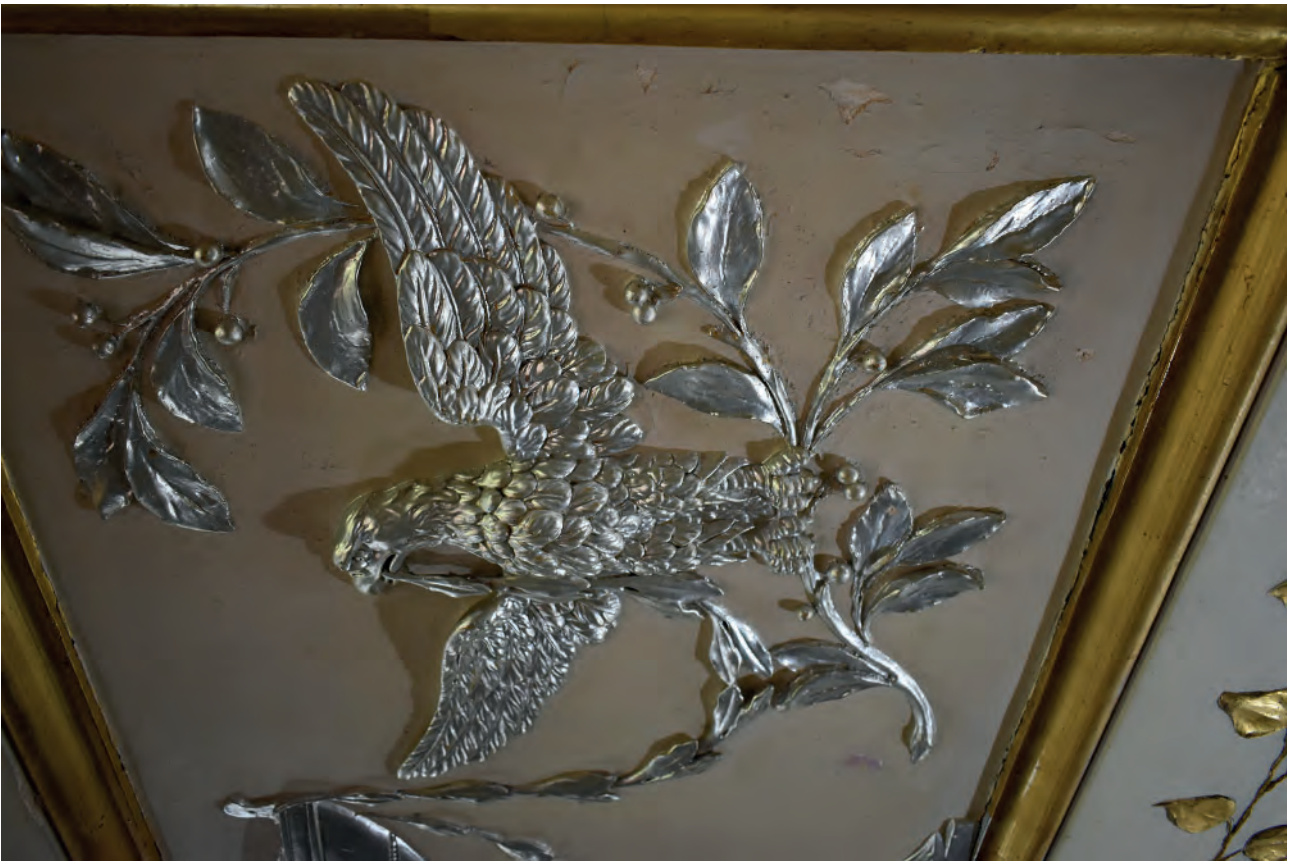
Plate 14: Temple Room, ceiling, example of flaking paint

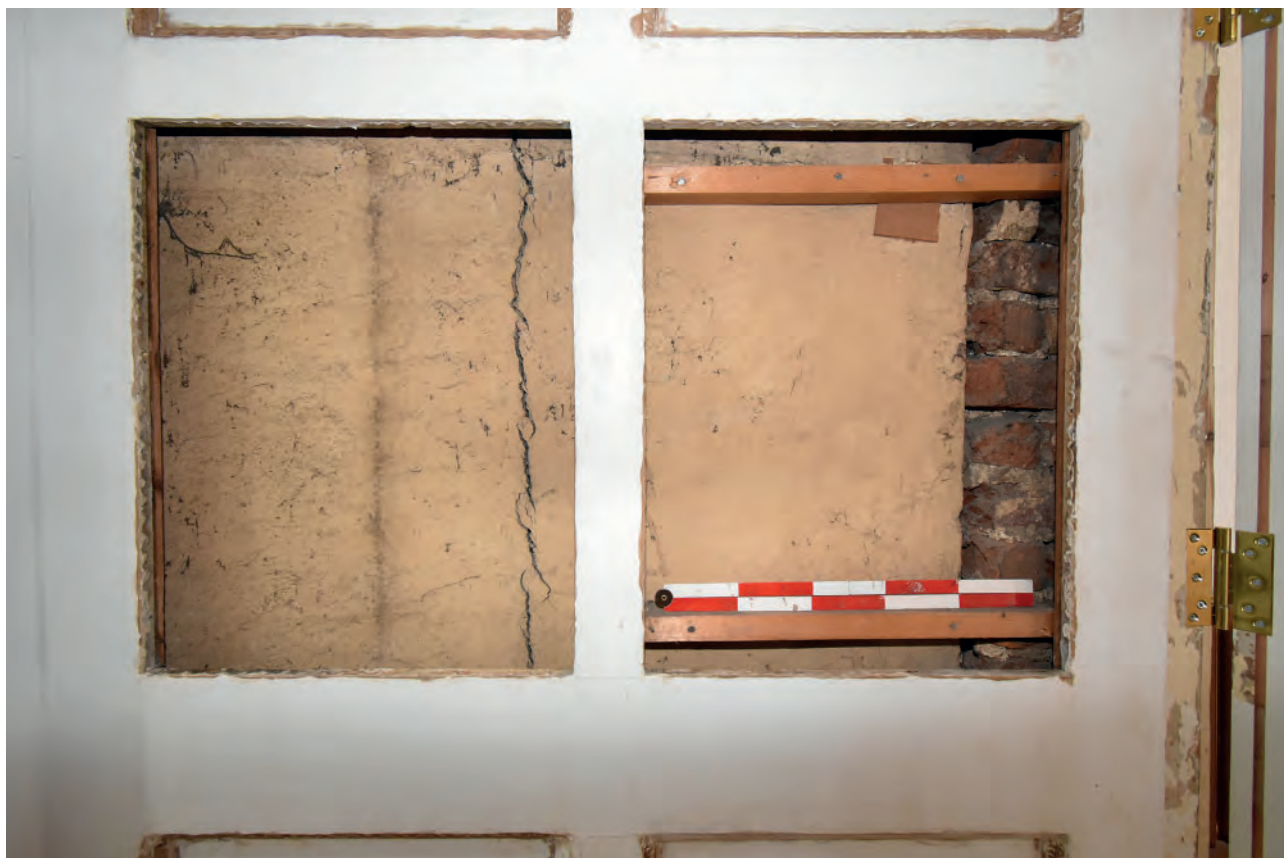
- 3.5.2 The doorway between the Temple Room and the Dining Room required repair comprising the replacement of several modern panels and the recreation of the original moulding. The panelling from the north side of the doorway included two phases of modern panels to the centre and bottom of the panelling, comprising hardboard and plywood, and had lost much of the moulding surrounding those replacements. The replacements had been carried out while the panelling was in situ (Plate 40). The panelling to the south of the doorway retained the original panels, although this had undergone repairs to splits consisting of linen strips glued to the rear of the panels (Plate 41). The walls behind the panelling are shown in plates 30 & 31.

Plate 40: Temple Room, doorway to Dining Room, evidence of panel repair

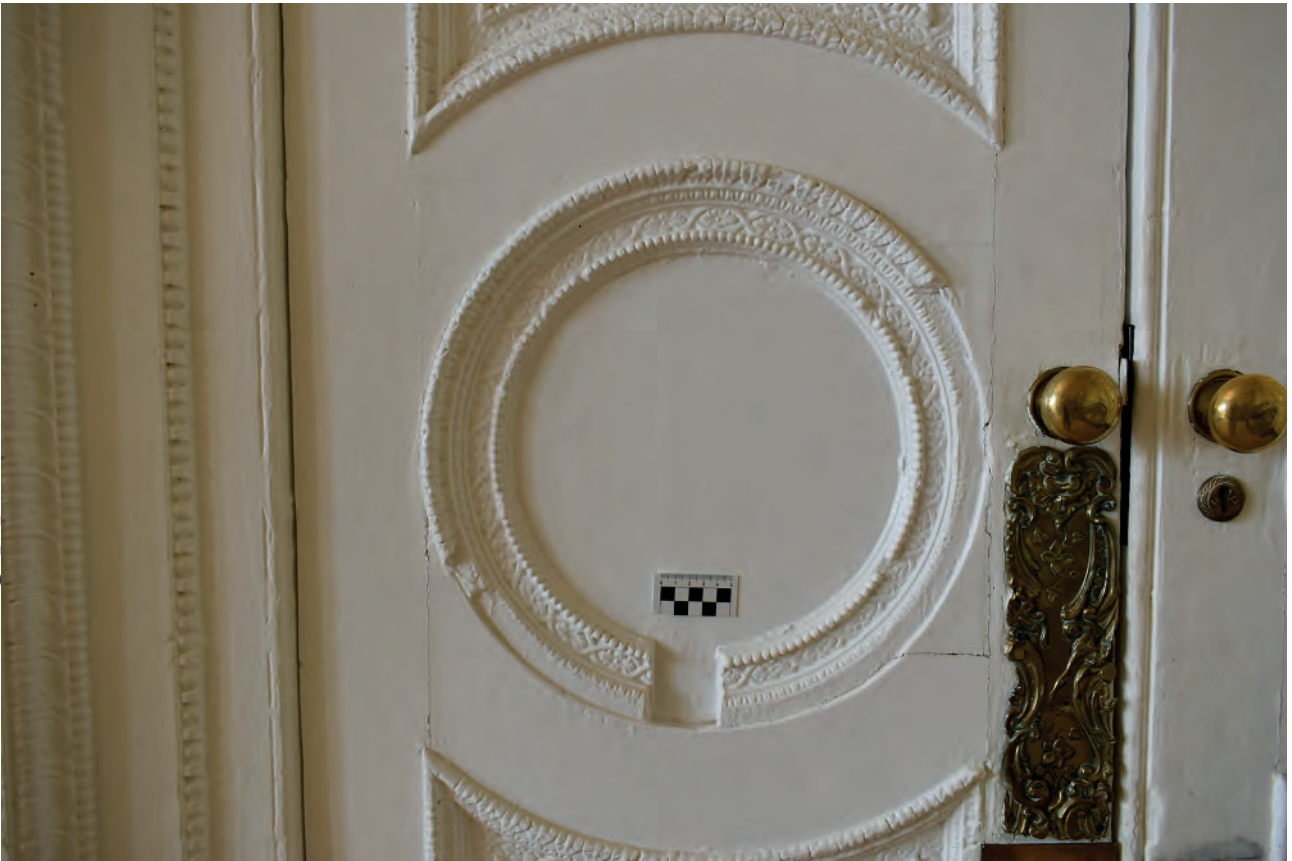
- 3.5.3 Mis-matching door furniture had been added during the life of the doors to the north end of the east and west walls, particularly that to the dining room (Plates 42-44) which also required several areas of replacement moulding. Numerous layers of paint were removed from the moulding of all doors and the moulding regilded (PI 46-48).

Plate 45: Temple Room, door to Dining Room, damage to moulding

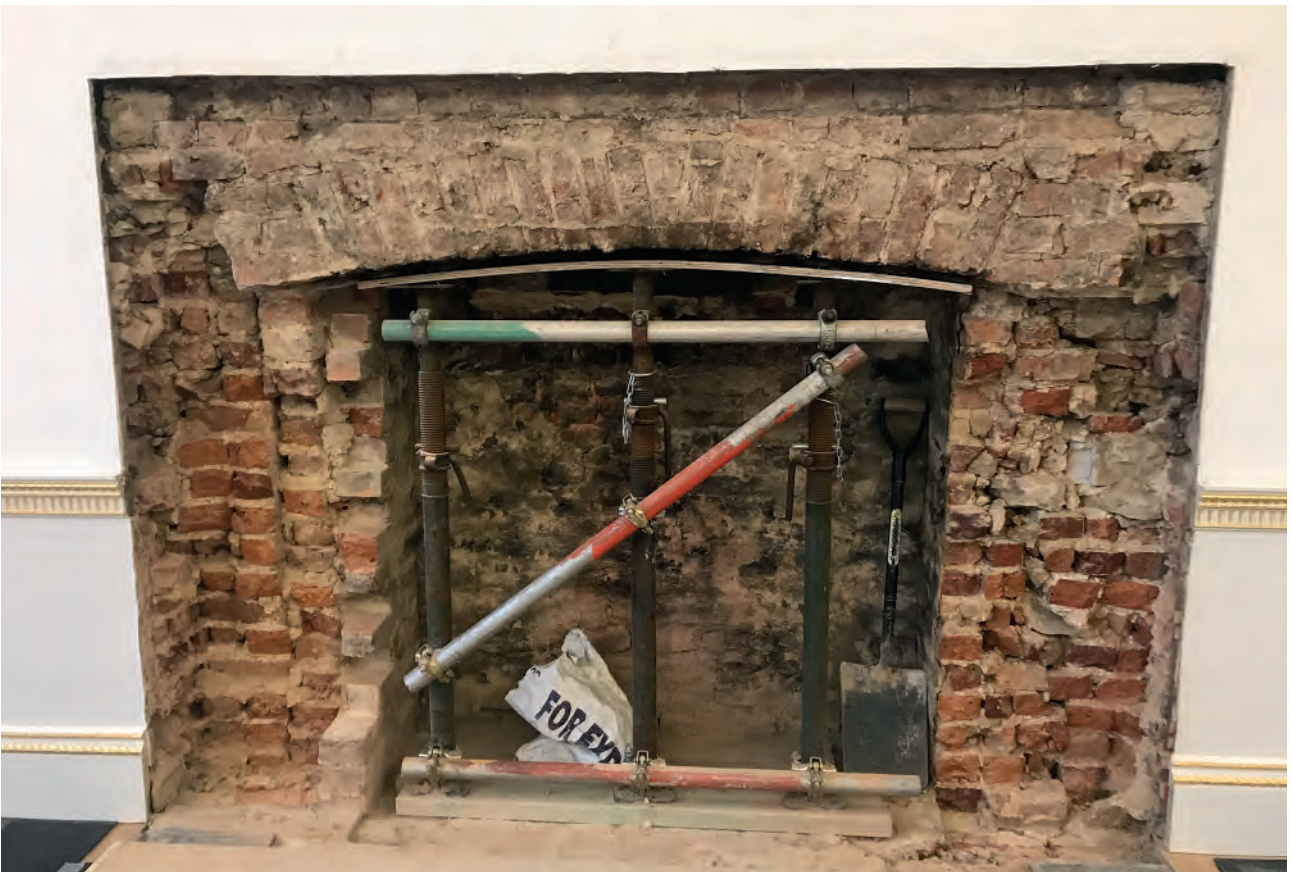
- 3.6.9 The brickwork of the sides of the original opening appear to have been roughly cut back to allow for the canted edge and the fireplace back of the c1922 fireplace and the gap filled with broken earlier bricks and mortar (Plate 64). The earlier bricks are well-fired fairly hard red bricks, 205-220mm x 100mm x 60-67mm (in the original Imperial 8.5" x 4" x 2.5") with very occasional stacking marks.
- 3.6.10 New pieces of dado and skirting board were moulded to match the existing and extend the original joinery to the edge of the new fireplace (Plate 65).

Plate 64: Temple Room, fireplace following stripping of 1922 material (provided by Nick Jones of Messenger)

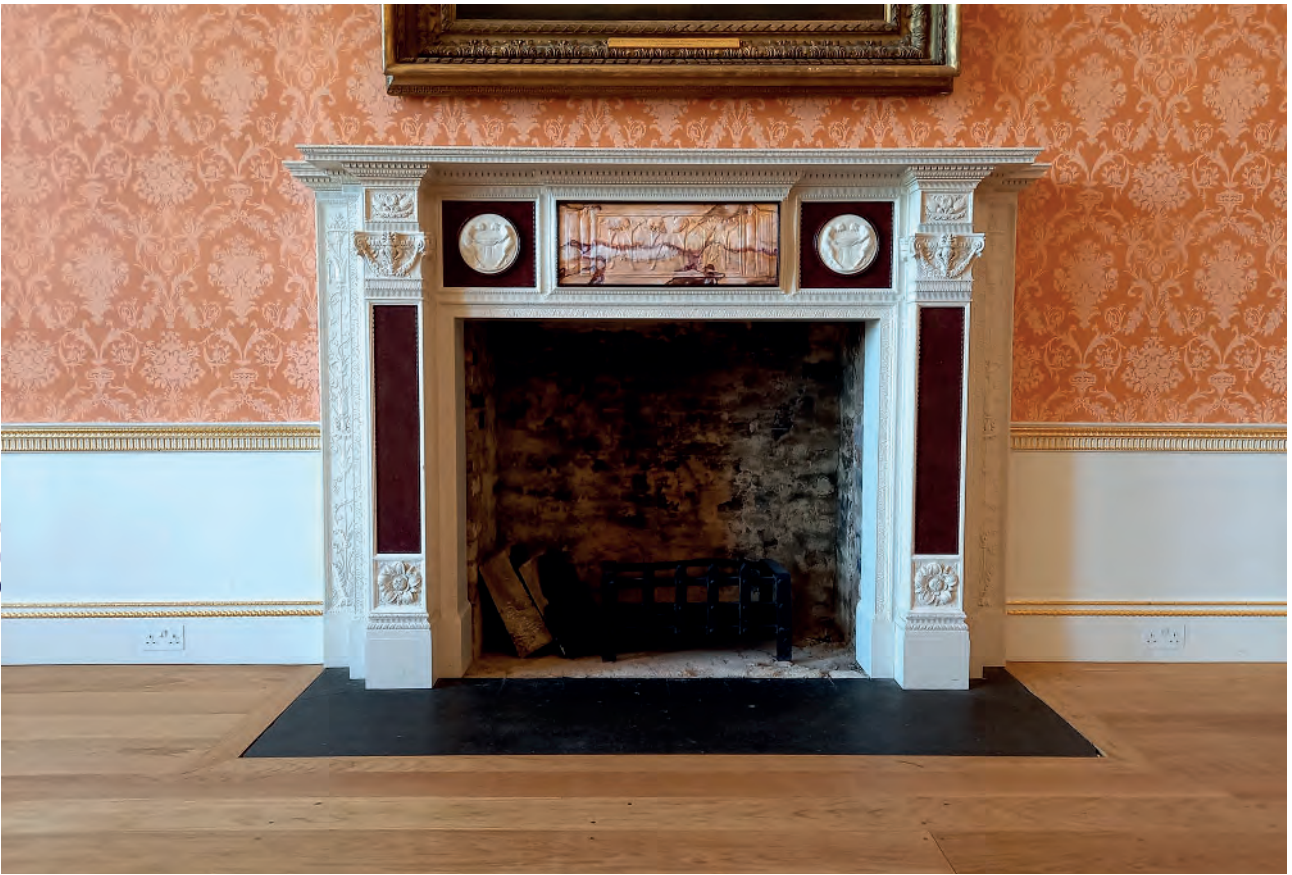
Plate 65: Temple Room, new fireplace

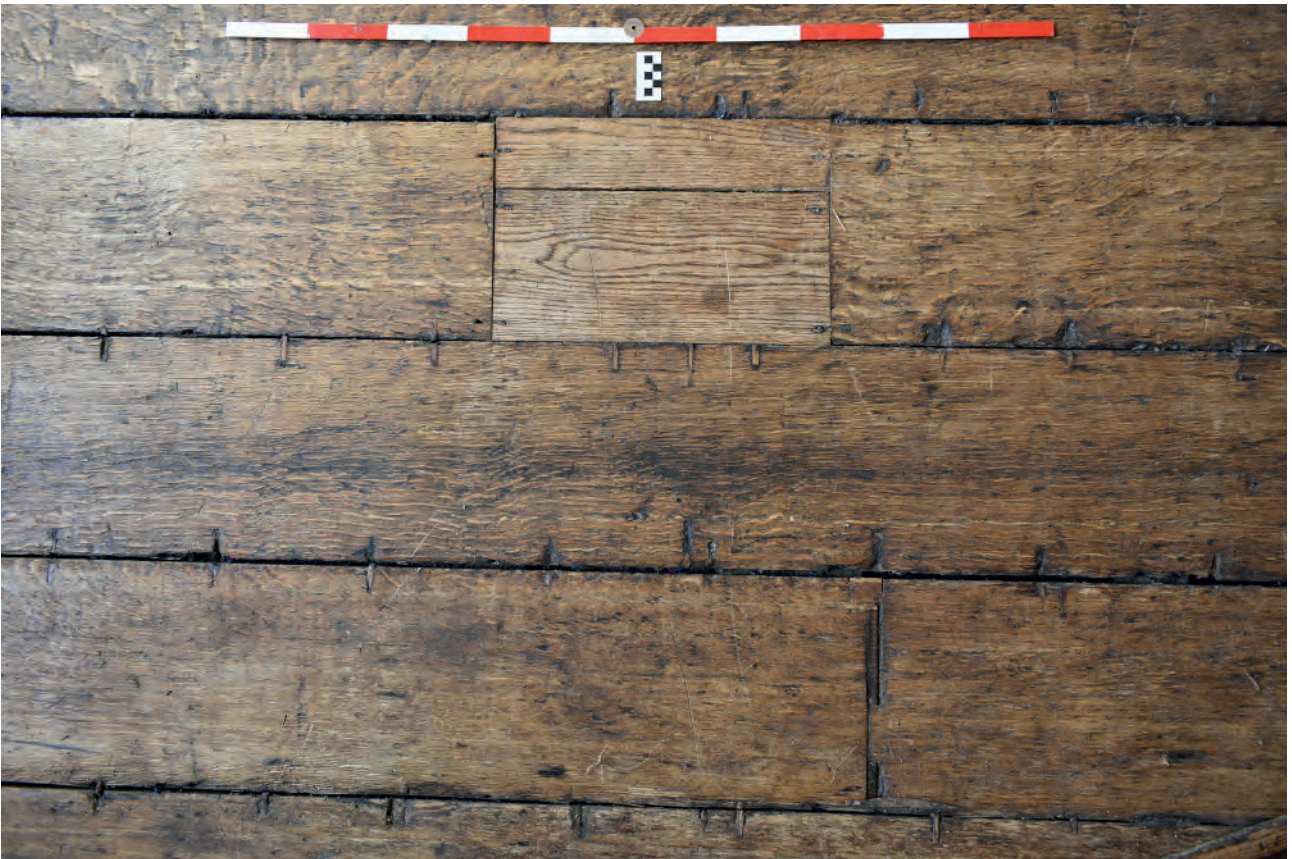
- 3.7.2 The floor was widely affected by severe wear, caused partially by several centuries of continuous use, but largely exacerbated by excessive use of a mechanical floor polisher on a daily basis which removed the surface of the floorboards in those areas likely to show scuff marks, particularly to the through-route between the doorways along the north of the room and in front of the window at the south of the room. The boards between the doors had been replaced with narrower, 120mm wide, 19mm thick, softwood boards in the later part of the 20th century. Original boards in shorter lengths had been reused for patching, and unrelated varnished boards had also been used in places (Plate 66).

Plate 66: Temple Room, floor, example of floorboard wear

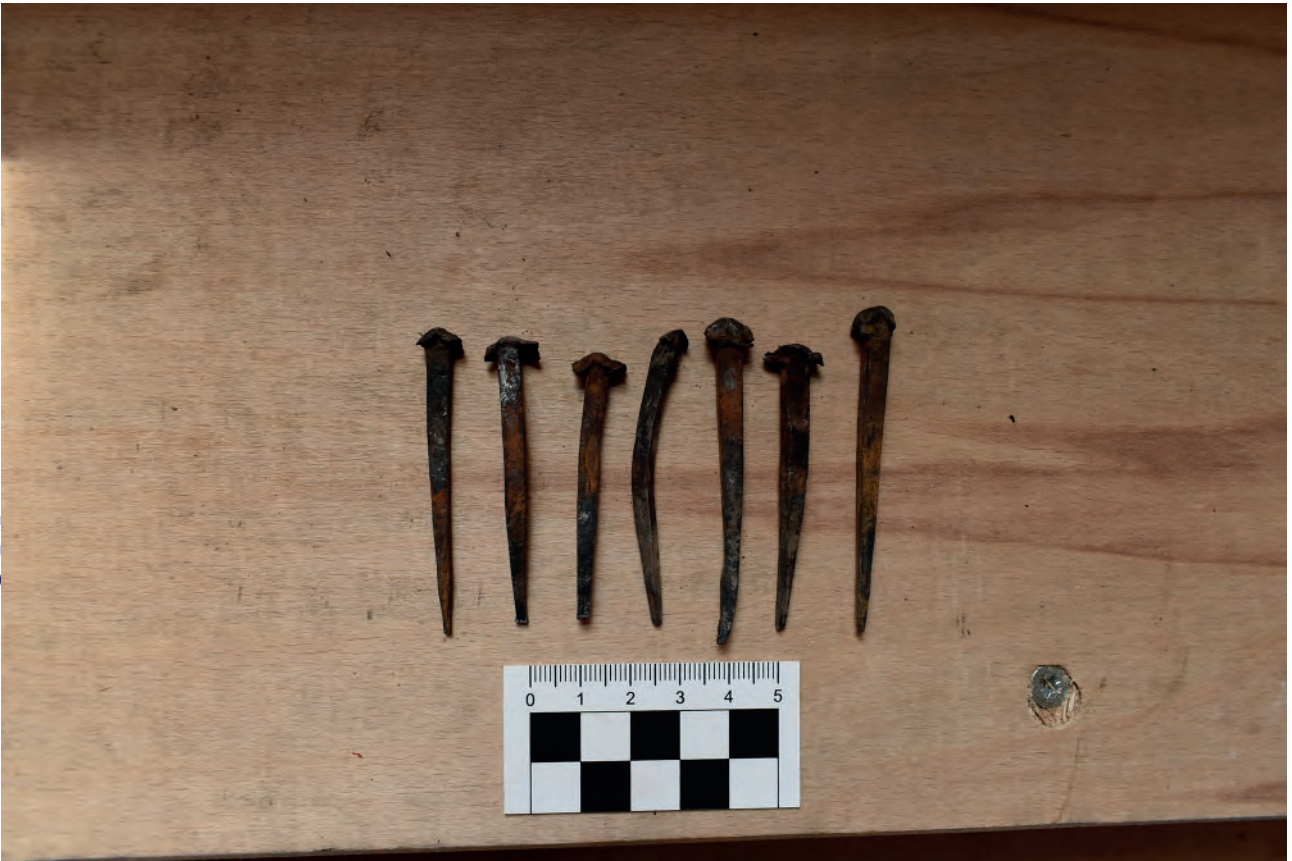
- 3.7.3 The boards were nailed at an angle to the joists and the adjacent floorboard dowelled to it (Plates 67 & 68). The ends of the boards were tongue and groove (Plate 69). The majority of the dowels which joined the boards were exposed in the floor surface, themselves worn approximately halfway through. The boards in front of the south window were worn to a thickness of 7mm at the area of most wear (Plate 70). The extent of the wear caused the floorboards to be unsafe: severe deflection during dancing during events was observed, and the extent of repair required rendered the floorboards unsalvageable.

Plate 67: Temple Room, floor, examples of floorboard nails

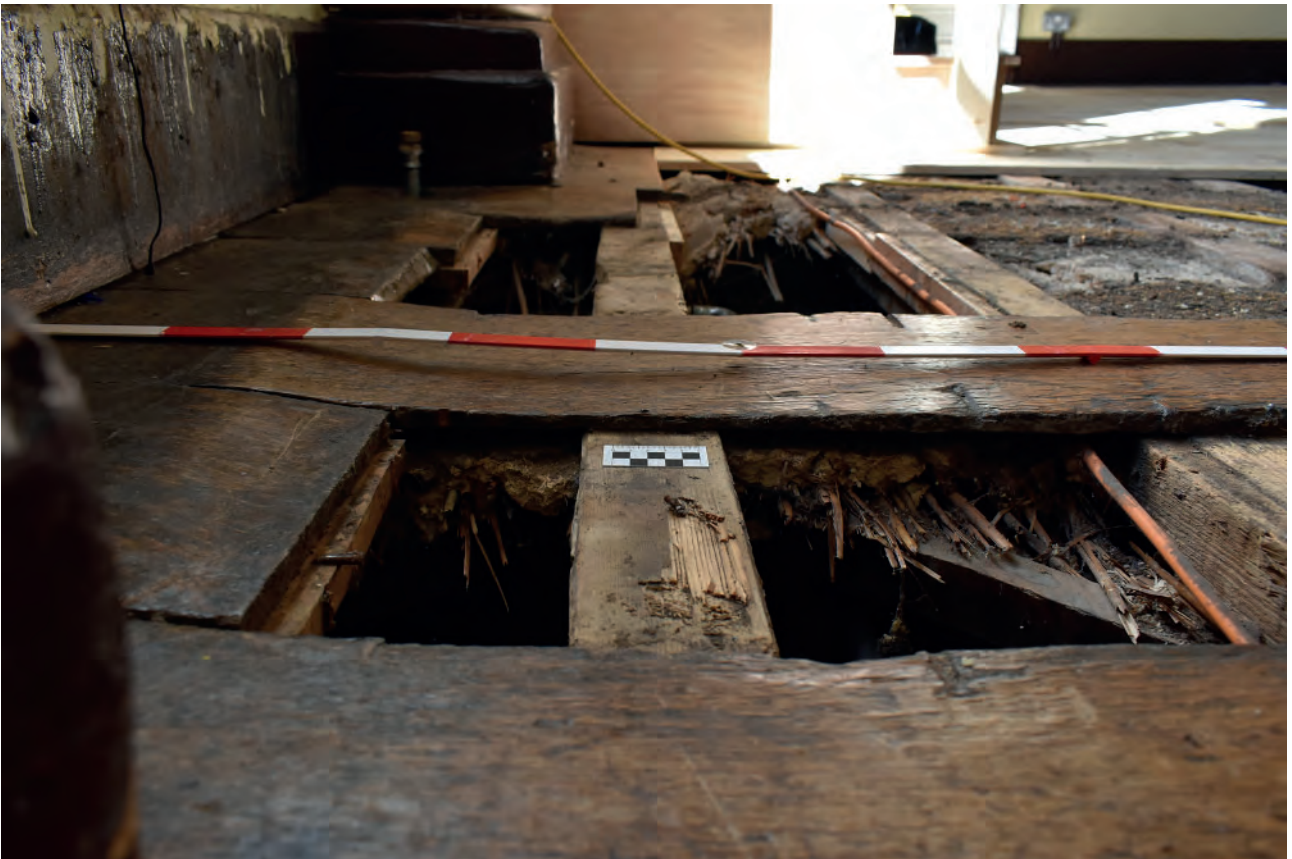
Plate 70: Temple Room, floor, example of floorboard wear in front of the window

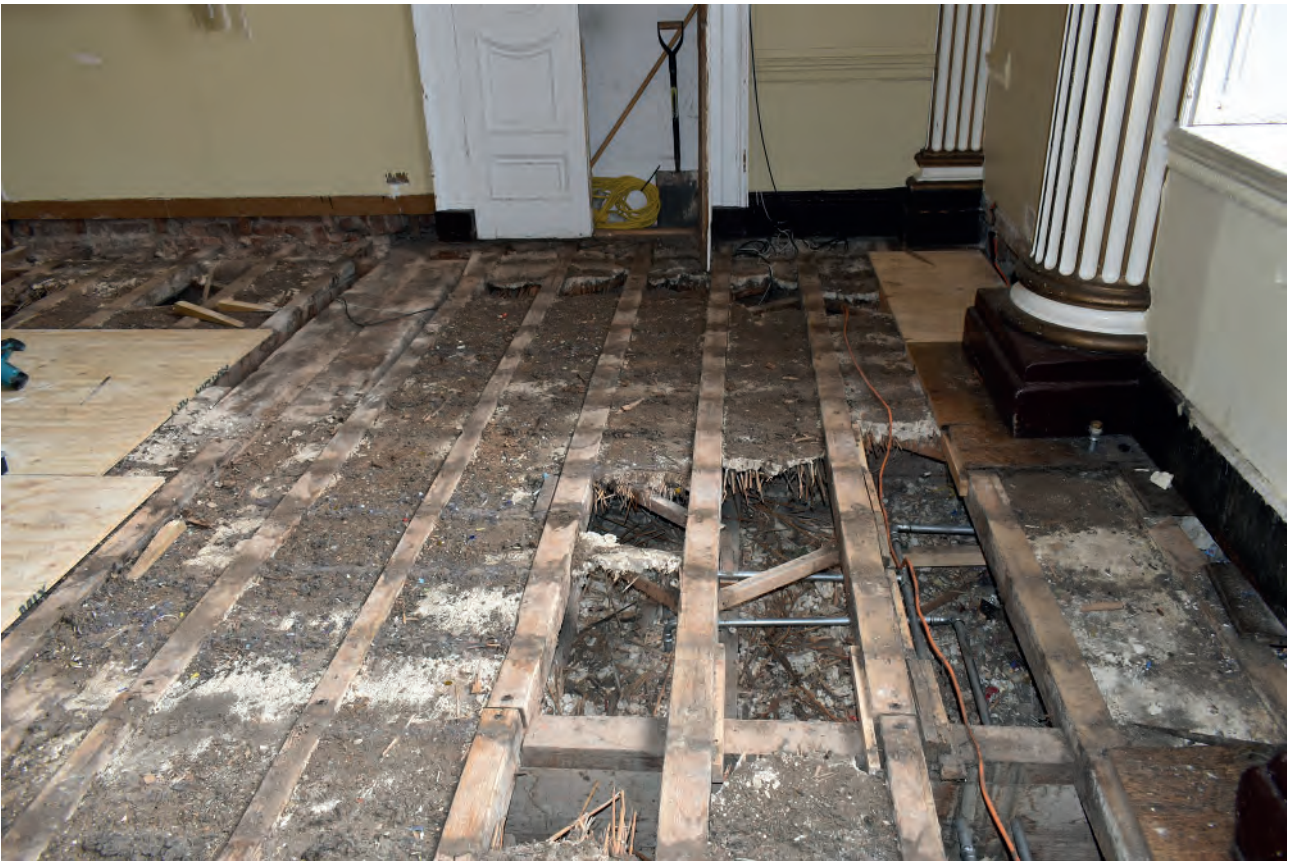
- 3.7.5 The pugging between the joists is supported on crossed pieces of timber. It consists of reeds with a layer of lime (Plates 80-82). It is feasible that these water reeds were sourced from the grounds, being a free and useful material and still observed in the current landscape of the National Trust land surrounding the school. Although reeds are usually associated with thatching of roofs, generally harvested in Norfolk, they grow alongside ditches and rivers in many parts of the country in insufficient quantities for thatching but would have been used for other uses such as providing a key for plastering (English Heritage, 2013, p. 336).
- 3.7.6 New oak boards were laid and the use of the mechanical polisher is to be limited (Plate 83).

Plate 80: Temple Room, floor, area of damaged pugging exposing floor structure

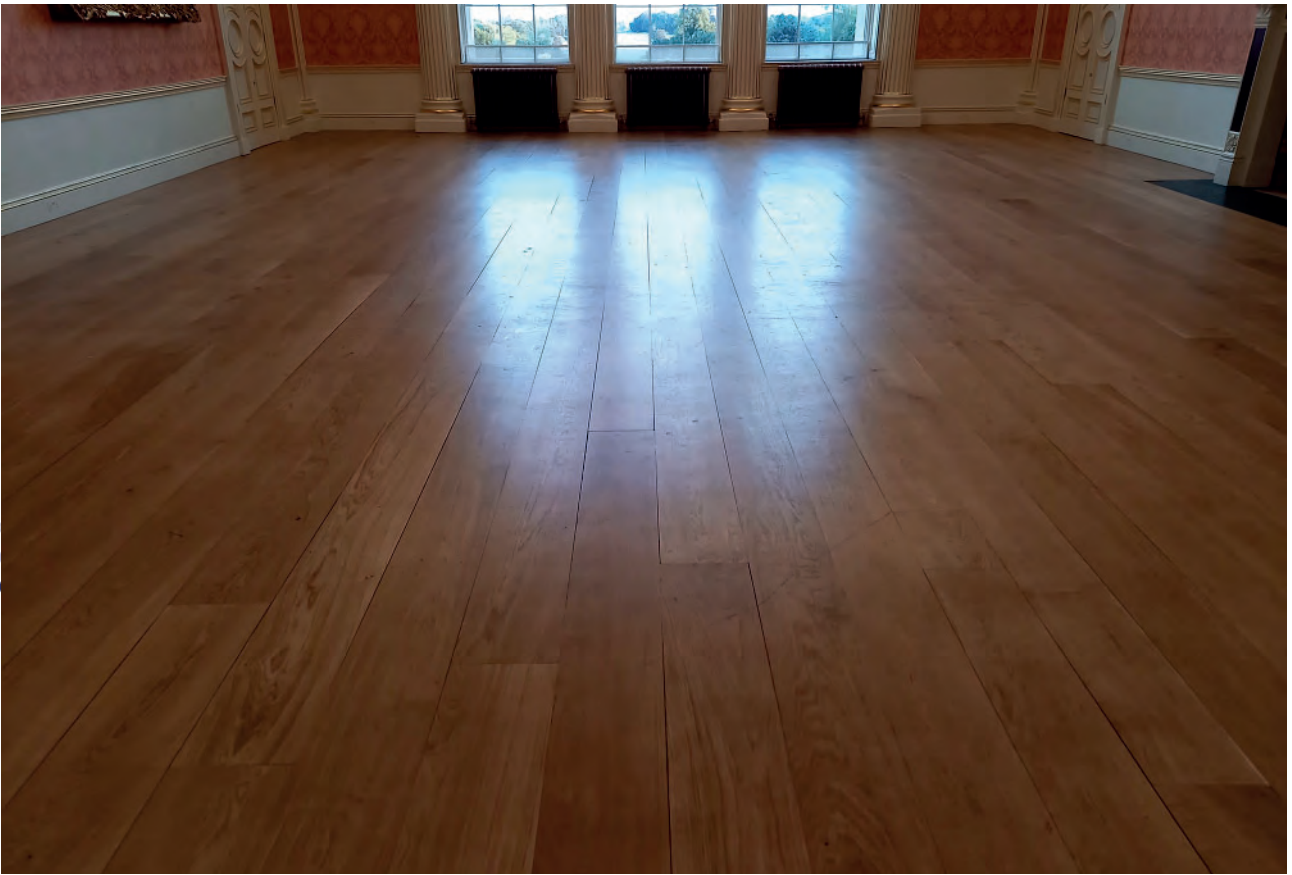
Plate 83: Temple Room, floor, following replacement

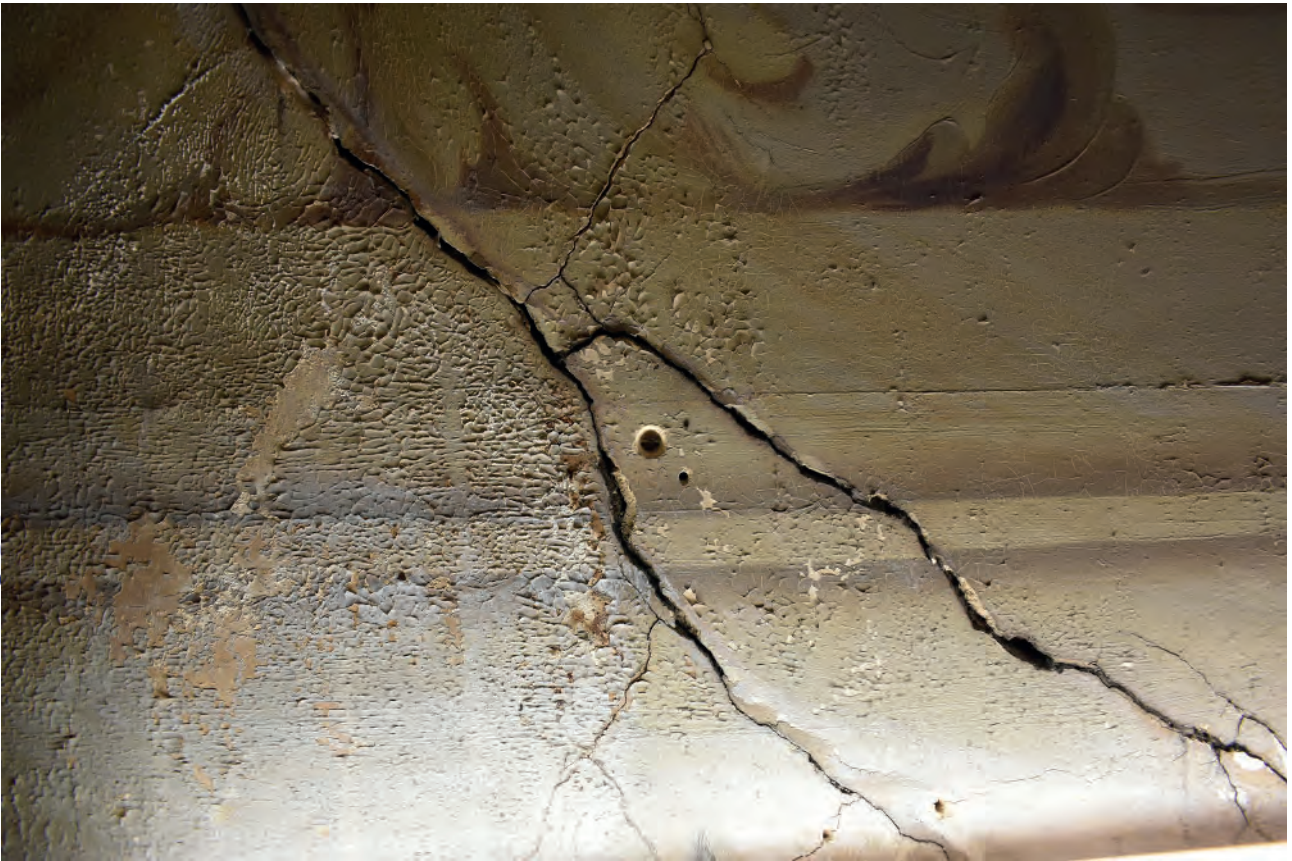
Plate 105: Dining Room, ceiling, example of poor earlier repair

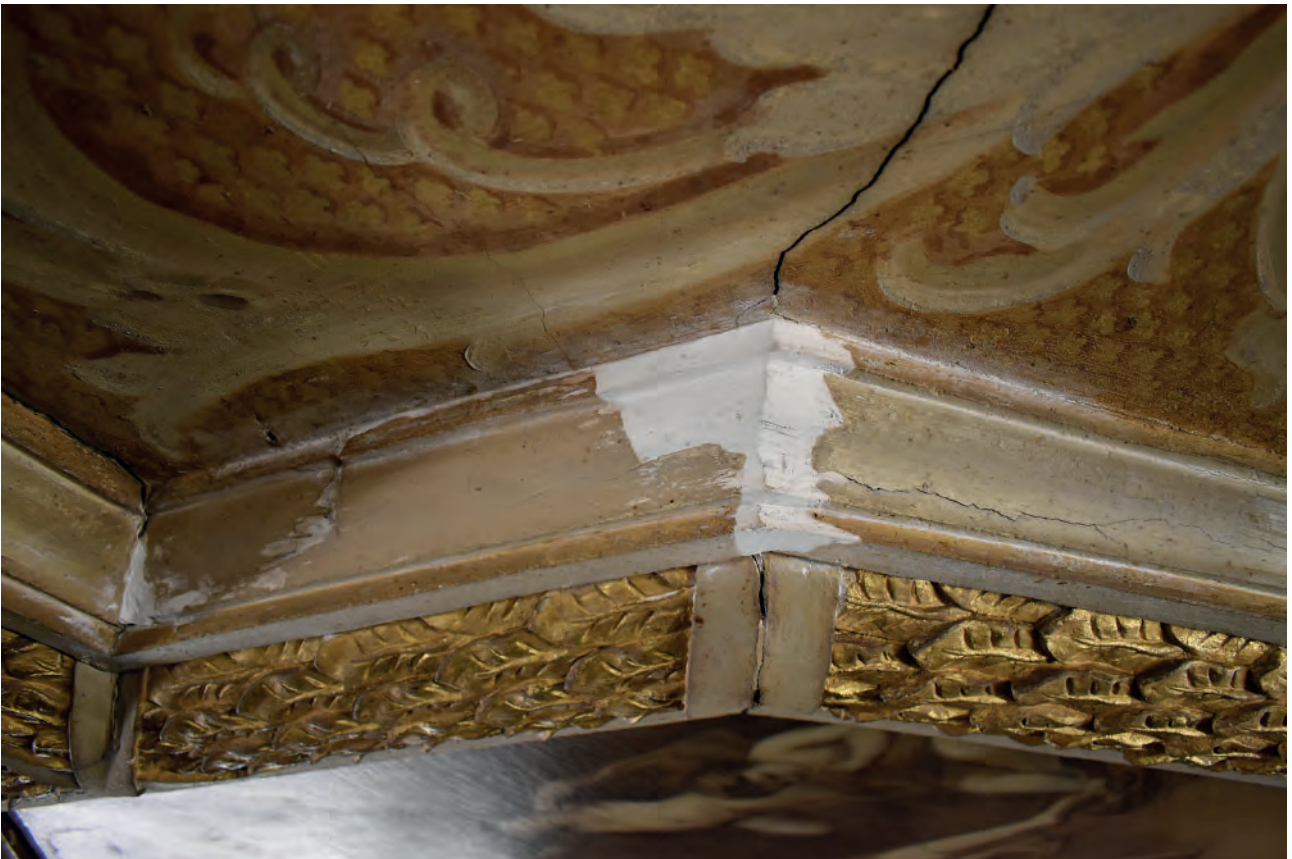
Plate 106: Dining Room, ceiling, example of poor earlier repair

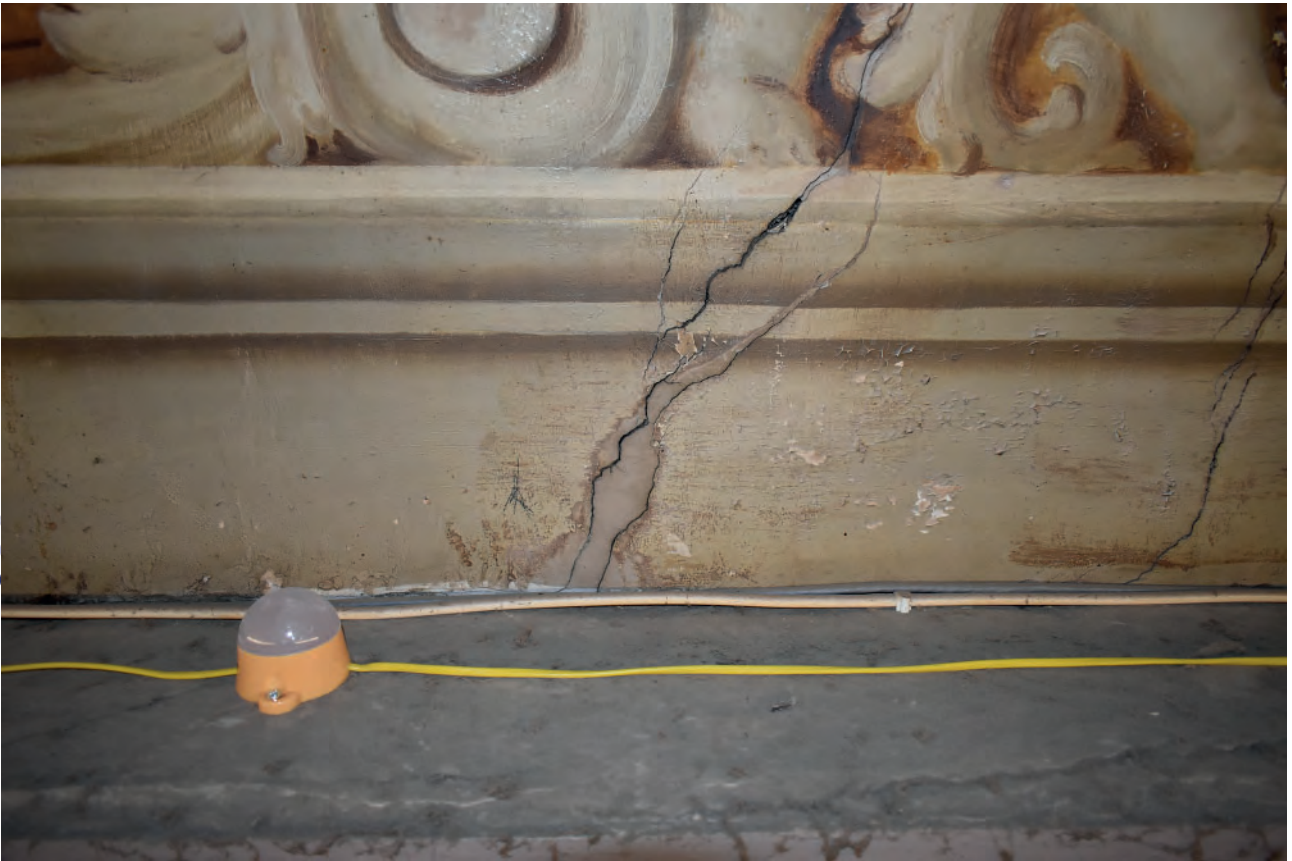
Plate 107: Dining Room, ceiling, example of poor earlier repair

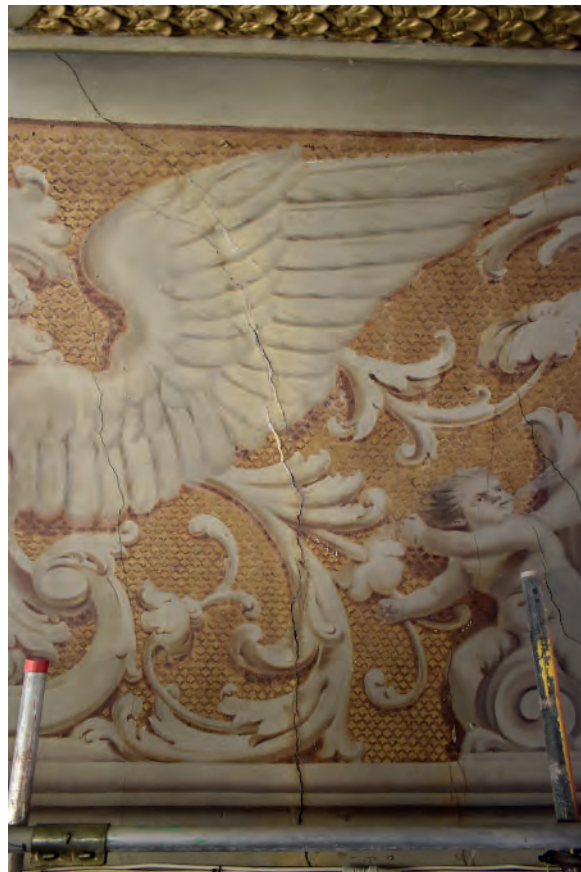
Plate 108: Dining Room, ceiling, example of cracking

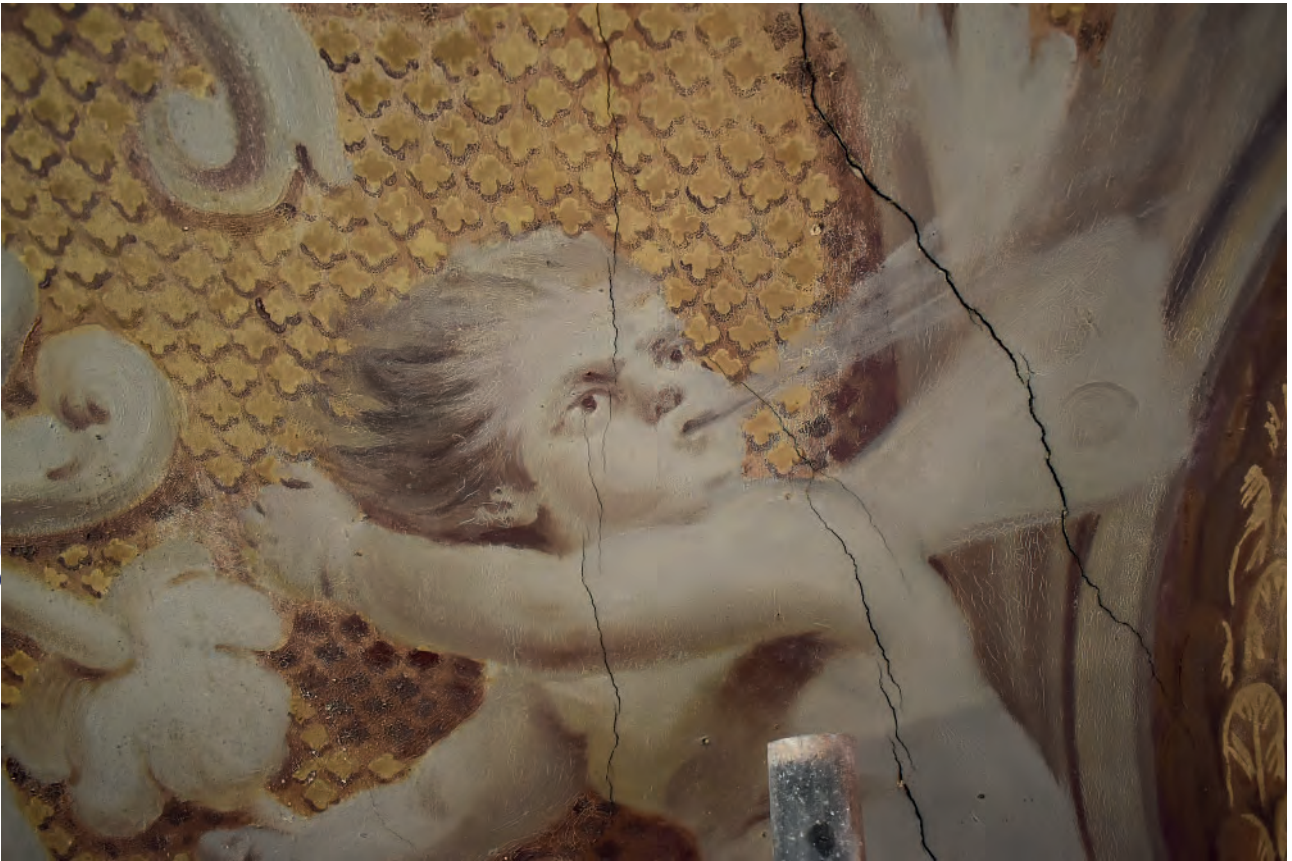
Plate 109: Dining Room, ceiling, example of cracking

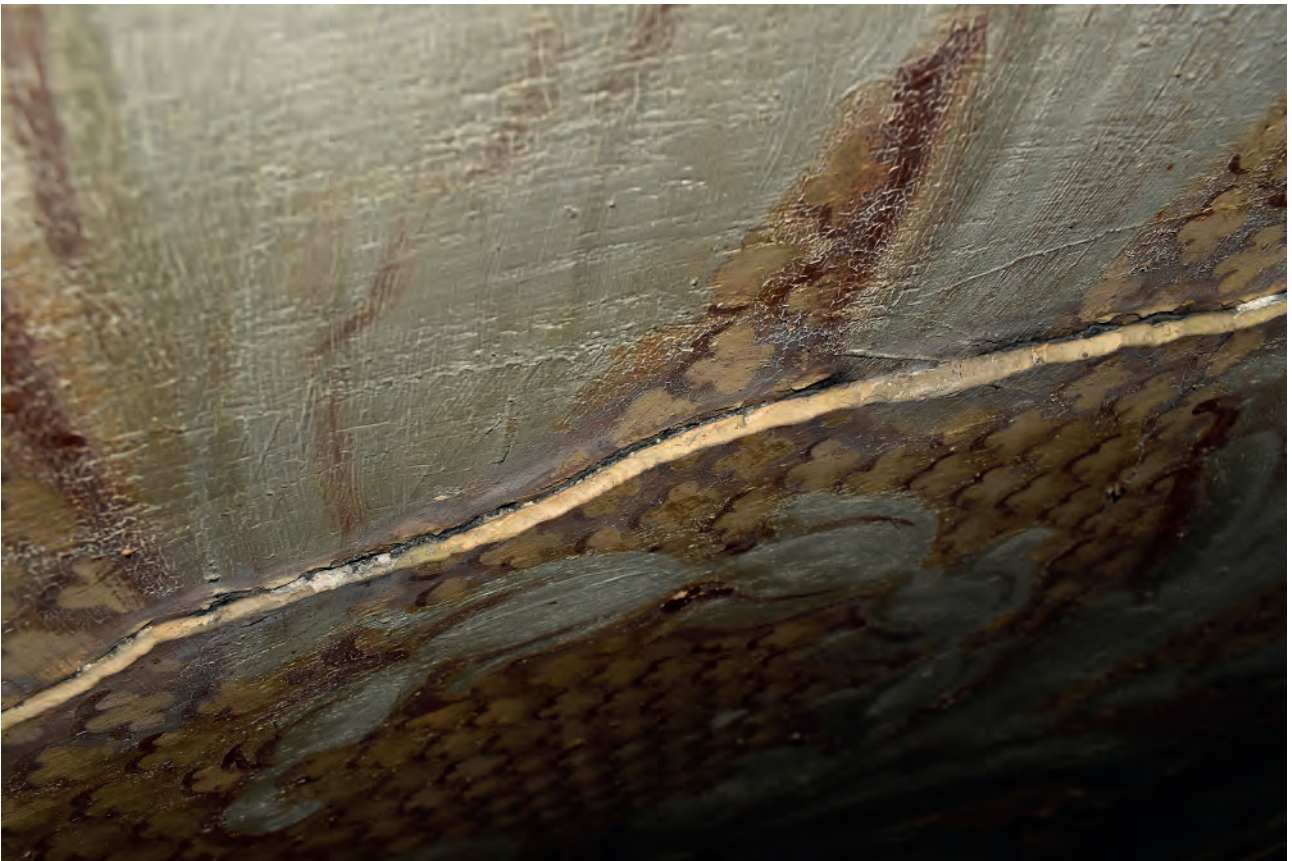
Plate 110: Dining Room, ceiling, example of cracking

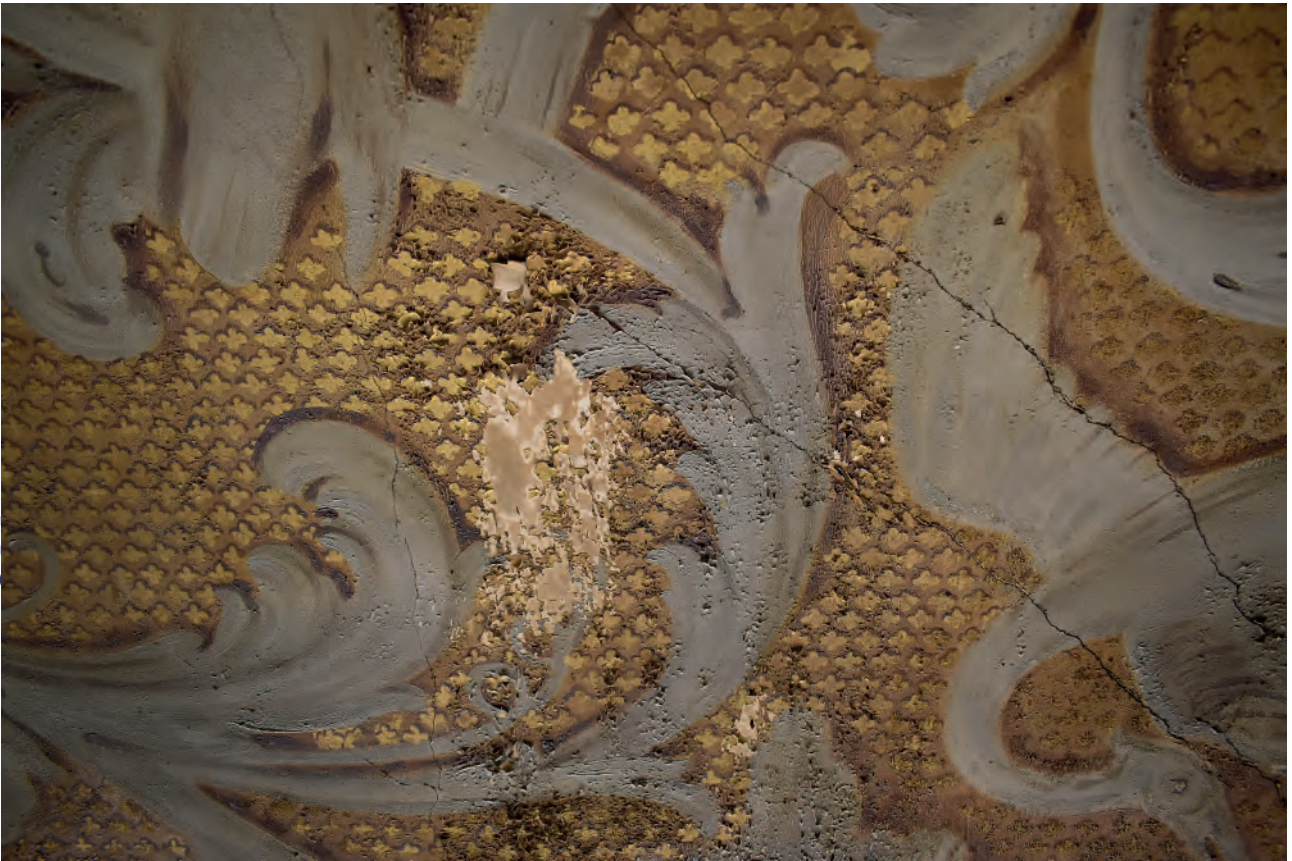
Plate 111: Dining Room, ceiling, example of flaking paint

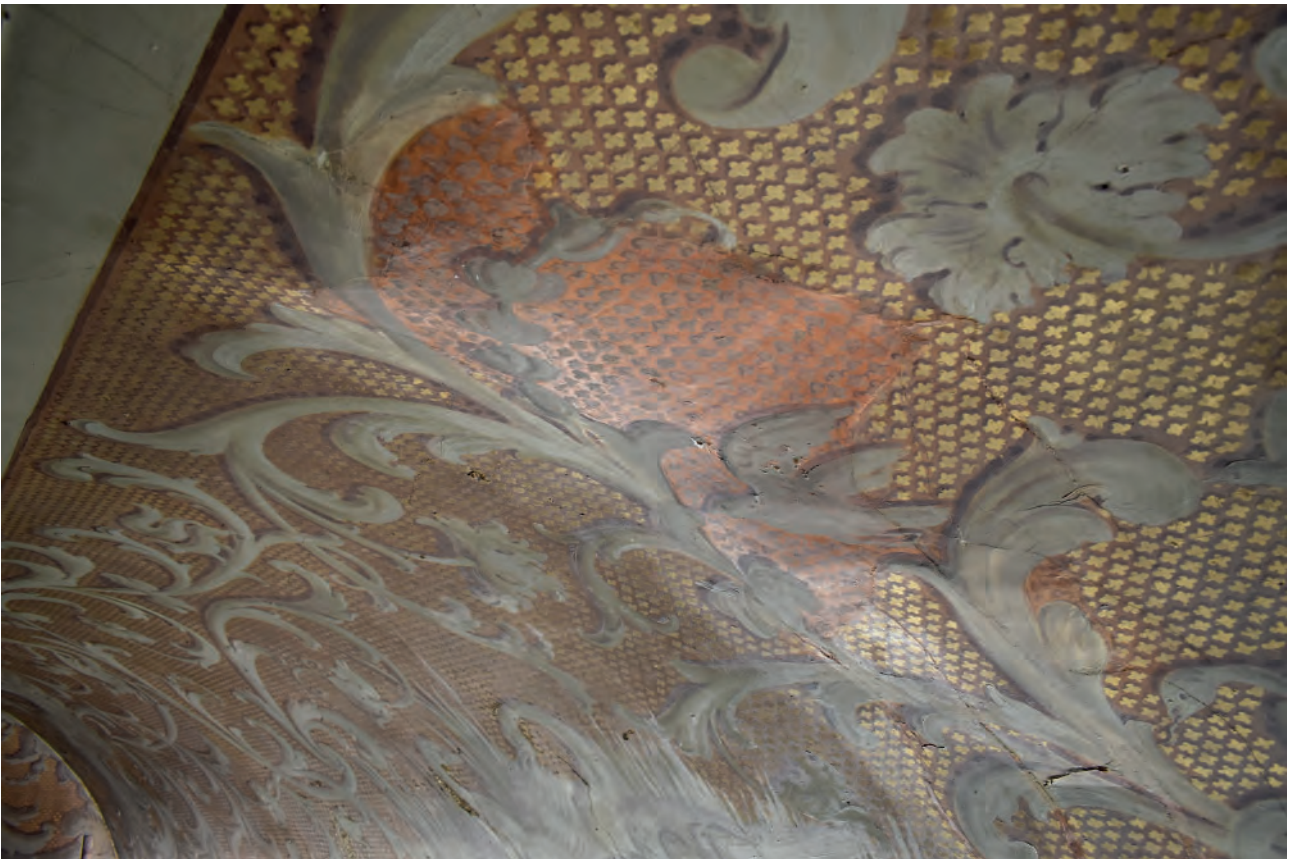
Plate 114: Dining Room, ceiling, example of poor repair and redecoration

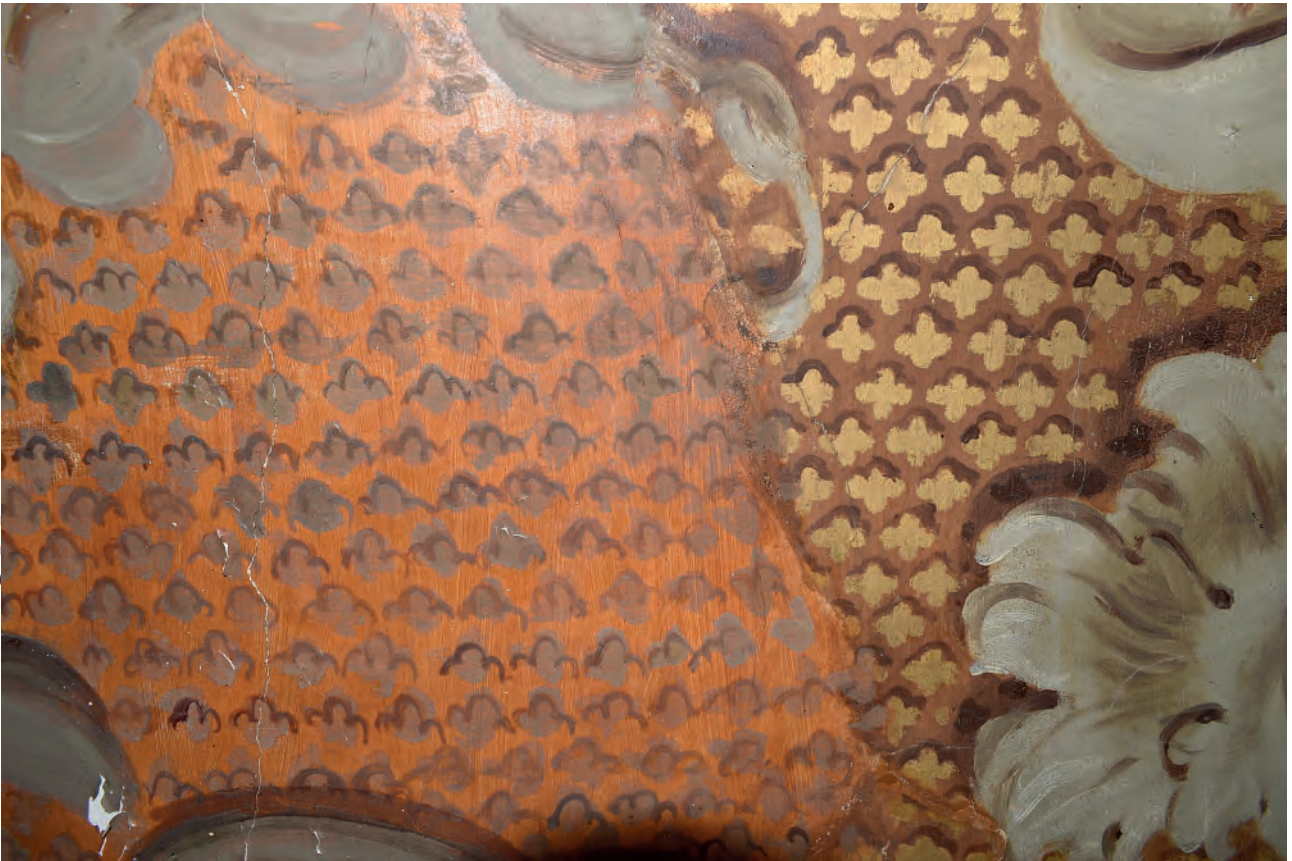
Plate 115: Dining Room, ceiling, example of poor repair and redecoration
