# Temple Room, Dining Room and West Corridor Stowe House, Buckinghamshire.

## Historic Building Recording

September 2022

**Client: Stowe House Preservation Trust**

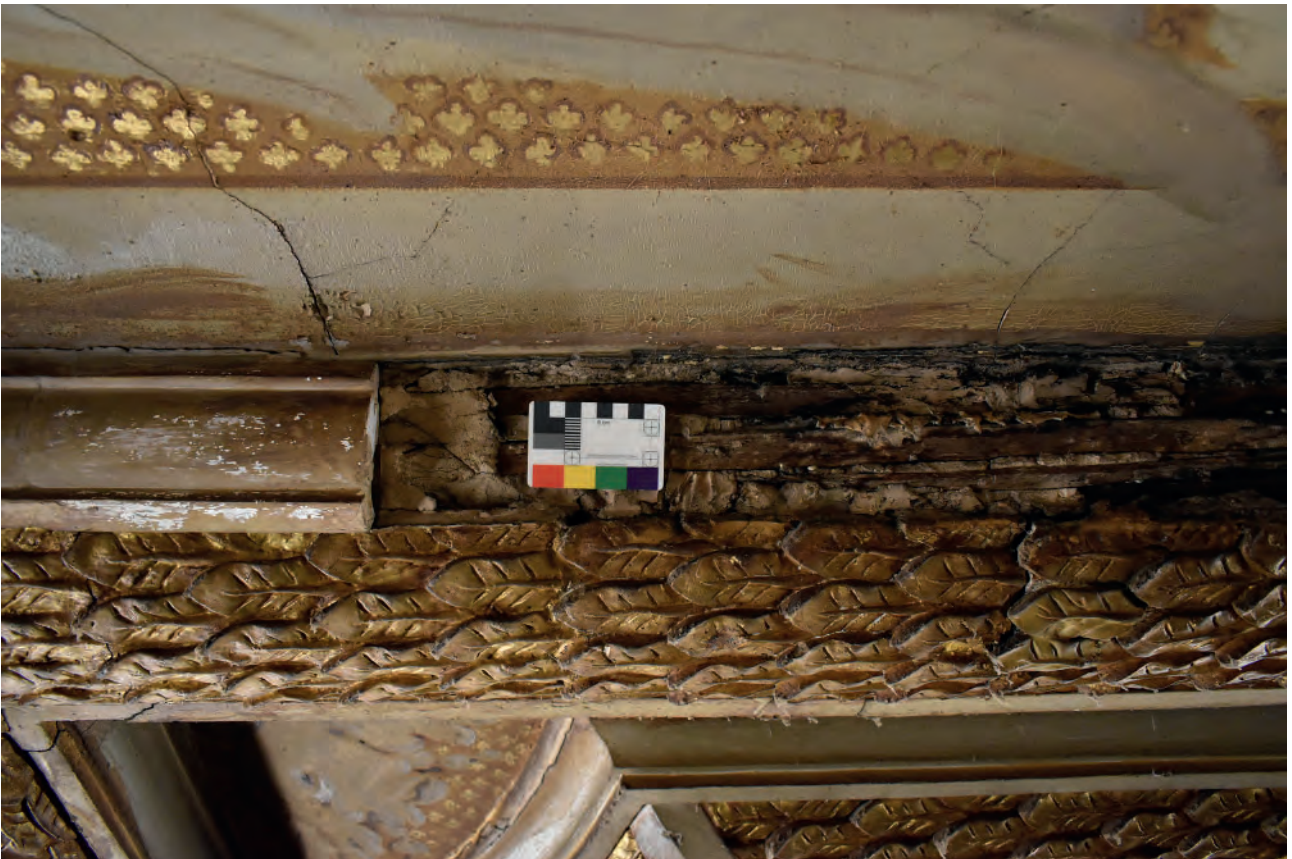
Plate 116: Dining Room, ceiling, example of poor condition of decorative beam

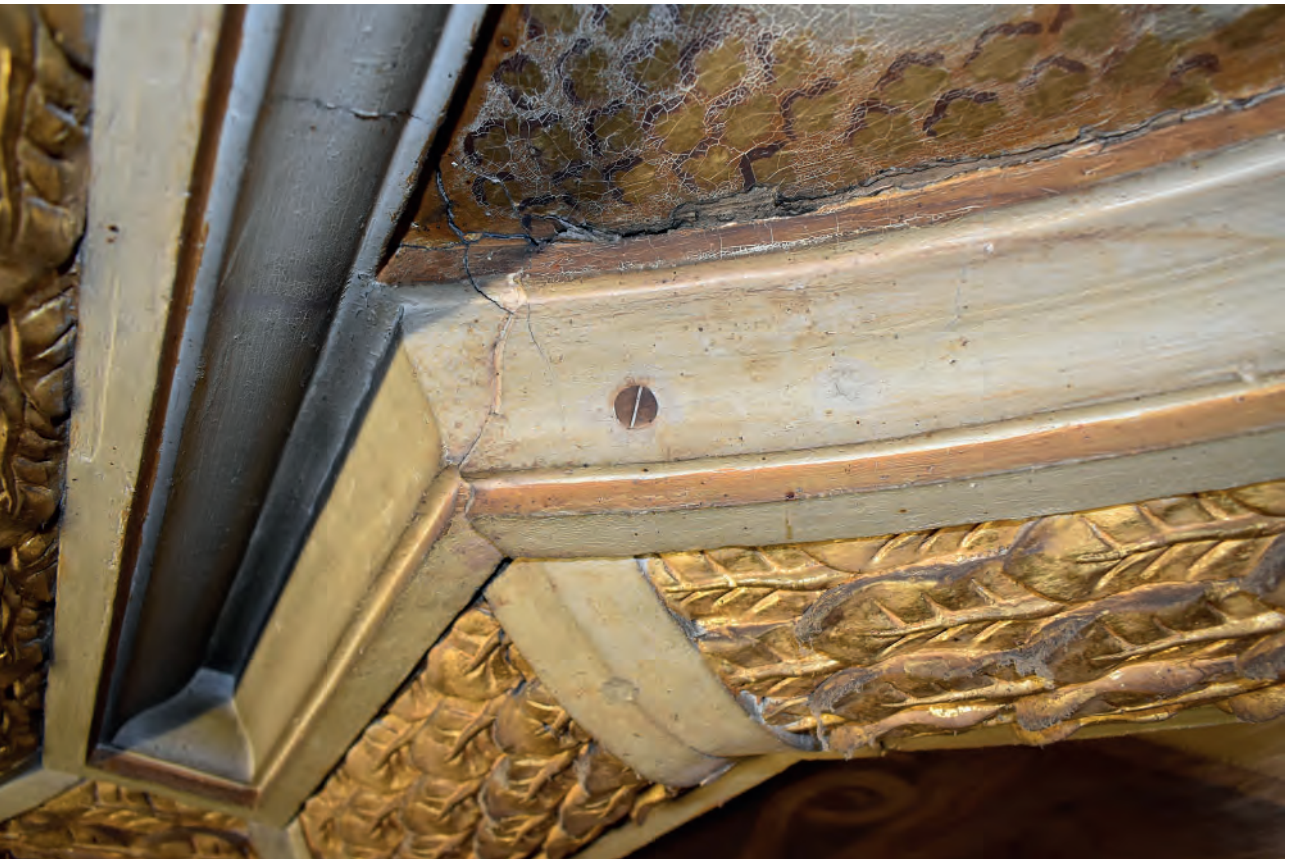
Plate 118: Dining Room, ceiling, example of poor repair of moulding

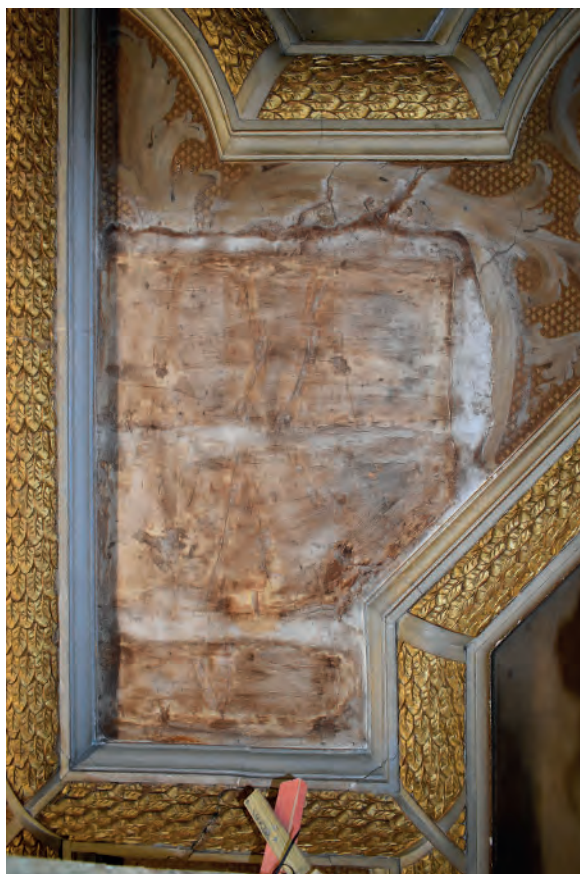
Plate 119: Dining Room, ceiling, area of damage and poor repair to the west end

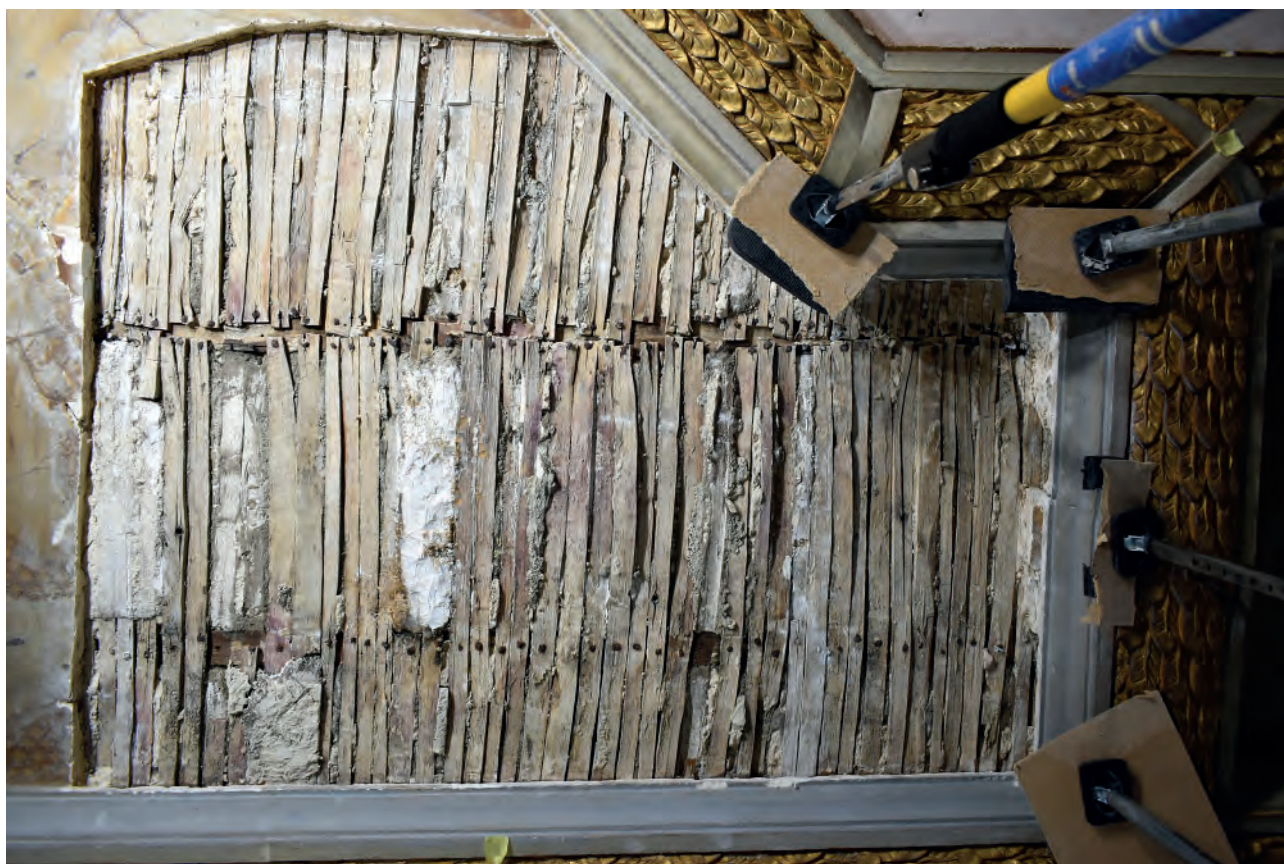
Plate 120: Dining Room, ceiling, during repair to the west end

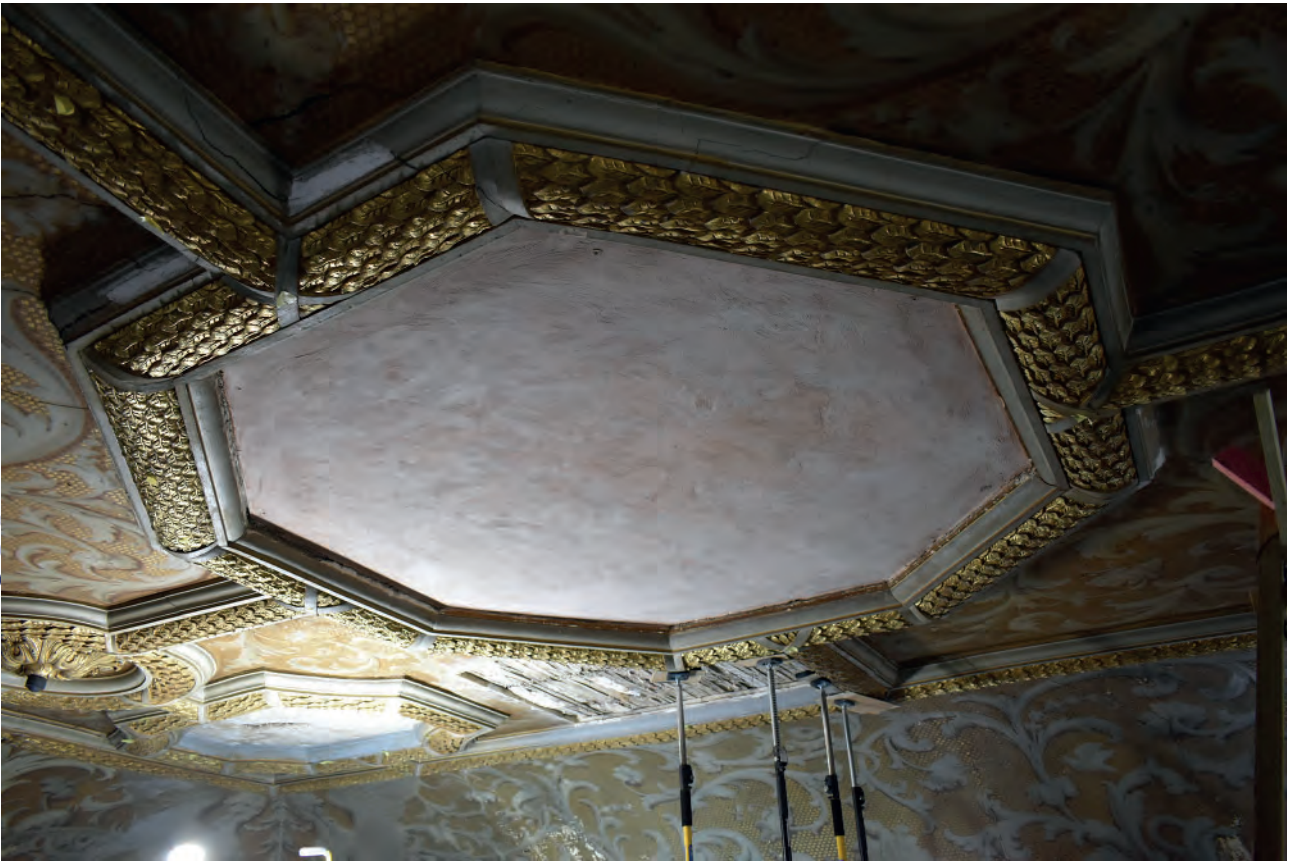
Plate 121: Dining Room, ceiling, example of earlier ceiling repair

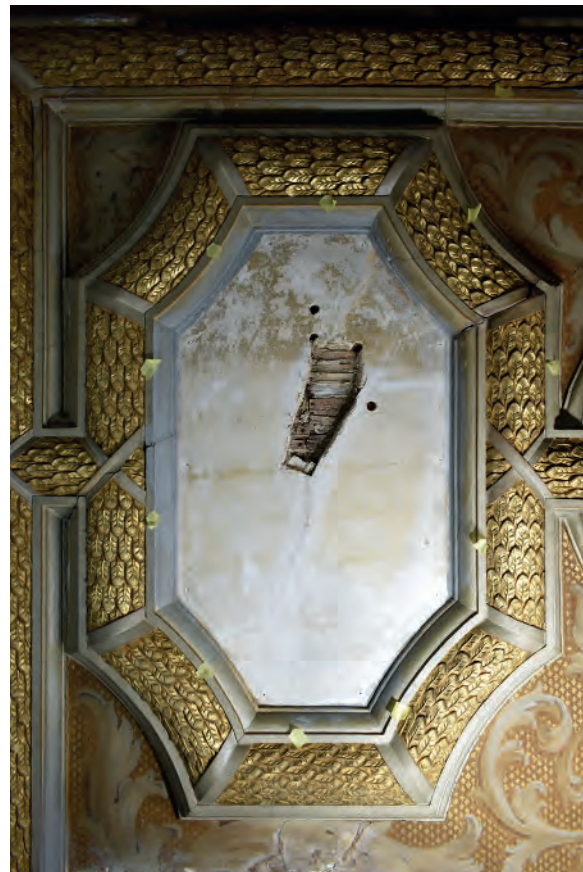
Plate 122: Dining Room, ceiling, example of earlier ceiling repair

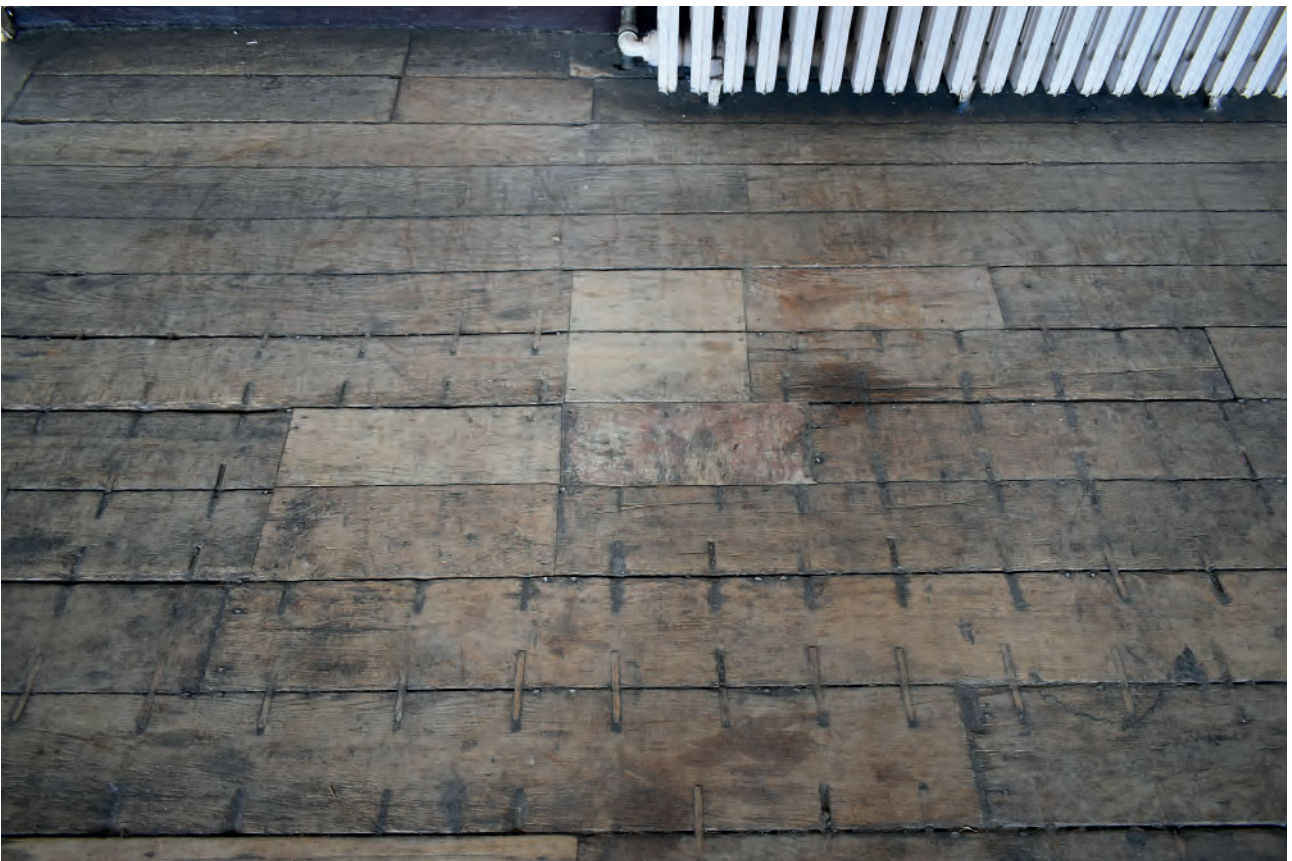
Plate 150: Dining Room, floor, example of worn floorboards

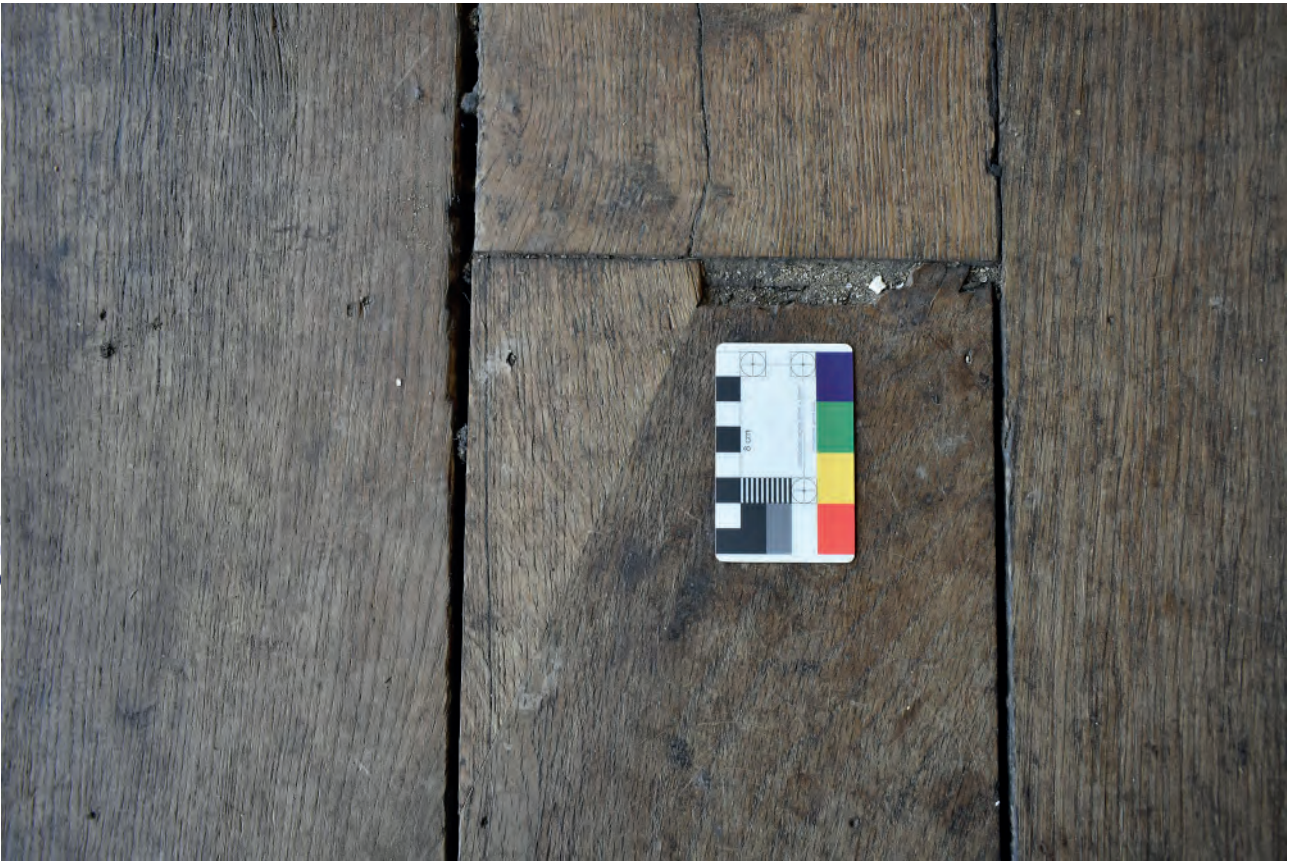
Plate 151: Dining Room, floor, example of early repair to the floorboards

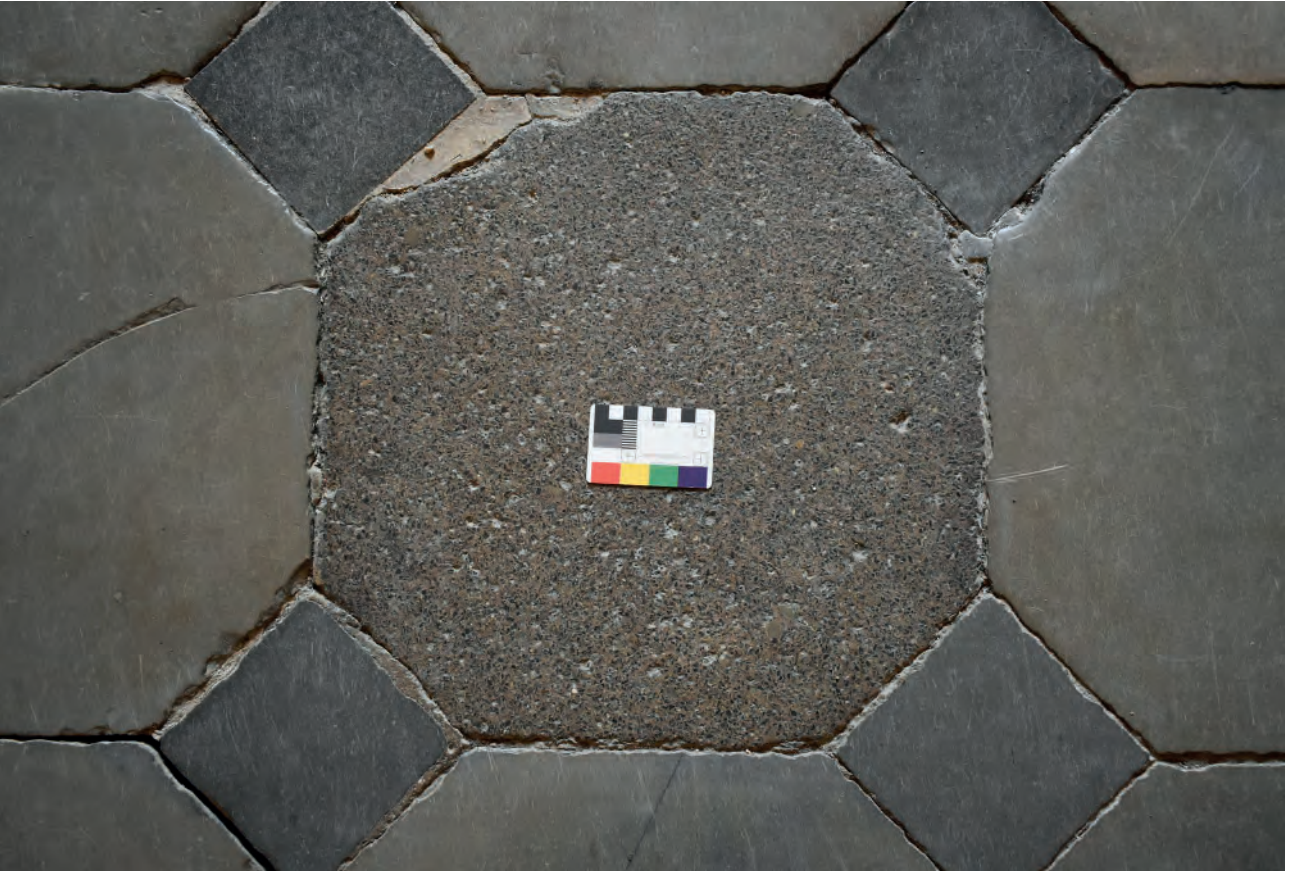
Plate 177: West Corridor, floor, example of concrete repair

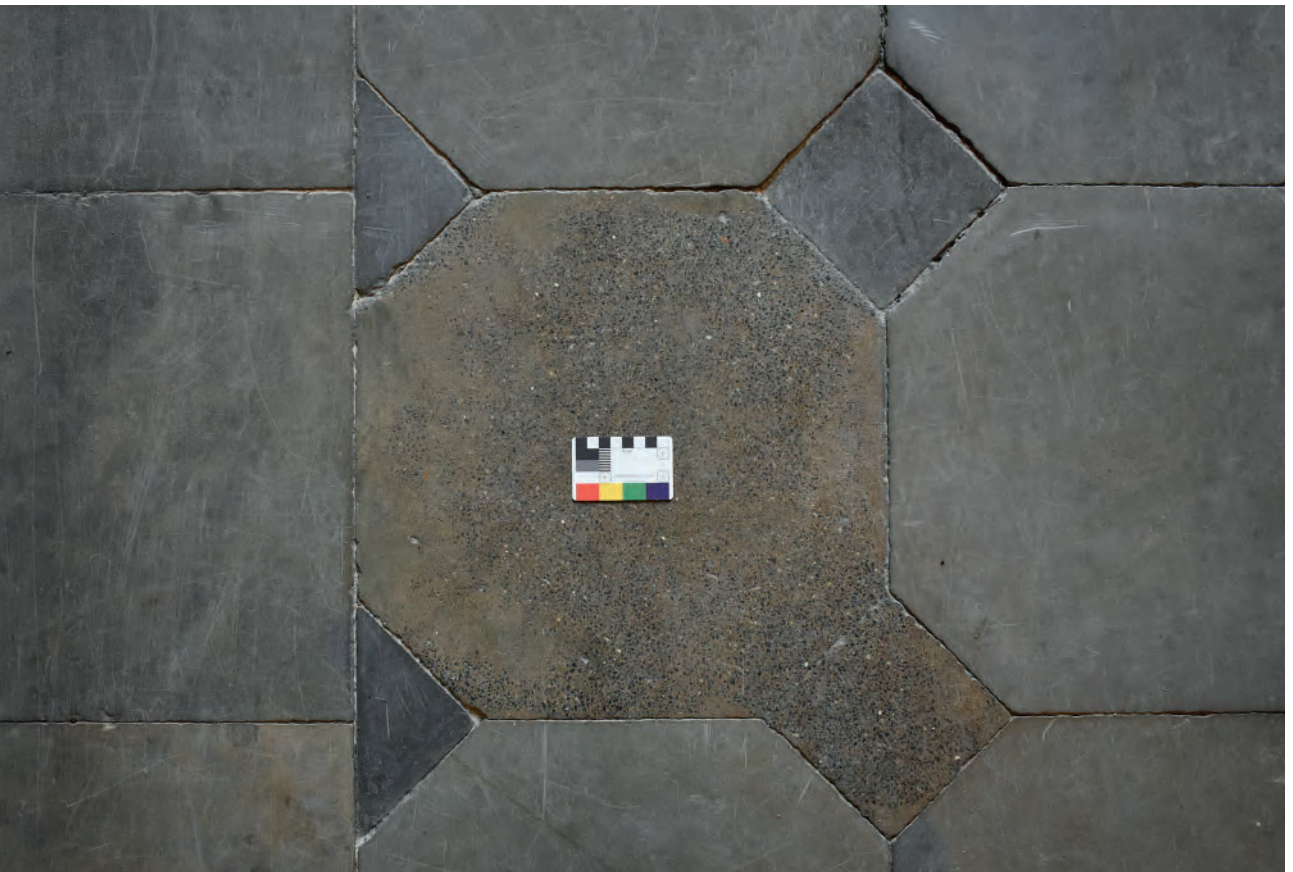
Plate 178: West Corridor, floor, example of concrete repair

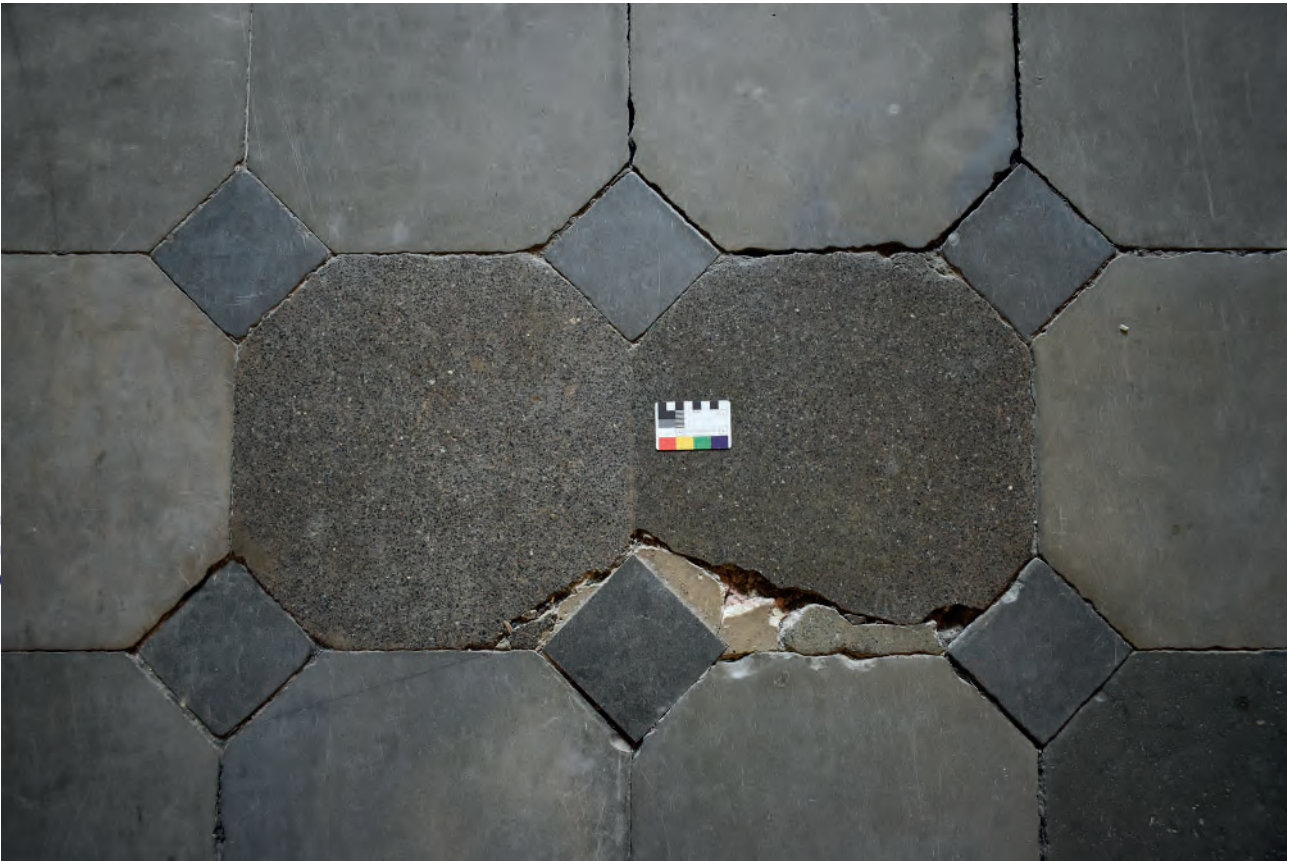
Plate 179: West Corridor, floor, example of concrete repair

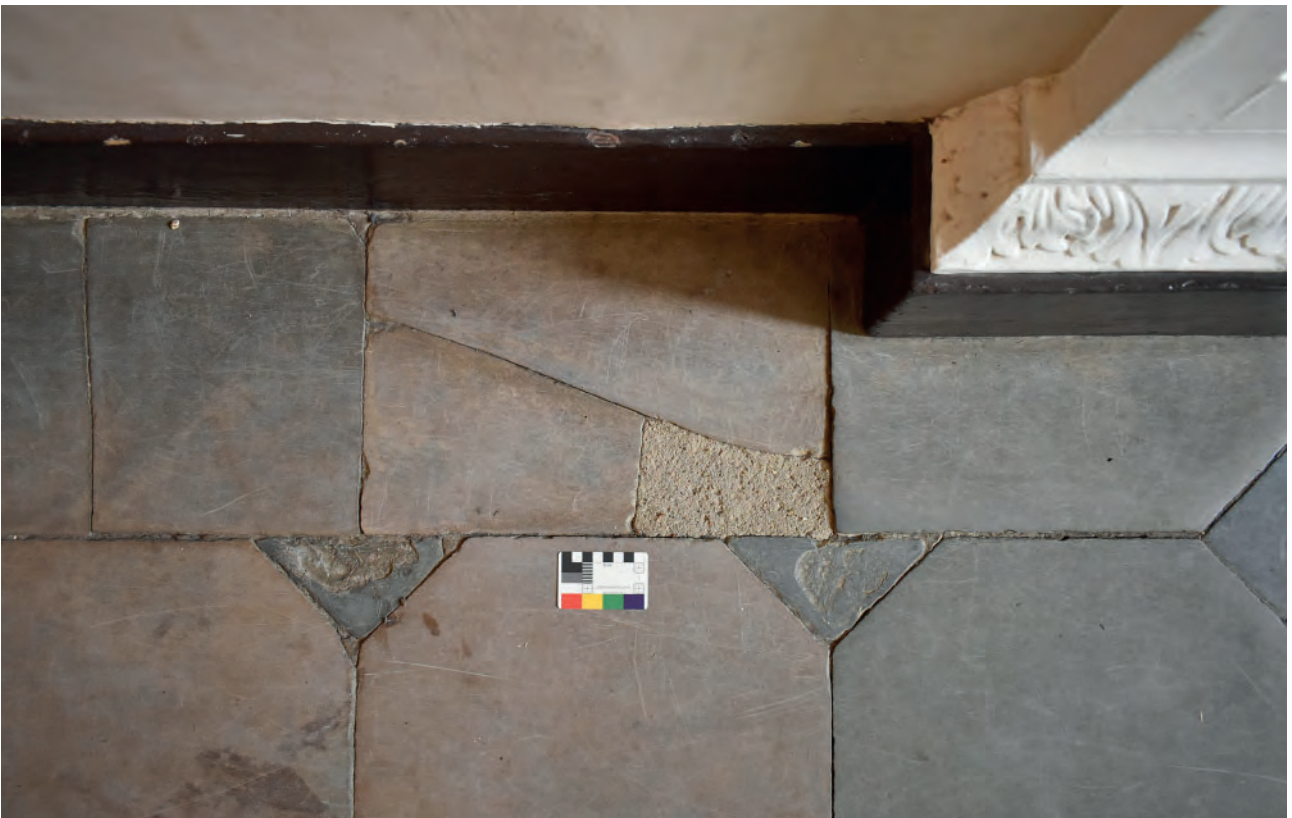
Plate 180: West Corridor, floor, example of concrete repair

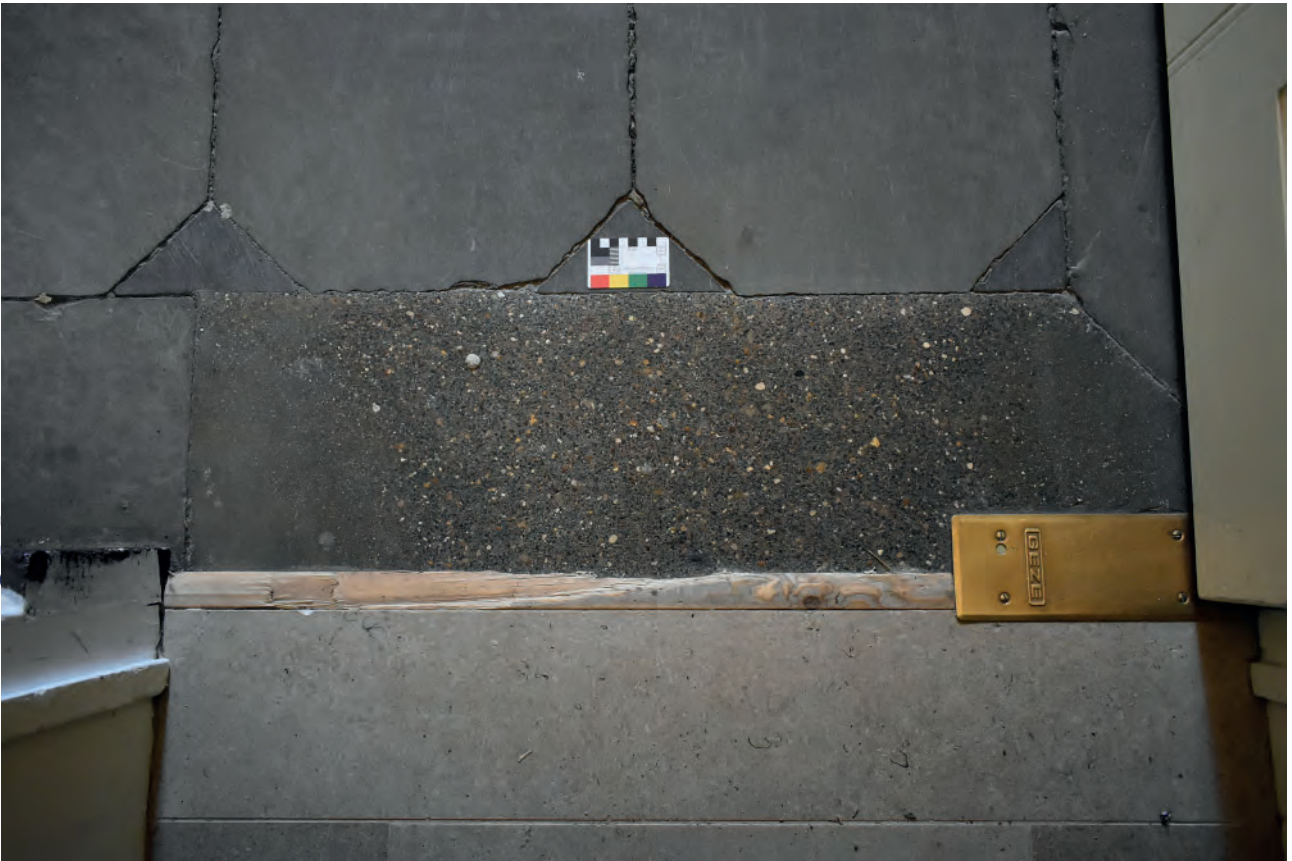
Plate 181: West Corridor, floor, example of concrete repair
